September 2, 2010

Project No. 07-1413-0077  
Doc. No. 150

**ANNUAL INSPECTION, JULY 8, 2010  
CARMACKS COPPER PROJECT, CARMACKS, YUKON**

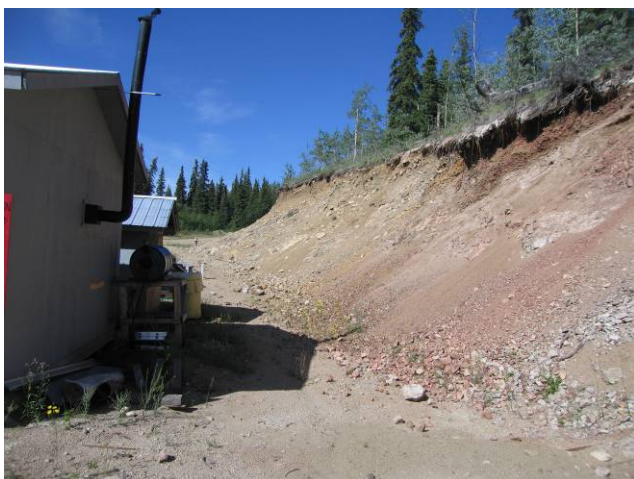
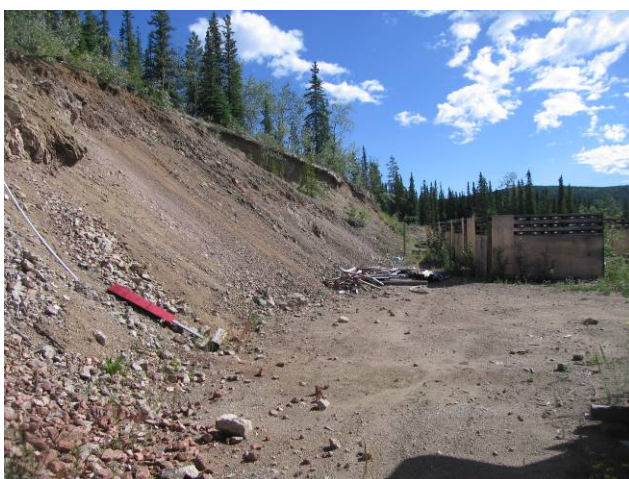
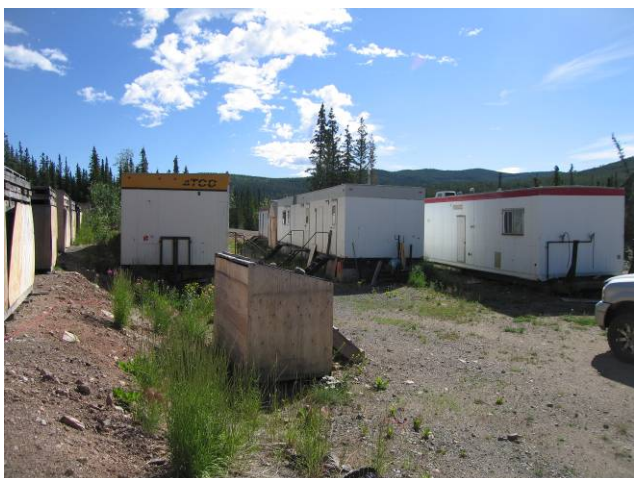
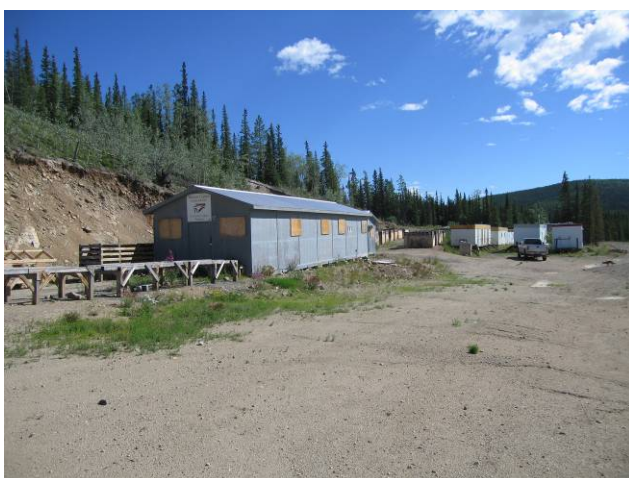
The inspection of the camp area indicated the camp is well maintained and there is no erosion of sediments from the pad area into the surrounding natural area. The slope behind or west of the camp is stable and is not impacting or causing any safety issues with the camp structures or operations. There is minor slumping of small sections of the slope, but these are not impacting camp safety nor would they represent an issue to workers on the project.

*Photographs 1 - 4: Carmacks Exploration Camp Infrastructure, which includes an office, core shack, equipment shed, temporary trailers for accommodations and kitchen facilities, and drill core storage area.*

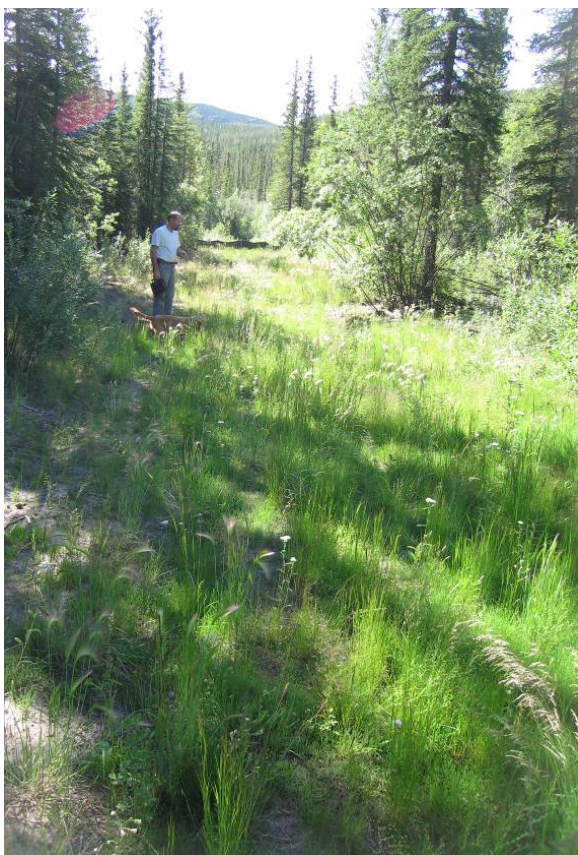
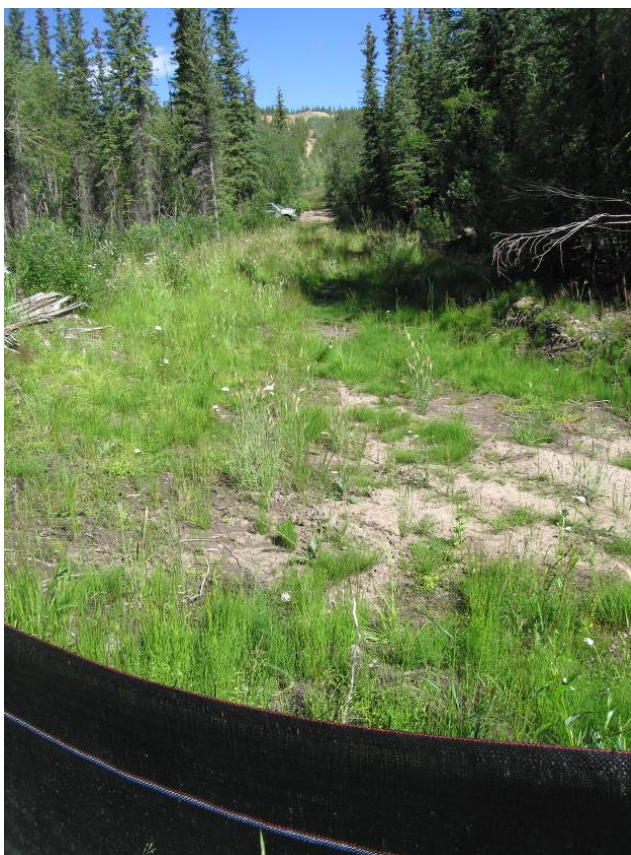
*Photographs 5 - 6: Drill pad access road located north of Williams Creek and downstream of the area of the proposed heap leach facility sediment pond. Photographs show vegetation re-growth which has occurred and is assisting in stabilizing previously transported sediments.*

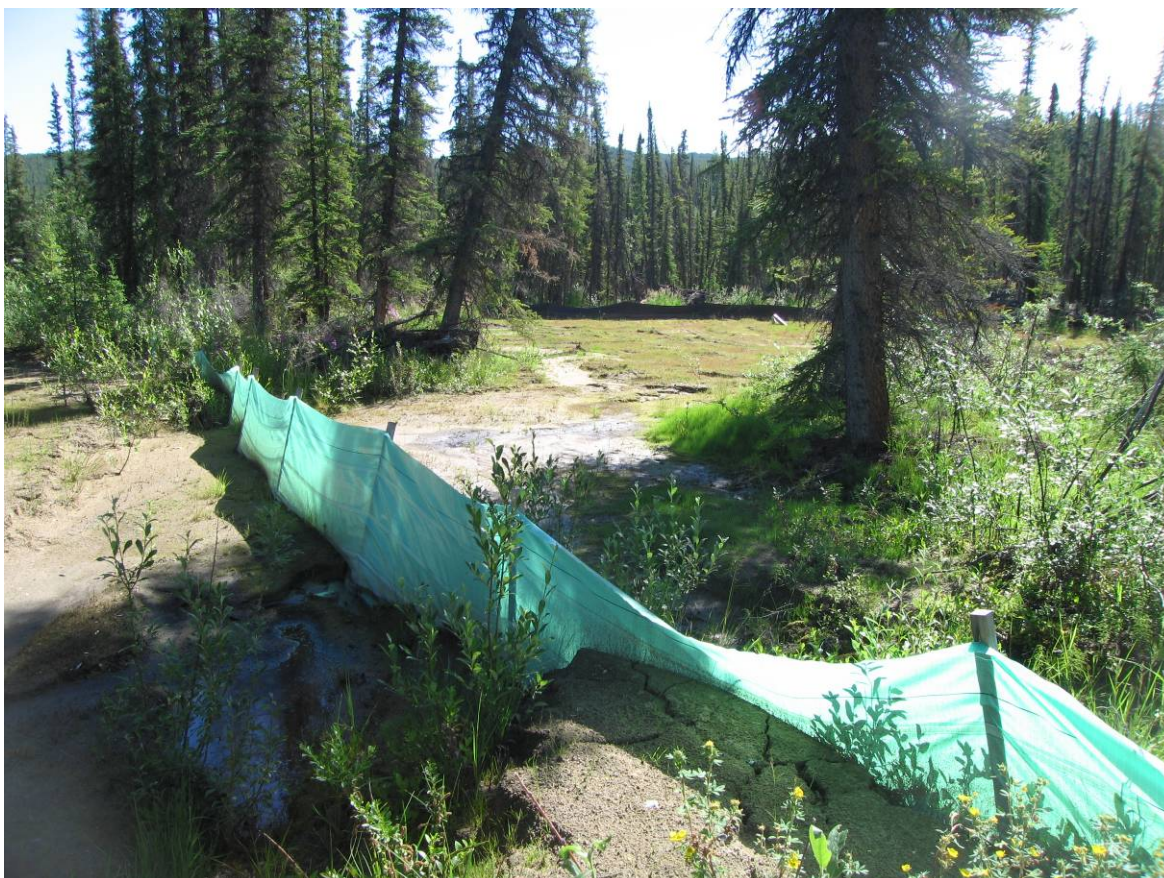
Further down slope, closer to Williams Creek, a series of silt fences have been installed and the area seeded. At the time of the inspection, re-growth in the area seeded in 2009 was observed to be occurring. Minor movement of sediment was observed beyond the lower silt fence. Sediment was observed to have entered a vegetated area beyond this silt fence, but there is no evidence that sediment has entered Williams Creek. On August 5, 2010, additional maintenance of the erosion control measures occurred. An additional silt fence was added to control further sediment movement beyond the existing fence. This work is deemed to be adequate at the current time. As with all temporary erosion control measures, annual inspection and ongoing minor maintenance activities should be anticipated.

*Photograph 7: Silt fences located between the area of the proposed heap leach facility sediment pond and Williams Creek were generally in good condition, however, some sediment was observed to have travelled beyond (bypassed) the silt fence in the foreground. However, no evidence of sediment entering Williams Creek was observed at the time of the inspection.*

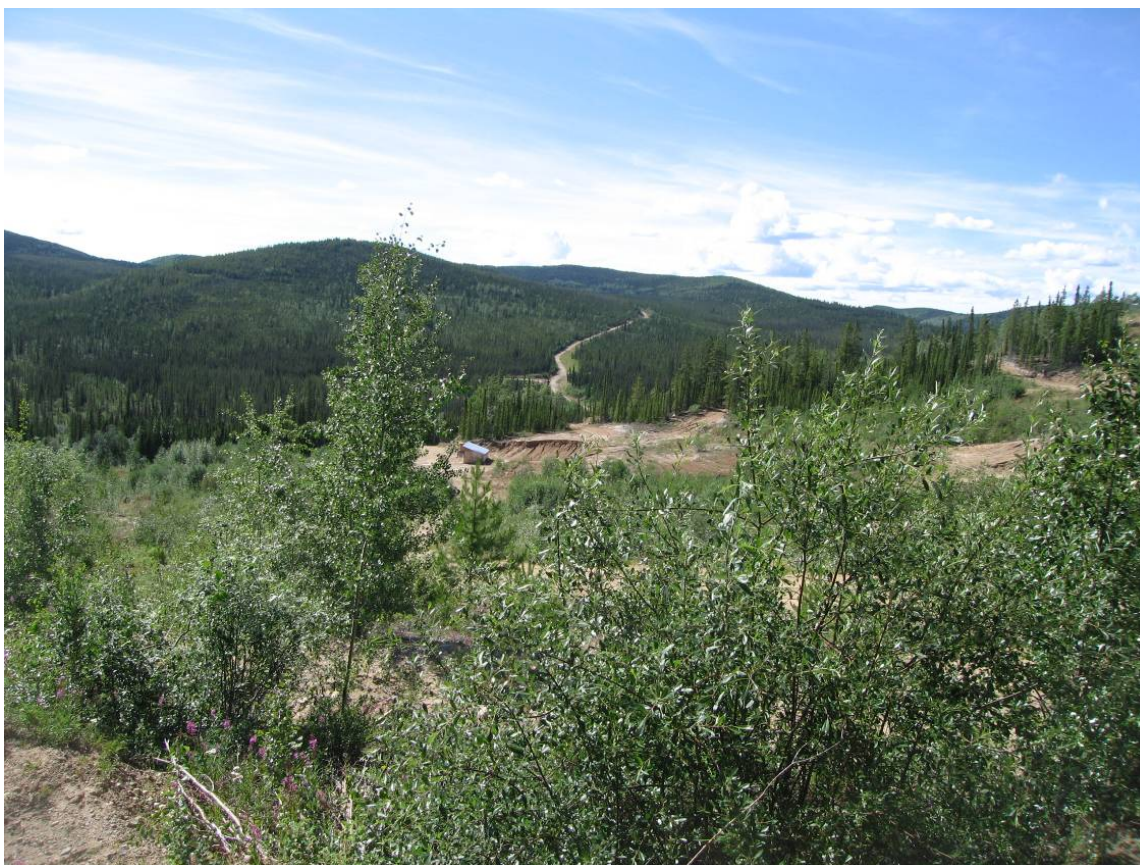
*Photograph 9: View of proposed heap leach facility and plant site area, taken from area of proposed open pit, looking southwest.*

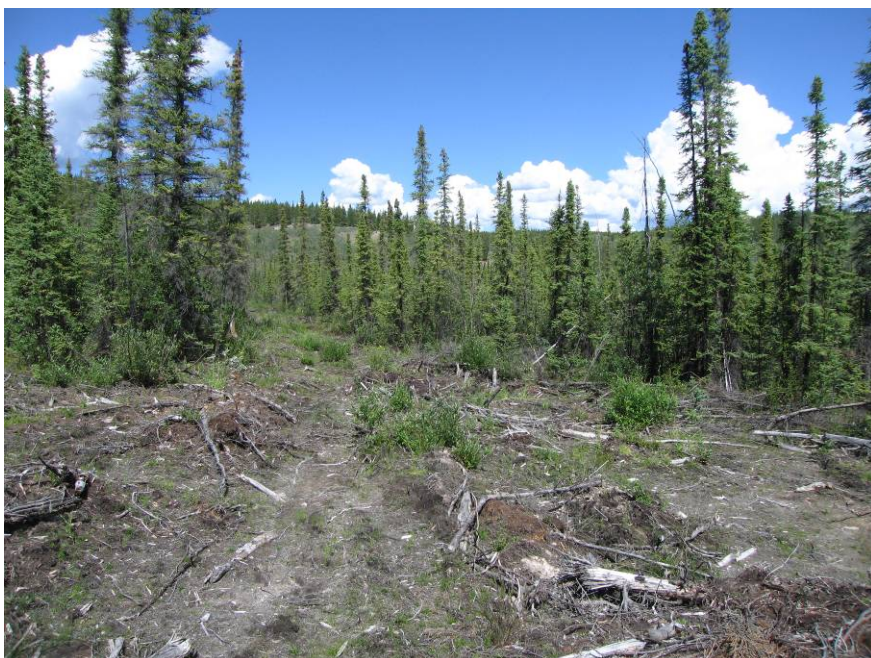
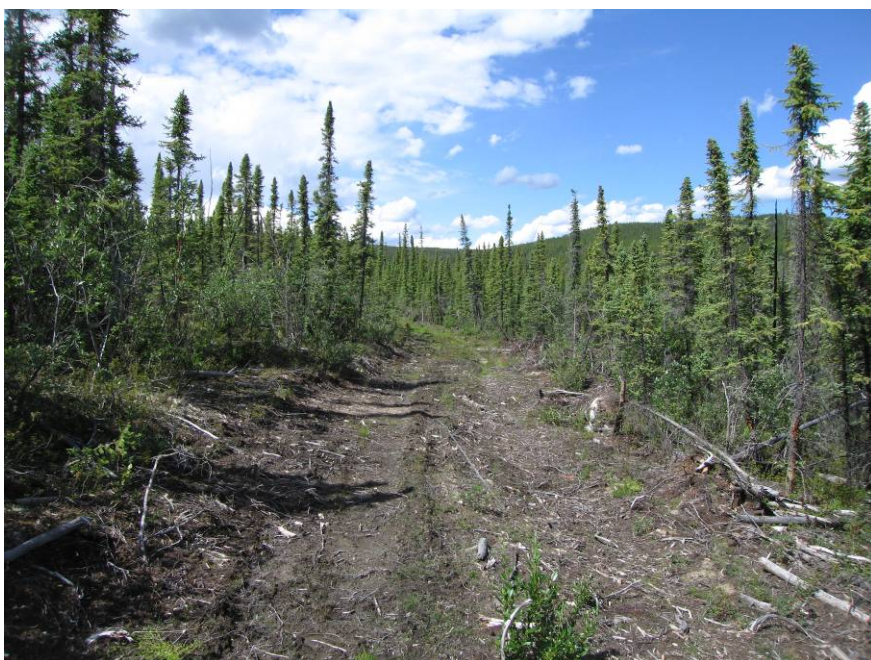
The area of the proposed waste rock storage area and the present access road crossing at North Williams Creek were inspected. The waste rock storage area is still tree covered and the drill pads in the area of the proposed waste rock storage area did not have any signs of sediment movement into the surrounding area. The small sediment catch basins at the drill pads still have capacity to manage more sediment, if required. Minor erosion along the ditches of the access road on the north side of North Williams Creek was observed. Small amounts of sediment had eroded and been trapped by the silt fences installed near the access road's crossing of North Williams Creek. The silt fences have reached their capacity to contain more sediment and require minor maintenance. On August 5, maintenance work was conducted in this area. A series of diversion ditches were created along the access road to divert water and sediment from the road area into adjacent vegetated areas. It is anticipated that this work will effectively reduce the movement of sediment towards North Williams Creek. Annual inspection and the requirement for minor maintenance of these sediment control measures should be anticipated.

*Photographs 10 - 11: Access roads within the proposed waste rock storage area.*

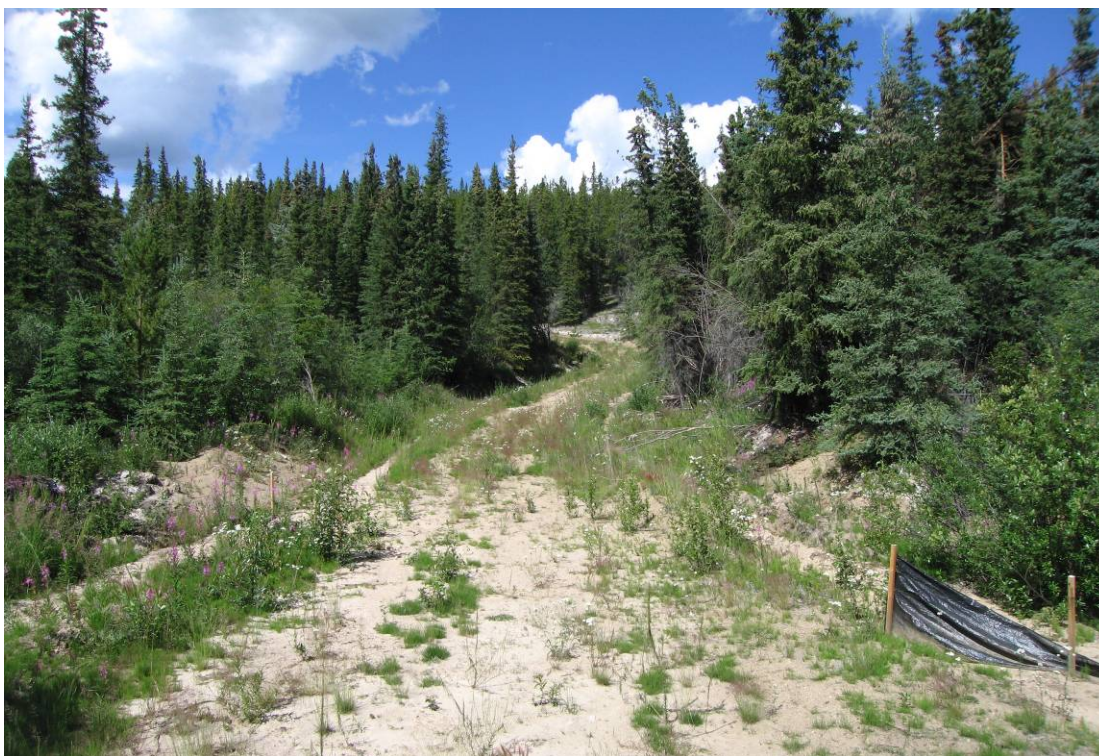
*Photograph 12: Access road east of North Williams Creek.*
