November 6, 2015

Reference No. 1417183-006-L-Rev0-1000

**ANNUAL INSPECTION, OCTOBER 14, 2015  
CARMACKS COPPER PROJECT, CARMACKS, YUKON**

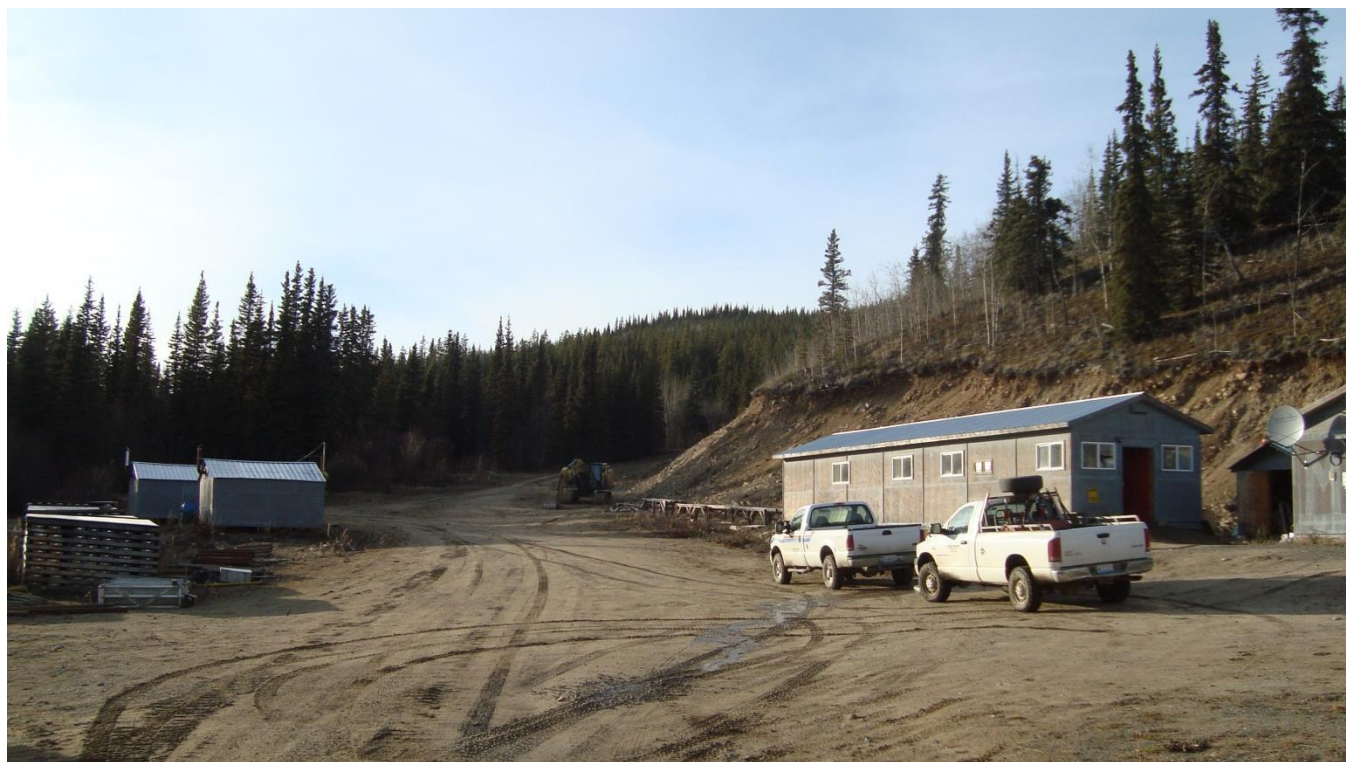
The inspection of the camp area (Photographs 1 and 2) indicated there is some thaw related settlement on the pad, which should be monitored as core storage racks may be affected. The inspection did not indicate erosion of sediments from the pad area into the surrounding natural area. There was some cracking observed in 2013 along the south edge of the pad (lower limited of pad), approximately 3 to 4 m from the pad edge. Additional cracking was observed in 2014 on the west edge of the pad, which is likely the result of thaw related settlement in the core storage area.

*Photograph 1: View looking west to exploration camp*

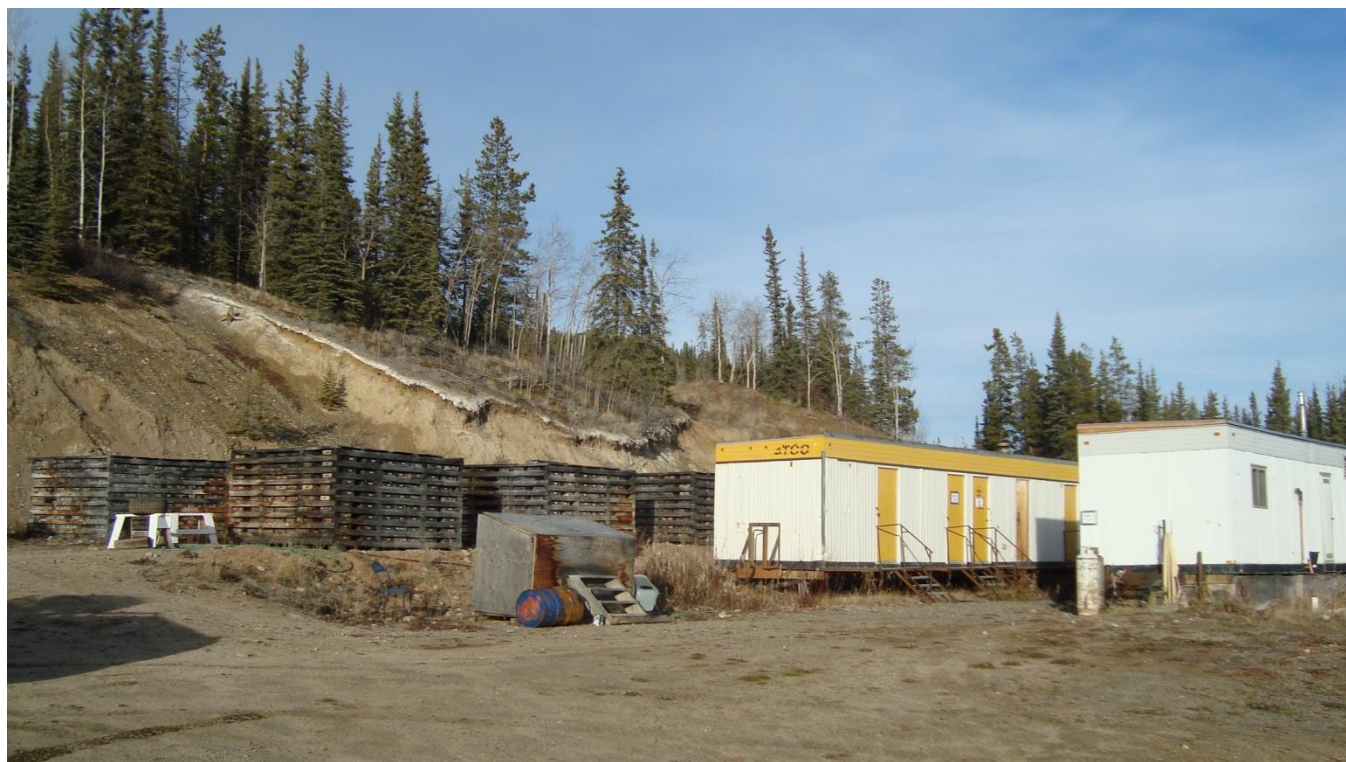
*Photograph 2: View looking northeast exploration camp*

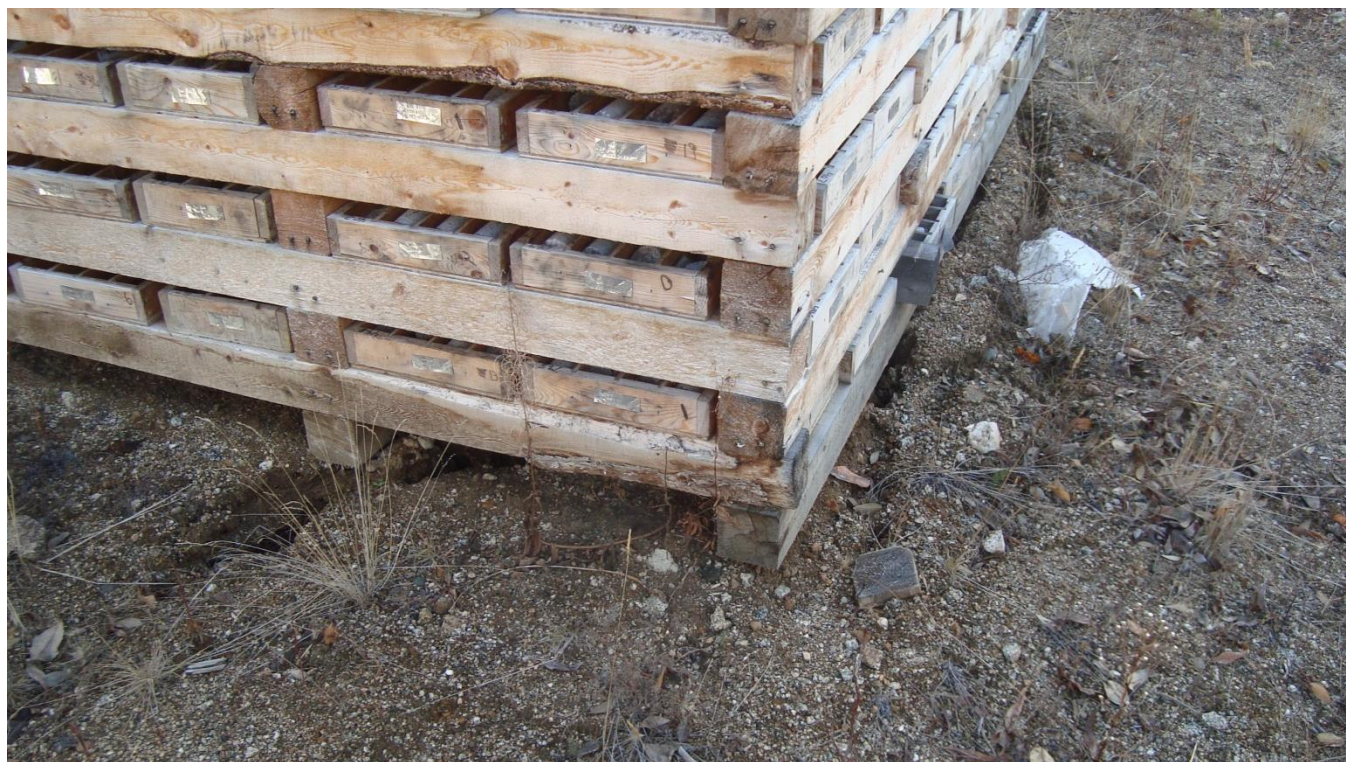
In 2015, new cracking was observed to the north of the southern row of core racks (Photographs 3 and 4). There is a trough, approximately 0.2 m deep located between the core racks, which is likely the result of thaw related settlement and does not pose an immediate safety concern.

*Photograph 3: Cracking in pad at southwest core rack area*

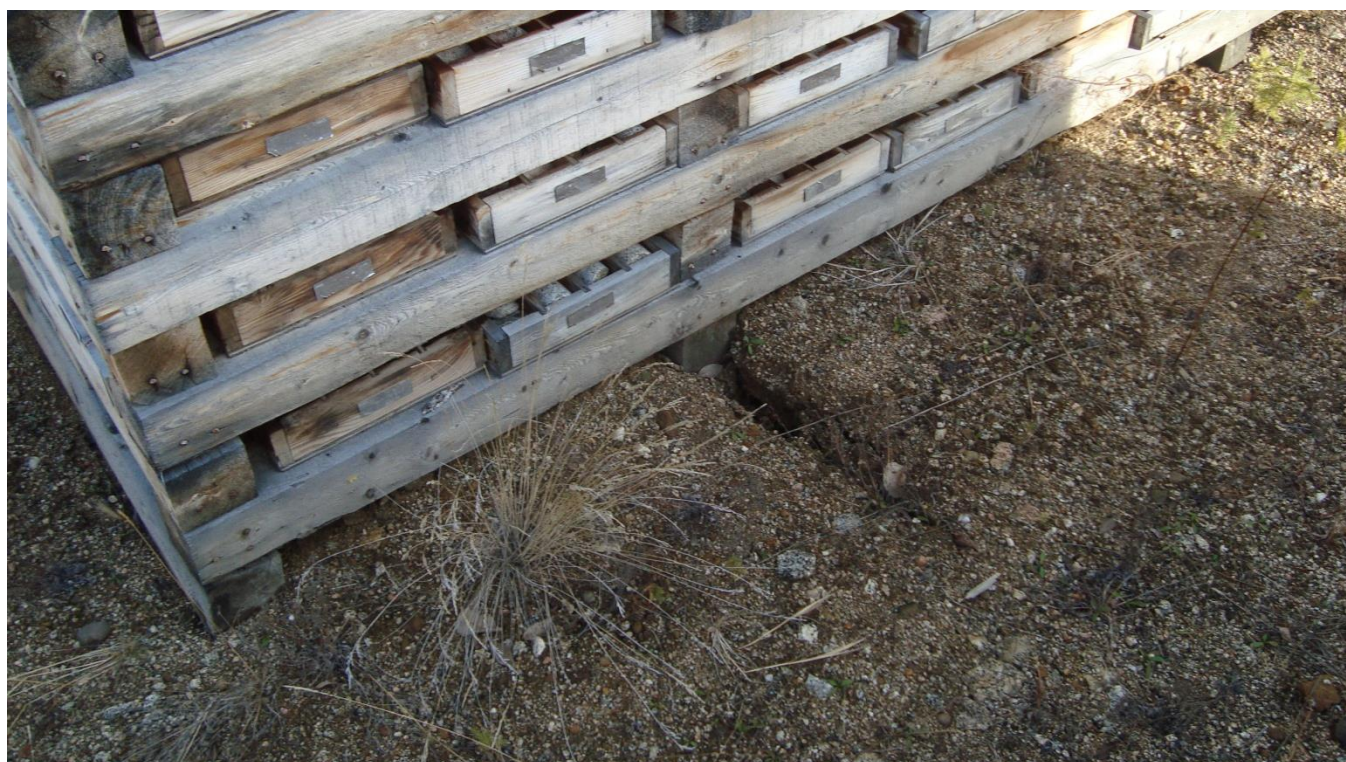
*Photograph 4: Cracking in pad at southwest core rack area*

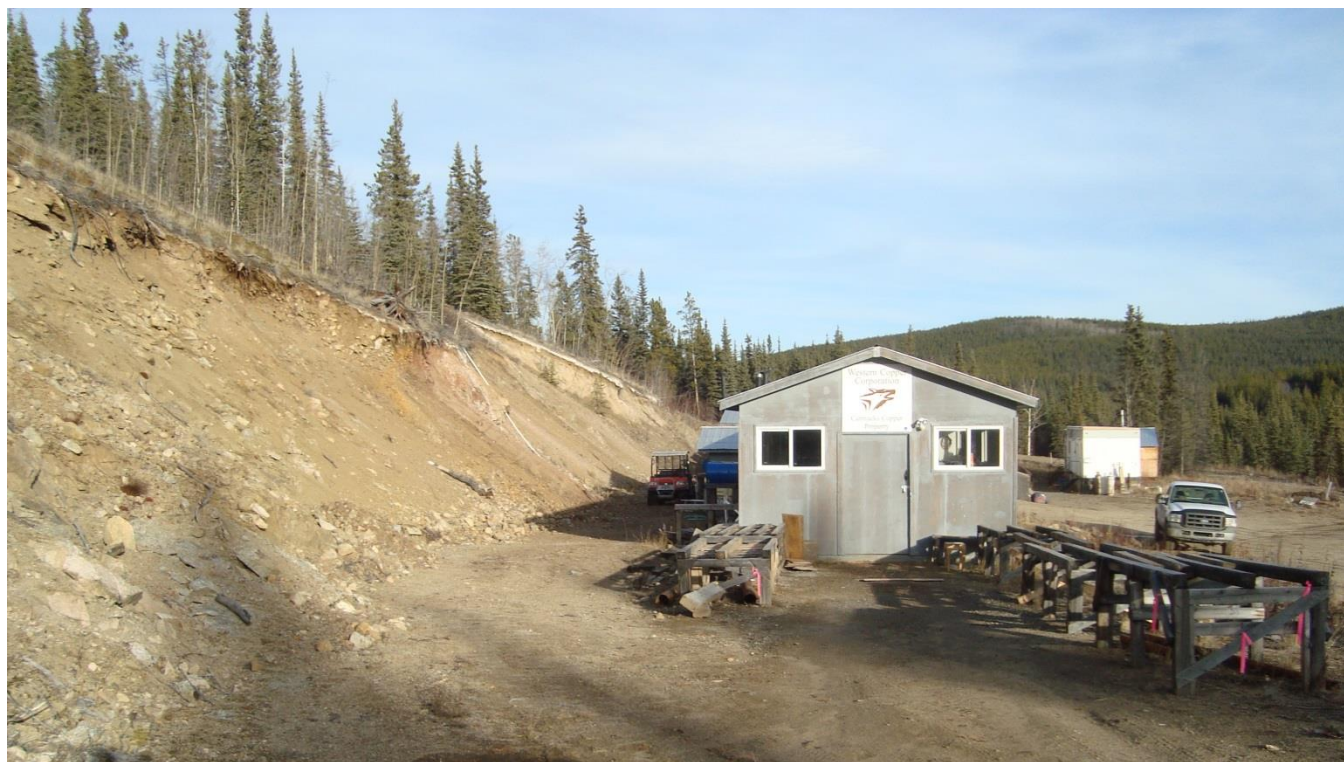
The slope behind the camp (Photographs 5 and 6) is stable and does not pose a safety concern for the camp structures or current operations. There is minor ravelling of small sections of the slope, but these are not impacting camp safety nor would they represent an issue to workers on the project. Some regrowth of vegetation was observed in the camp area.

Photograph 5: View looking east to slope immediately north of exploration camp

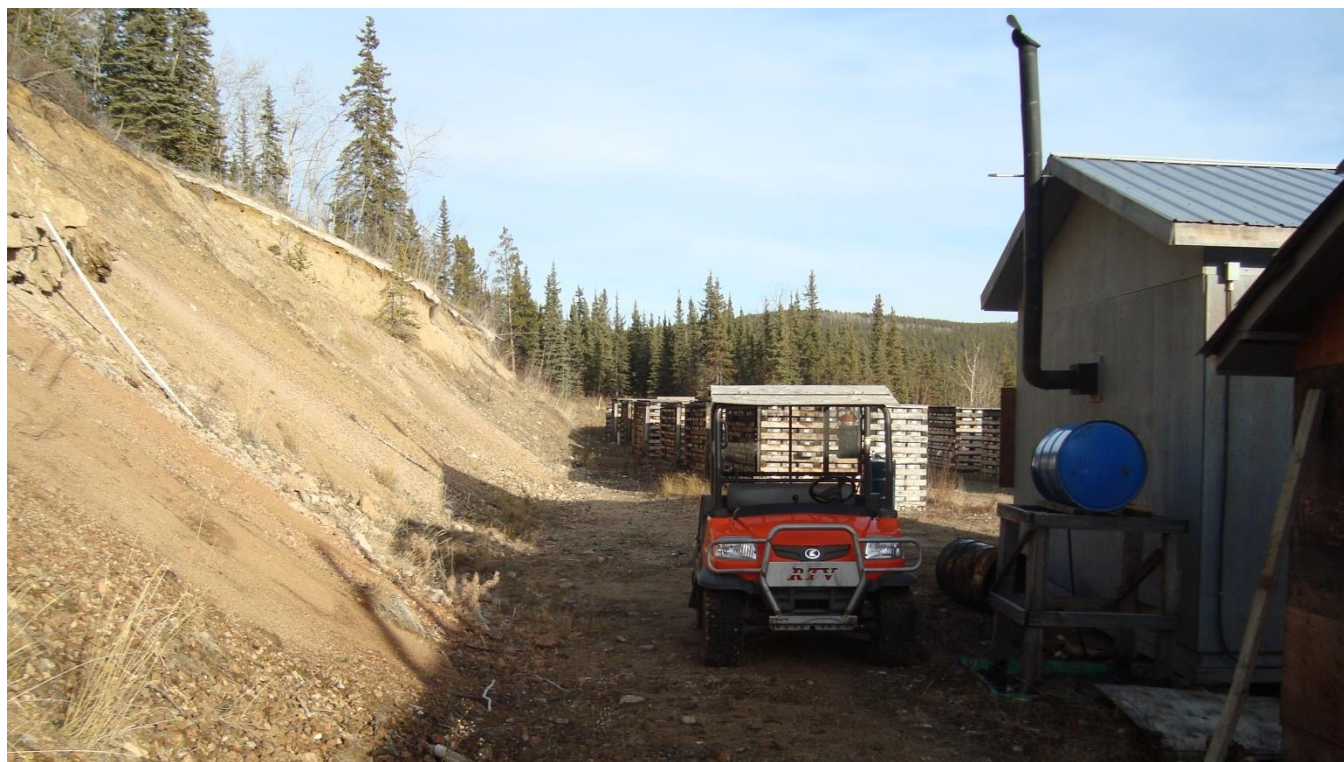
Photograph 6: View looking east to slope immediately north of exploration camp

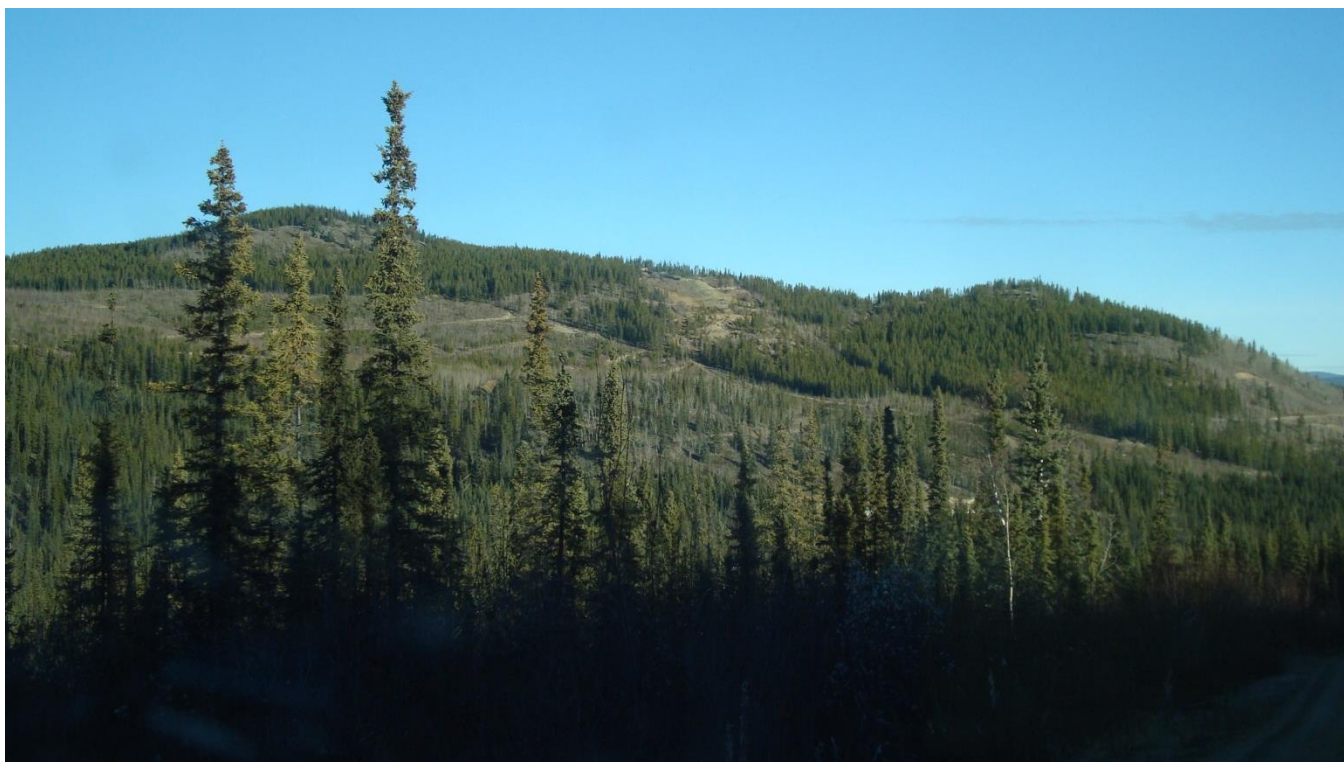
In addition to the camp, the inspection included the area proposed for the heap leach facility (Photograph 7), and water management pond. Site preparation in these areas has been limited to the clearing of trees and organic soils. This portion of the site also includes several access roads and drilling platforms previously used for exploration/investigation activities.

*Photograph 7: View looking north to area proposed for the heap leach facility and open pit area*

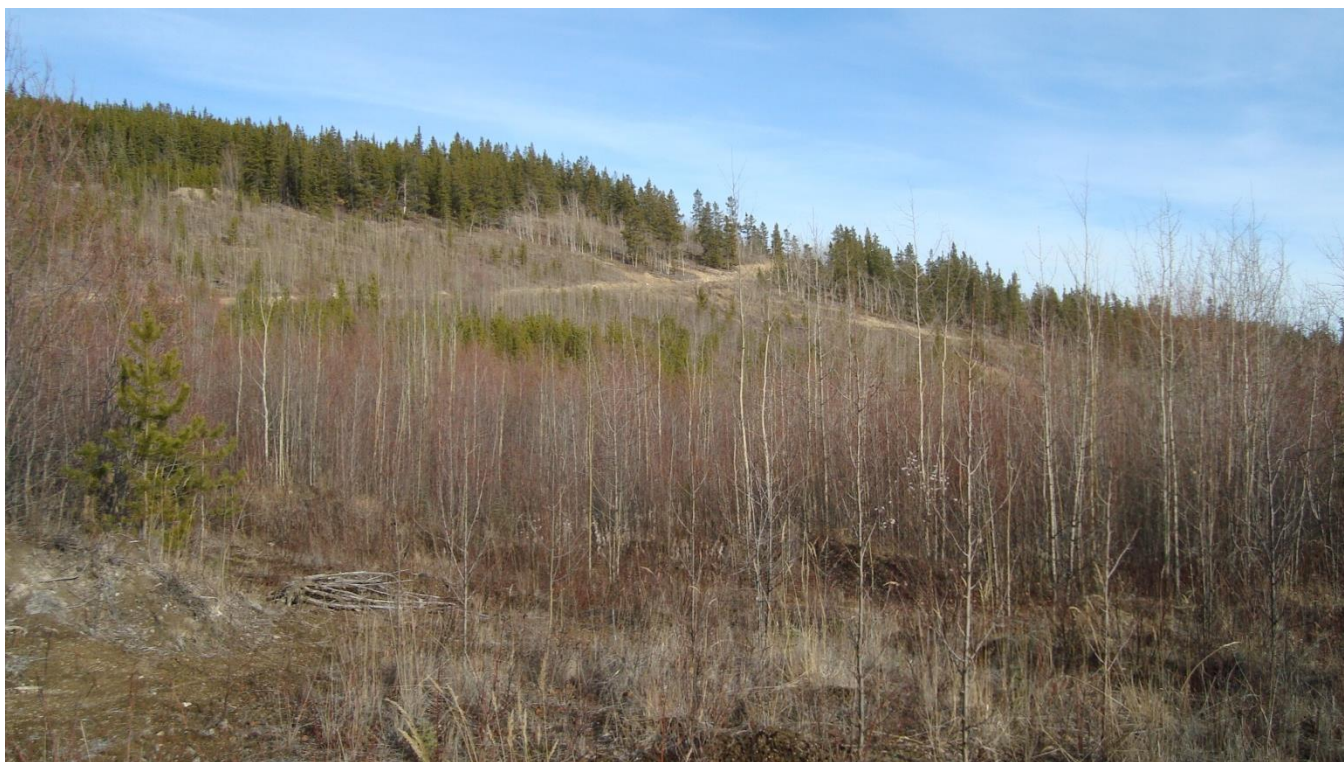
Since the initial clearing in 1997 and 1998, regrowth of vegetation has been occurring in the area (Photograph 8 and 9). Erosion and sediment control measures in this area were initially installed in September 2008 and further maintained in September 2009 and August 2010. The sediment control measures include ditches and berms to divert water into sediment catch basins, silt fences, and vegetated areas to break up flow and reduce the potential for erosion. The inspection indicated that there has been some erosion of sediments along the access roads and that the sediment basins are trapping and containing the sediment adequately.

*Photograph 8: Re-vegetation of area proposed for the heap leach facility*

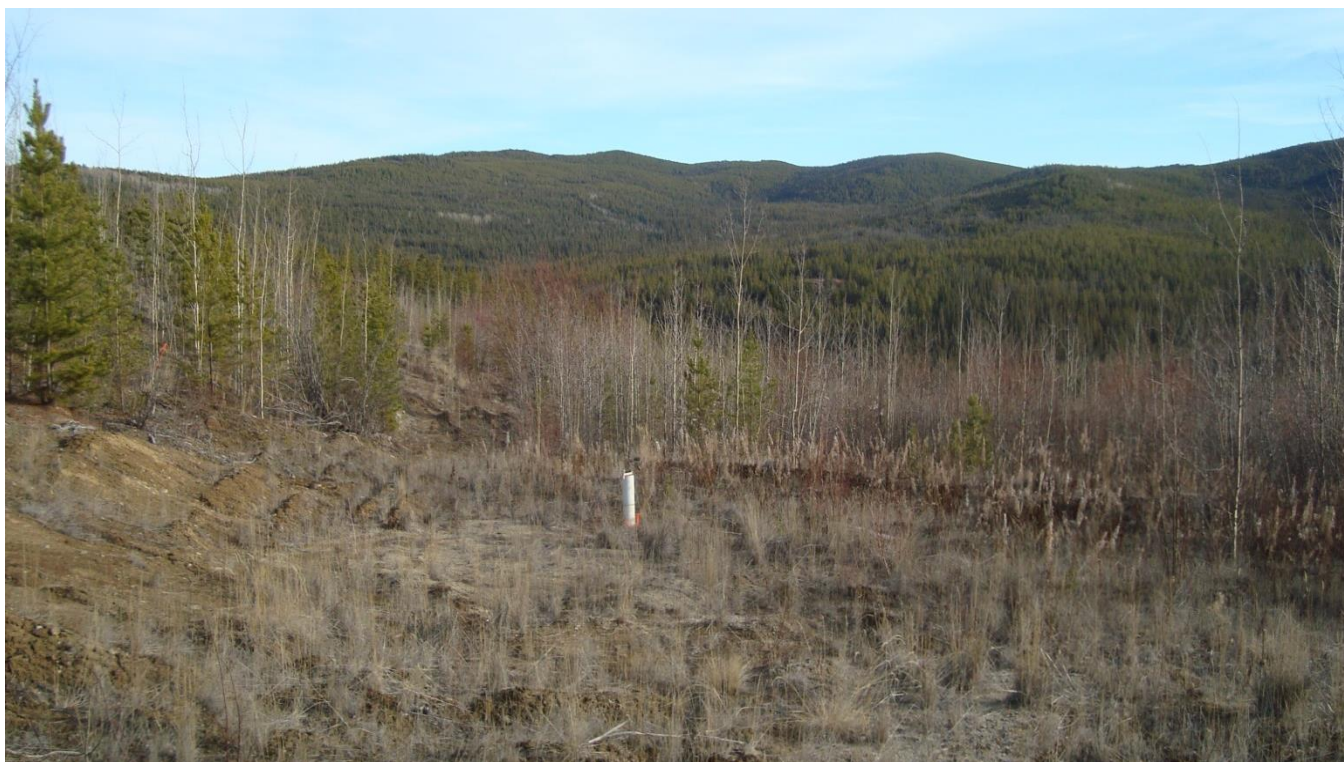
*Photograph 9: View looking east of re-vegetated drill pad in the area proposed for the heap leach facility*

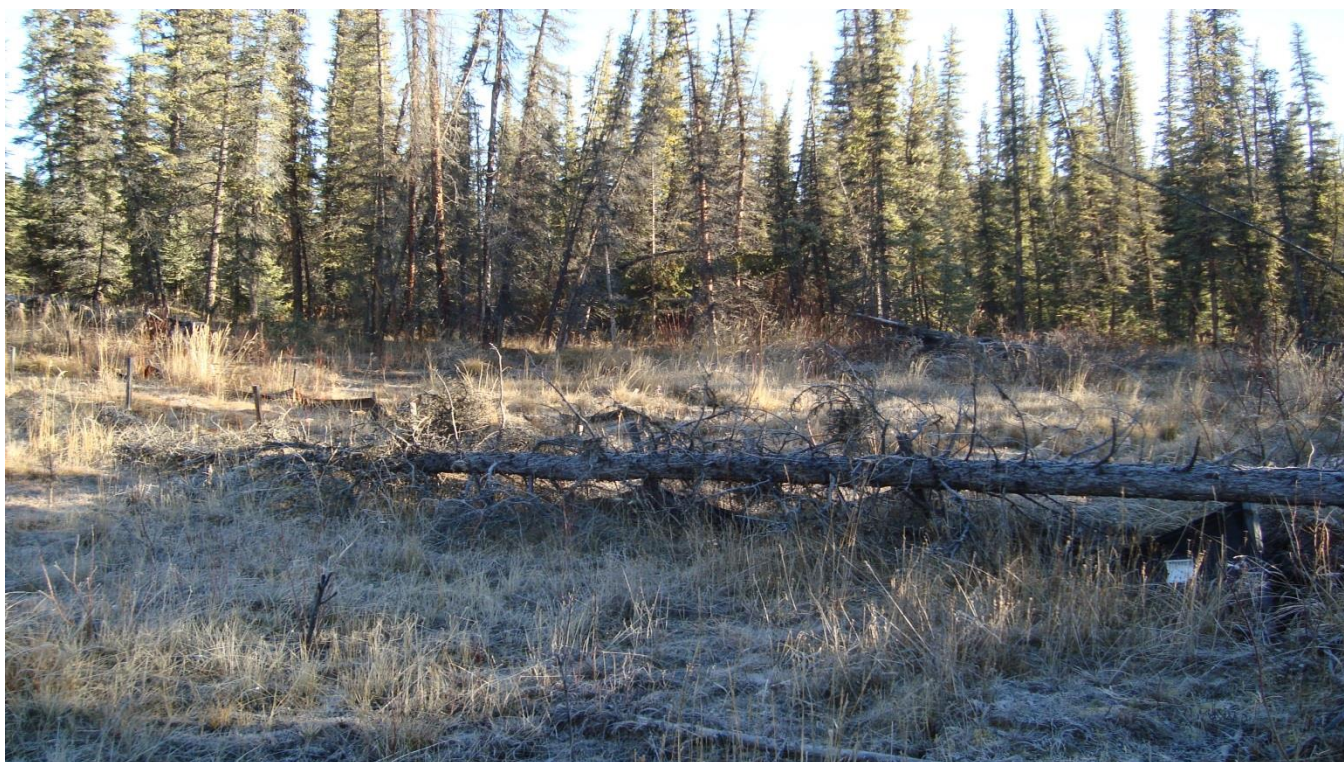
Further down slope of the proposed heap leach facility sediment pond, and within the floodplain of Williams Creek, silt fences have been installed and the area seeded where sediment from previous site erosion accumulated (Photographs 10 and 11). Grass seed was applied in 2009 to promote the re-establishment of vegetation and to further stabilize sediment. The approach was noted to be generally effective in 2011 and 2012, but with limited regrowth attributed to periodic pooling of water. The area was also re-vegetated with woody plants (willow cuttings), and plants appear to be tolerating saturated soil conditions. There was no evidence of sediment movement, indicating that re-vegetation has been effective in minimizing erosion.

At the time of the inspection, it was observed that the silt fencing surrounding these areas is working effectively; the fences are overgrown. No evidence of movement of sediment beyond the existing silt fences was observed, nor does it appear that sediment has entered Williams Creek. Limited growth of willow cuttings was observed. Silt fences are of a temporary nature that should be inspected annually and ongoing minor maintenance activities should be anticipated.

*Photograph 10: Re-vegetation and silt fence between area proposed for the heap leach facility and Williams Creek*

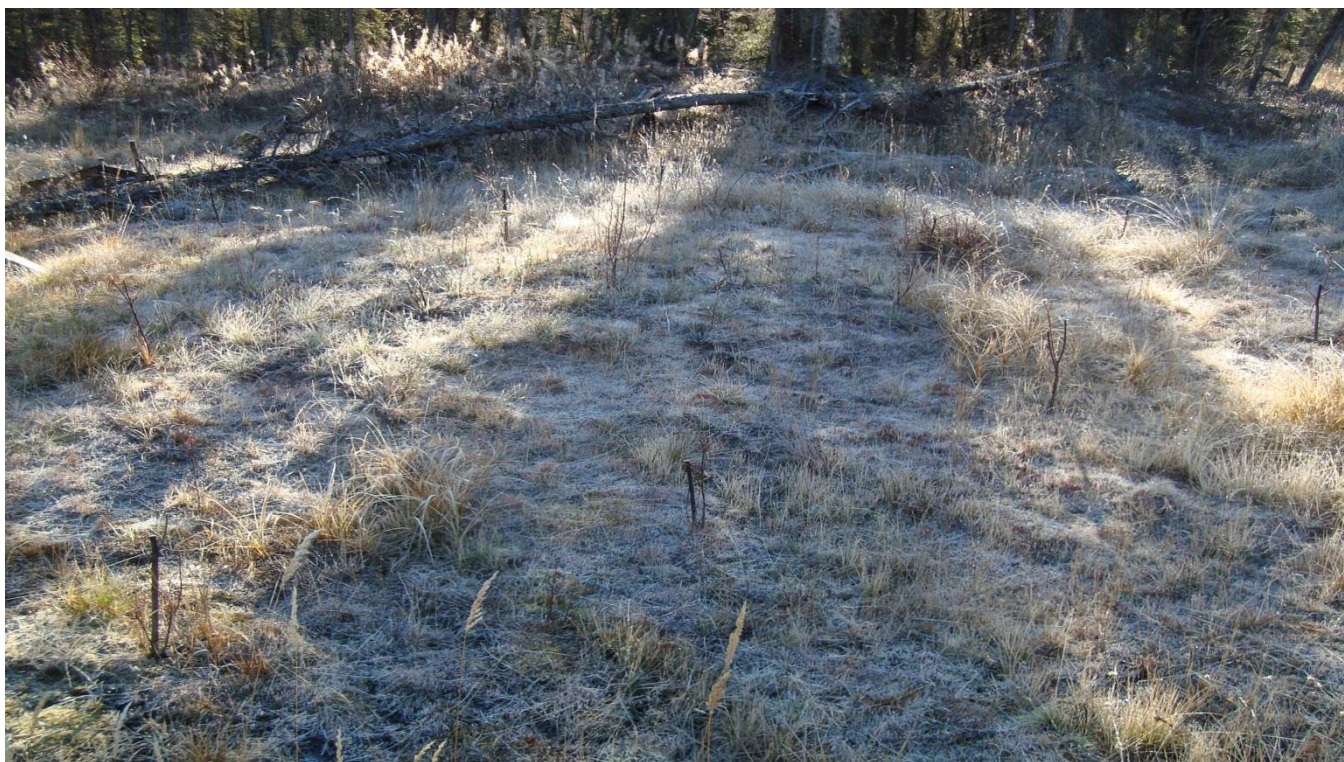
*Photograph 11: Re-vegetated area with willow cuttings between area proposed for heap leach facility and Williams Creek*

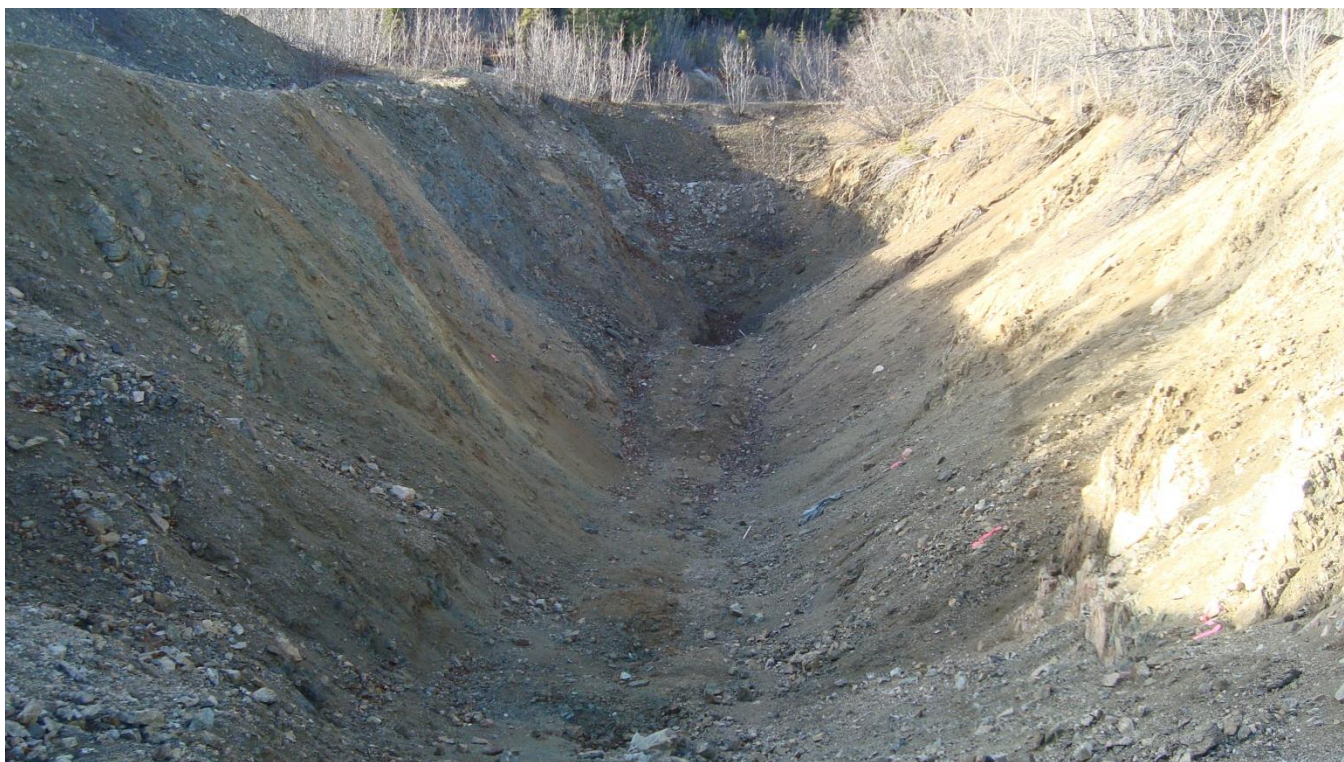
The area proposed for the open pit mine was inspected (Photographs 12 and 13). The slopes of the trenches excavated as part of the effort to obtain bulk samples during exploration activities were observed to be in reasonable condition and there was no observed slumping or failures of these slopes. The leached ore pile from the off-site test pad adjacent to the trench was observed to be stable and there was no erosion or slope movement of the material. Several of the closed drill pads were inspected and there did not appear to be any erosion noted from these areas that would require attention.

*Photograph 12: View looking northwest of bulk sample excavation site in the proposed open pit area*

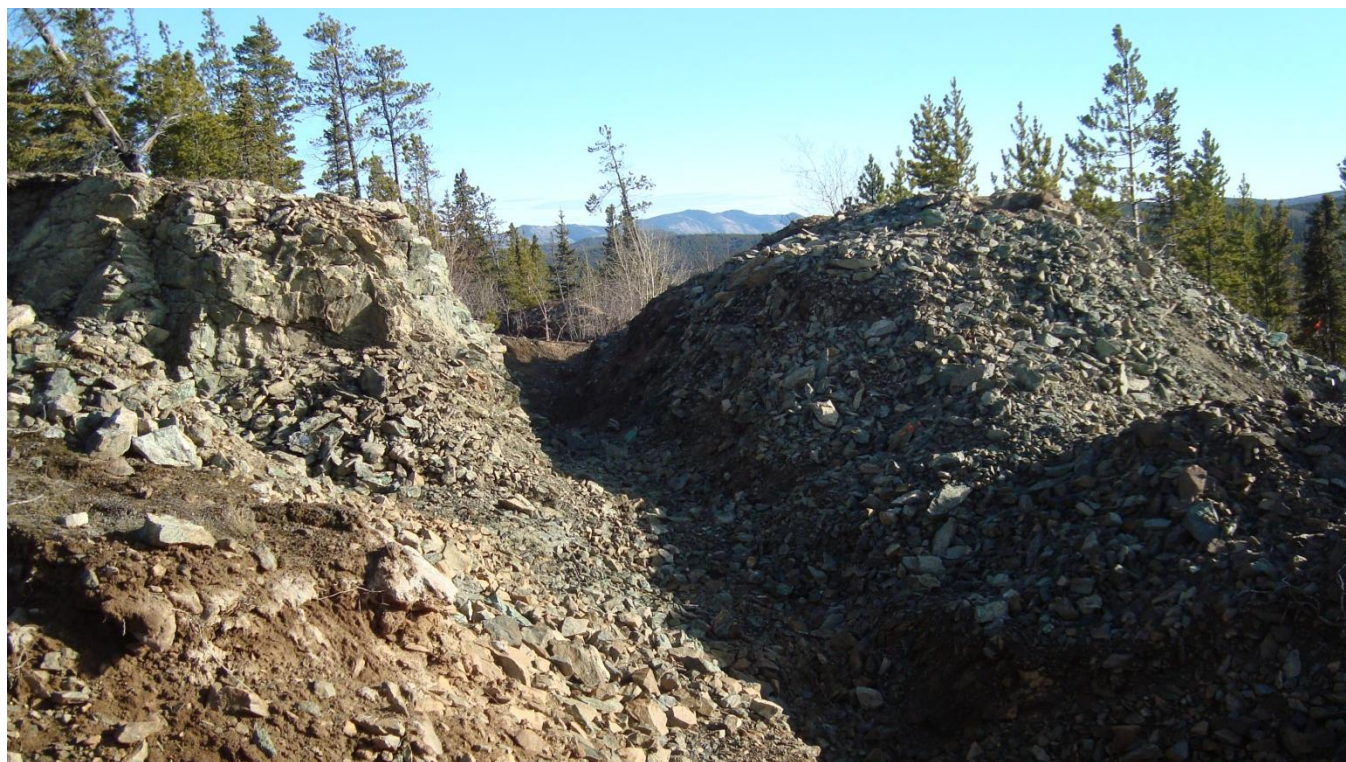
*Photograph 13: View looking east of bulk sample excavation site in the proposed open pit area*

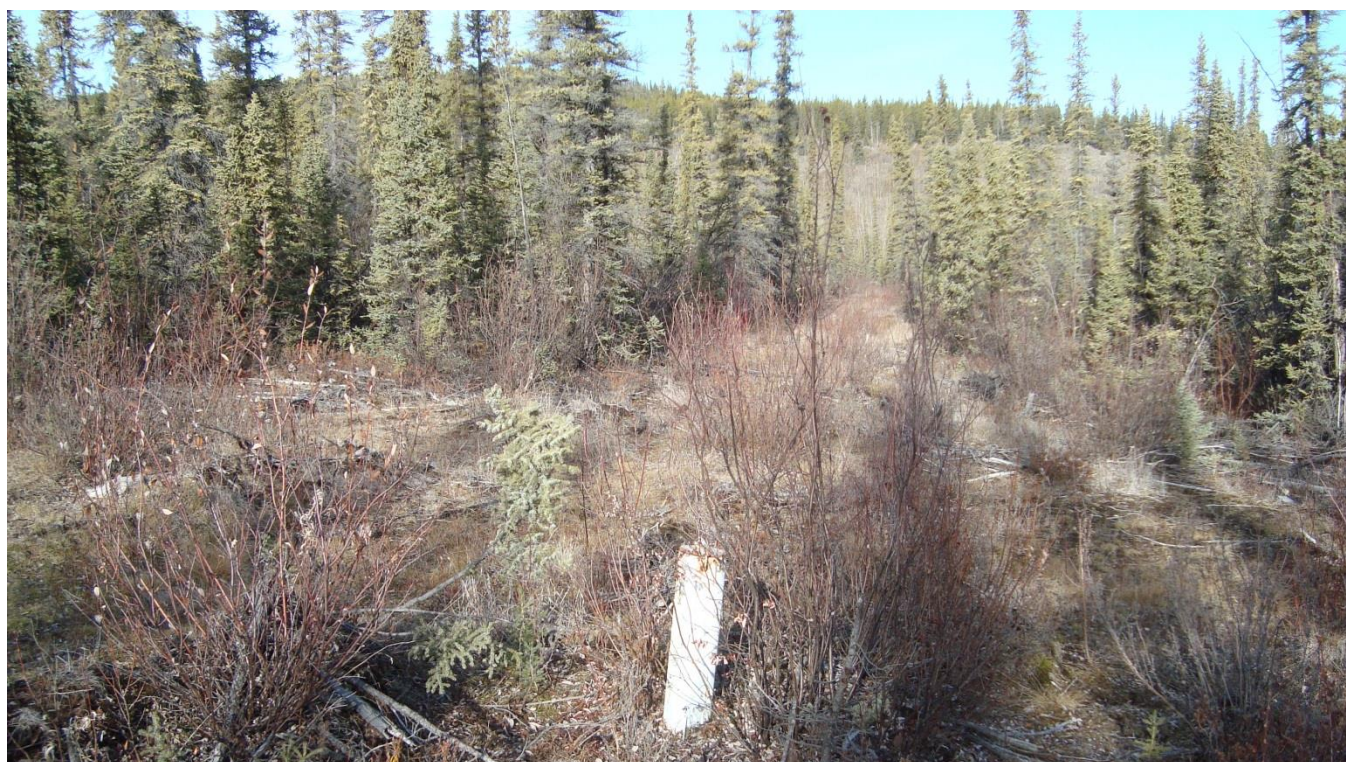
The proposed waste rock storage area was inspected. The waste rock storage area is still tree covered and the drill pads and access roads in the area are re-vegetating by volunteer species (Photograph 14). The small sediment catch basins at the drill pads still have capacity to manage additional sediment, if required.

*Photograph 14: View looking east of re-vegetated drill pad in the proposed waste rock storage area*

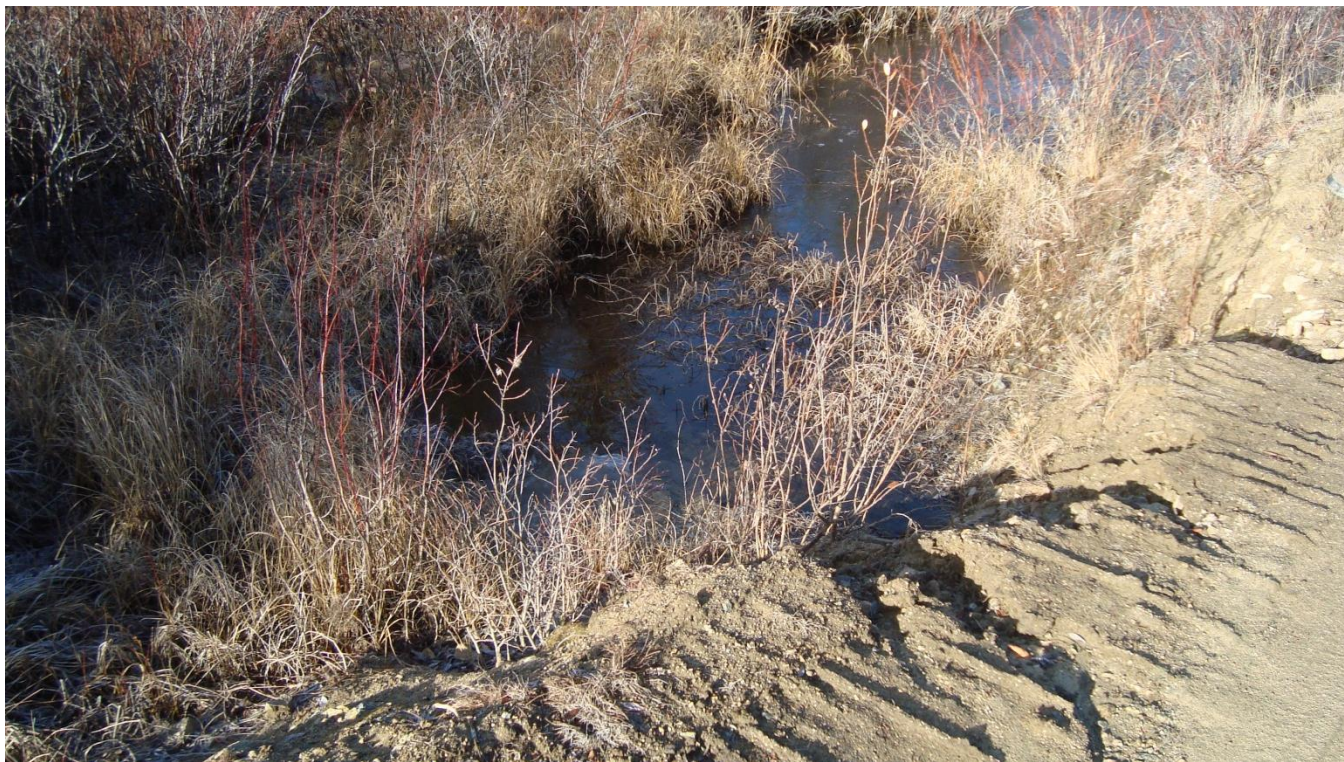
Local erosion on the main access road to the north of the waste rock storage area continues. The shoulders of the road at the culvert on North Williams Creek have eroded (Photograph 15 and 16). The access road should be inspected annually and ongoing maintenance of local erosion features should be anticipated.

*Photograph 15: View looking north of ponded water and erosion above culvert on access road at North Williams Creek*

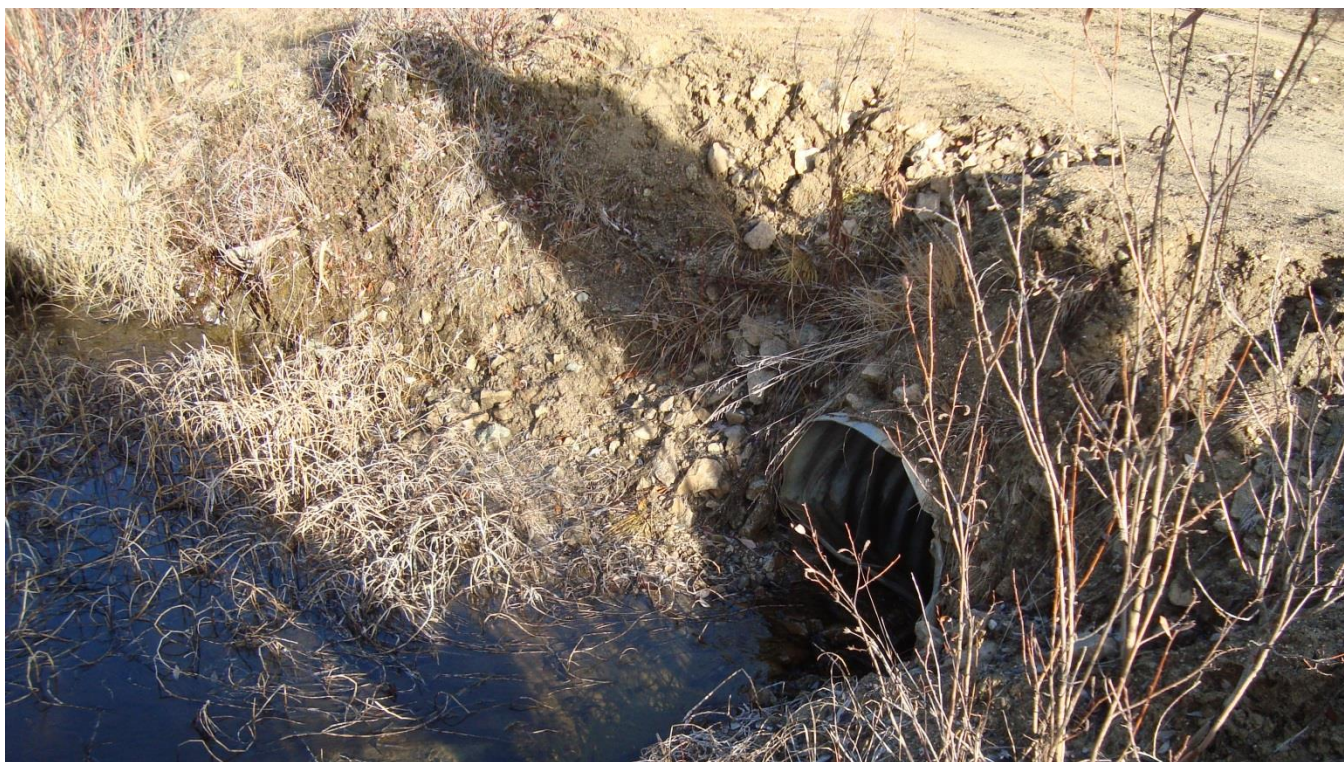
*Photograph 16: View looking east of erosion above culvert on access road at North Williams Creek*

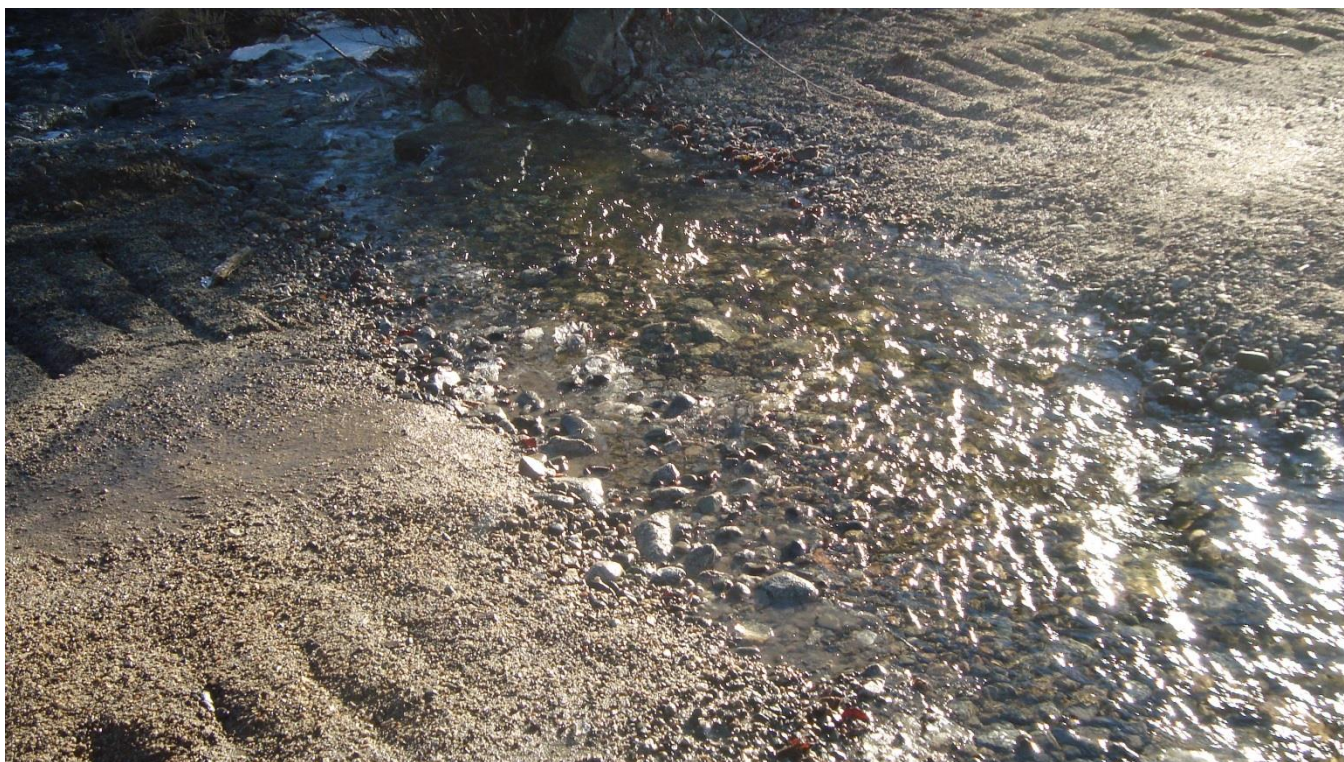
The culvert in the site access road, which allowed Williams Creek to flow under the road was previously removed in 2013. The crossing is now a 'ford' with the road bed depressed over a length of 10 m to a maximum depth of 0.4 m below the adjacent road grade or crest elevation (Photograph 17). The rockfill in the ford is well-graded and there is no indication of movement of finer materials. Ponded water was observed on the upstream side of the road, with flow across the road (Photograph 18).

*Photograph 17: View looking north of constructed 'ford' on access road at Williams Creek crossing*

The rockfill of the ford appears to be stable. It is recommended that the ford is inspected annually and monitored for erosion of finer materials, particularly following large rainfall events, and maintained as required. The ford is appropriate for the current status of the project. However, prior to site development, it is recommended that the culvert at the Williams Creek crossing is replaced and the access road armored against erosion at this location.

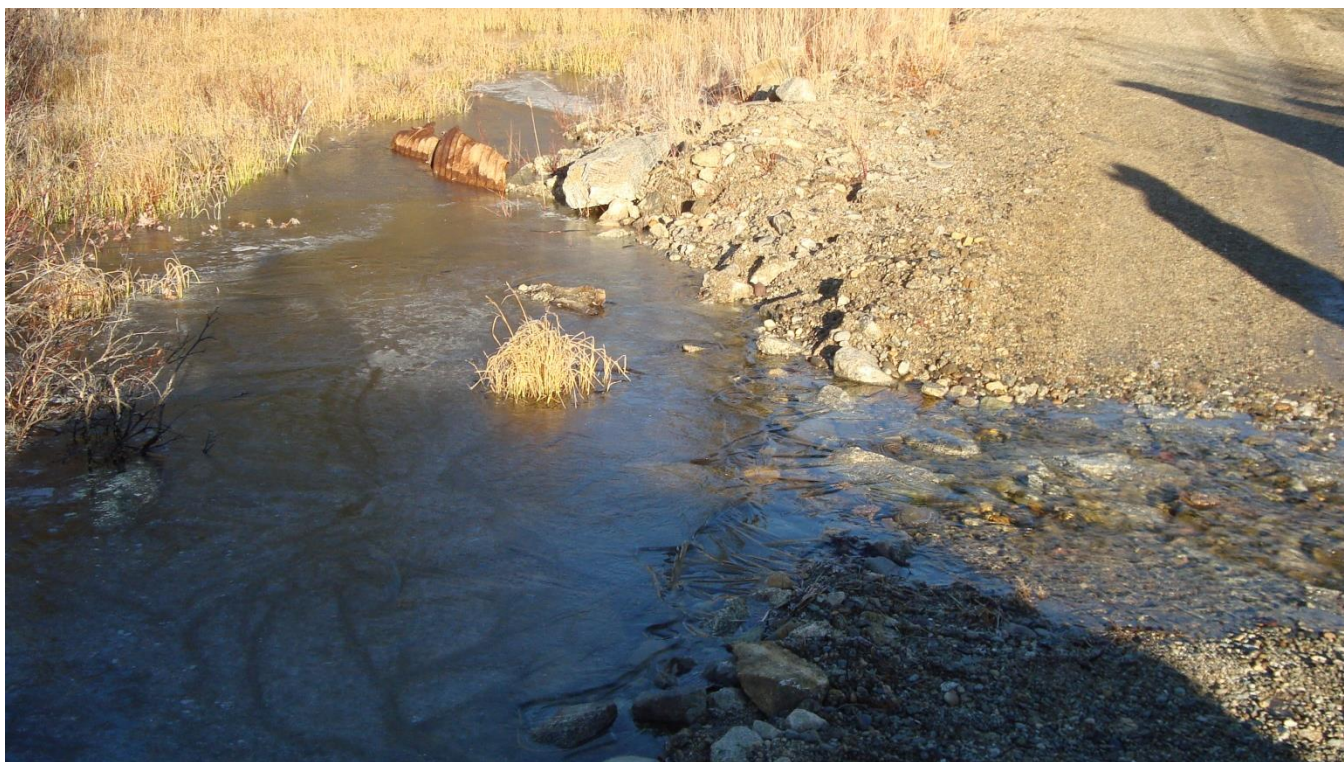
*Photograph 18: View looking north of ponded water behind 'ford' on access road at Williams Creek crossing*

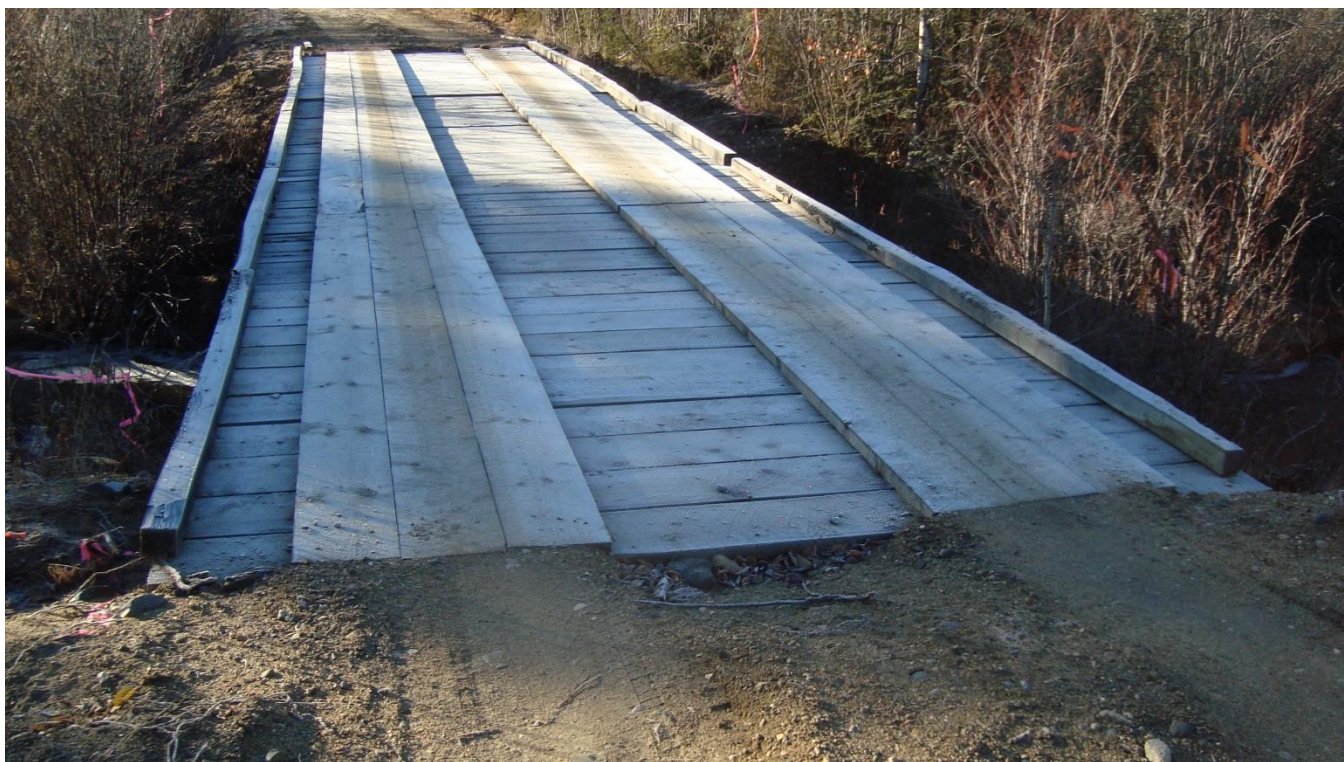
The access road crossing at Merrice Creek includes a single-span bridge set on grade. Following recommendations in the July 2014 inspection memorandum, the bridge was extended by approximately 3 m and seated 1 to 2 m on the abutments. Approximately 3 m of steel was welded to the existing span, bridge decking was replaced and extended, and the approaches were re-graded to the bridge deck elevation (Photographs 19 and 20). Further work is not required as the bridge seems appropriate for the current status of the project.

*Photograph 19: Site access road crossing Merrice Creek, view in direction of Carmacks*

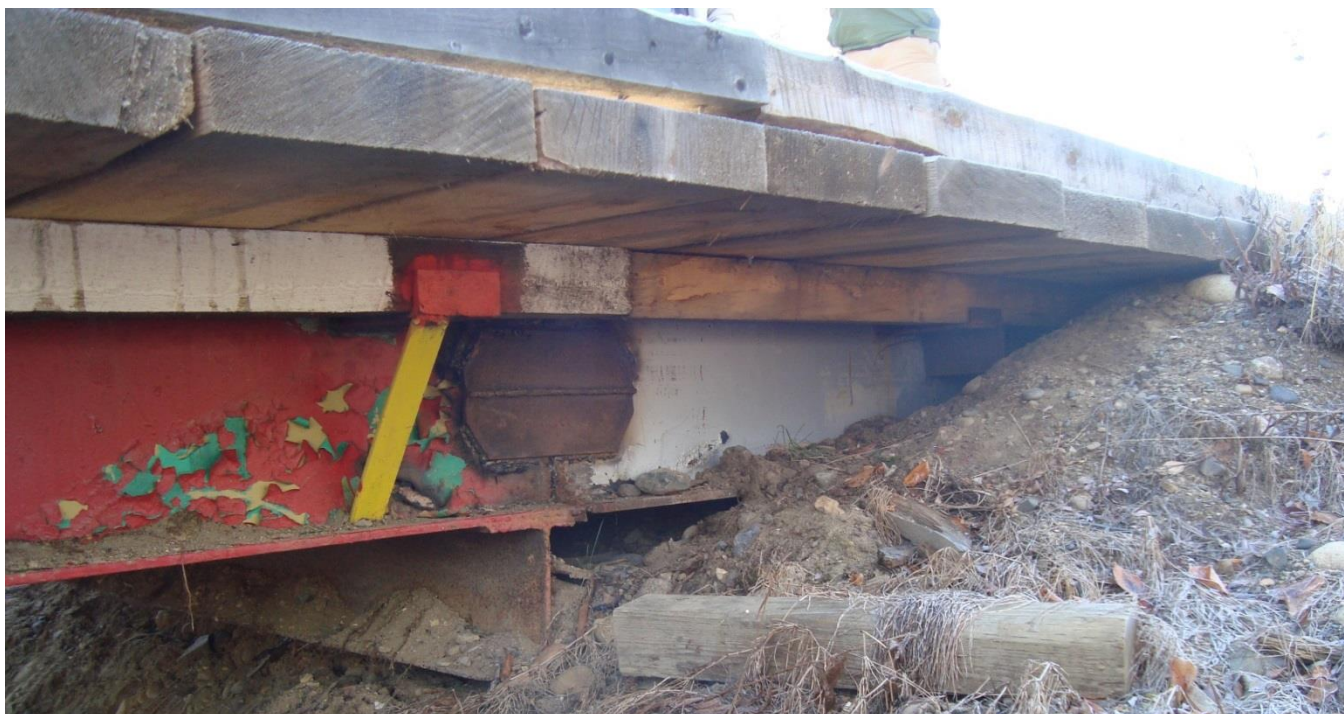
*Photograph 20: Site access road crossing Merrice Creek, view of extension and bridge abutment nearest to Carmacks*
