November 9, 2016

Document No. 1655978_LT0003_Rev0

2016 ANNUAL INSPECTION OF THE CARMACKS COPPER PROJECT, CARMACKS, YUKON

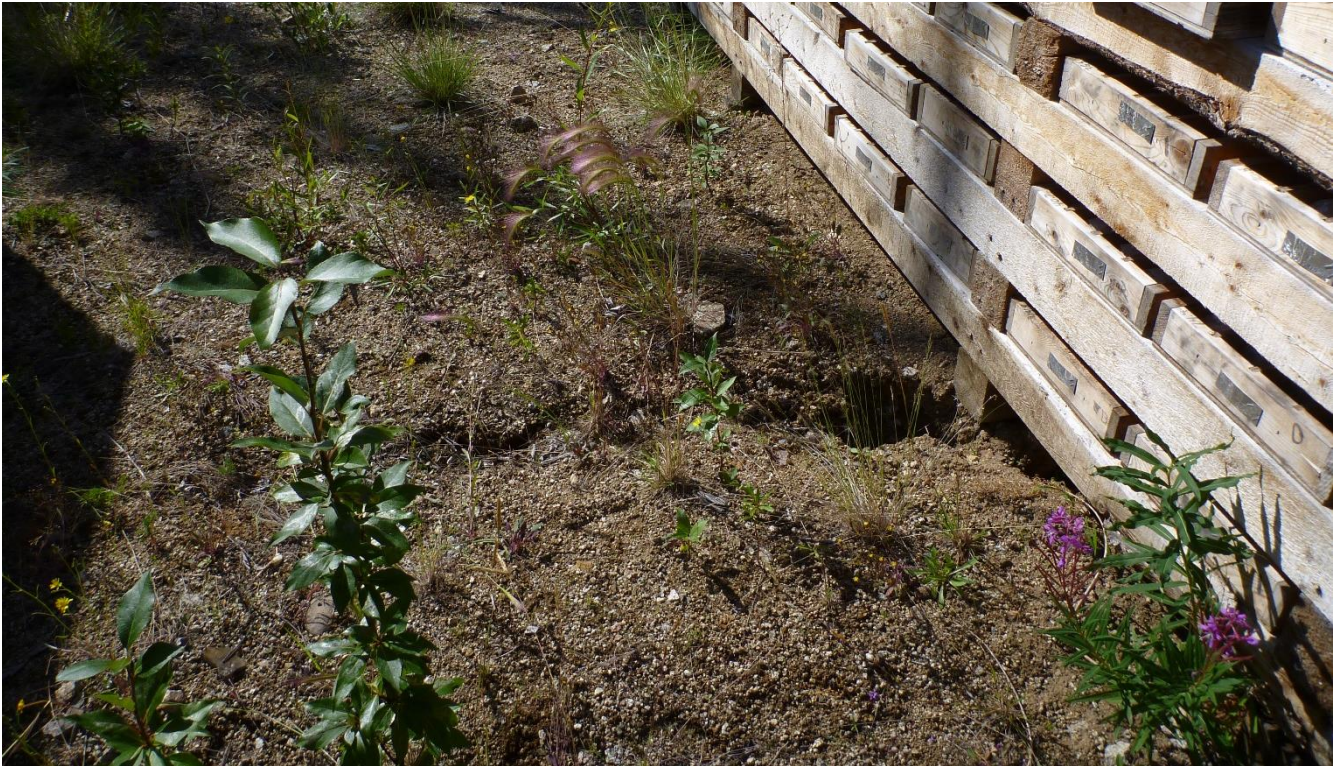
In previous years (2013 to 2015), inspections of the camp area have noted the presence of cracking, most likely resulting from thaw induced settlement beneath and adjacent to core storage racks. During the current inspection, only one crack was observed in the vicinity of the core storage racks (Photograph 1). In general, the appearance of cracks in the core storage rack area was much diminished from previous years (Photograph 2). This is likely the result of infilling of the cracks with sediment, the regrowth of vegetation around the core racks and a general decrease in the magnitude of settlements occurring with time. As in previous years, settlement in this area does not represent a safety concern and the inspection did not indicate erosion of sediments from the pad area into the surrounding natural area.

Photograph 1: Crack beneath core storage rack

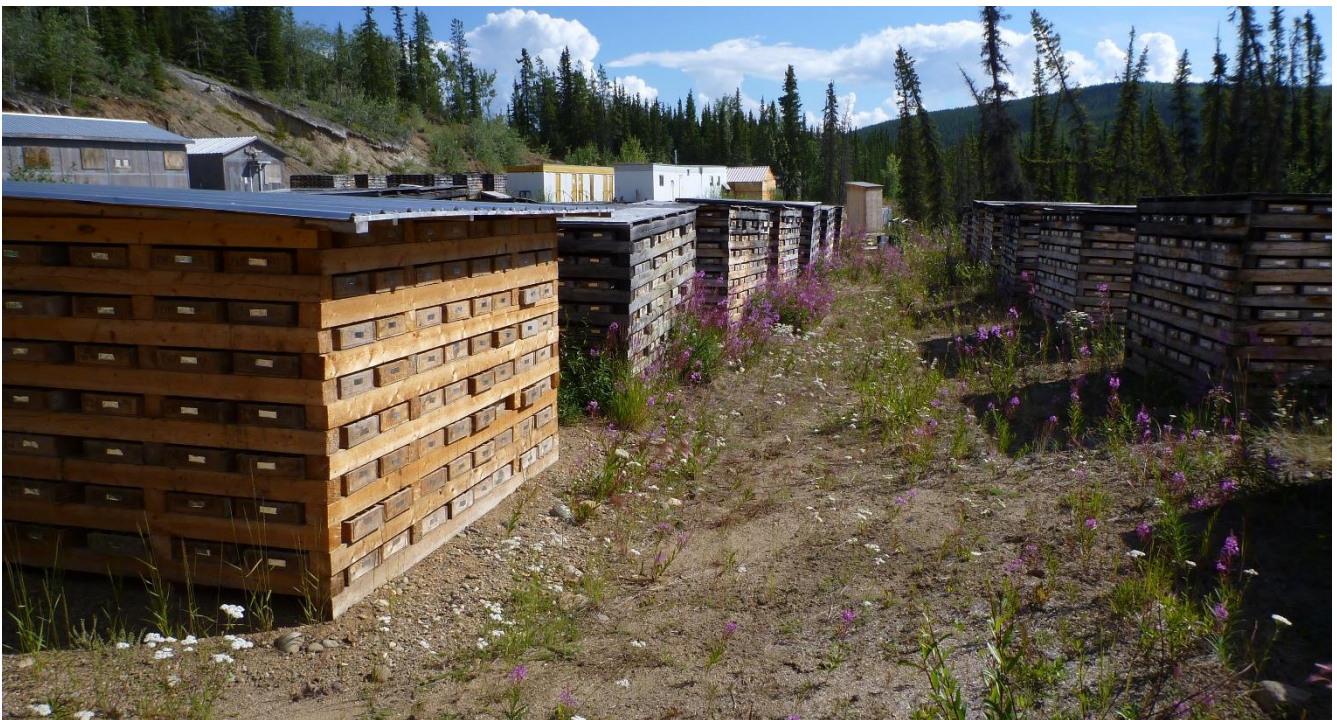
Photograph 2: Core storage racks

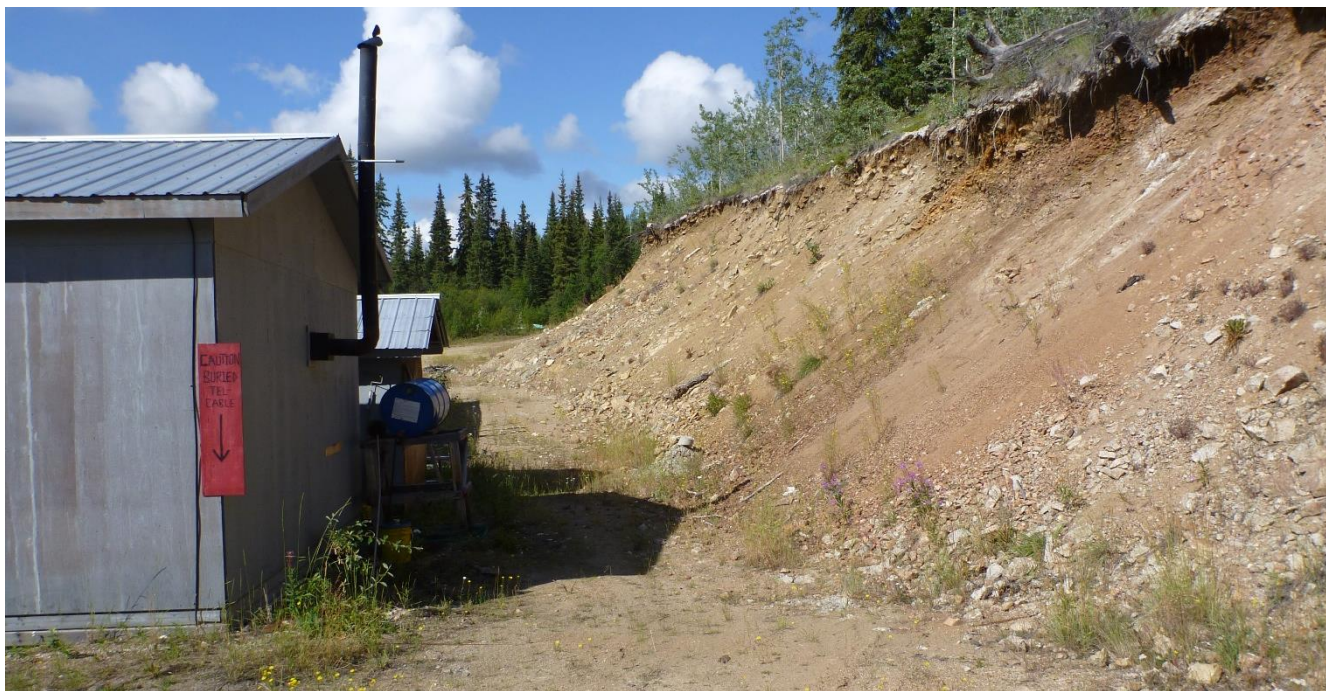
The slope behind the camp (Photograph 3) is stable and does not pose a safety concern for the camp structures or current operations. There is minor ravelling of small sections of the slope, but these are not impacting camp safety nor would they represent a risk for workers on the project. Some regrowth of vegetation was observed in the camp area.

Photograph 3: Cut-slope behind camp

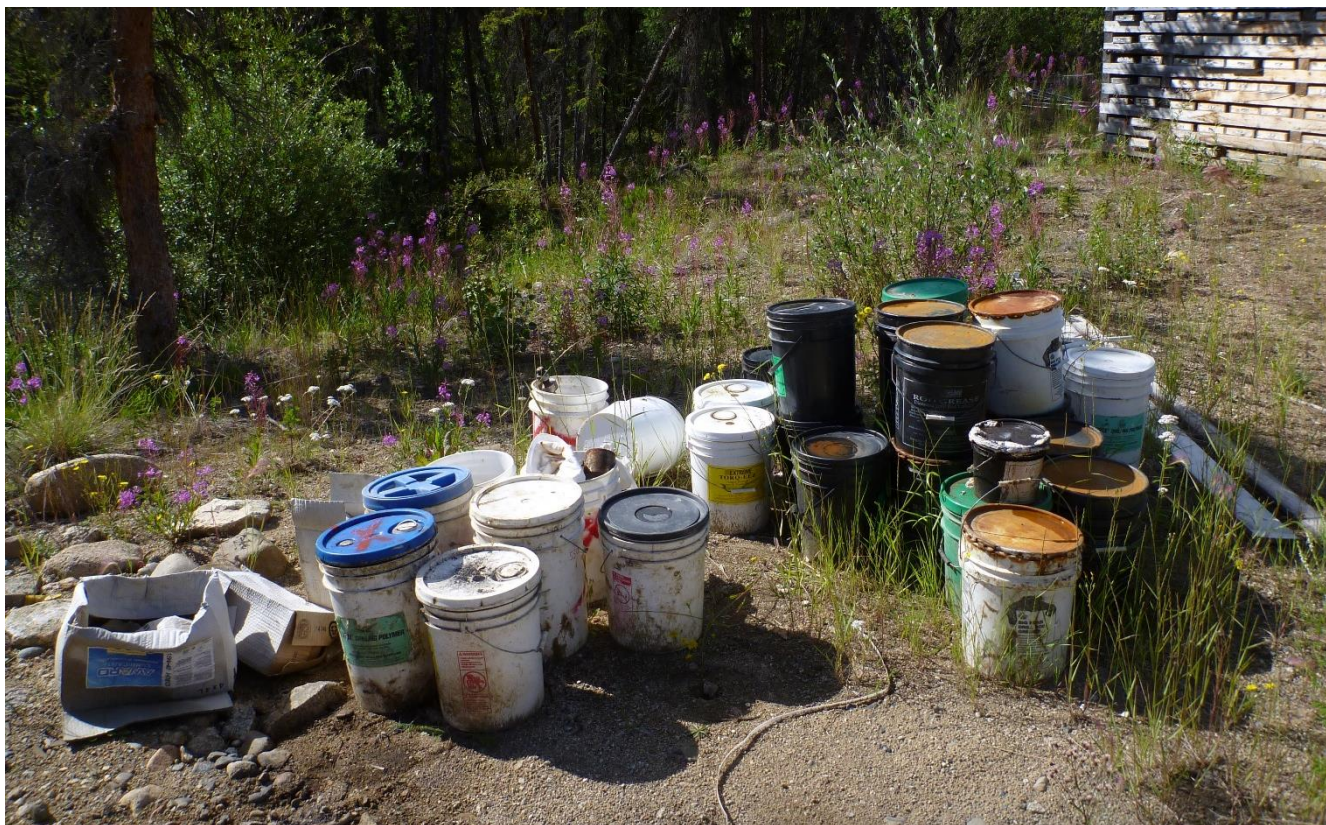
Waste and unused materials from a previous drilling campaign appear to have been stockpiled along the southern perimeter of the camp area, upslope of the adjacent natural vegetation (Photographs 4 and 5). Some of the containers are not sealed, with the potential that their contents could be released to the environment in the event of heavy rainfall or strong winds. We recommend that the containers and materials be disposed of offsite or be placed within a sealed and secured, secondary containment for storage on site.

Photograph 4: Drilling supplies, waste and storage containers

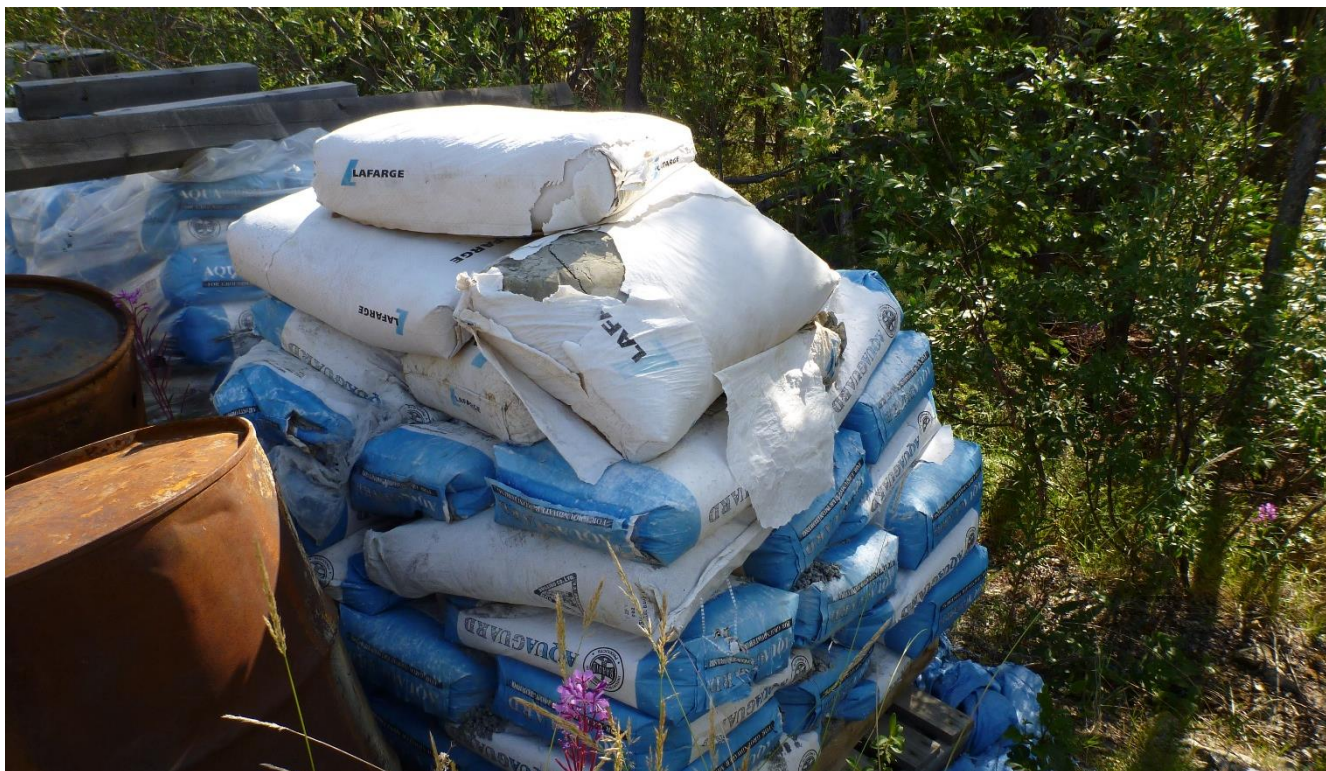
Photograph 5: Drilling supplies

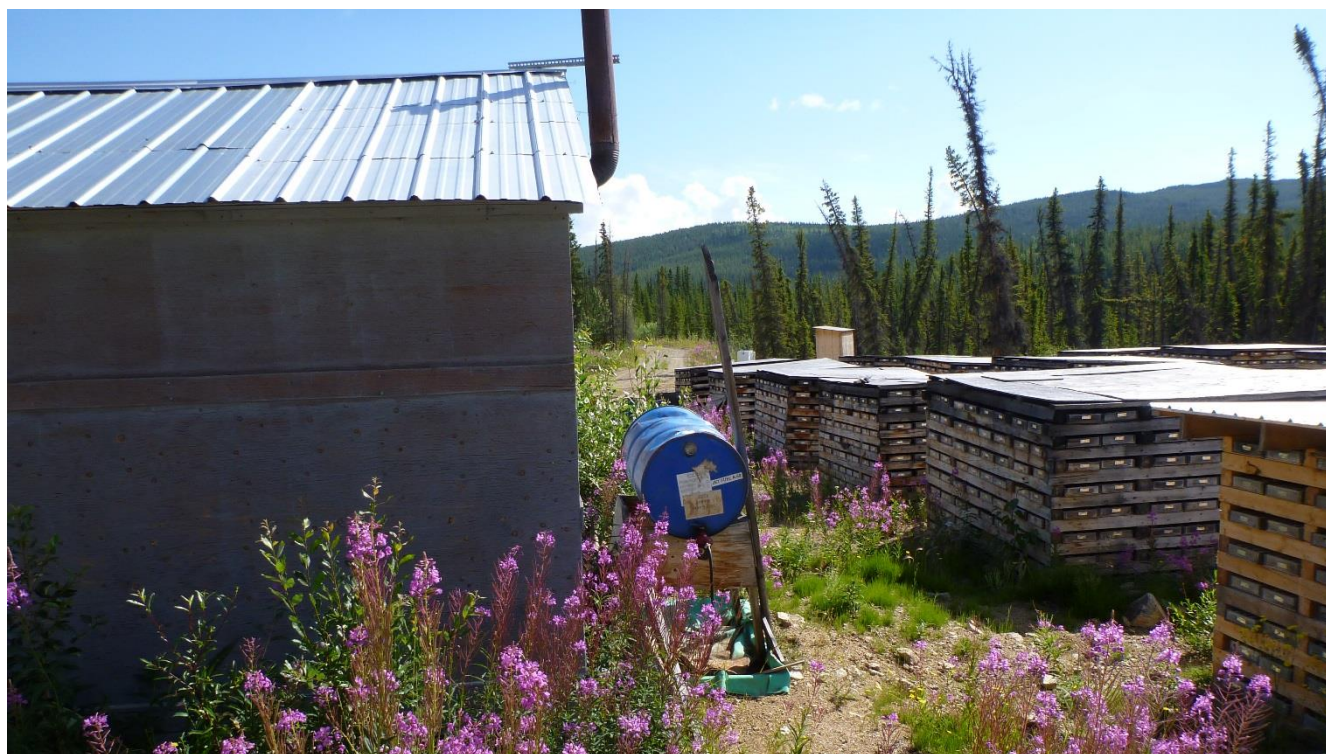
There are two heated core-logging shacks located adjacent to the core storage racks (Photograph 6). Each shack is connected to a partially-full 200 L diesel tank. The tanks, valves and hosing were in a satisfactory condition at the time of inspection. However, only one tank was fitted with a secondary containment liner to prevent potential leaks entering the ground (Photograph 7). We recommend that a liner be placed beneath each tank to act as secondary containment for potential leaks.

Photograph 6: Core logging shack

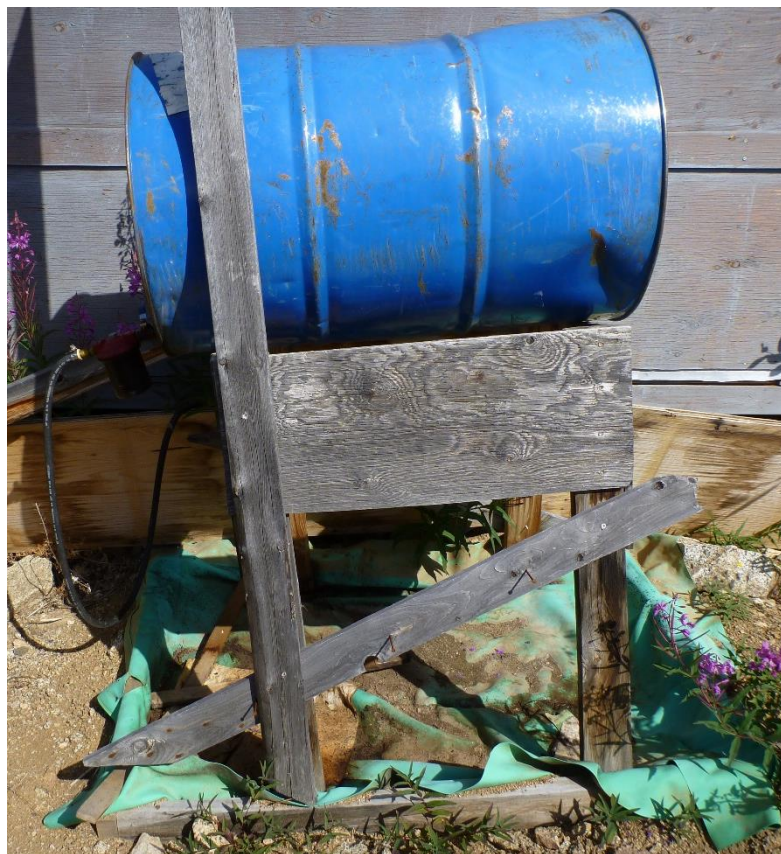
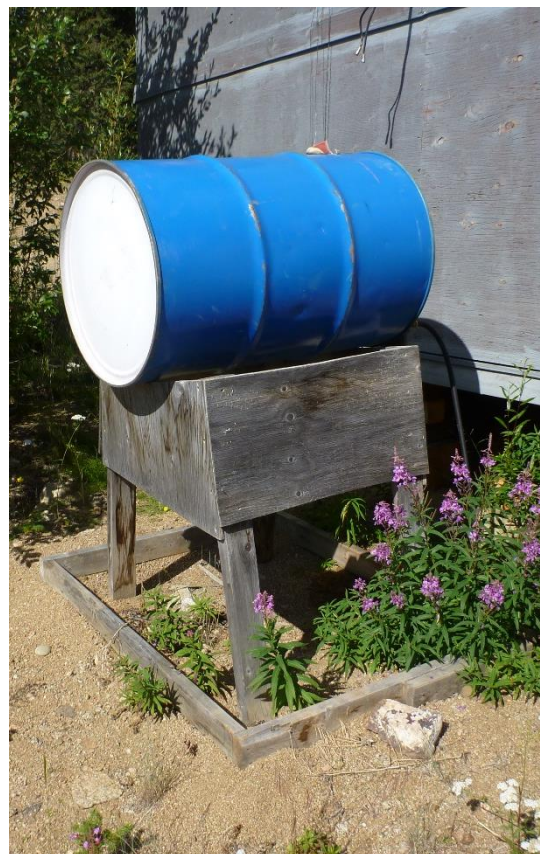
Photograph 7: Diesel tanks for core logging shacks

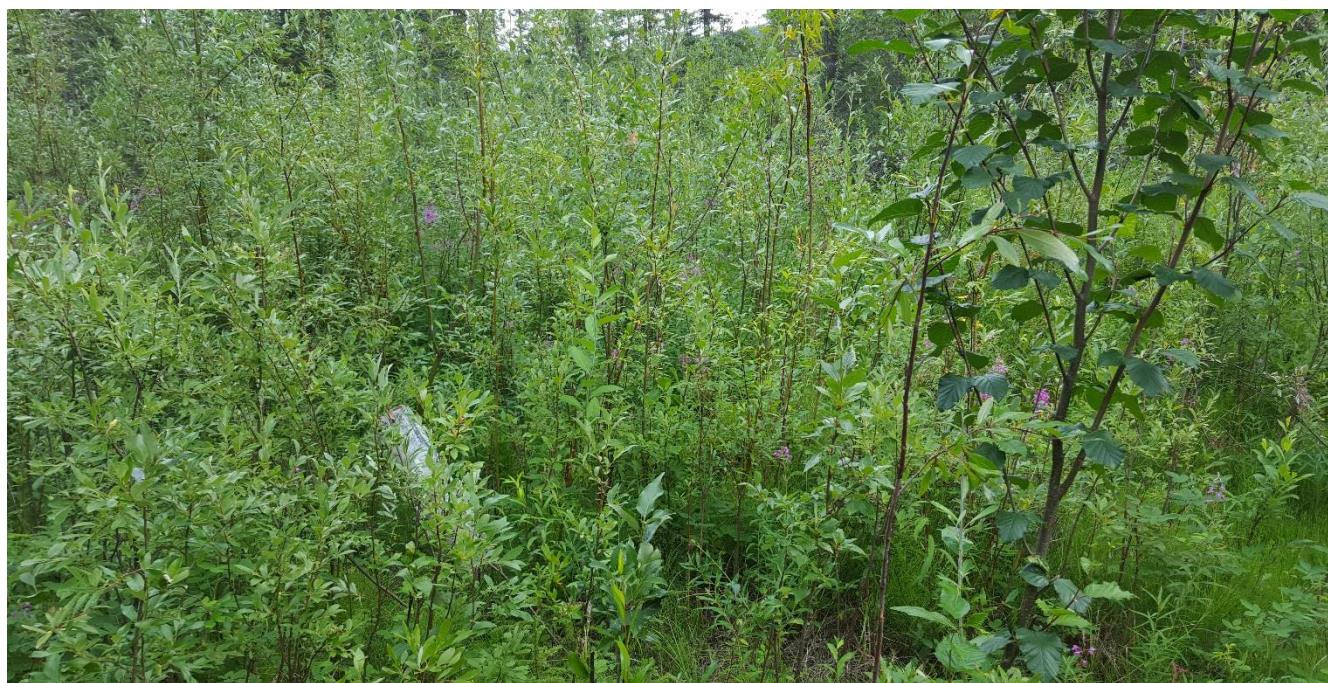
Since the initial clearing in 1997 and 1998, regrowth of vegetation has been occurring in the area (Photograph 8). Erosion and sediment control measures in this area were initially installed in September 2008 and further maintained in September 2009 and August 2010. The sediment control measures include ditches and berms to divert water into sediment catch basins, silt fences, and vegetated areas to break up flow and reduce the potential for erosion. There continues to be some minor erosion of sediments along the access roads, however, this appears to be attenuating as vegetation growth on the access roads increases. Sediment basins and controls are functioning adequately in areas that have seen no new activity.

Photograph 8: Vegetation regrowth at heap leach site

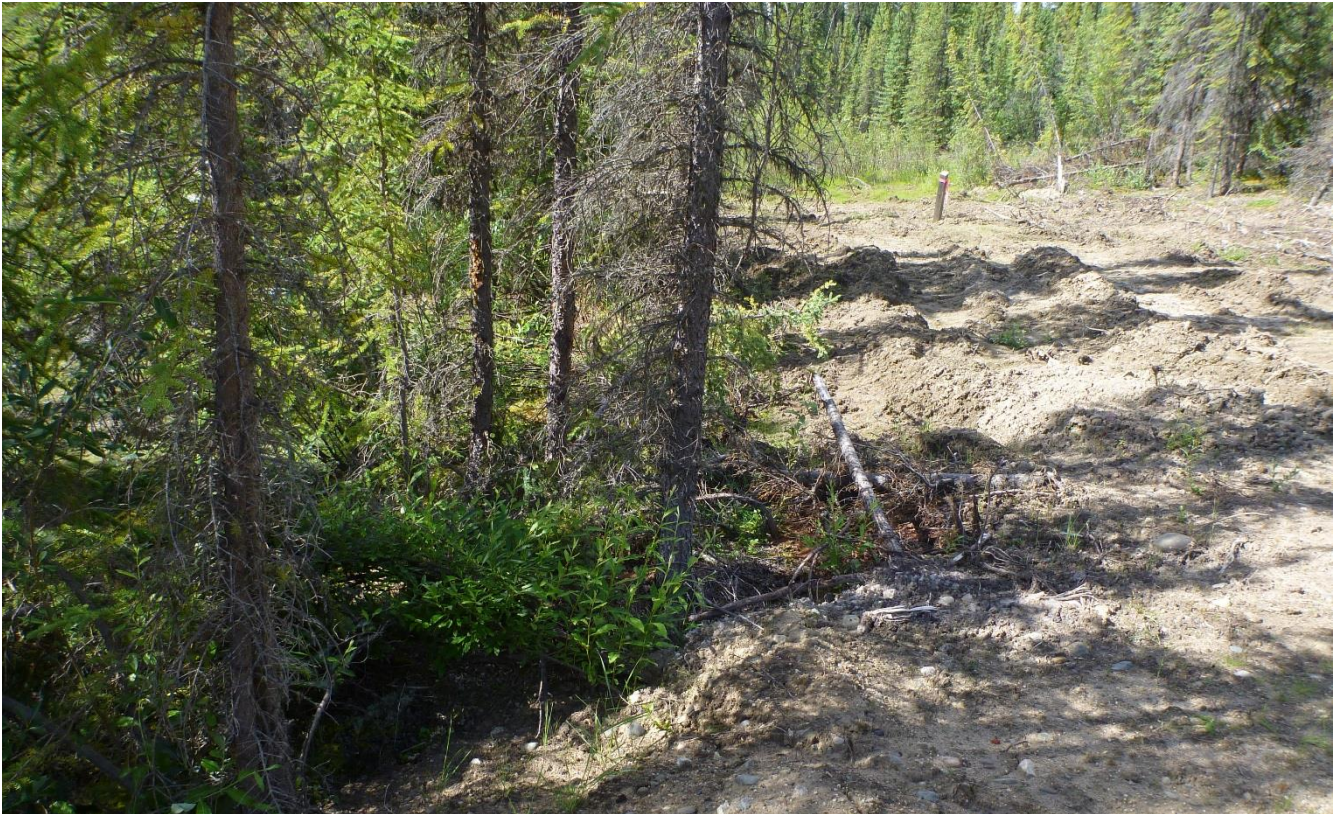
Clearing and drilling activities have been carried out since the 2015 inspection at a location down slope of the proposed heap leach facility, near the proposed water management pond (Photograph 9). Erosion gullies have developed in this area and sediment has flowed into the area immediately downstream (Photographs 10 and 11). We recommend that controls be implemented to arrest the flow of sediment from this area into the surrounding natural vegetation and reclaimed areas.

Photograph 9: Recent drilling activity

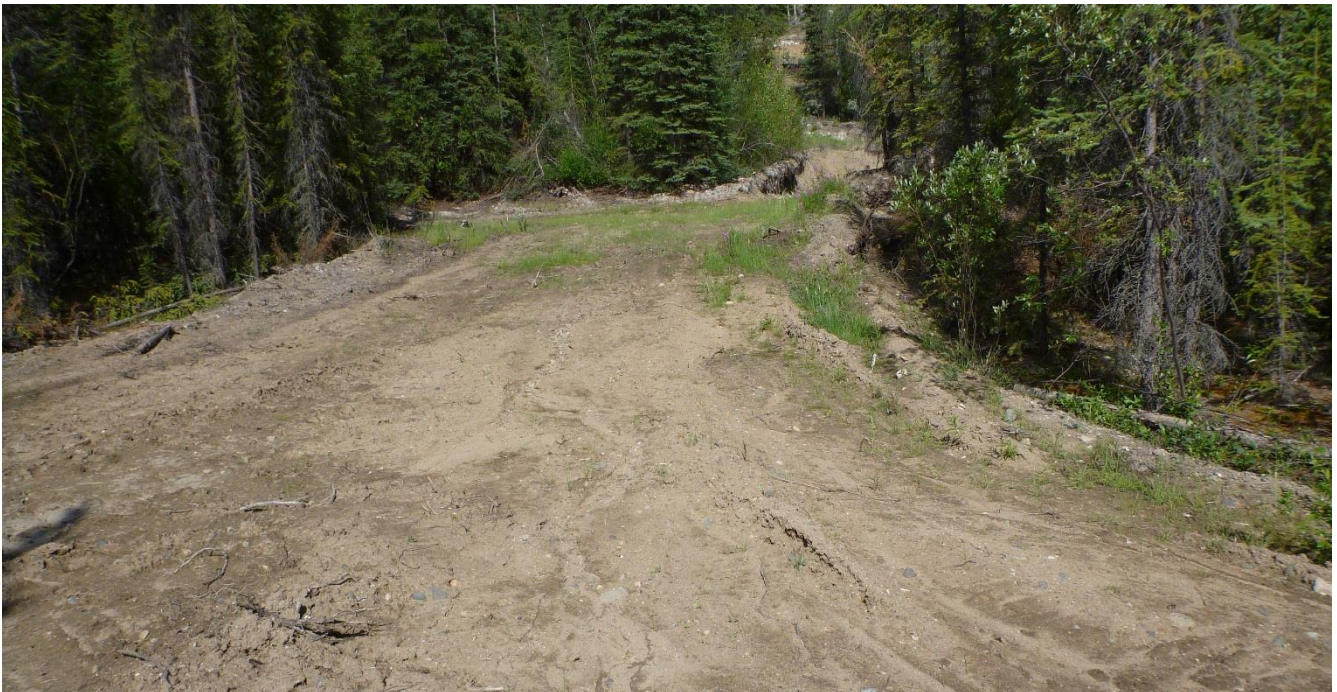
Photograph 10: Erosion of sediment from drill pad and access road

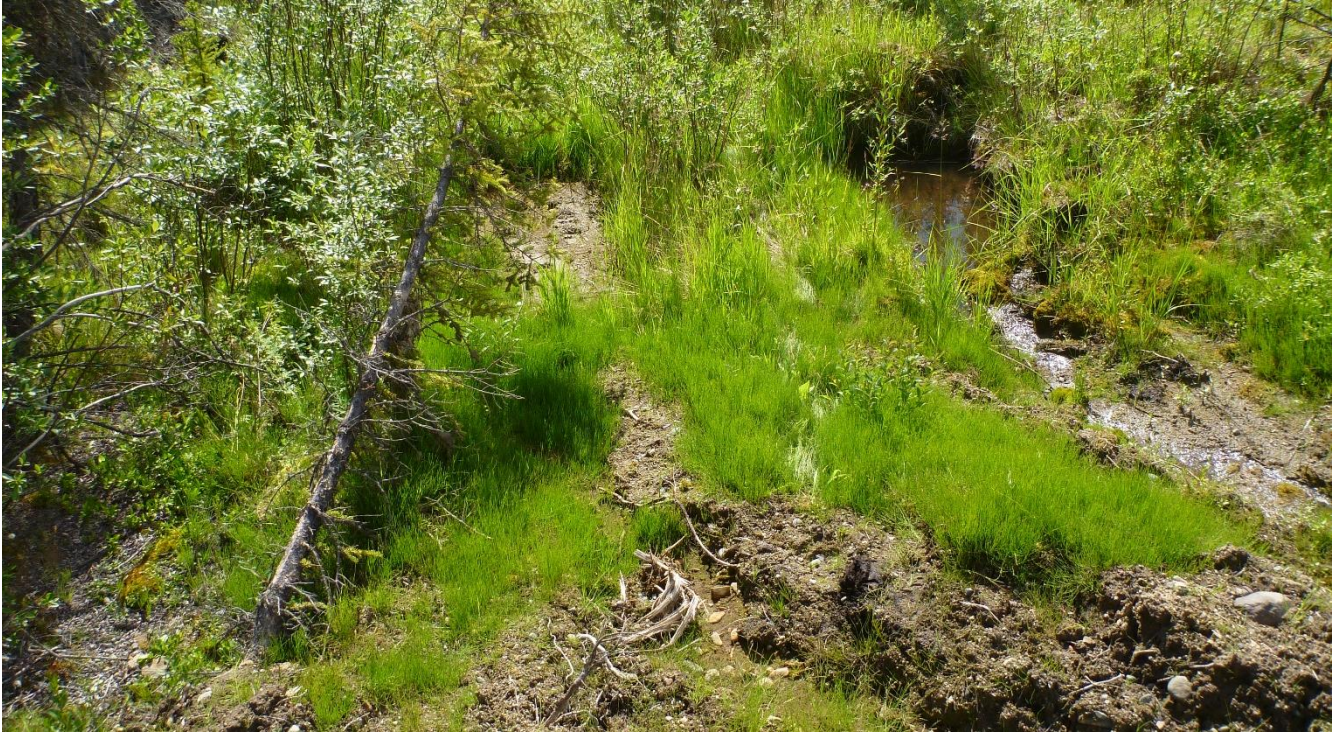
Photograph 11: Sediment and runoff from drill pad

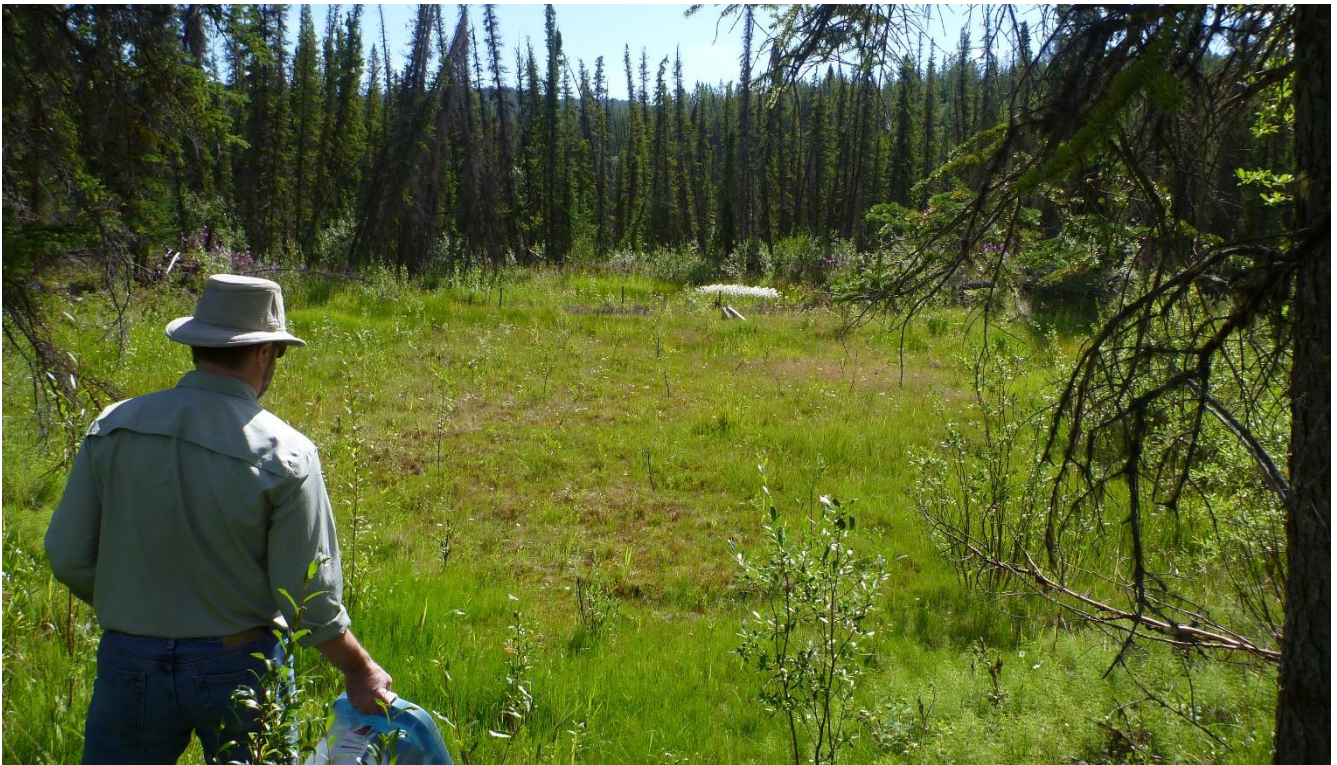
Further downstream, within the floodplain of Williams Creek, silt fences have been installed and the area seeded where sediment from previous site erosion accumulated (Photograph 12). Grass seed was applied in 2009 to promote the re-establishment of vegetation and to further stabilize sediment. The approach was noted to be generally effective in 2011 and 2012, but with limited regrowth attributed to periodic pooling of water. The area was also re-vegetated with woody plants (willow cuttings), and these plants are now well established. There was no evidence of sediment movement, indicating that re-vegetation has been effective in minimizing erosion. Silt fencing surrounding these areas is now overgrown and there is no evidence of sediment movement through the area (Photograph 13). Silt fences are typically a temporary measure and could be removed if no further disturbance is expected upstream.

Photograph 12: Reclaimed vegetation at toe of proposed heap leach area

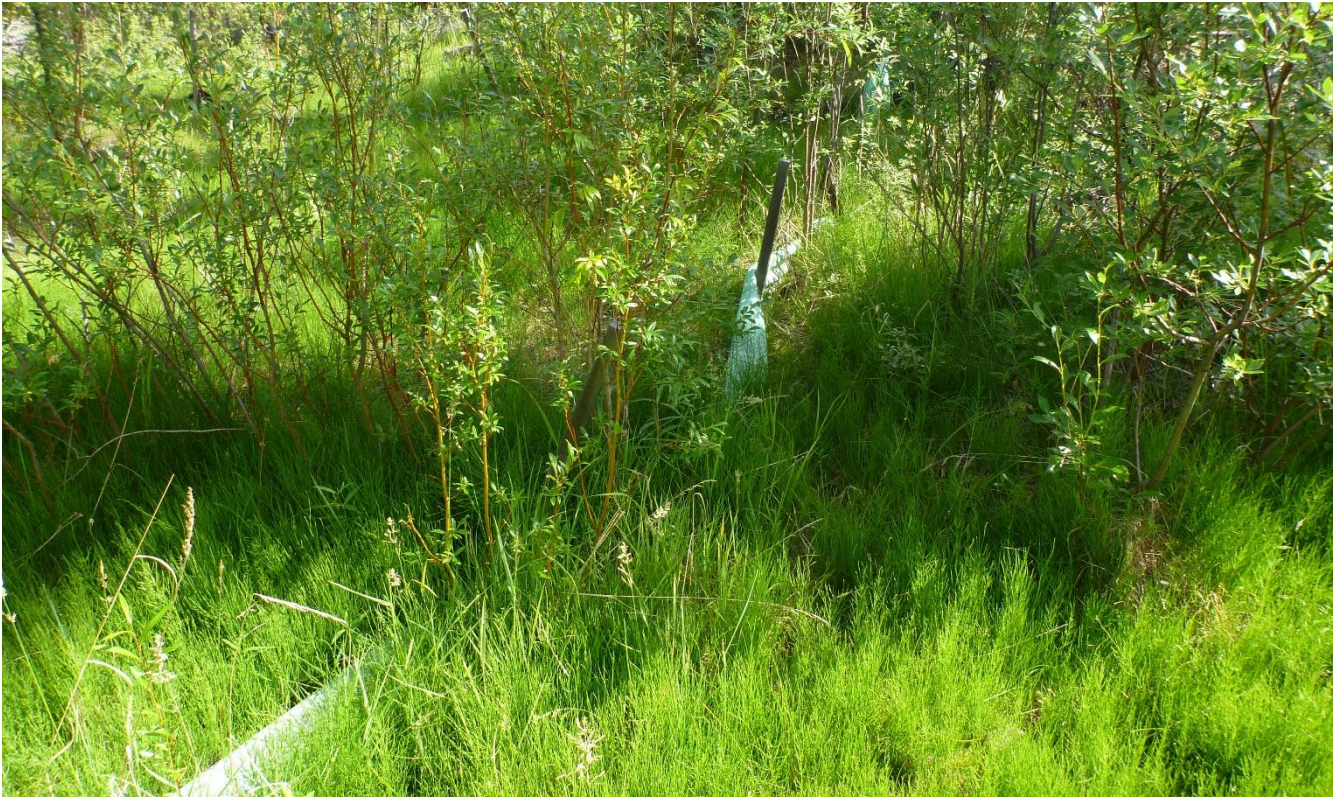
Photograph 13: Vegetation growth around sediment fencing

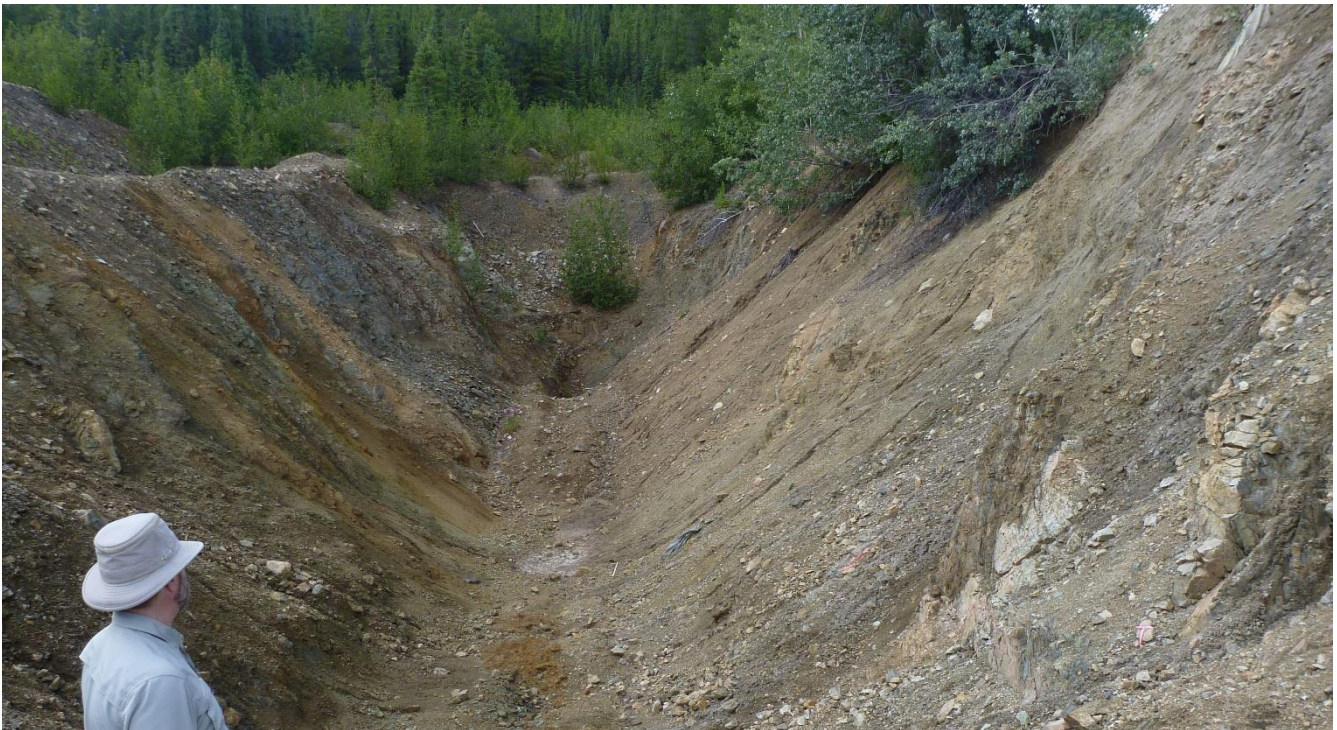
The area proposed for the open pit mine was inspected (Photograph 14). The slopes of the trenches excavated as part of the effort to obtain bulk samples during exploration activities were observed to be in satisfactory condition. There was no observed slumping or failures of the trenches and the slopes facilitate egress for wildlife. Several of the closed drill pads were inspected and there did not appear to be any erosion noted from these areas that would require attention.

Photograph 14: Bulk sample trench within open pit mine area

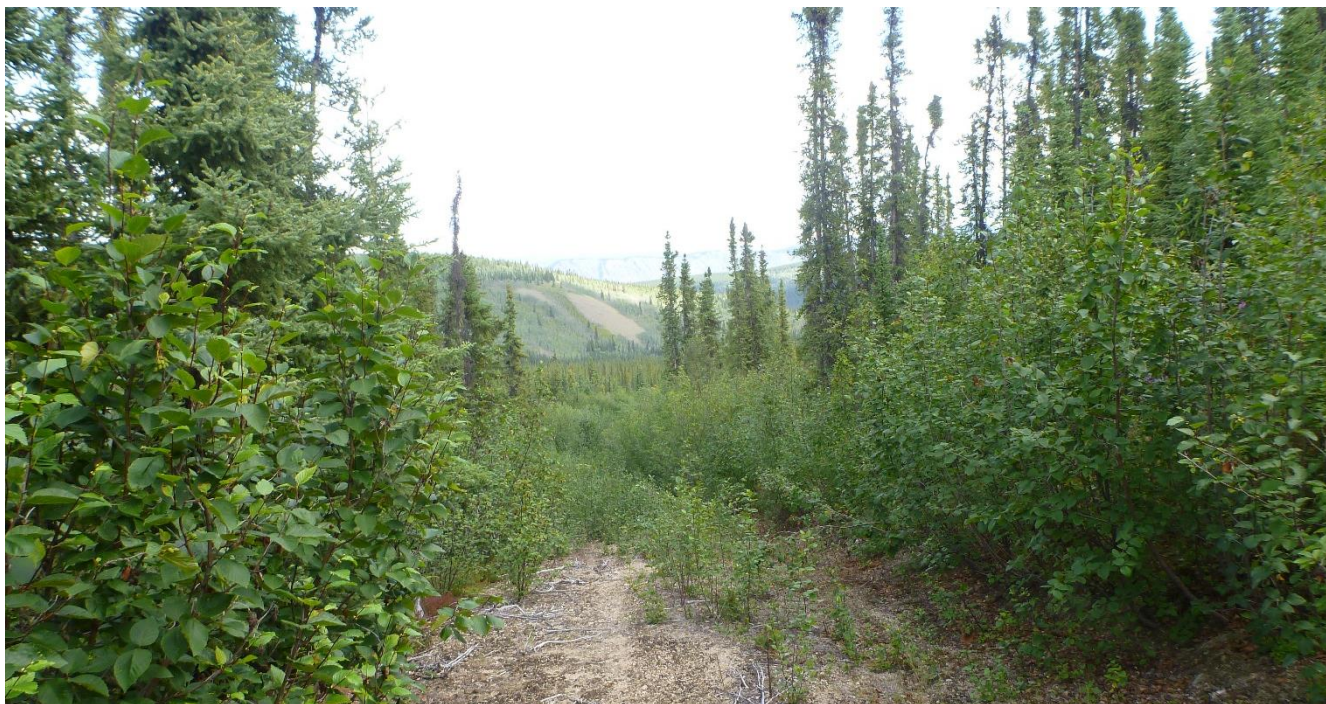
The proposed waste rock storage area was inspected. The waste rock storage area is tree covered and the drill pads and access roads in the area are re-vegetating by volunteer species to the extent that access on foot is now difficult (Photograph 15).

Photograph 15: Vegetation regrowth on access road at Waste Rock Storage Area

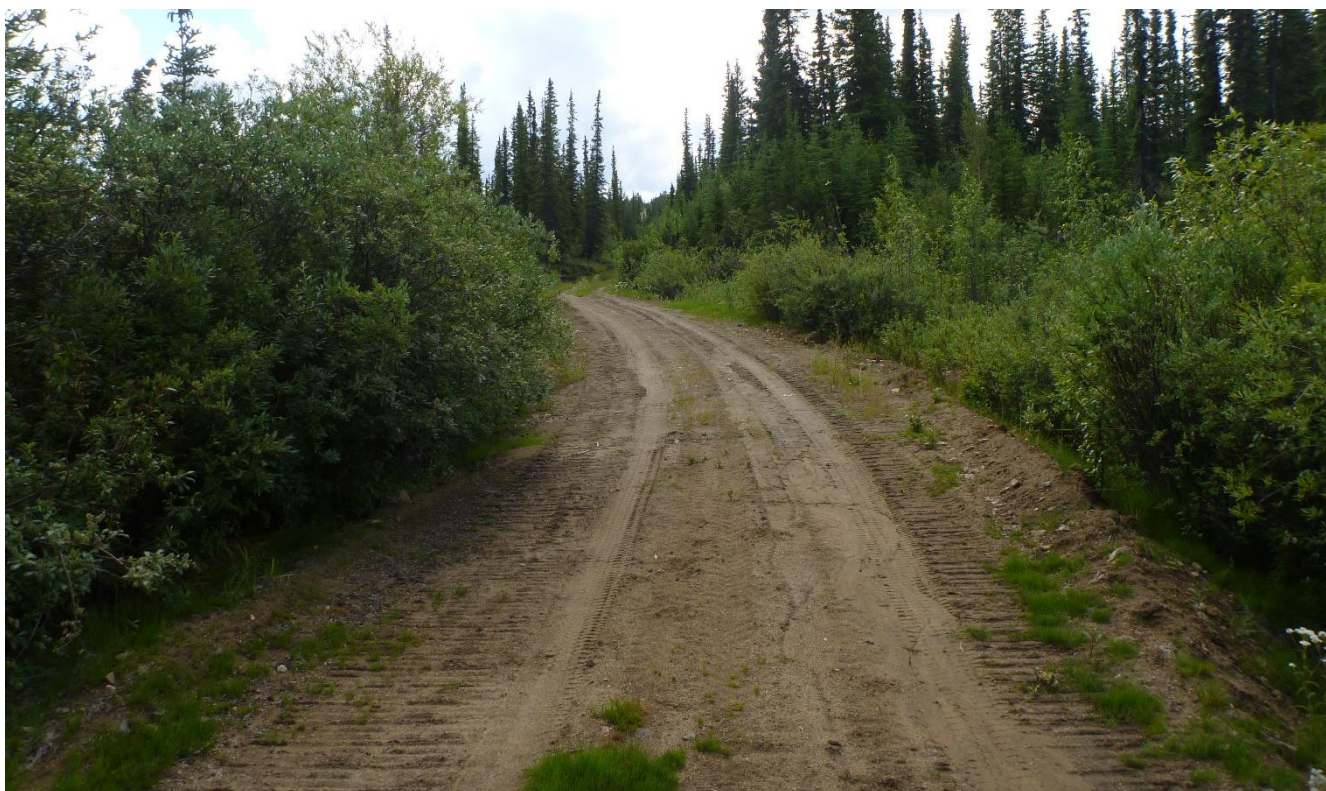
The main access road to the north of the waste rock storage area was observed to be in good condition with only minor erosion observed (Photograph 16). Minor erosion of the road shoulders was observed near at the culvert on North Williams Creek. The culvert has undergone some crushing and has accumulated some sediment (Photograph 17). However, the culvert remains more than adequate to accommodate the relatively minor flows at this location. The access road should be inspected annually and ongoing maintenance of drainage features and erosion should be anticipated.

Photograph 16: Access road to north of Waste Rock Storage Area

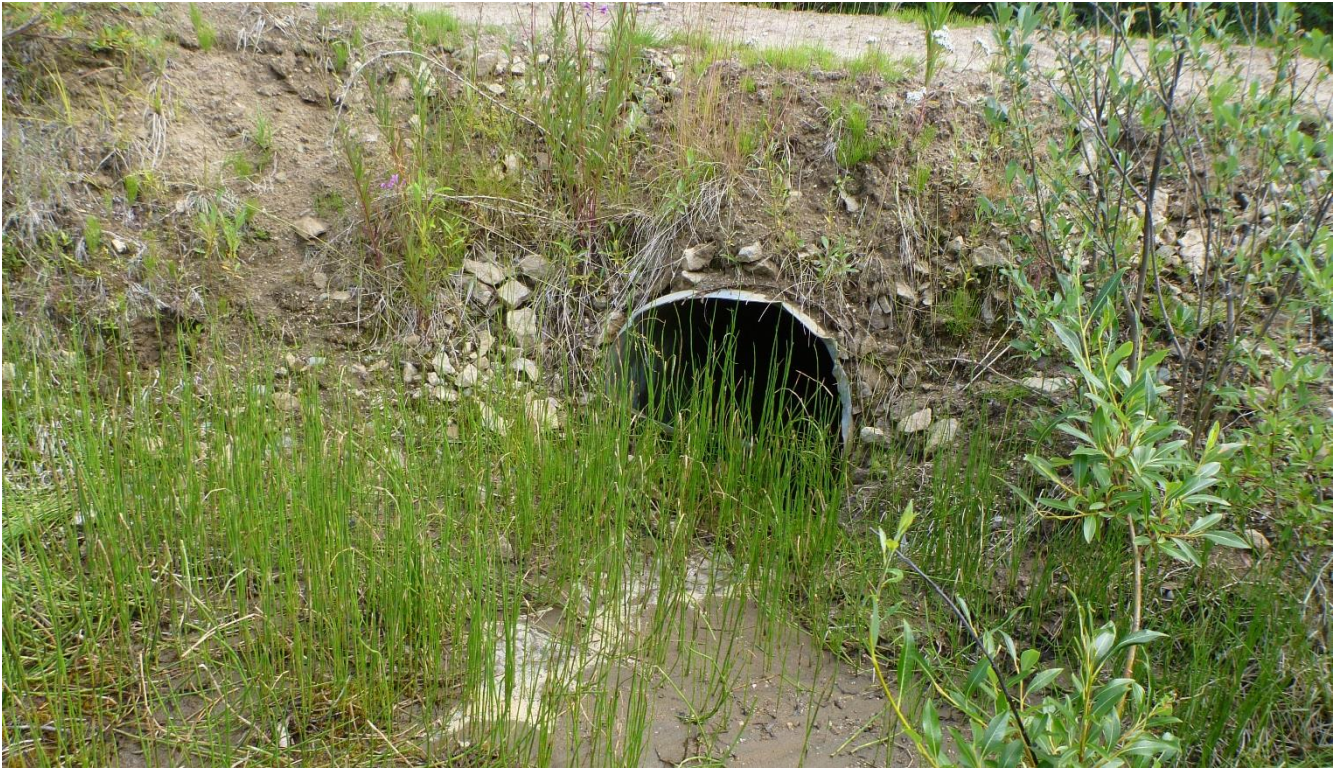
Photograph 17: Culvert beneath road at North Williams Creek

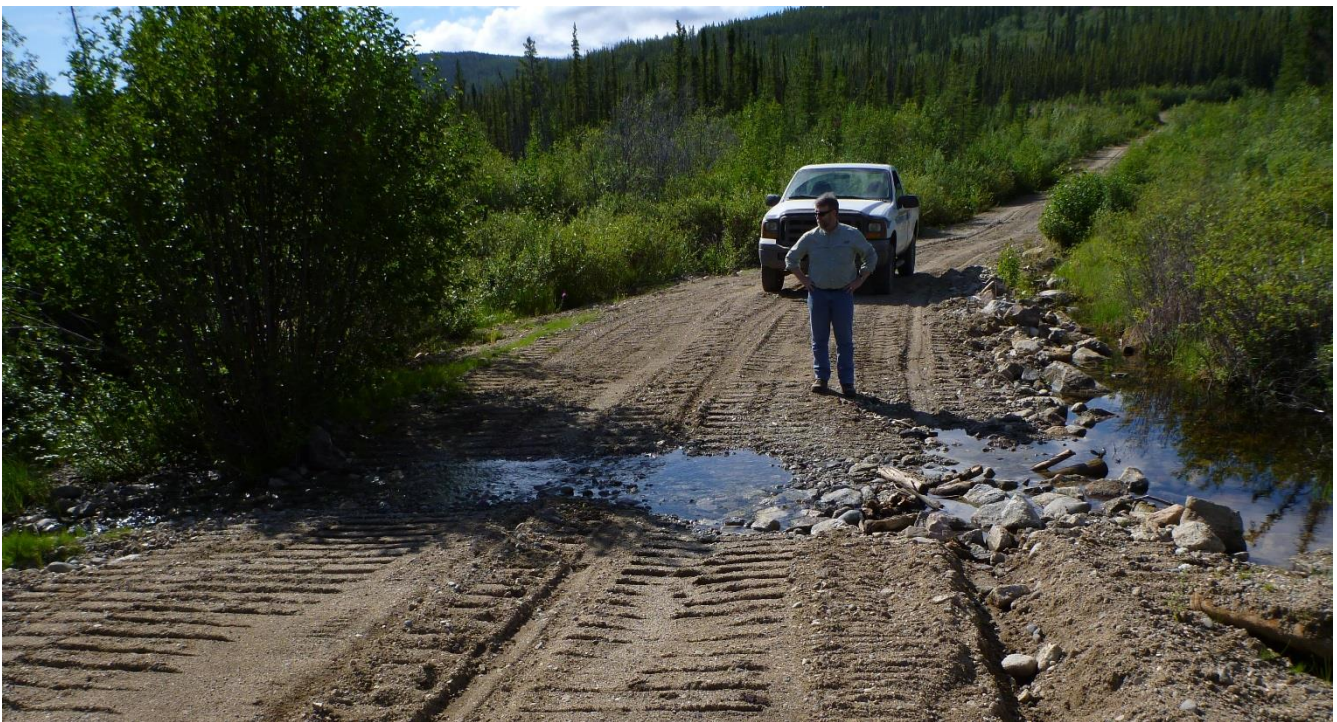
The ford road crossing installed at Williams Creek in 2013 continues to function as intended (Photograph 18). The rockfill in the ford is well-graded and there is no indication of movement of finer materials. Ponded water was observed on the upstream side of the road, with flow across the road. It is possible that a large rainfall event could result in erosion. We therefore recommended that the ford continue to be inspected annually and maintenance be carried out, if required. The ford is appropriate for the current status of the project. However, prior to site development, it is recommended that the culvert at the Williams Creek crossing is replaced and the access road armored against erosion at this location.

Photograph 18: Williams Creek Crossing

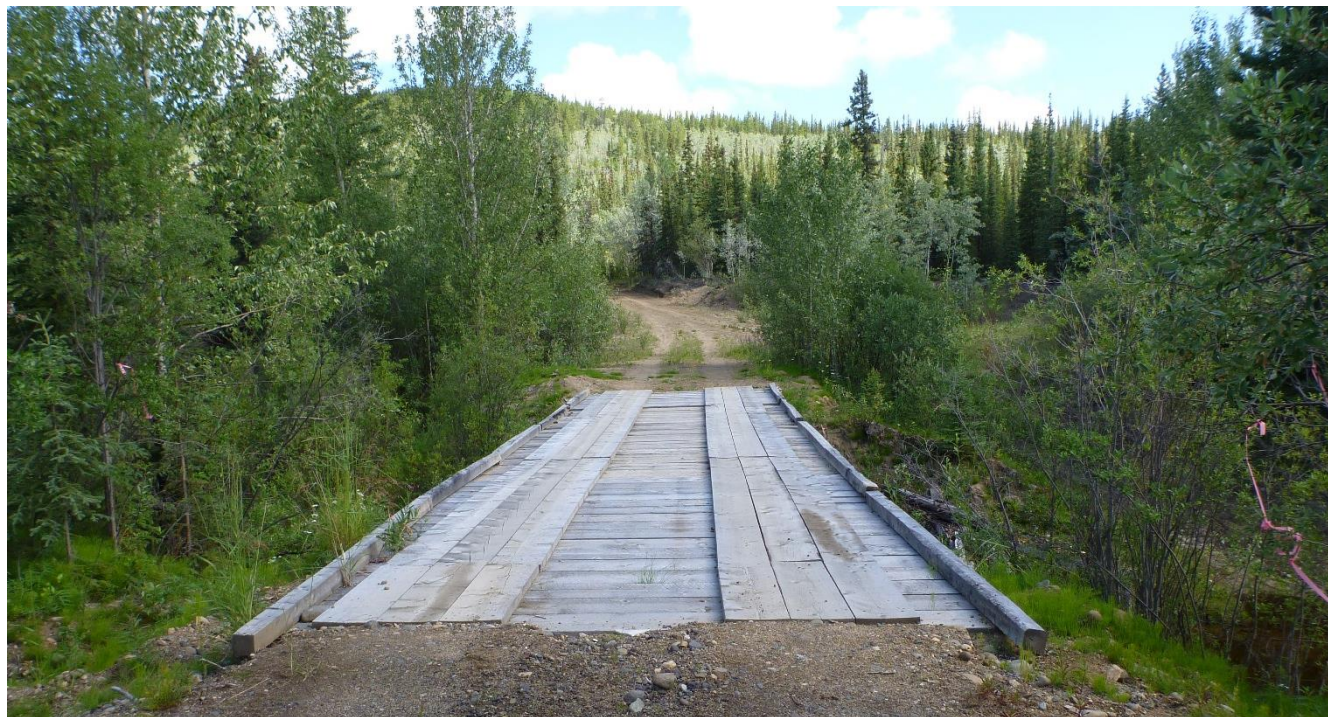
The access road crossing at Merrice Creek includes a single-span bridge set on grade (Photograph 19). Following recommendations in the July 2014 inspection memorandum, the bridge was extended by approximately 3 m and seated 1 to 2 m on the abutments. Approximately 3 m of steel was welded to the existing span, bridge decking was replaced and extended, and the approaches were re-graded to the bridge deck elevation.

Photograph 19: Bridge at Merrice Creek

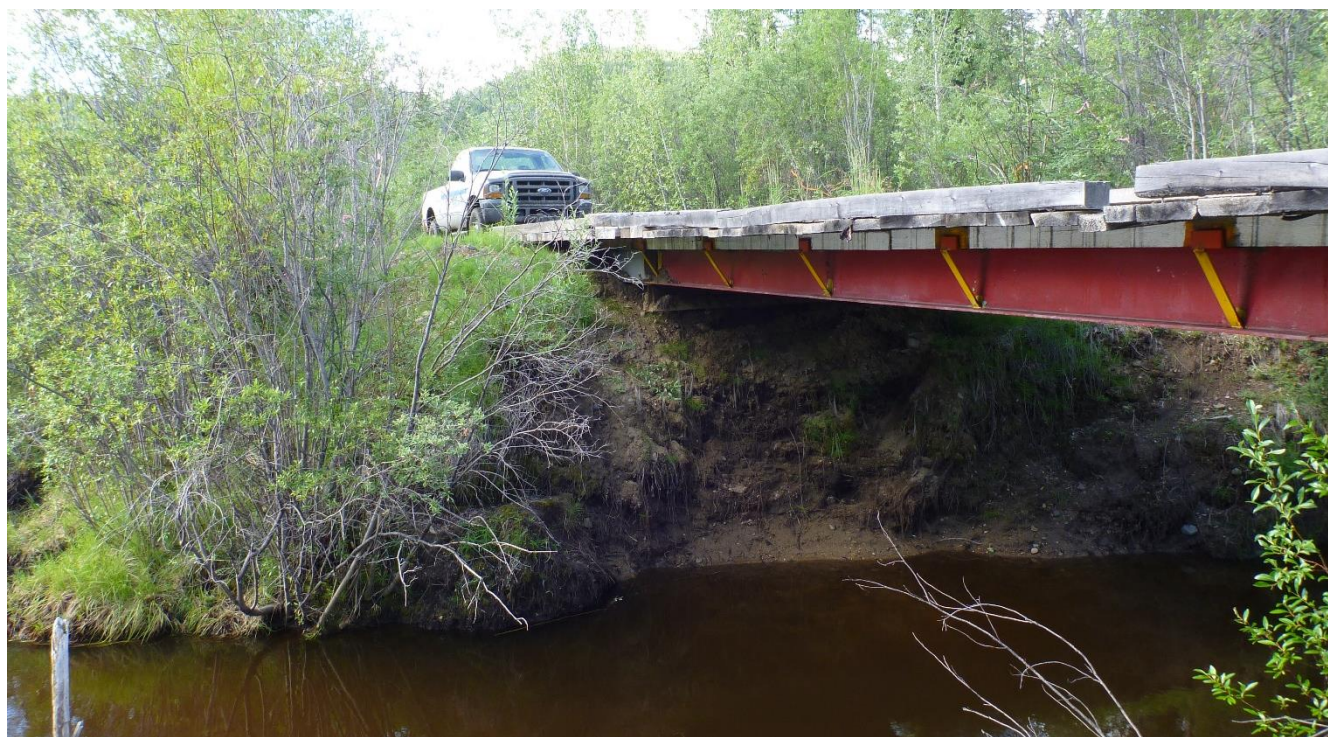
The bridge was observed to be in a satisfactory condition and is securely anchored at each of the abutments. The right (or southern) abutment is steep sided and there is evidence that erosion may be continuing to occur at this location under high-flow conditions (Photograph 20). The bridge should be monitored annually and following large rainfall events. In the event that erosion begins to compromise the stability of the abutment, consideration should be given to the installation of erosion protection at this location.

Photograph 20: Bridge right (south abutment)

- Water crossings, including the bridge abutments at Merrice Creek, should continue to be inspected annually and following major rainfall events. Minor maintenance should be carried out, as required to maintain the functionality and safety of these crossings.
- Controls should be implemented to manage runoff and sediment from the area of recent drilling activity located down slope of the proposed heap leach facility area, in the vicinity of the proposed water management pond.
- Waste and unused materials from drilling that are located along the southern perimeter of the camp area should be disposed of offsite or be placed within a sealed and secured, secondary containment for onsite storage.
- A lined containment bund should be installed beneath the 200 L diesel tank at the core logging shed to act as secondary containment for potential leaks.
