2017 ANNUAL QUARTZ MINING LICENCE REPORT

**Submitted to Yukon Government, Energy Mines and Resources
Yukon Quartz Mining Licence QML-0007**

Carmacks Copper Project, Yukon Territory

Carmacks Copper Project - 2017 Annual Inspection

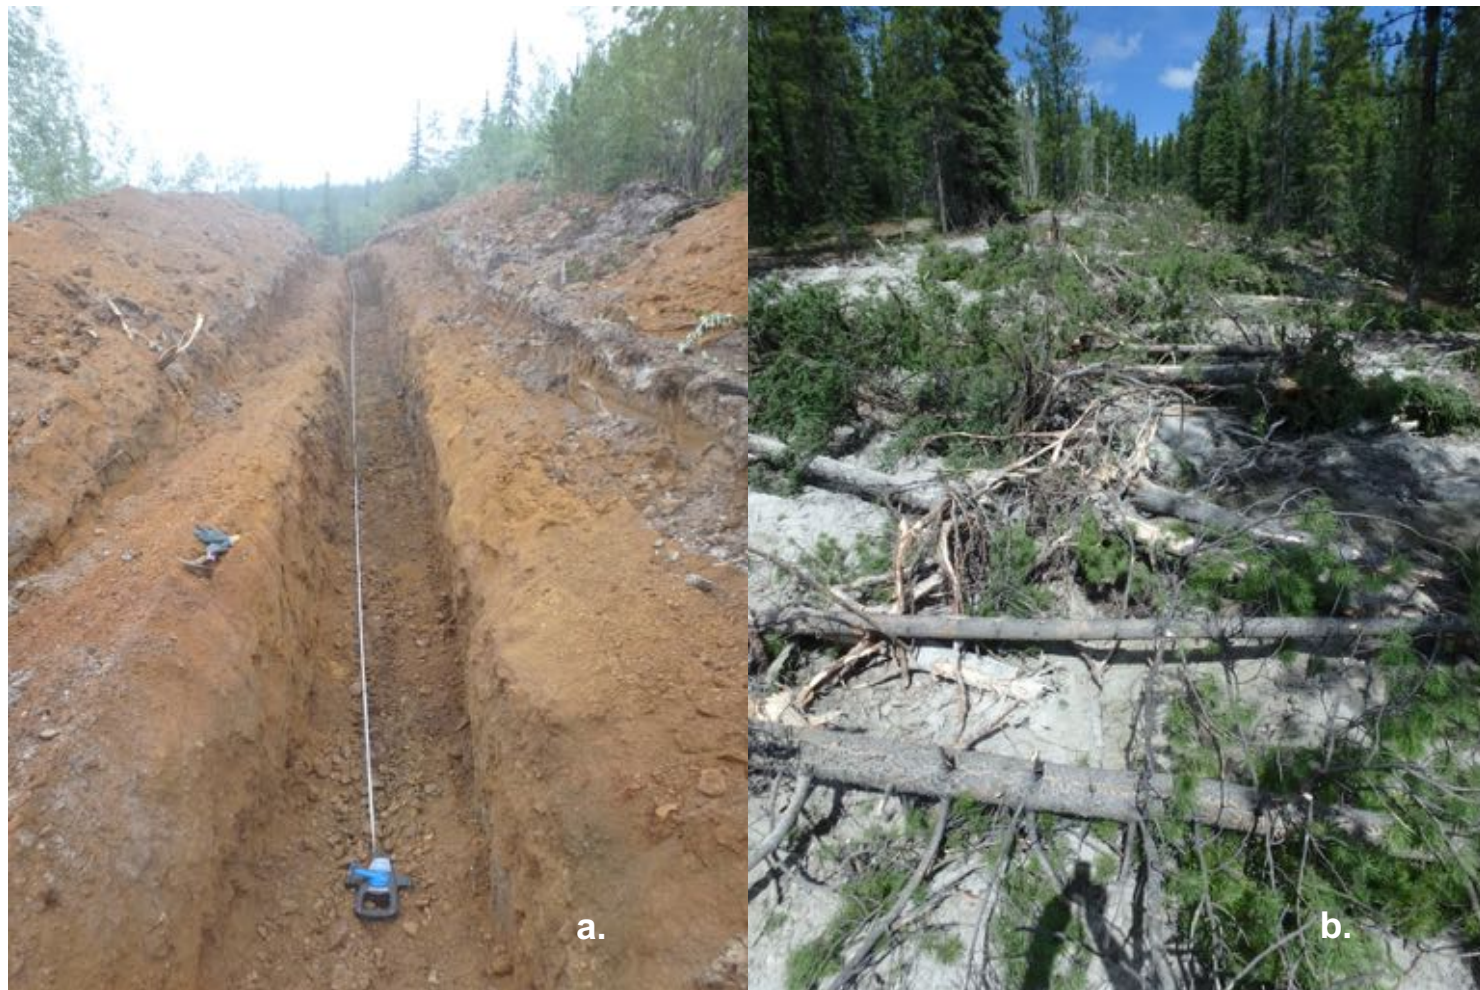
Figure 2. Typical trench conditions before (a. Trench TR-15-32A) and after (b. Trench TR16-26) reclamation.

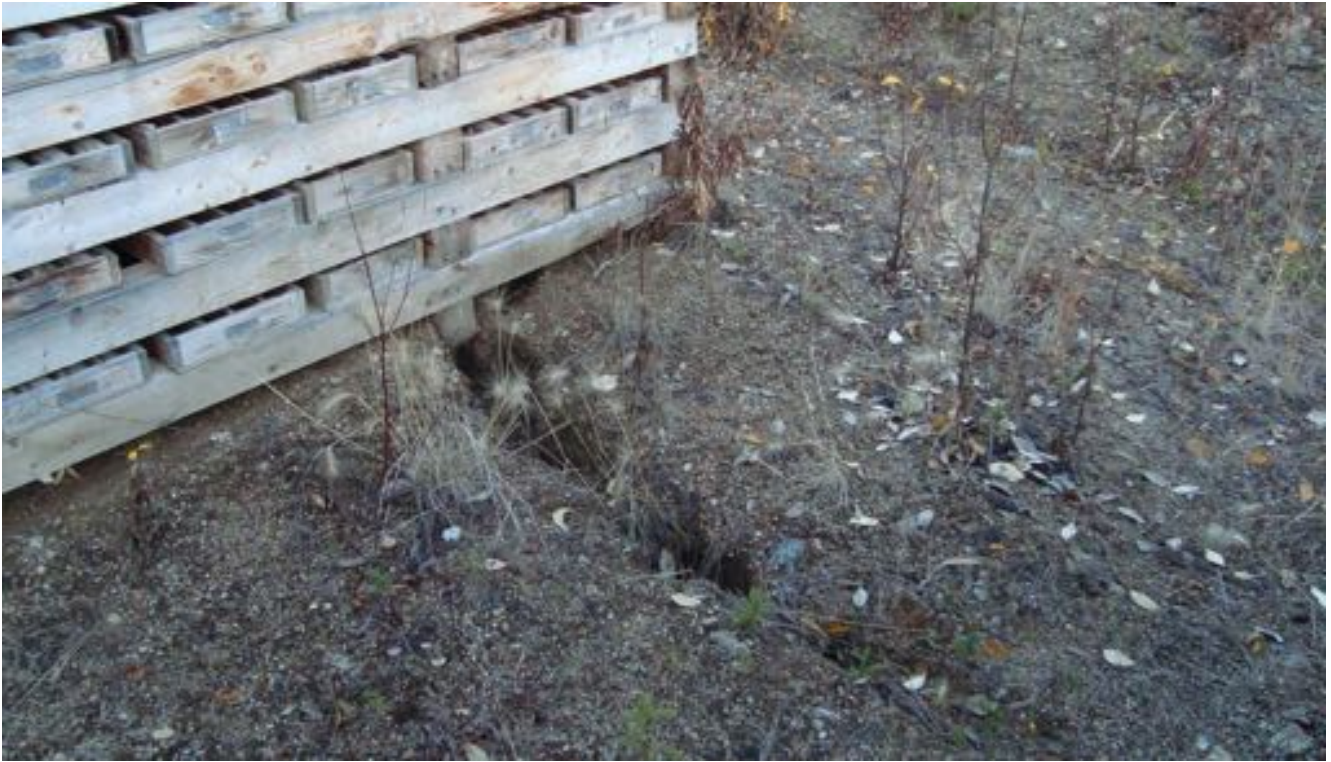
In previous years, inspections of the camp area have noted the presence of cracking, most likely resulting from thaw induced settlement beneath and adjacent to core storage racks. During the current inspection, only one crack was observed in the vicinity of the core storage racks (Photograph 1). In general, the appearance of cracks in the core storage rack area was consistent with the 2016 inspection. There appears to have been some infilling of cracks observed during previous inspections. The area is also characterised by the regrowth of vegetation around the core racks and a general decrease in the magnitude of settlements occurring with time. As in previous years, settlement in this area does not represent a safety concern and the inspection did not indicate erosion of sediments from the pad area into the surrounding natural area. Two new core racks have been constructed in 2017 and one was under construction at the time of the inspection (Photograph 2).

Photograph 1: Crack beneath core storage rack

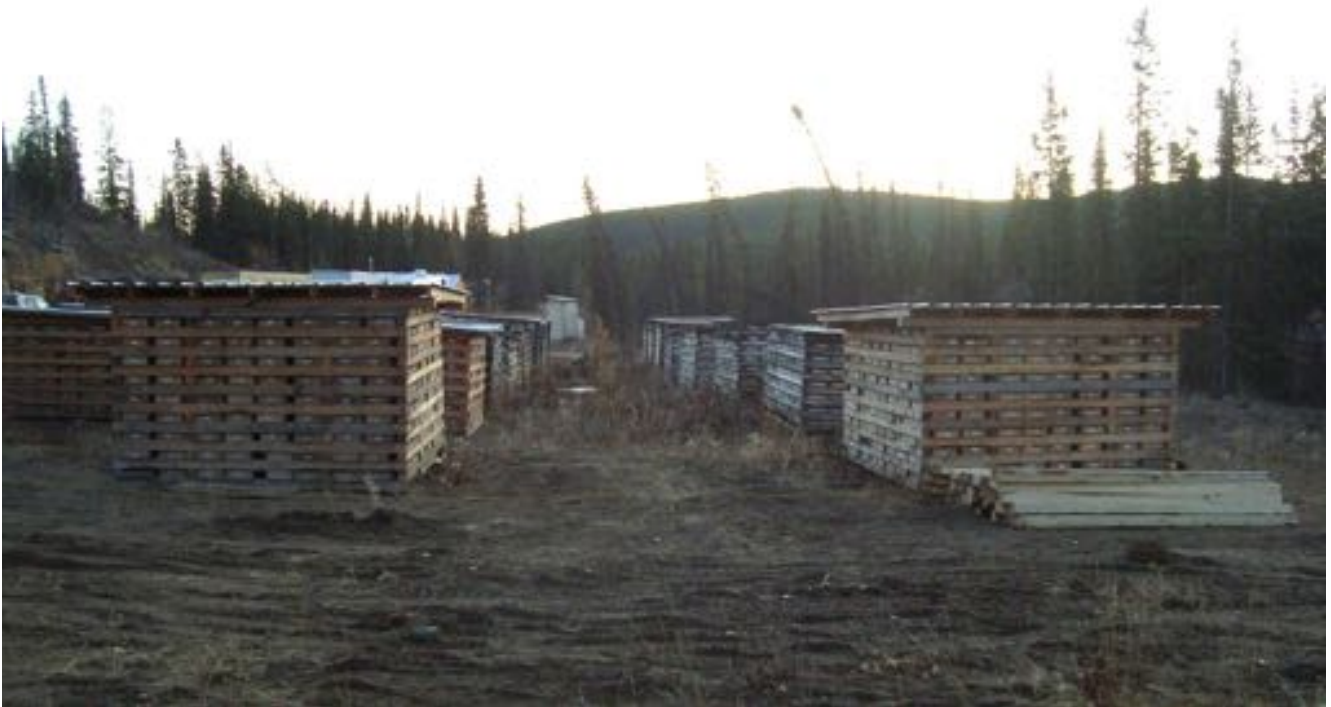
Photograph 2: Core storage racks

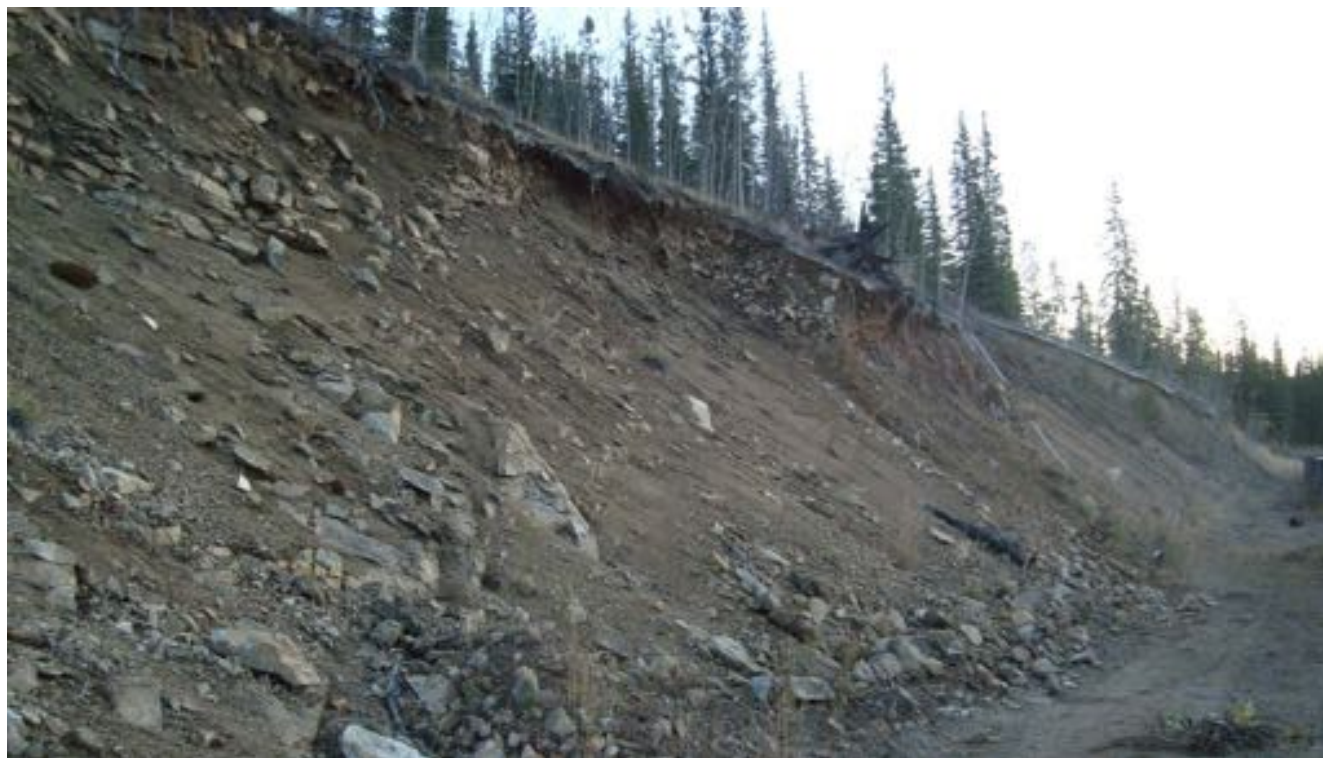
The slope behind the camp (Photograph 3) is stable and does not pose a safety concern for the camp structures or current operations. There is minor ravelling of small sections of the slope, but these are not impacting camp safety nor would they represent a risk for workers on the project. Some regrowth of vegetation was observed in the camp area.

Photograph 3: Cut-slope behind camp

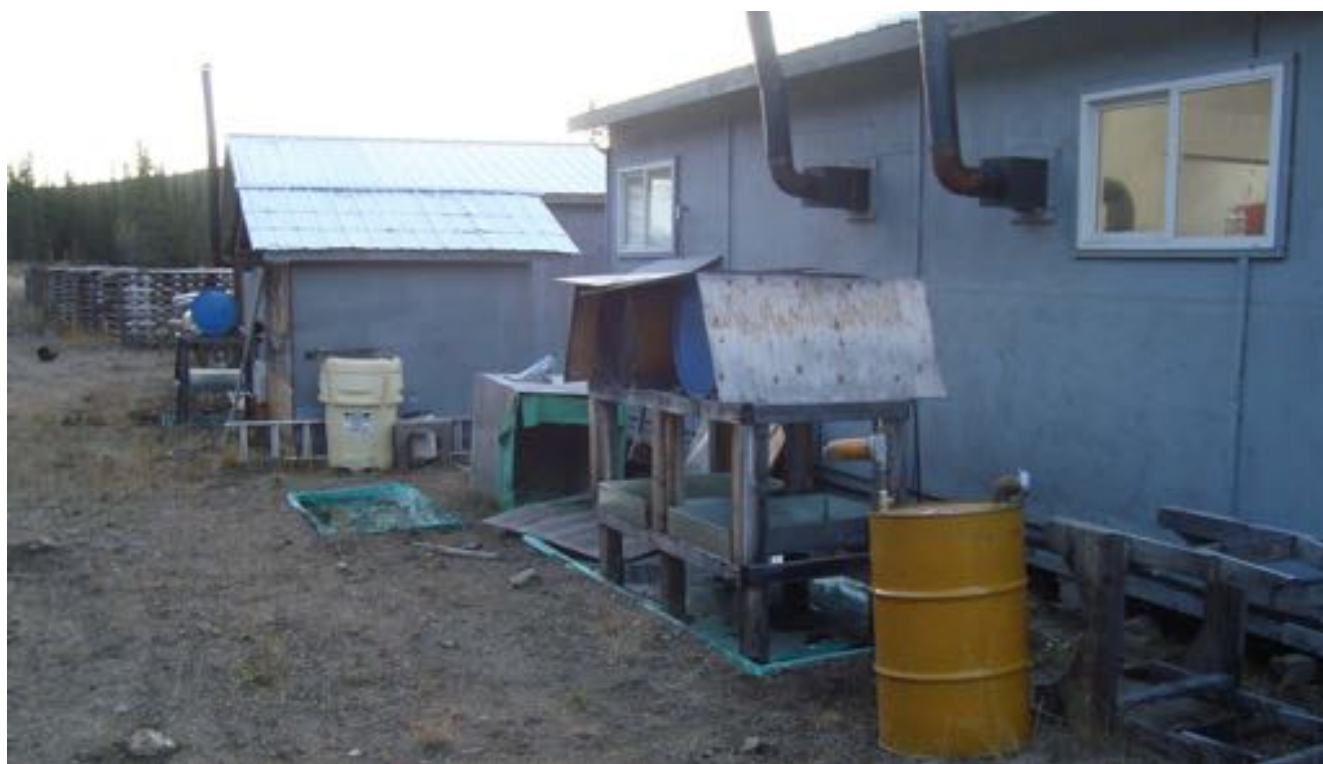
There are two heated buildings, the core shack (foreground) and geology office (background), located adjacent to the core storage racks (Photograph 4). The tanks, valves and hosing were in a satisfactory condition at the time of inspection. Liners have been placed beneath each tank to act as secondary containment for potential leaks and were in a satisfactory condition.

Photograph 4: Core logging shacks

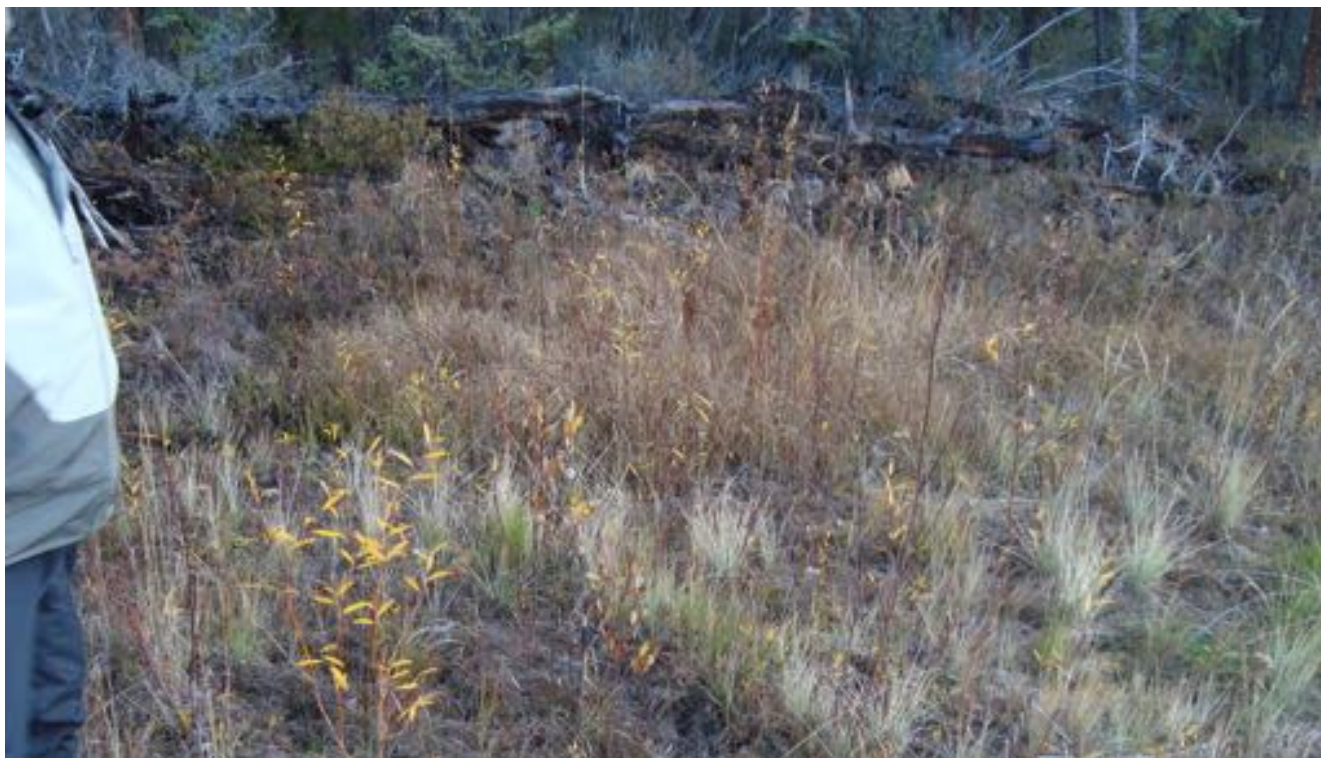
Further downstream, within the floodplain of Williams Creek, silt fences have been installed and the area seeded where sediment from previous site erosion accumulated (Photographs 9 and 10). Grass seed was applied in 2009 to promote the re-establishment of vegetation and to further stabilize sediment. The approach was noted to be generally effective in 2011 and 2012, but with limited regrowth attributed to periodic pooling of water. The area was also re-vegetated with woody plants (willow cuttings), and these plants are now well established. Volunteer species of grass and woody plants are performing very well. There was no evidence of sediment movement, indicating that re-vegetation has been effective in minimizing erosion. Silt fencing surrounding these areas is now overgrown and there is no evidence of sediment movement through the area. Silt fences are typically a temporary measure and could be removed if no further disturbance is expected upstream.

Photograph 9: Vegetation regrowth in Williams Creek floodplain

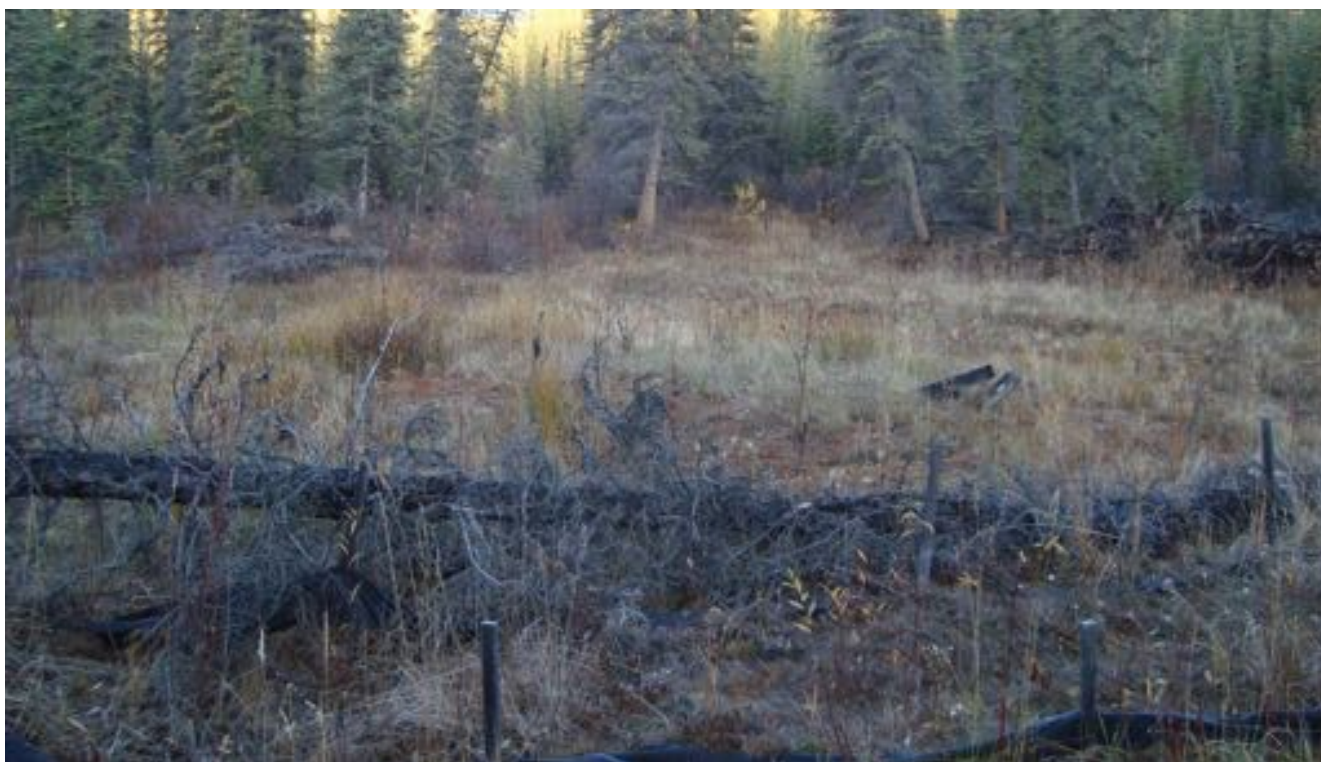
Photograph 10: Vegetation growth around sediment fencing

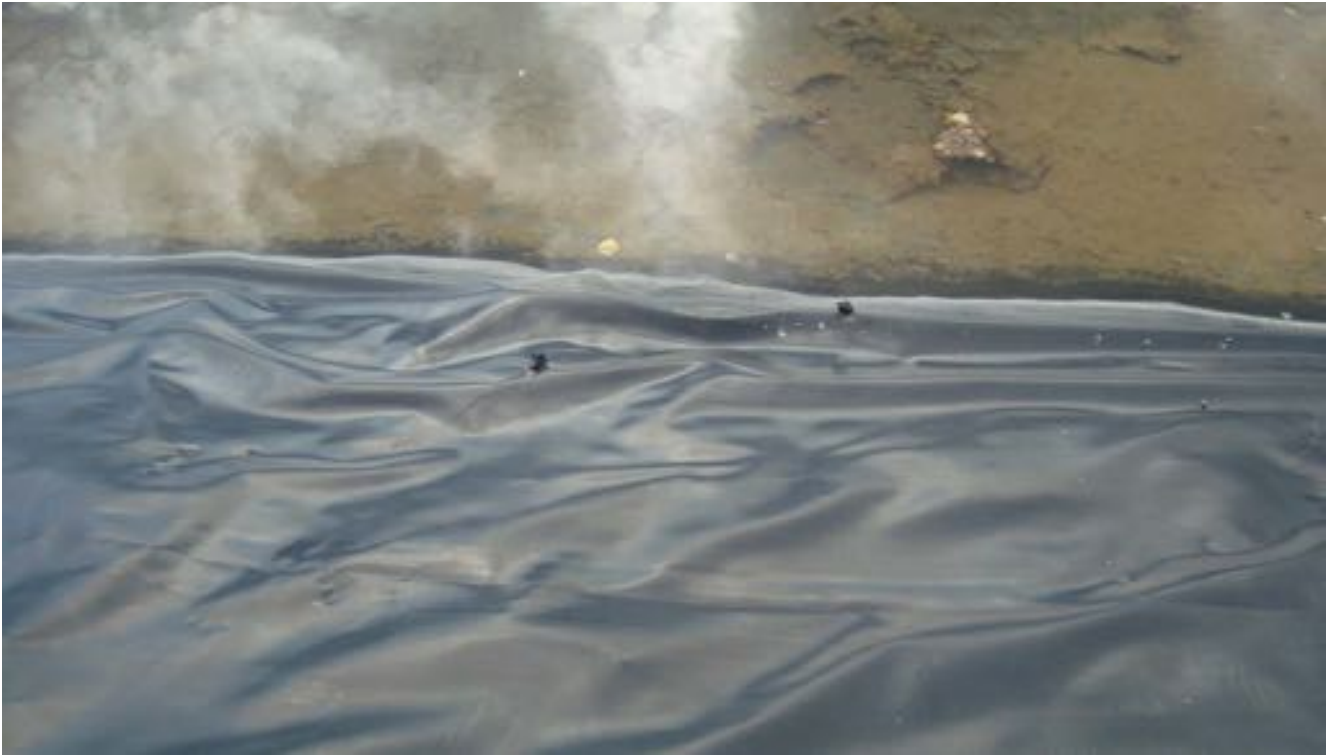
There was evidence that an animal had entered and exited the basin. The animal damaged the liner in a few locations (Photograph 13). The damage to the liner should be repaired. The fuel drums should be organized in a manner to allow wildlife egress from the basin.

Photograph 13: Liner damage at fuel storage area

- Water crossings, including the bridge abutments at Merrice Creek, should continue to be inspected annually and following major rainfall events. Minor maintenance should be carried out, as required to maintain the functionality and safety of these crossings.
- Controls should be implemented to manage runoff and sediment from the area of heavy traffic located in the area of North Williams Creek. The high traffic area should be regraded and repaired.
- The damage to the liner at the fuel storage area should be repaired. The fuel drums should be organized in a manner to allow access and egress for wildlife.

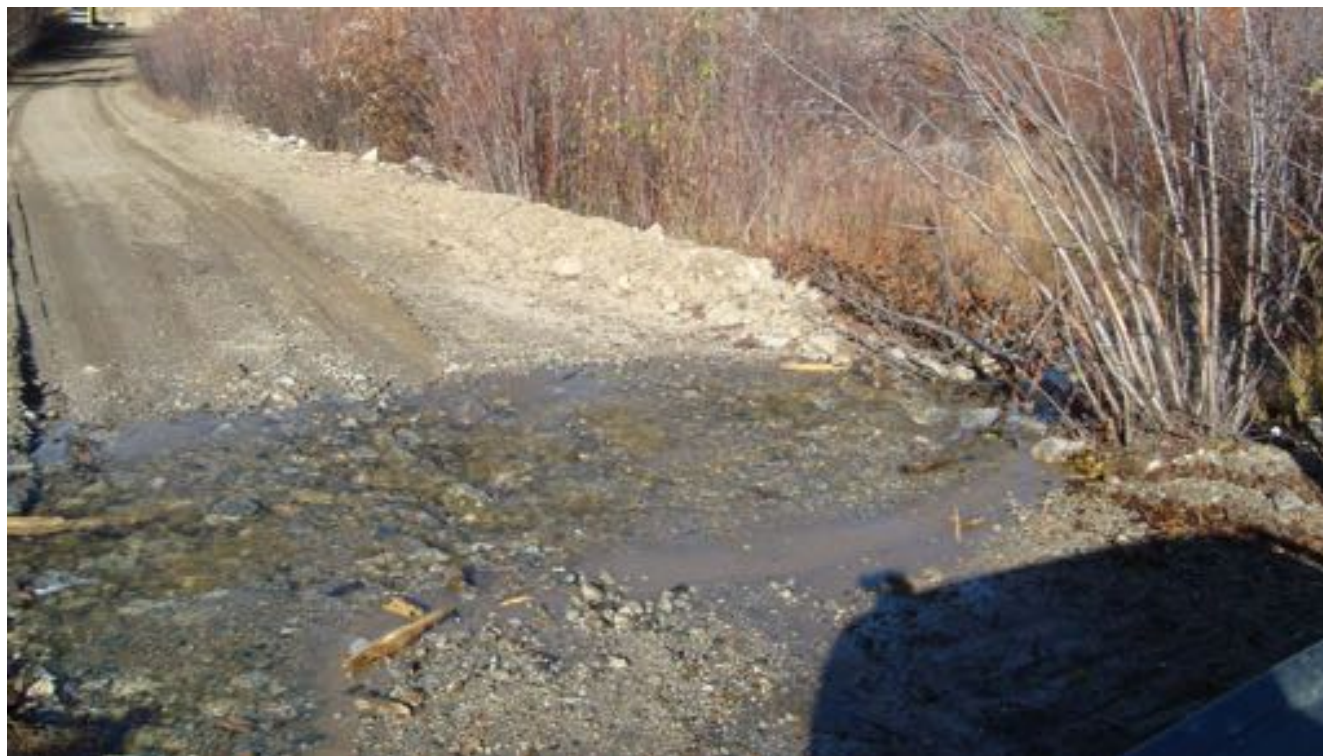
The ford road crossing installed at Williams Creek in 2013 continues to function as intended (Photograph 17). The rockfill in the ford is well-graded and there is no indication of movement of finer materials. Pondered water was observed on the upstream side of the road, with flow across the road. It is possible that a large rainfall event could result in erosion. We therefore recommended that the ford continue to be inspected annually and maintenance be carried out, if required. The ford is appropriate for the current status of the project. However, prior to site development, it is recommended that the culvert at the Williams Creek crossing is replaced and the access road armored against erosion at this location.

Photograph 17: Williams Creek crossing

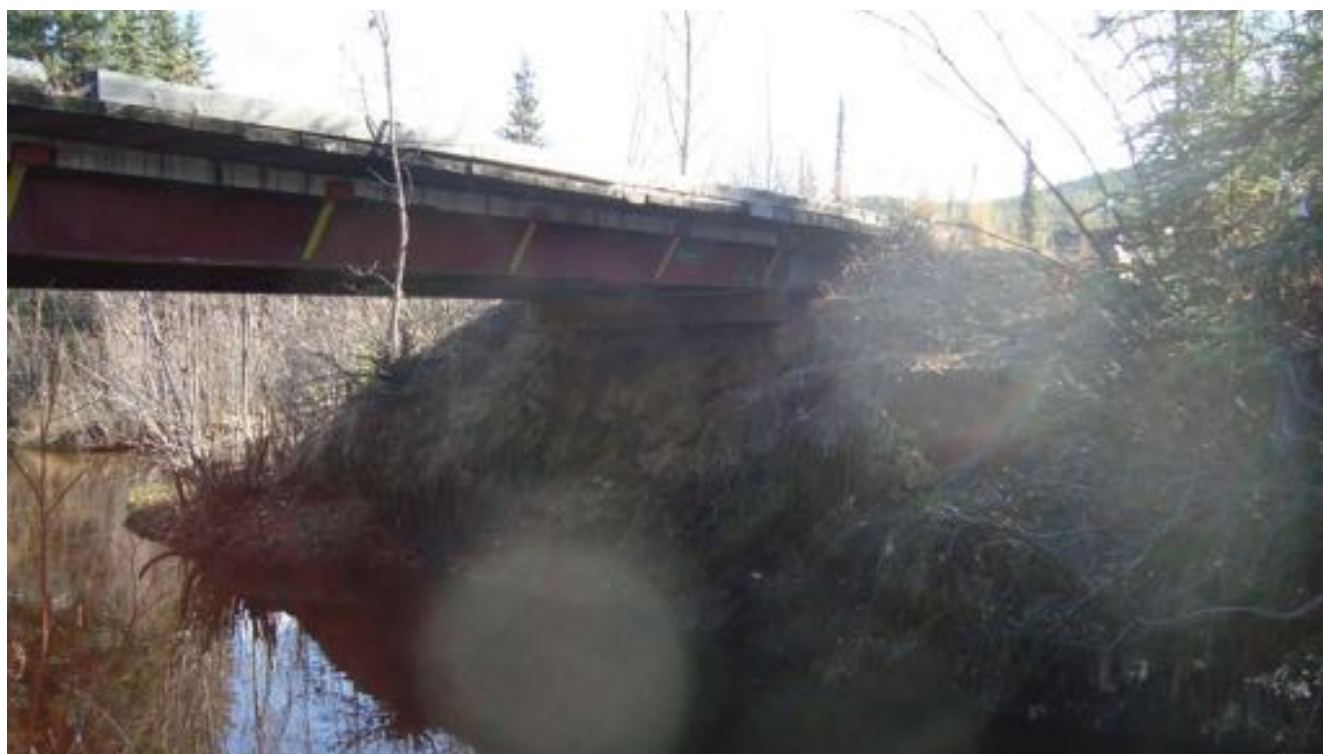
The access road crossing at Merrice Creek includes a single-span bridge set on grade (Photograph 18). Following recommendations in the July 2014 inspection memorandum, the bridge was extended by approximately 3 m and seated 1 to 2 m on the abutments. Approximately 3 m of steel was welded to the existing span, bridge decking was replaced and extended, and the approaches were re-graded to the bridge deck elevation.

The bridge was observed to be in a satisfactory condition and is securely anchored at each of the abutments. The right (or southern) abutment is steep sided and there is evidence that erosion may be continuing to occur at this location under high-flow conditions. The bridge should be monitored annually and following large rainfall events. In the event that erosion begins to compromise the stability of the abutment, consideration should be given to the installation of erosion protection at this location.

Photograph 18: Bridge crossing at Merrice Creek
