2018 ANNUAL QUARTZ MINING LICENCE REPORT

**Submitted to Yukon Government, Energy Mines and Resources
Yukon Quartz Mining Licence QML-0007**

Carmacks Copper Project, Yukon Territory

Appendix A Annual Engineer’s Inspection Report, October 24, 2018

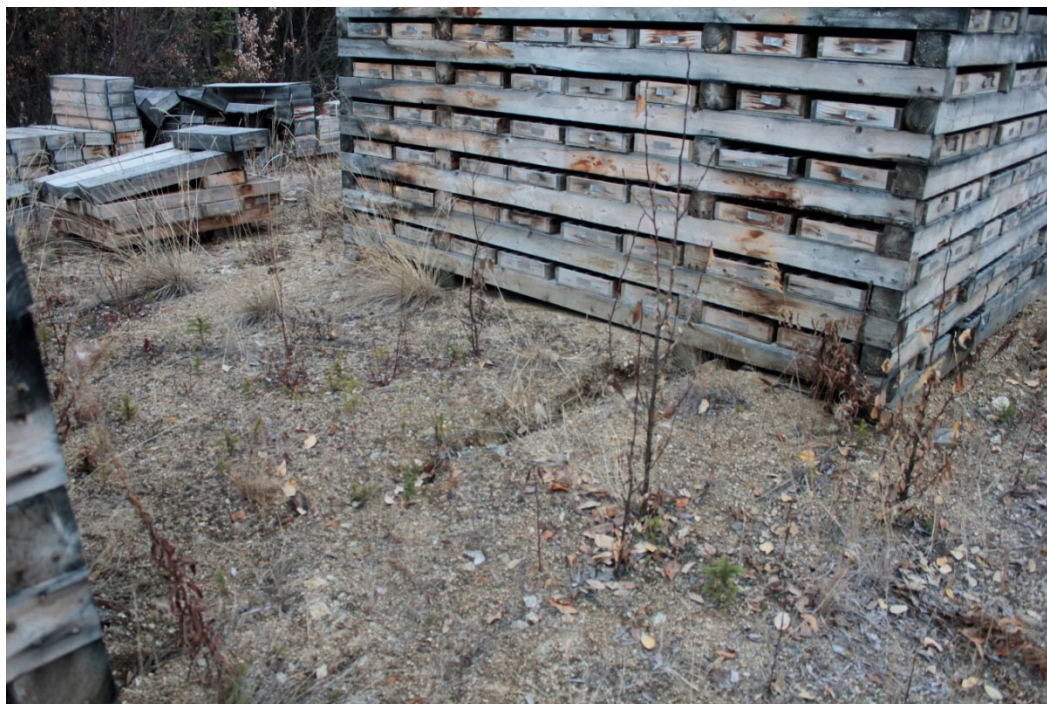
In previous years, inspections of the camp area have noted the presence of cracking, most likely resulting from thaw induced settlement beneath and adjacent to core storage racks. During the current inspection, only one crack was observed in the vicinity of the core storage racks (Photograph 1). In general, the appearance of cracks in the core storage rack area was consistent with the 2017 inspection. There appears to have been some infilling of cracks observed during previous inspections. The area is also characterised by the regrowth of vegetation around the core racks and a general decrease in the magnitude of settlements occurring with time. As in previous years, settlement in this area does not represent a safety concern and the inspection did not indicate erosion of sediments from the pad area into the surrounding natural area.

Photograph 1: Crack beneath core storage rack

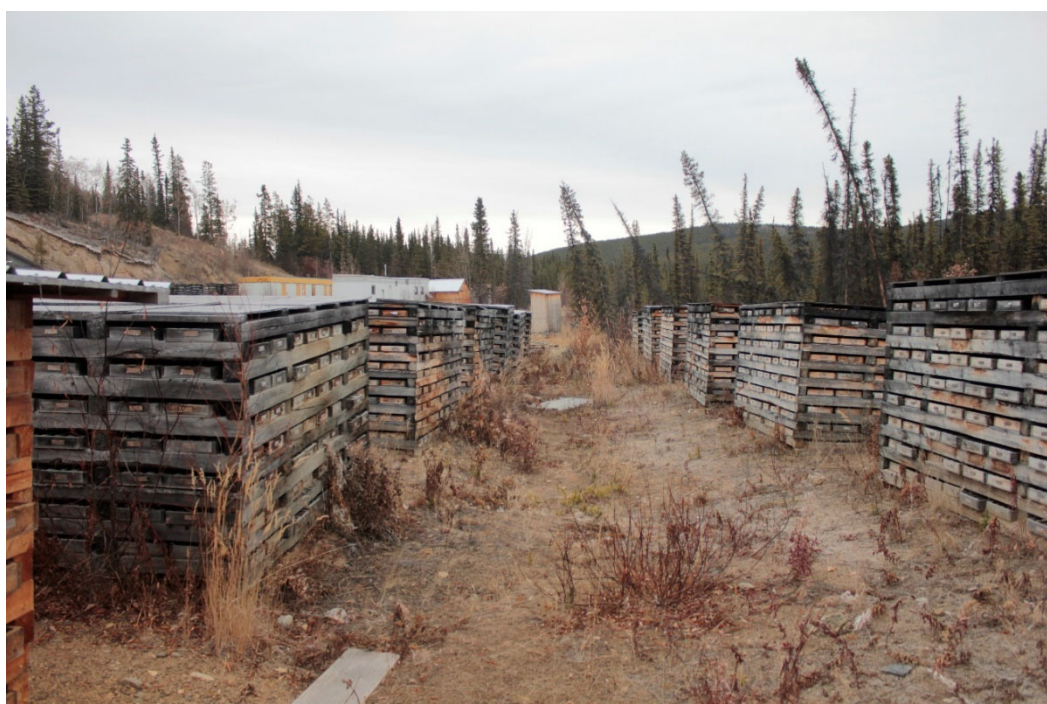
There are two heated buildings, the core shack and geology office, located adjacent to the core storage racks (Photograph 2). The tanks, valves and hosing were in a satisfactory condition, at the time of inspection. Liners have been placed beneath each tank to act as secondary containment for potential leaks and were also in a satisfactory condition.

Photograph 2: Core storage racks

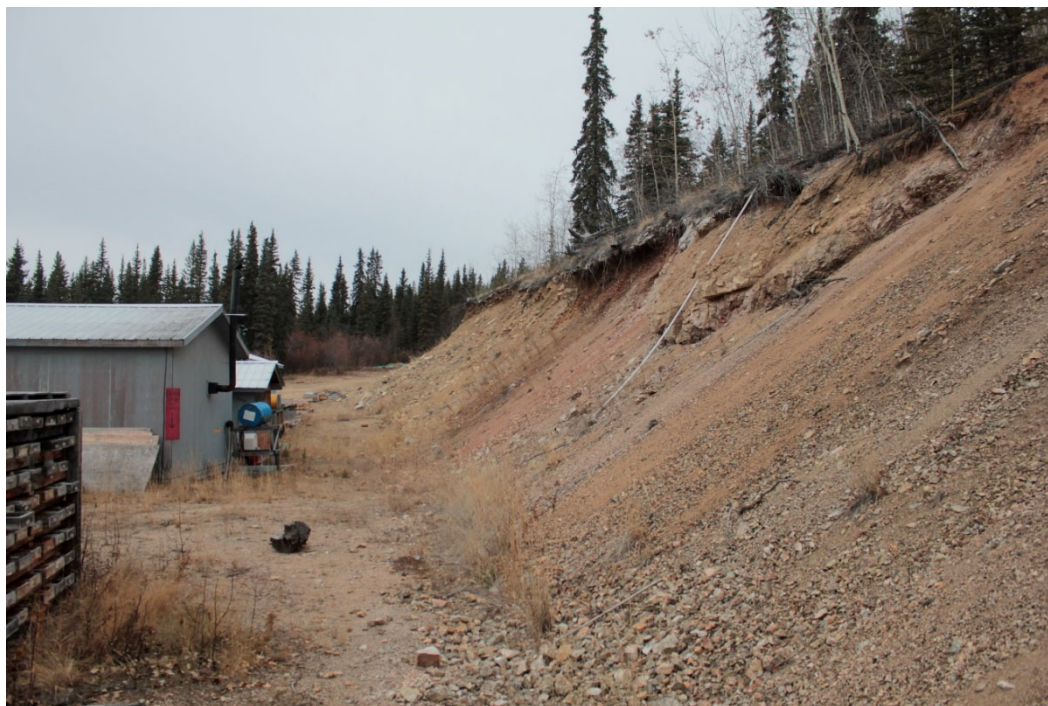
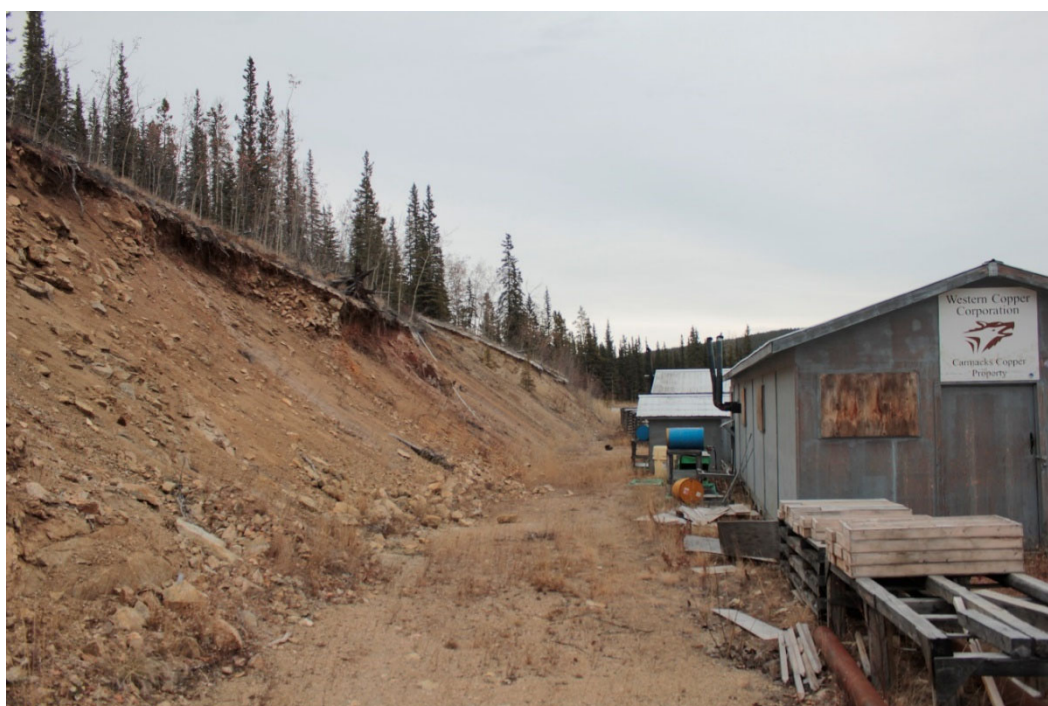
The slope behind the camp (Photographs 3 and 4) is stable and does not pose a safety concern for the camp structures or current operations. There is minor ravelling of small sections of the slope, but these are not impacting camp safety nor would they represent a risk for workers on the project. Some regrowth of vegetation was observed in the camp area.

Photograph 3: Cut-slope behind camp geology office and core shack

Photograph 4: Cut-slope behind the camp geology office and core logging shack

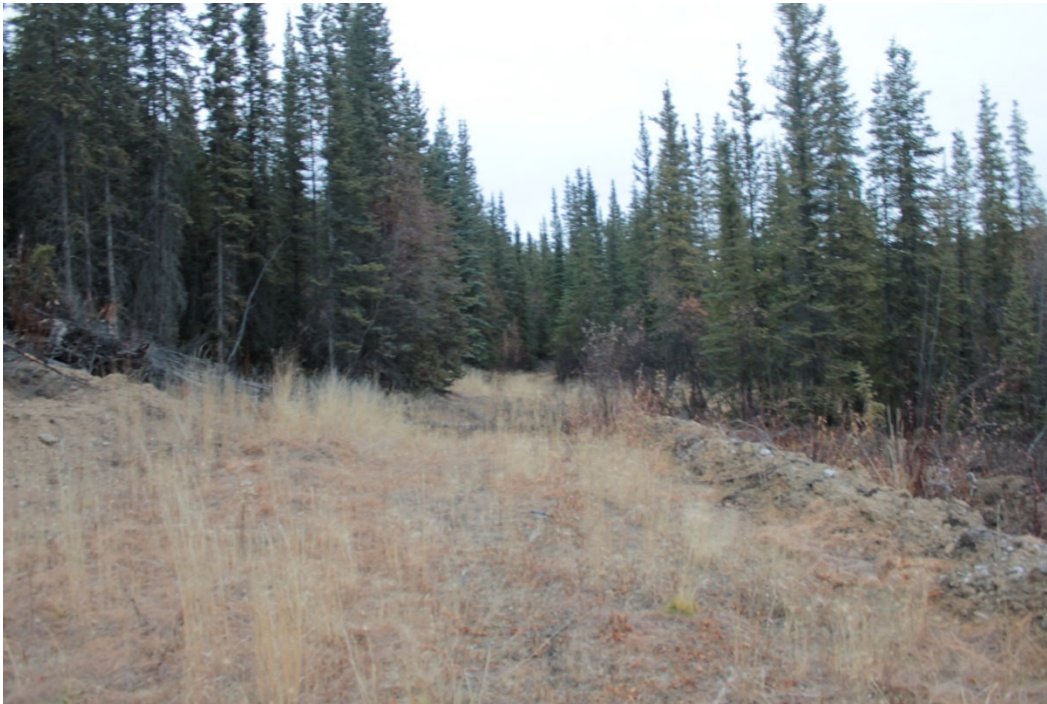
Photograph 5: Vegetation regrowth on access roads

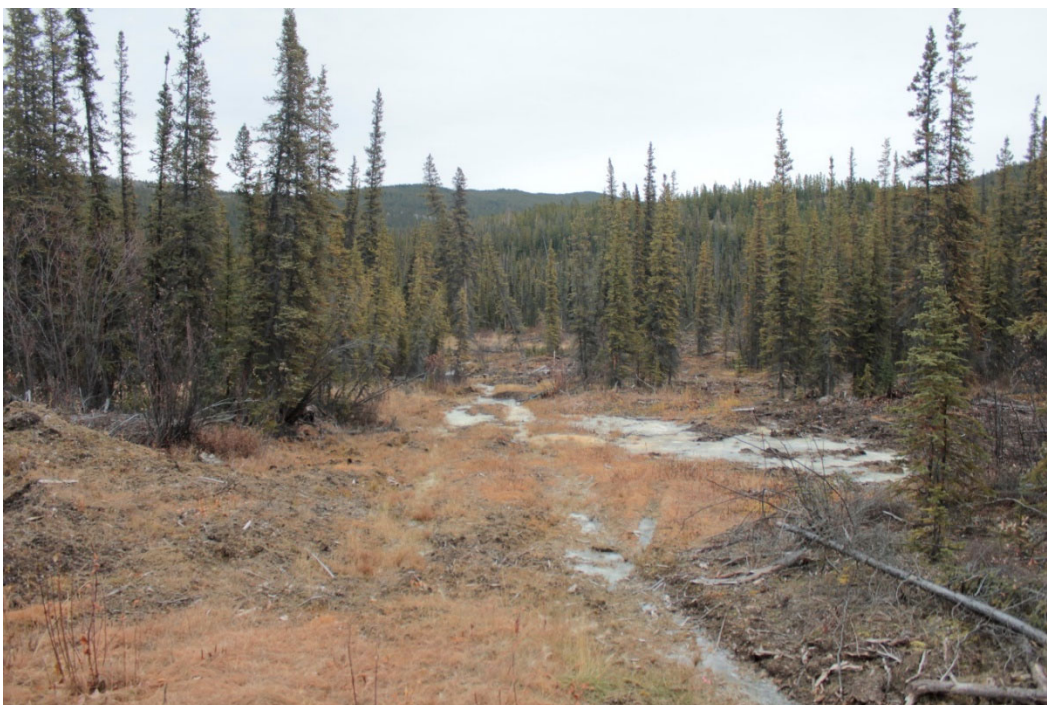
Photograph 6: Vegetation regrowth in 2015 drilling area and proposed water management pond area

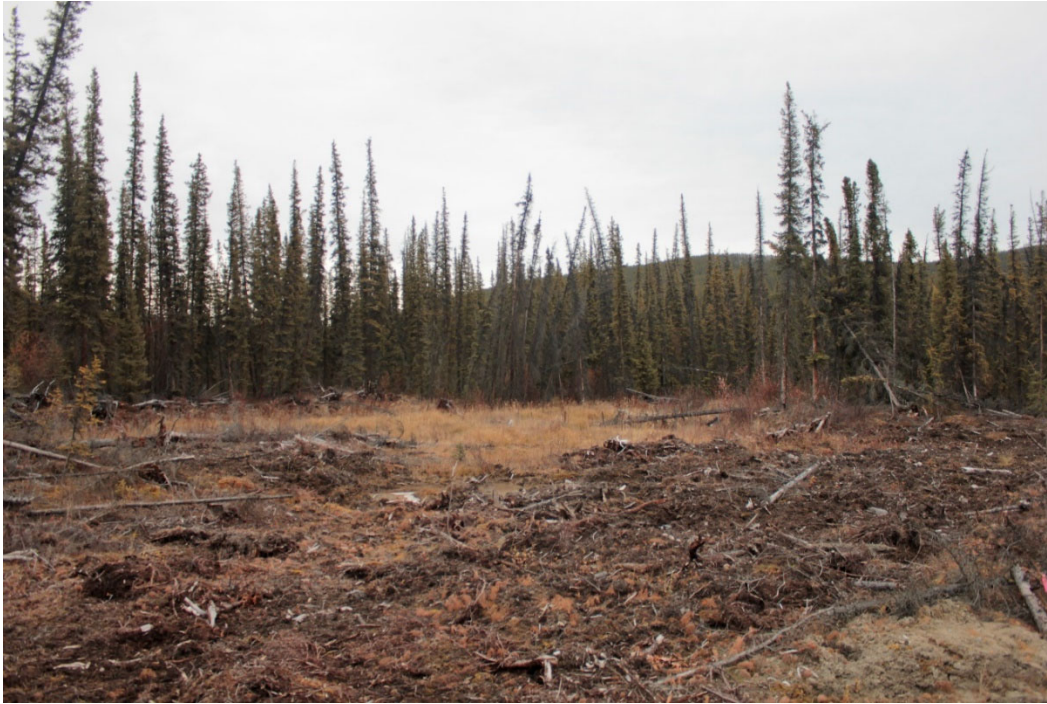
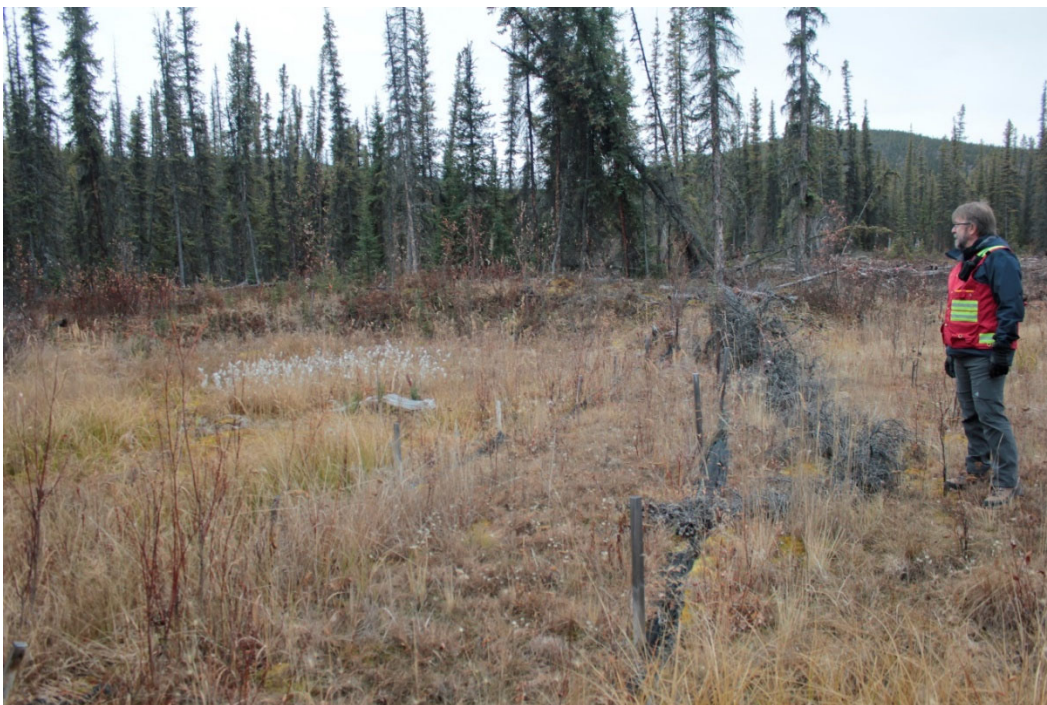
Further downstream, within the floodplain of Williams Creek, silt fences have been installed and the area seeded where sediment from previous site erosion accumulated (Photographs 7 and 8). Grass seed was applied in 2009 to promote the re-establishment of vegetation and to further stabilize sediment. The approach was noted to be generally effective in 2011 and 2012, but with limited regrowth attributed to periodic pooling of water. The area was also re-vegetated with woody plants (willow cuttings), and these plants are now well established. Volunteer species of grass and woody plants are performing very well. There was no evidence of sediment movement, indicating that re-vegetation has been effective in minimizing erosion. Silt fencing surrounding these areas is now overgrown and there is no evidence of sediment movement through the area. Silt fences are typically a temporary measure and could be removed if no further disturbance is expected upgradient.

Photograph 7: 2017 drilling area and vegetation regrowth in Williams Creek floodplain

Photograph 8: Vegetation growth around sediment fencing

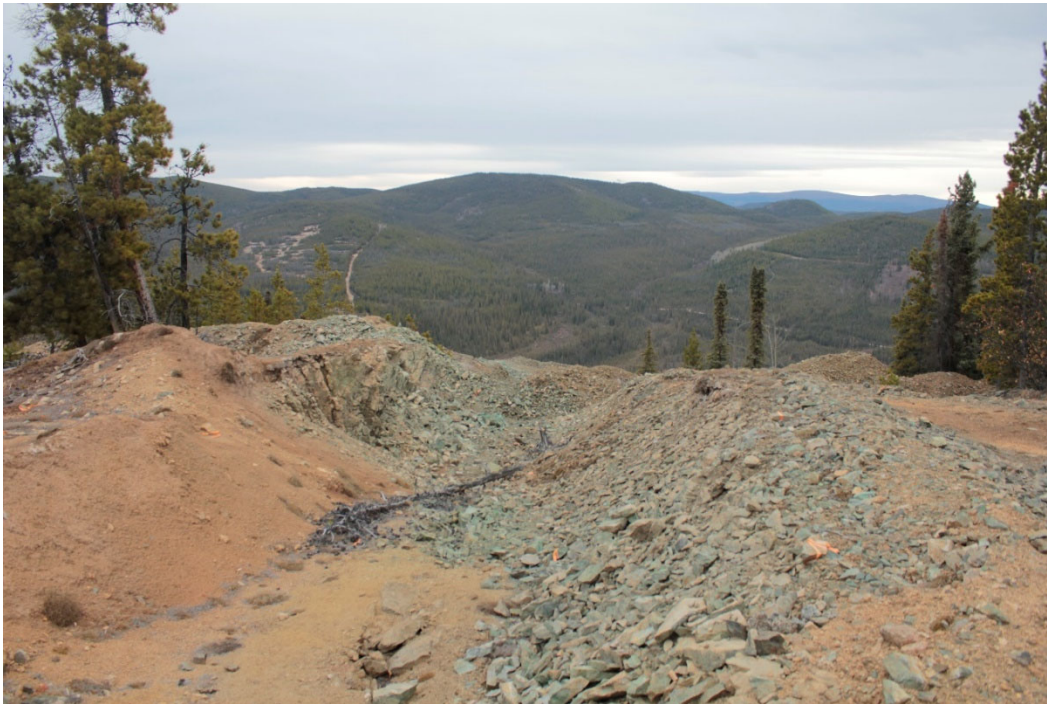
The area proposed for the open pit mine was inspected. The slopes of the trenches excavated as part of the effort to obtain bulk samples during exploration activities were observed to be in satisfactory condition (Photograph 9). There was no observed slumping or failures of the trenches and the slopes facilitate egress for wildlife. Several of the closed drill pads were inspected and there did not appear to be any erosion noted from these areas that would require attention.

Photograph 9: Exploration trench at the Discovery outcrop

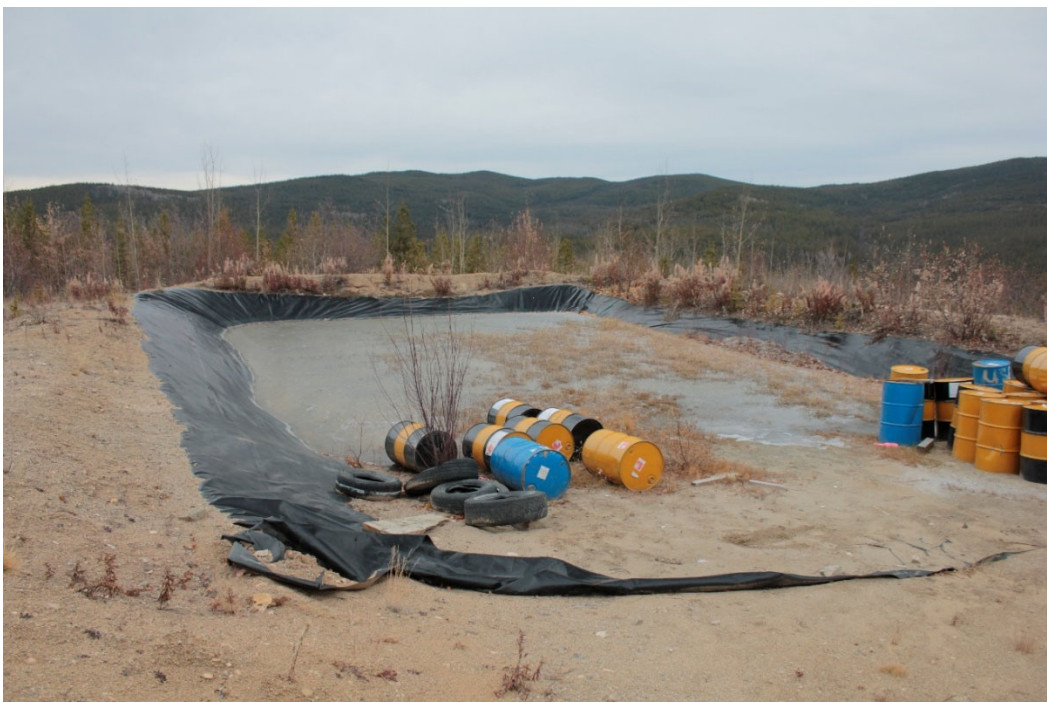
Photograph 10: Lined basin at fuel storage area

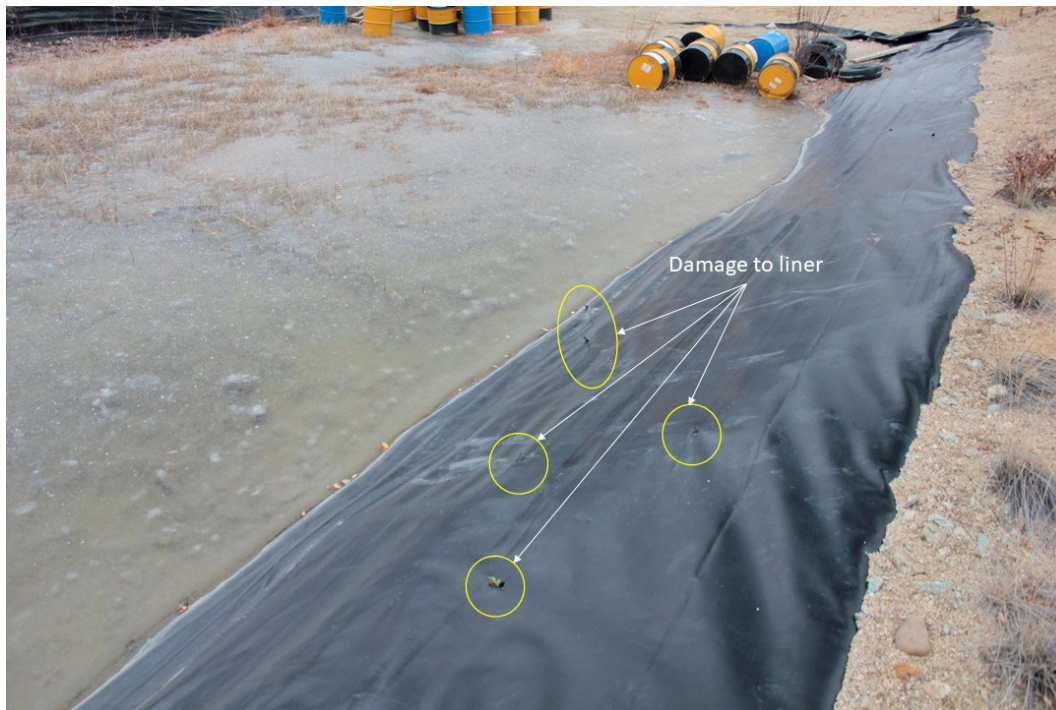
In the 2017 inspection, it was noted that an animal damaged the liner in a few locations (Photograph 11). The damage is still visible and the liner should be repaired. The fuel drums have since been organized in a manner to allow wildlife egress from the basin. There is some vegetation growth along the top of the containment berms and within the lined basin. There is one small shrub that is growing on the soil within the bermed area. There is the potential that the roots of the shrub penetrate through the liner. At the time when repairs to the liner are made, the shrub should be removed, the area inspected and repaired, if required.

Photograph 11: Liner damage at fuel storage area

- The beaver dam located downstream of the Merrice Creek crossing should be dismantled.
- Water crossings, including the bridge abutments at Merrice Creek, should continue to be inspected annually and following major rainfall events. Maintenance should be carried out, as required to maintain the functionality and safety of these crossings.
- The damage to the liner at the fuel storage area should be repaired.

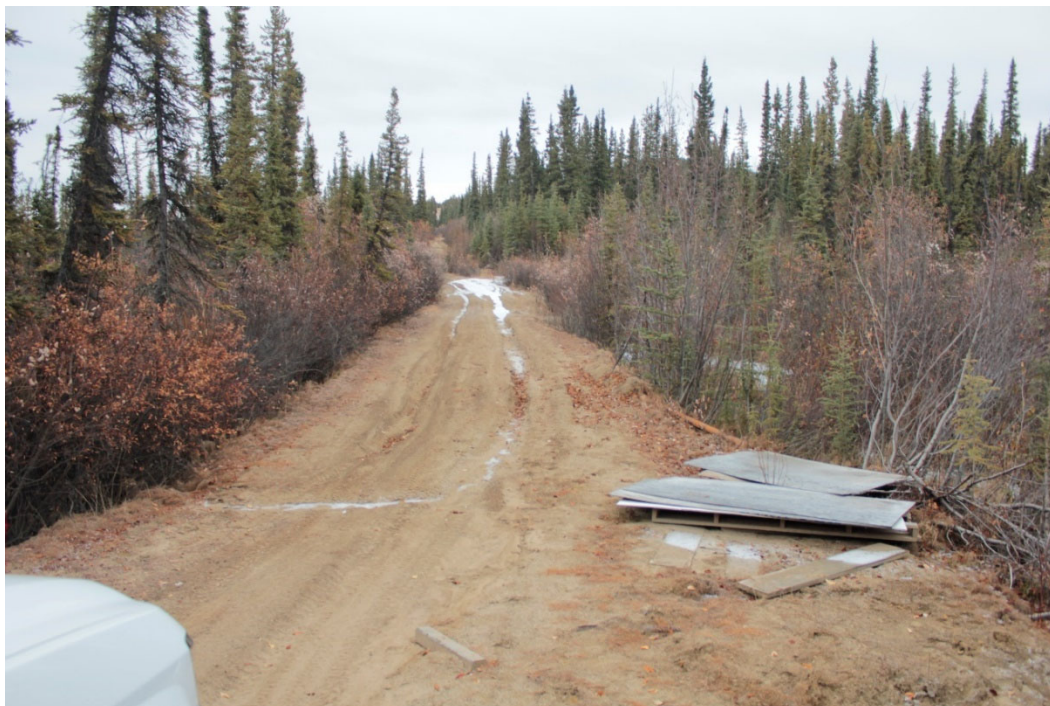
The main access road to the north of the proposed waste rock storage area was observed to be in good condition with only minor erosion observed. Damage to the road near North Williams Creek noted in the 2017 inspection report have since been repaired (Photograph 12). The North Williams Creek culvert has undergone some crushing and has accumulated some sediment (Photographs 13 and 14). However, the culvert remains adequate to accommodate the relatively minor flows observed at of the inspection. There is no visual evidence to indicate that erosion is occurring near the culvert. The access road should be inspected annually and ongoing maintenance of drainage features and erosion management should be anticipated.

Photograph 12: Road near North Williams Creek

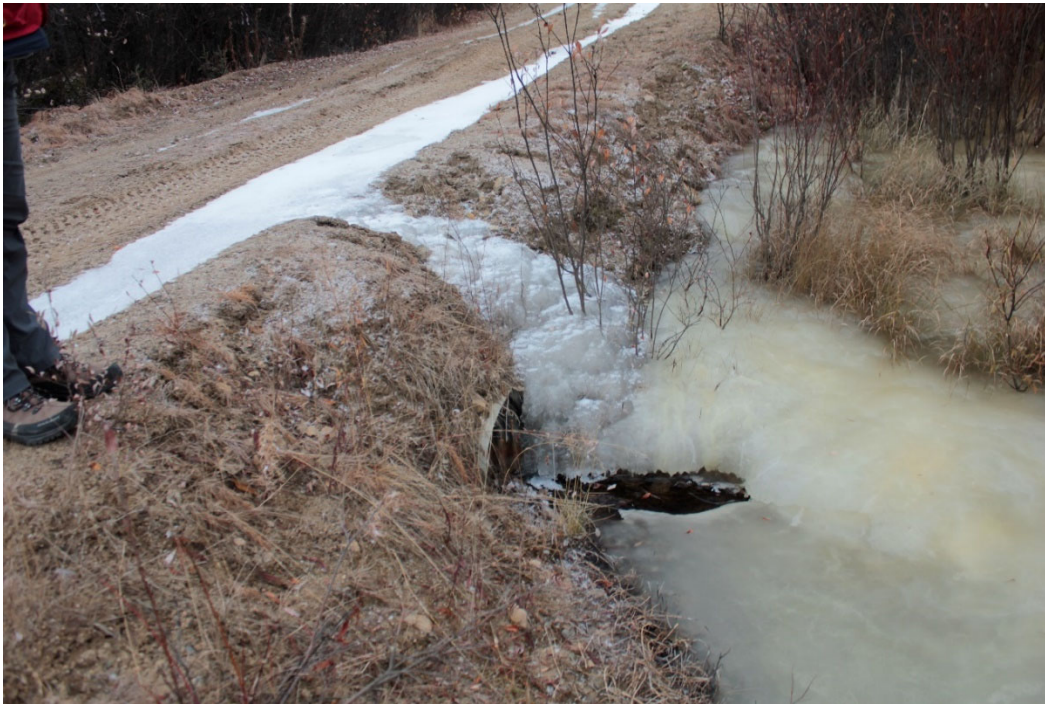
Photograph 13: Culvert inlet beneath road at North Williams Creek

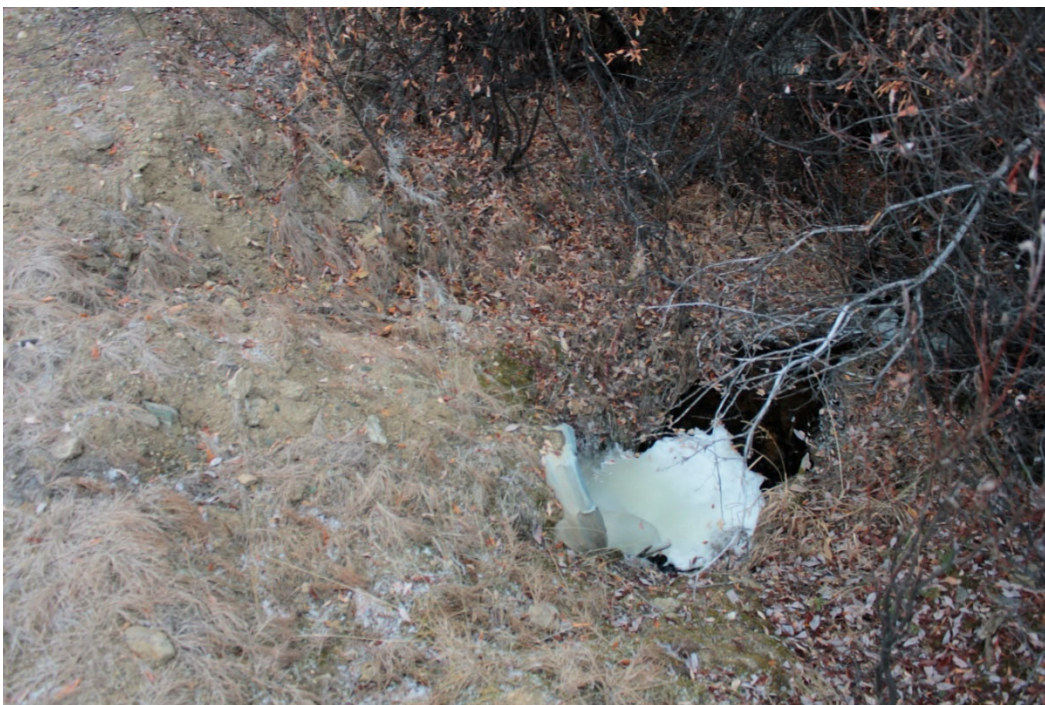
Photograph 14: Culvert outlet beneath road at North Williams Creek

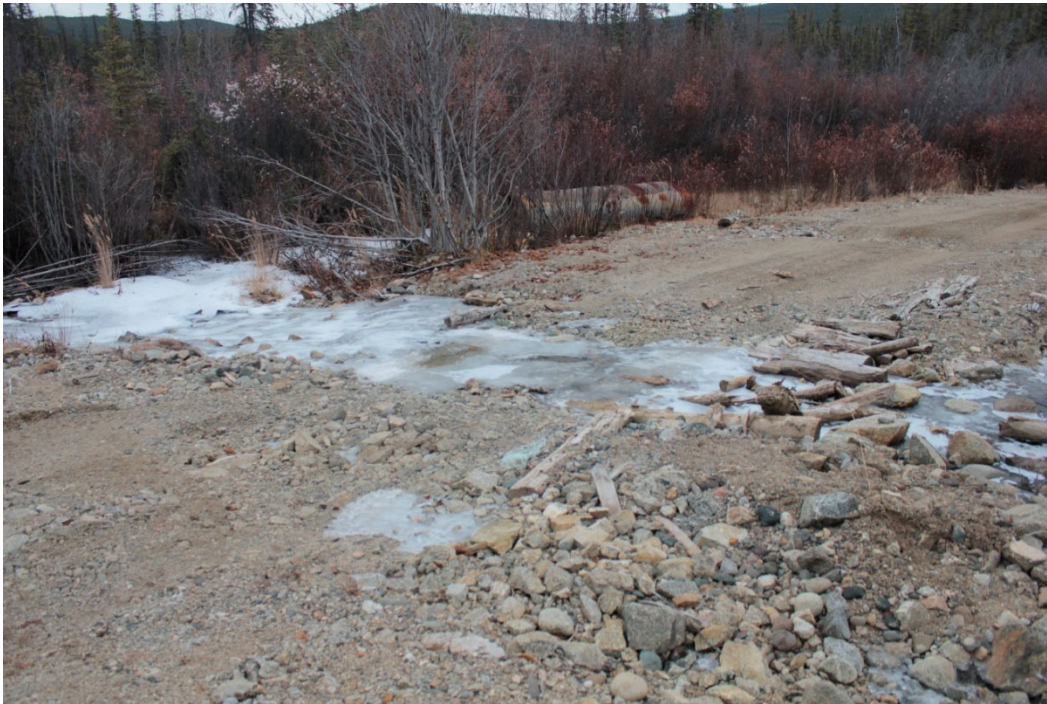
The ford road crossing installed at Williams Creek in 2013 continues to function as intended (Photograph 15). The rockfill in the ford is well-graded and there is no indication of movement of finer materials. Ponded water was observed on the upstream side of the road, with flow across the road. It is possible that a large rainfall event could result in erosion. We therefore recommended that the ford continue to be inspected annually and maintenance be carried out, if required. The ford is appropriate for the current status of the project. However, prior to site development, it is recommended that the crossing is to be upgraded.

Photograph 15: Williams Creek ford crossing

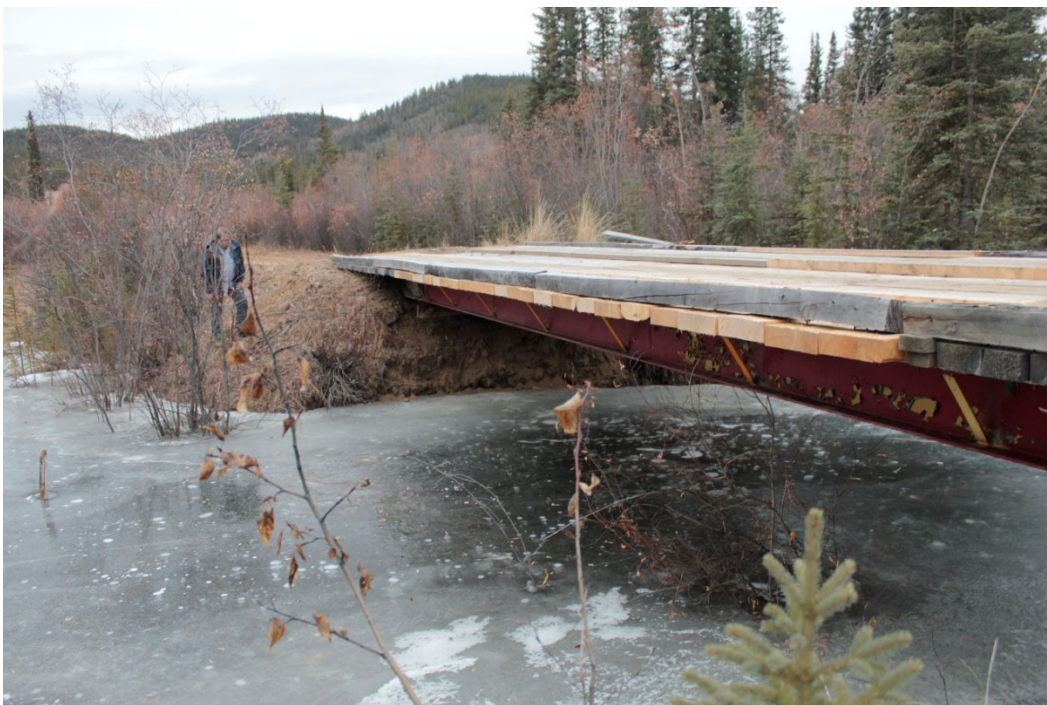
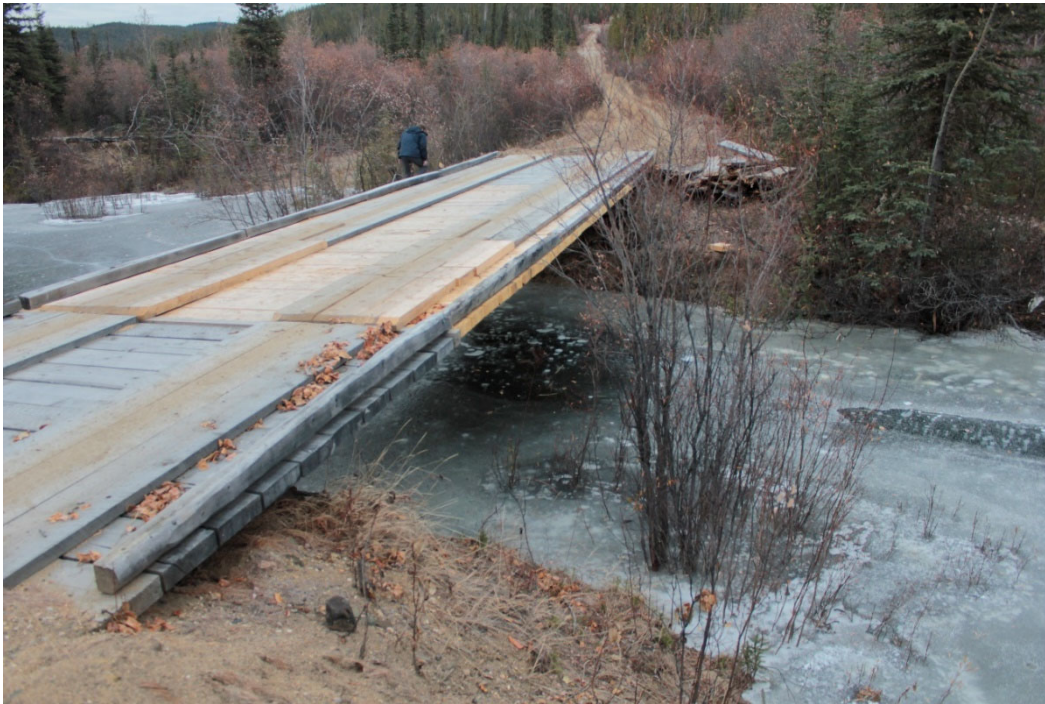
The access road crossing at Merrice Creek includes a single-span bridge (Photographs 16 and 17). Following recommendations in the July 2014 inspection memorandum, the bridge was extended by approximately 3 m and seated 1 to 2 m on the abutments. Approximately 3 m of steel was welded to the existing span, bridge decking was replaced and extended, and the approaches were re-graded to the bridge deck elevation.

At the time of the inspection there was a large beaver dam downstream of the bridge which had caused higher than normal water levels in Merrice Creek, for the time of year. The bridge was observed to be in a satisfactory condition and is securely anchored at each of the abutments. The right (or southern) abutment is steep sided and there is evidence that erosion may be continuing to occur at this location under high-flow conditions. The bridge should be monitored annually and following large rainfall events. In the event that erosion begins to compromise the stability of the abutment, consideration should be given to the installation of erosion protection at this location.

Photograph 16: Bridge crossing at Merrice Creek – downstream side

Photograph 17: Bridge crossing at Merrice Creek – upstream side
