October 9, 2012

Reference No. 1314270077-222-L-Rev0-1000

**ANNUAL INSPECTION, JULY 16, 2013  
CARMACKS COPPER PROJECT, CARMACKS, YUKON**

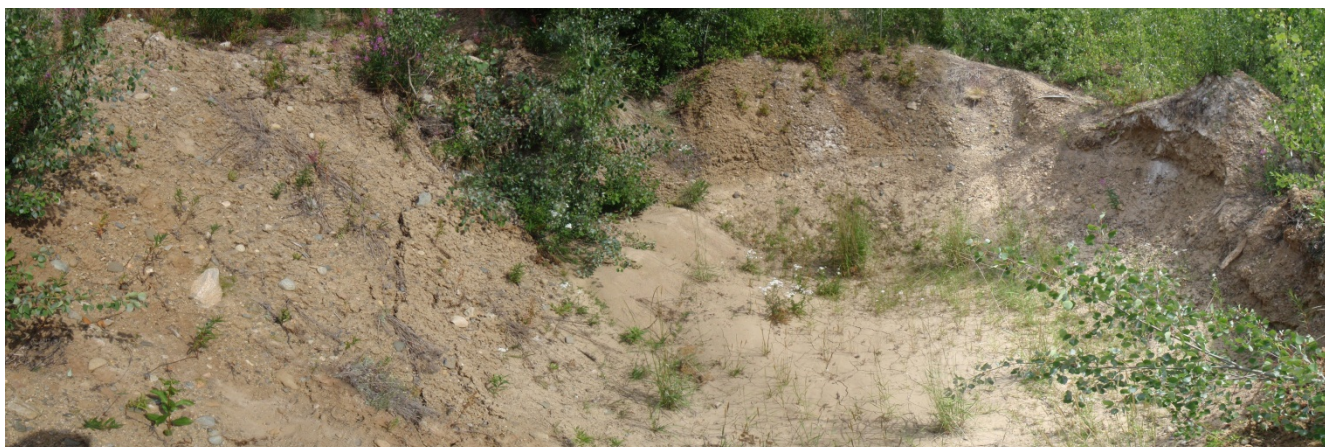
*Photograph 14: Drill pad sediment basin trap near the proposed Events Pond.*

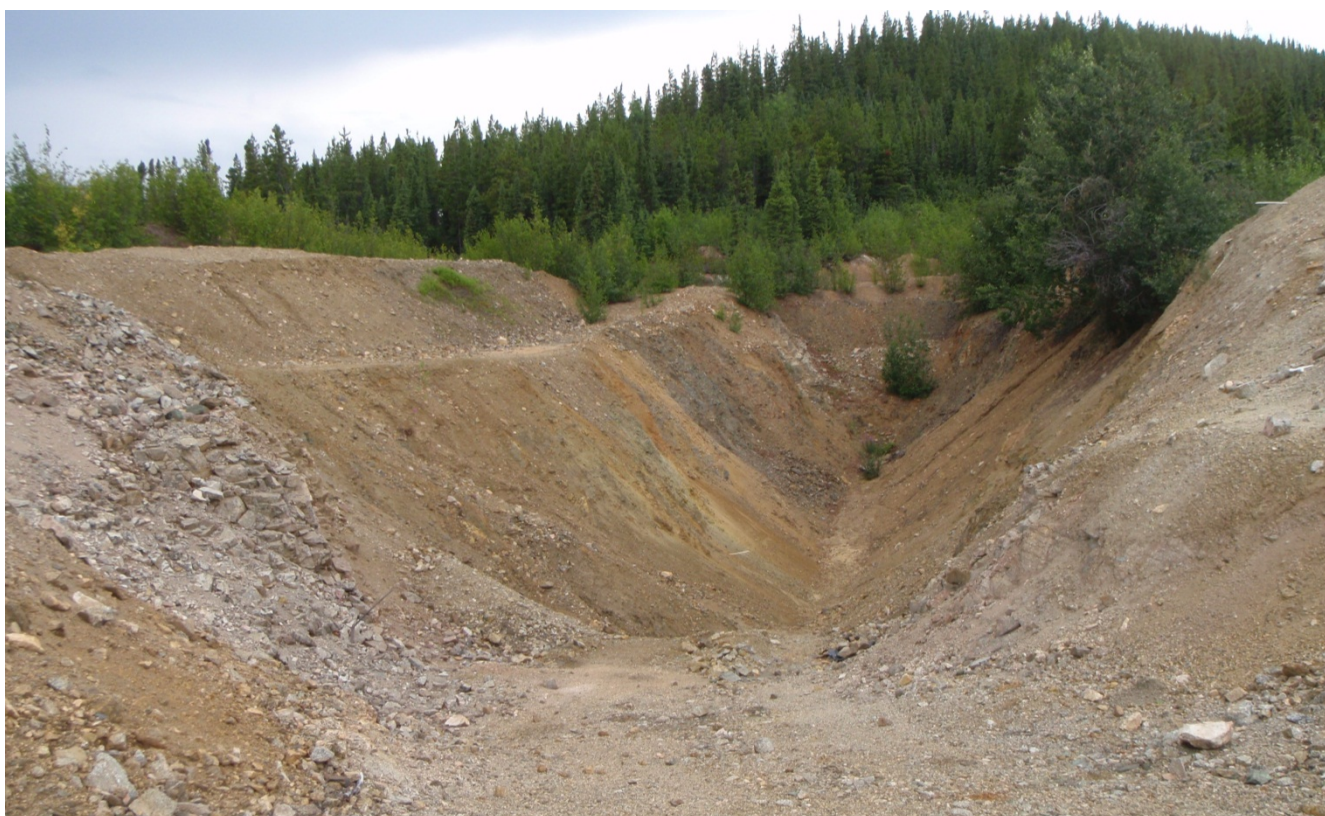
The area where the open pit is to be developed was inspected. The excavation slopes of the trenches developed as part of the effort to obtain bulk samples during exploration activities were observed to be in reasonable condition and there was no observed slumping or failures of these slopes. The leached ore pile from the off-site test pad adjacent the trench was observed to be stable and there was no erosion or slope movement of the material. Several of the closed drill pads were inspected and there did not appear to be any erosion noted from these areas that require attention.

*Photograph 16: Bulk sample excavation site.*

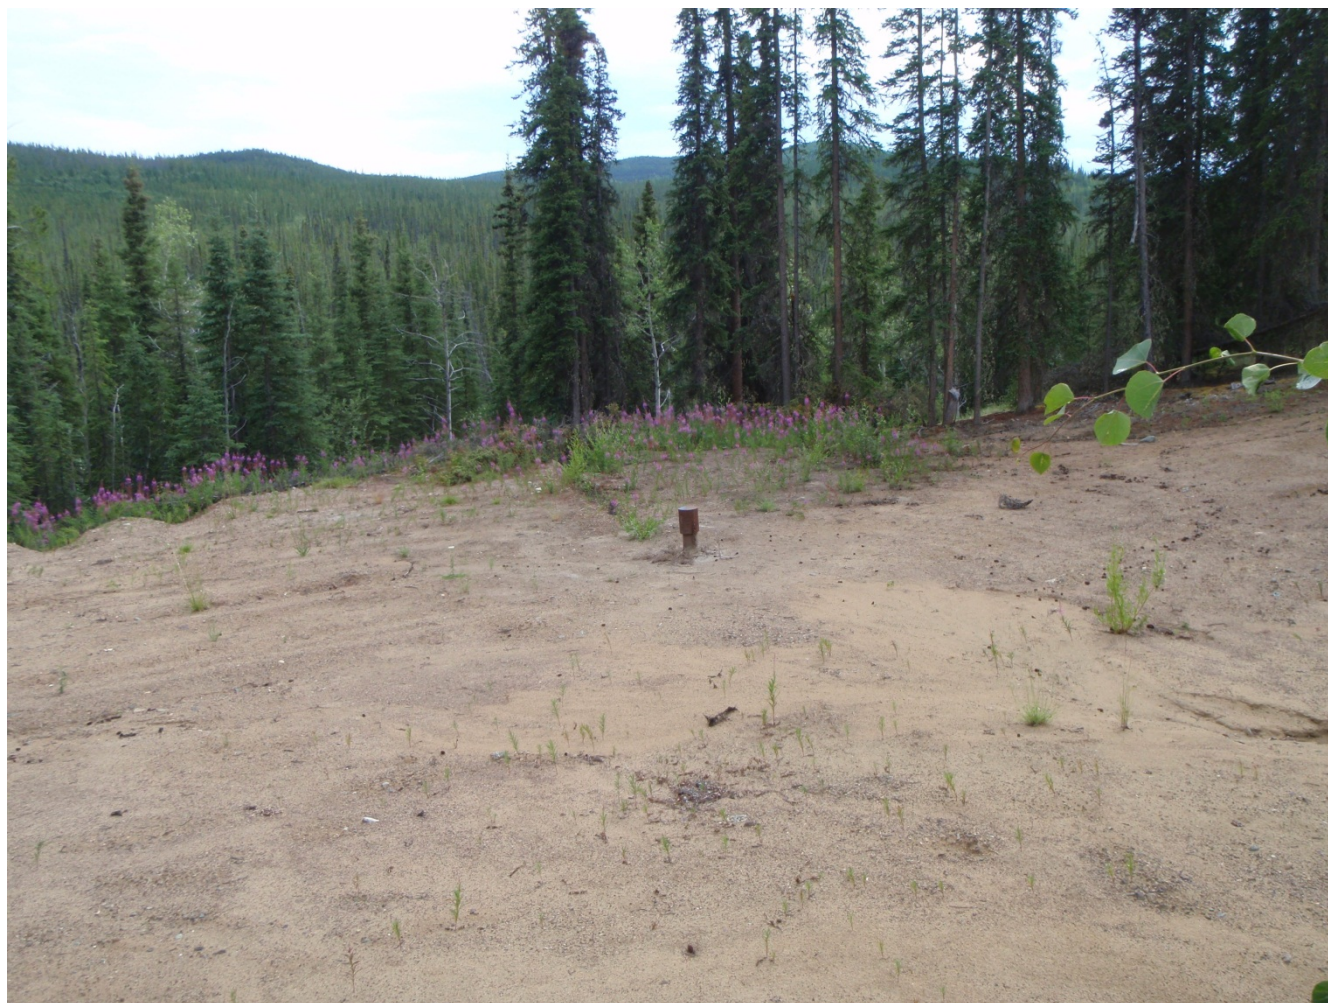
The proposed camp site was inspected and it is still tree covered. The site adjacent to the camp with two water wells was also inspected and there is no apparent movement of sediment beyond the work pads around the wells.

*Photograph 17: Water supply well and pad near proposed camp site.*
