2013 ANNUAL QUARTZ MINING LICENCE REPORT

Carmacks Copper Project, Yukon Territory

Reference No. 1314270077-222-L-Rev0-1000

**ANNUAL INSPECTION, JULY 16, 2013
CARMACKS COPPER PROJECT, CARMACKS, YUKON**

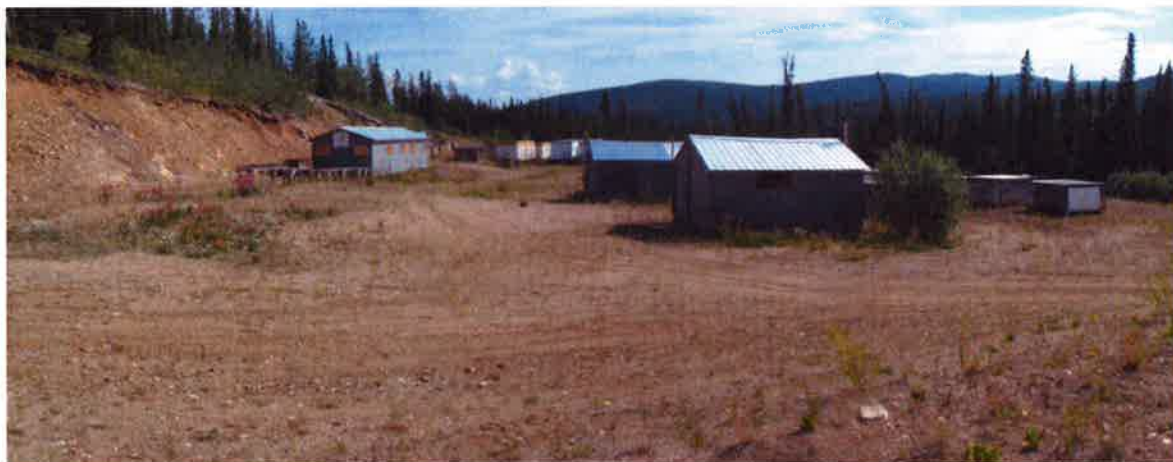
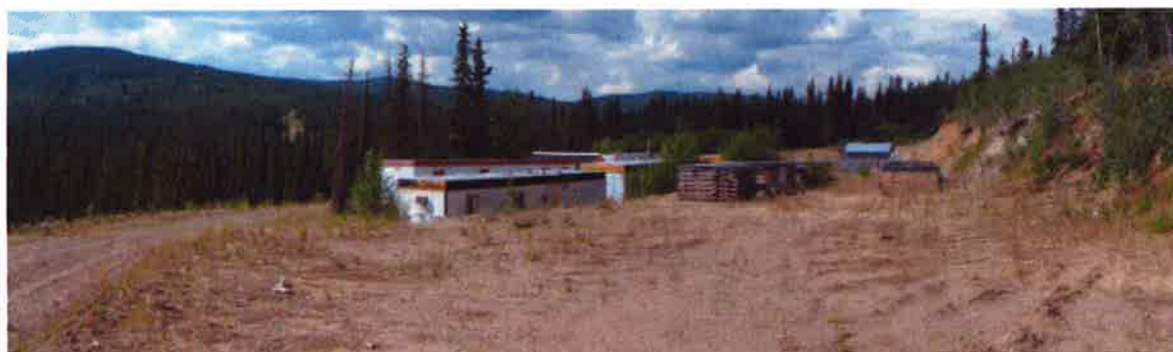
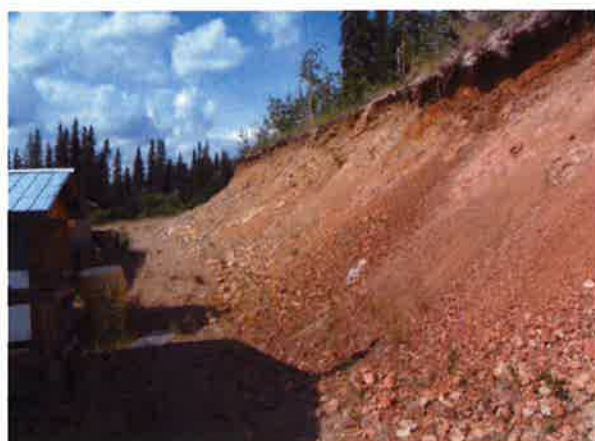
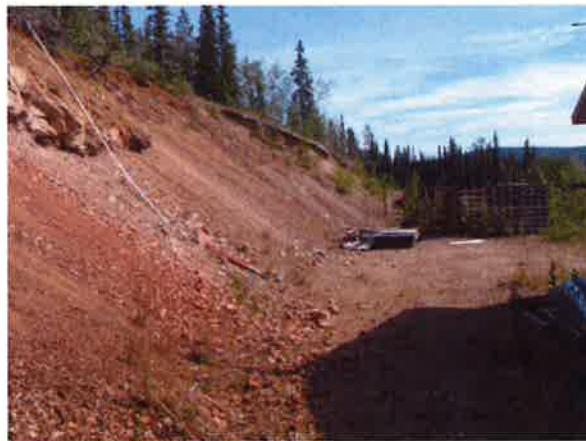
The inspection of the camp area indicated there is no erosion of sediments from the pad area into the surrounding natural area. The slope behind the camp is stable and is not impacting or causing any safety issues with the camp structures or operations. There is minor slumping and ravelling of small sections of the slope, but these are not impacting camp safety nor would they represent an issue to workers on the project. Some re-growth of vegetation was observed in the camp area. In addition, there was some cracking observed along the south edge of the pad (lower limit of pad), some 3 to 4 m from the pad edge.

Photographs 1 - 5: Carmacks exploration camp – views looking east to camp (top), looking west to camp (middle), slope immediately north of camp looking west (bottom left) and east (bottom right)

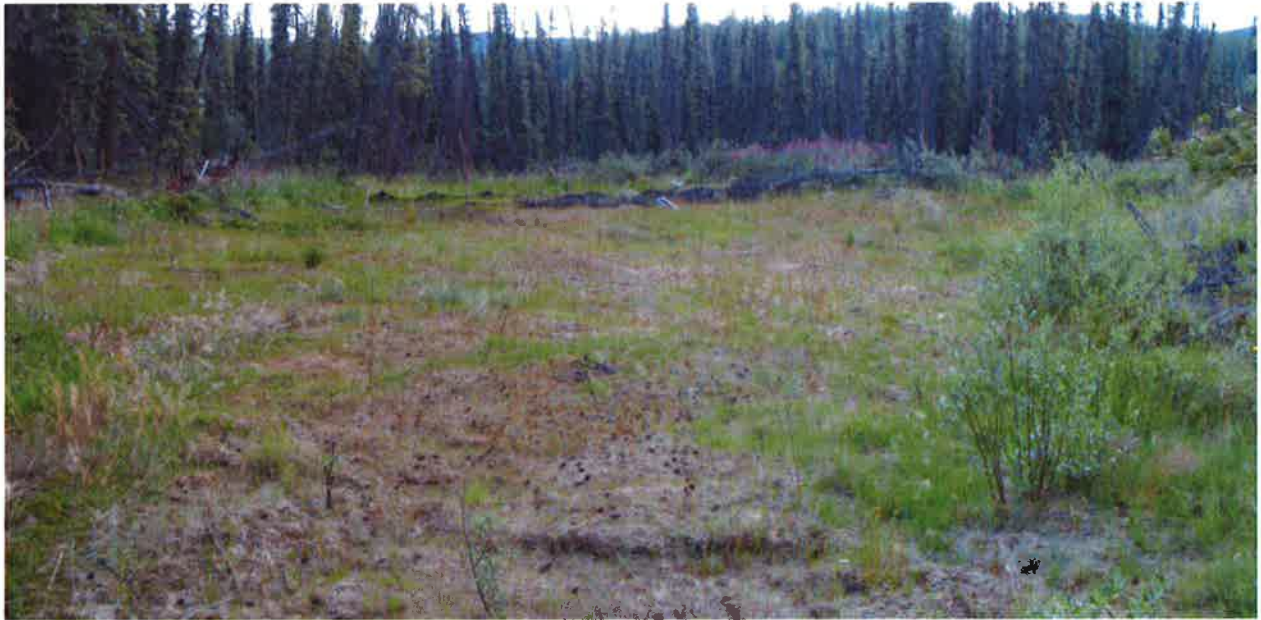
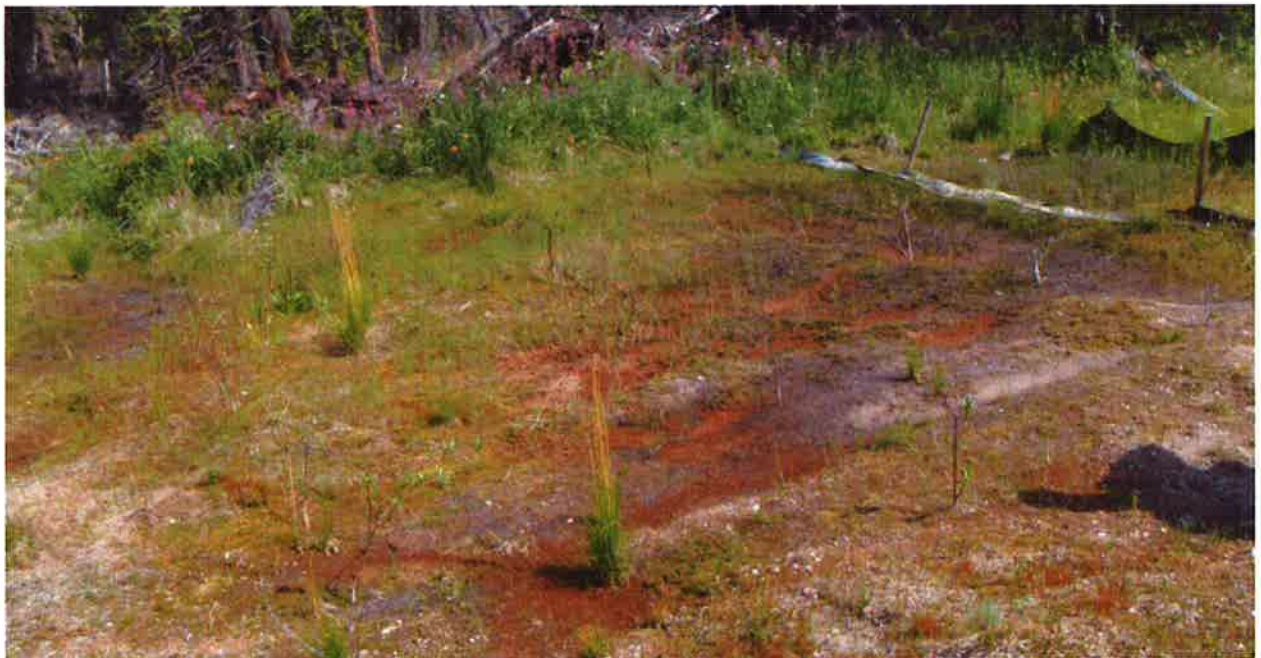
Further down slope of the proposed Heap Leach Facility Sediment Pond, and within the floodplain of Williams Creek, a series of silt fences have been installed and the area seeded where sediment from previous site erosion has accumulated. At the time of the inspection, it was observed that the silt fencing surrounding these areas is working effectively and there is no evidence of recent sediment movement. Grass seed was used in 2009 to promote the re-establishment of vegetation and further stabilize the sediment. The approach was noted to be generally effective in 2011 and 2012, but with limited re-growth attributed to periodic pooling of water. The area was re-vegetated with woody plants (willow cuttings), and plants appear to be tolerating saturated soil conditions. Conditions in 2013 were similar to 2012, with limited growth of the willow cuttings. No movement of sediment beyond the existing silt fences was observed, nor does it appear that sediment has entered Williams Creek. These erosion control measures are of a temporary nature that should be inspected annually and ongoing minor maintenance activities should be anticipated.

Photographs 6 - 7: Silt fences located between the area of the proposed Heap Leach Facility Sediment Pond and Williams Creek and re-vegetated area. Re-establishment of grass vegetation in this area appears to be hampered by the periodic pooling of water. Willow cuttings planted in 2011 had taken hold with limited new growth visible in 2013.

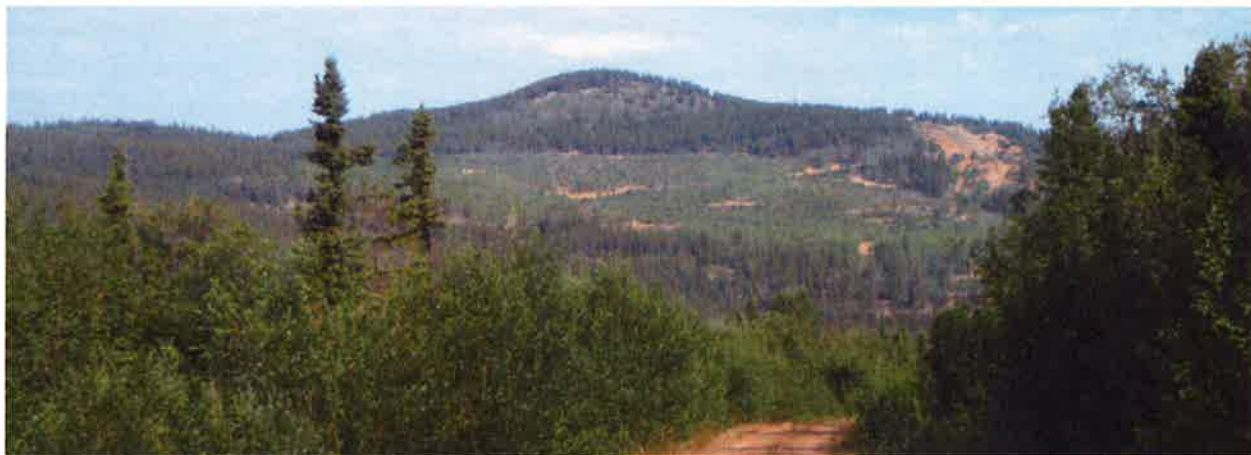
Photograph 8: View of proposed Heap Leach Facility and open pit areas (far slope) from site access road, looking north.

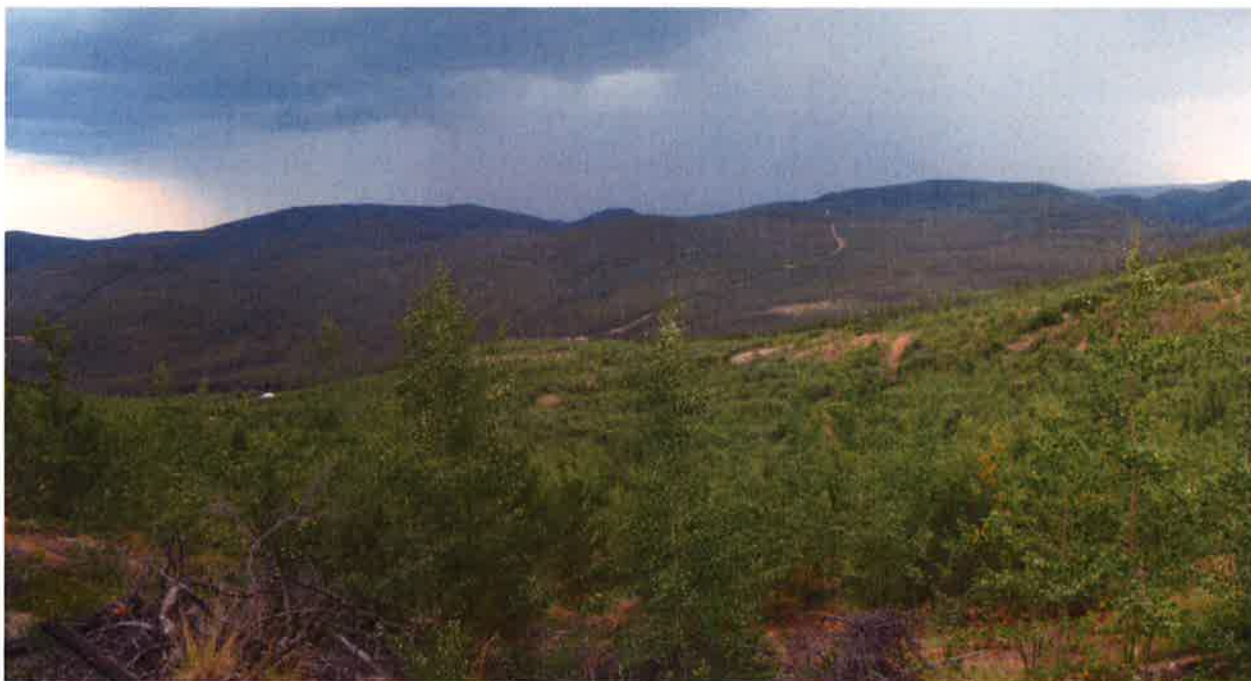
It is recommended that vegetation in the lower footprint area of the Heap Leach Facility and Confining Embankment be re-cleared of vegetation in 2013 or 2014 to promote thaw of permafrost ground prior to development of the area. Vegetation may allow re-establishment of permafrost and ground ice and should therefore the vegetation should be cleared to allow the ground to thaw over the warmer months.

Photograph 9: View of proposed Heap Leach Facility (foreground) looking south west.

It is recommended that vegetation in the lower footprint area of the Heap Leach Facility and Confining Embankment be re-cleared of vegetation in 2013 or 2014 to promote thaw of permafrost ground prior to development of the area. Vegetation may allow the re-establishment of permafrost and ground ice and the vegetation should therefore be cleared to allow the ground to thaw over the warmer months.

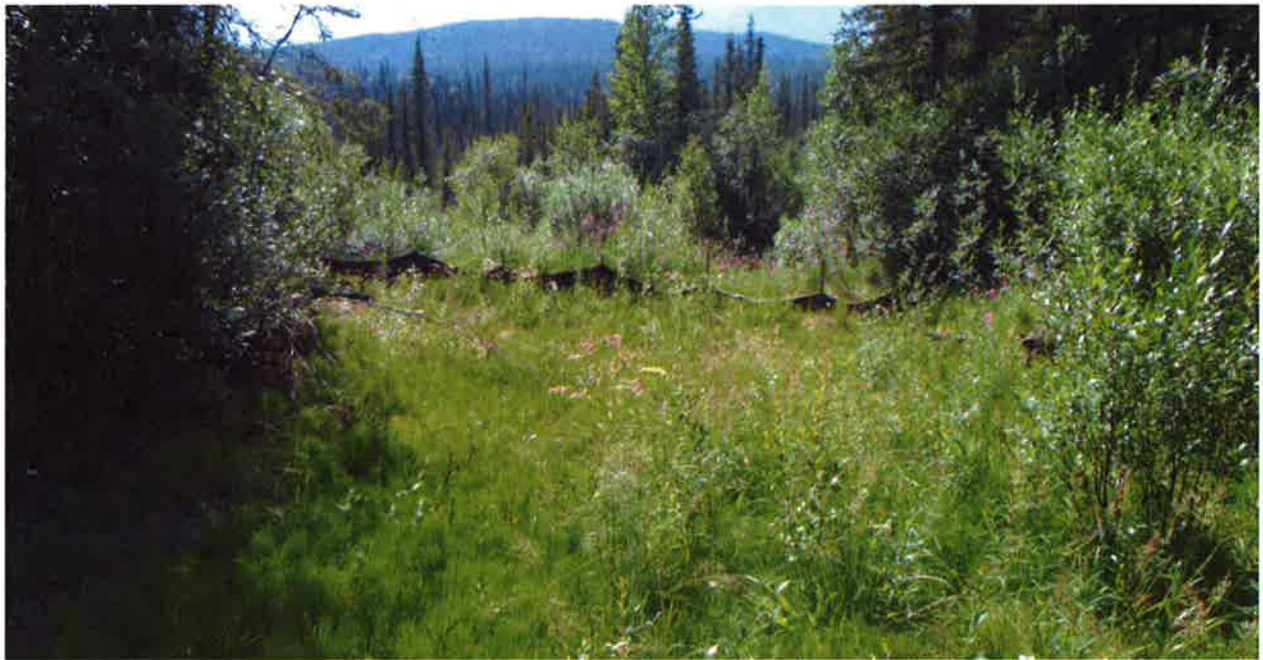
Photograph 10: Re-vegetation on drill access road in the Events Pond area.

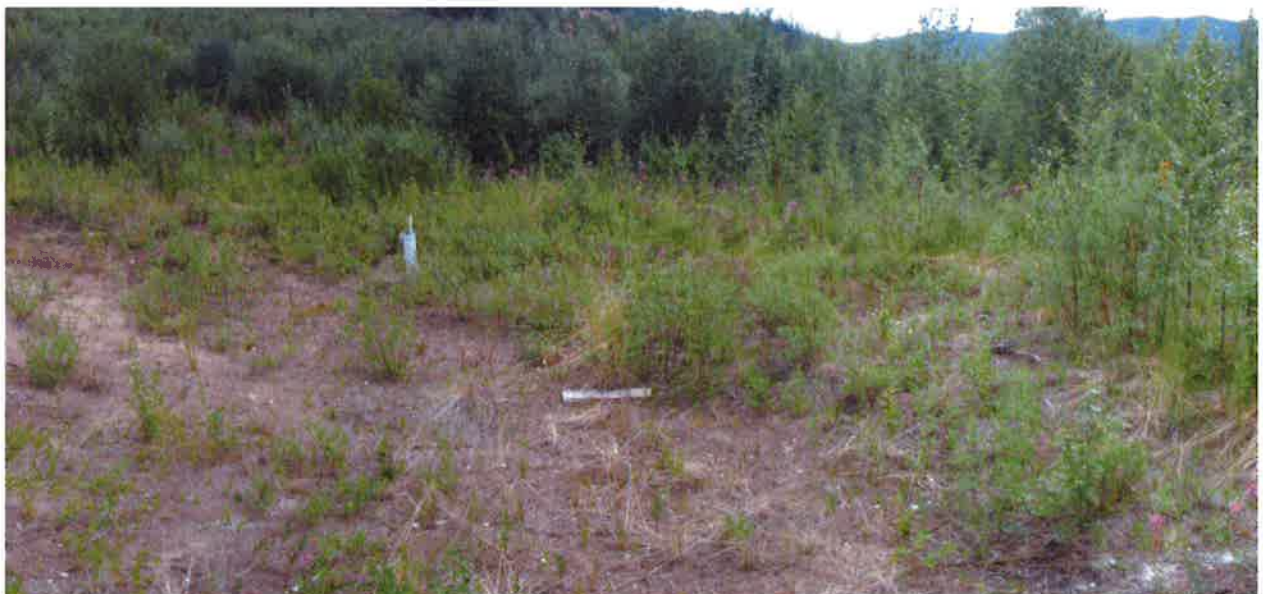
Photograph 11: Re-vegetation at BH17-07 drill pad in the Heap Leach Facility area.

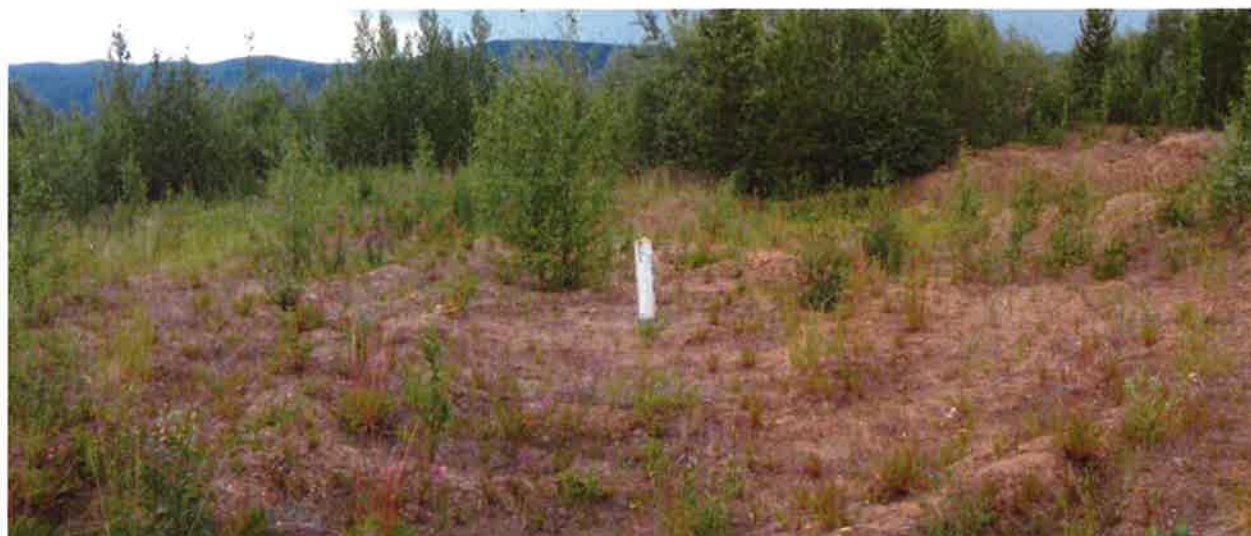
Photograph 12: Re-vegetation on BH-26-07 drill pad in the Heap Leach Facility area.

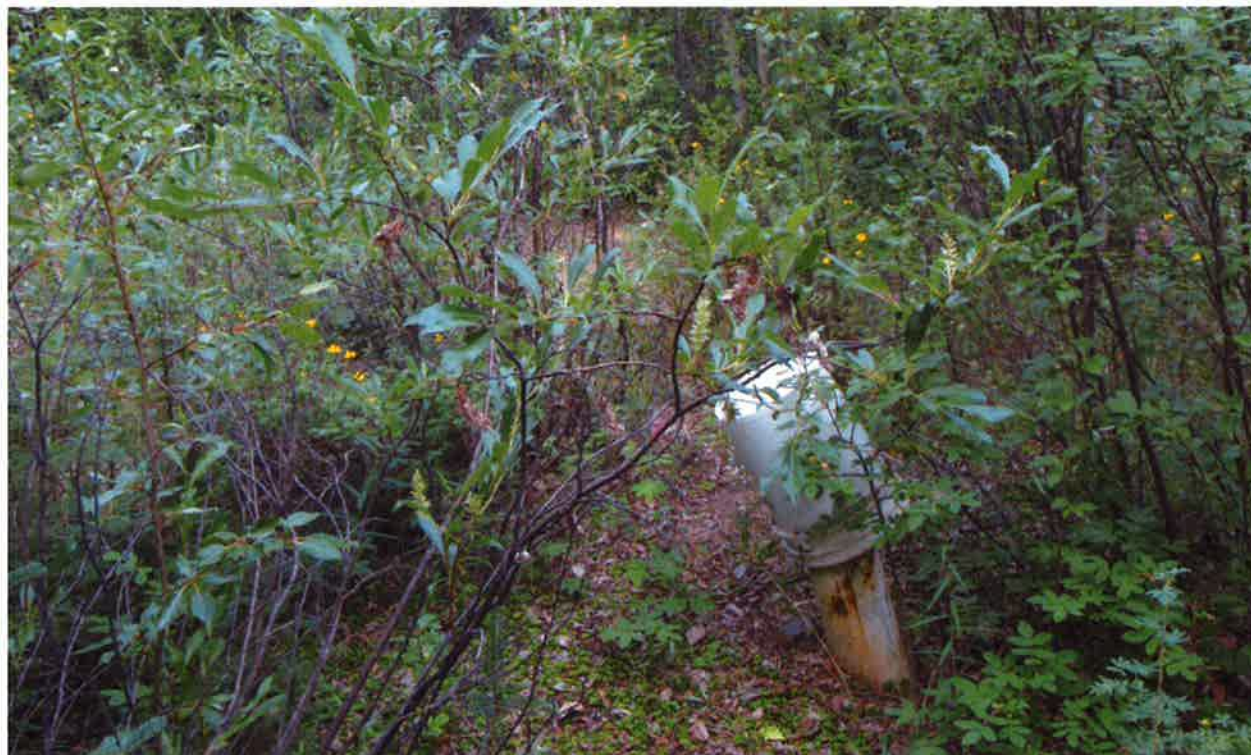
Photograph 13: Re-vegetation at DH95-H drill pad in the Heap Leach Facility area.

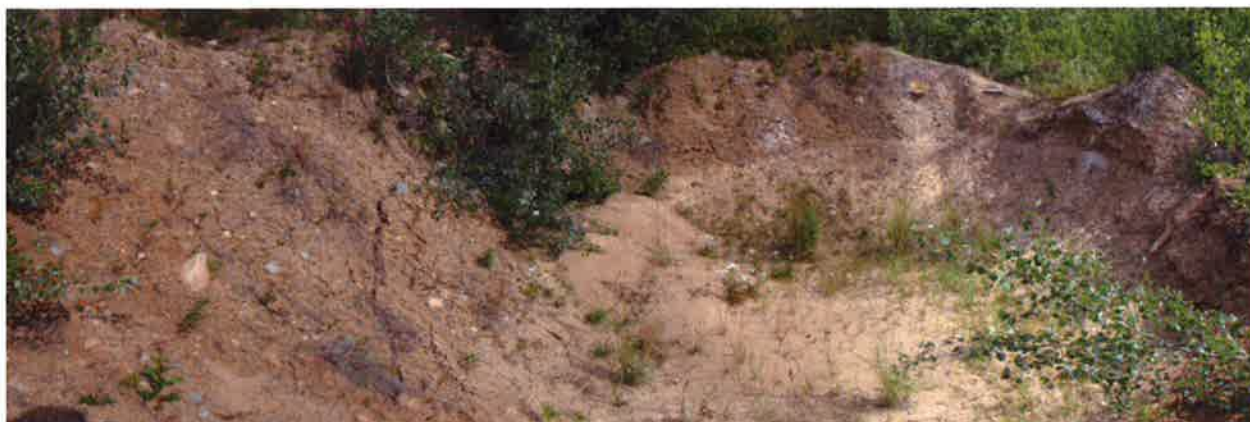
Photograph 14: Drill pad sediment basin trap near the proposed Events Pond.

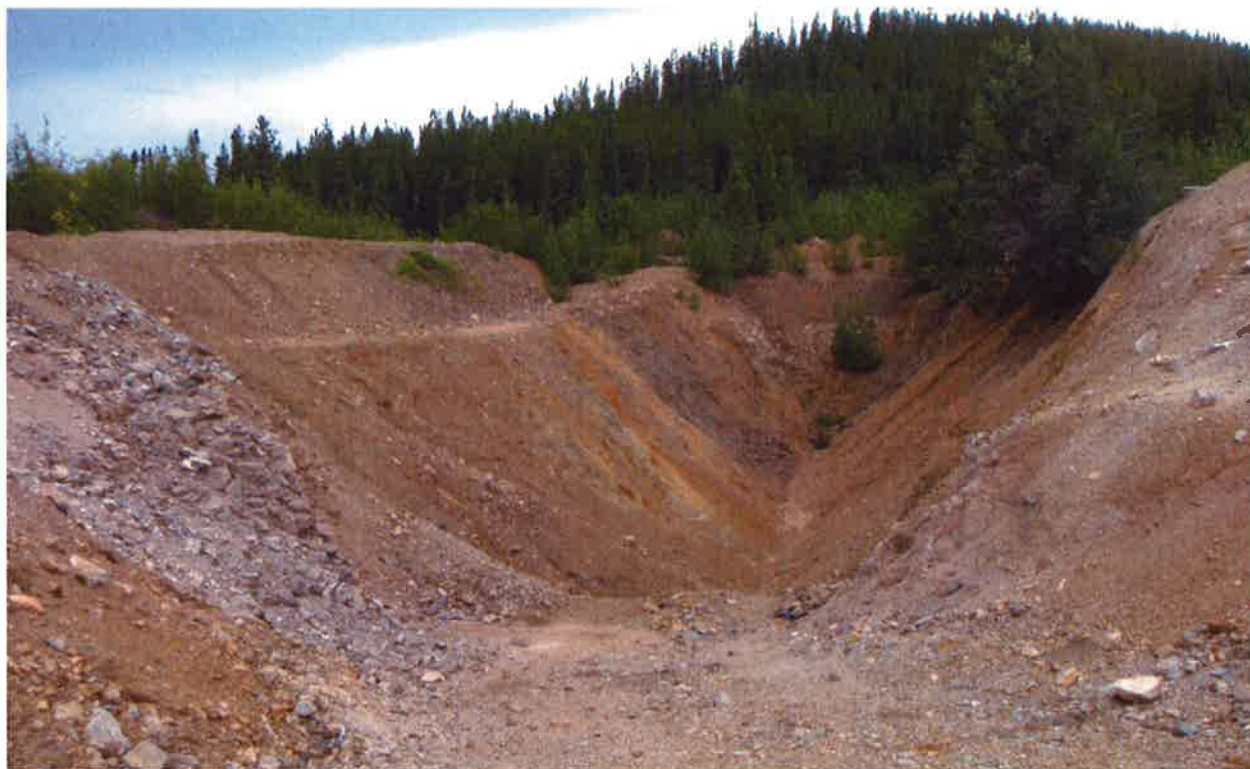
The area where the open pit is to be developed was inspected. The excavation slopes of the trenches developed as part of the effort to obtain bulk samples during exploration activities were observed to be in reasonable condition and there was no observed slumping or failures of these slopes. The leached ore pile from the off-site test pad adjacent the trench was observed to be stable and there was no erosion or slope movement of the material. Several of the closed drill pads were inspected and there did not appear to be any erosion noted from these areas that require attention.

Photograph 16: Bulk sample excavation site.

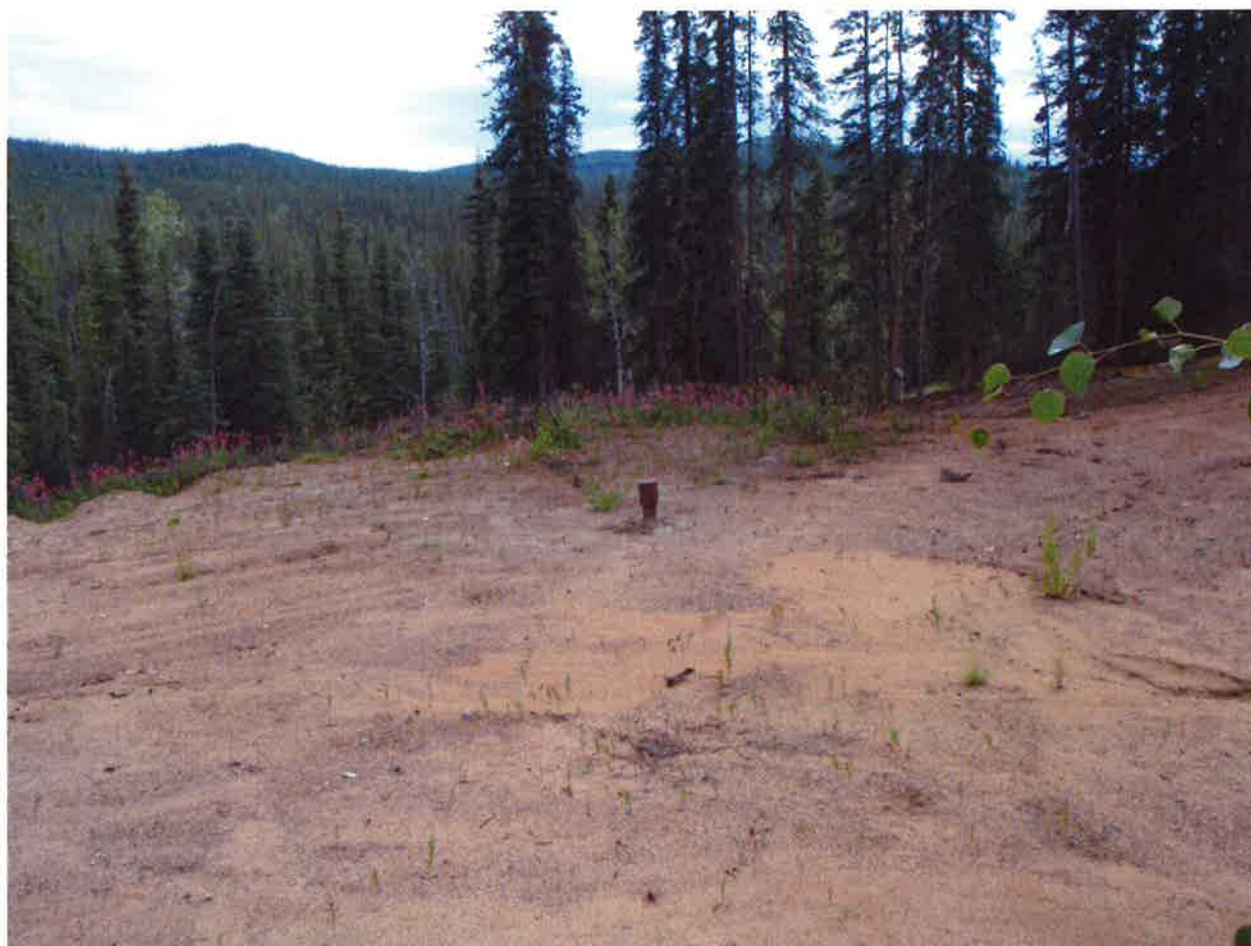
The proposed camp site was inspected and it is still tree covered. The site adjacent to the camp with two water wells was also inspected and there is no apparent movement of sediment beyond the work pads around the wells.

Photograph 17: Water supply well and pad near proposed camp site.

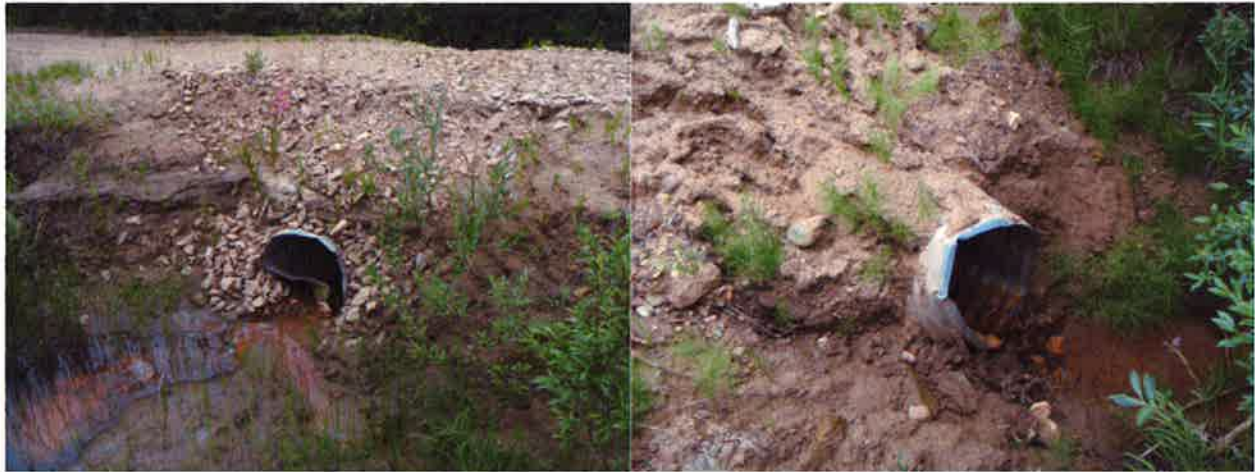
Local erosion on the main access road to the north of the Waste Rock Storage Area continues. The shoulders of the road at the culvert on North Williams Creek have eroded, reducing the road crest width at the culvert location. The road is washed out approximately 30 m past the culvert. A ponded area adjacent the road is anticipated to have temporarily flowed over and eroded the road fill due to reduced flow in the culvert near this location. The inlet of the culvert was observed to be bent. It is recommended that the culvert mouth be reshaped or opened to allow flow at capacity. The eroded area on the road should be filled with gravel to level the grade and re-establish the road.

Photographs 18 and 19: Inlet (left) and outlet (right) of culvert on main access road crossing of North Williams Creek located north of the Waste Rock Storage Area.

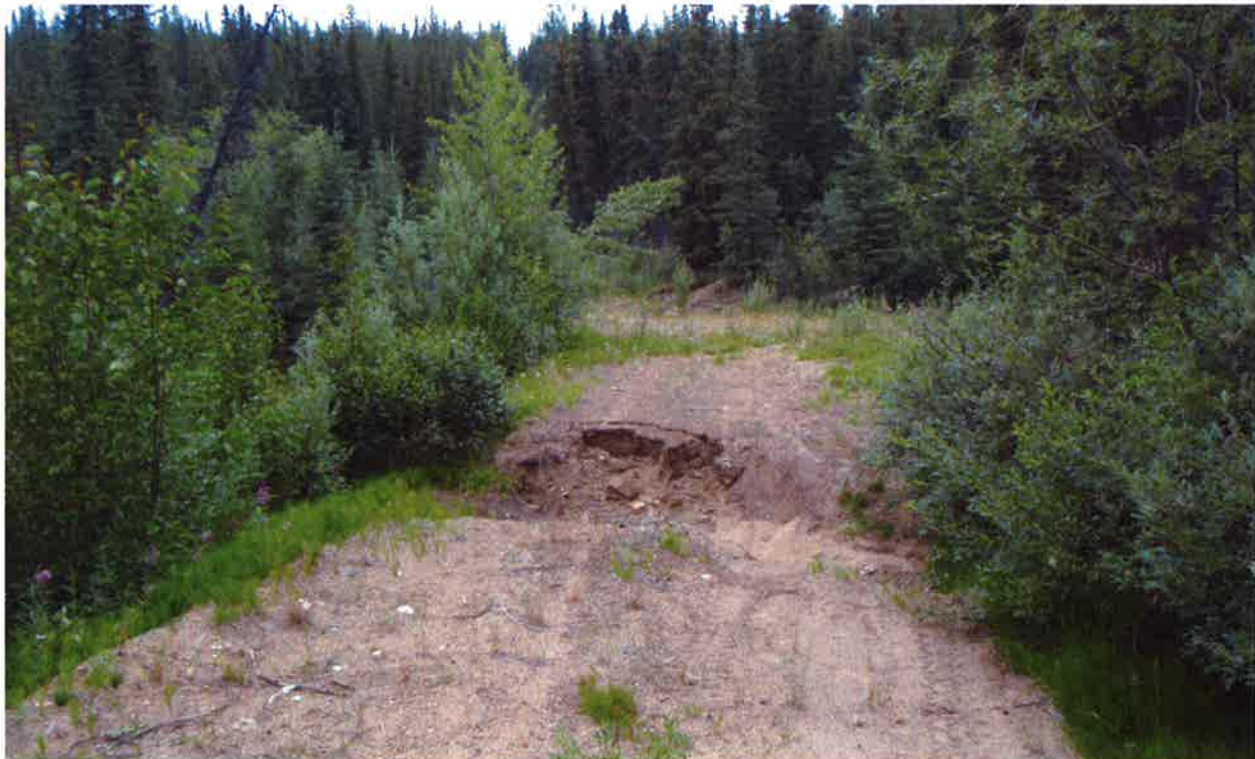
Photograph 20: Erosion on road near North Williams Creek crossing.

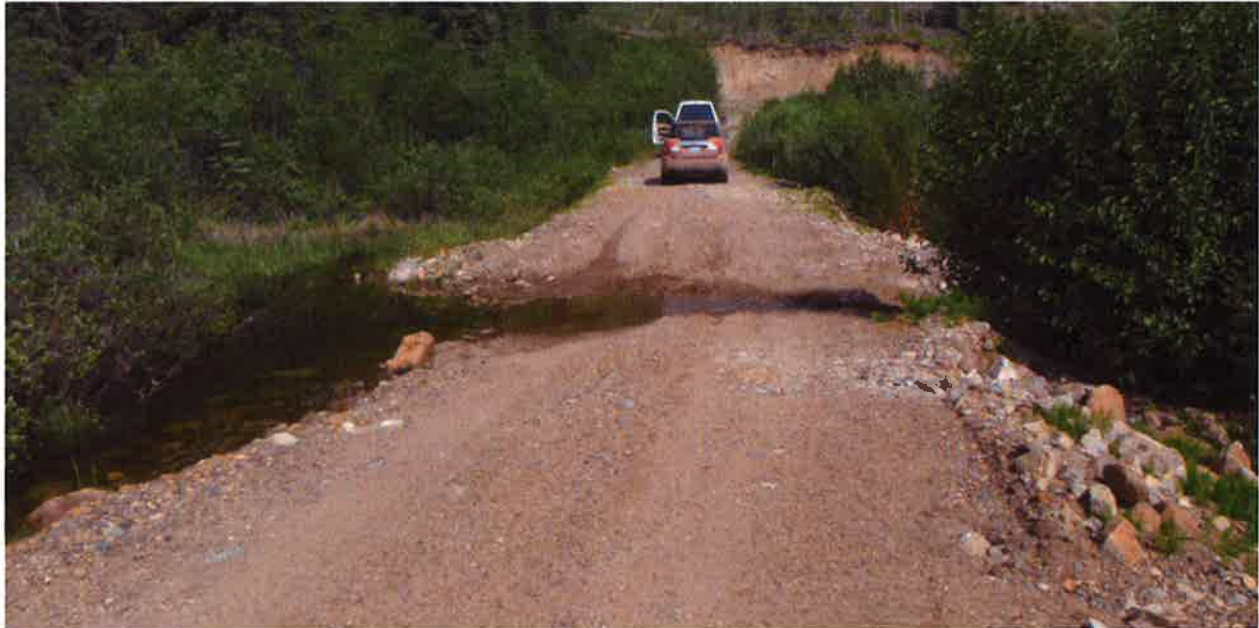
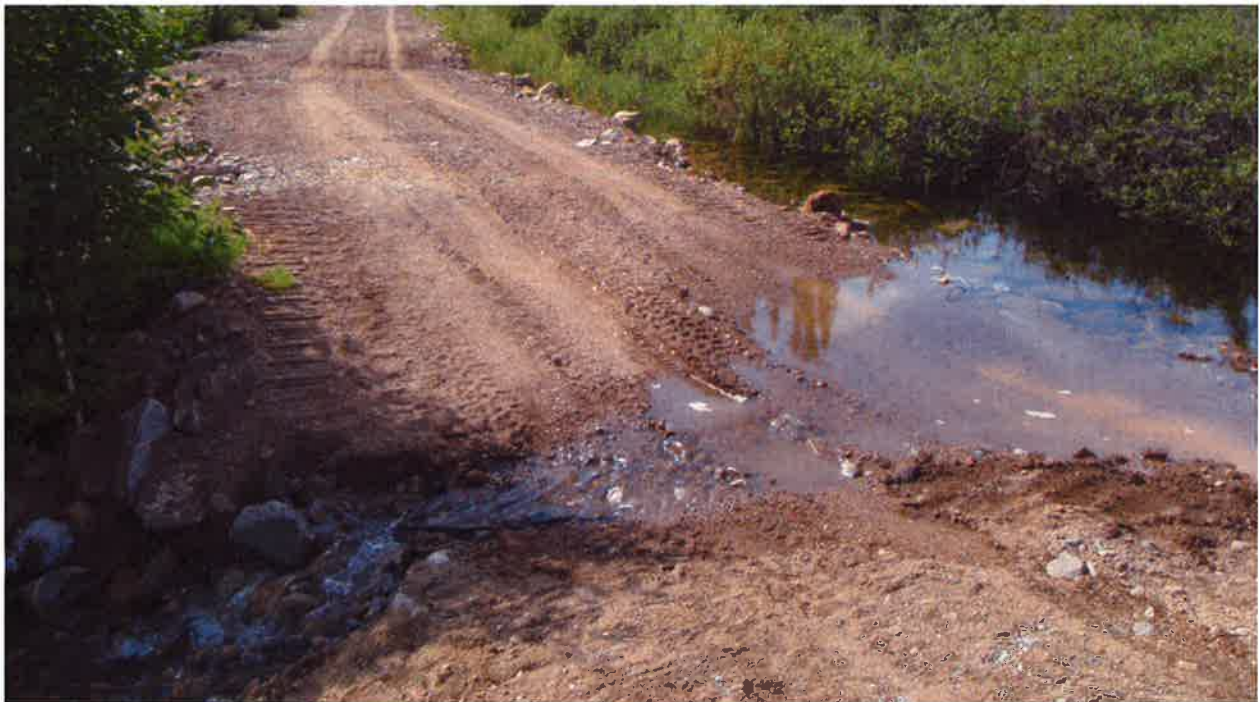
The culvert in the site access road which allowed Williams Creek to flow by the road was recently removed. The crossing is now a 'ford' with the road bed depressed over a length of 10 m to a maximum depth of 0.8 m below the adjacent road grade or crest elevation. Ponded water was observed on the upstream side of the road, with flow across the road. Scott Casselman reported that the culvert as angled upwards with the inlet in the air, and the culvert was therefore removed and the depression regarded as observed on July 10, 2013.

Without further erosion protection, it is anticipated that the general fill of the roadbed at Williams Creek will erode at the crossing location during high flow events. The culvert should therefore be replaced and armoured or the 'ford' should be upgraded to operate through next spring.

Photographs 21 - 22: *View of access road crossing of Williams Creek looking north (top) and south (bottom).*

- Clearing of vegetation in the footprint of the area of the lower Heap Leach Facility area and Confining Embankment to promote thaw of permafrost ground.
- Re-installation of the culvert on the site access road crossing of Williams Creek. The road embankment should be armored against erosion at the culvert location.
- Maintenance of the culvert on the main access road immediately north of the proposed Waste Rock Storage Facility.
- Filling and grading of the washouts on access roads in the Heap Leach Facility and Waste Rock Storage Facility areas.
- Clearing of the sediment trap on the access road to the lower re-vegetated area near Williams Creek east of the exploration camp, near the proposed Heap Leach Facility Sediment Pond location.

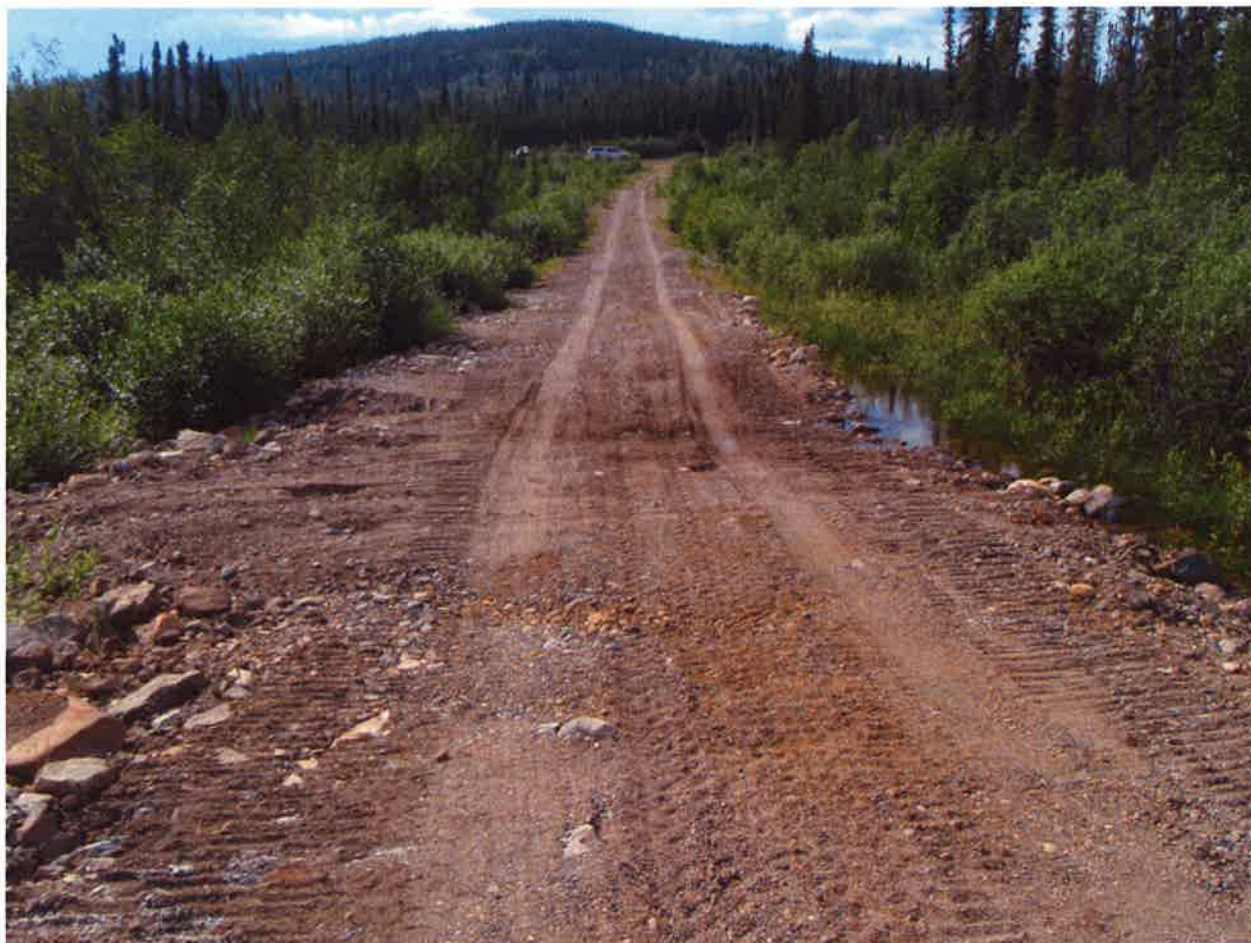
Some erosion noted during the 2012 inspection, indicated that flow had previously appeared to pass over an additional segment of the road near the Williams Creek crossing, eroding the road bed some 18 m south of the culvert location. It is anticipated that this was a temporary condition, which likely occurred at the beginning of the freshet, potentially when the culvert was still frozen/blocked by snow and ice. This southern eroded area was observed to have been repaired. Scott Casselman reported that the eroded area was repaired on July 10, 2013.

Photograph 23: View of access road repair just south of Williams Creek, looking south.

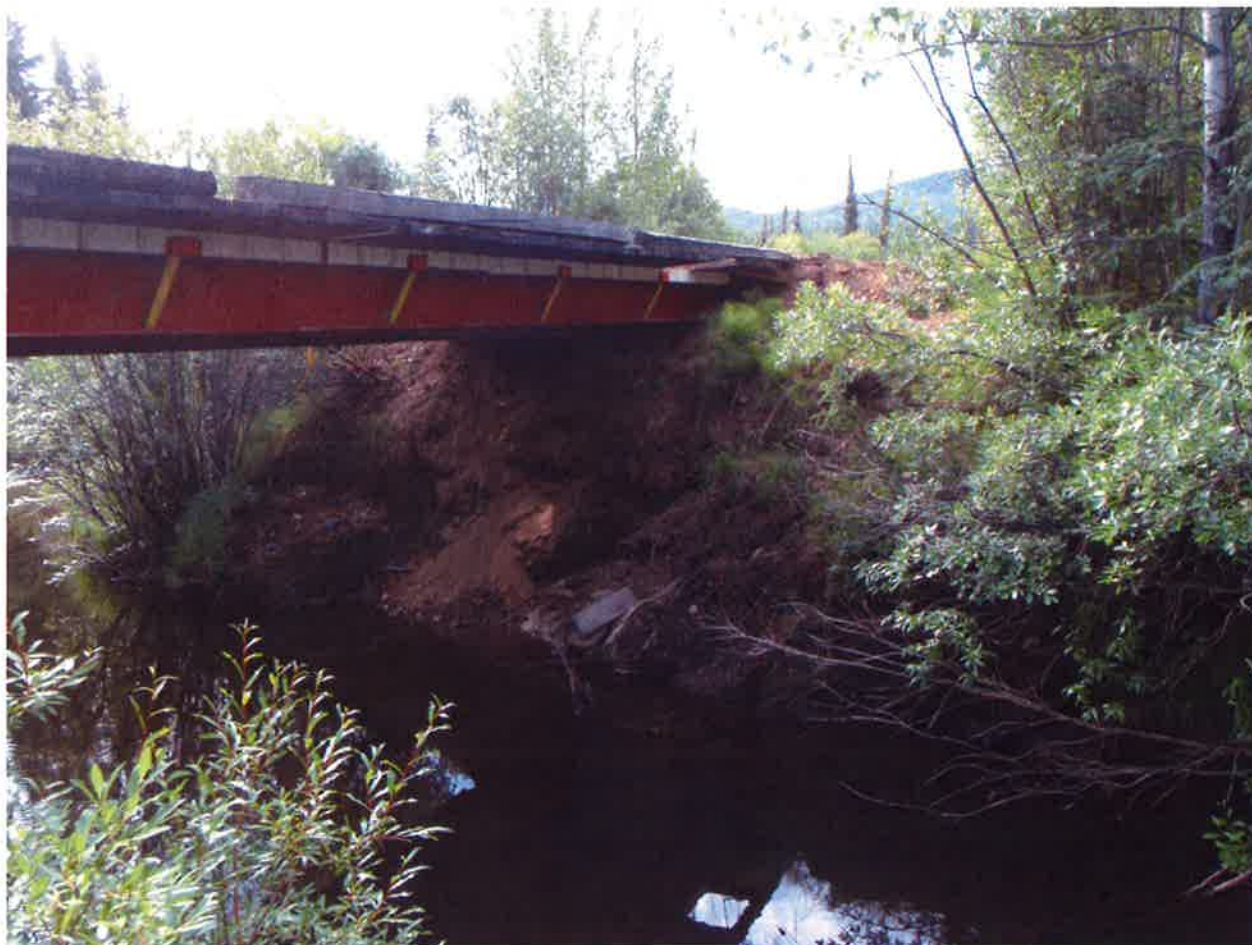
The access road crossing at Merrice Creek includes a single span bridge set on grade. No steelwork or abutment foundations were observed. In July 2012 the creek banks were being eroded and under cut at the crossing location. Scott Casselman reported that the bridge span was re-set on July 10, 2013, following recommendations in the July 2012 inspection memorandum. The abutment on the Village of Carmacks side of the bridge was reportedly leveled, or cut down, and then the span dragged back and re-set. During the July 2013 inspection the length of span seated on the Village side abutment was 0.5 to 0.75. The slope of the ground at the abutment immediately under the span at this location was observed to be over-steepened, approximately 1 horizontal to 2 vertical. The measures to stabilize the span therefore appear temporary and it is anticipated that the bridge will have to be re-set again in 2014 or in 2015.

Photograph 24: Site access road crossing of Merrice Creek, view of bridge abutment nearest to the Village of Carmacks.
Date Taken: July 16, 2013
