24 October 2018

Reference No. 18110616-002-Rev0

2018 ANNUAL INSPECTION OF THE CARMACKS COPPER PROJECT, CARMACKS, YUKON

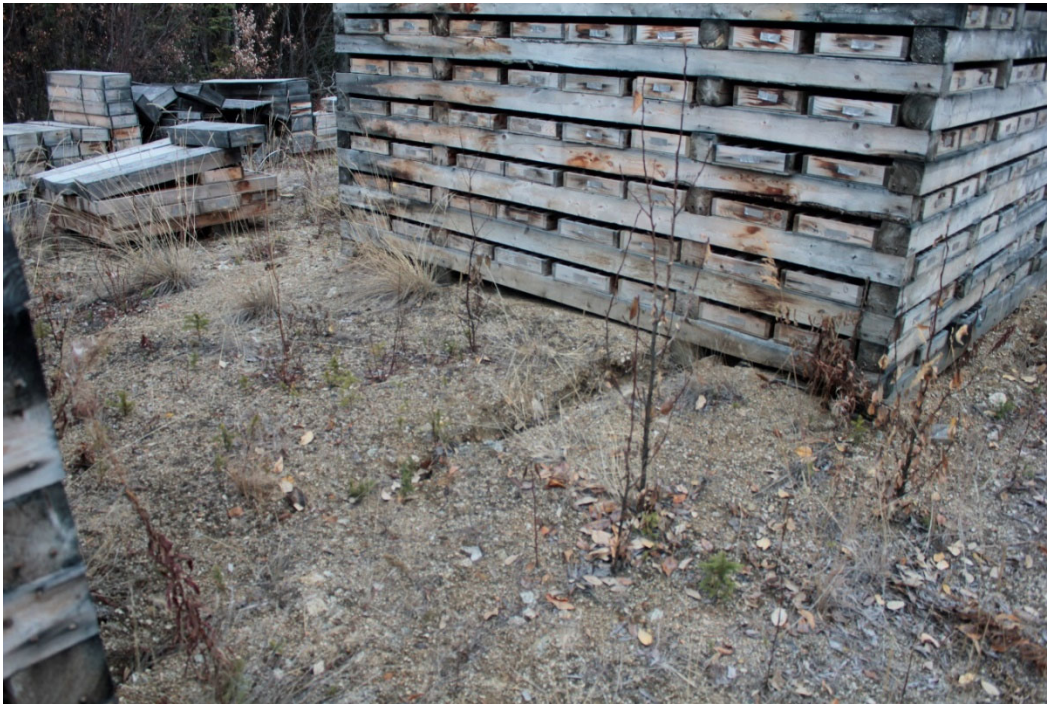
In previous years, inspections of the camp area have noted the presence of cracking, most likely resulting from thaw induced settlement beneath and adjacent to core storage racks. During the current inspection, only one crack was observed in the vicinity of the core storage racks (Photograph 1). In general, the appearance of cracks in the core storage rack area was consistent with the 2017 inspection. There appears to have been some infilling of cracks observed during previous inspections. The area is also characterised by the regrowth of vegetation around the core racks and a general decrease in the magnitude of settlements occurring with time. As in previous years, settlement in this area does not represent a safety concern and the inspection did not indicate erosion of sediments from the pad area into the surrounding natural area.

Photograph 1: Crack beneath core storage rack

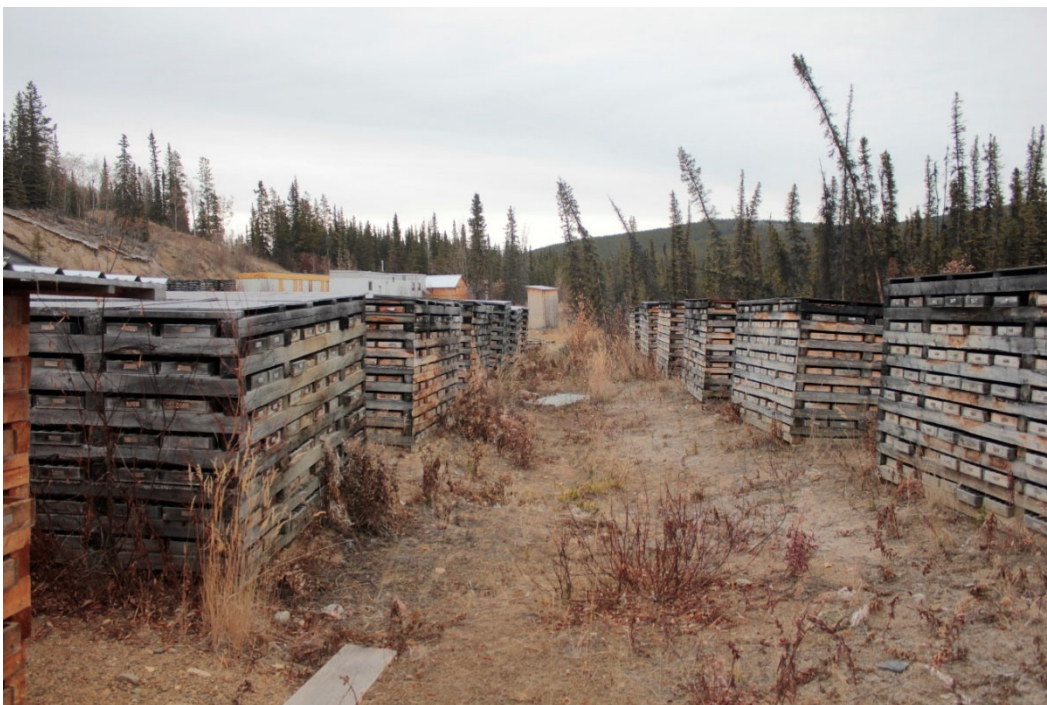
There are two heated buildings, the core shack and geology office, located adjacent to the core storage racks (Photograph 2). The tanks, valves and hosing were in a satisfactory condition, at the time of inspection. Liners have been placed beneath each tank to act as secondary containment for potential leaks and were also in a satisfactory condition.

Photograph 2: Core storage racks

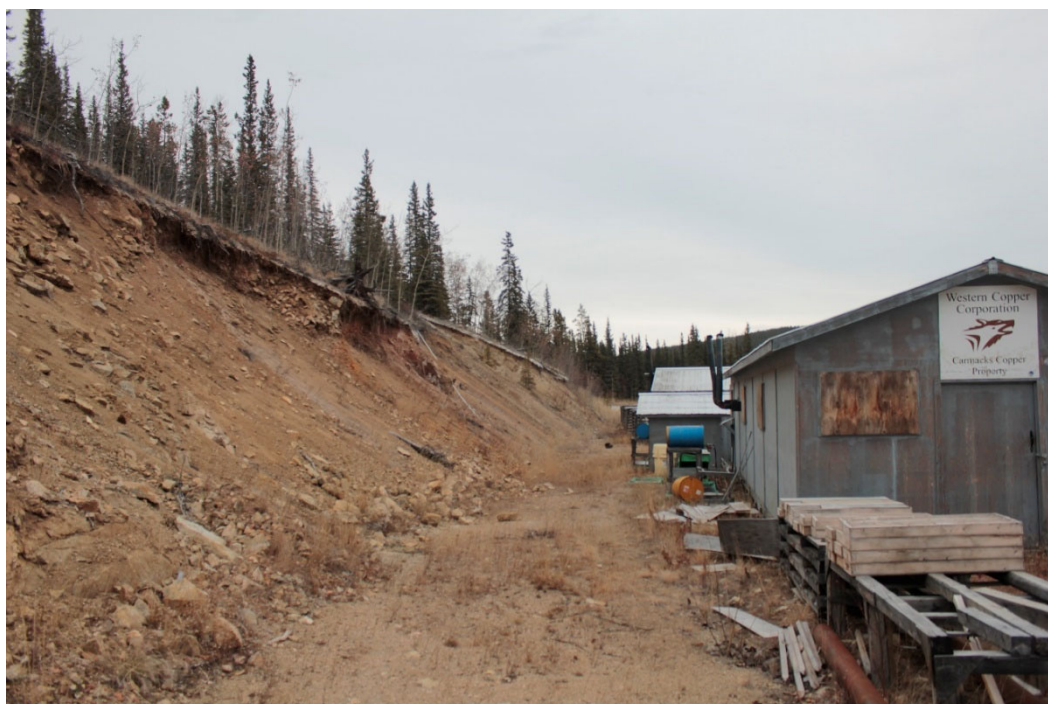
The slope behind the camp (Photographs 3 and 4) is stable and does not pose a safety concern for the camp structures or current operations. There is minor ravelling of small sections of the slope, but these are not impacting camp safety nor would they represent a risk for workers on the project. Some regrowth of vegetation was observed in the camp area.

Photograph 3: Cut-slope behind camp geology office and core shack

Photograph 4: Cut-slope behind the camp geology office and core logging shack

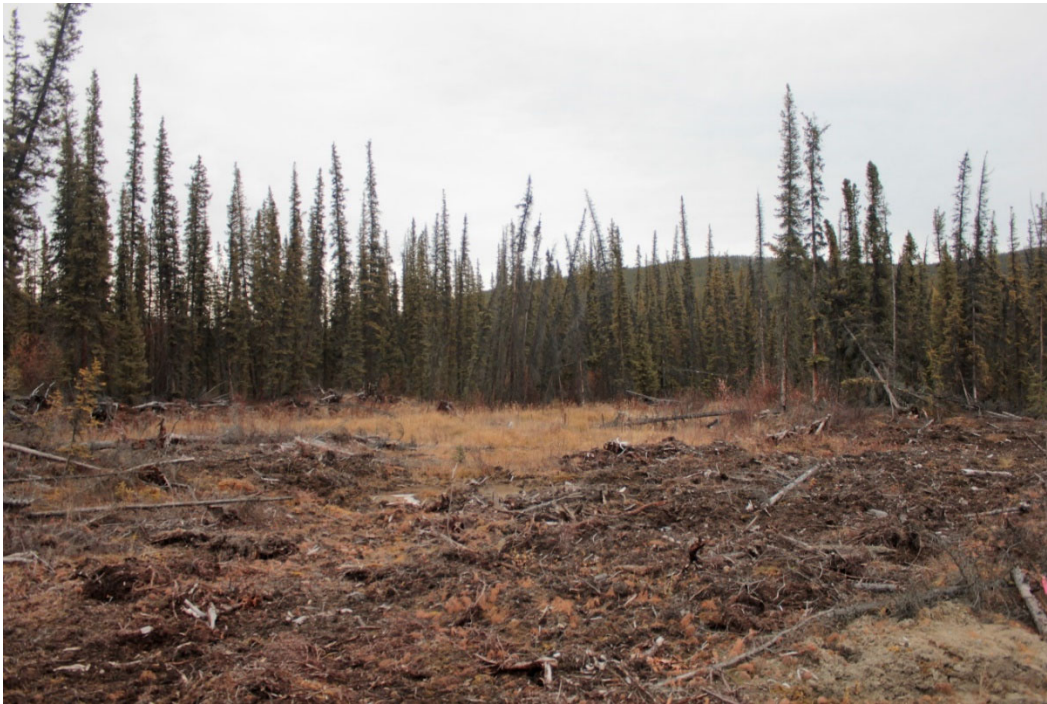
Further downstream, within the floodplain of Williams Creek, silt fences have been installed and the area seeded where sediment from previous site erosion accumulated (Photographs 7 and 8). Grass seed was applied in 2009 to promote the re-establishment of vegetation and to further stabilize sediment. The approach was noted to be generally effective in 2011 and 2012, but with limited regrowth attributed to periodic pooling of water. The area was also re-vegetated with woody plants (willow cuttings), and these plants are now well established. Volunteer species of grass and woody plants are performing very well. There was no evidence of sediment movement, indicating that re-vegetation has been effective in minimizing erosion. Silt fencing surrounding these areas is now overgrown and there is no evidence of sediment movement through the area. Silt fences are typically a temporary measure and could be removed if no further disturbance is expected upgradient.

Photograph 7: 2017 drilling area and vegetation regrowth in Williams Creek floodplain

Photograph 8: Vegetation growth around sediment fencing

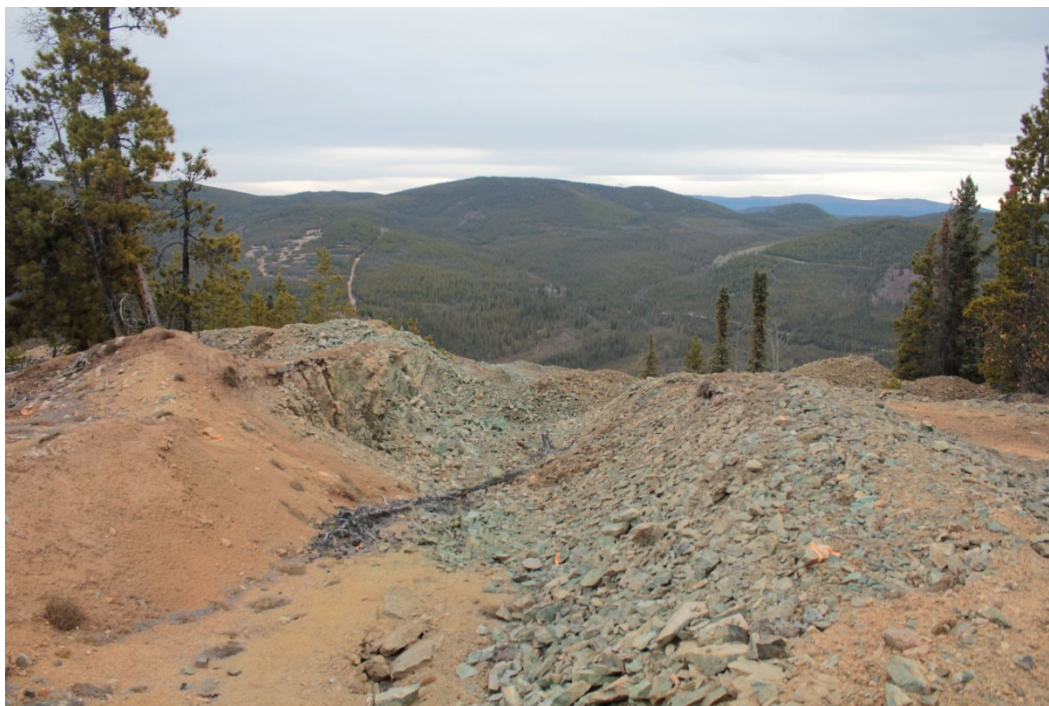
The area proposed for the open pit mine was inspected. The slopes of the trenches excavated as part of the effort to obtain bulk samples during exploration activities were observed to be in satisfactory condition (Photograph 9). There was no observed slumping or failures of the trenches and the slopes facilitate egress for wildlife. Several of the closed drill pads were inspected and there did not appear to be any erosion noted from these areas that would require attention.

Photograph 9: Exploration trench at the Discovery outcrop

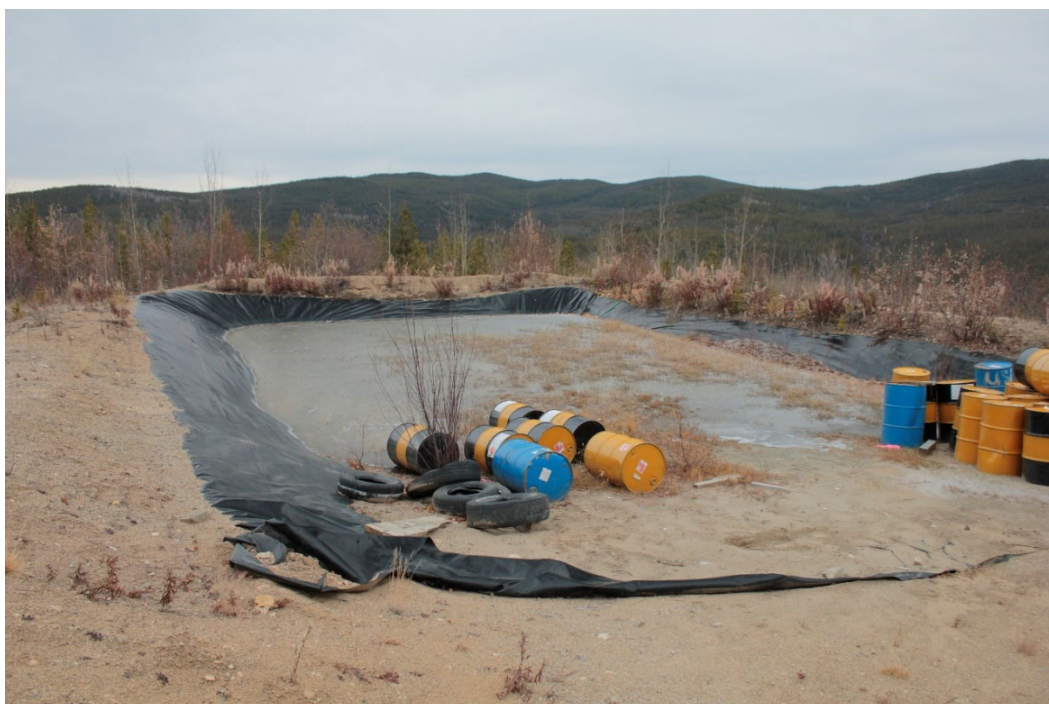
The existing fuel storage area was inspected. It comprises a bunded and lined basin constructed to contain any spilled fuel and currently a few dozen drums of diesel fuel. After several days of rain, prior to the inspection, approximately 0.3 m of water had accumulated in the basin (Photograph 10). The bund is less than 3 m in height and the basin capacity is less than 10,000 m³; therefore, the fuel storage area is appropriately permitted under the QML without need for a water license (Yukon Environment Dam Guide).

Photograph 10: Lined basin at fuel storage area

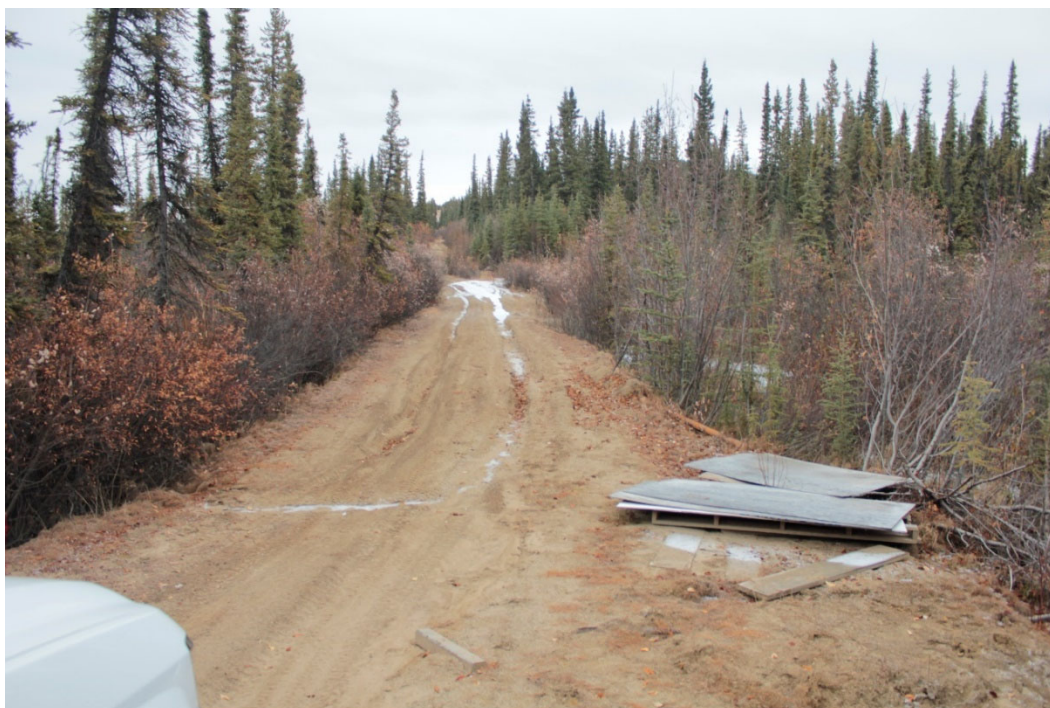
The main access road to the north of the proposed waste rock storage area was observed to be in good condition with only minor erosion observed. Damage to the road near North Williams Creek noted in the 2017 inspection report have since been repaired (Photograph 12). The North Williams Creek culvert has undergone some crushing and has accumulated some sediment (Photographs 13 and 14). However, the culvert remains adequate to accommodate the relatively minor flows observed at of the inspection. There is no visual evidence to indicate that erosion is occurring near the culvert. The access road should be inspected annually and ongoing maintenance of drainage features and erosion management should be anticipated.

Photograph 12: Road near North Williams Creek

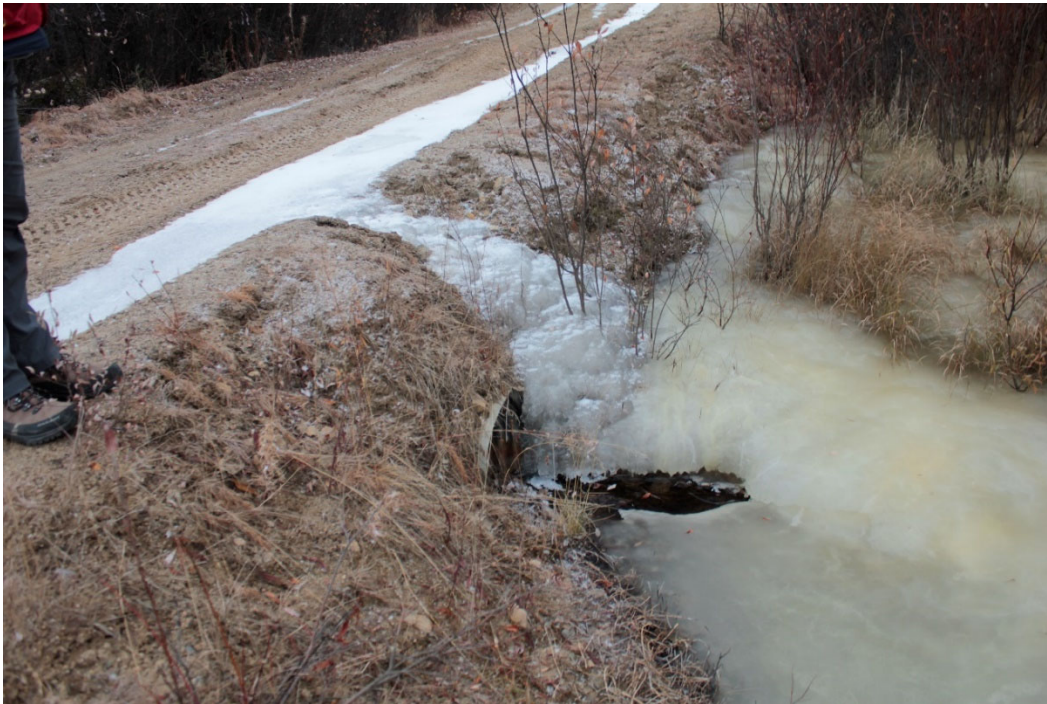
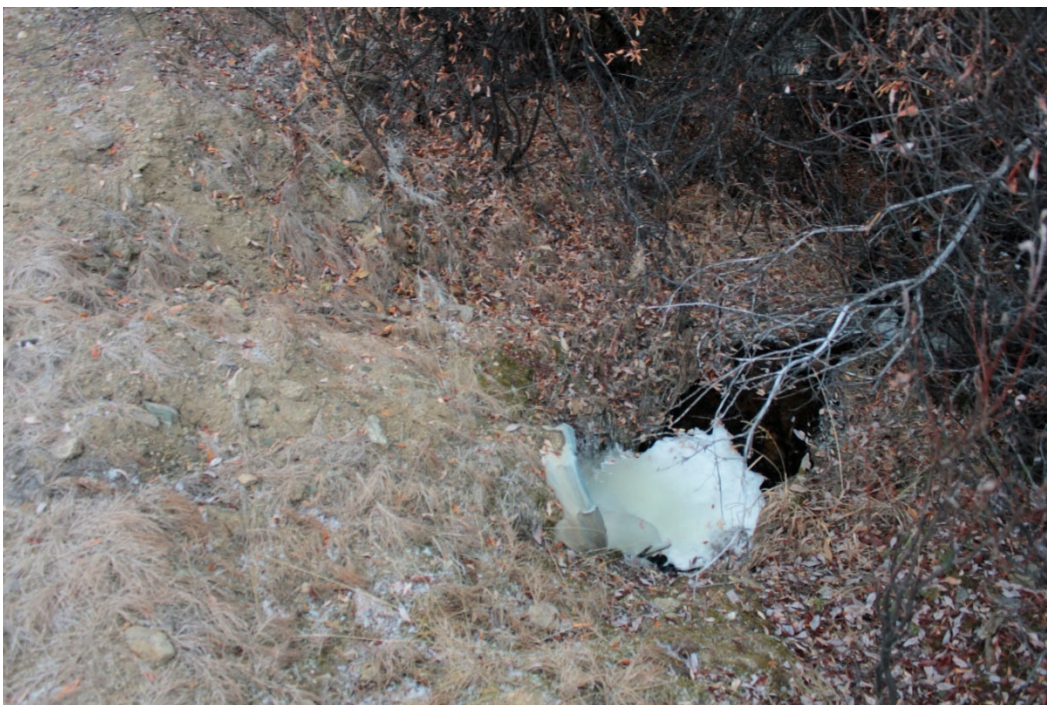
Photograph 13: Culvert inlet beneath road at North Williams Creek

Photograph 14: Culvert outlet beneath road at North Williams Creek

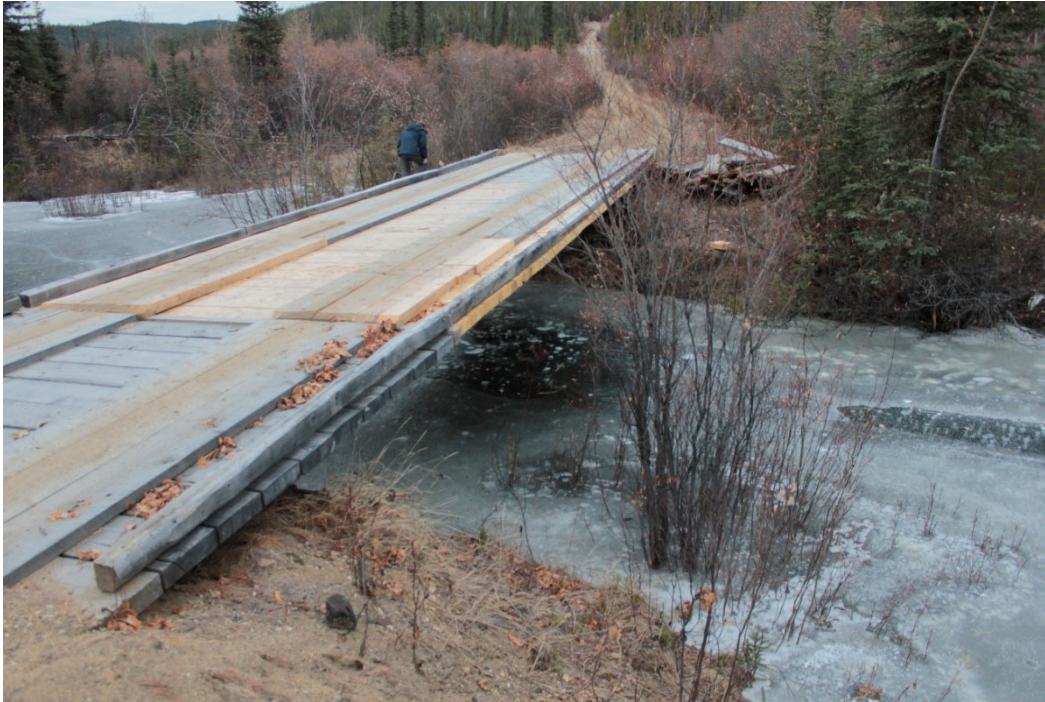
The access road crossing at Merrice Creek includes a single-span bridge (Photographs 16 and 17). Following recommendations in the July 2014 inspection memorandum, the bridge was extended by approximately 3 m and seated 1 to 2 m on the abutments. Approximately 3 m of steel was welded to the existing span, bridge decking was replaced and extended, and the approaches were re-graded to the bridge deck elevation.

At the time of the inspection there was a large beaver dam downstream of the bridge which had caused higher than normal water levels in Merrice Creek, for the time of year. The bridge was observed to be in a satisfactory condition and is securely anchored at each of the abutments. The right (or southern) abutment is steep sided and there is evidence that erosion may be continuing to occur at this location under high-flow conditions. The bridge should be monitored annually and following large rainfall events. In the event that erosion begins to compromise the stability of the abutment, consideration should be given to the installation of erosion protection at this location.

Photograph 16: Bridge crossing at Merrice Creek – downstream side

Photograph 17: Bridge crossing at Merrice Creek – upstream side

- The beaver dam located downstream of the Merrice Creek crossing should be dismantled.
- Water crossings, including the bridge abutments at Merrice Creek, should continue to be inspected annually and following major rainfall events. Maintenance should be carried out, as required to maintain the functionality and safety of these crossings.
- The damage to the liner at the fuel storage area should be repaired.
