24 October 2018

Reference No. 18110616-002-Rev0

2018 ANNUAL INSPECTION OF THE CARMACKS COPPER PROJECT, CARMACKS, YUKON

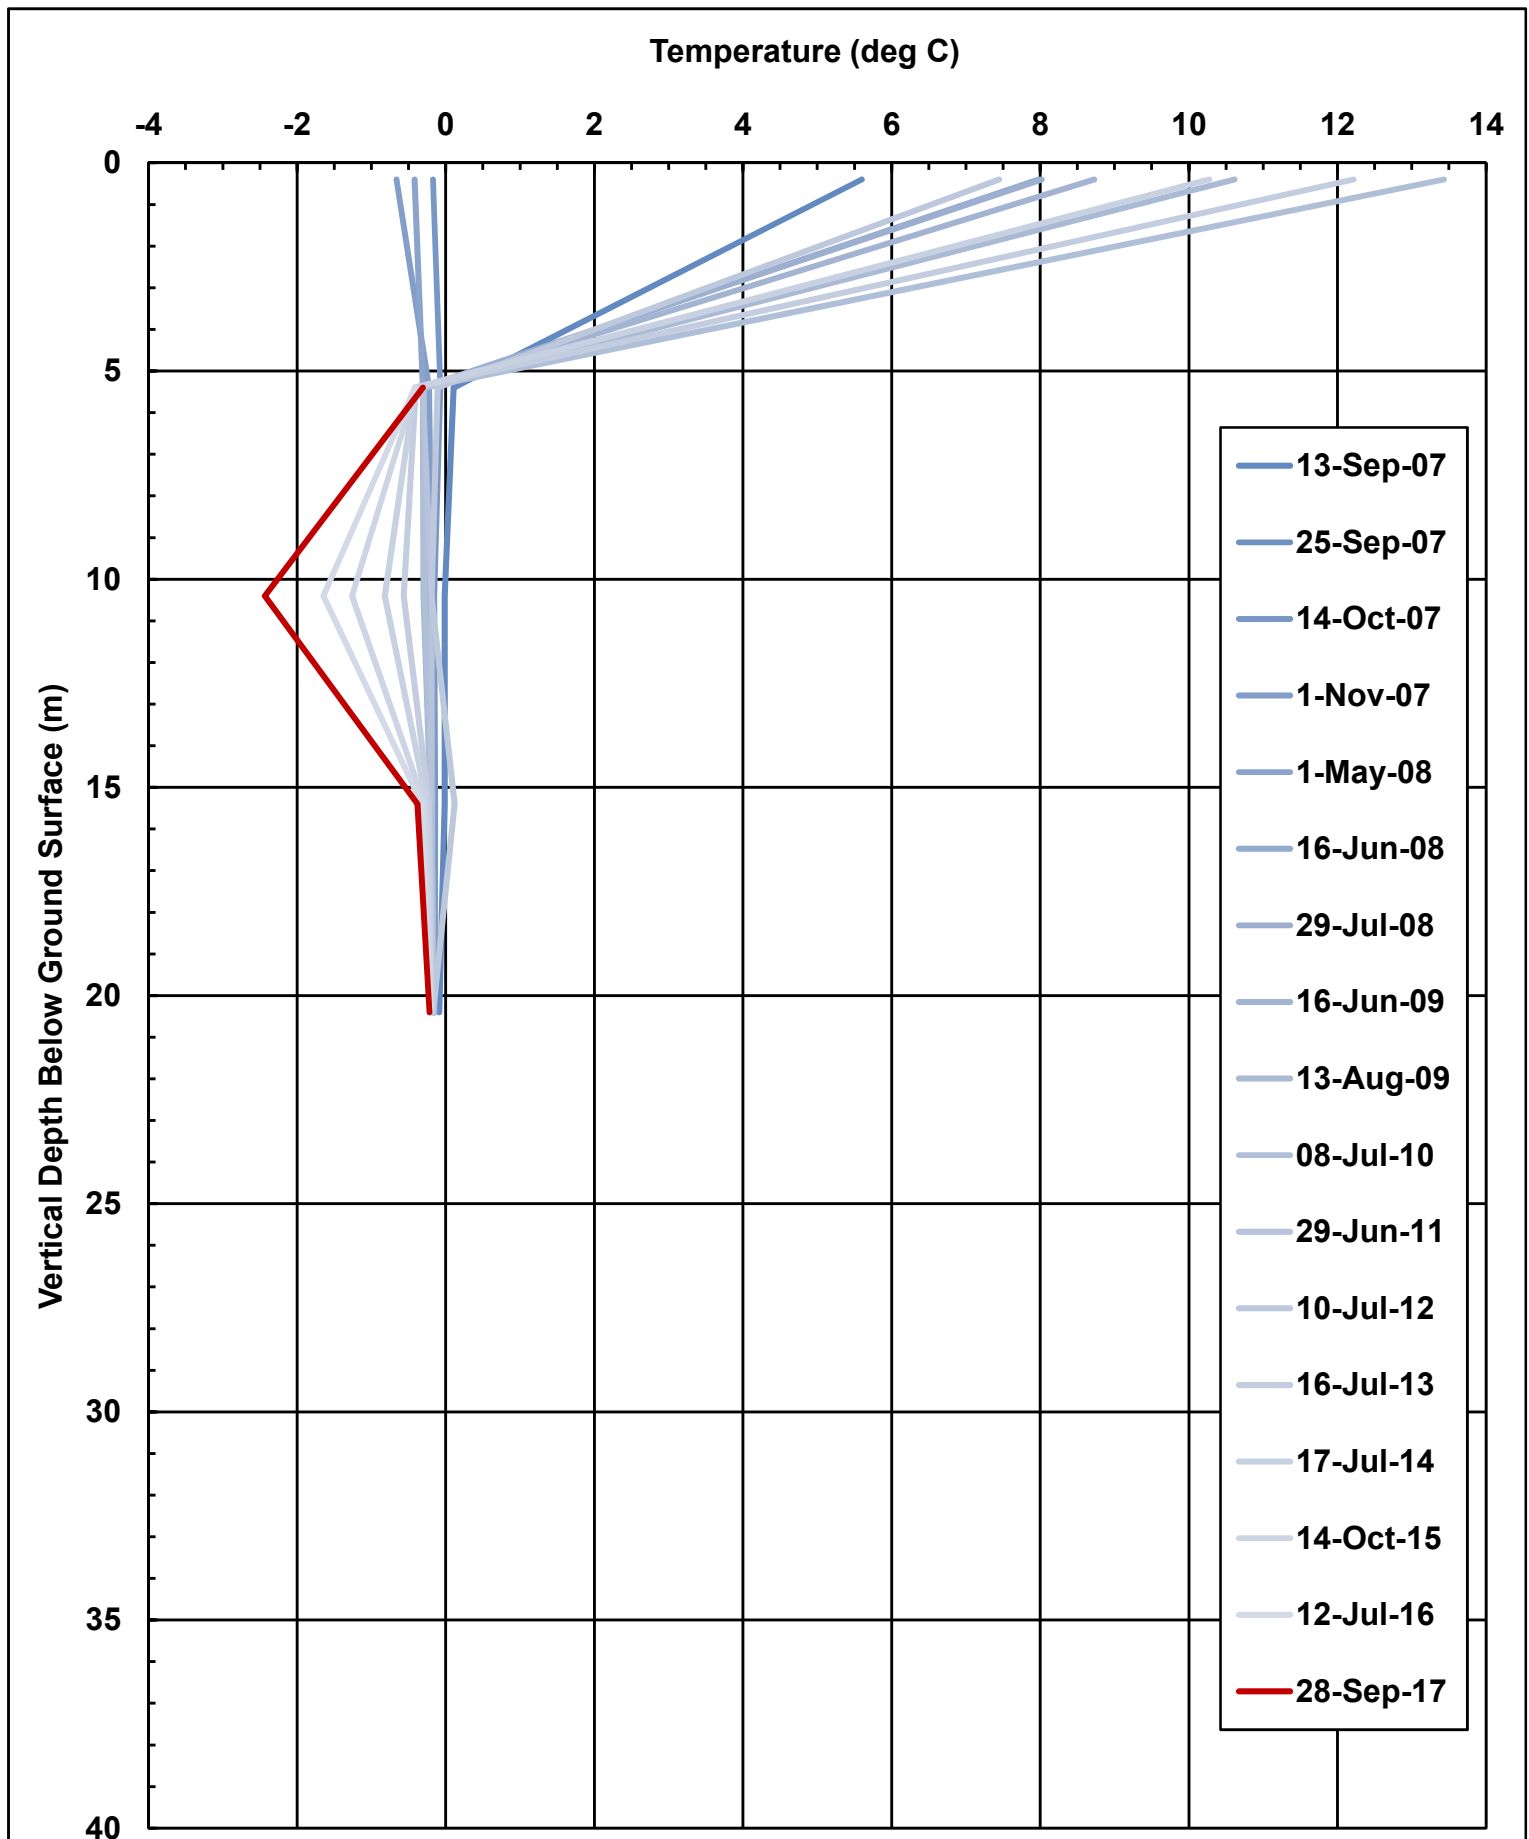
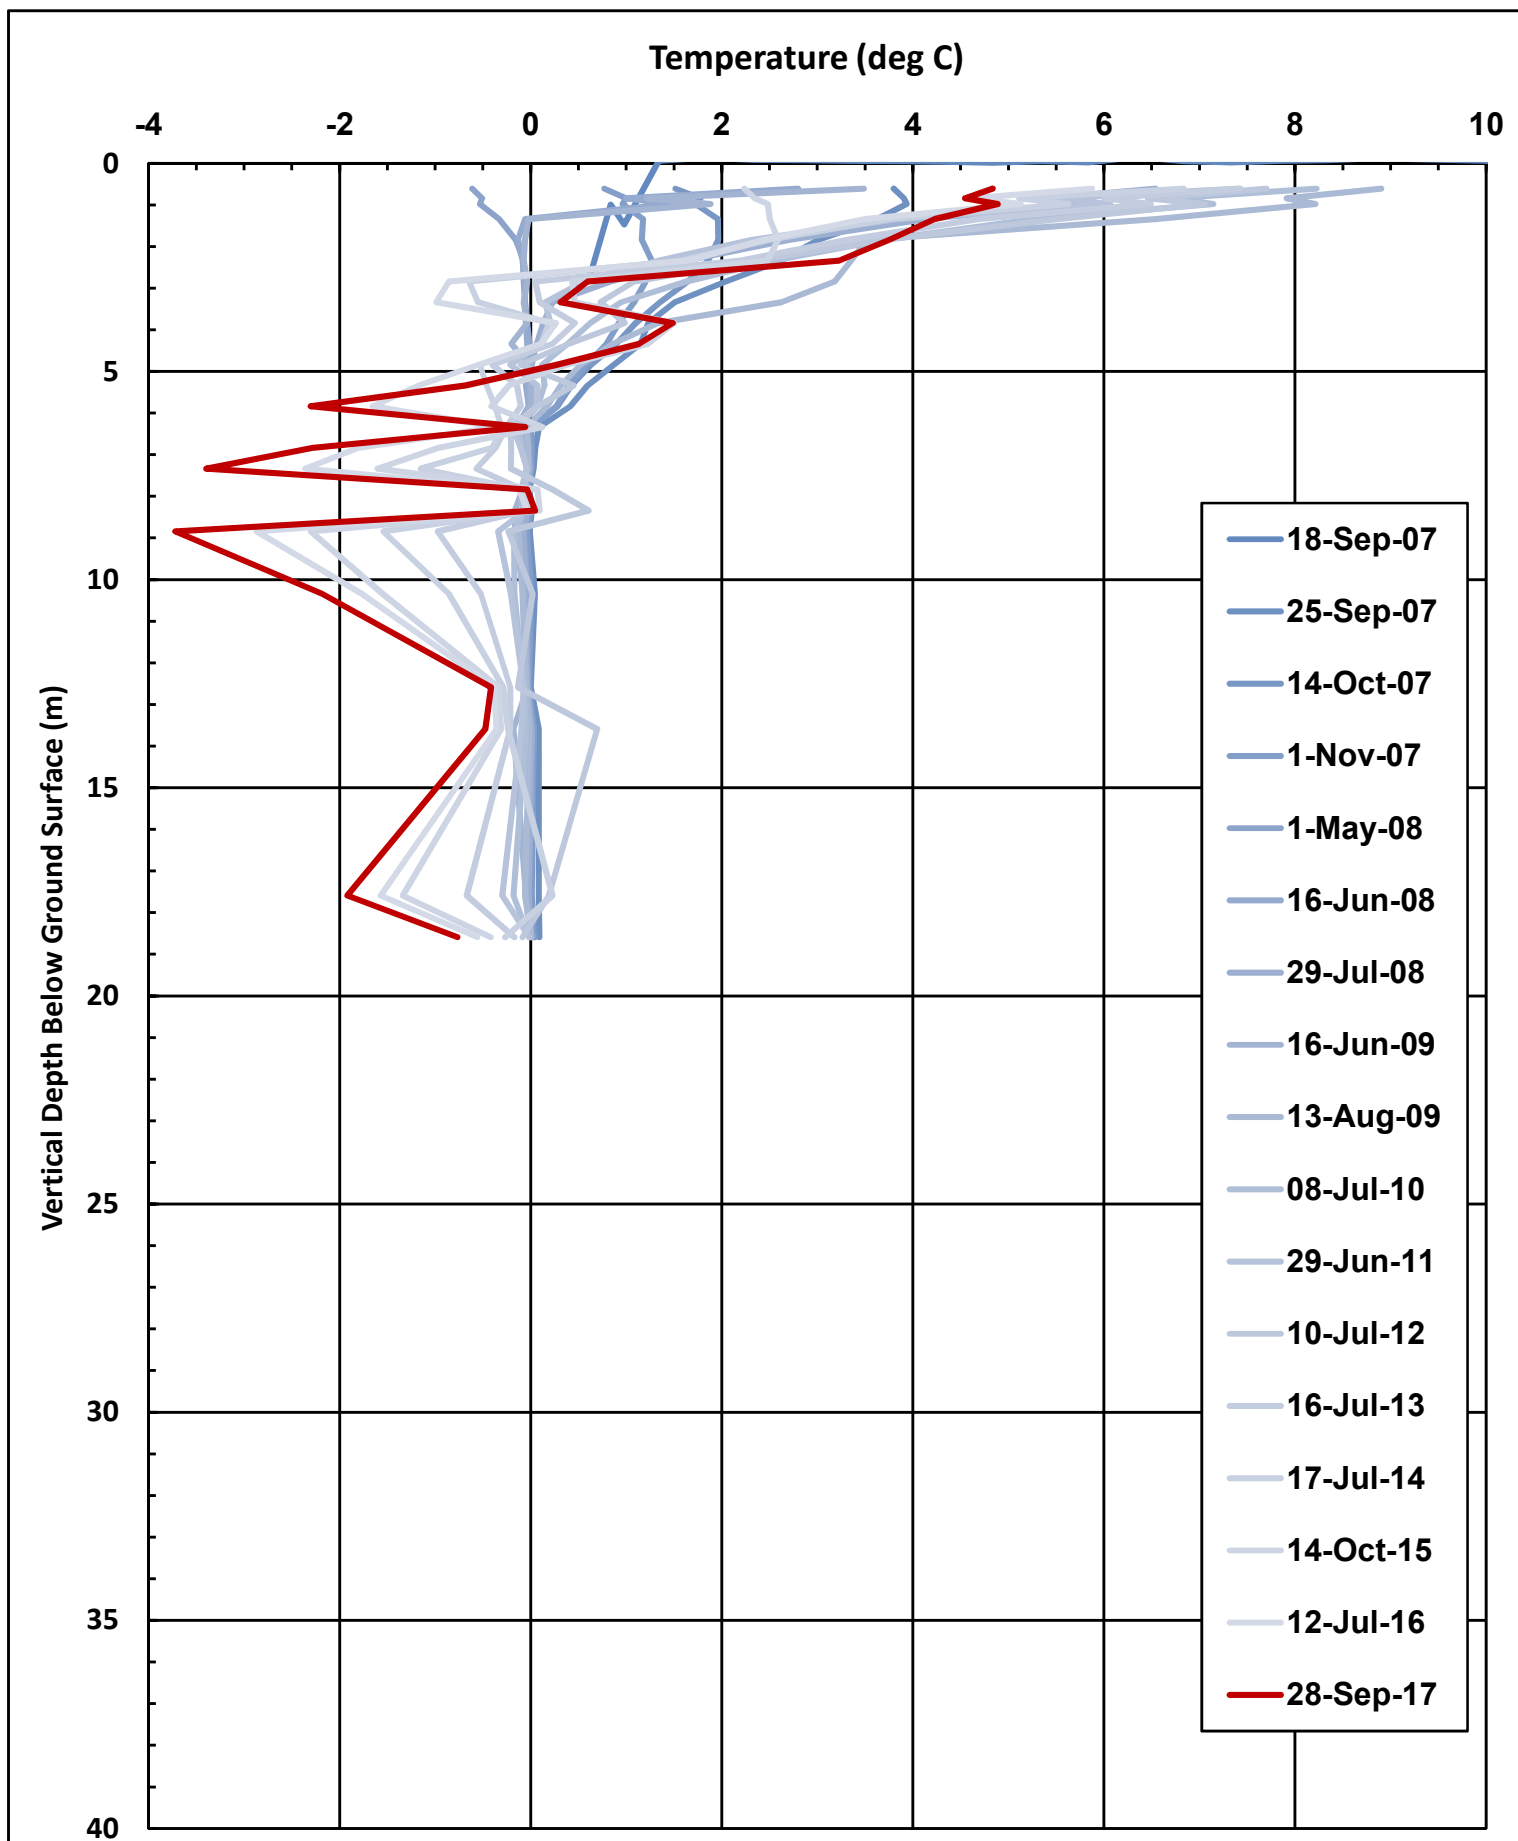
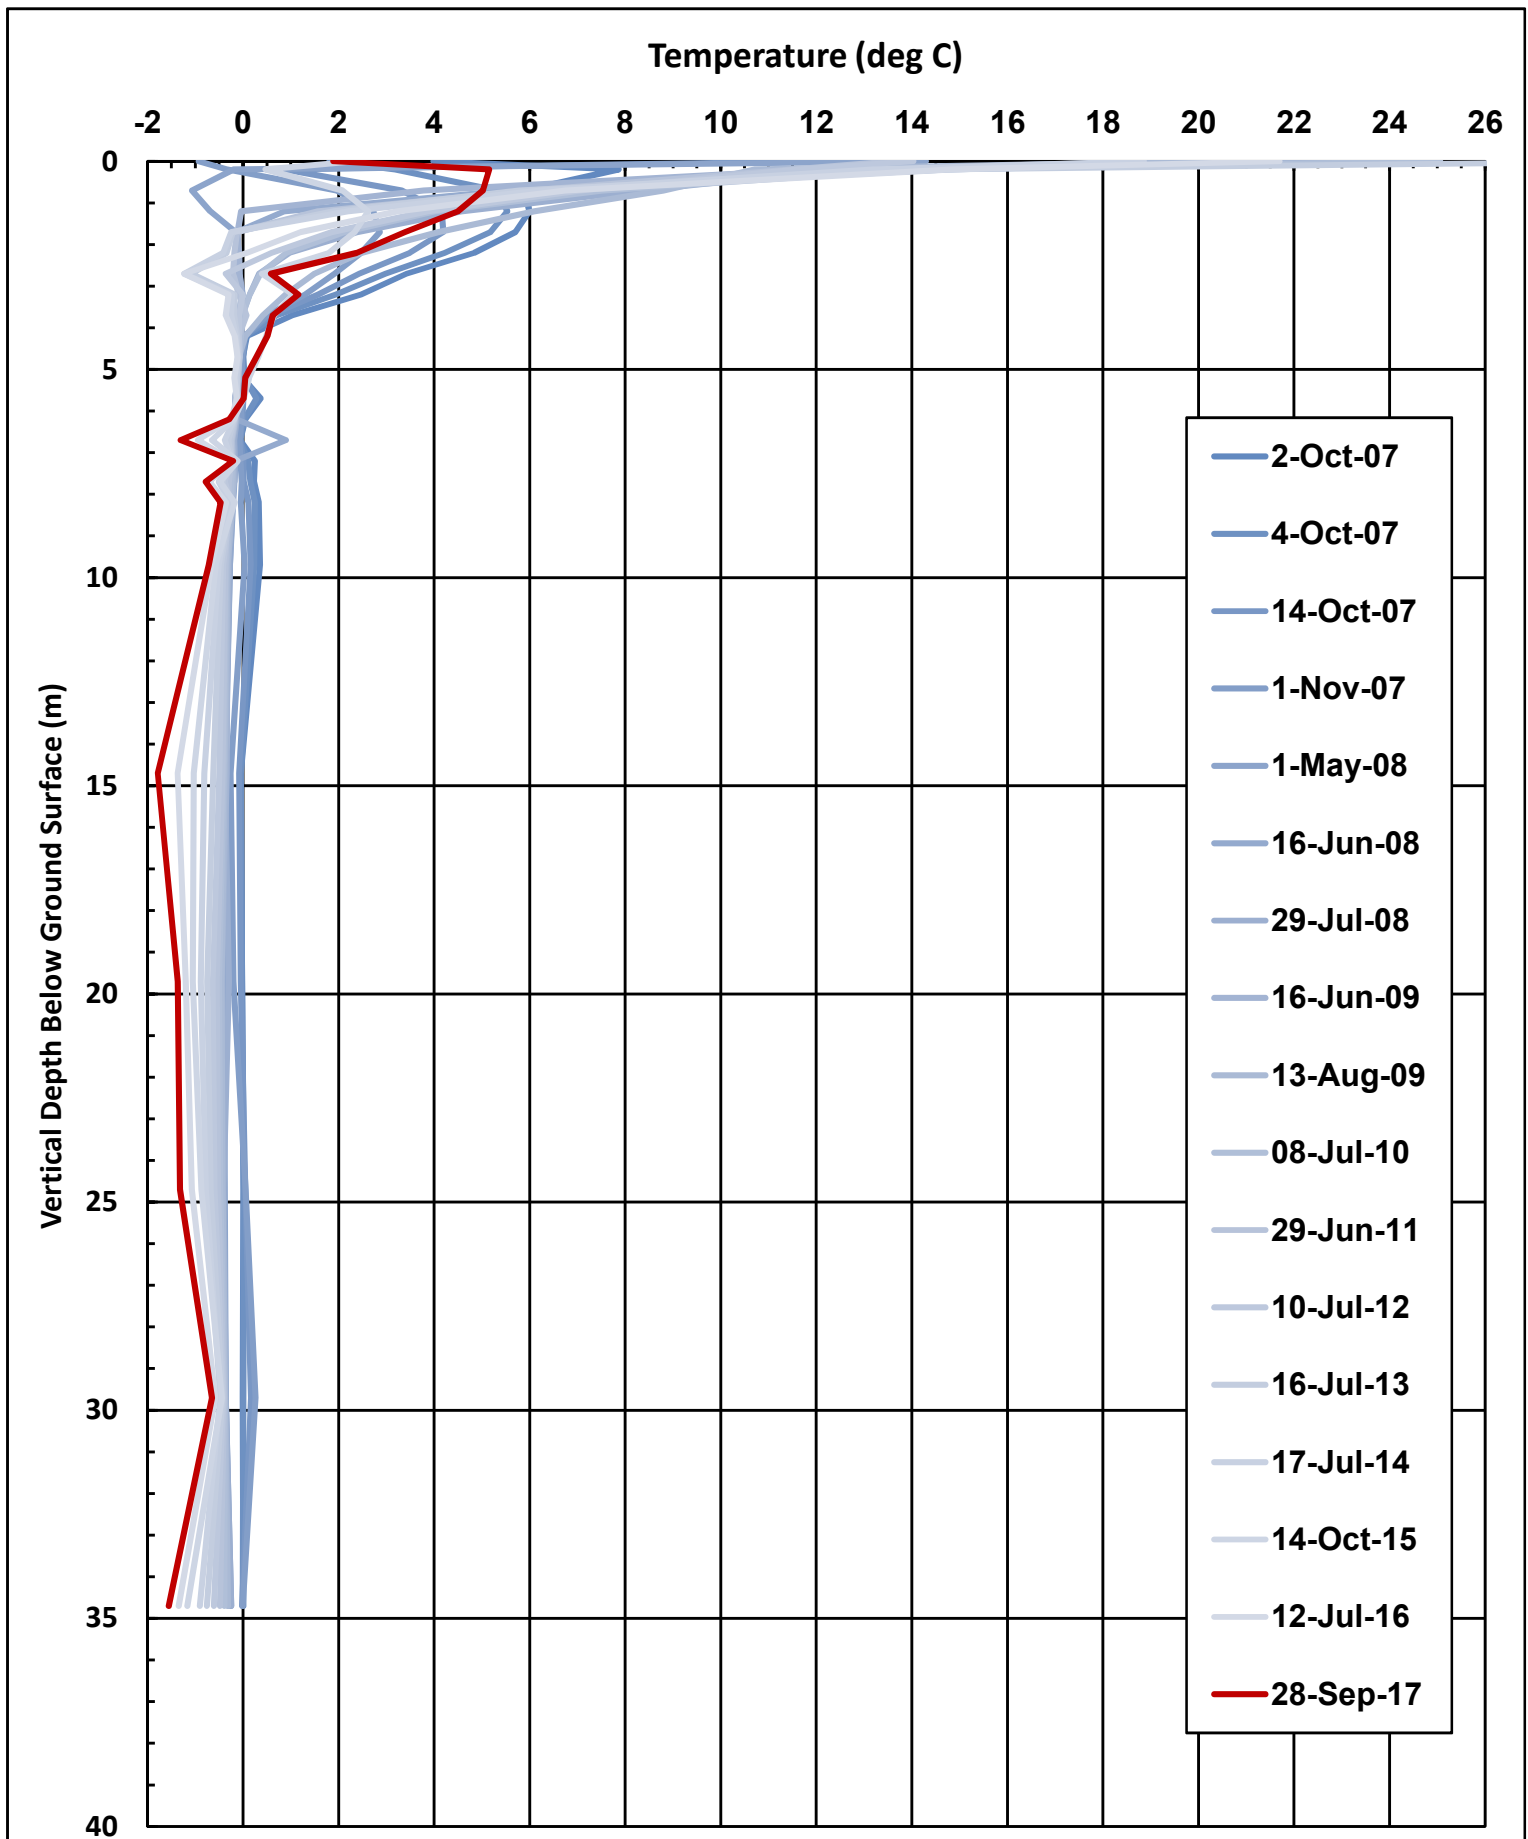
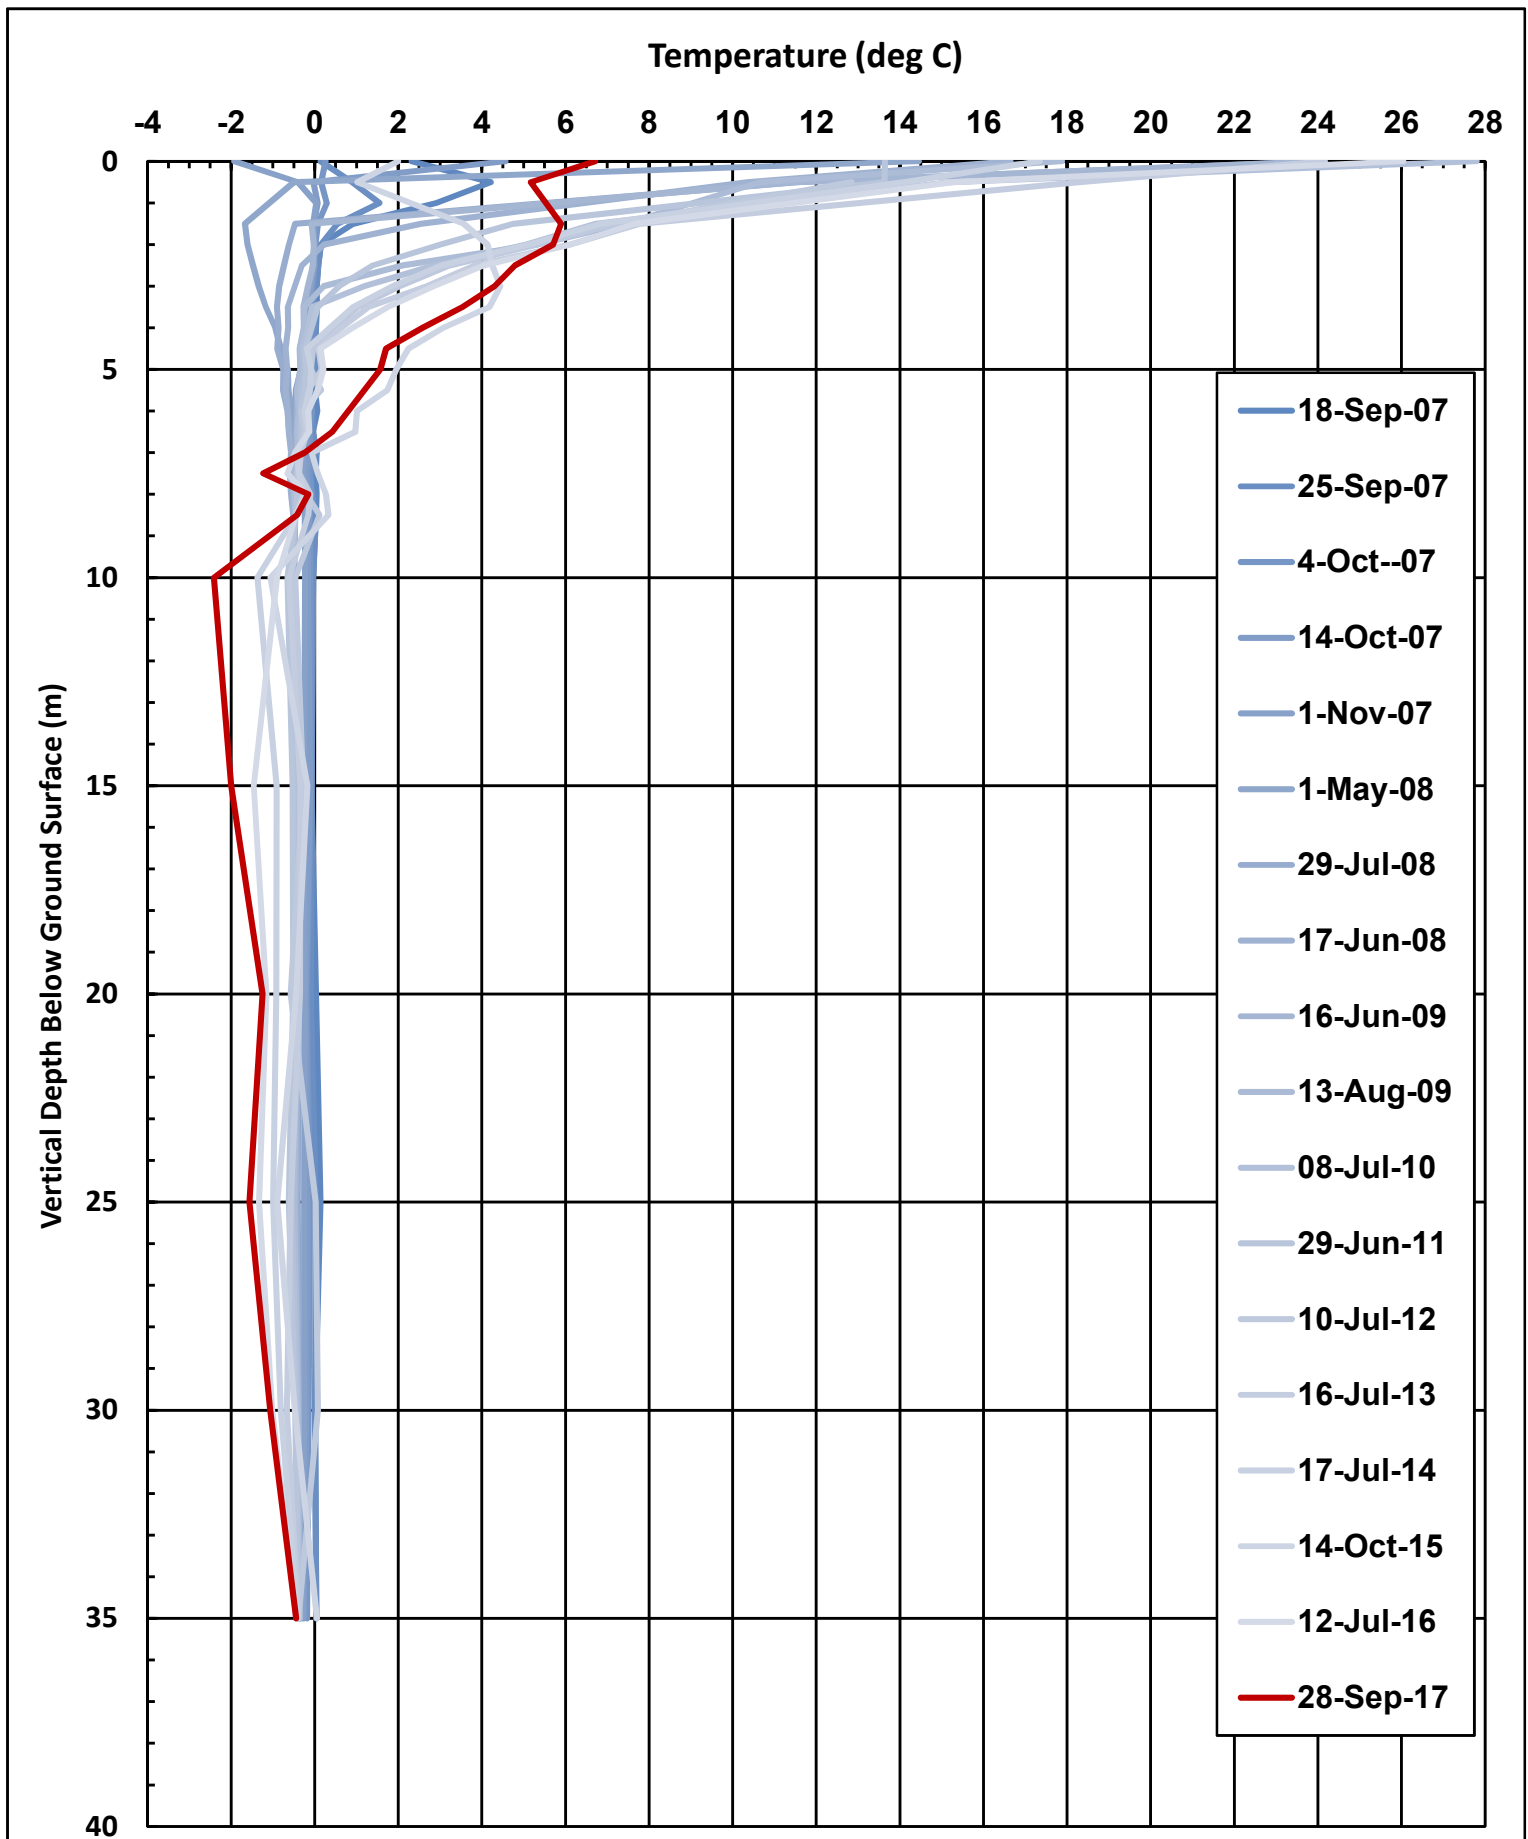
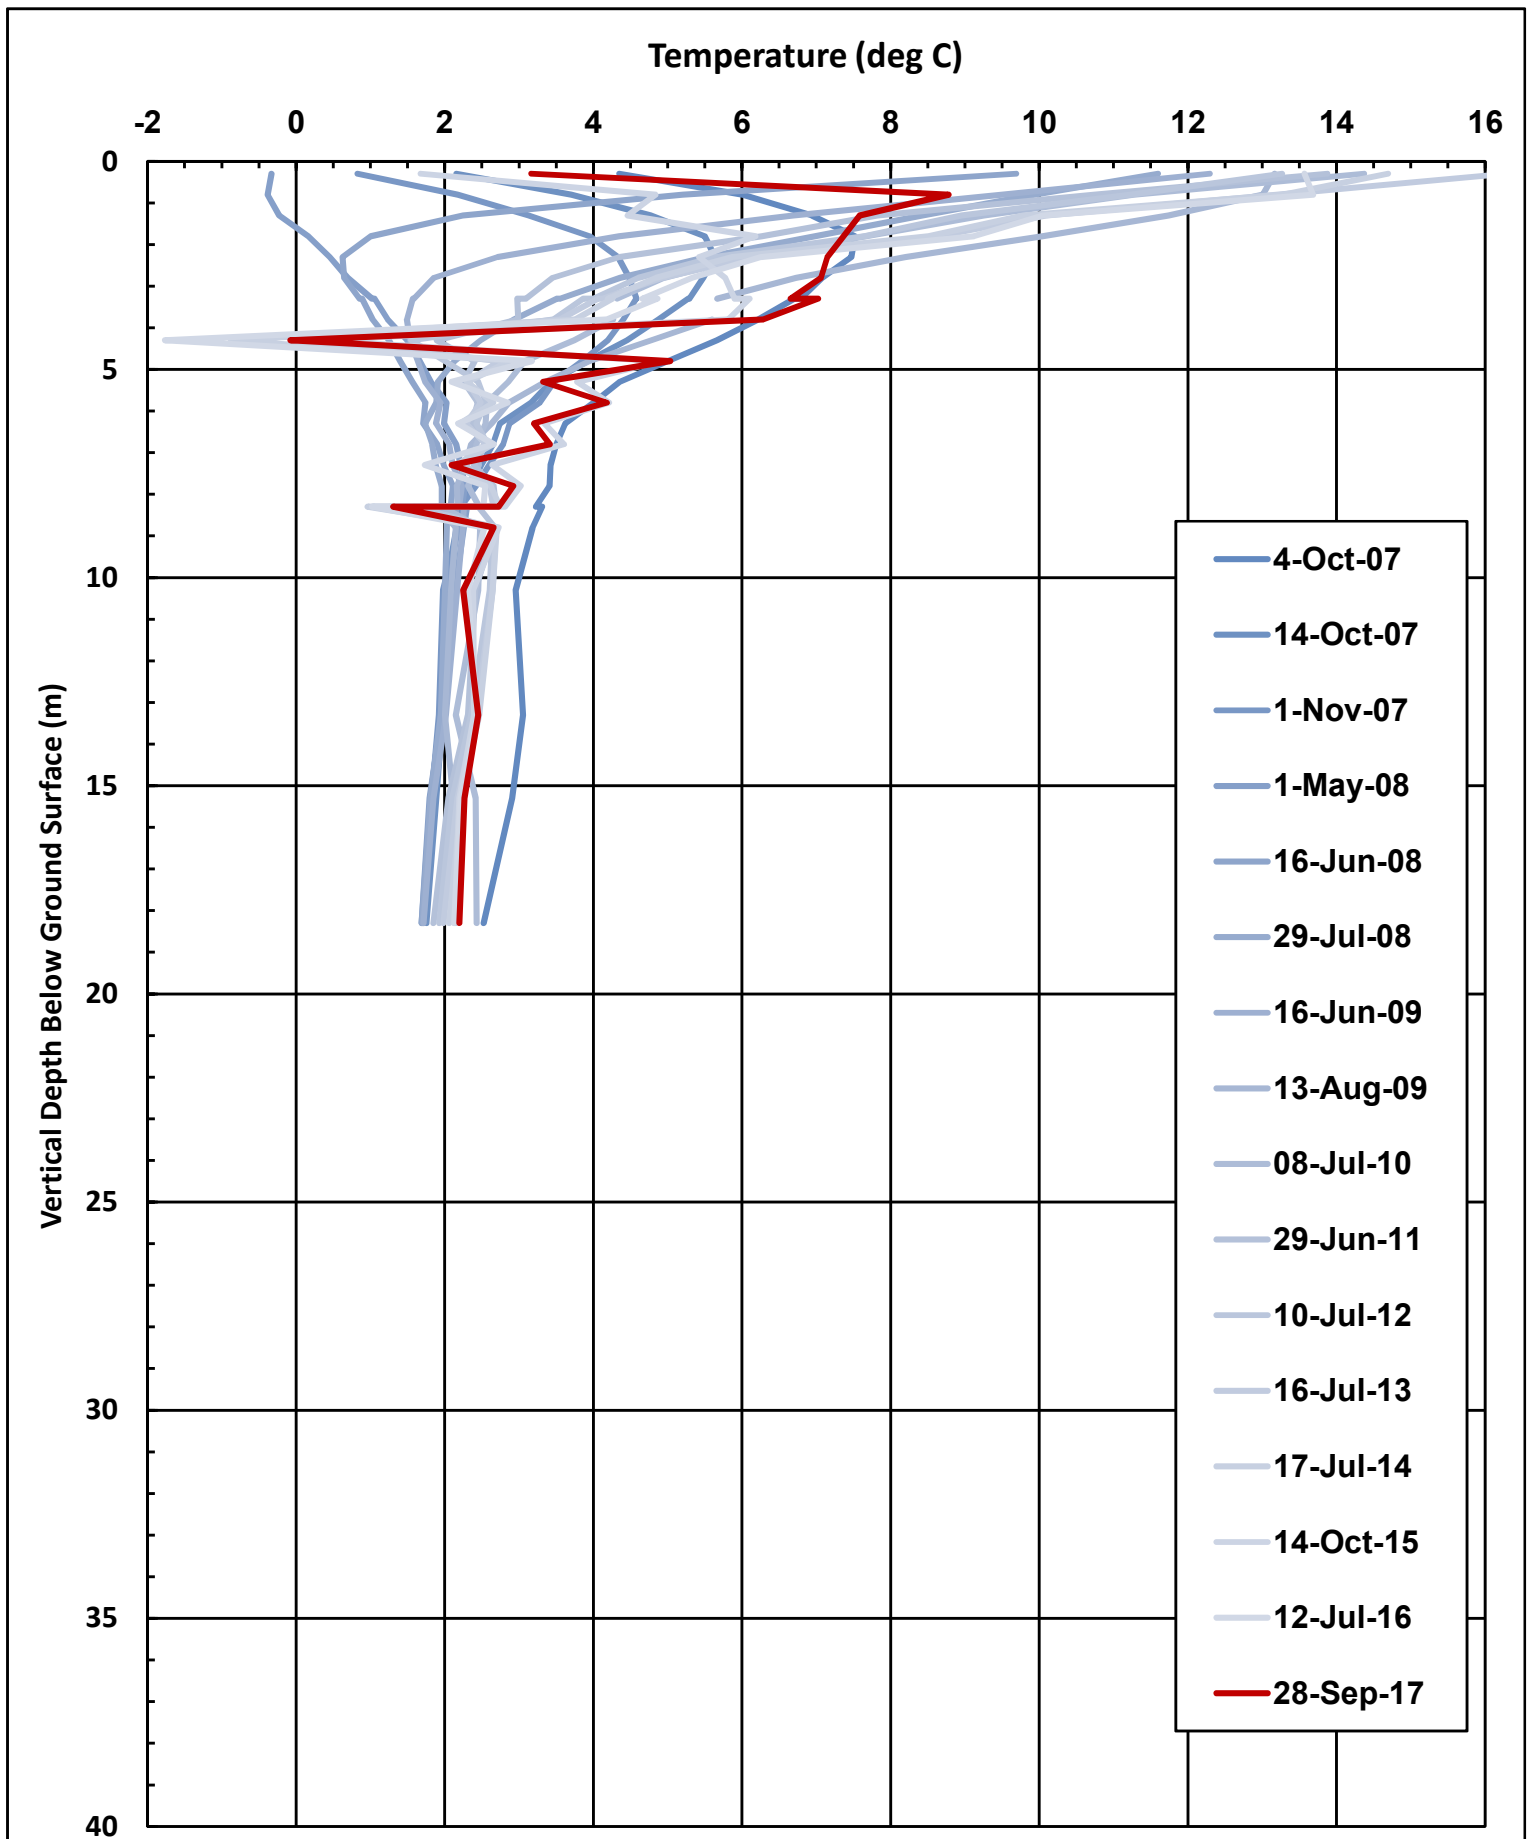
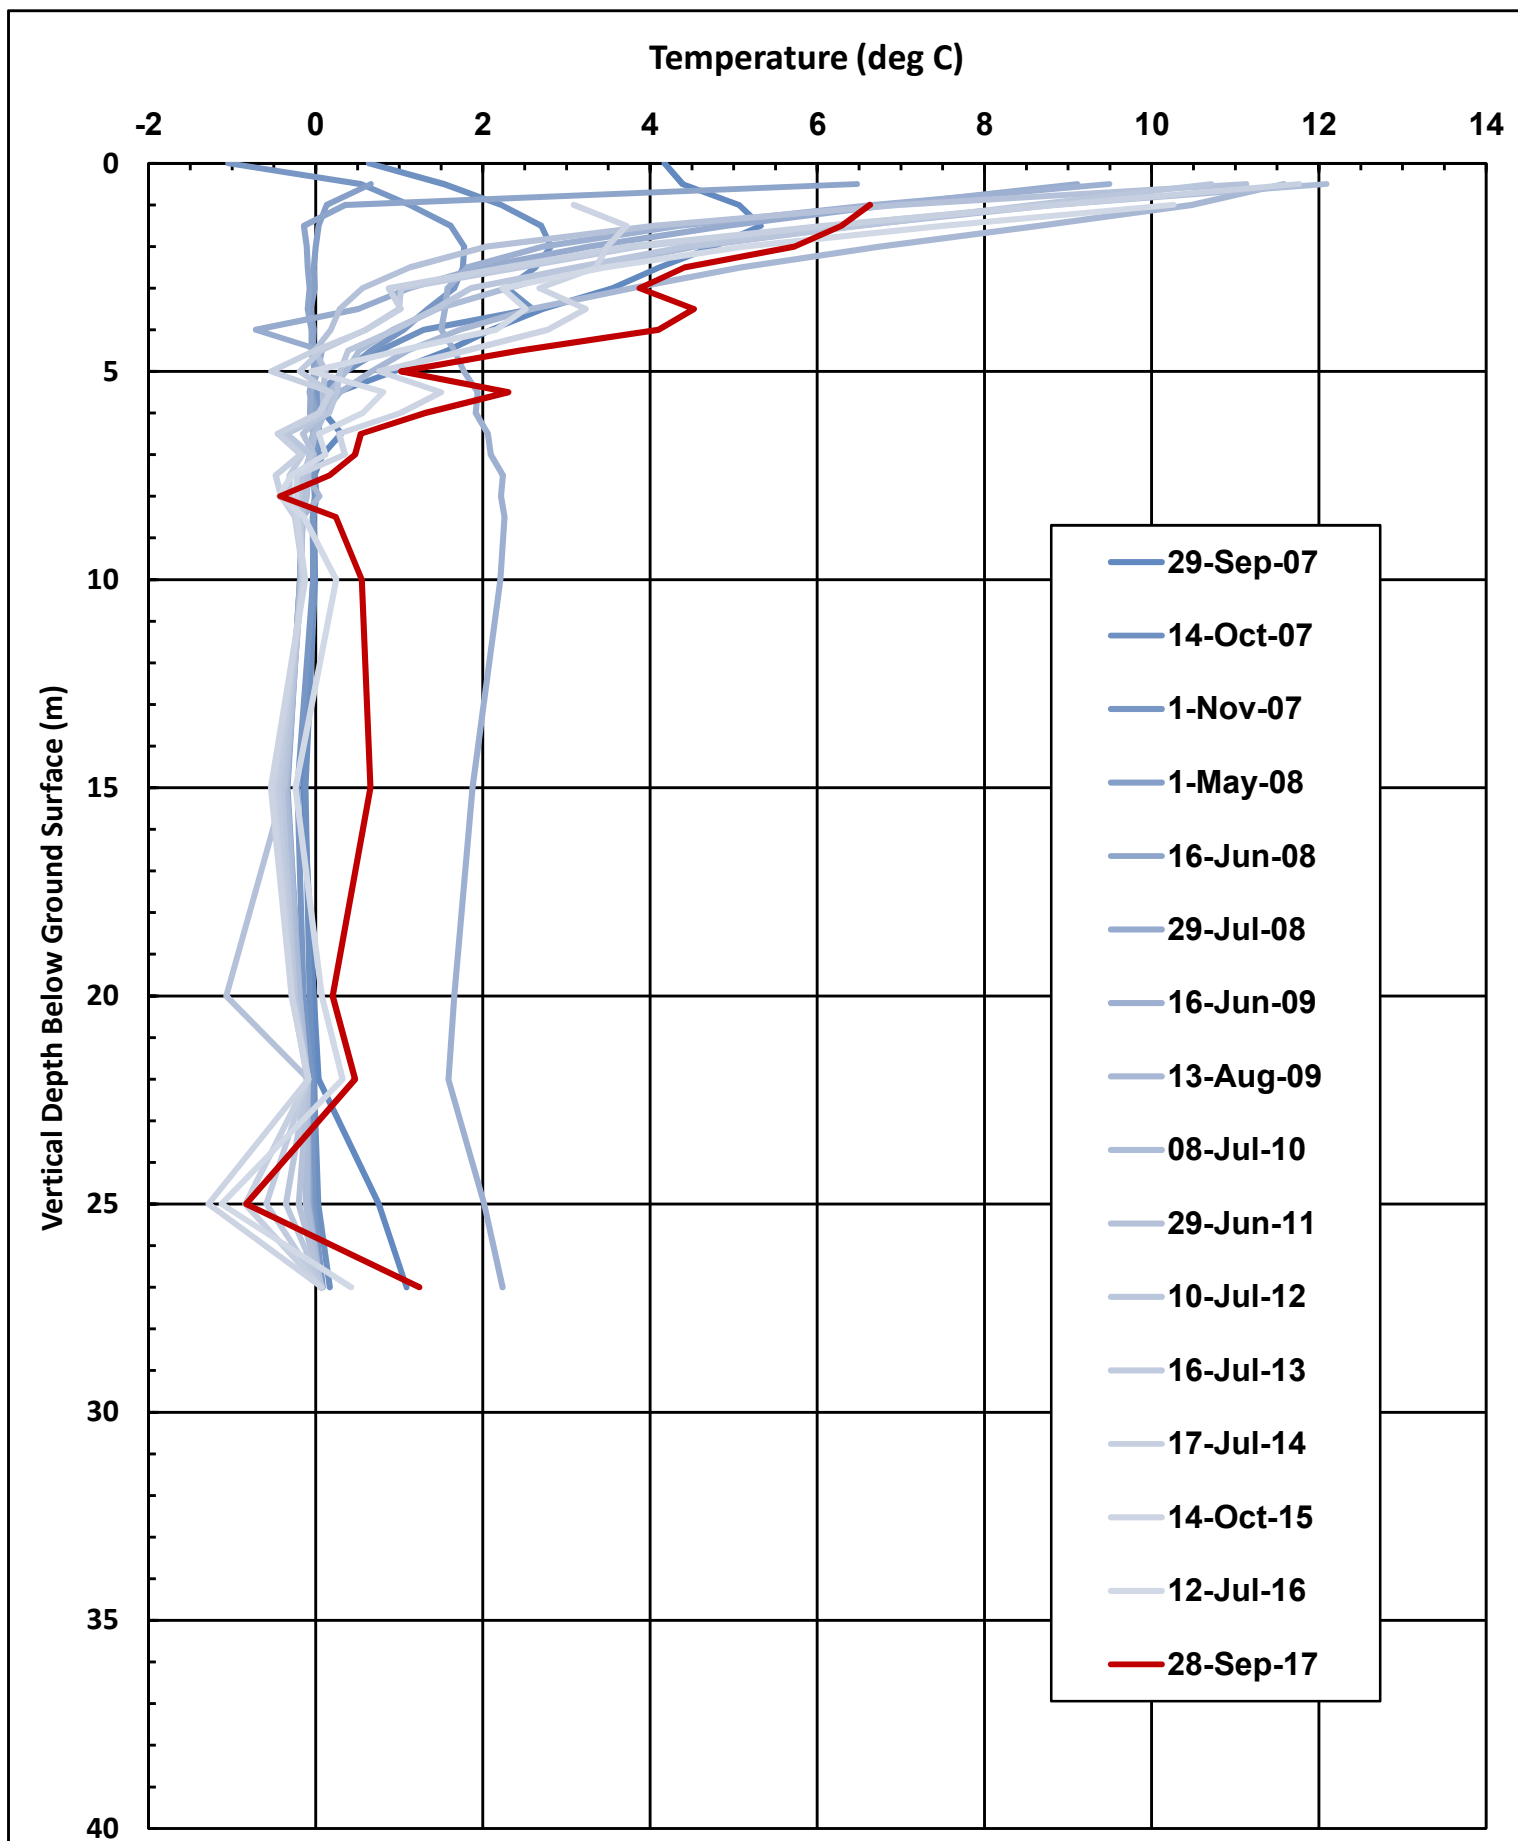
Thermistor Plots

Thermistor monitoring data, through 2017 demonstrate that clearing of the Heap Leach Facility area in 1997, promoted thawing of the discontinuous permafrost. However, in recent years that progress has been lost due to vegetation regrowth. Based on thermistor monitoring from 2007 to 2017, shown in Attachment 3, the Heap Leach Facility area would need to be re-cleared to facilitate thawing. Further monitoring would be initiated prior to any planned clearing of the heap pad area.

In general, thermistors BH-01-07, BH-03-07 and BH-06-07, located at the heap leach site, have continued to show a gradual year-on-year decrease in temperatures at depths greater than 5 to 7 m, depending on location. Similar trends are also apparent in BH-12 07, BH-18-07 and BH-29-07, located within the proposed waste rock storage area. The remaining thermistors indicate little or no permafrost, over the depth monitored, and in general show a warming trend. Note the monitoring depth varies by location.

The project is located in an area of discontinuous permafrost, which is relatively warm. Based on site data, where permafrost exists, the mean annual temperature ranges from about -0.4 to -2°C, below a depth of 10 m. This is evident from the thermistor plots, which can be interpreted to estimate the active thaw layer and permafrost, where present. The thermistor plots indicate the presence of permafrost at the following locations:

- BH-01-07, BH-03-07 and BH-06-07 to the south and west of the proposed heap leach facility area, where the active thaw layer is approximately 5 to 7 m thick with permafrost below.
- BH-12-07, BH-18-07 and BH-29-07 within the proposed waste rock storage area, where the active thaw layer varies from approximately 5 to 8 m thick with permafrost below.

No permafrost has been observed at thermistors BH-13-07, BH-23-07, and BH-26-07 over the monitored depths of 18.3 m, 15.0 m, and 12.0 m, respectively. These instruments are within the proposed Heap Leach Facility area. Permafrost may exist below the depth monitored.
