**Re: 2012 Annual Physical Inspection , Quartz Mining Licence QML-0009  
Bellekeno Mine, Yukon**

ALEXCO KENO HILL MINING CORP.  
QUARTZ MINING LICENCE QML-0009  
2012 ANNUAL PHYSICAL INSPECTION  
BELLEKENO MINE SITE  
KENO HILL SILVER DISTRICT  
YUKON

**Subject:** 2012 Annual Inspection – Surface Engineered Earth Structures  
Bellekeno Minesite, Keno City, Yukon

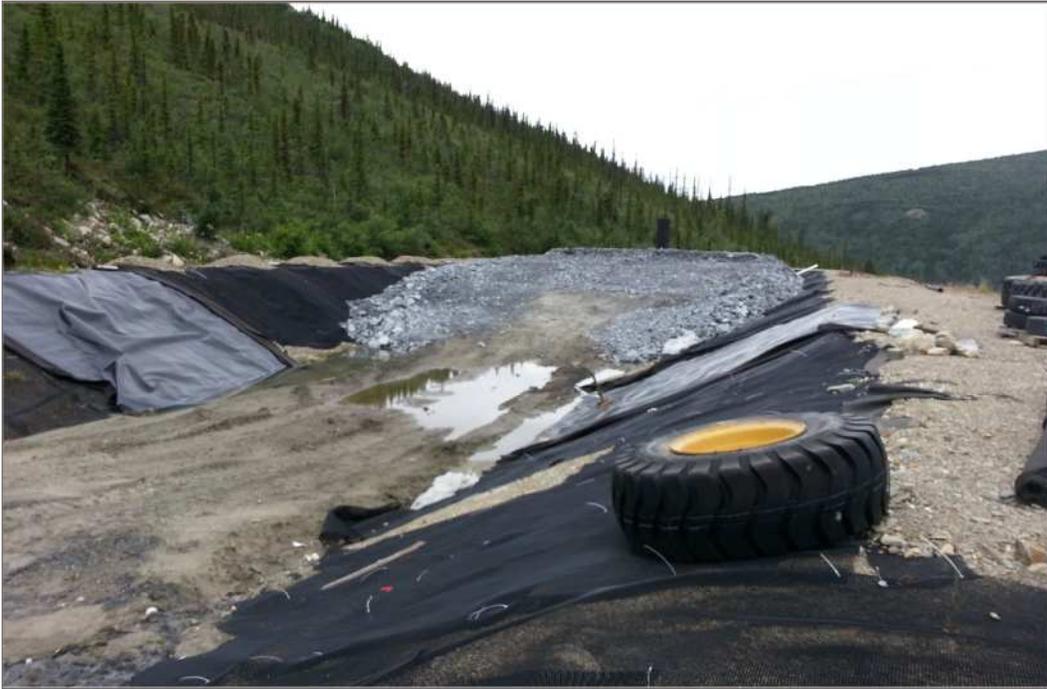
The PAG Waste Storage Facility is located south of the Bellekeno Mine portal, as shown on Figure 1. The perimeter berms of the facility appeared intact with no visible signs of instability or erosion (Photos 1 and 2). The vertical geotextile wrapped extraction culvert, waste piles, and completed liner system appeared stable (Photo 3).

**Photo 1:** PAG Waste Storage Facility  
Completed and partially completed sections of liner.  
July 13, 2012

The storage facility has not been completed and little work has been done since the 2011 Inspection to bring it nearer to completion. While the material being stored within the facility appeared to be properly contained; construction of the facility should be completed to reduce the risk of uncontrolled release and allow for additional storage capacity.

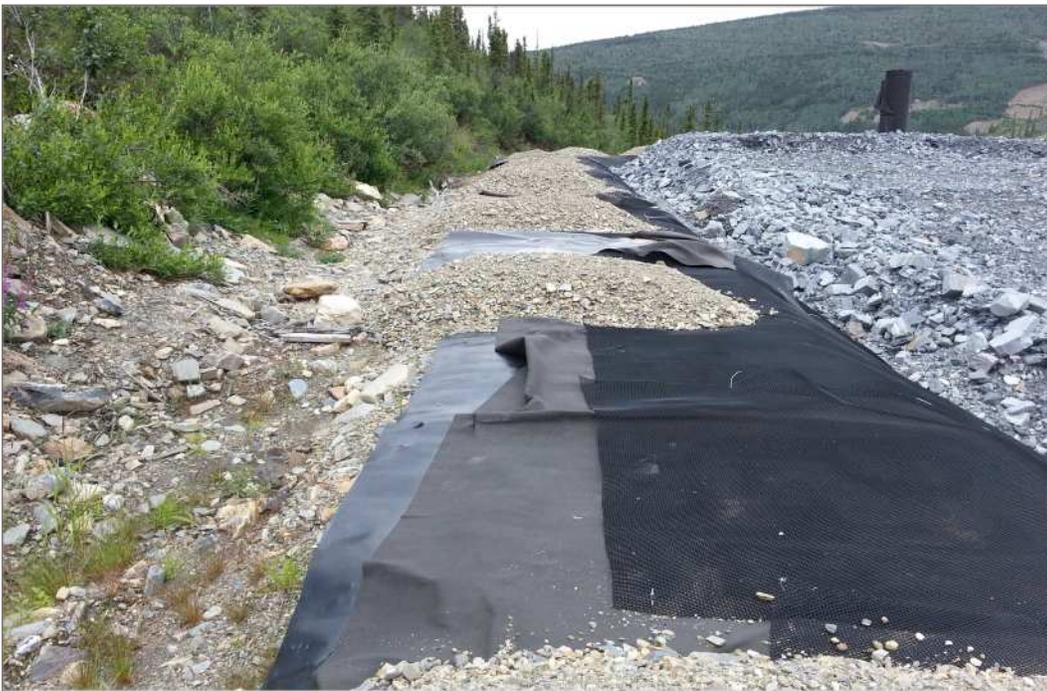
**Photo 2:** PAG Waste Storage Facility  
Liner not adequately anchored along west berm  
July 13, 2012

Within the completed portion of the facility (northern half) the liner anchoring trench along the east berm appeared finished. Elsewhere, loose material was piled on top of the berm to hold the liner in place (Photo 4). The liner anchoring trench should be finished for the remainder of the completed facility (north and west berms).

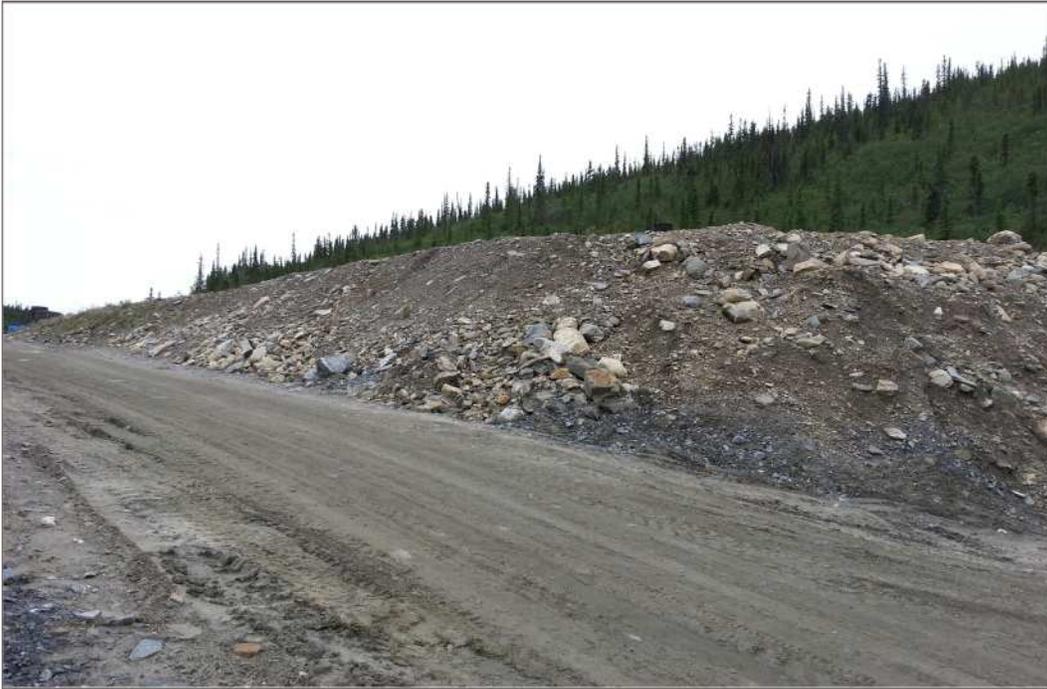
**Photo 3:** PAG Waste Storage Facility  
East perimeter berm  
July 13, 2012

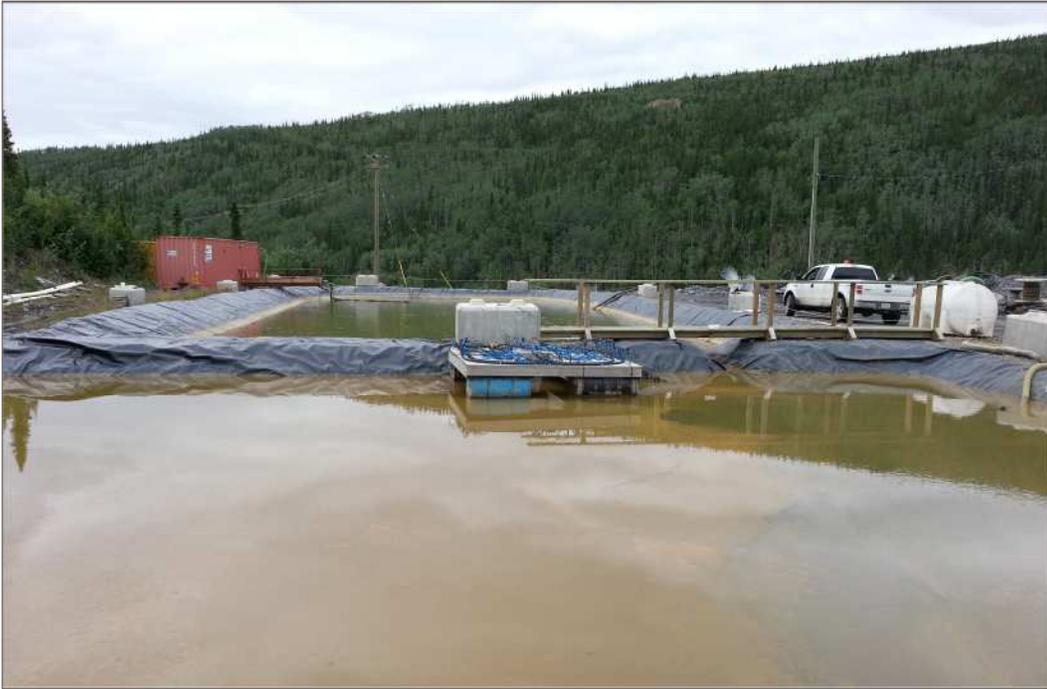
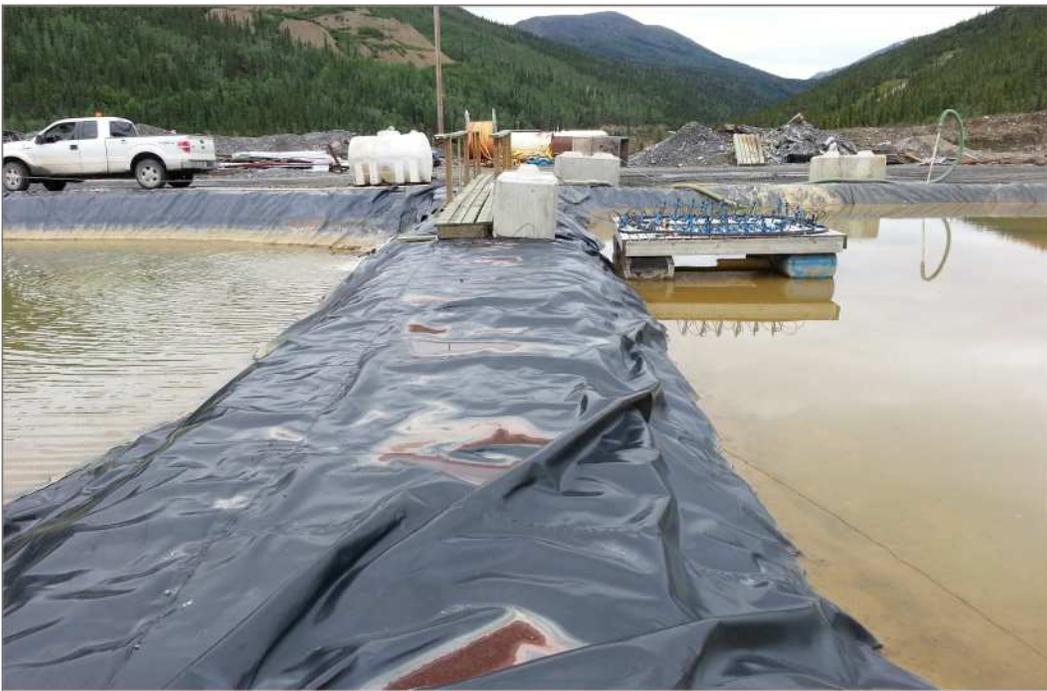
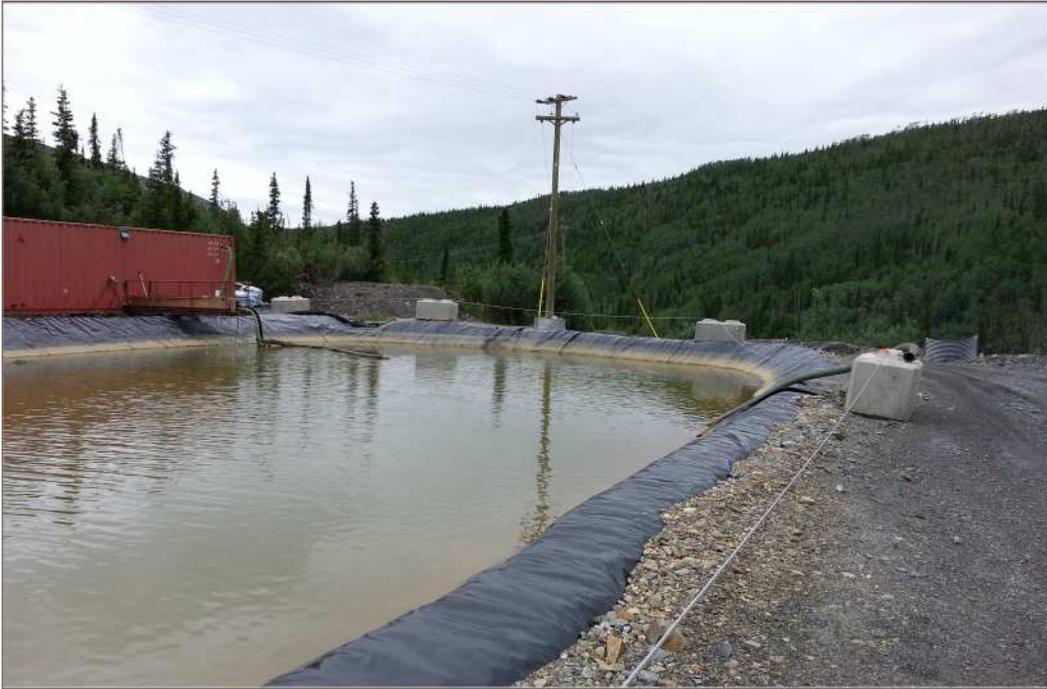
The Bellekeno 625 water treatment pond is located east of the Bellekeno Mine haul road where it passes the waste rock pile. The location is shown on Figure 1. The pond and surrounding structures (vehicle barriers, walkways, and piping) appeared stable at the time of the inspection. The liner system appeared intact and no liner tension or bulging was observed. The pond berms and liner anchoring trenches appeared intact and stable. No remedial action is recommended for the Bellekeno 625 water treatment pond at this time (Photos 5 through 7).

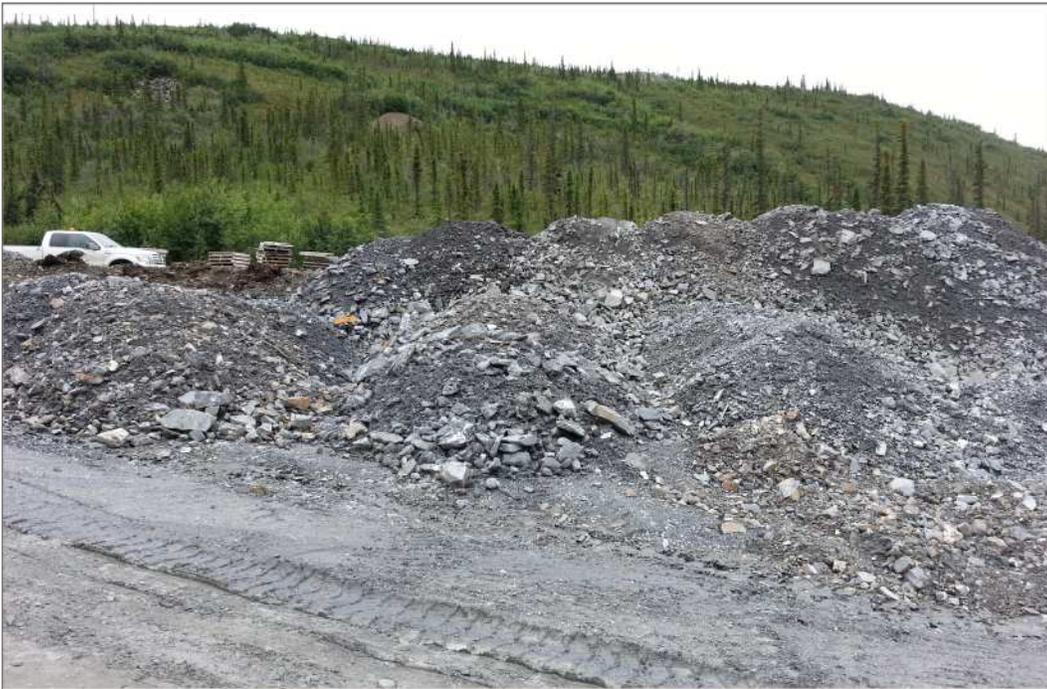
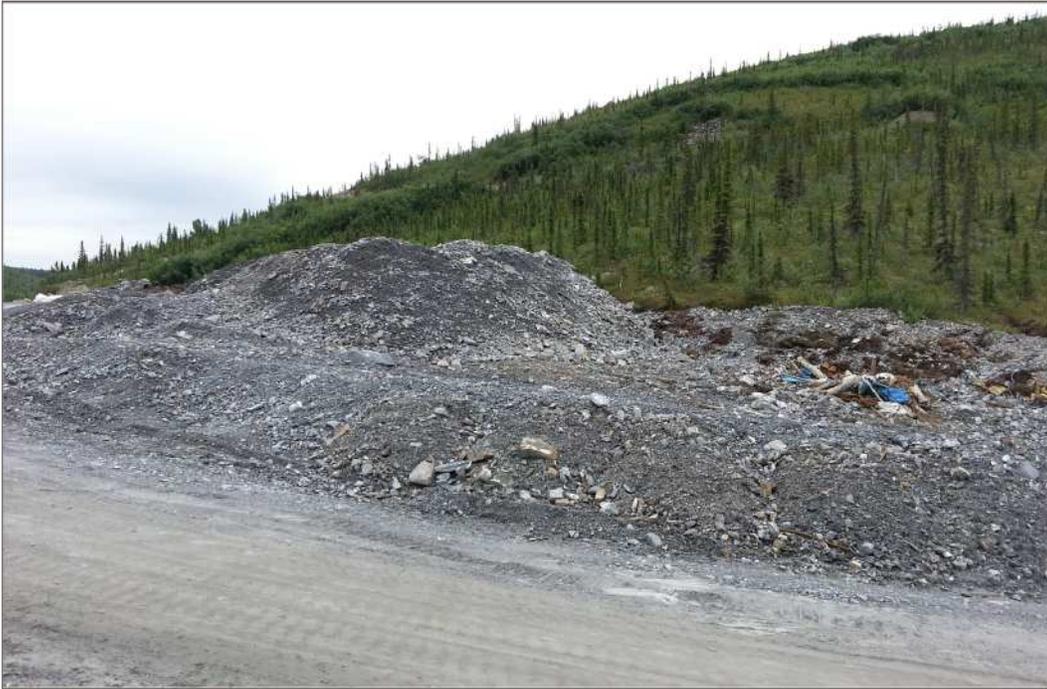
The waste rock pile is located along the Bellekeno Mine haul road, north of the portal. The location is shown on Figure 1. The pile and side slopes appeared stable at the time of the inspection (Photos 8 and 9). No remedial action is recommended for the waste rock pile at this time.

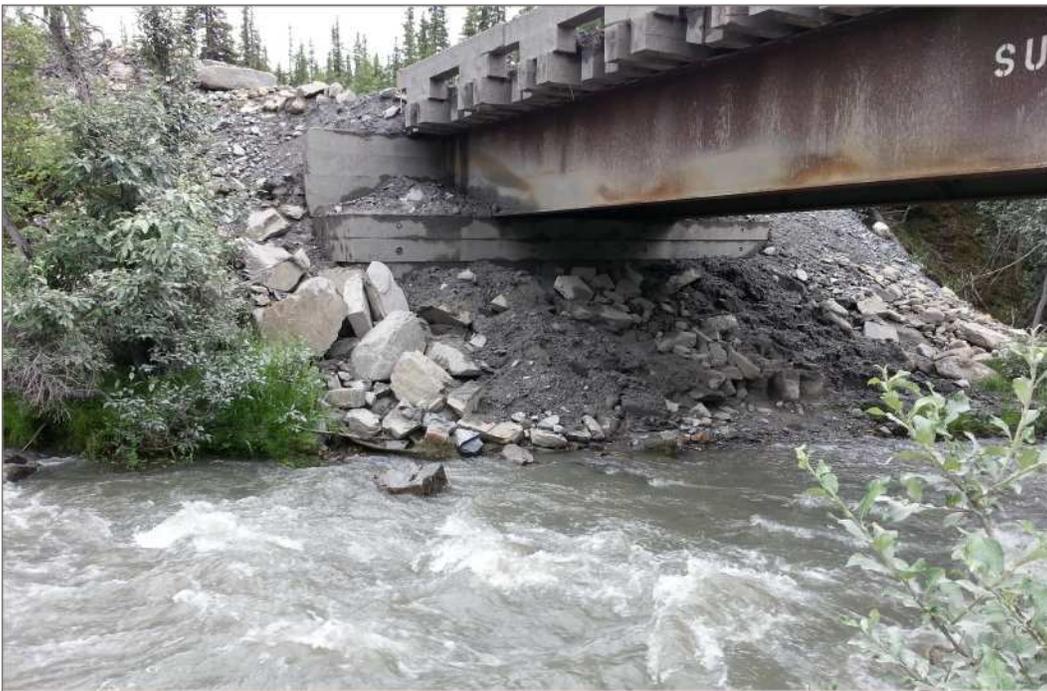
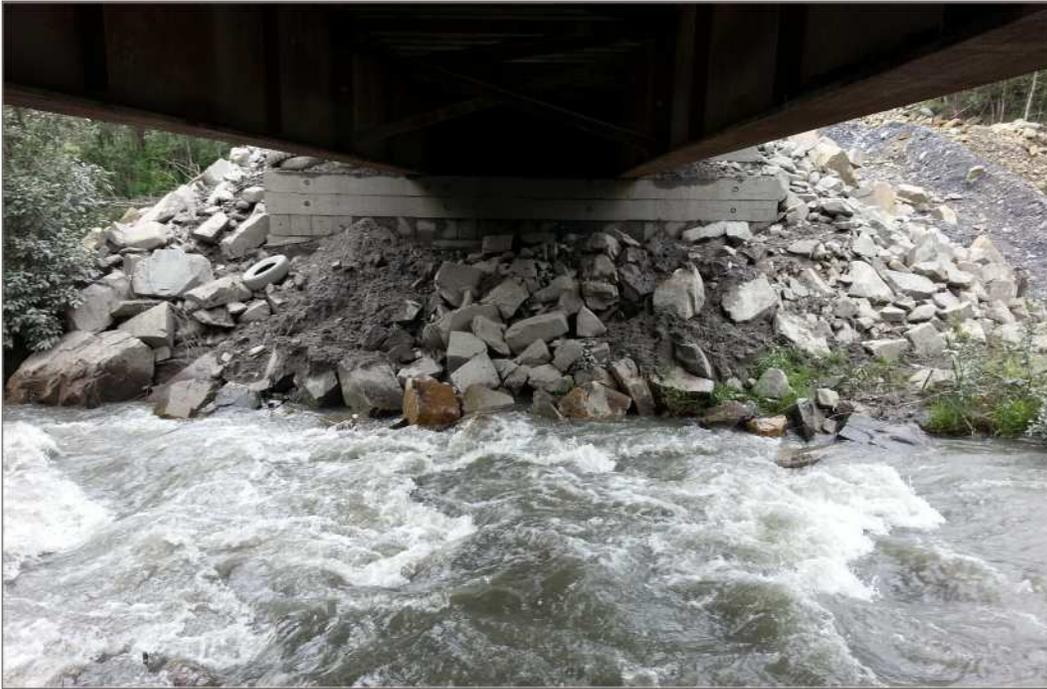
The Lightning Creek Bridge is located on the Bellekeno Mine haul road near Keno City. The location is shown on Figure 1. The bridge abutments are constructed of earth filled timber cribbing and no indications of movement or instability were observed at the time of the inspection (Photos 10 and 11).

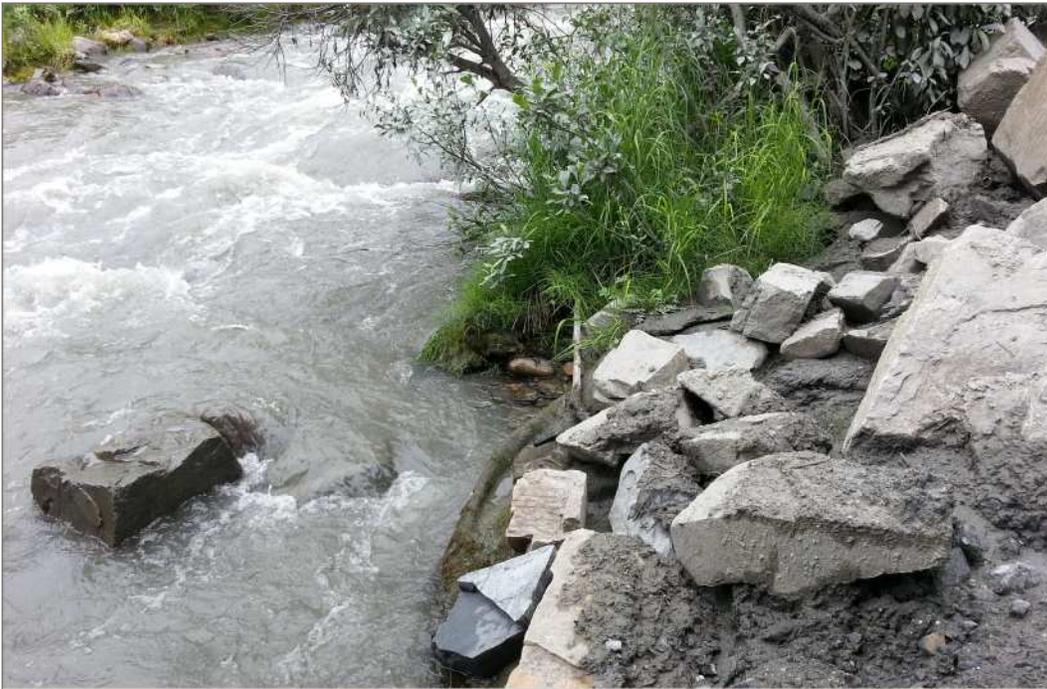
bank of Lightning Creek to protect the abutments from scour does not adequately cover the underlying geotextile near the creek's edge (Photo 12). Additional riprap should be placed as an added precaution.

**Photo 12:** Lightning Creek Bridge Abutments  
Exposed geotextile on East Abutment  
July 13, 2012

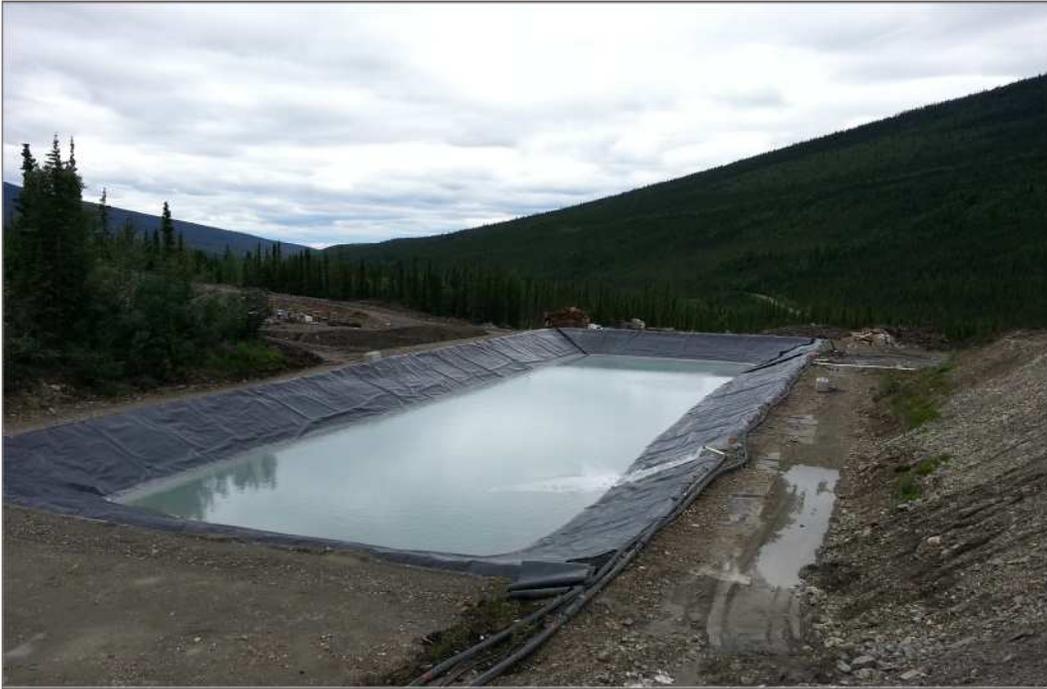
**Photo 13:** Mill Water Storage Pond  
July 13, 2012

The mill water storage pond is located at the Bellekeno Mill Site approximately 1 km west of Keno City. The location is shown on Figure 1. No visible seepage was observed and the pond berms appeared stable at the time of the inspection. The liner system appeared intact with no loose seams, liner tension, or liner bulging observed (Photos 13 and 14).

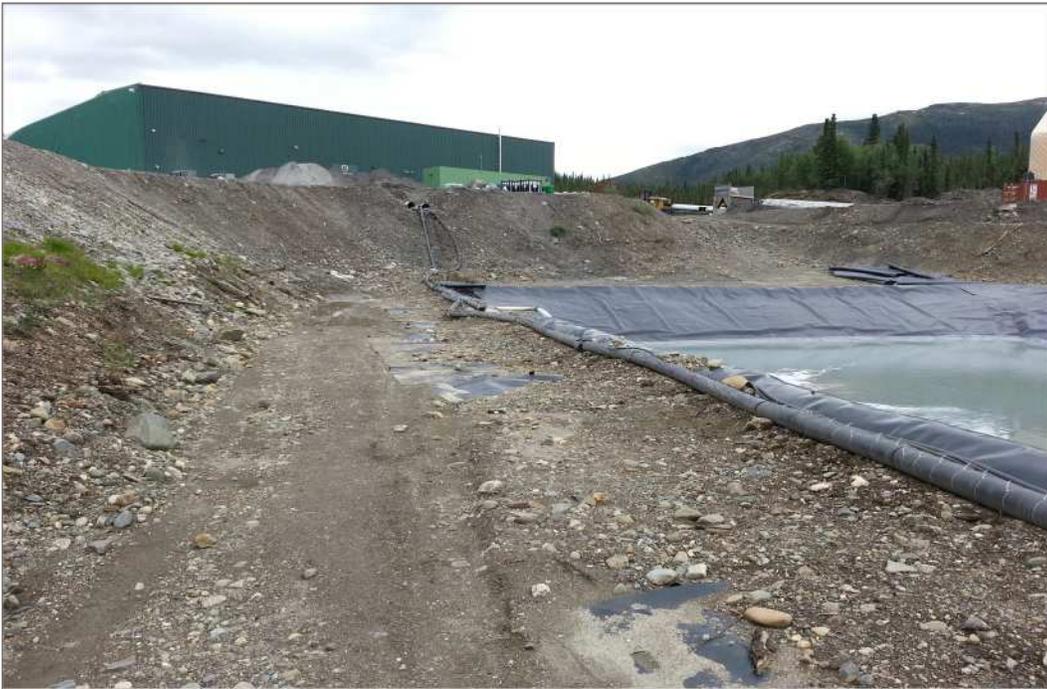
**Photo 14:** Mill Water Storage Pond  
Exposed liner along pond berm  
July 13, 2012

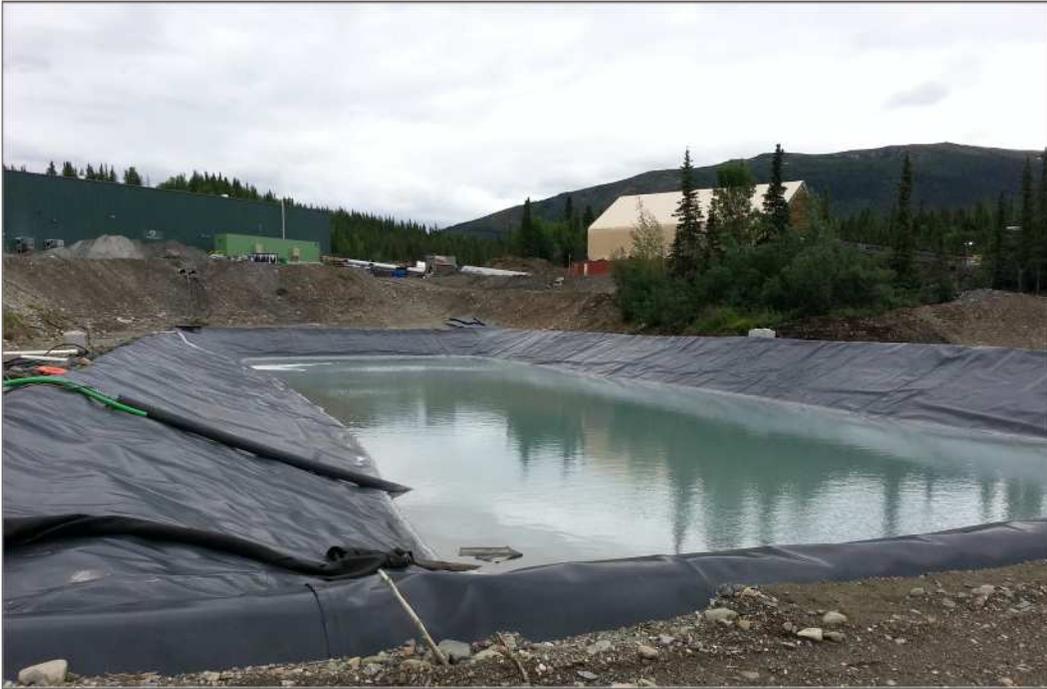
**Photo 15:** Mill Water Storage Pond  
July 13, 2012

The liner anchoring trench for the North West side of the pond is not completed and is exposed along the entire length of the pond (Photo 15). To reduce the potential of damage due to high winds, it is recommended that the liner be properly anchored and buried.

From a safety standpoint, it is also recommended that ropes or ladders be laid into the pond along its length. As the pond does not freeze in the winter, if a worker falls into the water they will be able to exit the high slopes more easily.

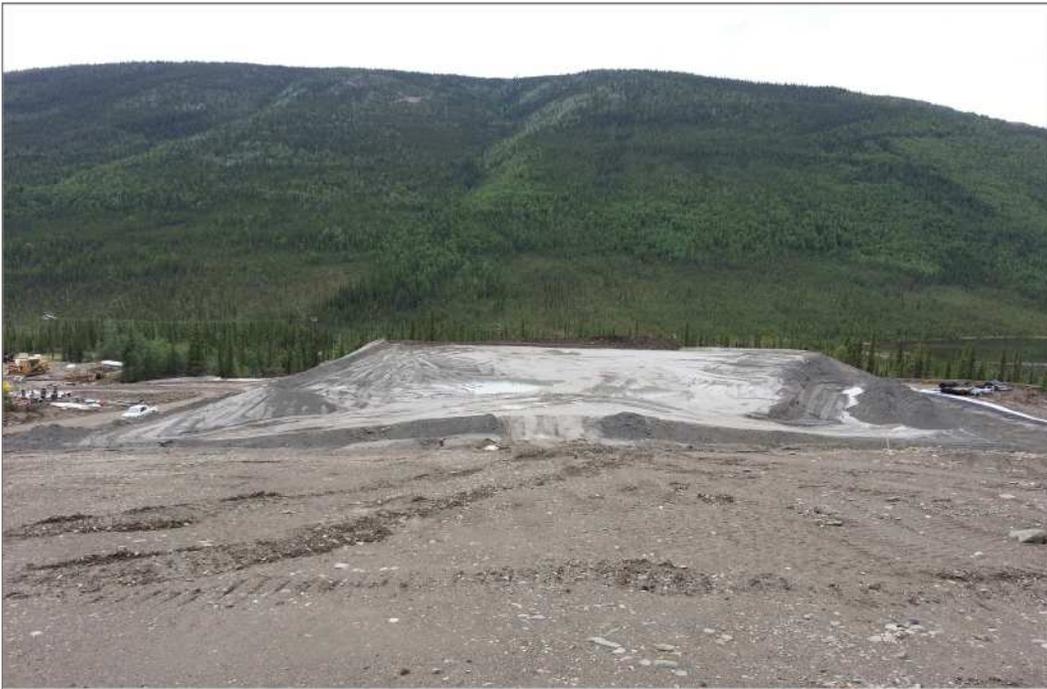
The tailings appear to have been placed in accordance with the design with the lower bench being mostly completed to date (Photo 16). The crest elevation has been brought back down to its final design elevation in accordance with the 2011 inspection recommendations. This has allowed the placement of cover material to begin over the west facing slope (Photo 17).

**Photo 16:** DSTF Lower Bench  
Facing west  
July 13, 2012

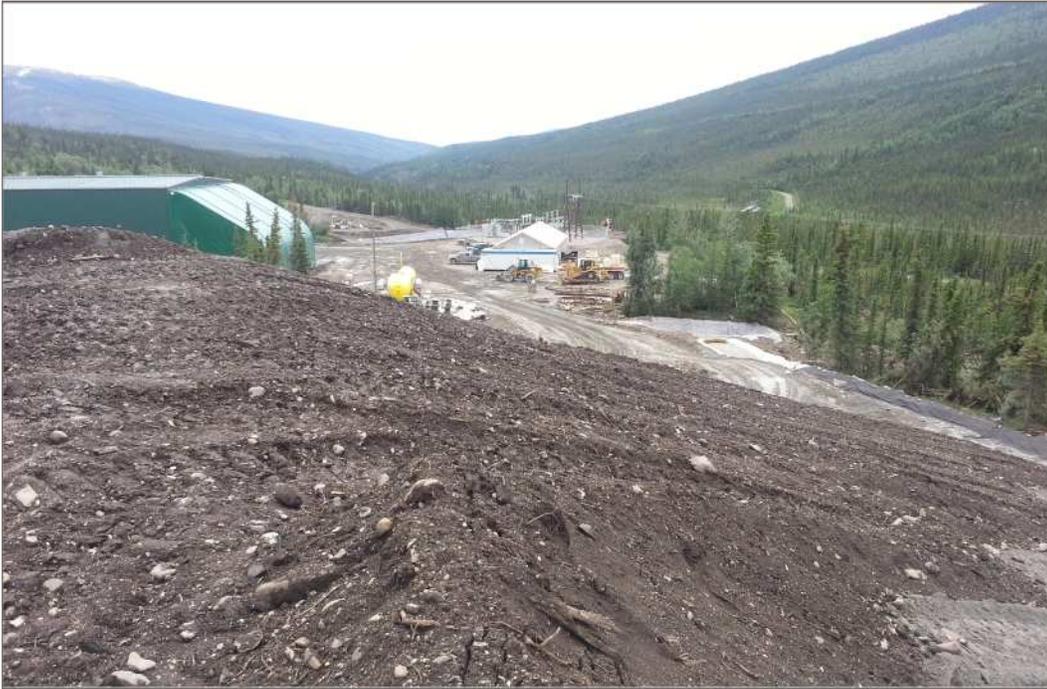
**Photo 17:** DSTF Lower Bench  
Early stages of cover placement  
July 13, 2012

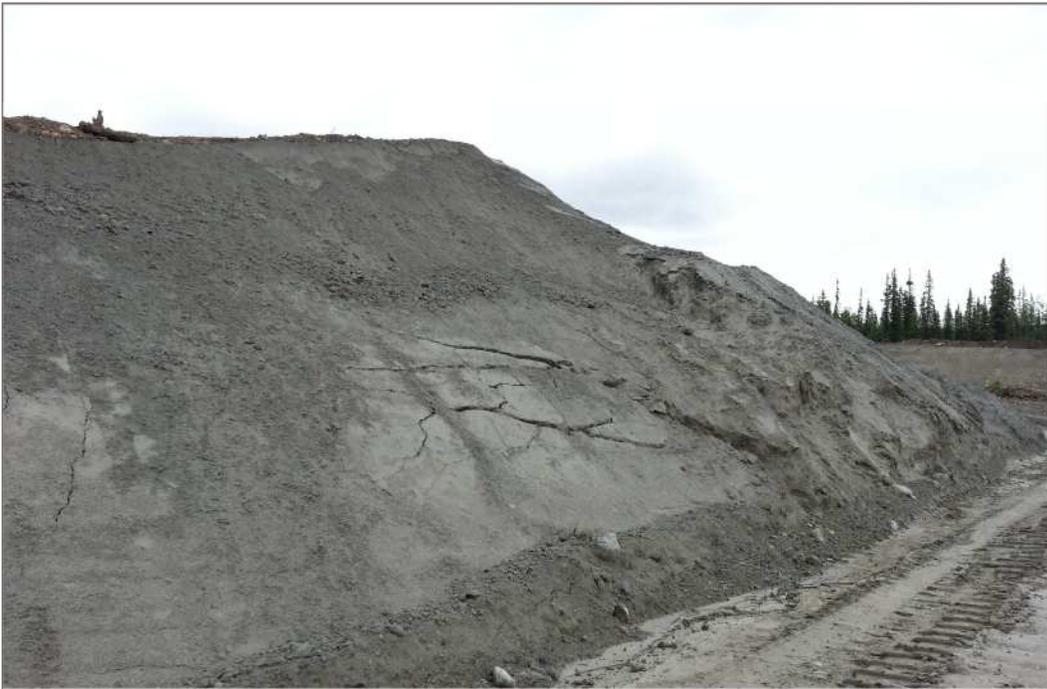
Minor cracking along the south slope face and adjacent to the haul road was observed at the time of the inspection (Photo 18). This is likely due to the combination of loose placement of material along the slope surface and heavy rainfall in the weeks leading up to the inspection. It is recommended that the affected areas be pulled back in benches and re-worked.

**Photo 18:** DSTF Lower Bench  
Cracking on south slope along haul road  
July 13, 2012
