December 19, 2014

ISSUED FOR USE – REVISION I

FILE: W14103450-01

**Subject:** 2014 Annual Inspection – Surface Engineered Earth Structures  
Bellekeno Mine, Keno City, YT

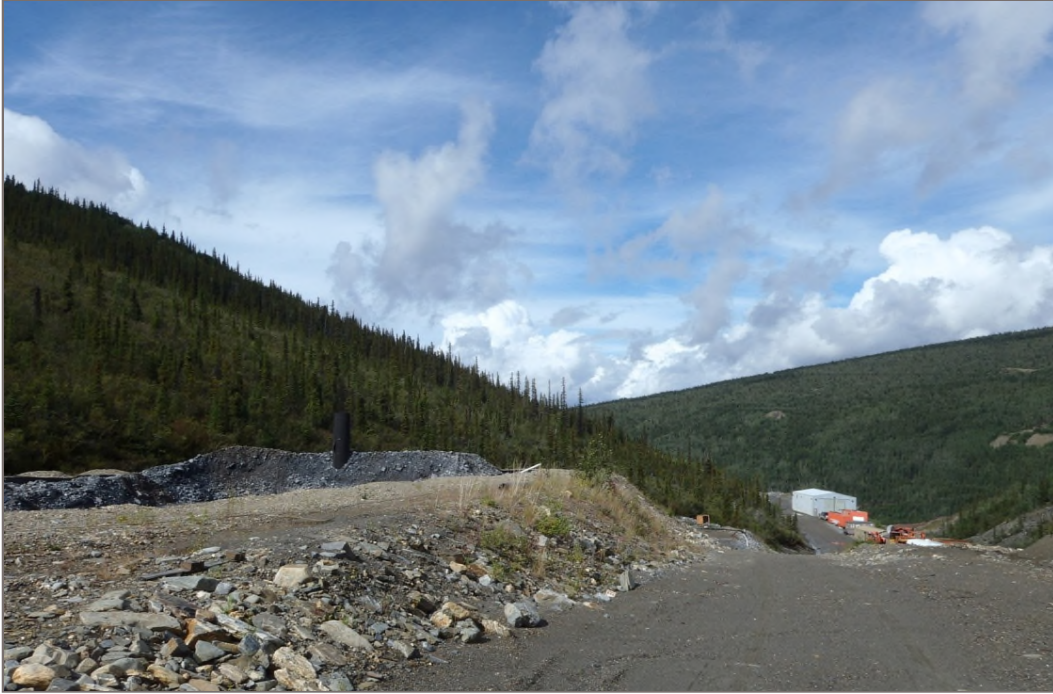
The PAG waste storage facility is located south of the existing Bellekeno portal, as shown on Figure 1. At the time of the inspection the facility perimeter berms appeared intact (Photo 1) with no visible signs of instability (tension cracks, erosion rills, slumps, etc.). The facility was impounding some surface water (Photo 2). This is likely a result of the laydown area immediately south (upslope) of the facility being generally graded toward the entrance (Photo 3). To reduce the amount of surface runoff water captured by the facility, the upslope laydown area can be regraded to drain away from the facility entrance or a diversion berm can be constructed to direct surface runoff around the entrance to the facility. This work can be completed during regular facility maintenance and is not a facility stability concern.

**Photo 1:** PAG Waste Storage Facility  
Facility berms and sideslopes  
Facing north – August 12, 2014

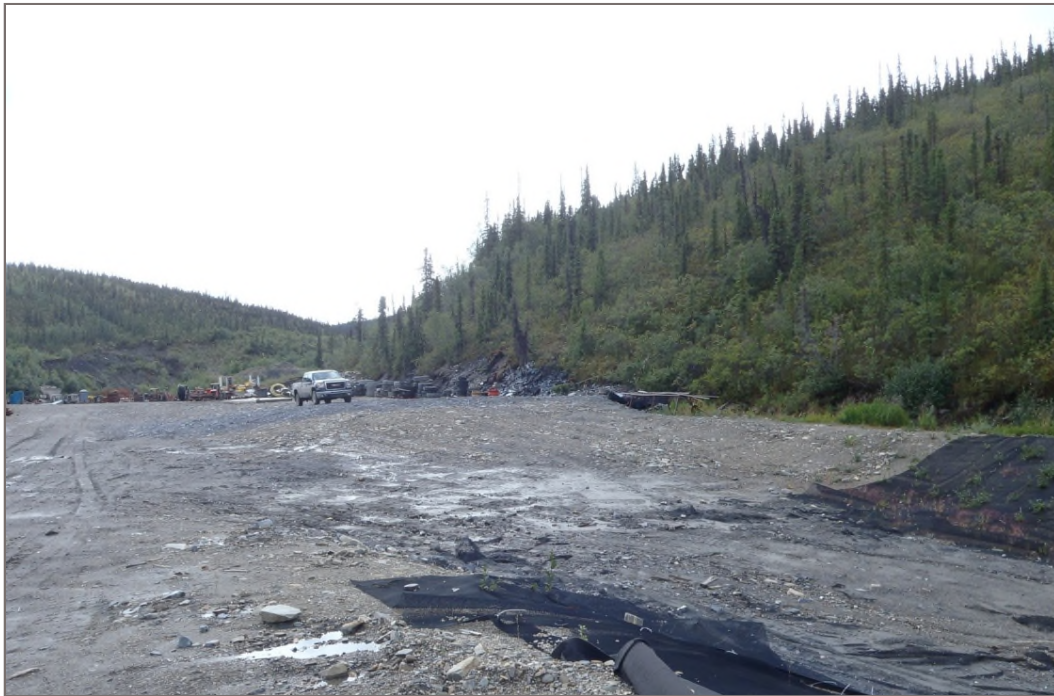
**Photo 3: PAG Waste Storage Facility**  
Laydown area graded toward facility entrance  
Facing south – August 12, 2014

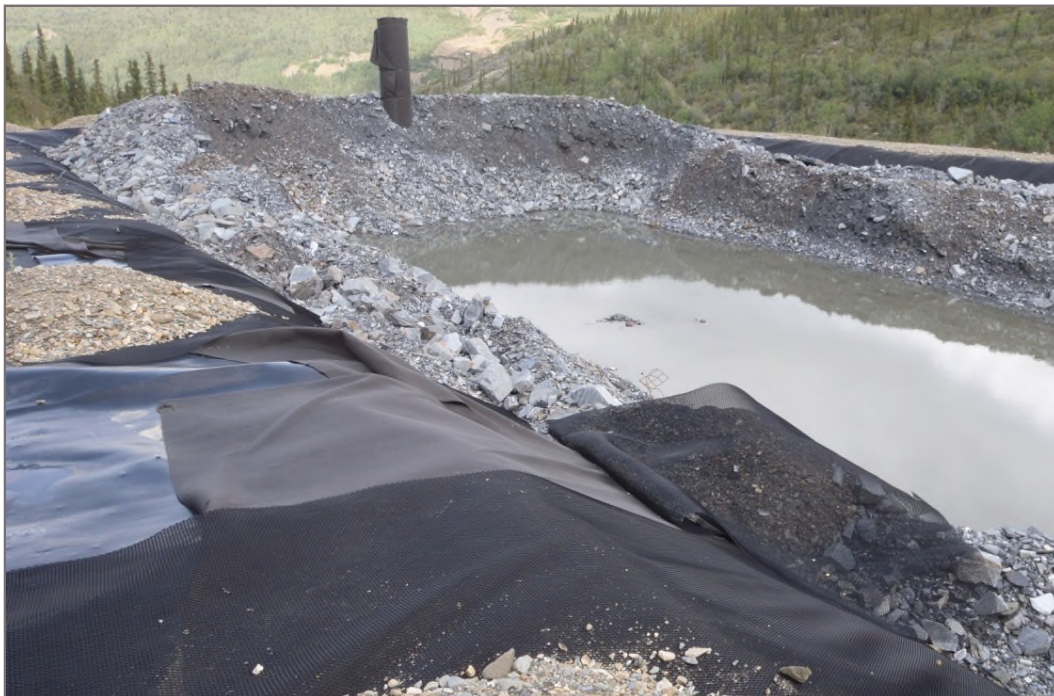
The north and west liner anchor trenches along the berm crests remain incomplete. For several years a recommendation to complete the trenching to adequately anchor the liner system has been made. The liner components have now been displaced by wind, due to insufficient anchoring (Photo 4). The liner system should be properly anchored before wind rips the material.

**Photo 4: PAG Waste Storage Facility**  
Liner components displaced due to wind  
Facing east – August 12, 2014

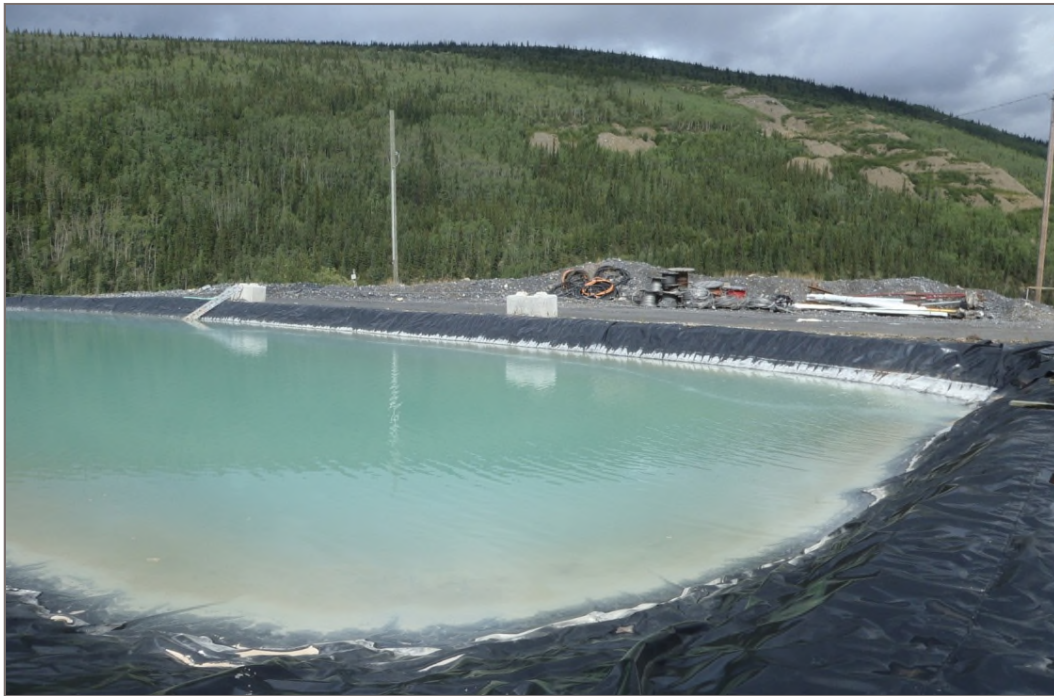
**Photo 7: Bellekeno 625 Water Treatment Ponds**  
Intact perimeter berms and liners  
Facing east – August 12, 2014

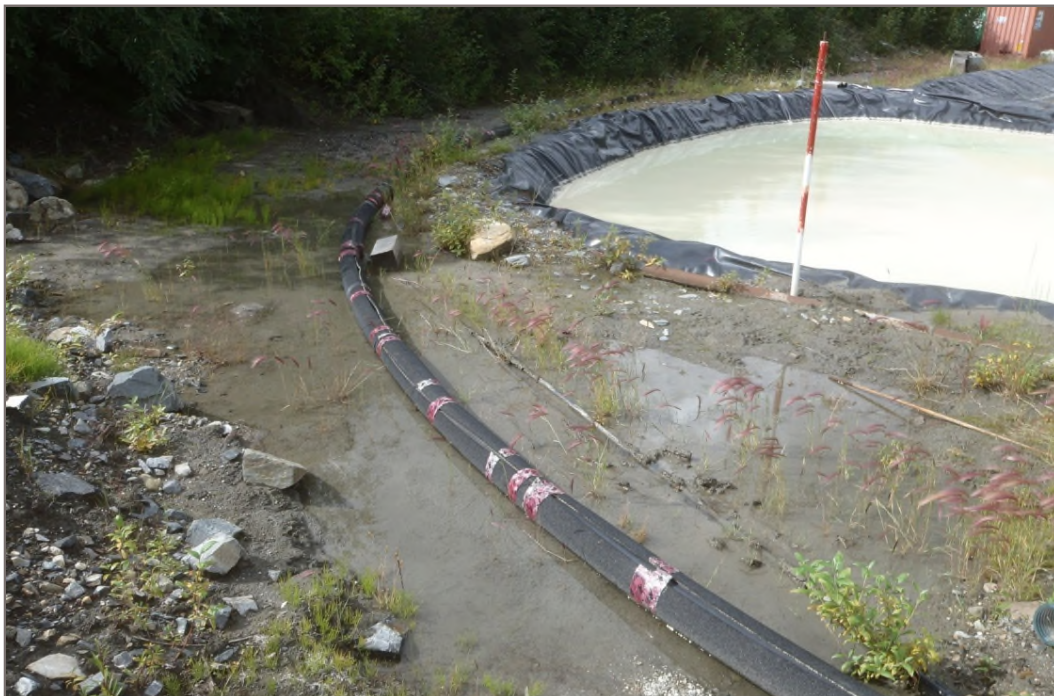
**Photo 8: Bellekeno 625 Water Treatment Ponds**  
Surface water and sediment accumulation outside southwest corner of primary pond  
Facing west – August 12, 2014

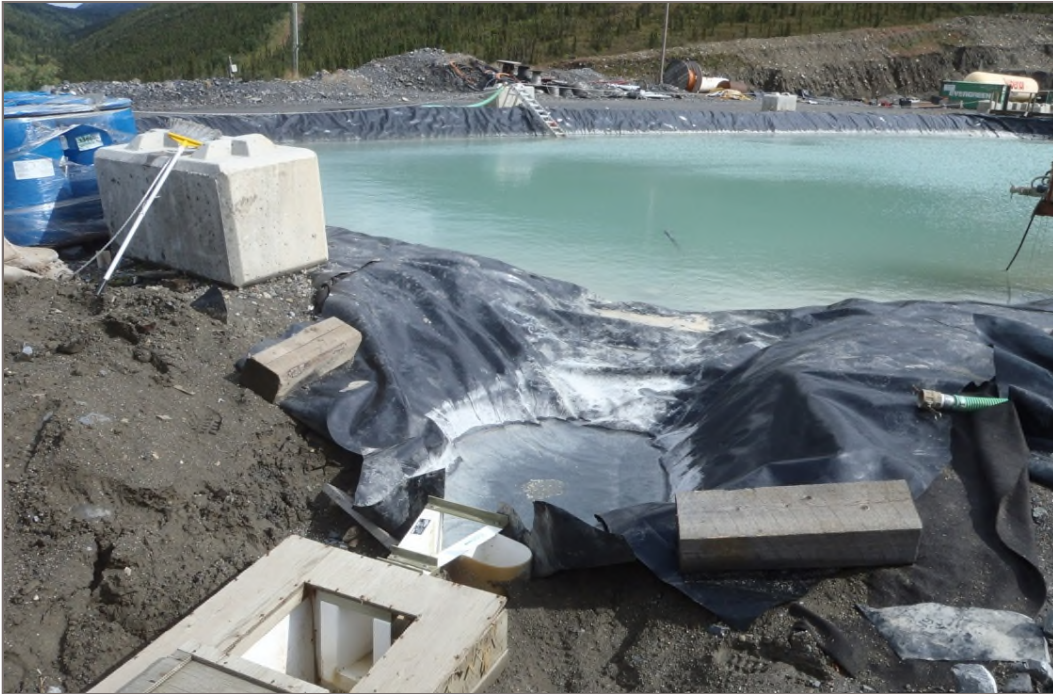
**Photo 9:** Bellekeno 625 Water Treatment Ponds  
Freeboard in secondary pond at outlet location  
Facing east – August 12, 2014

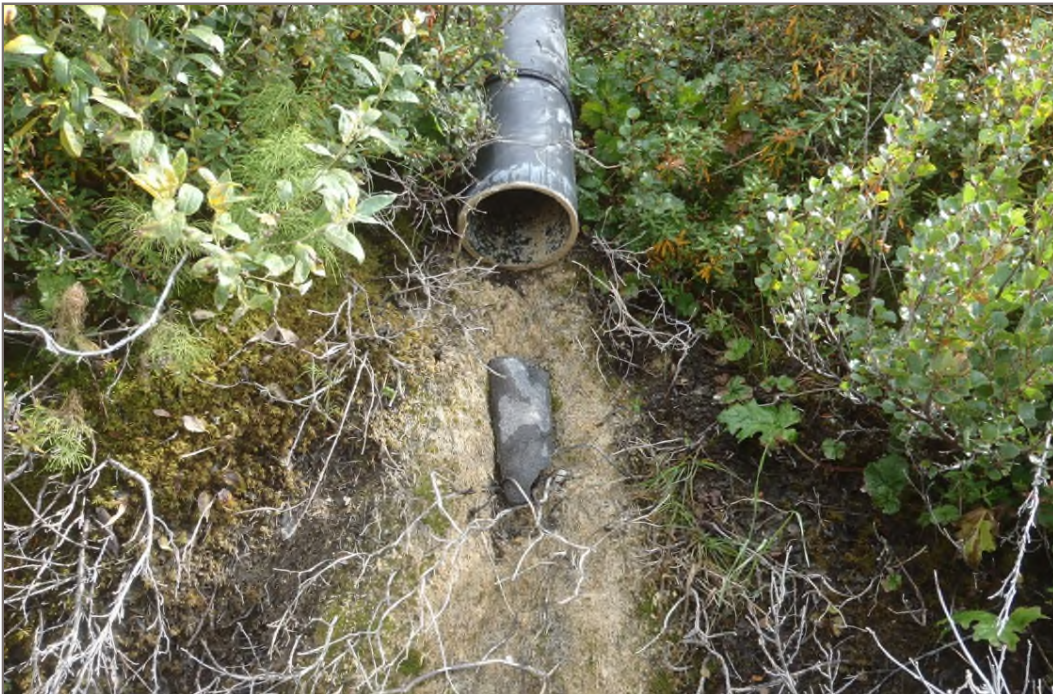
The primary treatment pond had a freeboard of about 0.5 m below the perimeter berm crest at the time of the inspection. Water in the secondary pond was about 0.1 m below the discharge invert elevation and the pond had a freeboard of about 1.0 m below the perimeter berm crest (Photo 9). The discharge line appeared intact at the time of the inspection. Consistent with recommendations made in previous years, rip-rap armouring is required at the discharge location (Photo 10) to limit damage to the natural hillside.

**Photo 10:** Bellekeno 625 Water Treatment Ponds  
Discharge location  
Facing south – August 12, 2014

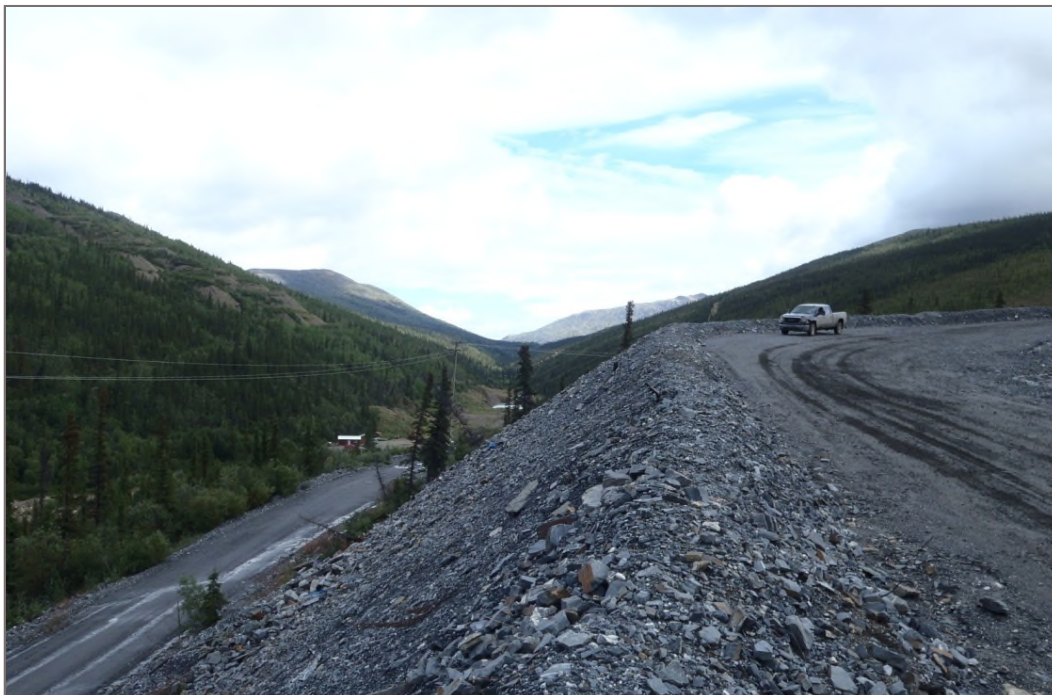
**Photo 11: Bellekeno Waste Rock Pile**  
Intact sideslopes  
Facing east – August 12, 2014

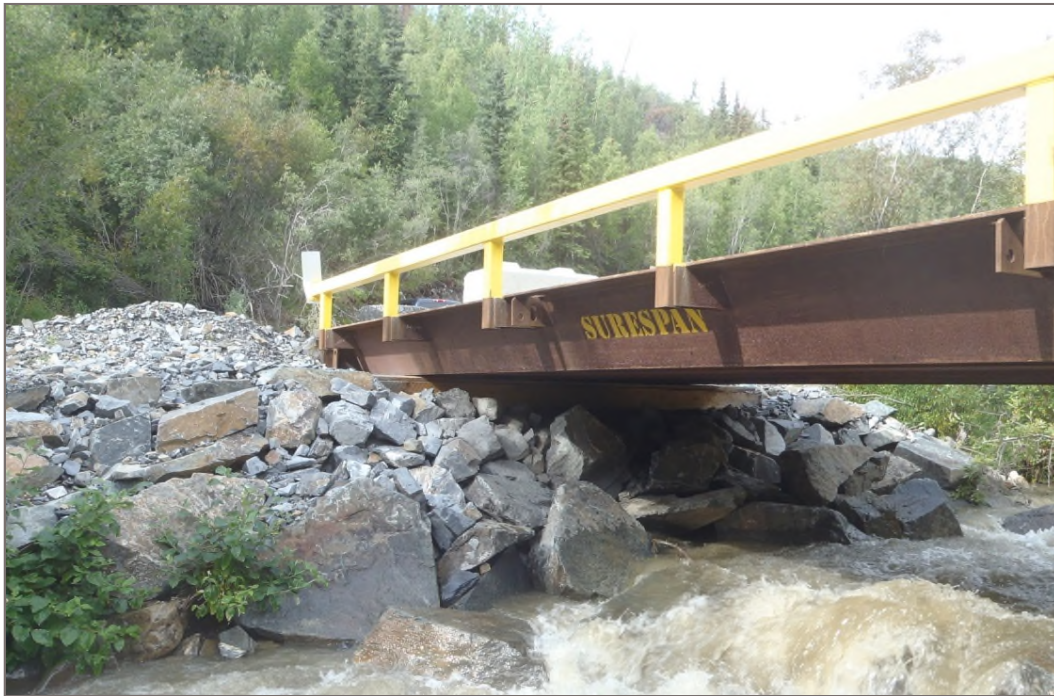
**Photo 15: Lightning Creek Bridge Abutments (Onek Road)**  
Rip-rap armouring bridge abutments  
Facing north – August 12, 2014

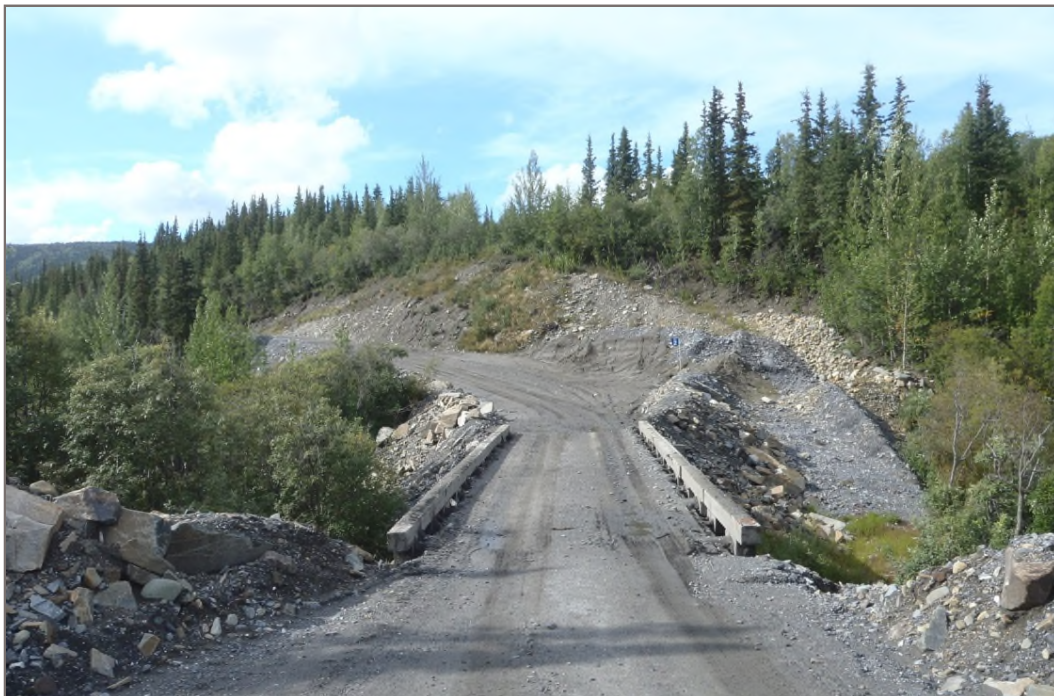
**Photo 16: Lightning Creek Bridge Abutments (Bellekeno Haul Road)**  
Bridge overview  
Facing west – August 12, 2014

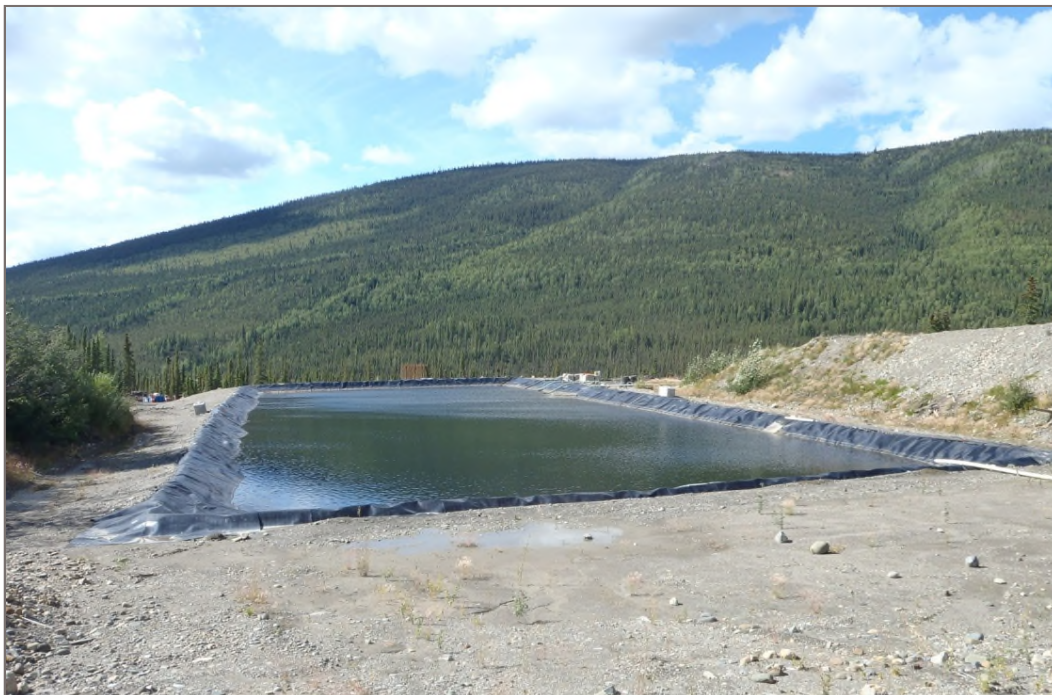
**Photo 19: Mill Water Storage Pond**  
Water level in pond  
Facing west – August 13, 2014

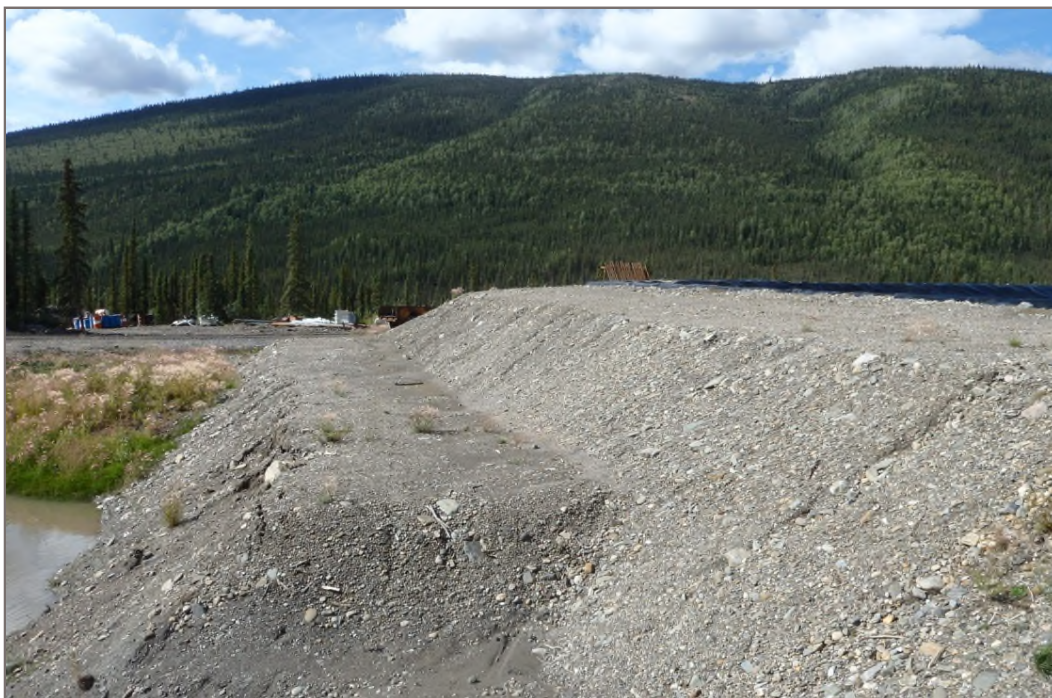
Following up on observations made during the annual inspection last year, no additional erosion was noted along the exterior berm in the southwest portion of the pond (Photo 20).

**Photo 20: Mill Water Storage Pond**  
Stable berm sideslope  
Facing west – August 13, 2014

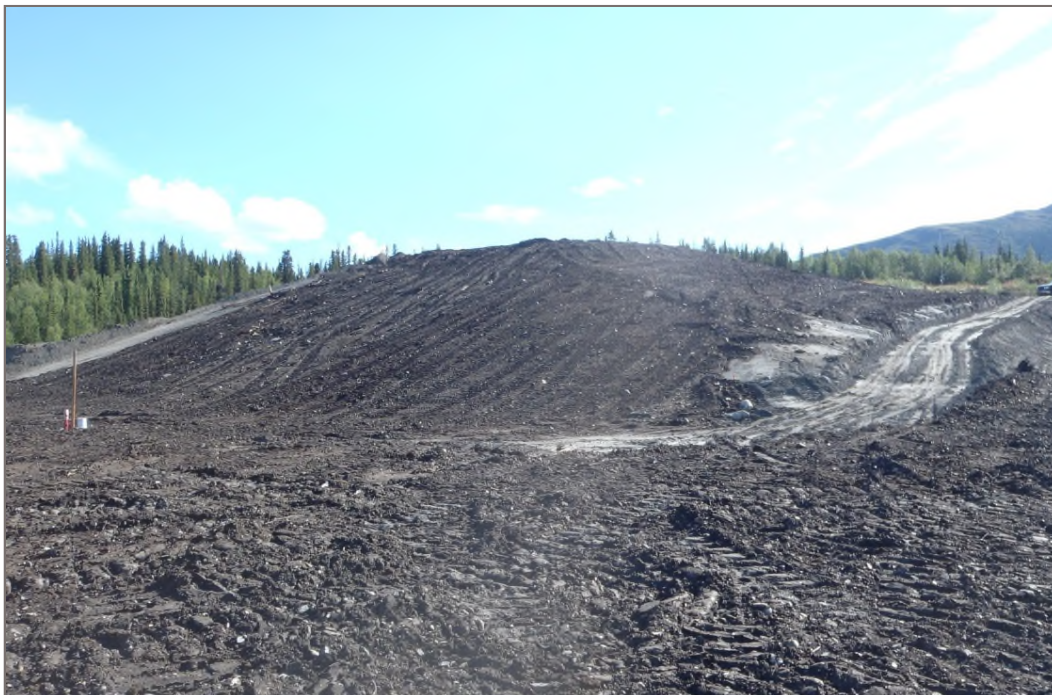
**Photo 23: Dry Stacked Tailings Facility**  
Progressive reclamation of upper bench (cover and seed mixture applied)  
Facing east – August 13, 2014

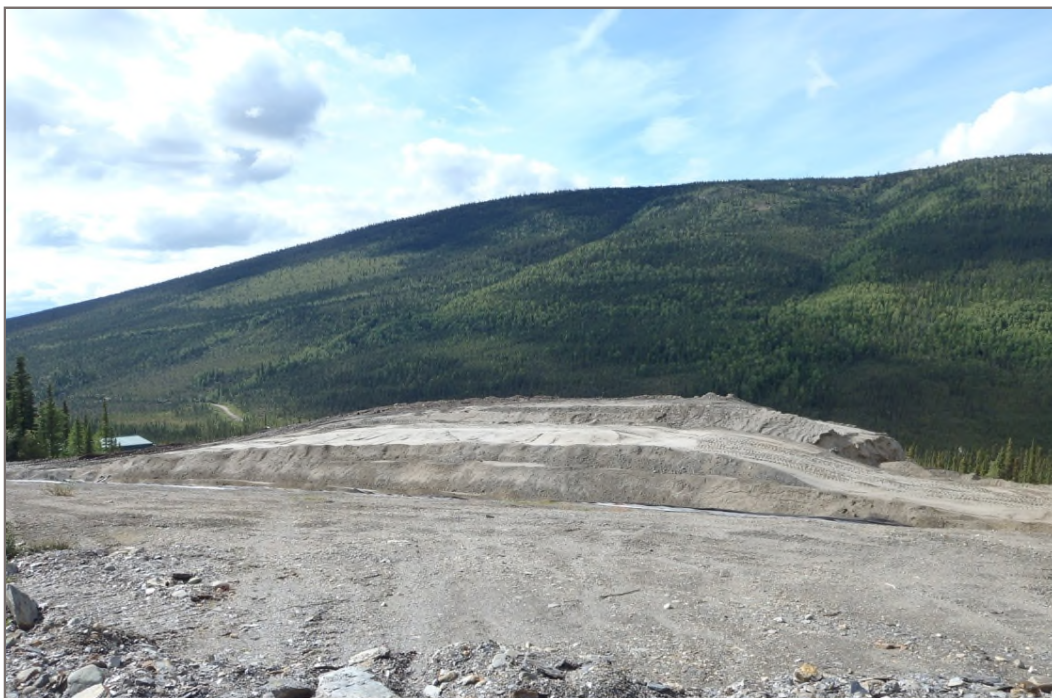
**Photo 24: Dry Stacked Tailings Facility**  
Top of facility where tailings placement will continue  
Facing west – August 13, 2014
