2014 Geotechnical Annual Review, Minto Mine, YT

Minto Explorations Ltd.

SRK Consulting (Canada) Inc.
1CM002.028
November 2014

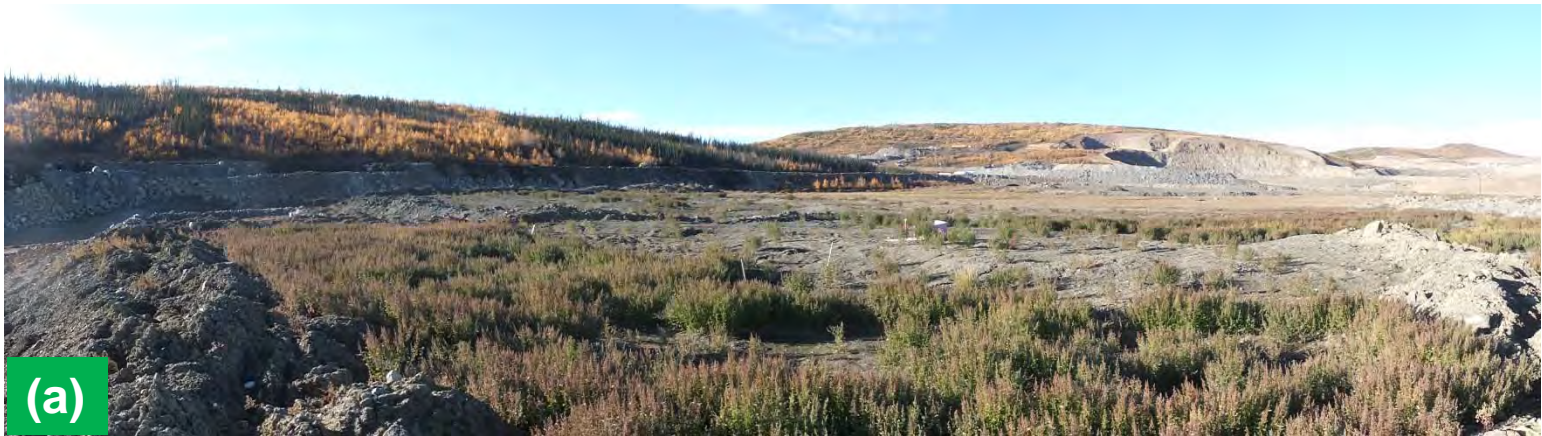
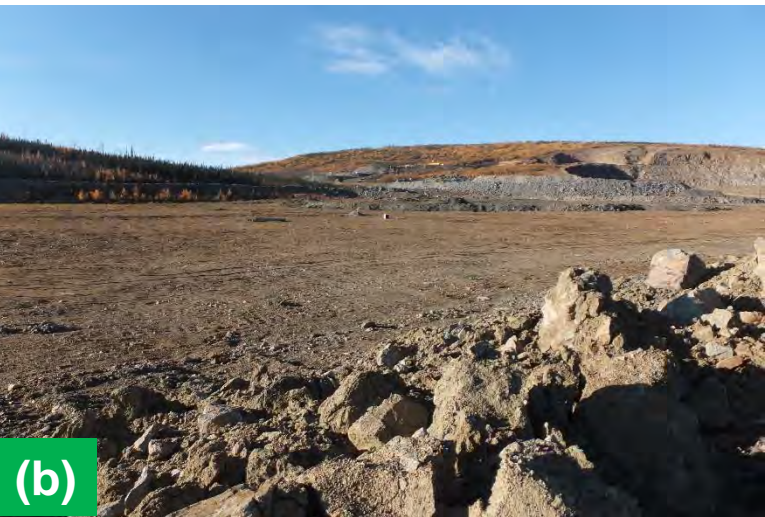
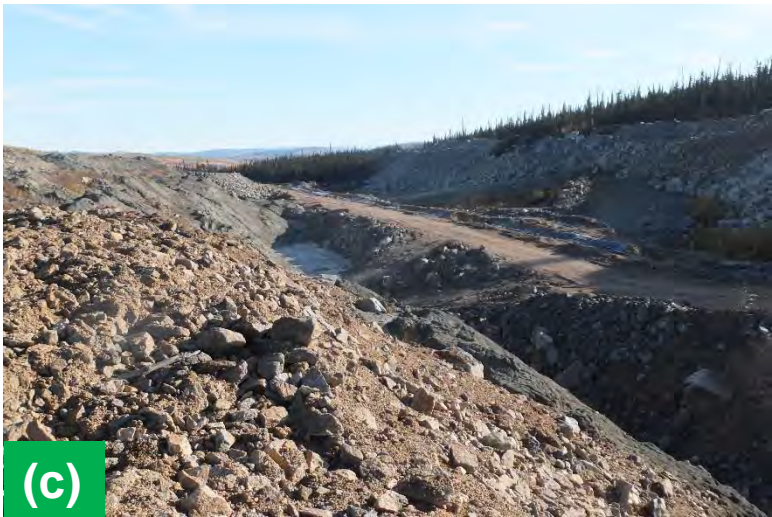
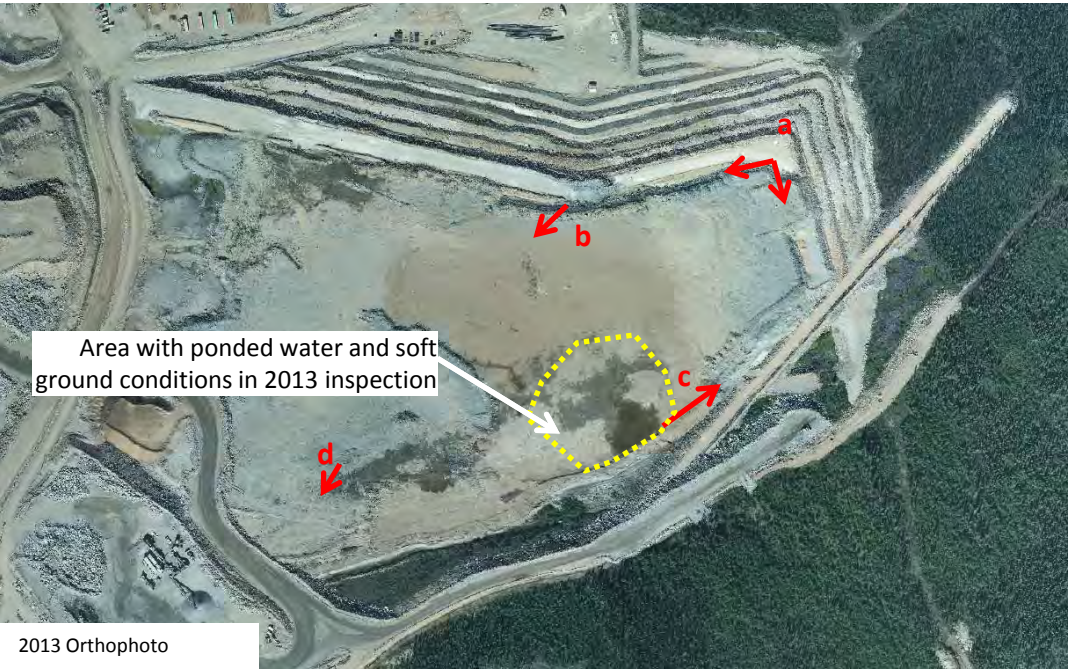
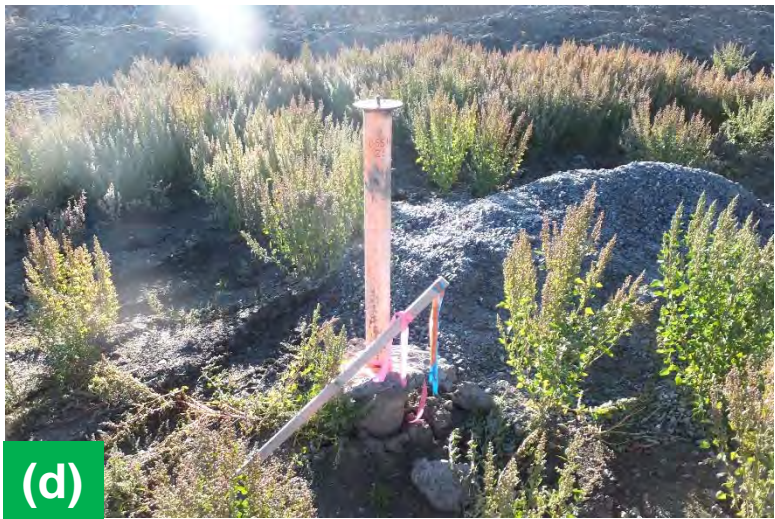
- Approximately 2 to 4 meters of overburden was placed over the tailings as a temporary cover during the winter of 2012-13. The cover was designed with 2% grade to drain to the north.
- There are a significant number of thaw bulbs, surface cracking and differential settlement throughout the cover, which can be expected due to the winter placement of the cover materials.
- Since the last SRK inspection in 2013, significant vegetation growth has occurred in the north east corner of the DSTSF, and the cover is significantly drier. The area that was noted to have soft ground conditions and was unwalkable during the 2013 inspection (noted in the plan below) was able to be walked over during this years inspection.

- Photo (a) shows the cover surface from the north east corner.
- Photo (b) shows the cover in the western portion of the DSTSF. There is considerably less vegetation established in the area.
- Photo (c) shows the south edge of the DSTSF where tailings remain exposed at surface on the south slope of the facility adjacent to the Tailings Diversion Ditch. Water was observed to be impounded against the DSTSF on the south side of the facility at various locations. Seep locations and areas where the water was observed to flow beneath the tailings. The water can be attributed to melting snow, recent precipitation and from water not captured by, or flowing under, the Tailings Diversion Ditch.
- Photo (d) shows survey hub DSSH 25, which is experiencing frost heave with approximately 30 cm of cement exposed at its base.

- The remaining areas of exposed tailings should be covered and the uphill area south of the DSTSF should be regraded as required to control surface drainage, avoid ponding, and limit infiltration of water into the tailings as per Clause 36 and 37 of the water license QZ96-006, Amendment 8.
- The condition of all survey hubs on site should be reviewed. Hubs experiencing frost heave should be noted and replaced with hubs that are not susceptible to frost heave.

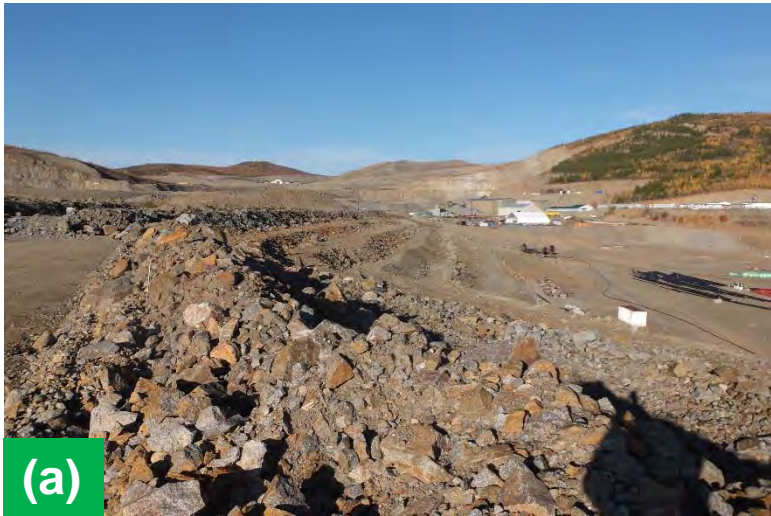
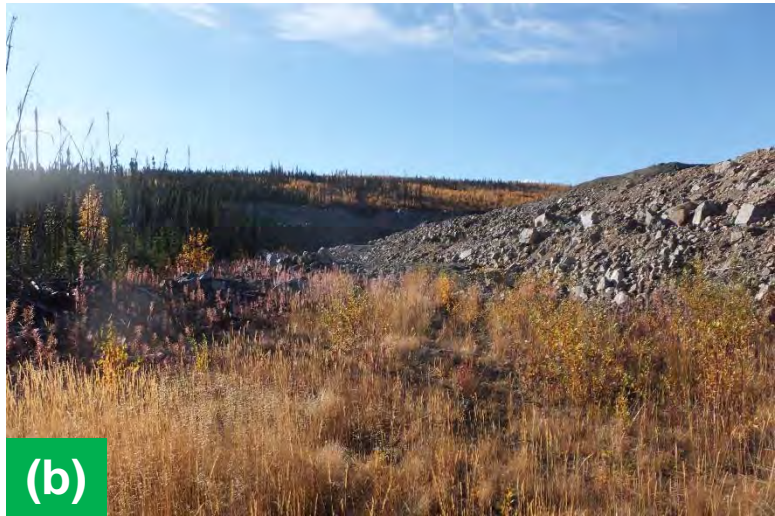
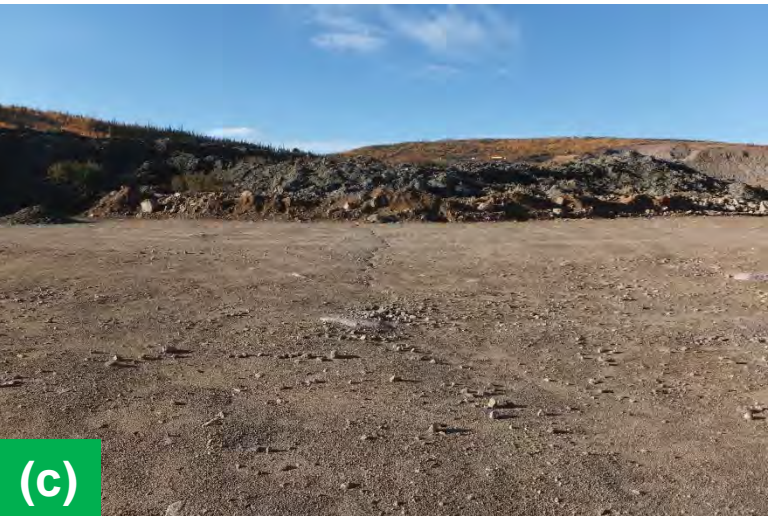
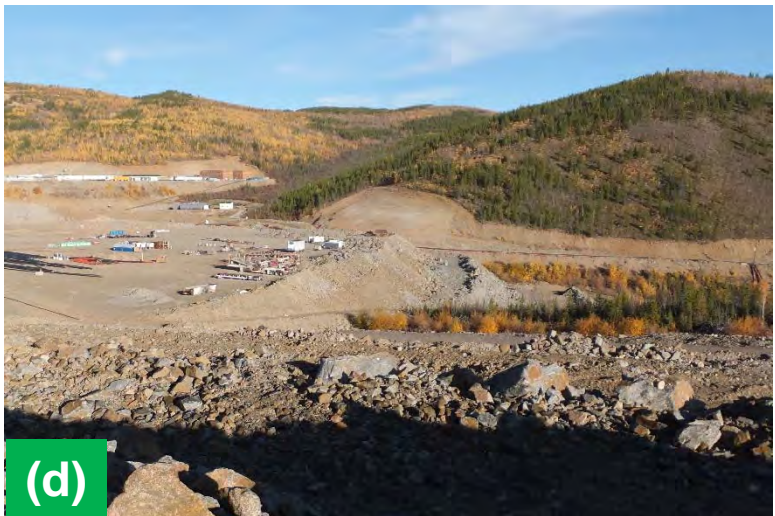
- Photos (a) to (c) show the condition of the waste rock shell and slopes.
 - One tension crack was observed at the northeast corner of the DSTSF at the crest (Photo c) The crack is 2.5 cm wide at its widest point. This area should continue to be inspected to monitor for crack progression.

- No other signs of instability were observed.
- Photos (d) and (e) show the condition of the Mill Valley Fill Extension.
 - Since the last inspection by SRK in September 2013, the area of settlement and cracking (area noted in plan below) was graded and filled in. The settlement and cracking was believed to be caused by differential settlement between two lifts placed at different times. The newer lift may have been settling within the coarser material at the older outer bench face or due to snow melting (if placed during winter).

- Continue to monitor the 2013 crack and settlement area.
- Continue to monitor the 2014 crack and install two survey nails/pins (one on each side of the crack) to measure the relative displacement. Consider spray painting lines across the crack to aid in monitoring any future displacement.

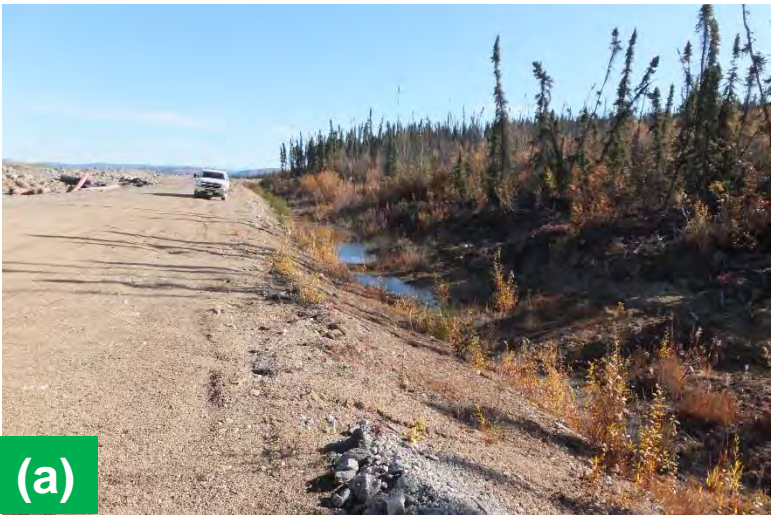
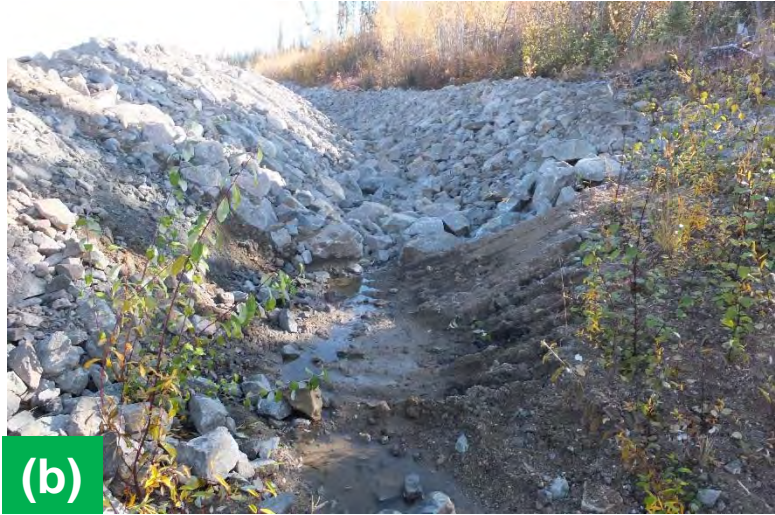
1 Dry Stack Tailings Facility – Tailings Diversion Ditch

- Since the last SRK inspection in September 2013, construction of the eastern portion of the Tailings Diversion Ditch has been substantially completed according to the EBA design outlined in the memo, “Upstream Water Management for the Mill Valley Fill Expansion and Dry Stack Tailings Storage Facility” dated 2011.
- In general, the berm and ditch appeared functional, with conditions in the western portion similar to those observed in previous inspections. No signs of instability or ditch obstructions were noted.

- (a) View of the upstream portion of the channel. The area remains unchanged compared to 2013 inspection.
- (b) View of the upstream end of the recently constructed eastern portion of the TDD. The channel generally consists of a layer of GCL overlain by rip-rap with a minimum channel depth (compared to the downslope berm of 1.5 m). A small flow of water (<0.1 L/s) was entering the ditch at the time of the inspection.
- (c) View of the eastern portion of the ditch looking east. No visible signs of flow could be observed.
- (d) View of the downstream end of the eastern portion of the TDD looking northeast.

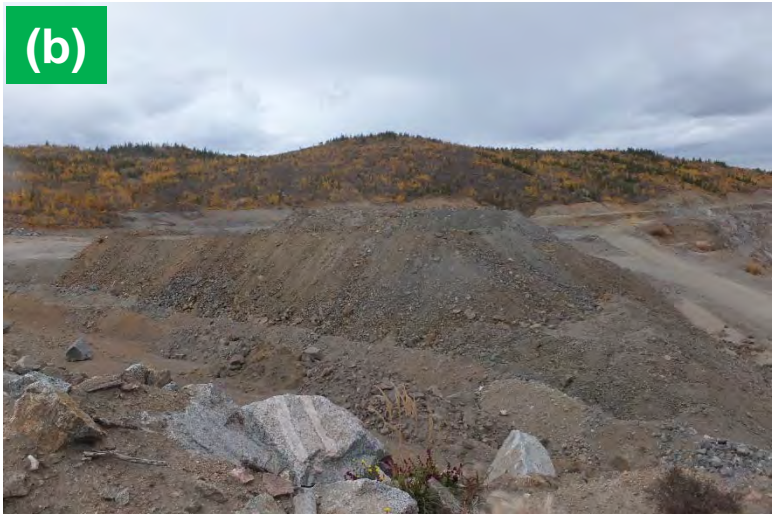
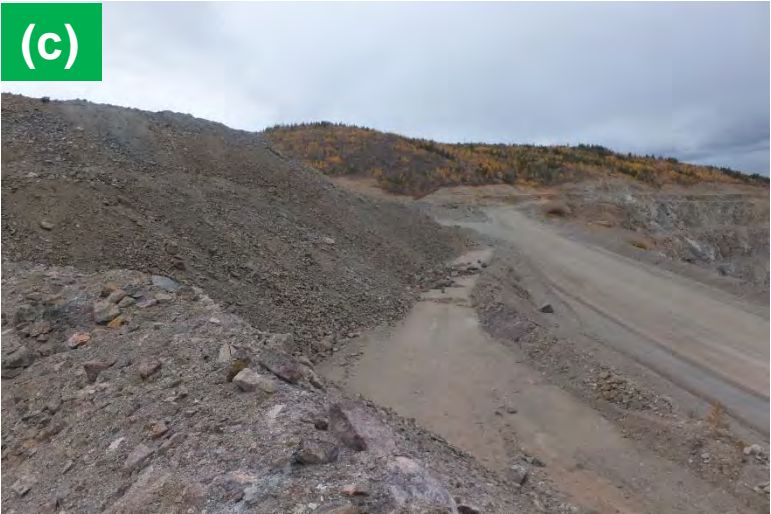
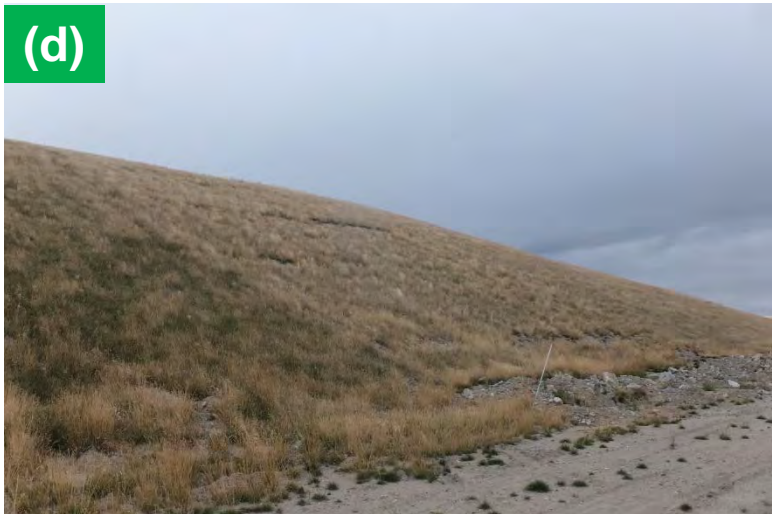
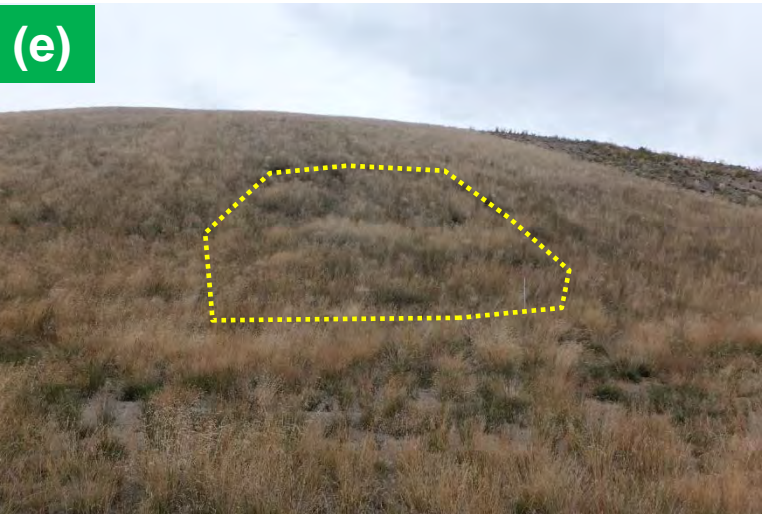
- No signs of instability were observed.
- Photo (a): Overview of the Main Waste Dump and Low Oxide Stockpile looking northwest.
- Photos (b) and (c): View of the Oxidized Ore Stockpile.

- Photos (b) and (c): View of the dump toe. Minor rills and gullies are present at the base of the regraded slope where vegetation is not yet established. No signs of instability were observed.

- Photo (d): View of the regraded slope taken from the mid-bench toe. Minor rills and gullies are present at the base of the slope. No signs of instability were observed.

- Photo (e): Location of the small surficial slough noted in the previous 2012 and spring 2013 inspections. The slough is contained within the cover material with minor bulging present at the base of the slope. The slough appears to be self-healing and no action is required.

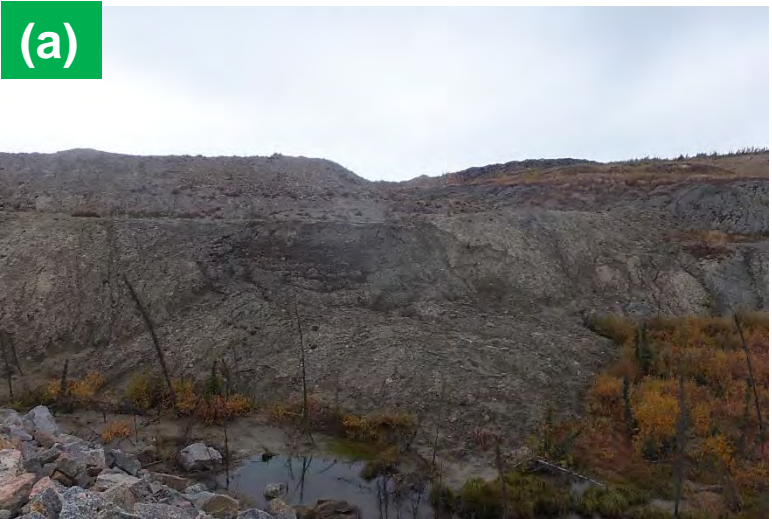
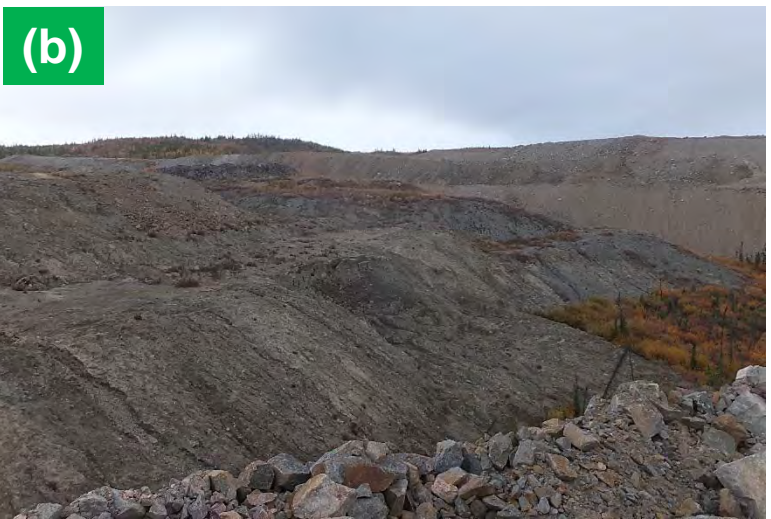
- Photos (a) and (b) show the shallow slope failure noted in the Spring 2014 Geotechnical inspection. Previous year's inspections noted localized slumping, discontinuous tension cracks, and erosion gullies within the area. The scarp is within approximately 5 m of the original crest. The failure has not compromised the overall dump slope angle and as a result, the failure is not expected to reduce the overall stability of the dump.
- Other areas of the ROD remain the same as noted in previous years' inspections:
 - Slumping, settlement and tension cracks are expected in the dump as it is constructed with frozen overburden with thawing expected.
 - Discontinuous tension cracks and differential settlement observed along the perimeter crest.
 - Ground undulation is typically 0.3 m and is prevalent throughout the facility.

- Continue to monitor the slope failure area for further signs of movement or instability.

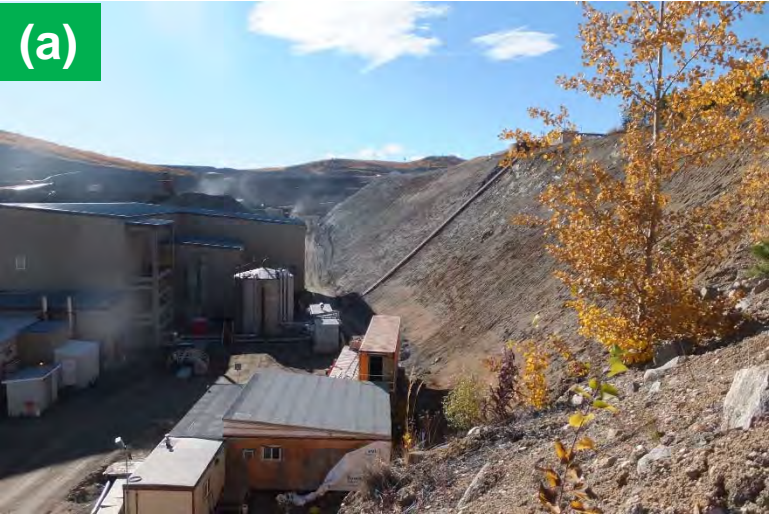
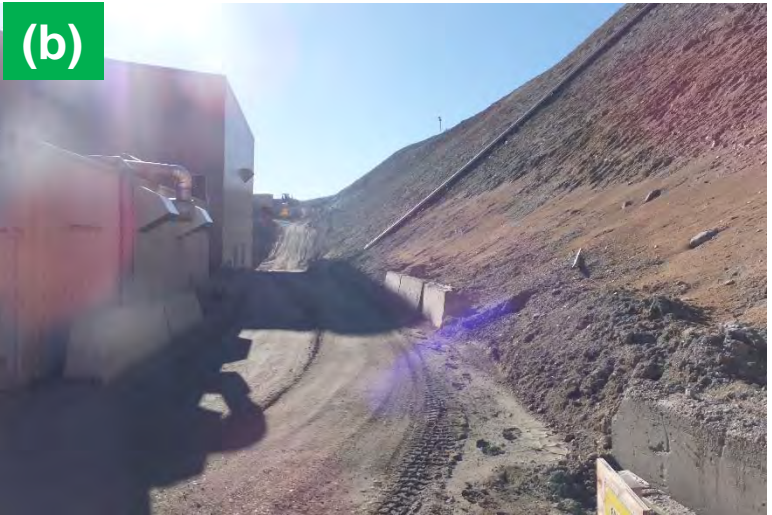
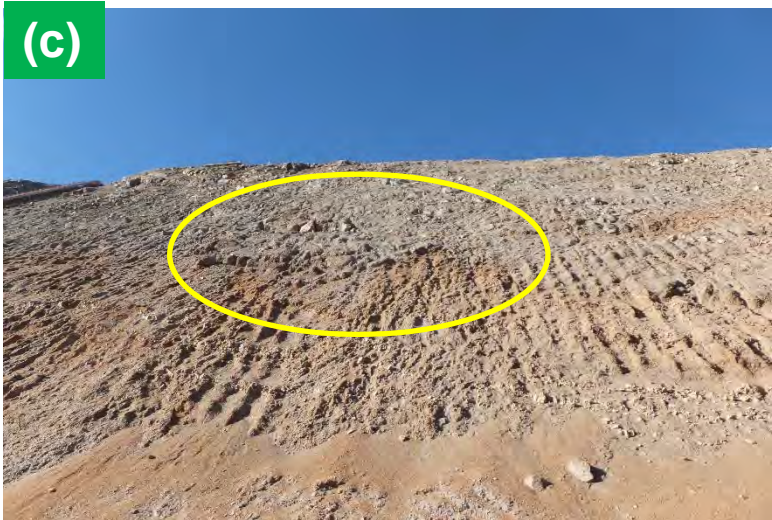
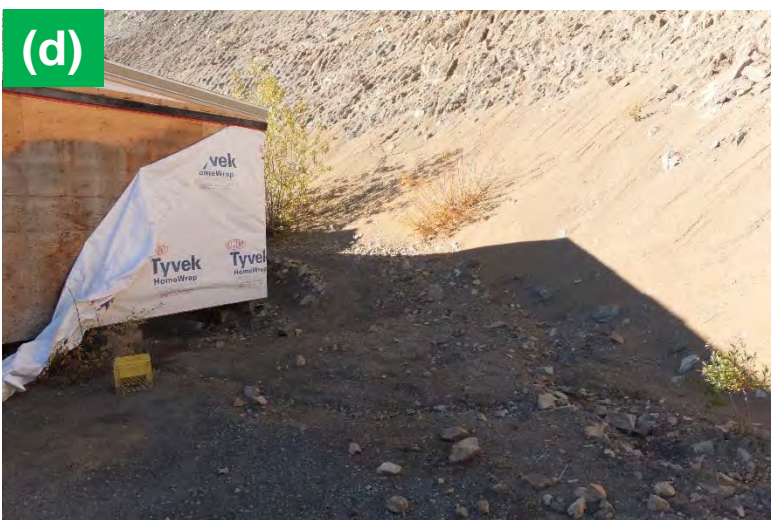
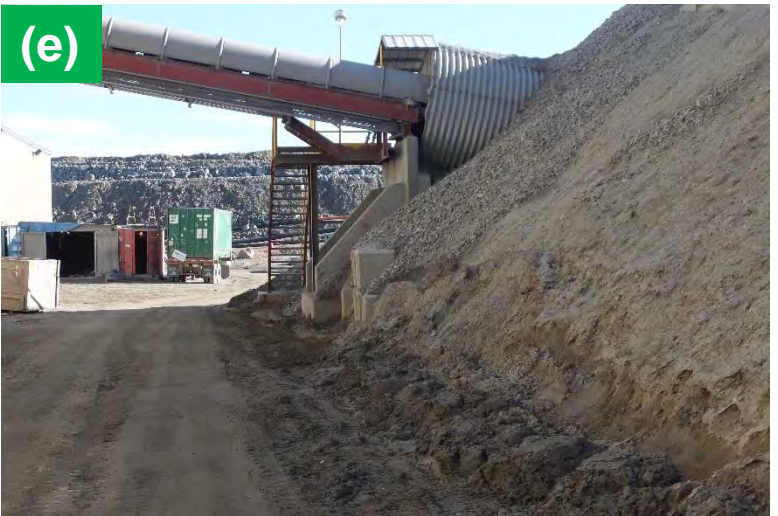
Conditions of the mill area are the same as those reported in previous site inspections.

- a) The slope above the main mill site appears stable. Safety berms at the top of the slope are in good condition.
- b) East end of the mill slope looking west. Eroded sand/gravel is generally present at the base of the slope with occasional cobbles/boulders up to 300 mm.

- c) As noted in previous inspections, a small slough is present near the center of the slope approximately 10 m east of the electrical corridor. Some materials have raveled down the slope and the concrete barriers at the toe are approaching the capacity for containment. East end of the mill slope looking north.

- d) Two small seeps observed in previous inspections were dry during the inspection. The seep location is noted in the plan below.
- e) First identified in the Spring 2014 inspection, the retaining wall at the mill's apron feeder tunnel appears to be tilting forward with a potential to overtop. There was no noticeable change in condition between the fall and spring inspection photographs.

- Continue to monitor the retaining wall near the mill's apron feeder tunnel and maintain a photographic record of its condition.

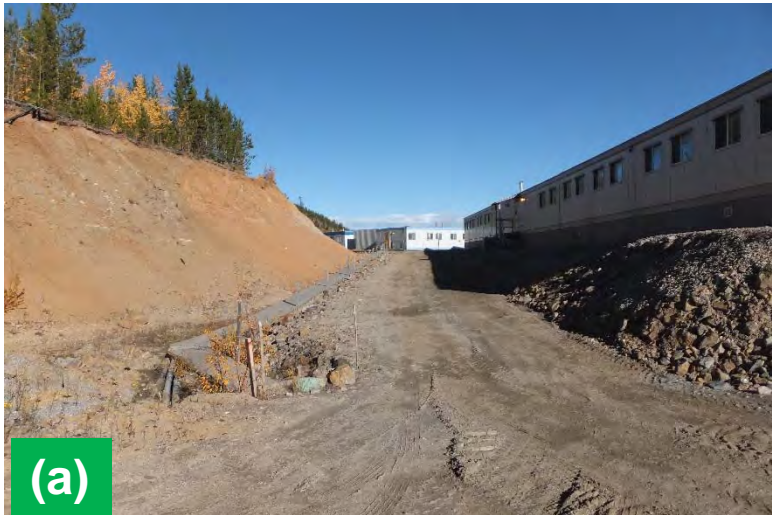
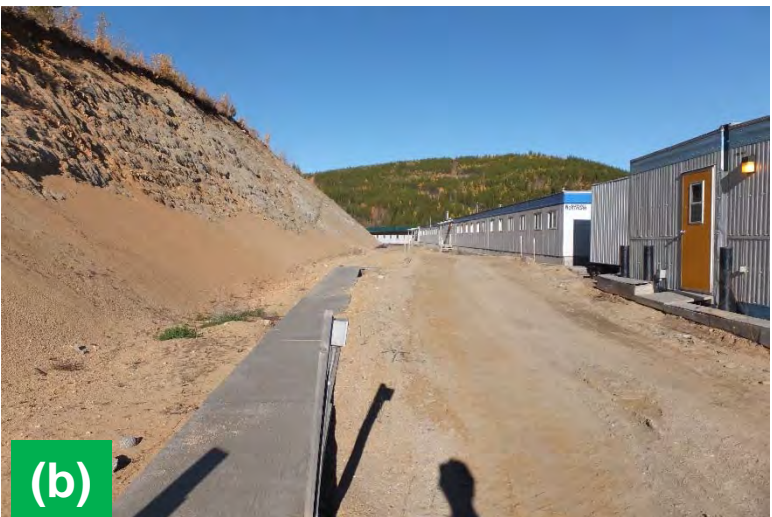
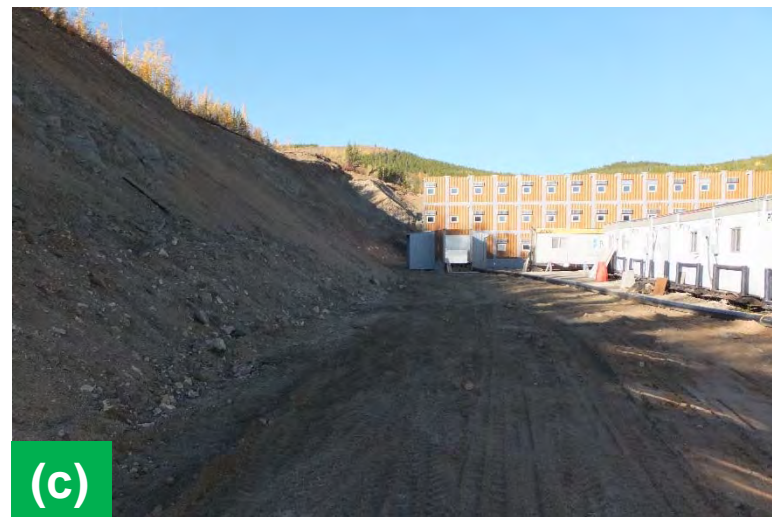
8 Camp Site

- a) & b) Slope above the main camp site appears stable.
- Eroded sand/gravel is generally present at the base of the slope with occasional cobbles/boulders up to 300 mm.
- c) View of the new camp site looking north. No signs of instability in this area.
- d) View of the seep at the northwest corner of the camp expansion.
- e) & f) Erosion channels present south of the camp site near the carpenters shop. Conditions are similar to the Fall 2013 inspection.

- The area above the erosion channels on the camp pad should be regraded to promote runoff away from the channels.
- The channel by the carpenter's shop should be filled with rip-rap or a half culvert to provide a path for the water to drain.
- It is recommended that these actions be completed in the following year. In place of the surface grading, a small ditch could be constructed near the slope crest to direct runoff to the drop channel or half-culvert.

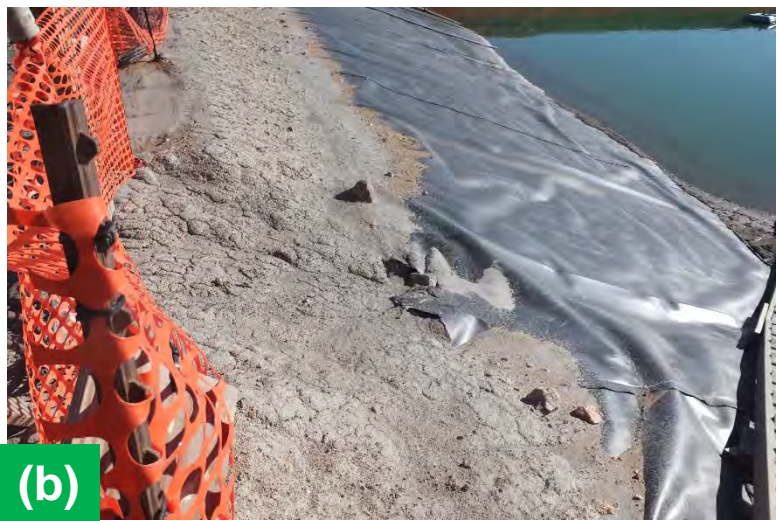
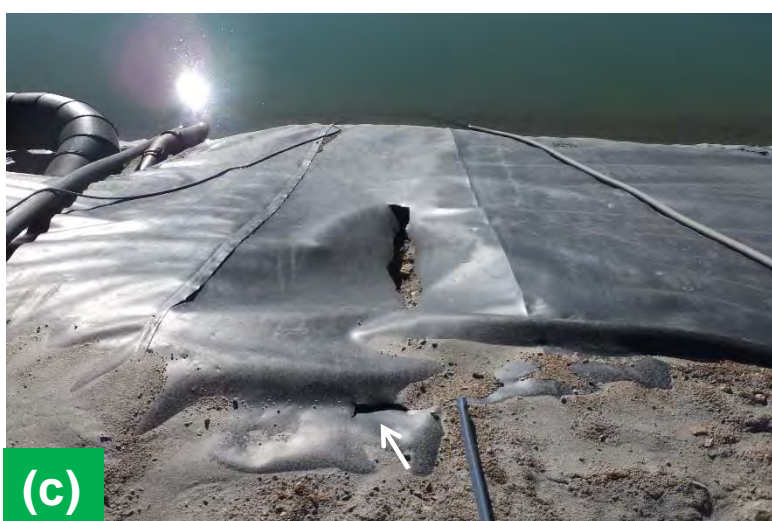
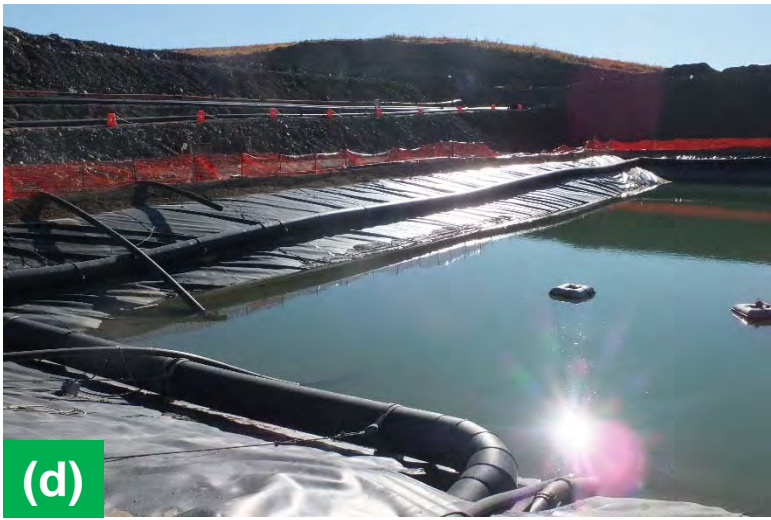
Conditions of the Mill Water Pond are unchanged compared to the 2012 and Fall 2013 inspections.

- b) View of the tear in the liner at the north corner of the pond. The tear is approximately 1 m in length and first noted in the 2008 inspection.
- c) Two tears in the liner midway along the northeast edge of the pond. These tears were first observed in 2009. The largest tear is approximately 1.5 m in length and is parallel to the slope. The smaller tear (white arrow) is approximately 0.5 m in length and orientated across the slope. A void is present beneath the slope that in previous inspections has been noted to be increasing in size due to water penetration from surface.

- d) View of the south east side of the pond and by-pass pipe. The bypass pipe and metal clamps are resting on pieces of plywood placed on top of the liner.

- The liner tears should be patched the next time a liner crew is onsite. For the liner tear noted in Photo (c), Figure 14, sand should be placed to fill the void beneath the tear.
- The sediments accumulated in the surface runoff ponds and culverts should be cleaned out.

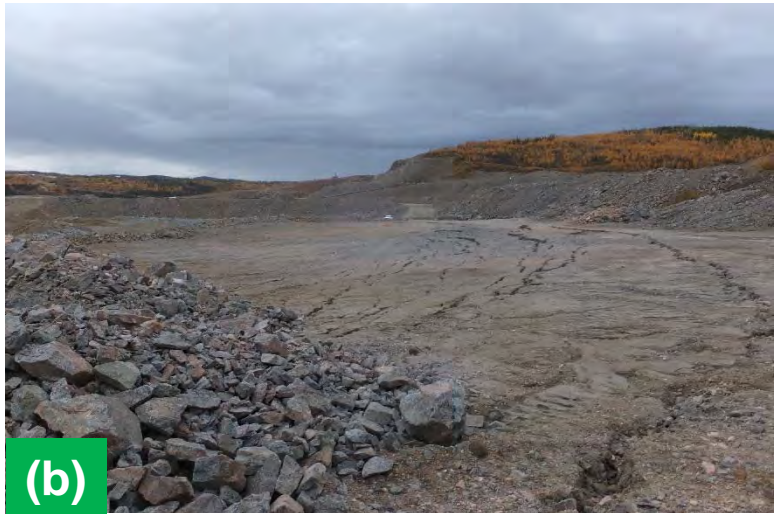
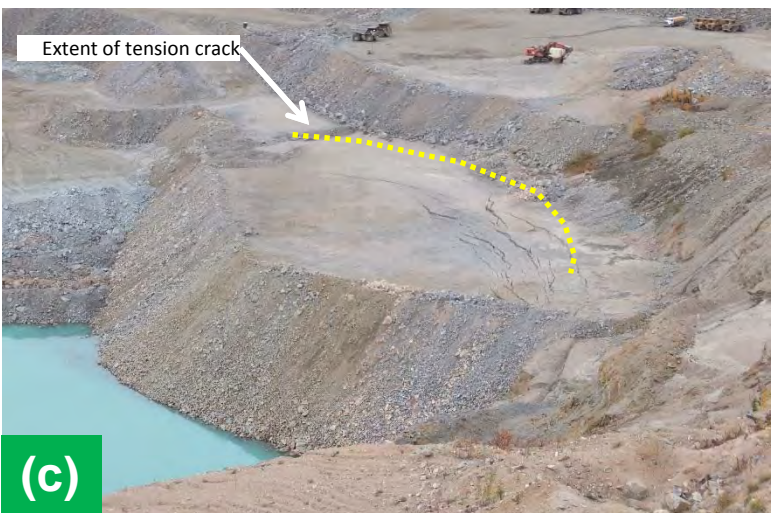
Photo a: View of the Main Pit, South Wall Buttress and In-Pit Dump taken from the north west corner of the pit.
 Photos b and c: View of the tension cracks on the In-Pit Dump located west of the South Wall Buttress. This area has been blocked off and is inaccessible to equipment. Cracks on the In-Pit Dump are up to 50 cm wide with a 40 cm elevation difference across the crack. The movement is believed to be due to the large dump height, with the material end dumped directly into the pit water.

- The tension crack area should be continue to be visually monitored. A photographic record should be maintained to inspect for changes in condition.
- Additional survey hubs should be placed on the South Wall Buttress to monitor movement.
