Sä Dena Hes Mine, Yukon Territory 2018 Dam Safety Inspection

SRK Consulting (Canada) Inc.
November 2018

Project No: 1CT008.068

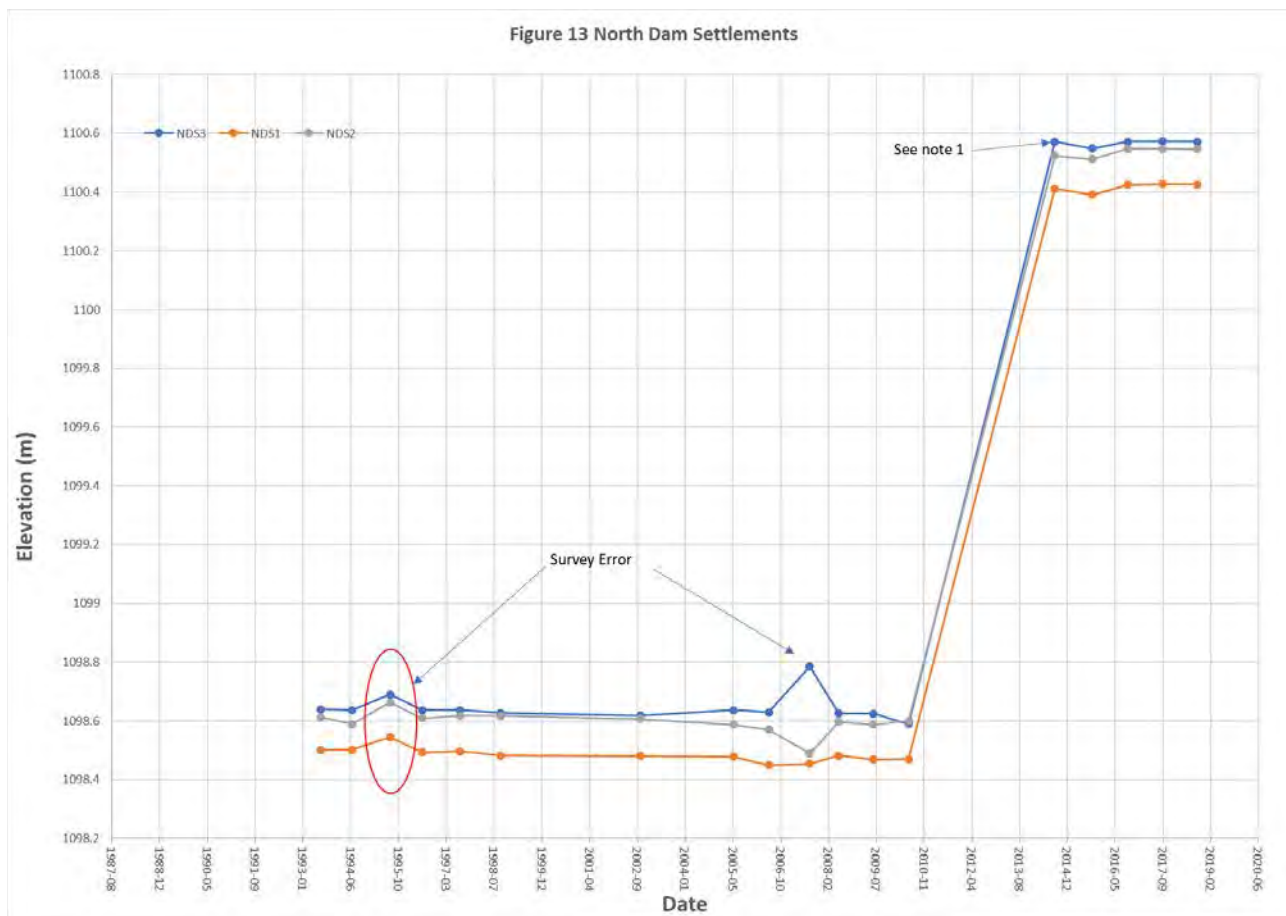
Figure 13: North Dam Settlements

Teck has been surveying the settlement gauges on the North Dam since 1993. Results are shown on Table 4-1. The results are elevations taken from the top of the steel pins that were set within the crest of the dam during construction. The last set of readings taken using the 1990 datum was completed in 2010. A recent set of readings was completed in 2017 based on the 2012 datum. The readings are consistent with those observed in previous years, with settlement

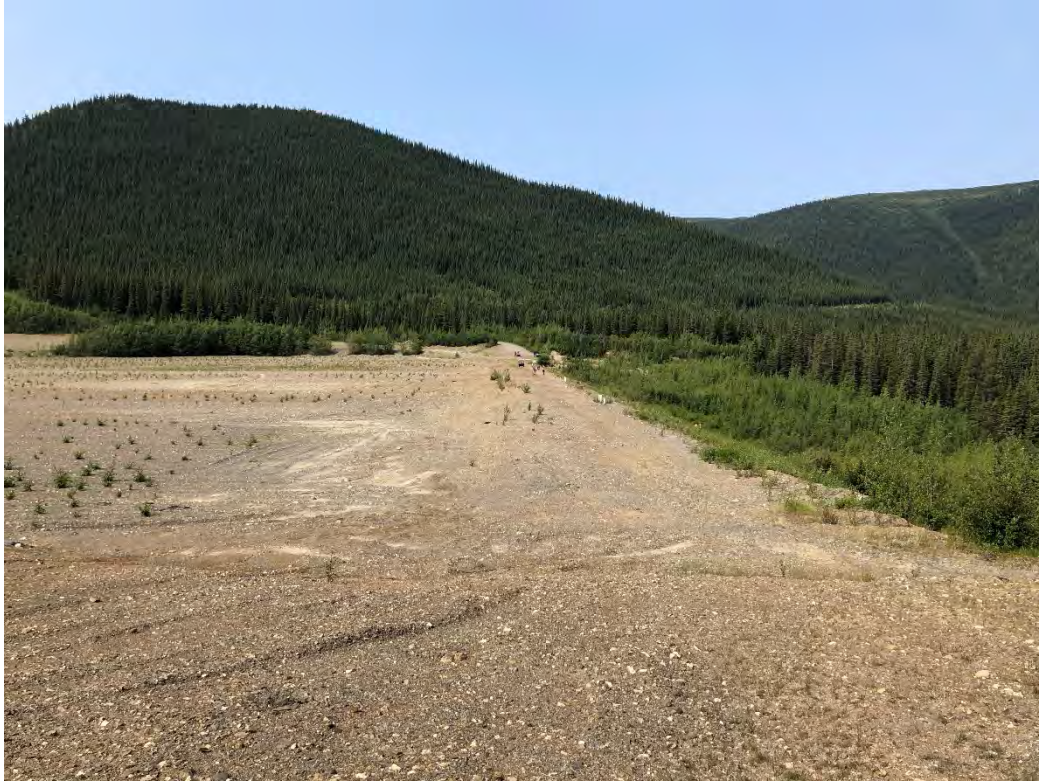
Photo 1: North Dam Crest looking west

The crest of the North Dam looking west is shown in Photo 1, The dam is in good condition and t shows no signs of deformation or abnormal settling. The downstream slope of the dam (Photo 2) shows no signs of surficial movement or erosion nor is there any sign of bulging at the downstream toe.

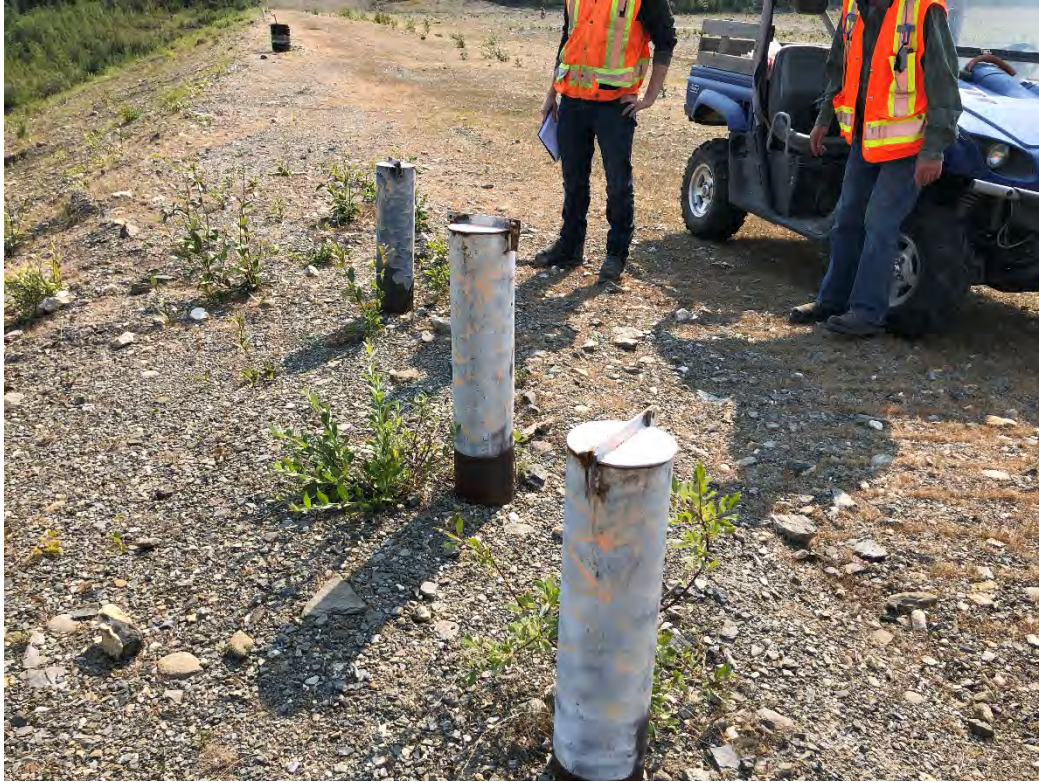
The piezometers and settlement gauges (Photos 3, 4, 5 and 6) on the North Dam are in good condition and continue to function as designed. Orange coloured piezometer caps provide visible identification for the monitoring team. However, it was noted that two of the piezometers (PVC pipes) namely NDW-2B and NDW-1A do not have plastic caps and are not labelled.

Photo 3: North Dam Piezometers NDW-3A and 3B, NDS-3

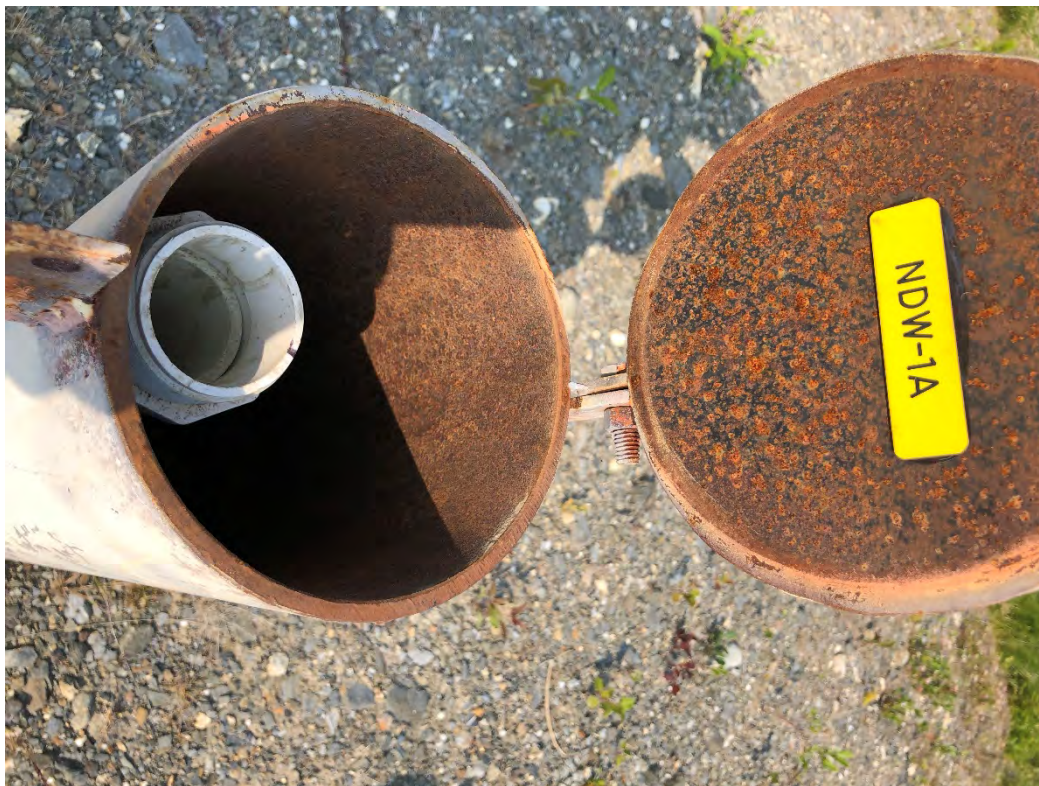
Structure	ID No.	Deficiency or Non Conformance	Applicable Regulatory or OMS Reference	Recommended Action	Priority ¹	Recommended Deadline/ Status
North Dam	2018-1	NDW-2B and 1A missing caps	OMS 5.3.2	Install plastic caps and label	3	Before end of 2018 Completed October 18, 2018 Closed

Photo 4: Missing cap on Piezo NDW 1A.

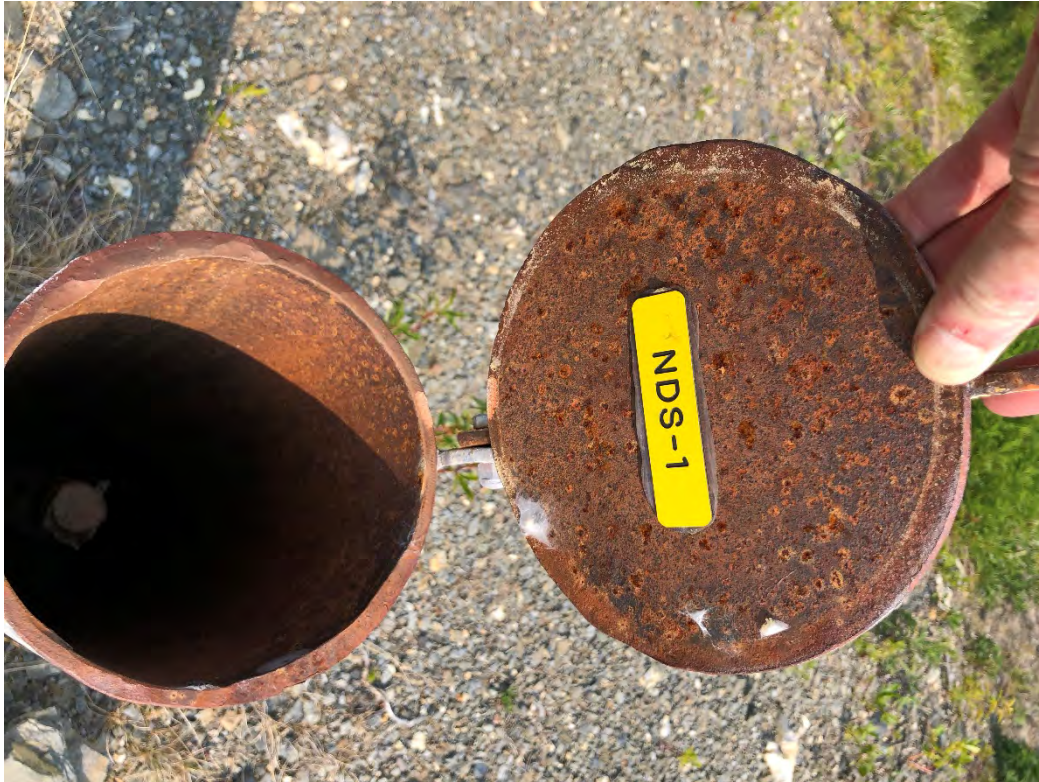
Photo 5: Settlement Gauge NDS-1

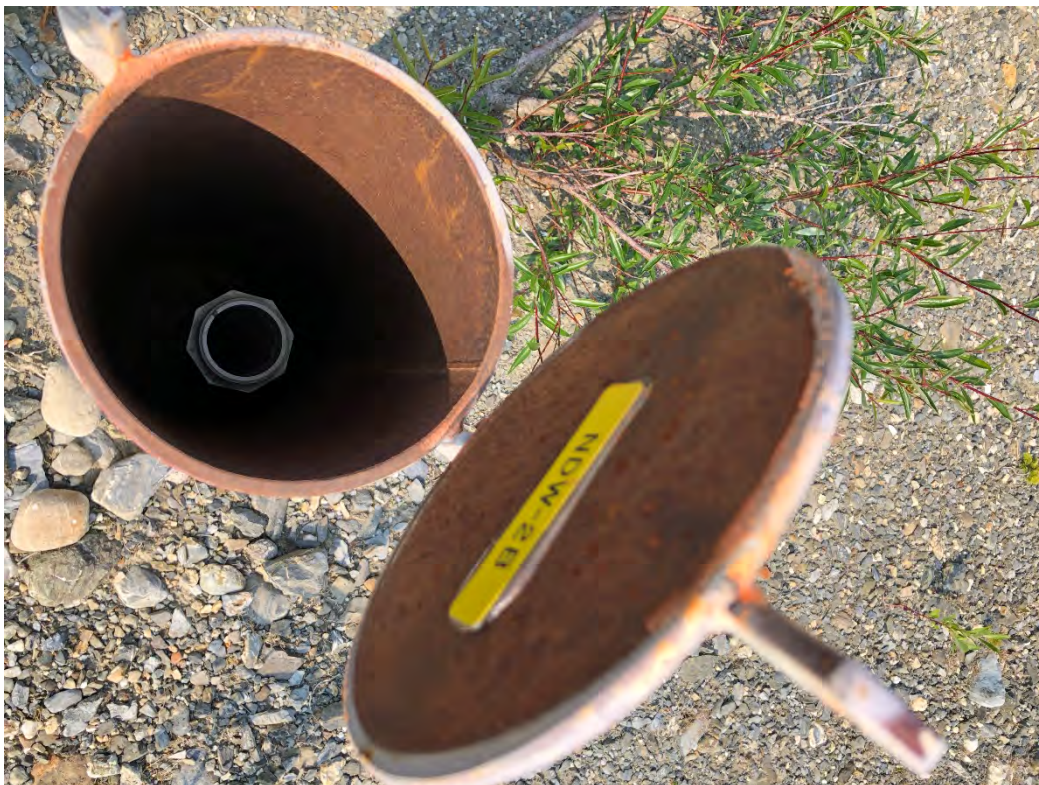
Photo 6: Missing cap on Piezometer NDW-2B

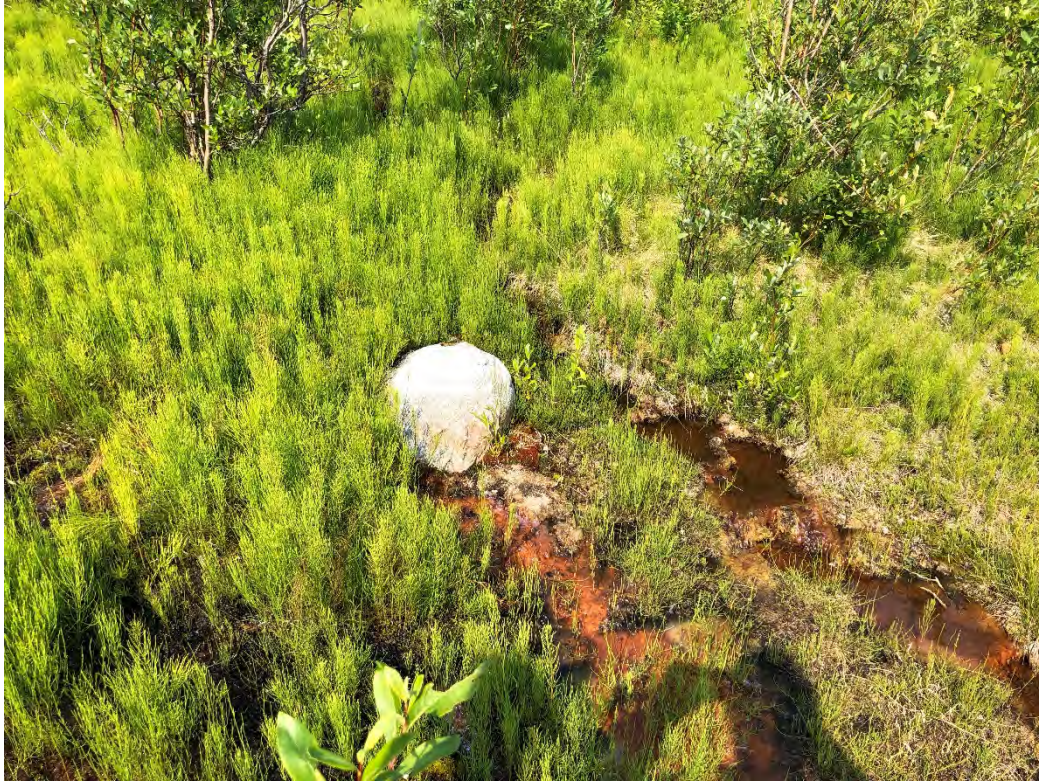
Photo 7: Seepage at toe of North Dam, mainly due to hillside seepage from the west

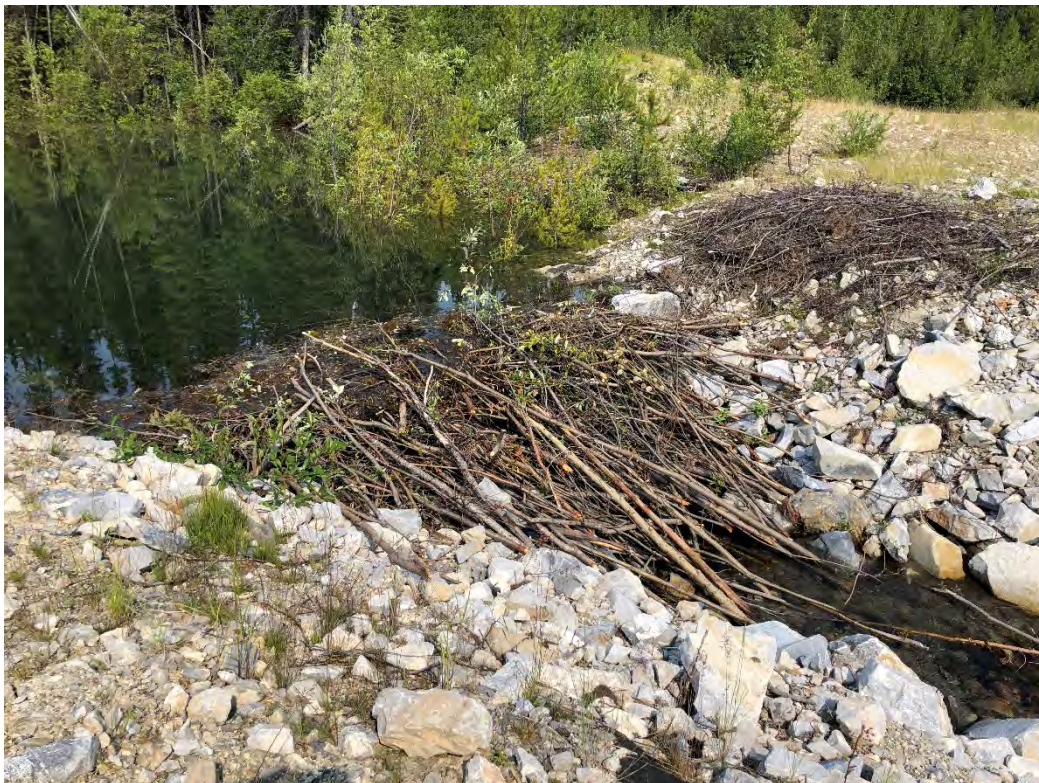
Structure	ID No.	Deficiency or Non Conformance	Applicable Regulatory or OMS Reference	Recommended Action	Priority ¹	Recommended Deadline/ Status
North Creek Channel	2018-2	Beaver Dam at inlet to channel	OMS 5.6.3	Remove beaver dam in channel	3	Before End of 2018 / Completed July 26 Closed
Jewelbox Waste Rock Dump	2018-3	Erosion Gully in North east corner	OMS 6.5.6 and 5.3.1	Install additional Monitoring pins	3	Before End of 2018 / Completed July 26 Closed

A riprapped channel conveys the North Creek over the original location of the decommissioned North Creek Dyke. It was noted at the inlet of the channel that beavers had again built a dam which was restricting flow (Photo 12). The dam raises the water level of the pond behind the structure and increases the risk of a rapid release of water that could result in erosion of the riprap protection in the channel. The dam was removed in 2018. Best Practice dictates that beaver dams be removed when identified during the routine inspections. Photo 13 shows a view looking upstream of the channel. At the outlet of the channel (Photo 14) some of the riprap had previously been dislodged by the flow, exposing a small area of the underlying filter fabric. There has been no noticeable change to this area since it was observed last year. The channel remains stable and no remediation is required.

Photo 12: Beaver dam at inlet to North Creek crossing

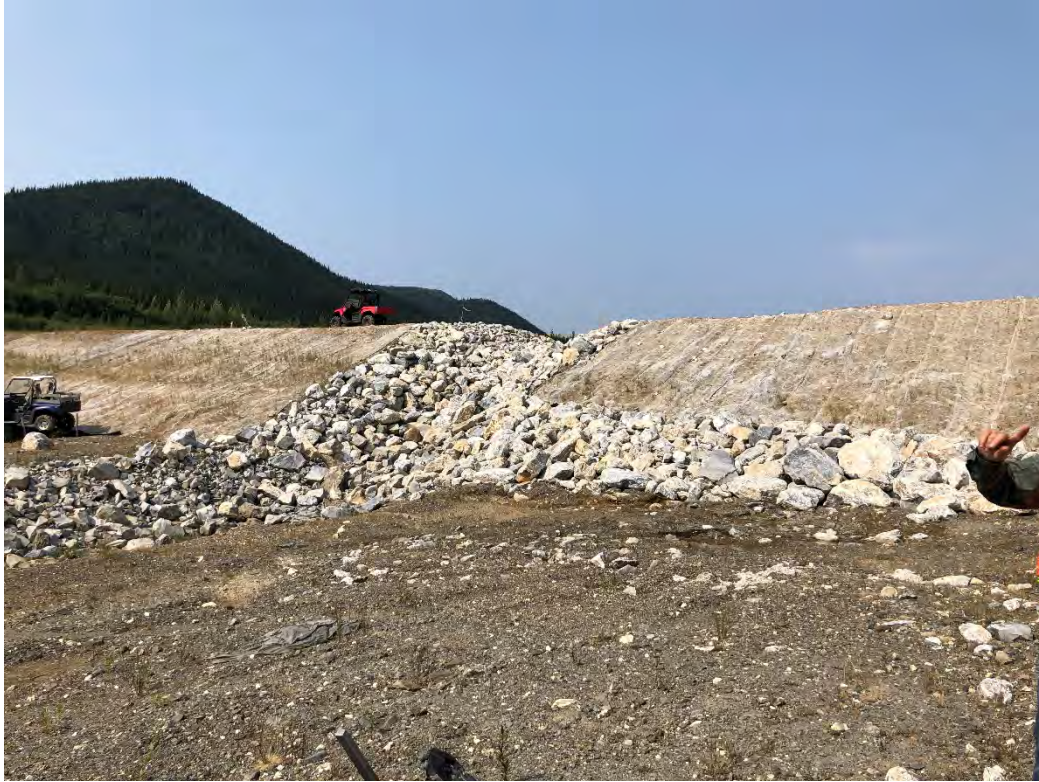
The spillway (Photo 17) remains in stable condition with no noticeable subsidences.

Photo 17: View looking north of the spillway at the SRS

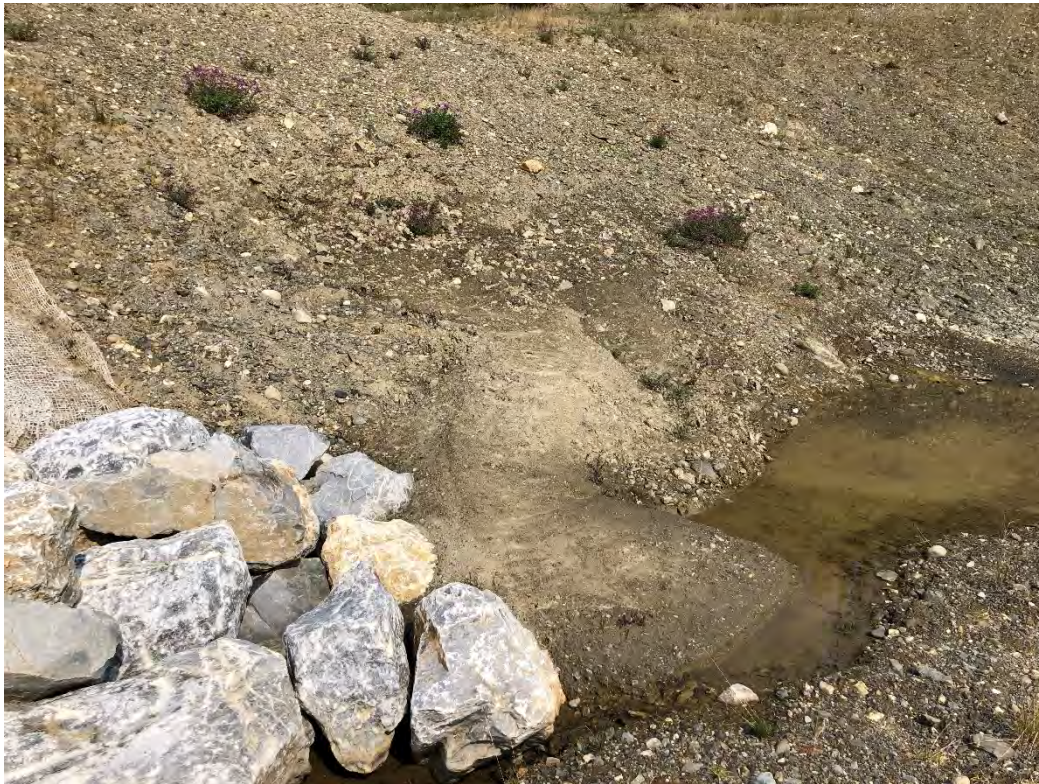
Seepage from the hillside area to the east of the structure is still evident along the downstream toe of the SRS (Photo 19). A small active boil that has been noted in previous inspections was still present. This boil is a remnant of pore pressures that were evident during and after the construction of the South Dam which prompted the construction of a toe buttress. The pore pressures were a result of the hydraulic gradient across the dam due to the stored water in behind the embankment. The pore pressures were accentuated by the sand and gravel zones in the foundation soils below the dam. Since the removal of the South Dam, the pore pressures have significantly reduced but the small head of water due to the retained pond behind the SRS dyke is the likely source of the boil.

The pond behind the SRS has a maximum depth of about 1.5 m and the overall hydraulic gradient through the structure is low and corresponds to no piping potential. The seepage through the dyke is barely measurable. There is one small boil that has been noted at the downstream toe of the SRS dyke, but no loss of fines detected.

Photo 19: View of the eastern end of the riprap buttress along the D/S toe of the SRS dyke

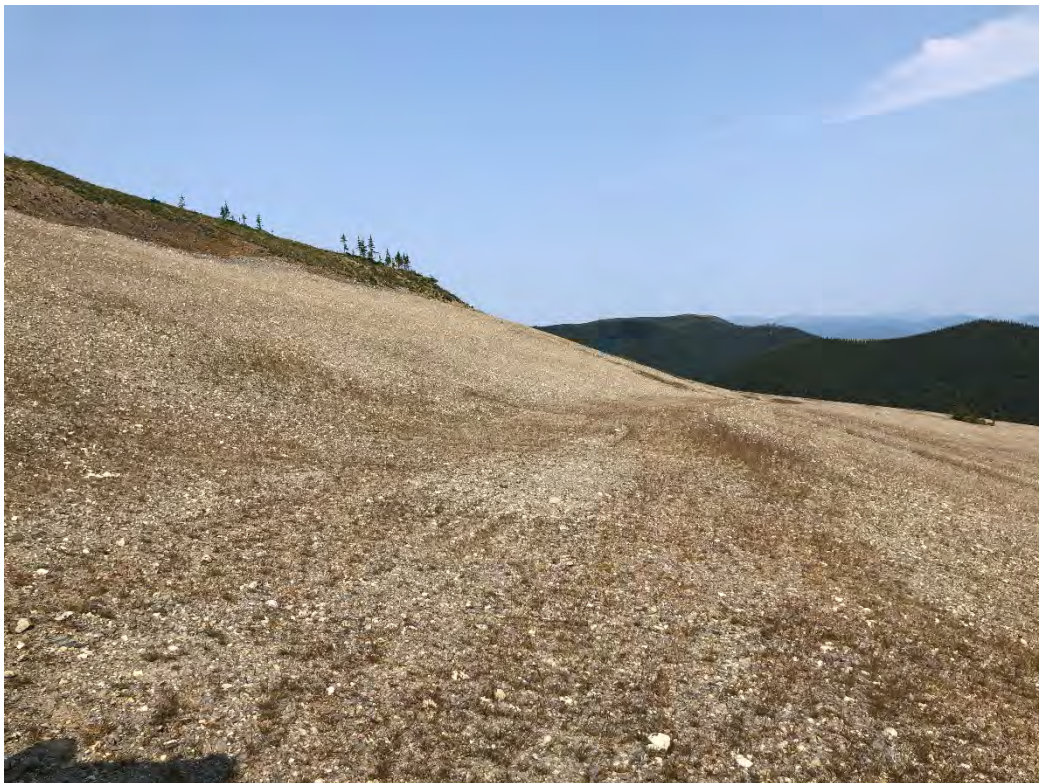
SRK inspected the resloped Main Zone and Jewelbox waste dumps (Photo 24 and Figure 12). It was noted that at the northeast end of the JewelBox dump, there was evidence of some erosion (Photos 25 and 26). Following the 2017 DSI, monitoring pins were installed at the base of the erosion gully to monitor any deepening of the gully over time. It was noted that the gully had not deepened but there was evidence of some minor sideways erosion. This erosion does not impact the stability of the dump.

Photo 24: Regraded slopes of Jewelbox waste rock dump

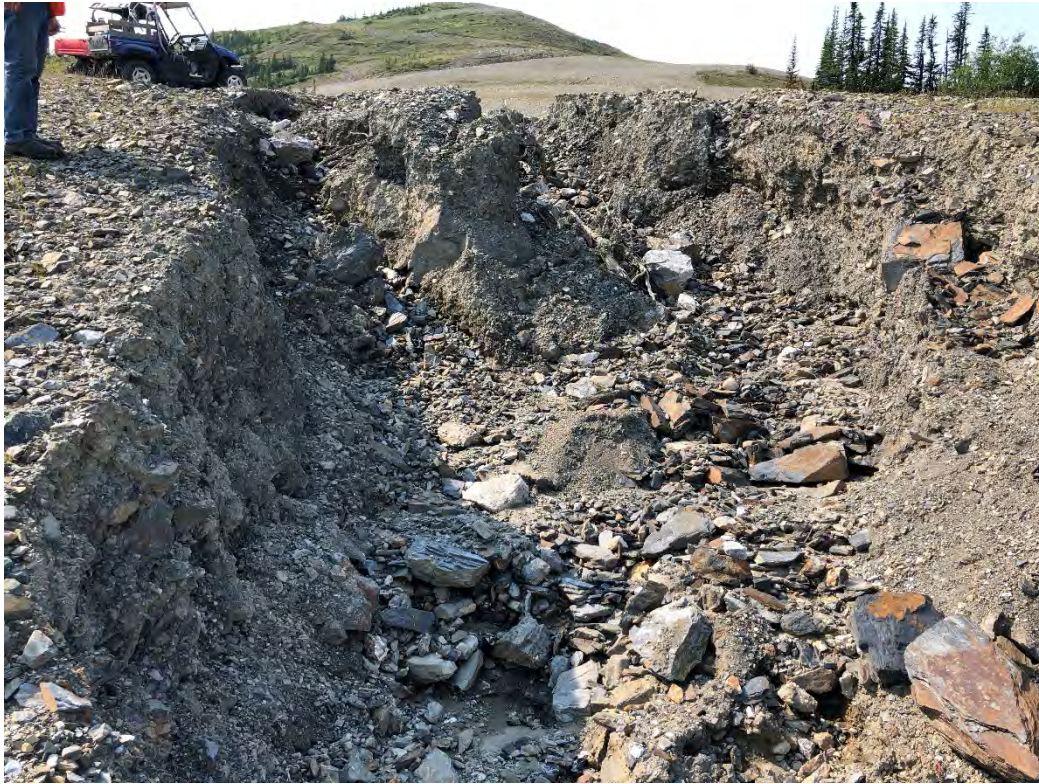
Photo 25: Erosion gully at toe of Jewelbox Waste rock dump

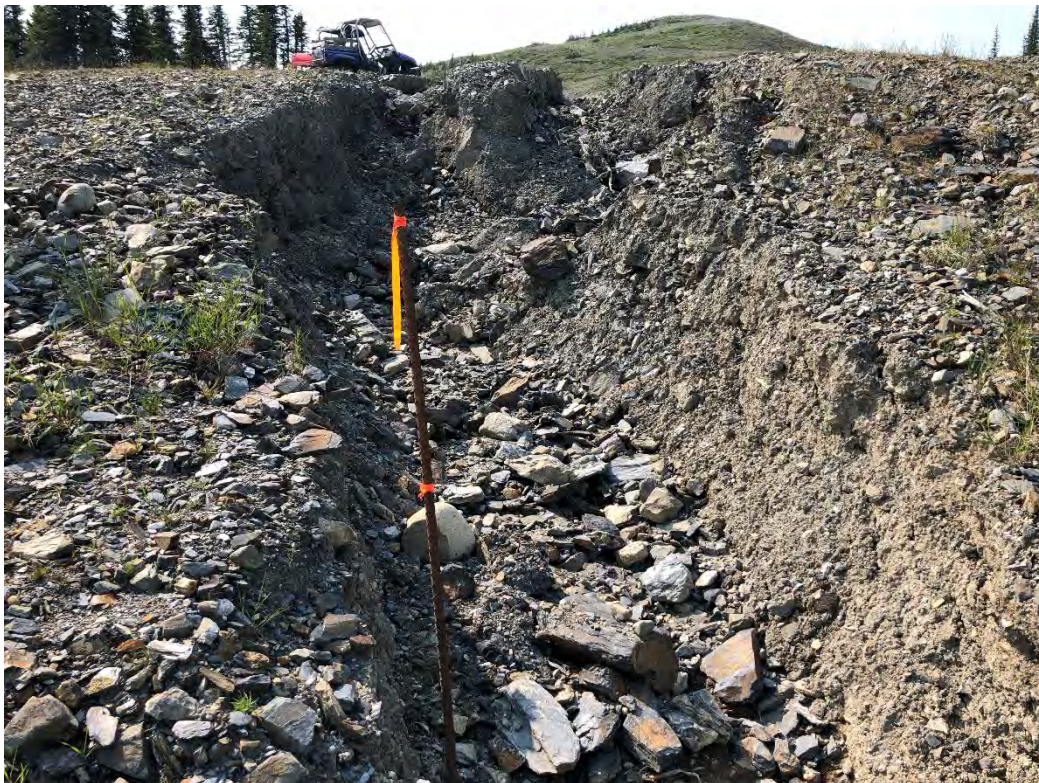
Photo 26: erosion gully at toe of Jewelbox waste rock dump with monitoring pin

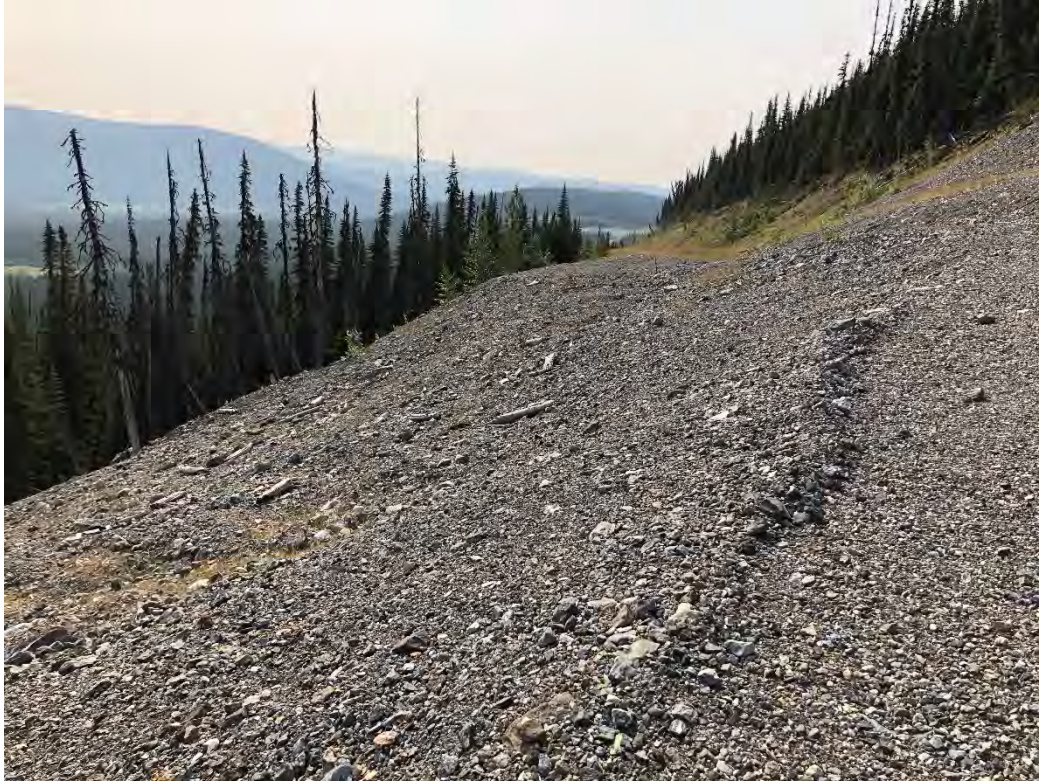
Minor settlement of the fill that was placed over the 1200 portal was noted during the 2017 inspection. The settled area was inspected this year (Photo 27) and no further settlement was noted.

Photo 27 minor subsidence on the slope of the backfill at Portal 1200 on Burnick
