2017 ANNUAL RECLAMATION REPORT for Quartz Mining License QML-0004

Name of Property: Sä Dena Hes Mine

Company Name: Sä Dena Hes Operating Company c/o Teck Resources Limited

March 31, 2018

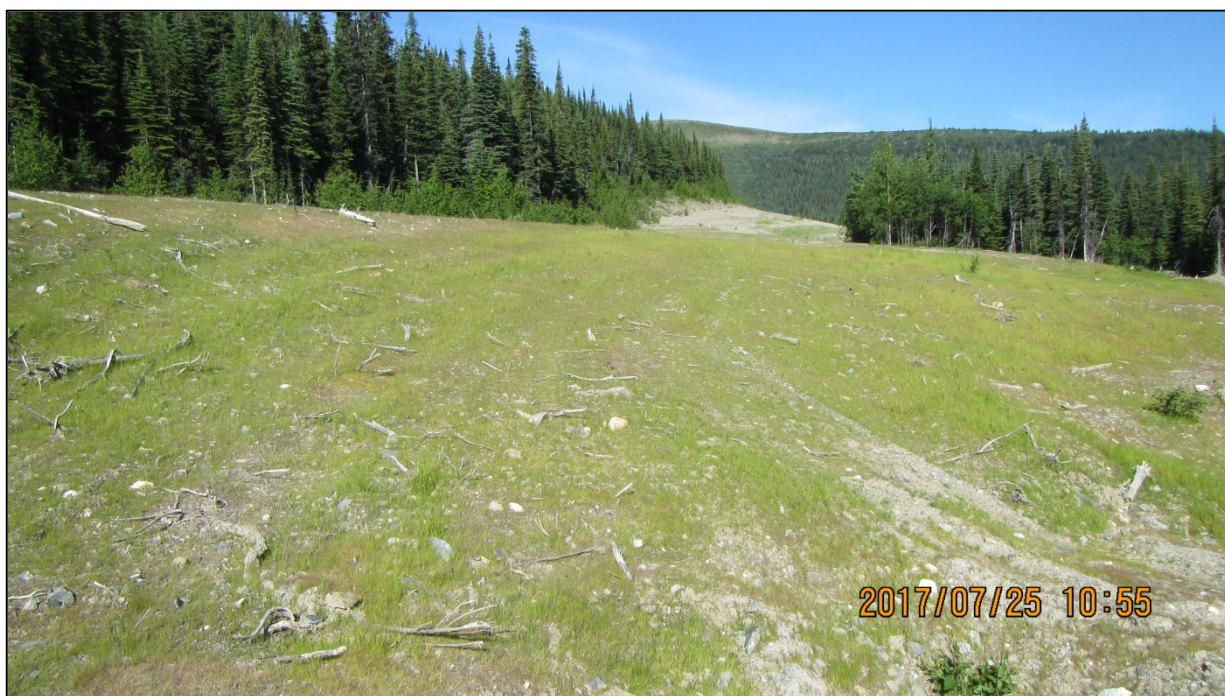
In 2015, grass was hand seeded at an application rate of 44 kg/ha, in various areas throughout the mine site. A low elevation seed mix was used on the reclaimed roads and the lower borrow pit. A high elevation seed mix was used at the Burnick and Jewel Box waste rock zones. Seven grass monitoring plots were established. Overall the grass growth was gradually increasing in all plots since the assessment in 2017.

Photograph 1: Grass growing in seeded area
