29 October 2019

Reference No. 18110616-004-L-Rev0-2019

2019 ANNUAL INSPECTION OF THE CARMACKS COPPER PROJECT, CARMACKS, YUKON

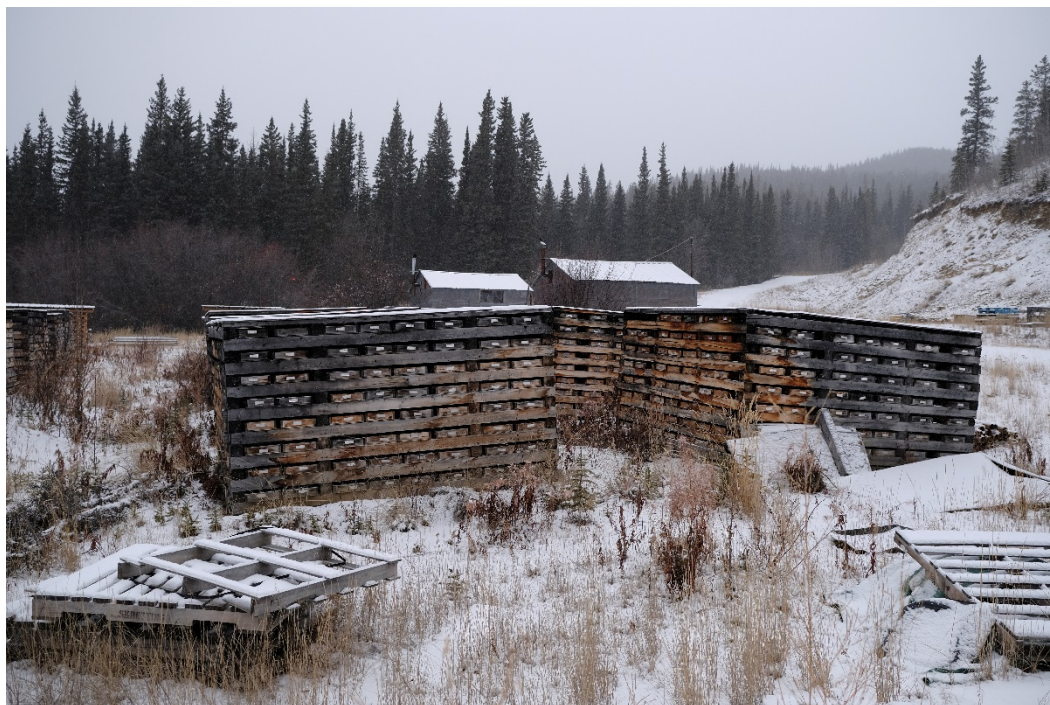
In previous years, inspections of the camp area have noted the presence of cracking, most likely resulting from thaw induced settlement beneath and adjacent to core storage racks. During the current inspection, only one crack was observed in the vicinity of the core storage racks. In general, the appearance of cracks in the core storage rack area was consistent with the 2018 inspection. There appears to have been some infilling of cracks observed during previous inspections. The area is also characterised by the regrowth of vegetation around the core racks and a general decrease in the magnitude of settlements occurring with time. As in previous years, settlement in this area does not represent a safety concern and the inspection did not indicate erosion of sediments from the pad area into the surrounding natural area.

There are two heated buildings, the core shack and geology office, located adjacent to the core storage racks (Photograph 1). The tanks, valves and hosing were in a satisfactory condition, at the time of inspection. Liners have been placed beneath each tank to act as secondary containment for potential leaks and were also in a satisfactory condition.

Photograph 1: Core Storage Racks

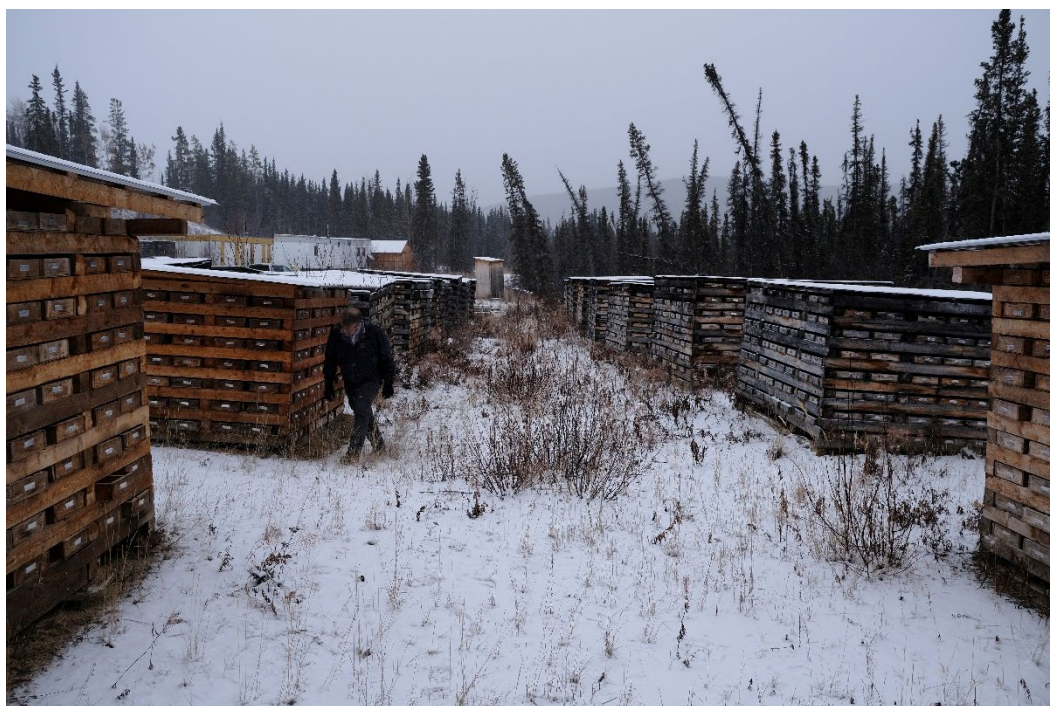
Photograph 2: Core Storage Racks

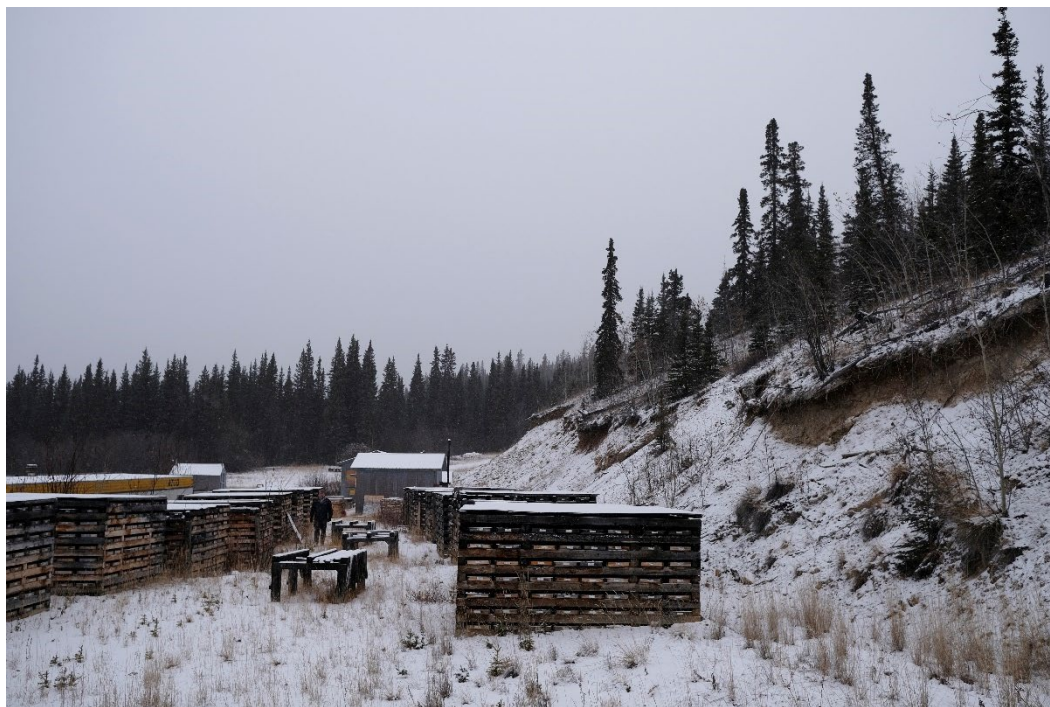
The slope behind the camp (Photographs 3 and 4) is stable and does not pose a safety concern for the camp structures or current operations. There is minor ravelling of small sections of the slope, but these are not impacting camp safety nor would they represent a risk for workers on the project. Some regrowth of vegetation was observed in the camp area.

Photograph 3: Cut-slope behind Camp Geology Office and Core Shack

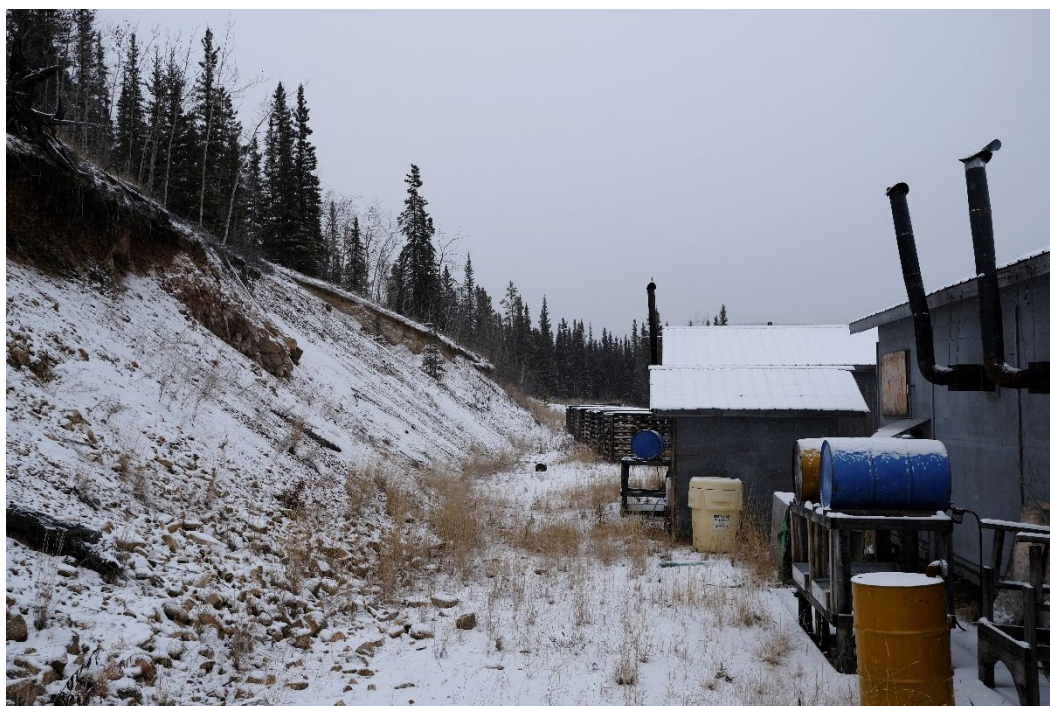
Photograph 4: Cut-slope behind the Camp Geology Office and Core Logging Shack

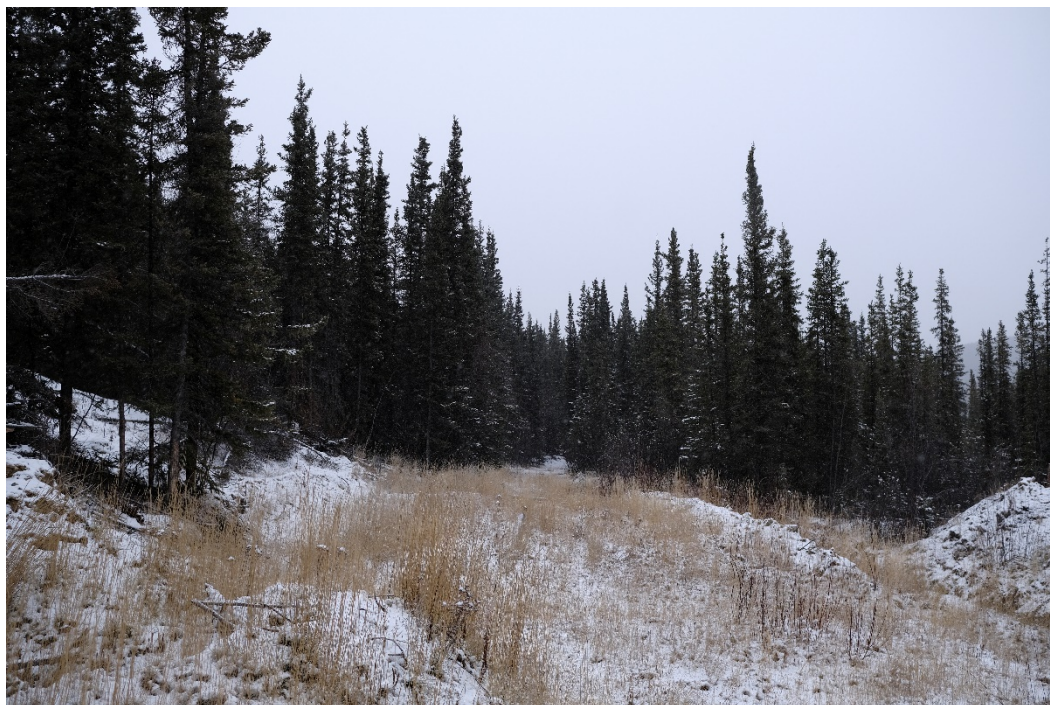
Since the initial clearing in 1997 and 1998, regrowth of vegetation has been occurring in the area. Small coniferous trees are established throughout this area. Erosion and sediment control measures in this area were initially installed in September 2008 and further maintained in September 2009 and August 2010. The sediment control measures include ditches and berms to divert water into sediment catch basins, silt fences, and vegetated areas to break up flow and reduce the potential for erosion. There continues to be some minor erosion of sediments along the access roads, however, this appears to be attenuating as vegetation growth on the access roads increases (Photograph 5).

Photograph 5: Vegetation Regrowth on Access Roads

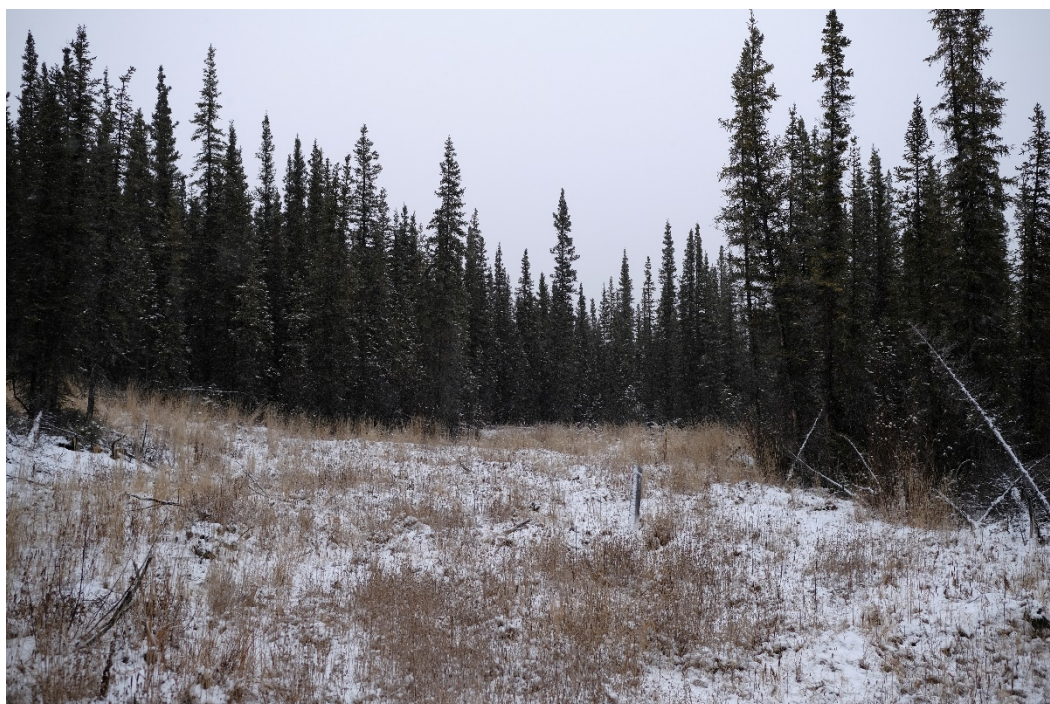
Clearing and drilling activities were carried out in 2015 and 2017 at a location down slope of the proposed heap leach facility, near the proposed water management pond (Photograph 6). Regrowth of vegetation, primarily volunteer species of grass, has mitigated loss of sediment from the former drill pads and is suitably rehabilitating.

Photograph 6: Vegetation Regrowth in 2015 Drilling Area and Proposed Water Management Pond Area

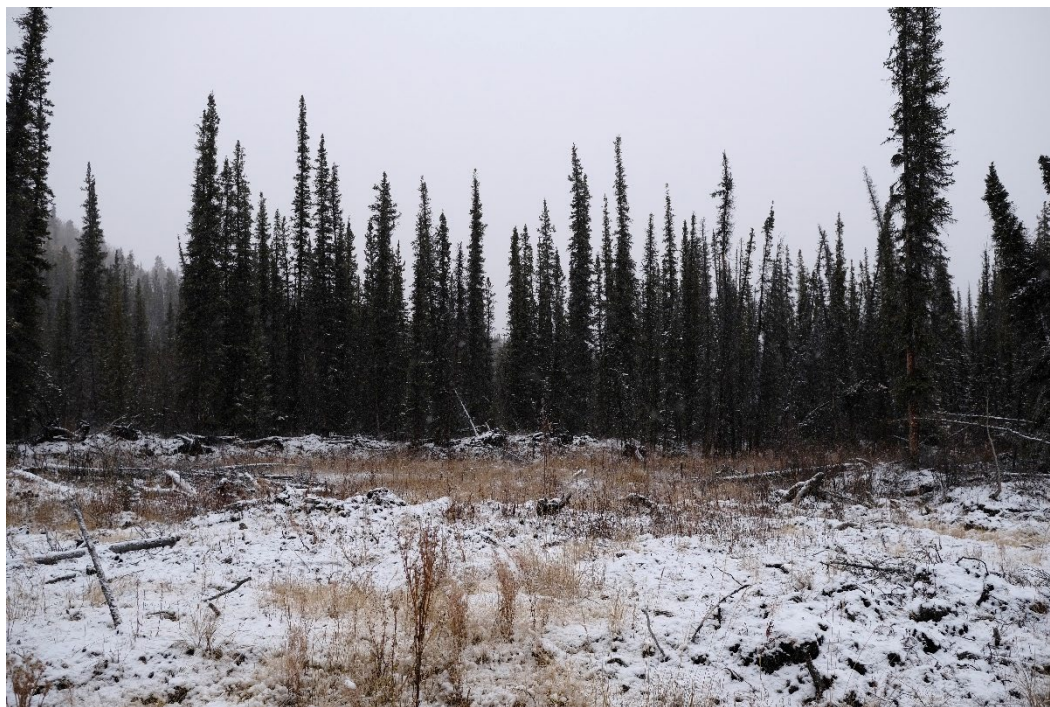
Further downstream, within the floodplain of Williams Creek, silt fences have been installed and the area seeded where sediment from previous site erosion accumulated (Photographs 7 and 8). Grass seed was applied in 2009 to promote the re-establishment of vegetation and to further stabilize sediment. The approach was noted to be generally effective in 2011 and 2012, but with limited regrowth attributed to periodic pooling of water. The area was also re-vegetated with woody plants (willow cuttings), and these plants are now well established. Volunteer species of grass and woody plants are performing very well. There was no evidence of sediment movement, indicating that re-vegetation has been effective in minimizing erosion. Silt fencing surrounding these areas is now overgrown and there is no evidence of sediment movement through the area. Silt fences are typically a temporary measure and could be removed if no further disturbance is expected upgradient.

Photograph 7: 2017 Drilling Area and Vegetation Regrowth in Williams Creek Floodplain

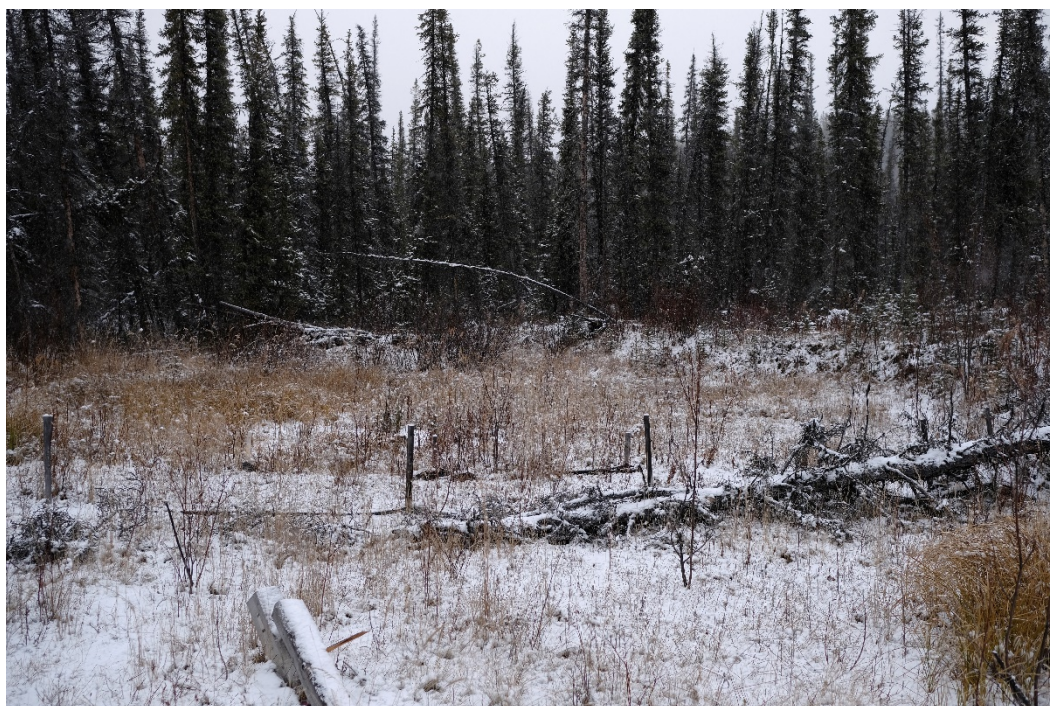
Photograph 8: Vegetation Growth around Sediment Fencing

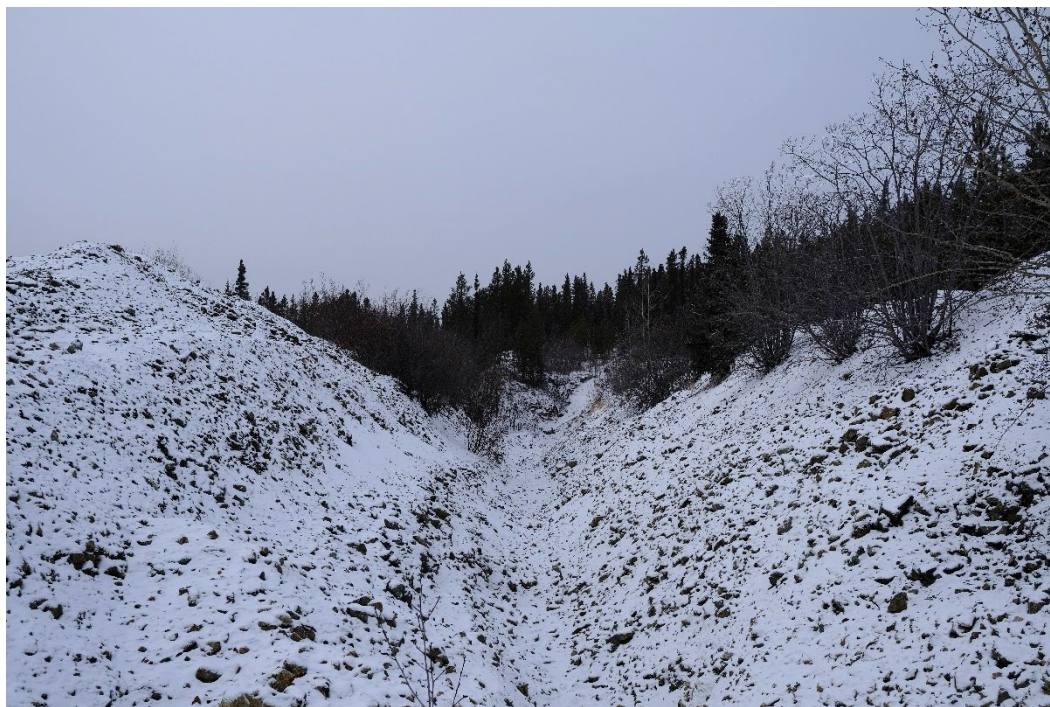
The area proposed for the open pit mine was inspected. The slopes of the trenches excavated as part of the effort to obtain bulk samples during exploration activities were observed to be in satisfactory condition (Photograph 9). There was no observed slumping or failures of the trenches and the slopes facilitate egress for wildlife. Several of the closed drill pads were inspected and there did not appear to be any erosion noted from these areas that would require attention.

Photograph 9: Exploration Trench at the Discovery Outcrop

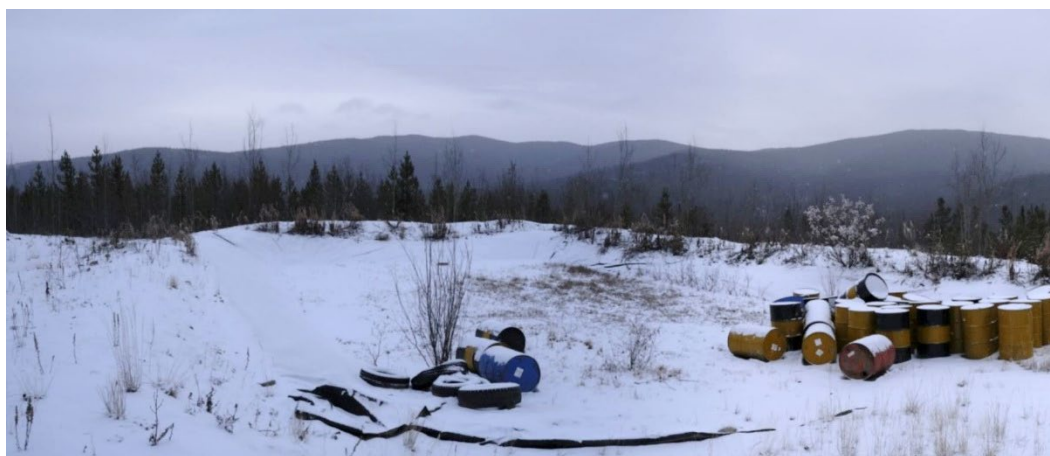
The existing fuel storage area was inspected. It comprises a bunded and lined basin constructed to contain any spilled fuel and currently a few dozen drums of diesel fuel. Approximately 0.2 m of water has accumulated in the basin (Photograph 10). The bund is less than 3 m in height and the basin capacity is less than 10,000 m³; therefore, the fuel storage area is appropriately permitted under the QML without need for a water license (Yukon Environment Dam Guide).

Photograph 10: Lined Basin at Fuel Storage Area

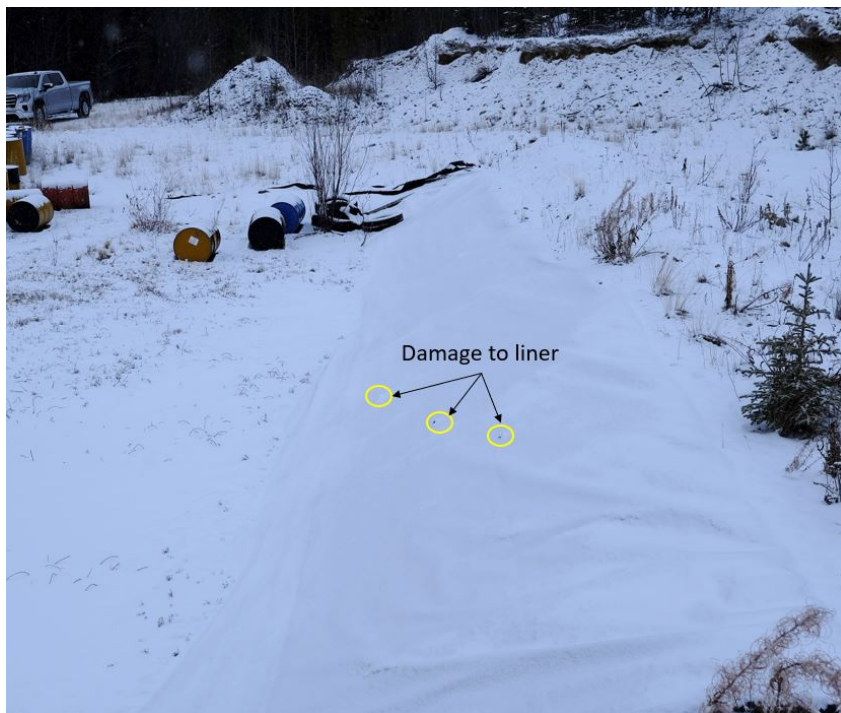
In the 2017 inspection, it was noted that an animal damaged the liner in a few locations (Photograph 11). The damage is still visible and repairs have yet to be completed. The fuel drums have since been organized in a manner to allow wildlife egress from the basin. There is some vegetation growth along the top of the containment berms and within the lined basin. There is one small shrub that is growing on the soil within the bermed area. There is the potential that the roots of the shrub penetrate through the liner. At the time when repairs to the liner are made, the shrub should be removed, the area inspected and repaired, if required.

Photograph 11: Liner Damage at Fuel Storage Area

- The beaver dam located downstream of the Merrice Creek crossing should be dismantled.
- Water crossings, including the bridge abutments at Merrice Creek, should continue to be inspected annually and following major rainfall events. Maintenance should be carried out, as required to maintain the functionality and safety of these crossings.
- The damage to the liner at the fuel storage area should be repaired.

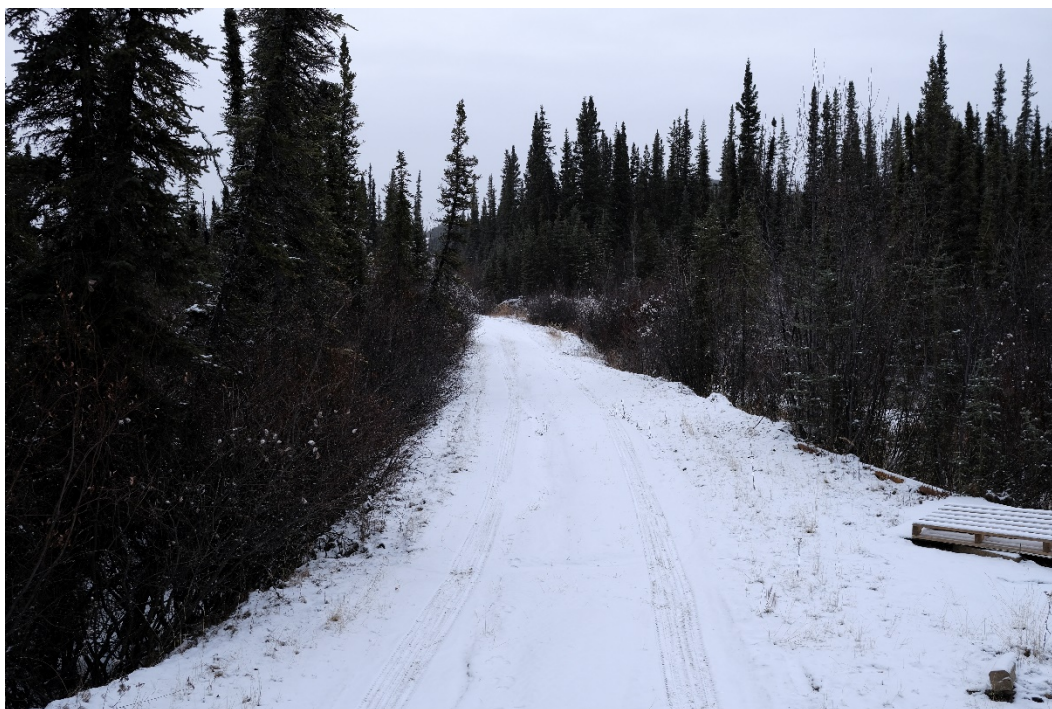
The main access road to the north of the proposed waste rock storage area was observed to be in good condition with only minor erosion observed. Damage to the road near North Williams Creek noted in the 2017 inspection report have since been repaired. The North Williams Creek culvert has undergone some crushing and has accumulated some sediment (Photographs 13 and 14). However, the culvert remains adequate to accommodate the relatively minor flows observed at the time of the inspection. There is no visual evidence to indicate that erosion is occurring near the culvert. The access road should be inspected annually and periodic maintenance of drainage features and erosion management should be anticipated.

Photograph 12: Road Near North Williams Creek

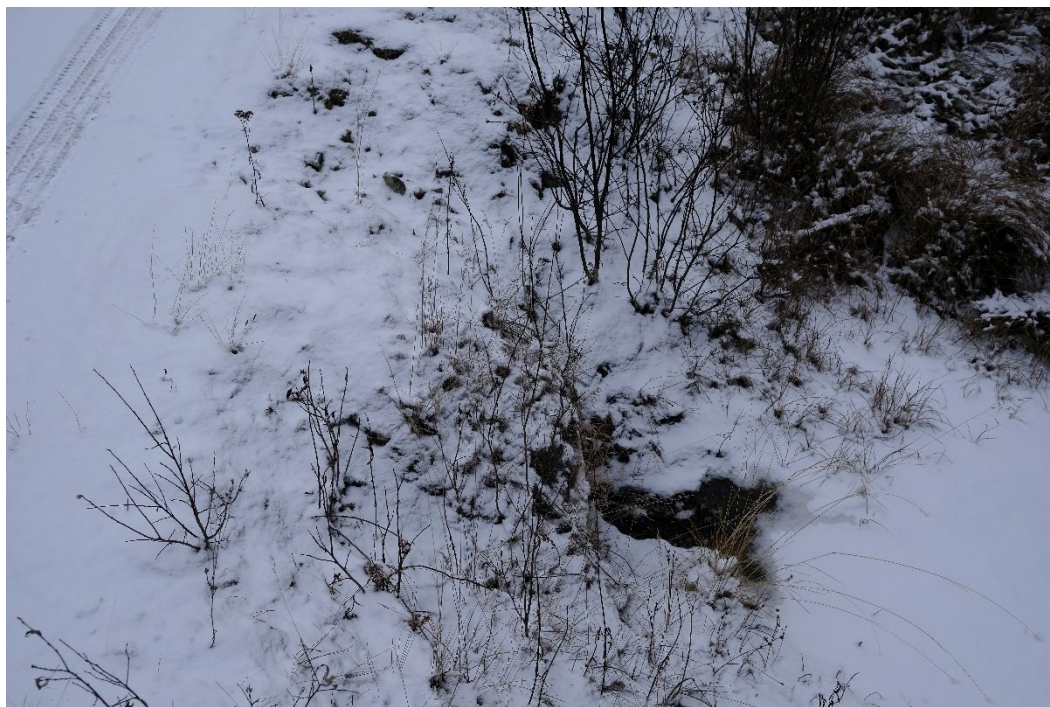
Photograph 13: Culvert Inlet beneath road at North Williams Creek

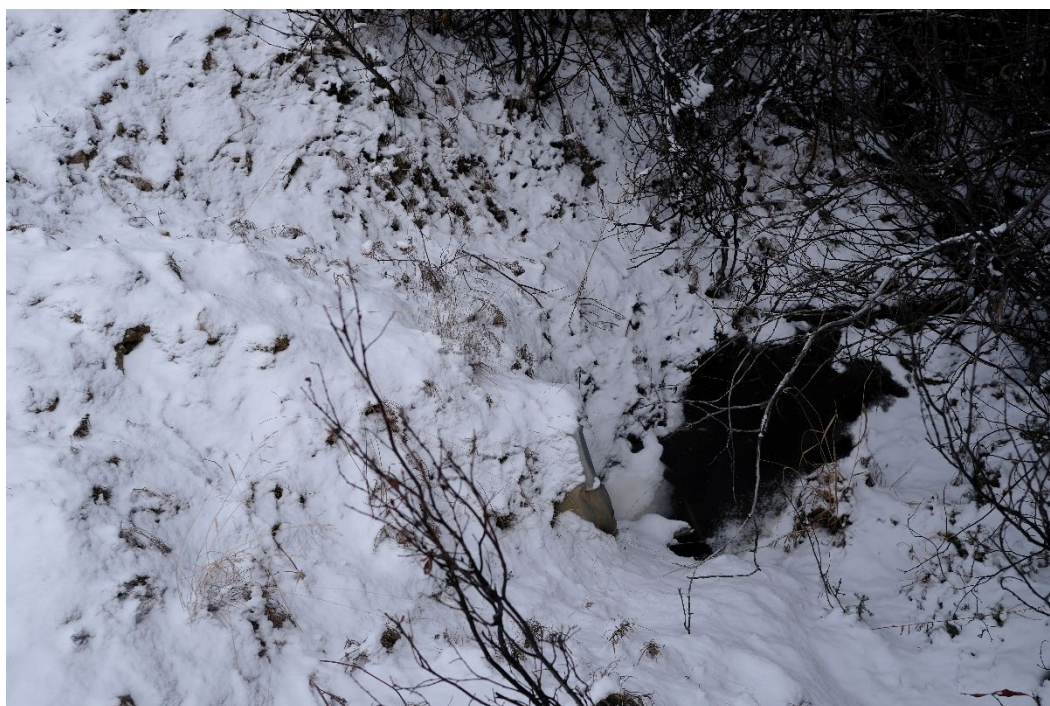
Photograph 14: Culvert Outlet beneath Road at North Williams Creek

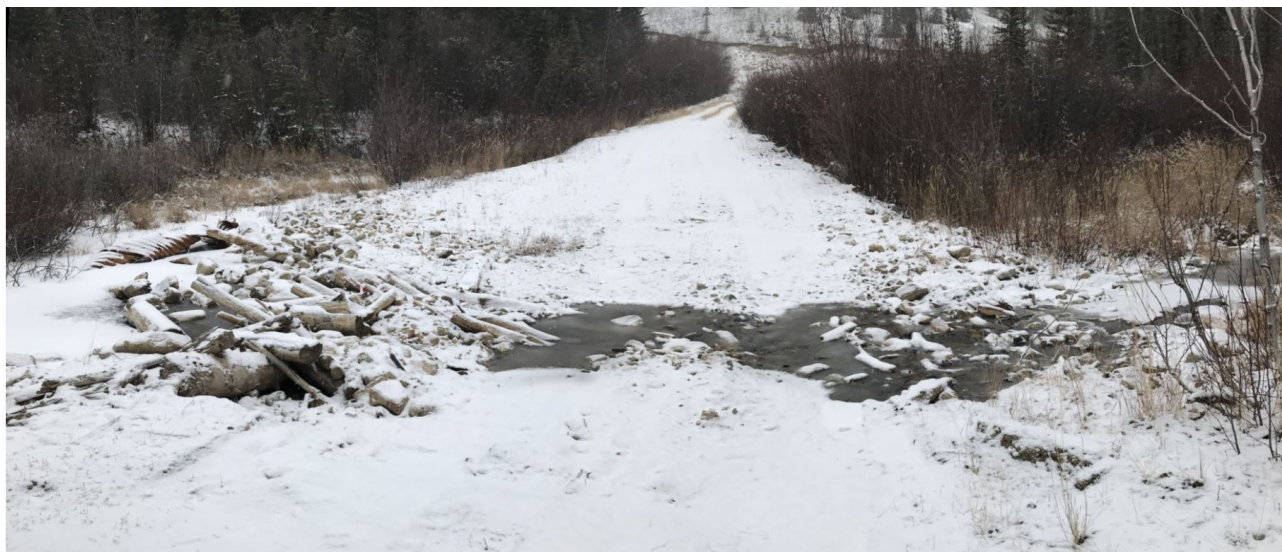
The ford road crossing installed at Williams Creek in 2013 continues to function as intended (Photograph 15). The rockfill in the ford is well-graded and there is no indication of movement of finer materials. Ponded water was observed on the upstream side of the road, with flow across the road. It is possible that a large rainfall event could result in erosion. We therefore recommended that the ford continue to be inspected annually and maintenance be carried out, if required. The ford is appropriate for the current status of the project. However, prior to site development, it is recommended that the crossing is upgraded.

Photograph 15: Williams Creek Ford Crossing

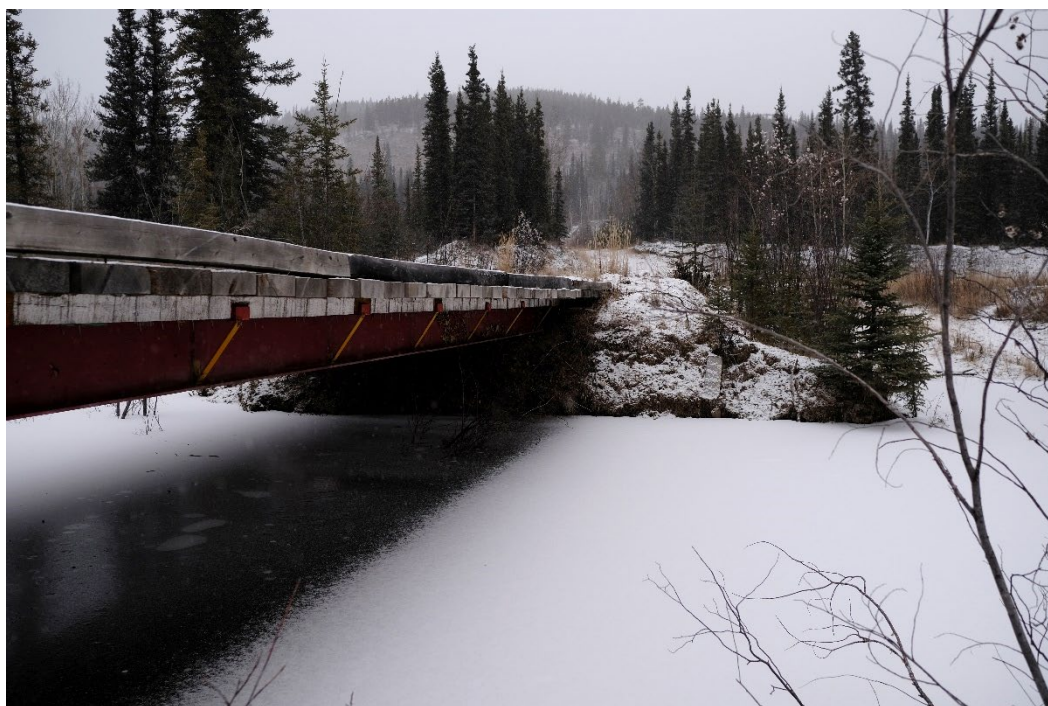
The access road crossing at Merrice Creek includes a single-span bridge (Photographs 16 and 17). Following recommendations in the July 2014 inspection memorandum, the bridge was extended by approximately 3 m and seated 1 to 2 m on the abutments. Approximately 3 m of steel was welded to the existing span, bridge decking was replaced and extended, and the approaches were re-graded to the bridge deck elevation.

Photograph 16: Bridge Crossing at Merrice Creek – Downstream Side

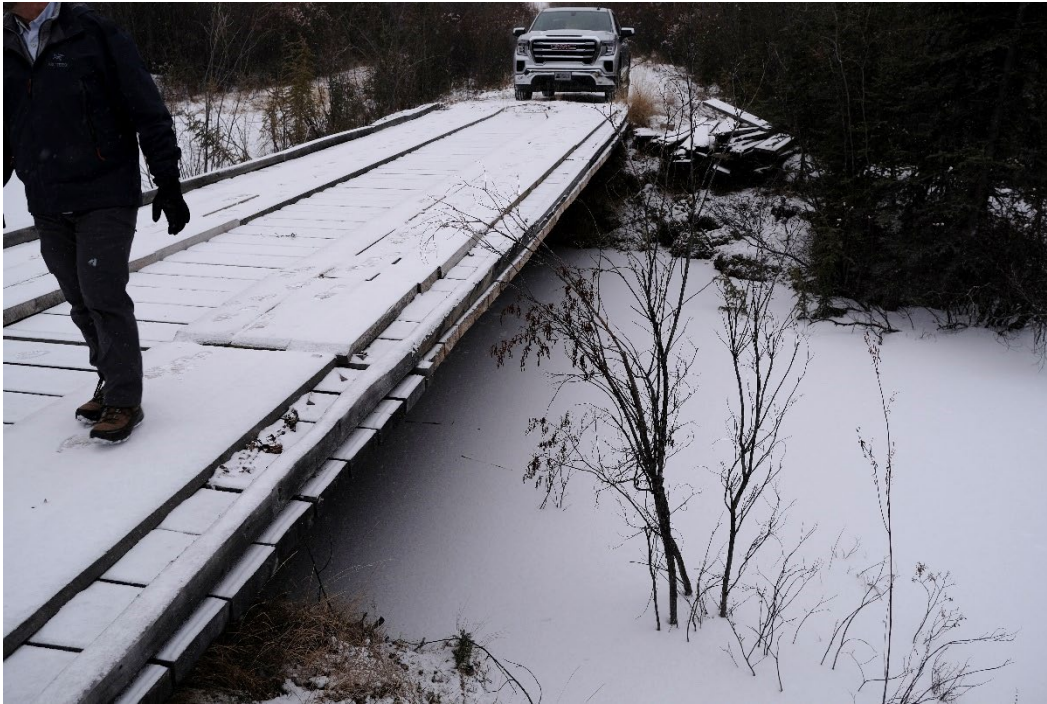
Photograph 17: Bridge Crossing at Merrice Creek – Upstream Side

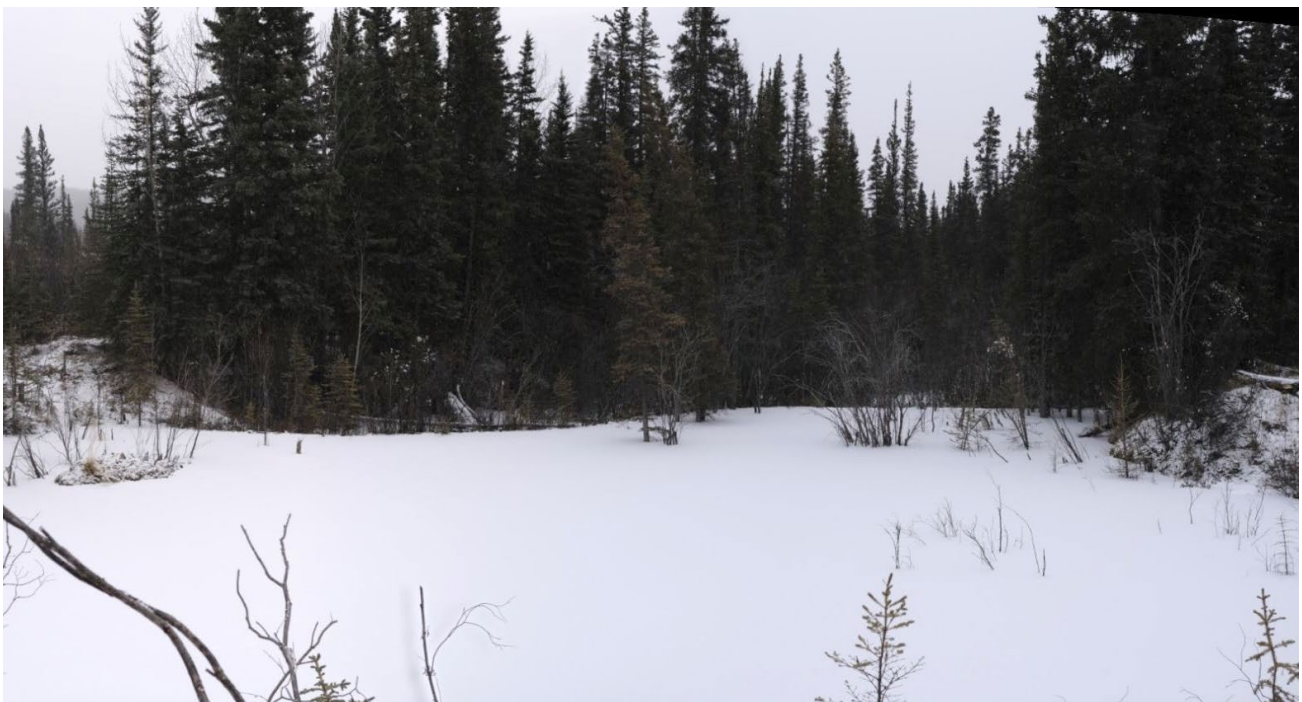
At the time of the inspection there was a large beaver dam downstream of the bridge which had caused higher than normal water levels in Merrice Creek, for the time of year (Photograph 18). The bridge was observed to be in a satisfactory condition and is securely anchored at each of the abutments. The right (or southern) abutment is steep sided and there is evidence that erosion may be continuing to occur at this location under high-flow conditions. The bridge should be monitored annually and following large rainfall events. In the event that erosion begins to compromise the stability of the abutment, consideration should be given to the installation of erosion protection at this location.

Photograph 18: Bridge Crossing at Merrice Creek – Downstream Beaver Dam
