## **2019 ANNUAL QUARTZ MINING LICENCE REPORT**

**Submitted to Yukon Government, Energy Mines and Resources  
Yukon Quartz Mining Licence QML-0007**

**March 2020**

**Carmacks Copper Project, Yukon Territory**

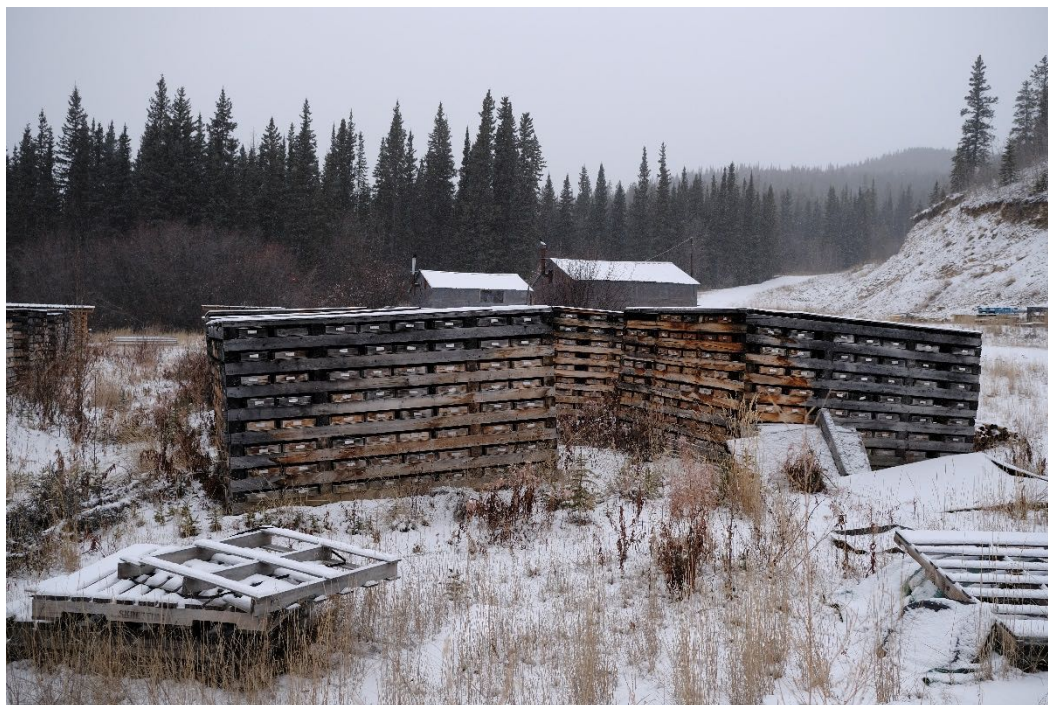
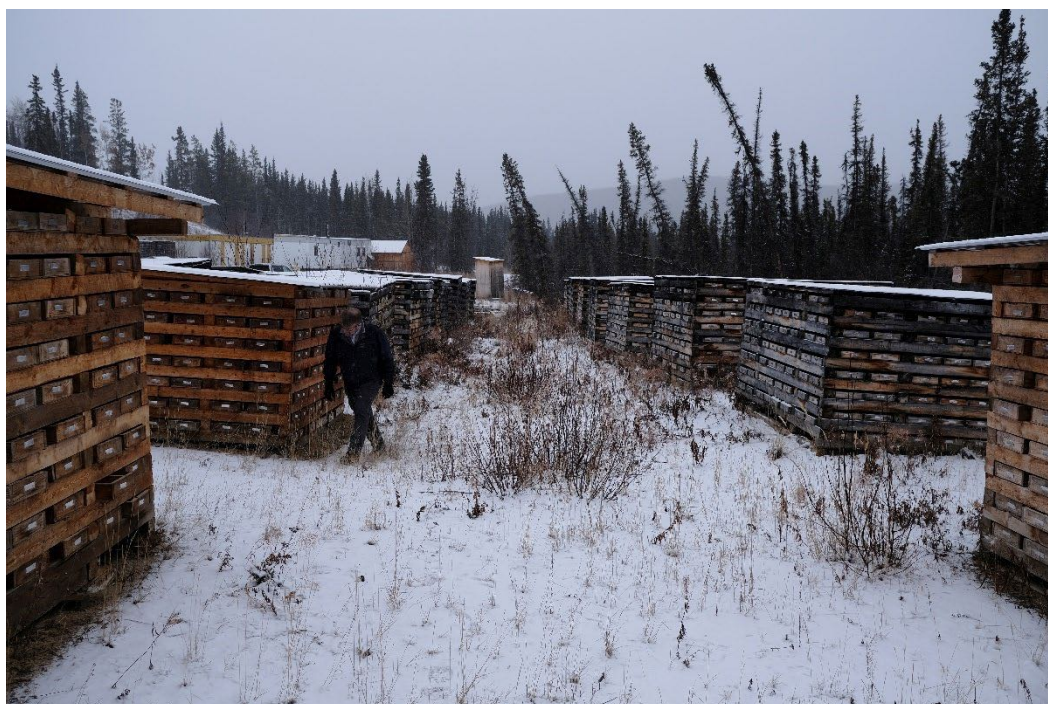
There are two heated buildings, the core shack and geology office, located adjacent to the core storage racks (Photograph 1). The tanks, valves and hosing were in a satisfactory condition, at the time of inspection. Liners have been placed beneath each tank to act as secondary containment for potential leaks and were also in a satisfactory condition.

**Photograph 1: Core Storage Racks**

**Photograph 2: Core Storage Racks**

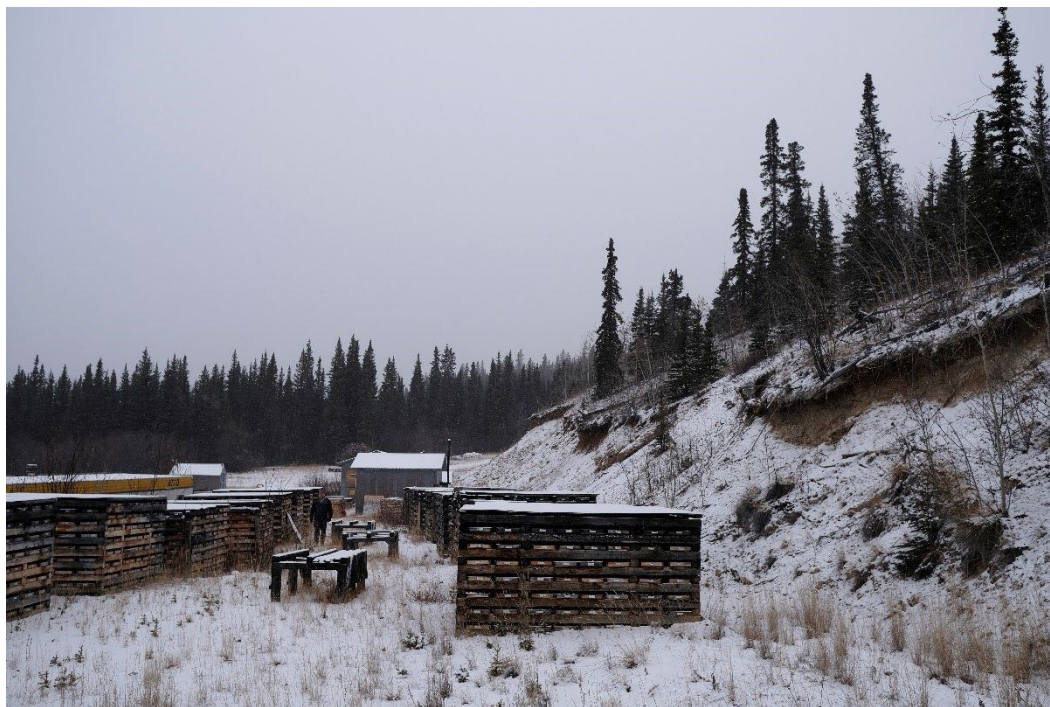
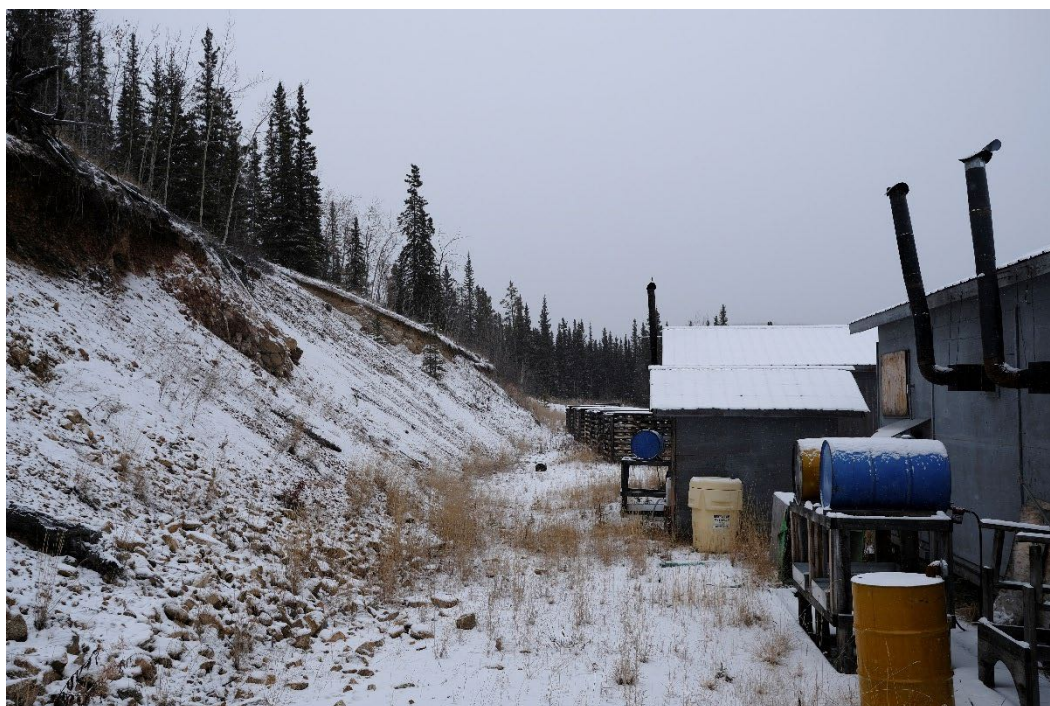
The slope behind the camp (Photographs 3 and 4) is stable and does not pose a safety concern for the camp structures or current operations. There is minor ravelling of small sections of the slope, but these are not impacting camp safety nor would they represent a risk for workers on the project. Some regrowth of vegetation was observed in the camp area.

**Photograph 3: Cut-slope behind Camp Geology Office and Core Shack**

**Photograph 4: Cut-slope behind the Camp Geology Office and Core Logging Shack**

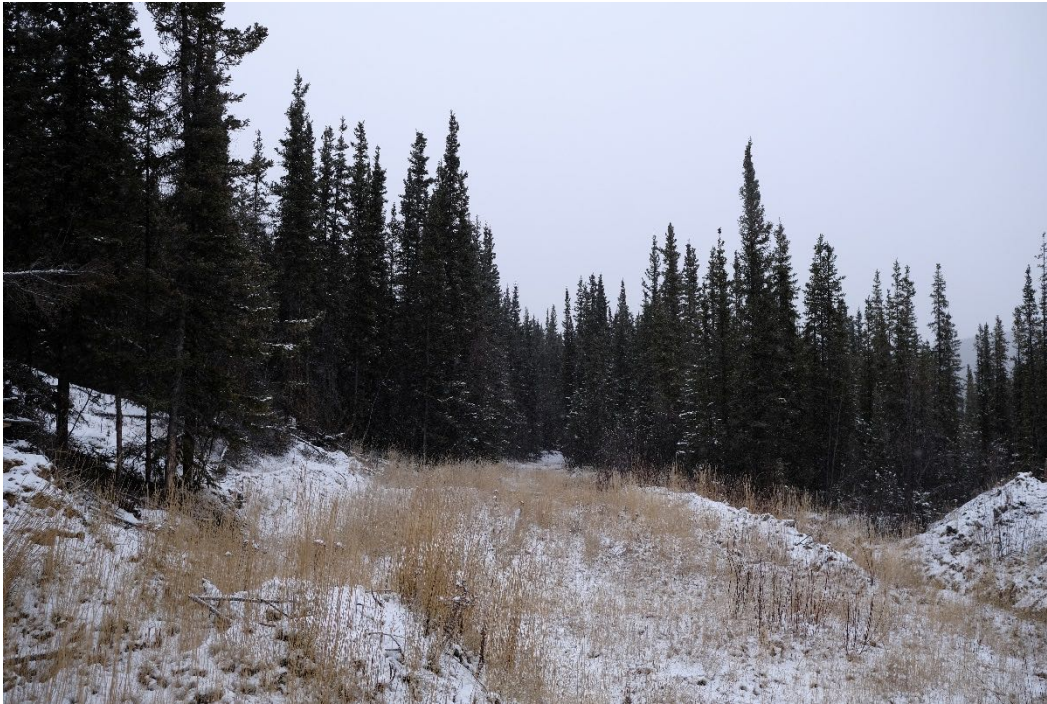
**Photograph 5: Vegetation Regrowth on Access Roads**

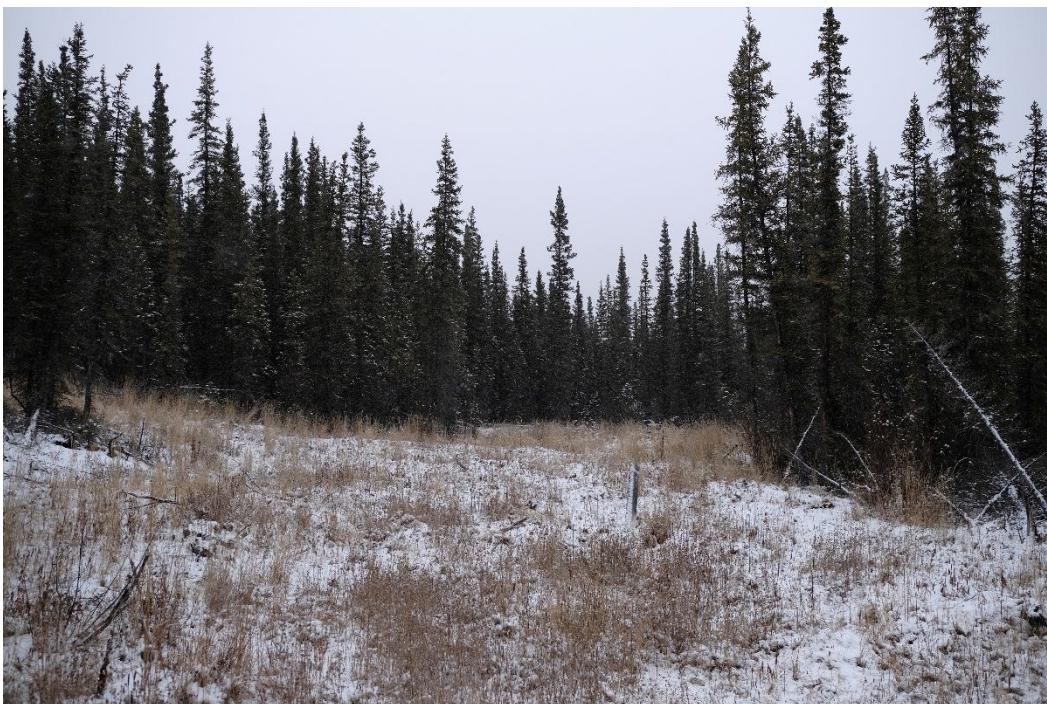
**Photograph 6: Vegetation Regrowth in 2015 Drilling Area and Proposed Water Management Pond Area**

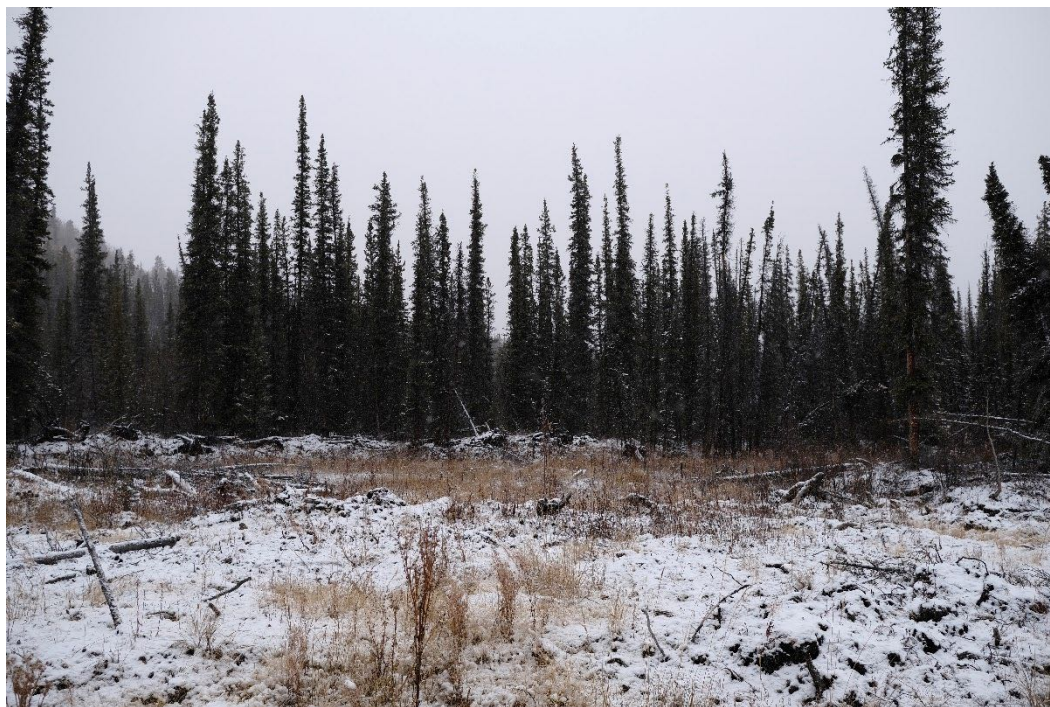
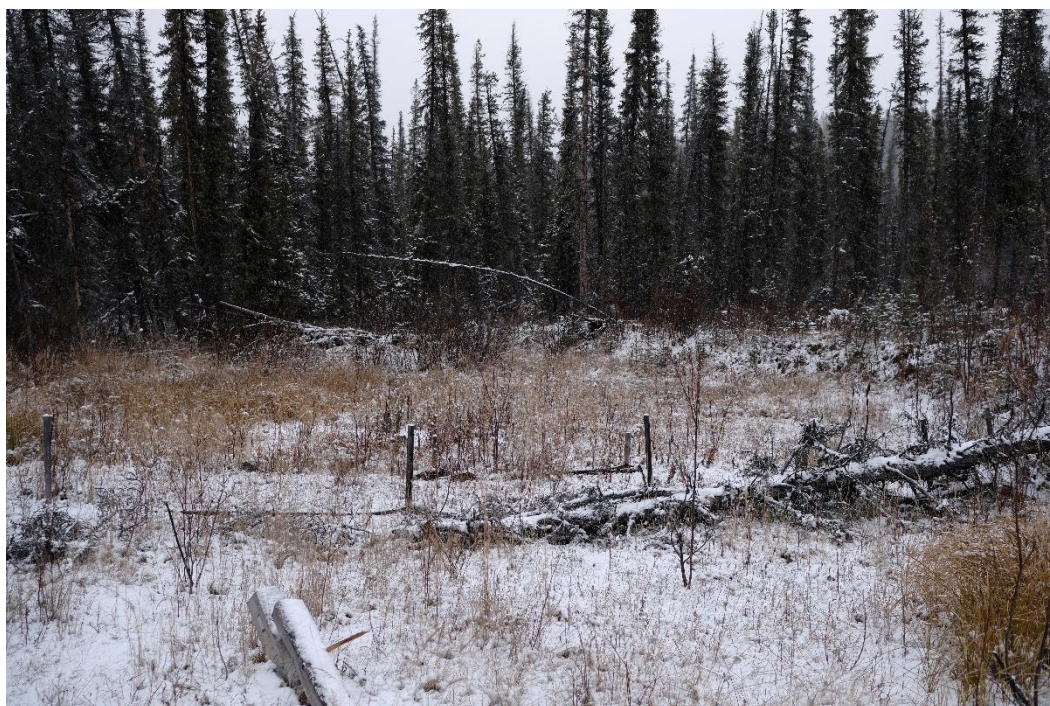
Further downstream, within the floodplain of Williams Creek, silt fences have been installed and the area seeded where sediment from previous site erosion accumulated (Photographs 7 and 8). Grass seed was applied in 2009 to promote the re-establishment of vegetation and to further stabilize sediment. The approach was noted to be generally effective in 2011 and 2012, but with limited regrowth attributed to periodic pooling of water. The area was also re-vegetated with woody plants (willow cuttings), and these plants are now well established. Volunteer species of grass and woody plants are performing very well. There was no evidence of sediment movement, indicating that re-vegetation has been effective in minimizing erosion. Silt fencing surrounding these areas is now overgrown and there is no evidence of sediment movement through the area. Silt fences are typically a temporary measure and could be removed if no further disturbance is expected upgradient.

**Photograph 7: 2017 Drilling Area and Vegetation Regrowth in Williams Creek Floodplain**

**Photograph 8: Vegetation Growth around Sediment Fencing**

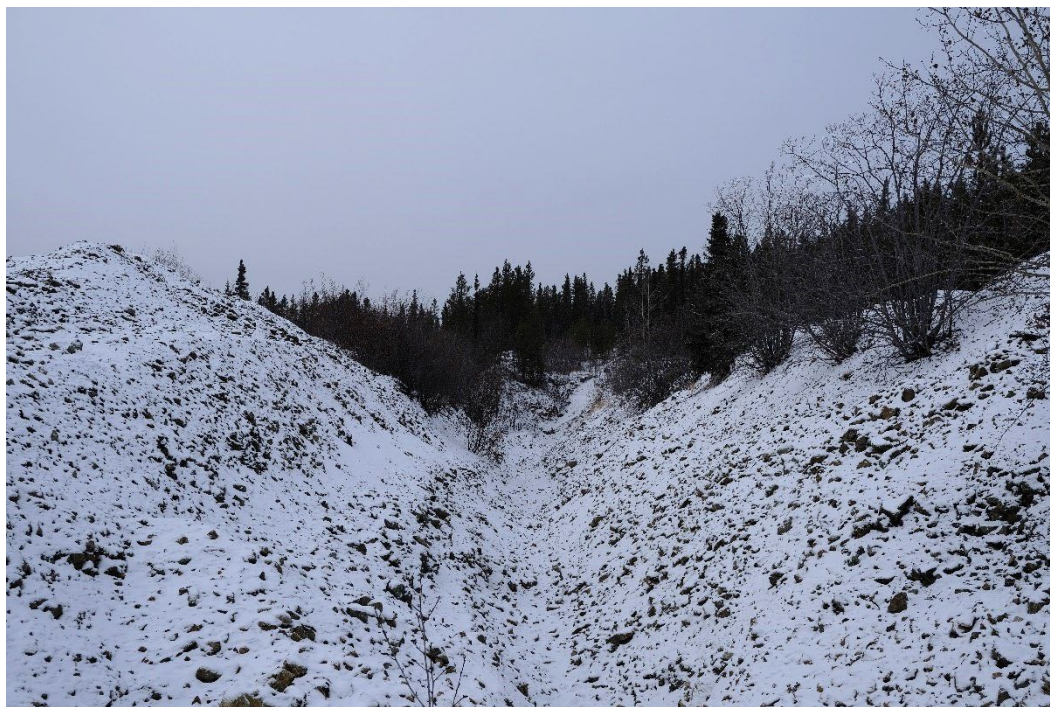
The area proposed for the open pit mine was inspected. The slopes of the trenches excavated as part of the effort to obtain bulk samples during exploration activities were observed to be in satisfactory condition (Photograph 9). There was no observed slumping or failures of the trenches and the slopes facilitate egress for wildlife. Several of the closed drill pads were inspected and there did not appear to be any erosion noted from these areas that would require attention.

**Photograph 9: Exploration Trench at the Discovery Outcrop**

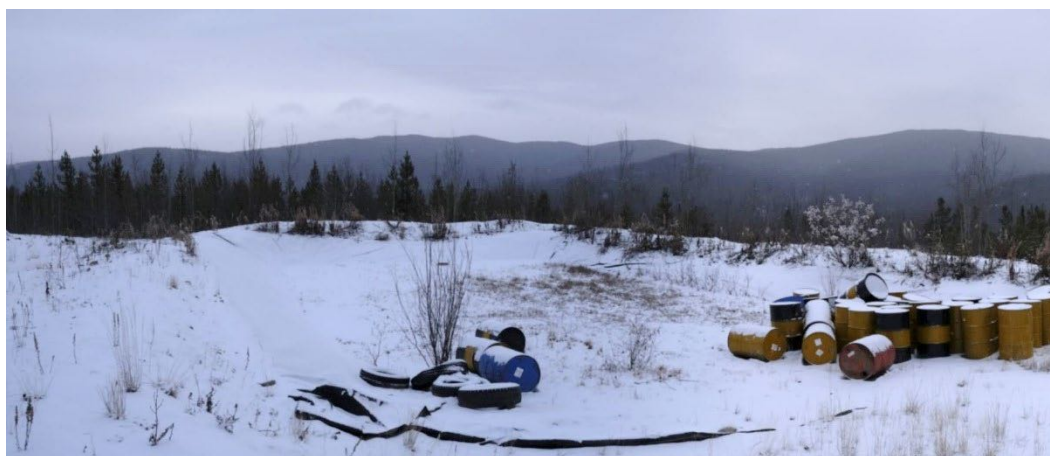
**Photograph 10: Lined Basin at Fuel Storage Area**

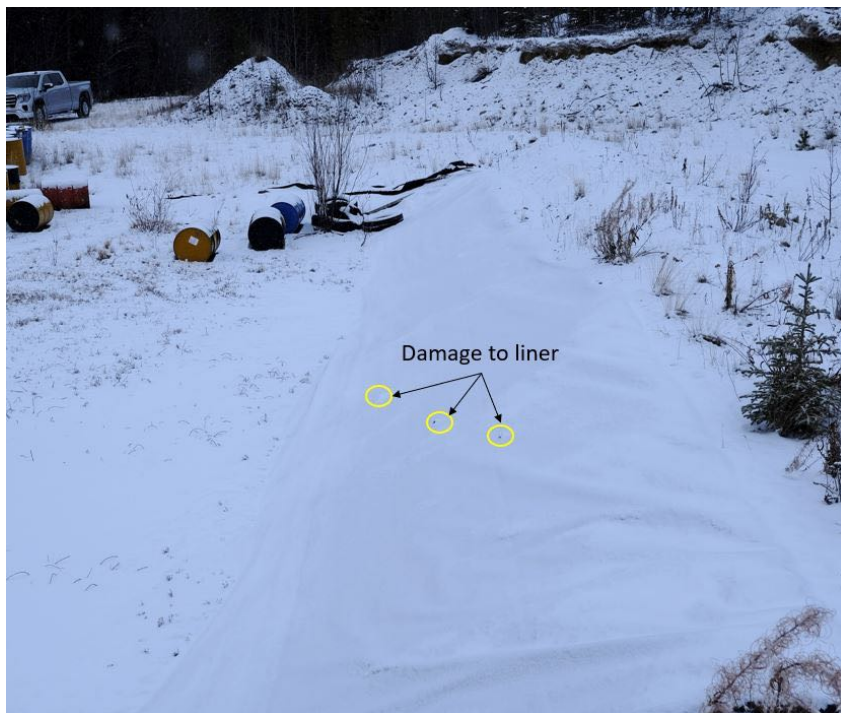
In the 2017 inspection, it was noted that an animal damaged the liner in a few locations (Photograph 11). The damage is still visible and repairs have yet to be completed. The fuel drums have since been organized in a manner to allow wildlife egress from the basin. There is some vegetation growth along the top of the containment berms and within the lined basin. There is one small shrub that is growing on the soil within the bermed area. There is the potential that the roots of the shrub penetrate through the liner. At the time when repairs to the liner are made, the shrub should be removed, the area inspected and repaired, if required.

**Photograph 11: Liner Damage at Fuel Storage Area**

- The beaver dam located downstream of the Merrice Creek crossing should be dismantled.
- Water crossings, including the bridge abutments at Merrice Creek, should continue to be inspected annually and following major rainfall events. Maintenance should be carried out, as required to maintain the functionality and safety of these crossings.
- The damage to the liner at the fuel storage area should be repaired.

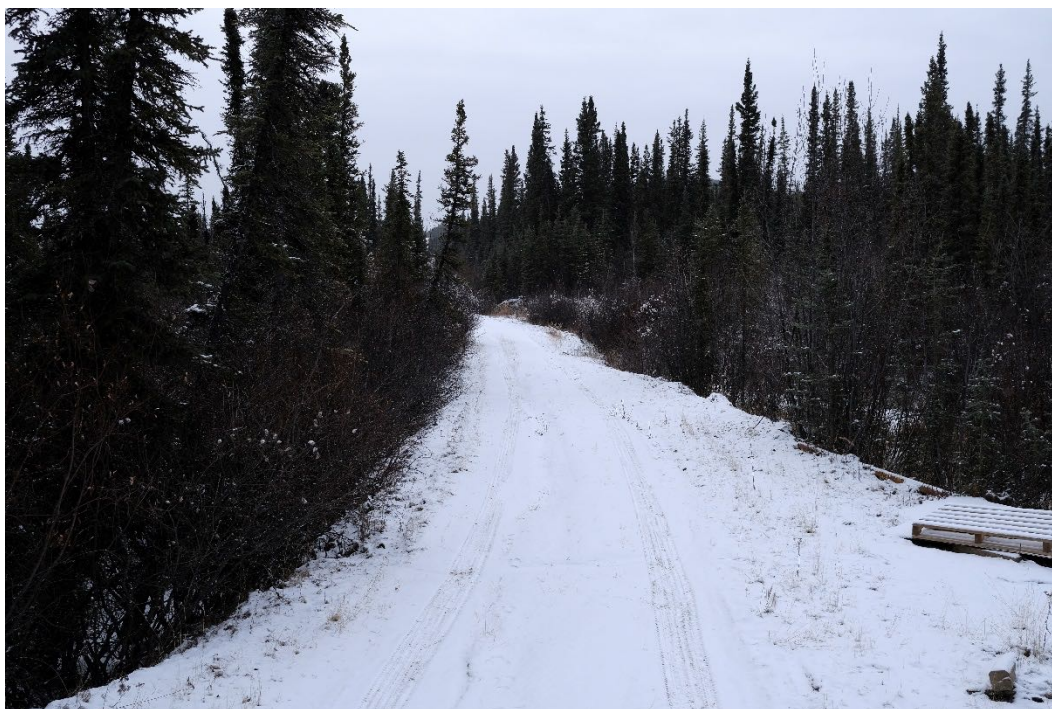
**Photograph 12: Road Near North Williams Creek**

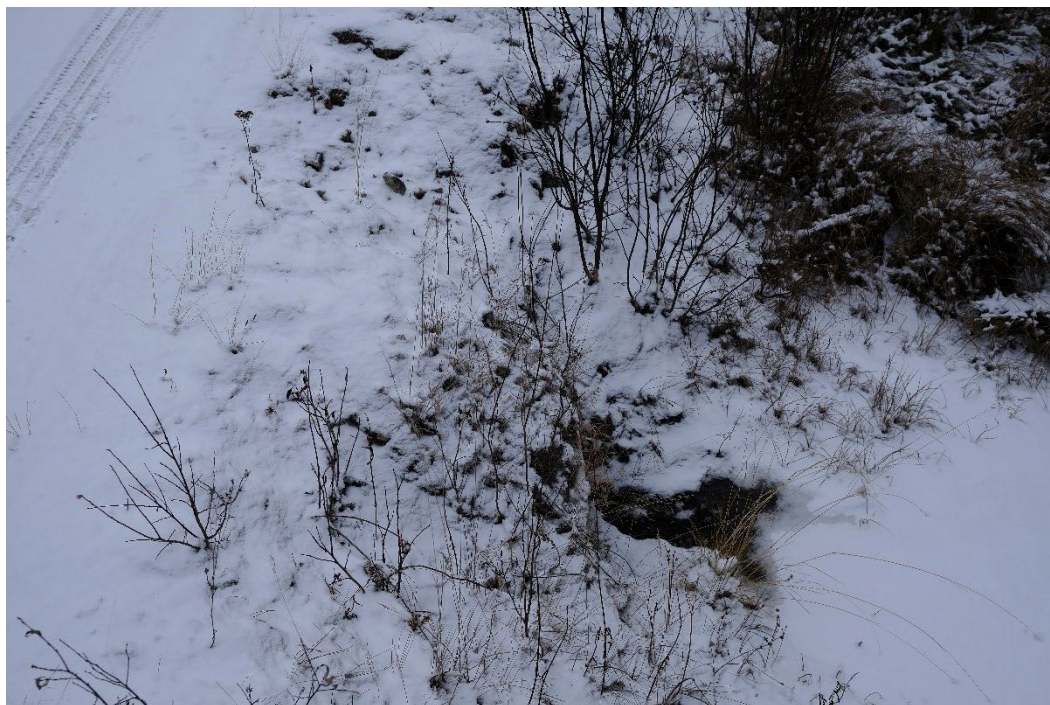
**Photograph 13: Culvert Inlet beneath road at North Williams Creek**

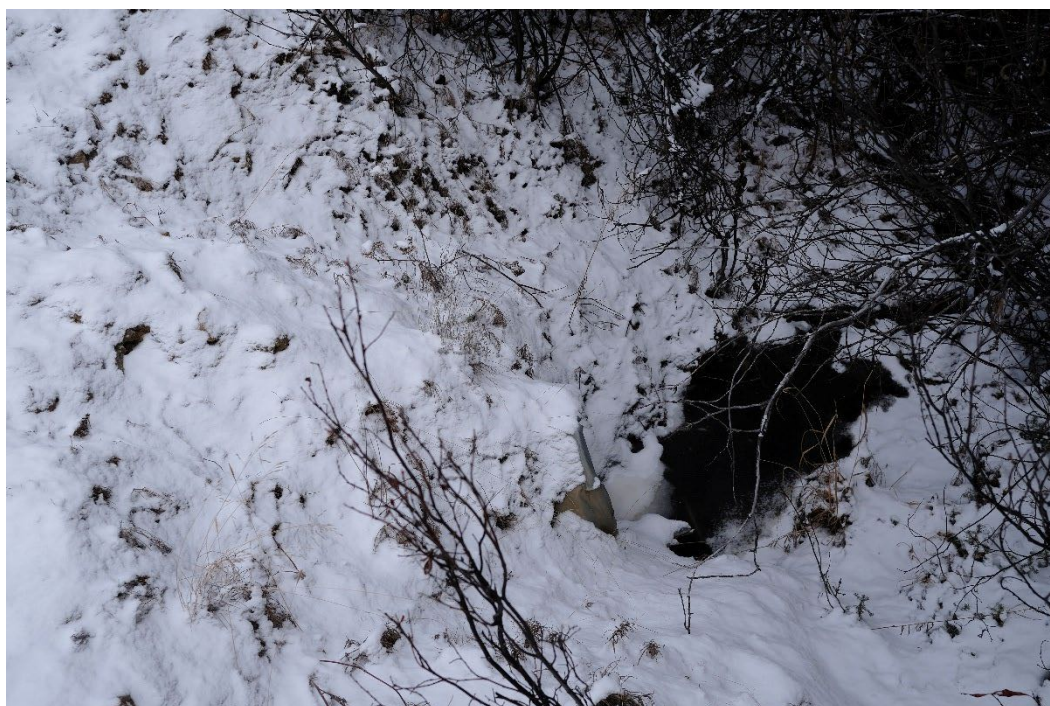
**Photograph 14: Culvert Outlet beneath Road at North Williams Creek**

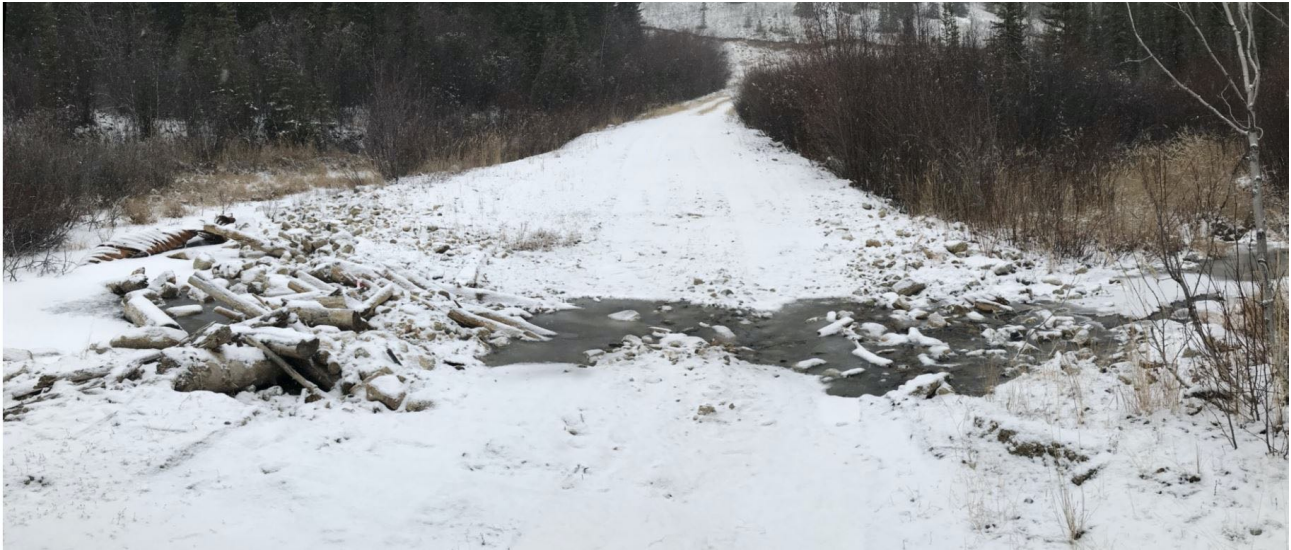
The ford road crossing installed at Williams Creek in 2013 continues to function as intended (Photograph 15). The rockfill in the ford is well-graded and there is no indication of movement of finer materials. Ponded water was observed on the upstream side of the road, with flow across the road. It is possible that a large rainfall event could result in erosion. We therefore recommended that the ford continue to be inspected annually and maintenance be carried out, if required. The ford is appropriate for the current status of the project. However, prior to site development, it is recommended that the crossing is upgraded.

**Photograph 15: Williams Creek Ford Crossing**

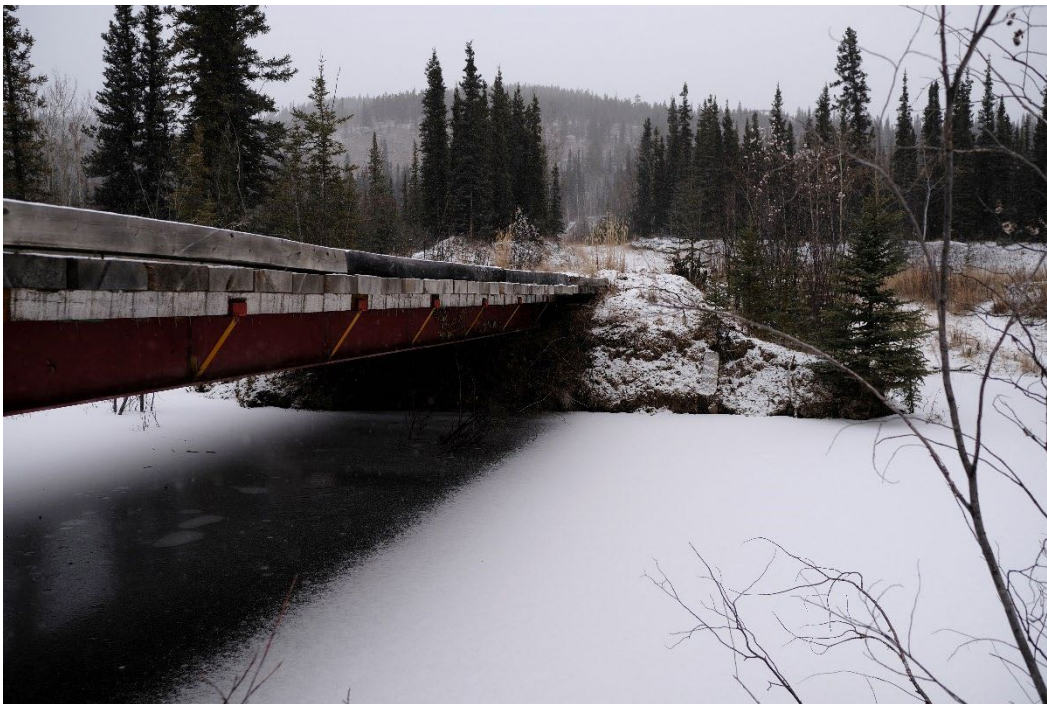
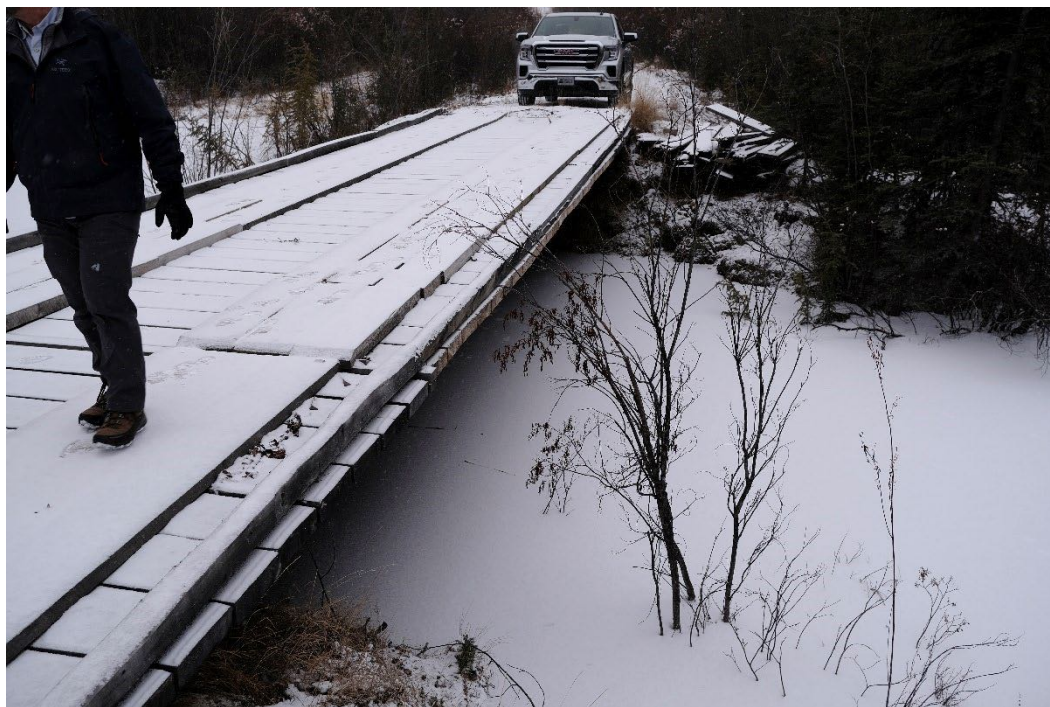
The access road crossing at Merrice Creek includes a single-span bridge (Photographs 16 and 17). Following recommendations in the July 2014 inspection memorandum, the bridge was extended by approximately 3 m and seated 1 to 2 m on the abutments. Approximately 3 m of steel was welded to the existing span, bridge decking was replaced and extended, and the approaches were re-graded to the bridge deck elevation.

**Photograph 16: Bridge Crossing at Merrice Creek – Downstream Side**

**Photograph 17: Bridge Crossing at Merrice Creek – Upstream Side**

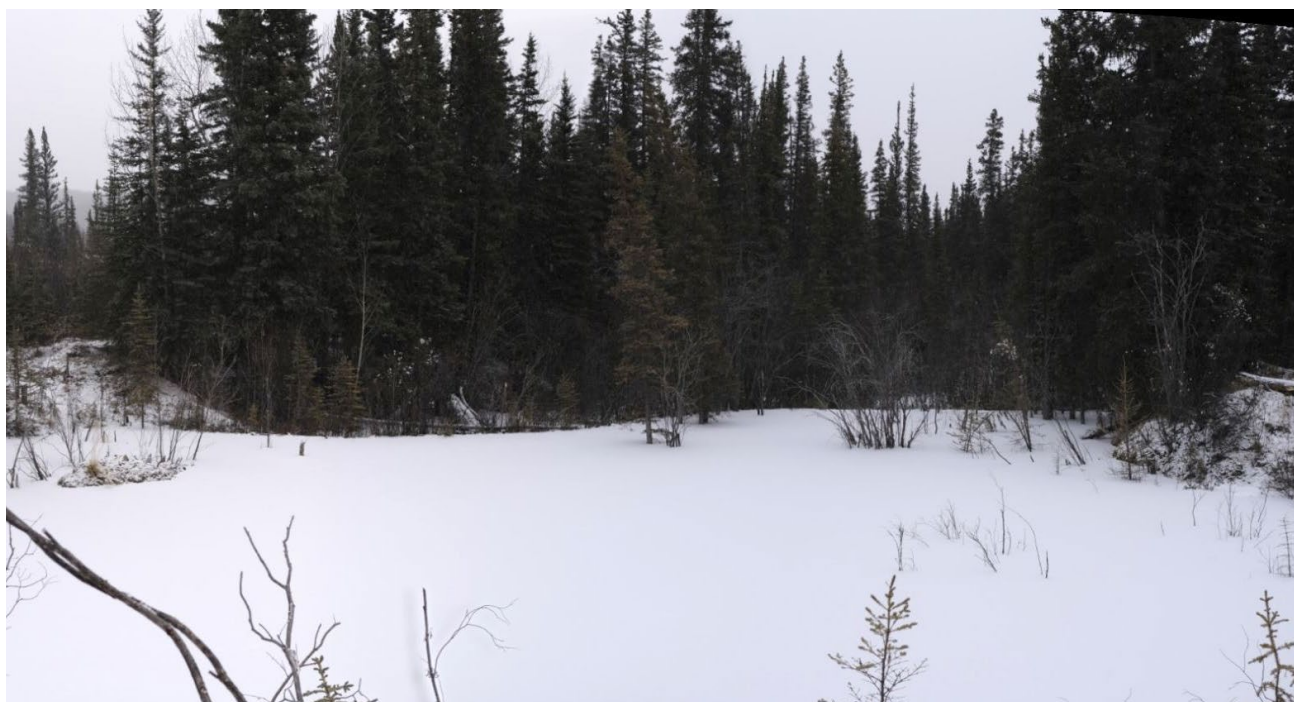
At the time of the inspection there was a large beaver dam downstream of the bridge which had caused higher than normal water levels in Merrice Creek, for the time of year (Photograph 18). The bridge was observed to be in a satisfactory condition and is securely anchored at each of the abutments. The right (or southern) abutment is steep sided and there is evidence that erosion may be continuing to occur at this location under high-flow conditions. The bridge should be monitored annually and following large rainfall events. In the event that erosion begins to compromise the stability of the abutment, consideration should be given to the installation of erosion protection at this location.

**Photograph 18: Bridge Crossing at Merrice Creek – Downstream Beaver Dam**
