## TECHNICAL MEMORANDUM

**Reference No.** 20405023-002-TM-Rev0-1000

### 2021 ANNUAL INSPECTION OF THE CARMACKS COPPER PROJECT, CARMACKS, YUKON

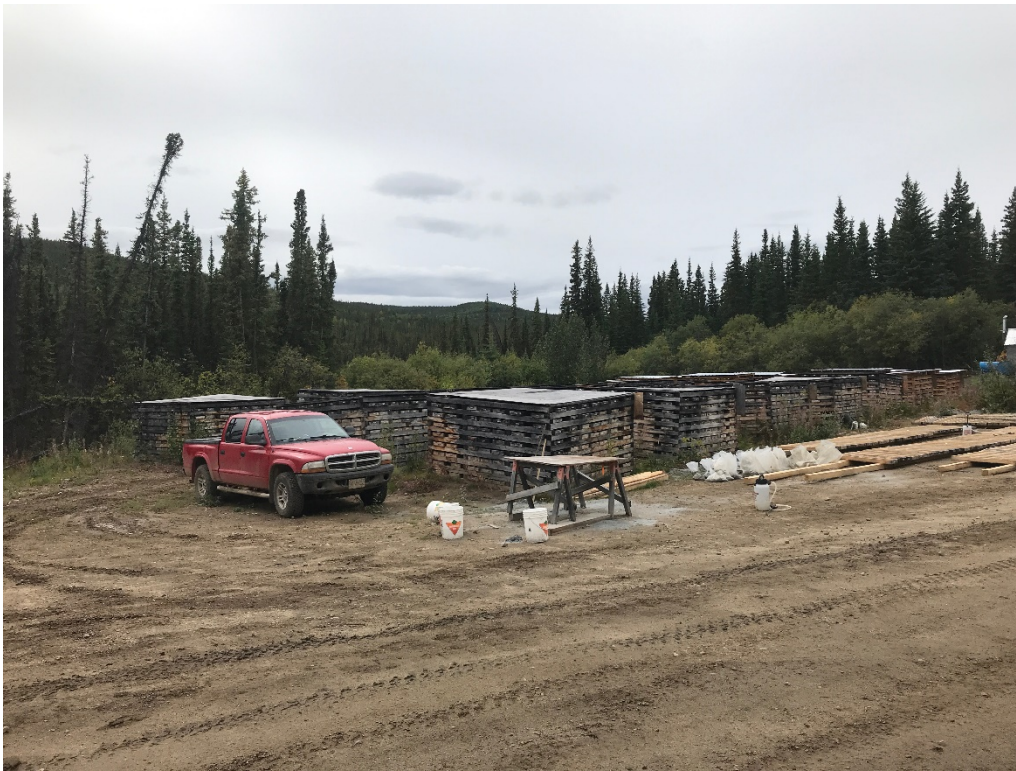
There are two heated buildings, the core shack and geology office, located adjacent to the core storage racks (Photograph 1). The tanks, valves and hosing were in a satisfactory condition, at the time of inspection. Liners and spill pads have been placed beneath each tank to act as secondary containment for potential leaks and were also in a satisfactory condition. During the 2021 inspection there were several wall tents installed within the camp area to support the 2021 exploration drilling program. The area around these wall tents was in a satisfactory condition, at the time of inspection.

**Photograph 1: Core Storage Racks Looking South**

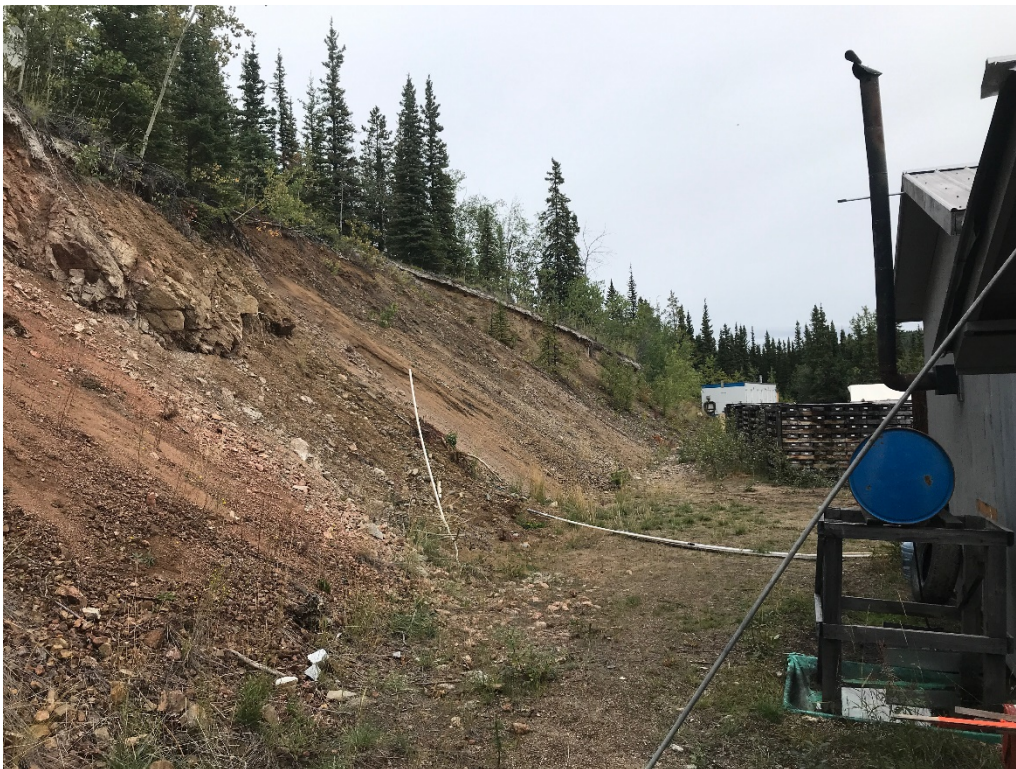
The slope behind the camp (Photographs 2 and 3) is stable and does not pose a safety concern for the camp structures or current operations. There is minor ravelling of small sections of the slope, but these are not impacting camp safety nor would they represent a risk for workers on the project. Some regrowth of vegetation was observed in the camp area.

**Photograph 2: Slope Behind Camp Geology Office and Core Shack Looking NE**

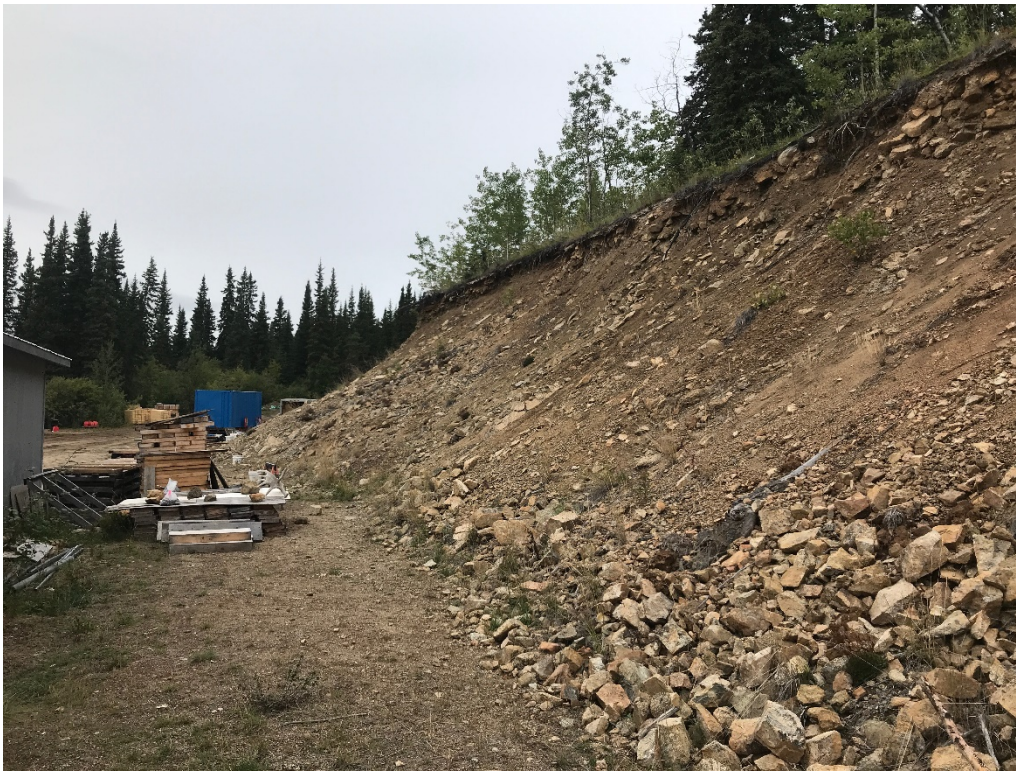
**Photograph 3: Slope Behind the Camp Geology Office and Core Logging Shack Looking North**

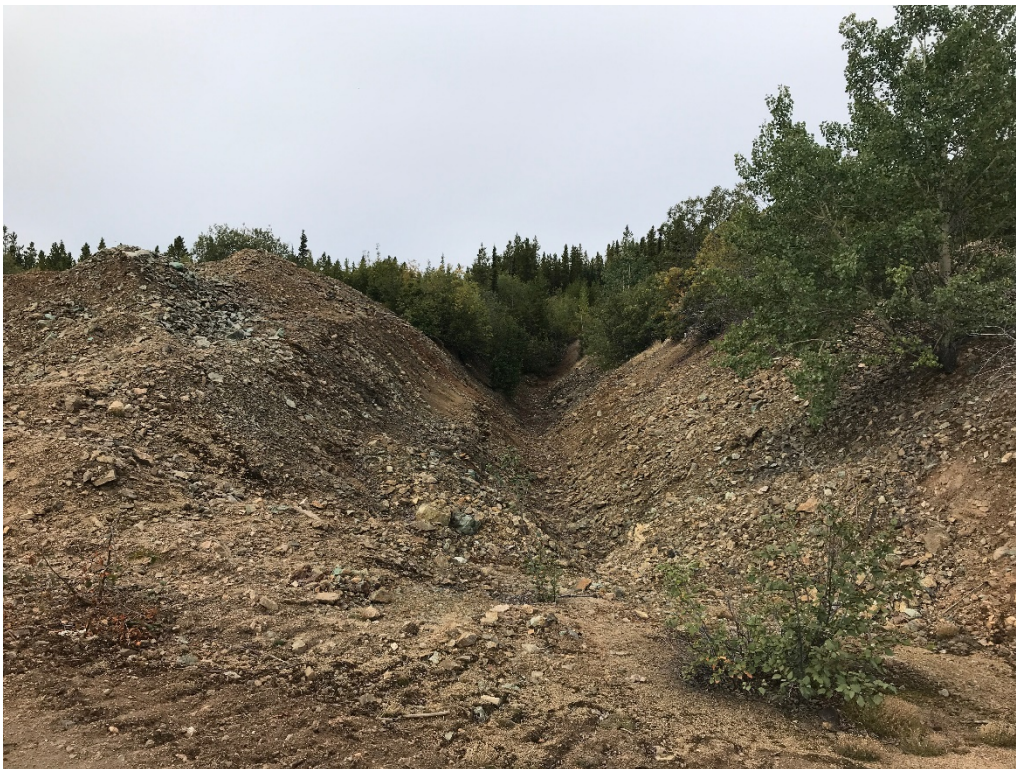
The area proposed for the open pit mine was inspected. The slopes of the trenches excavated as part of the effort to obtain bulk samples during exploration activities were observed to be in satisfactory condition (Photograph 8). There was no observed slumping or failures of the trenches and the slopes facilitate egress for wildlife. Several of the drill pads were inspected and there did not appear to be any erosion noted from these areas that would require attention.

**Photograph 4: Exploration Trench at the Discovery Outcrop Looking SW**

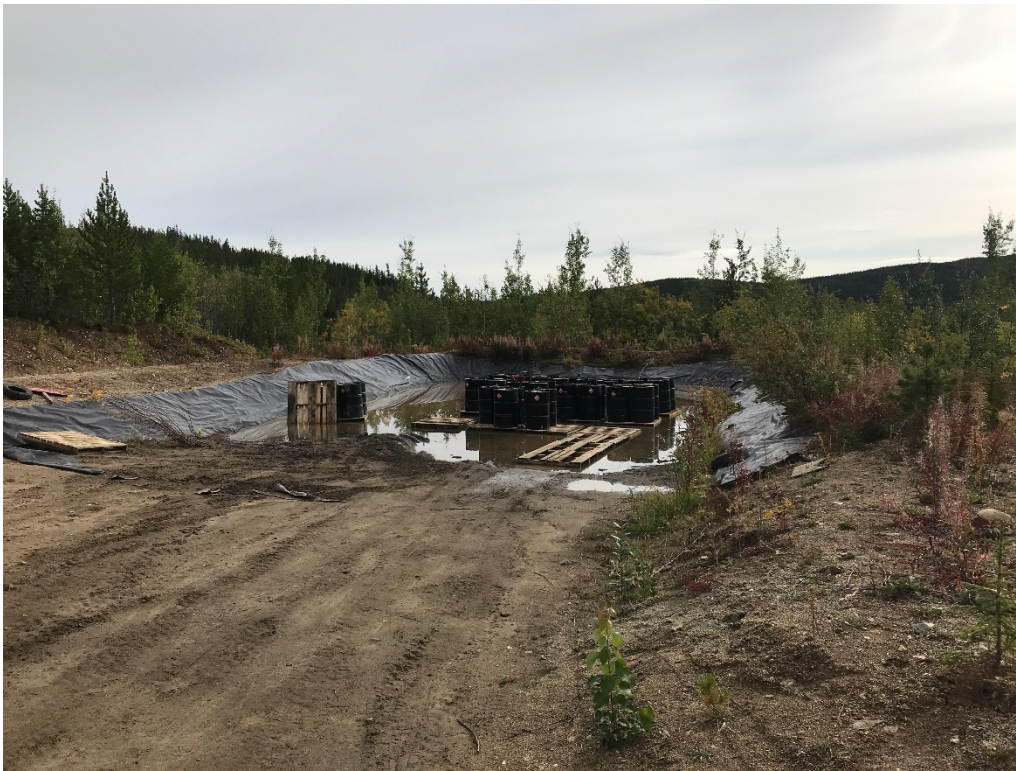
The existing fuel storage area was inspected. It comprises a bunded and lined basin constructed to contain any spilled fuel and currently a few dozen drums of diesel fuel. Approximately 0.2 m of water has accumulated in the basin (Photograph 5). The bund is less than 3 m in height and the basin capacity is less than 10,000 m<sup>3</sup>; therefore, the fuel storage area is appropriately permitted under the QML without need for a water license (Yukon Environment Dam Guide).

**Photograph 5: Lined Basin at Fuel Storage Area Looking NE**

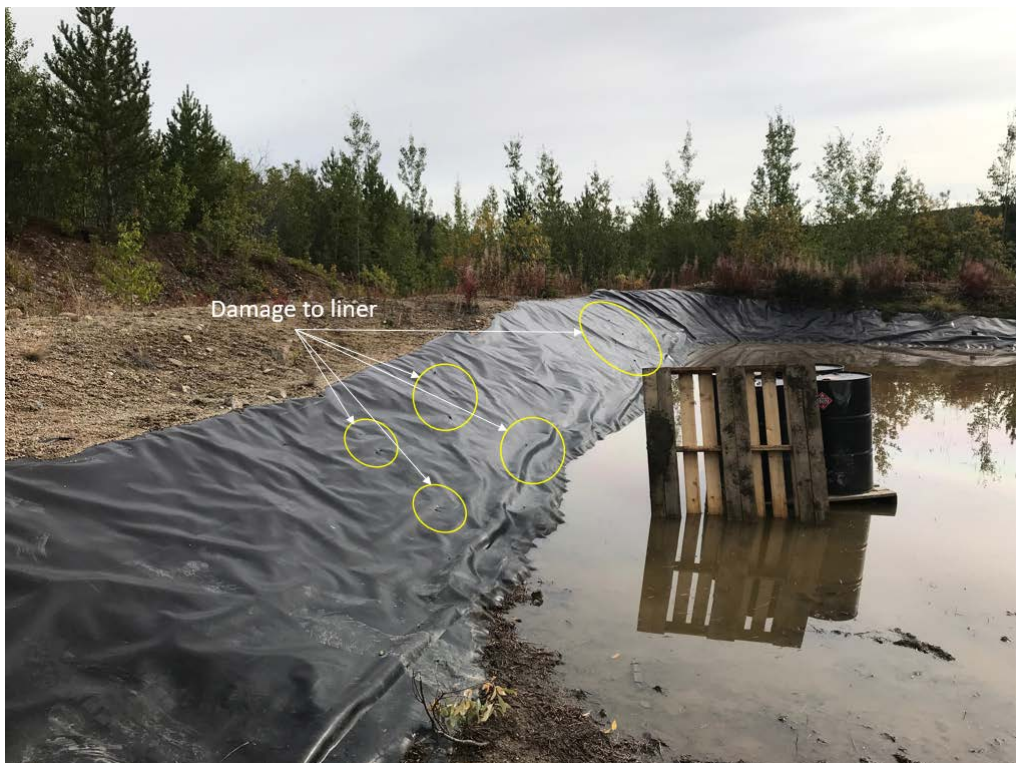
The damage to the liner along the North slope noted in previous inspections is still visible (Photograph 6). New damage along the South slope was observed during the 2021 inspection (Photograph 7). This damage consists of several holes ranging from 2 cm to 30 cm in diameter. Repairs to the liner have yet to be completed. The fuel drums have since been organized in a manner to allow wildlife egress from the basin. There is some vegetation growth along the top of the containment berms and within the lined basin. There is one 1.2 m high willow on the NW corner and several small willows along the South slope growing within the bermed area. There is the potential that the roots of willows and other shrubs could penetrate through the liner. At the time when repairs to the liner are made, the willows and other shrubs should be removed, the area inspected and repaired, if required.

**Photograph 6: Liner Damage along North Slope at Fuel Storage Area Looking East**

- Water crossings, including the bridge abutments at Merrice Creek, should continue to be inspected annually and following major rainfall events. Maintenance should be carried out, as required to maintain the functionality and safety of these crossings.
- The damage to the liner at the fuel storage area should be repaired.

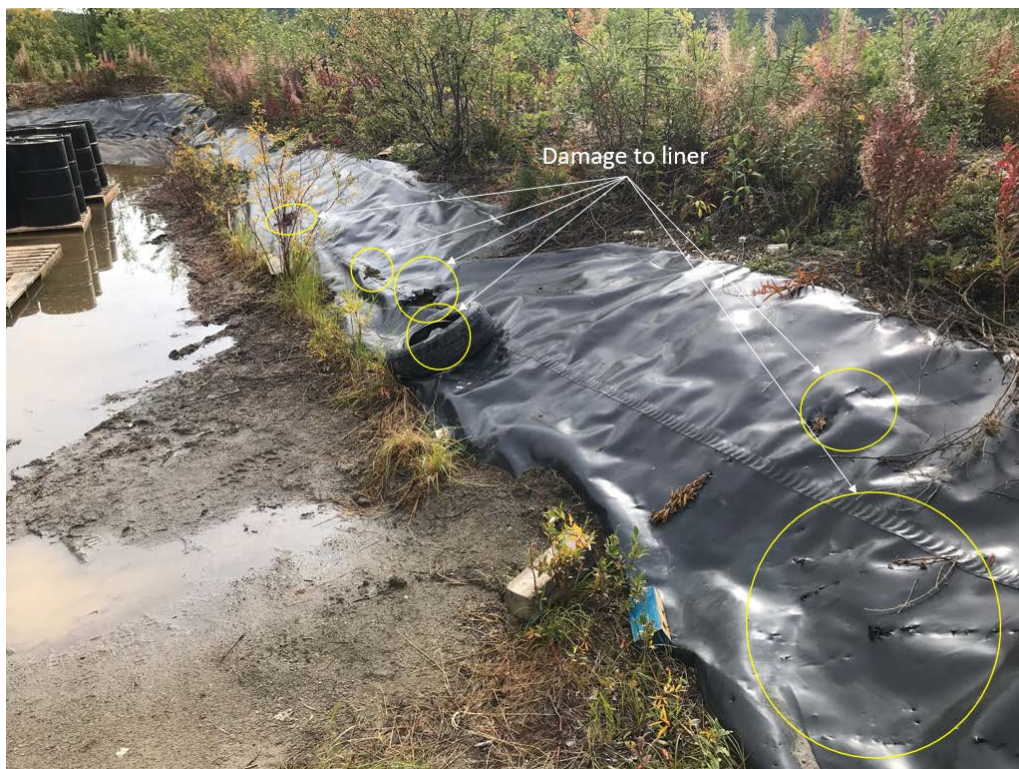
**Photograph 7: Liner Damage along South Slope at Fuel Storage Area Looking East**

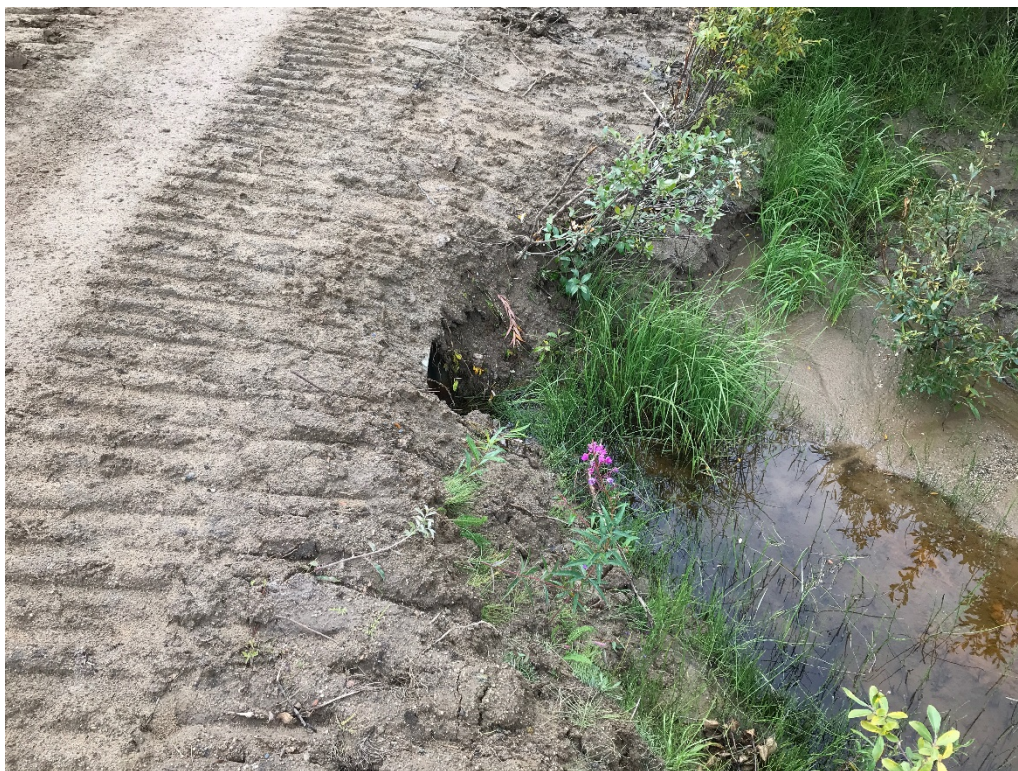
The access road to the north of the proposed waste rock storage area was observed to be in good condition with only minor erosion observed. The North Williams Creek culvert has undergone some crushing and has accumulated some sediment (Photographs 8 and 9). However, the culvert remains adequate to accommodate the relatively minor flows observed at the time of the inspection. There is no visual evidence to indicate that erosion is occurring near the culvert. The access road should be inspected annually and periodic maintenance of drainage features and erosion management should be anticipated.

**Photograph 8: Culvert Inlet Beneath Road at North Williams Creek Looking SE**

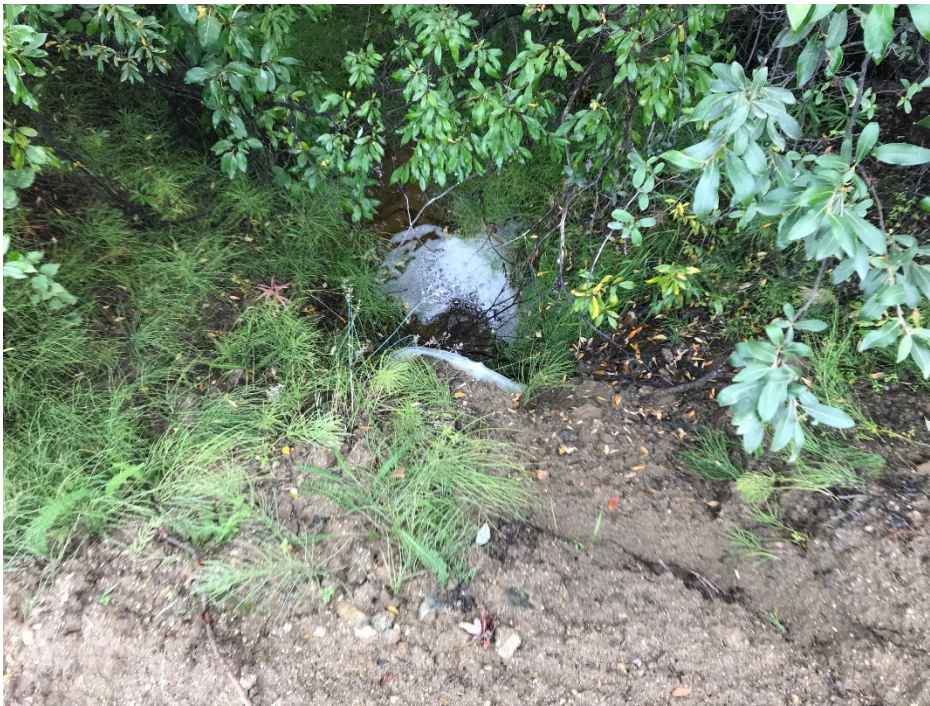
**Photograph 9: Culvert Outlet Beneath Road at North Williams Creek Looking East**

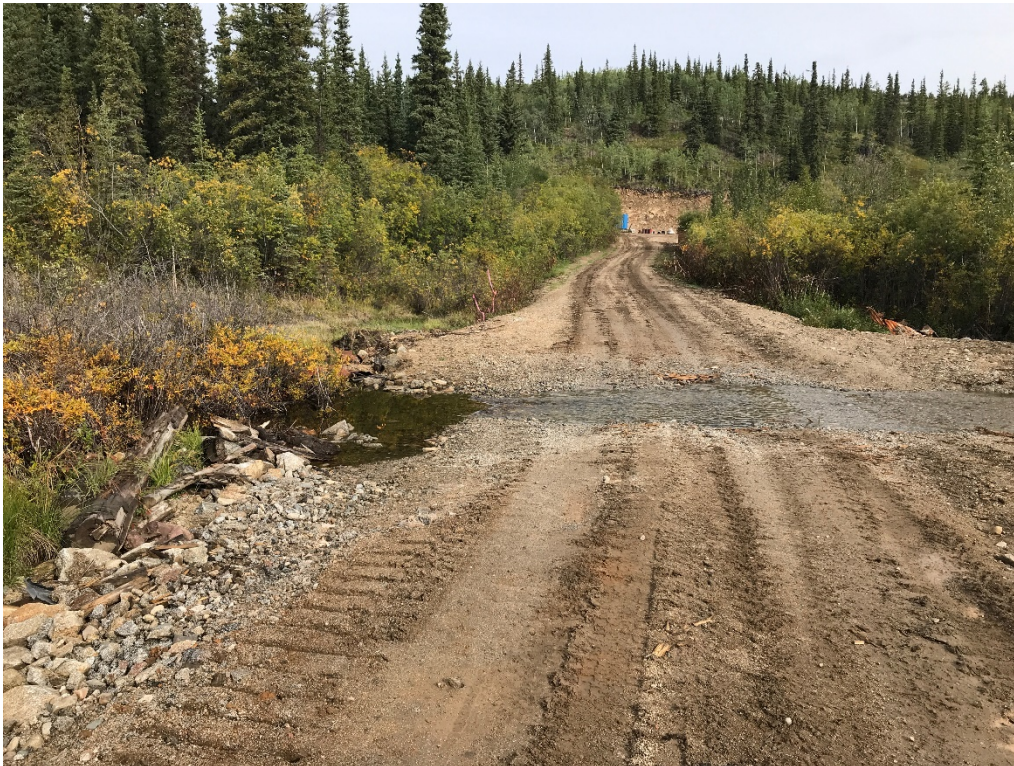
The ford road crossing installed at Williams Creek in 2013 continues to function as intended (Photographs 10 and 11). The rockfill in the ford is well-graded and there is no indication of movement of finer materials. Ponded water was observed on the upstream side of the road, with flow across the road. It is possible that a large rainfall event could result in erosion. We therefore recommended that the ford continue to be inspected annually and maintenance be carried out, if required. The ford is appropriate for the current status of the project. However, prior to site development, it is recommended that the crossing is upgraded.

**Photograph 10: Williams Creek Ford Crossing Looking North**

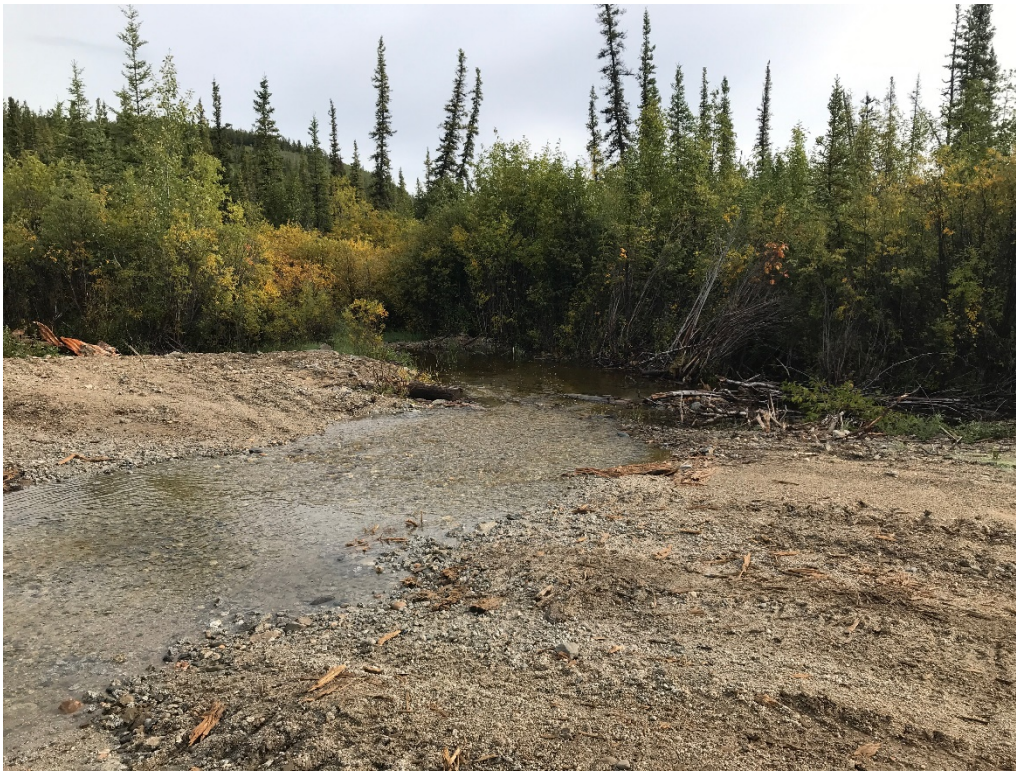
**Photograph 11: Williams Creek Ford Crossing Looking NE**

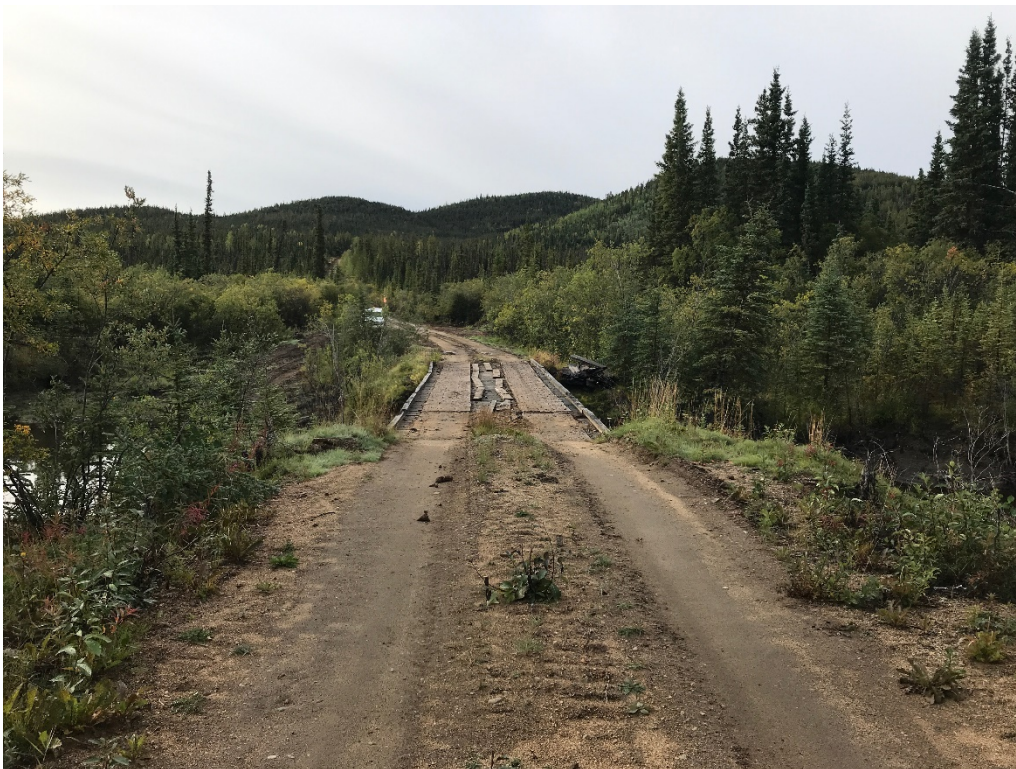
The access road crossing at Merrice Creek includes a single-span bridge (Photographs 12 to 15). Following recommendations in the July 2014 inspection memorandum, the bridge was extended by approximately 3 m and seated 1 to 2 m on the abutments. Approximately 3 m of steel was welded to the existing span, bridge decking was replaced and extended, and the approaches were re-graded to the bridge deck elevation.

**Photograph 12: Bridge Crossing at Merrice Creek Looking South**

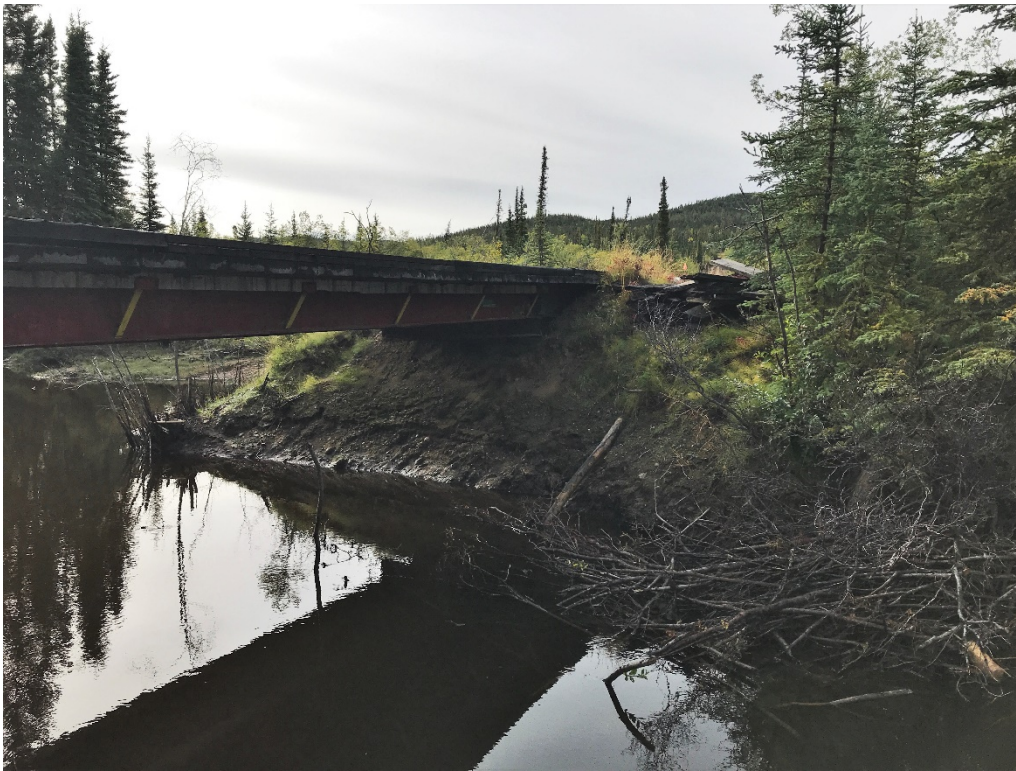
**Photograph 13: Bridge Crossing at Merrice Creek – Upstream Side Looking South**

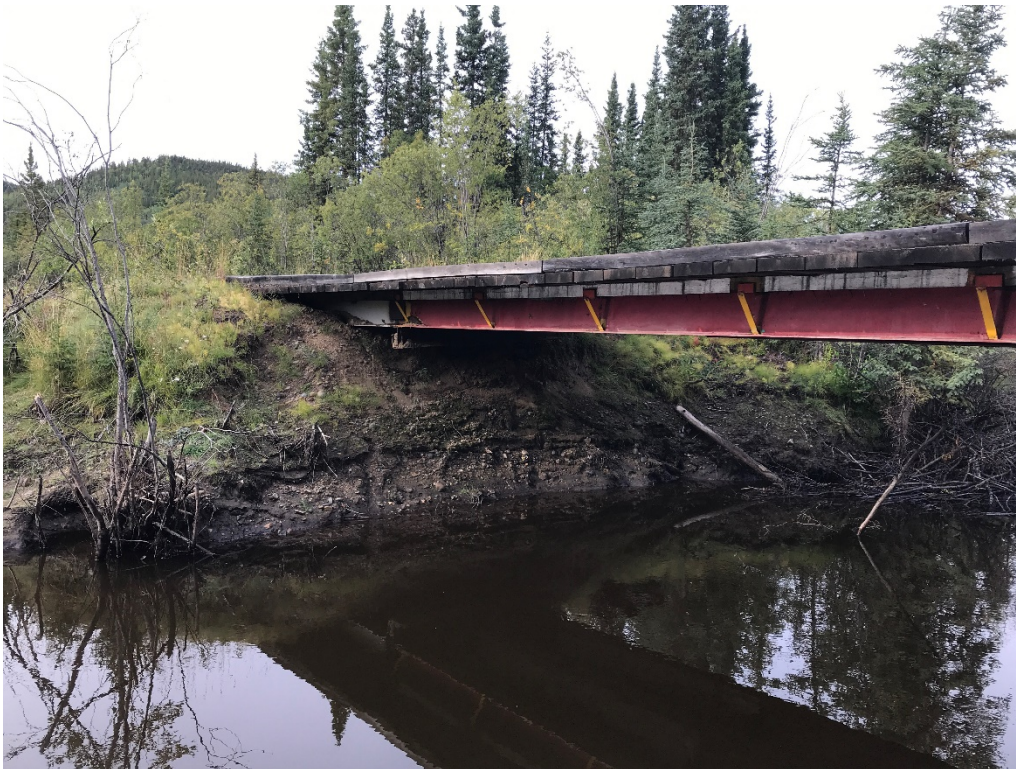
**Photograph 14: Bridge Crossing at Merrice Creek – Downstream Side Looking SW**

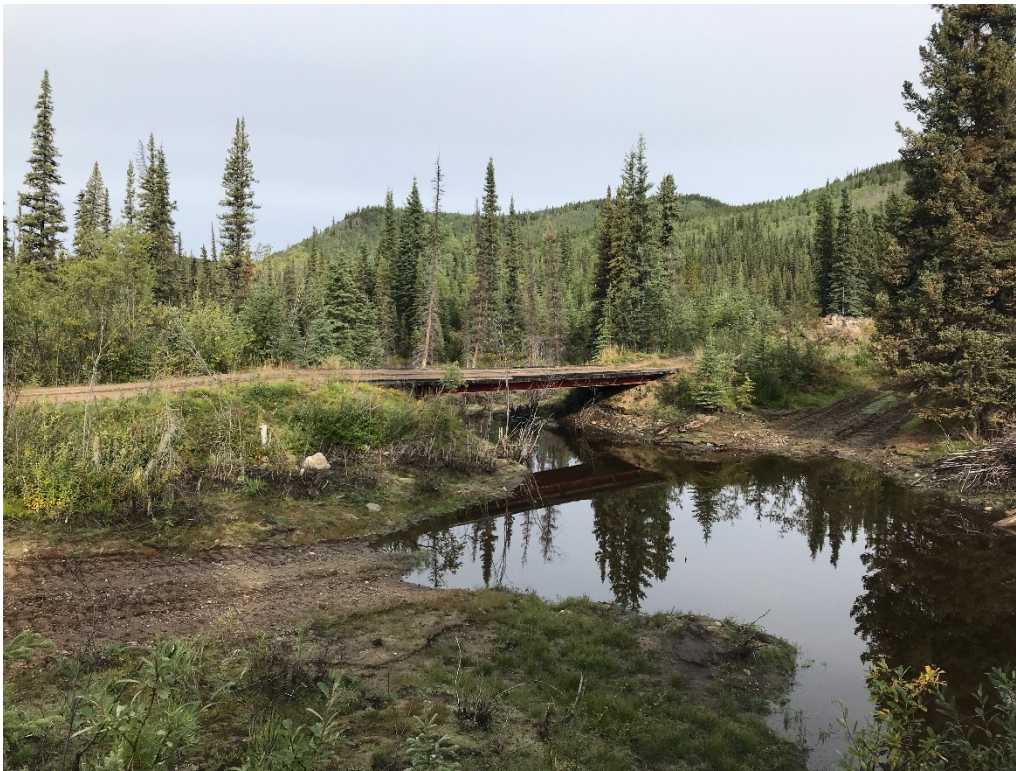
**Photograph 15: Bridge and Equipment Ford Crossing at Merrice Creek Looking NW**

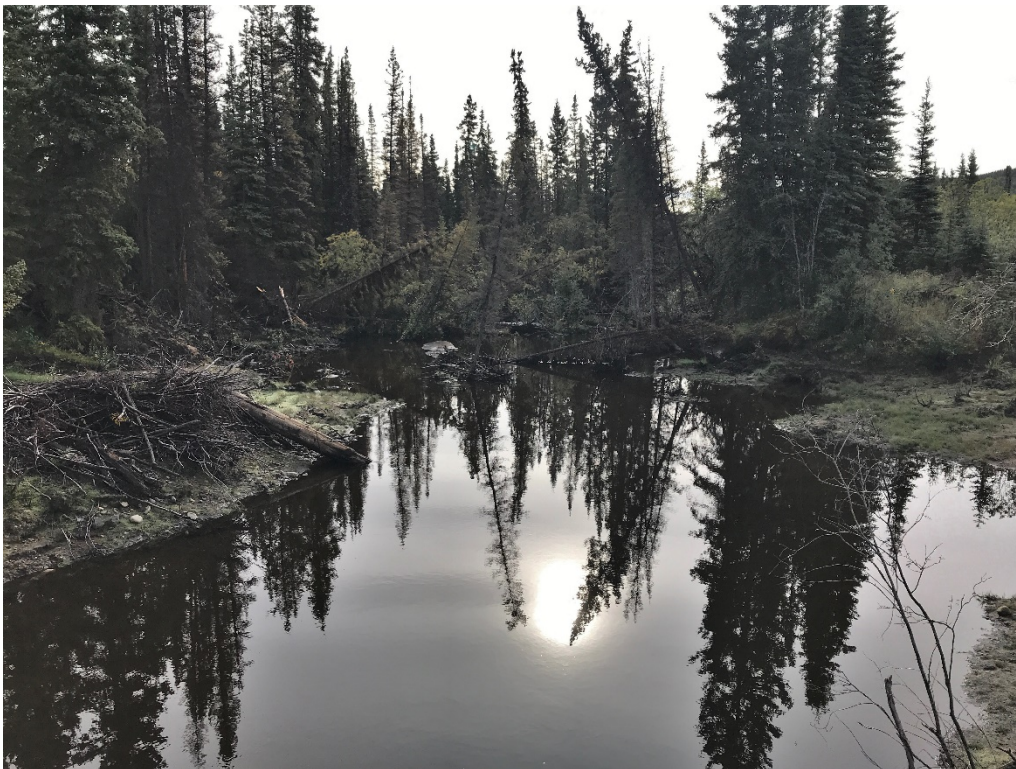
During the 2019 inspection a beaver dam was observed downstream of the bridge which had caused higher than normal water levels in Merrice Creek, this beaver dam has since been removed and the water levels in Merrice Creek were lower in comparison to 2019 (Photograph 16). The bridge was observed to be in a satisfactory condition and is securely anchored at each of the abutments. The right (or southern) abutment is steep sided and there is evidence that erosion may be continuing to occur at this location under high-flow conditions. The bridge should be monitored annually and following large rainfall events. In the event that erosion

begins to compromise the stability of the abutment, consideration should be given to the installation of erosion protection at this location.

**Photograph 16: Bridge Crossing at Merrice Creek – Removed Beaver Dam Looking SE**
