## **EAGLE GOLD HEAP LEACH FACILITY AND CYANIDE MANAGEMENT REVIEW**

**ENERGY, MINES & RESOURCES, YUKON GOVERNMENT**

JULY 2022

PROJECT 4667

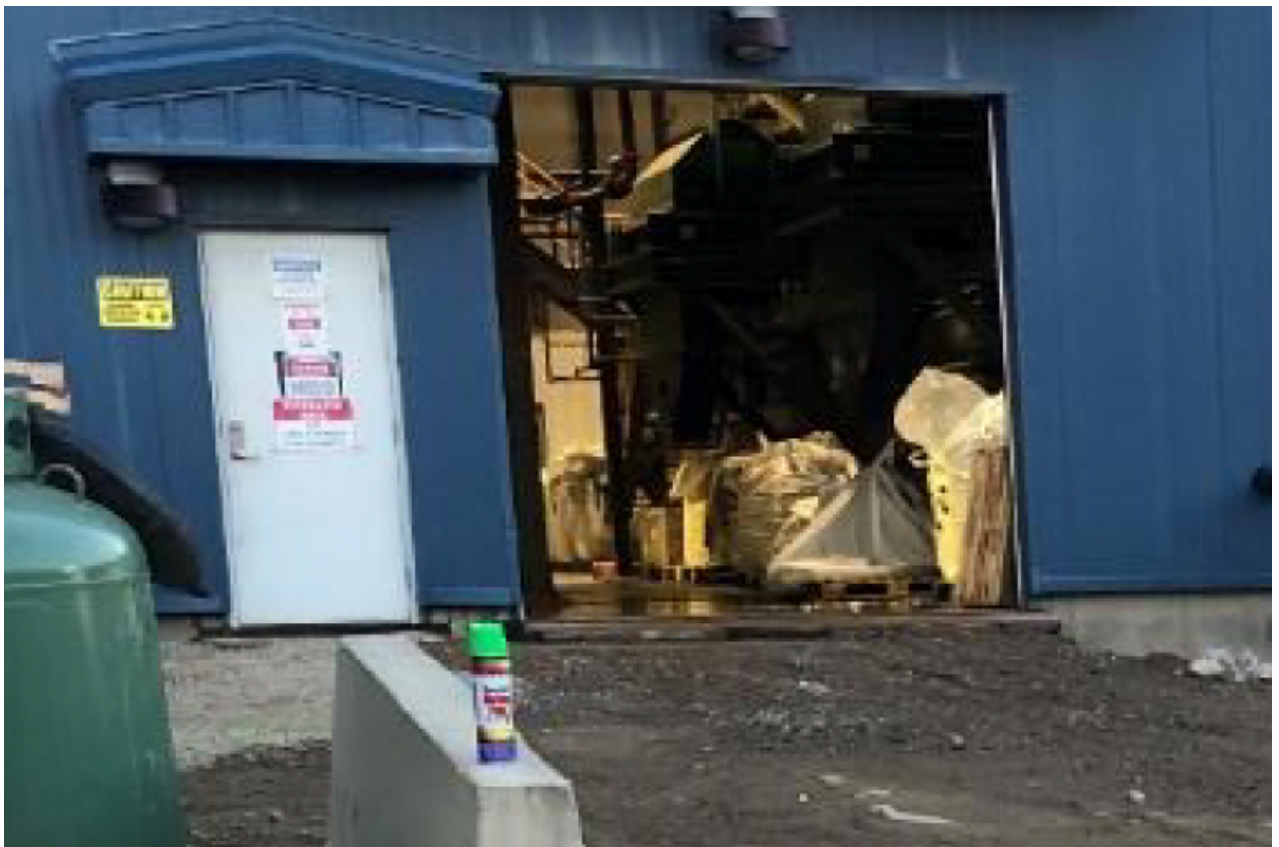
Photo 1: Southeast ADR bay door showing flow path from containment (enlarged from Photo 2-1 of the spill report)

Since moving pipes and clogged screens are common in ADR plants, this does not seem to address the actual root cause. The area where the spill occurred was within the ADR plant, but the containment was inadequate to hold this spill. This is in contrast with Section 4.1 of the Forte report (page 14) which states “Any spillage within the ADR plant are contained within the process plant containment.” Since any part of an ADR plant can be exposed to process solution the primary root cause is the lack of adequate containment, which was missed in the audit.

2.1a: The ADR plant should be retrofitted to provide adequate containment as described in the CMP and the ADR Plan, or otherwise as intended by the Cyanide Code and best industry practices. This retrofitting should include measures adequate to ensure full containment. The retrofitting as envisioned in this recommendation should be relatively minor work. This should be completed in 2022.

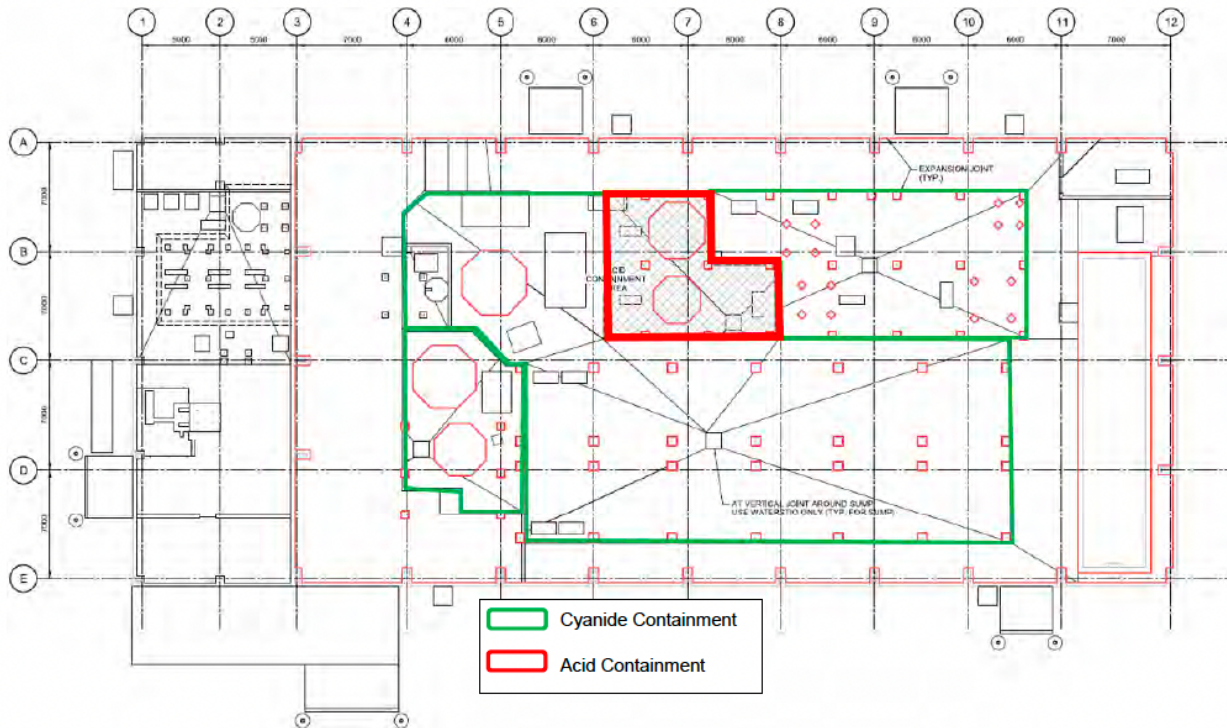
Figure 4.2-1: Cyanide Storage and Mixing Area Containment

Figure 4.2-1 of the CMP (reproduced below) shows the area of “cyanide containment” as essentially the entire ADR plant (the green outline) including the area of the spill. Section 5.7.5 states “Process solution pipelines within the ADR area are all installed within concrete secondary containment. All barren solution risers and distribution lines will be placed within the lined footprint of the HLF, thus any potential leakage is captured within the pad, ultimately reporting to the In-Heap Pond. The pregnant and barren solution pipelines to the HLF riser arrangements and associated pumping stations that do not drain directly to the HLF impoundment will be placed in lined trenches, with any leakage, stormwater, or snowmelt accumulation in the liner system reporting to either the HLF impoundment.” Section 2.2 of the ADR Plant Operations Plan (ADR Plan) (StrataGold, March 2019) states “Beyond concrete containment with the building, The ADR Plant itself rests on pad also designed for cyanide containment. The pad underneath the building is lined and graded such that overflow would be directed into a lined trench that flows back into the Heap Leach Facility (Figure 2.2-2).” Figure 2.2-2 of the ADR Plan is also reproduced below.

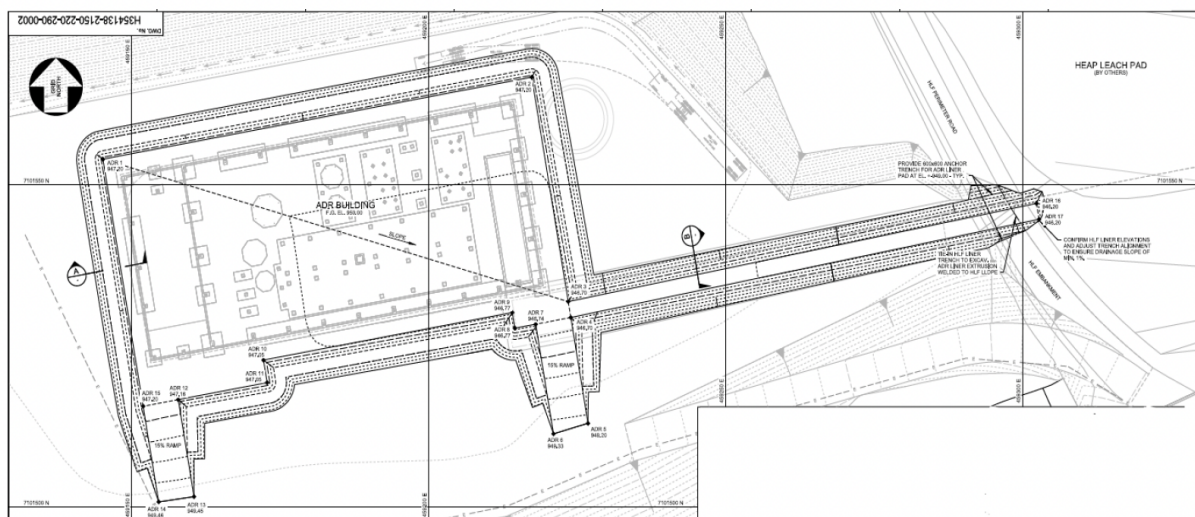
Figure 2.2-2: ADR Plant Secondary Containment

grading allowed process solution to escape containment rather than flow to the heap pad.” Item #1 accurately represents the as-built condition of the ADR plant but is inconsistent with the Forte report, the CMP, and the ADR Plan. Importantly, items 1 & 2 are not in compliance with Cyanide Code Standard of Practice 4.1, which states “Implement management and operating systems designed to protect human health and the environment including contingency planning and inspection and preventative procedures.” That is, since the ADR plant can have process solution anywhere, the plant should include full secondary containment. Further, any potential escape routes from the in-plant containment should be directed towards external containment.
