Subject: 2022 Annual Geotechnical Inspection – Mining Related Structures

2022 Annual Geotechnical Inspection of Earth Structures Hecla Mining Company

NOVEMBER 29, 2022
ISSUED FOR USE
FILE: 704-ENG.WARC04286-01

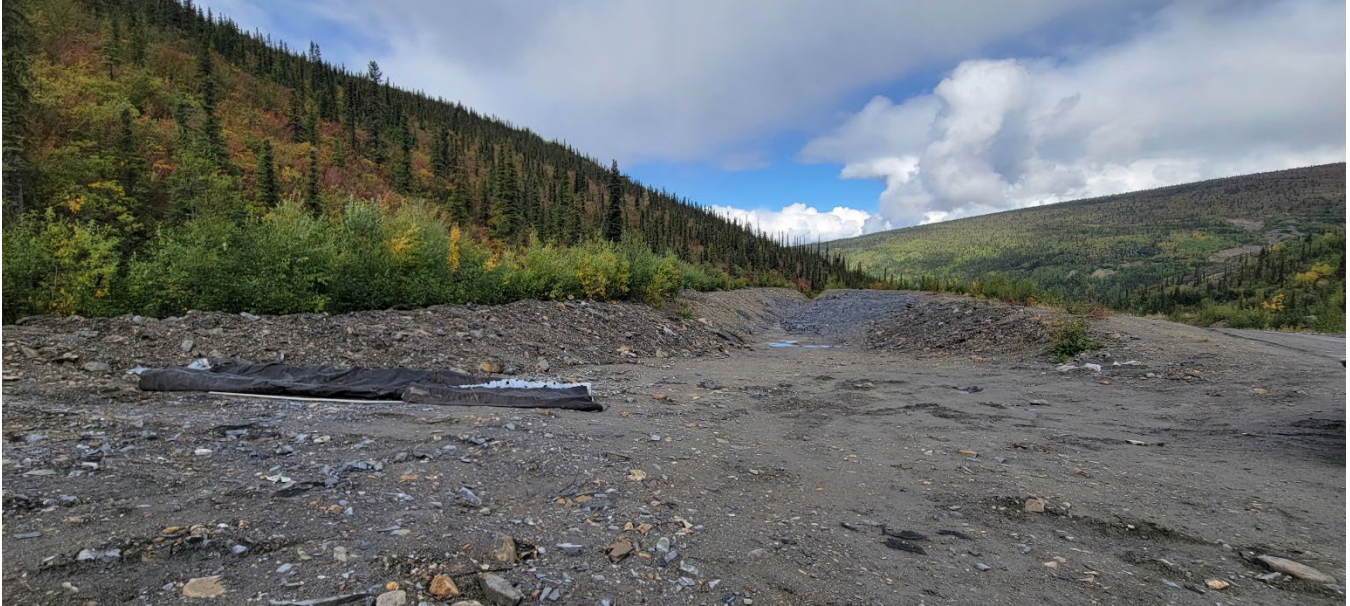
The PAG observed during previous inspections appears to have been removed, and Tetra Tech understands it was placed underground.

At the time of the inspection, the remaining perimeter berms appeared intact with no visible signs of instability or distress. A drainage relief was excavated at the downstream end of the facility to minimize water ponding.

Photo 1: Bellekeno PAG Storage Facility, facing north (I. MacIntyre, Aug. 28, 2022)

No remedial actions related to geotechnical performance are recommended at this time.

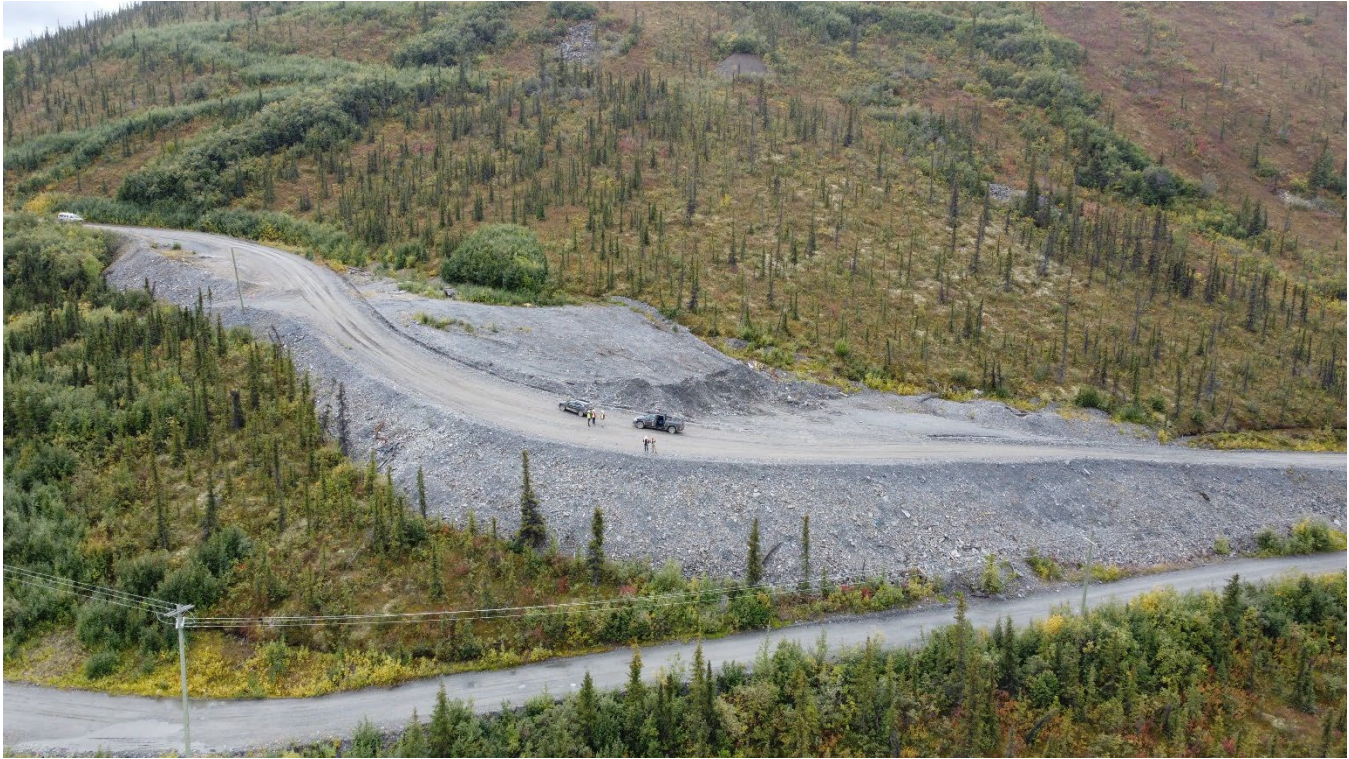
At the time of the inspection the waste rock pile crest, slopes, and toe showed no signs of deep-seated instabilities, significant movement, distress, sloughing or bulging. The condition of the facility appears generally unchanged from previous inspections.

Photo 2: Bellekeno Road Waste Rock Pile, facing southwest (I. MacIntyre, Aug. 28, 2022)

No remedial actions related to geotechnical performance are recommended at this time.

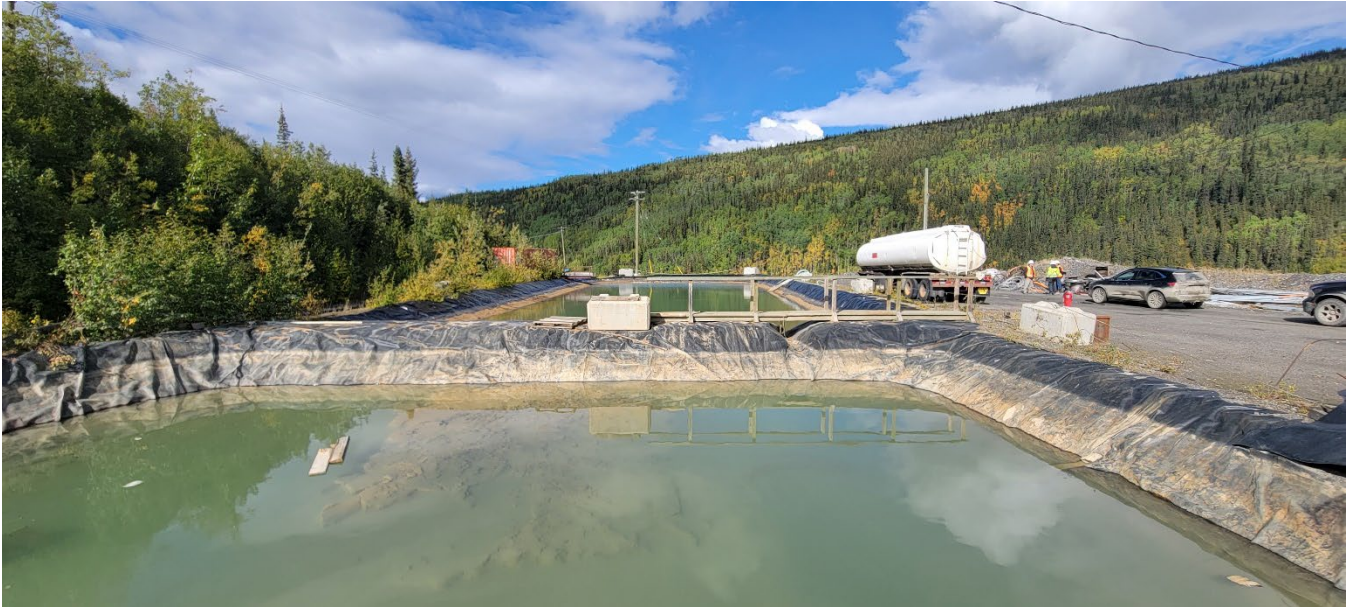
The conditions at the discharge do not appear to have changed. Flow is discharged directly onto the natural slope. While the slope is vegetated, some erosion is visible immediately around the discharge. While minor for now, the erosion may increase in severity, and options should be evaluated to provide some armoring around the discharge point.

Photo 3: Bellekeno 625 Water Treatment Ponds, facing northwest (I. MacIntyre, Aug. 28, 2022)

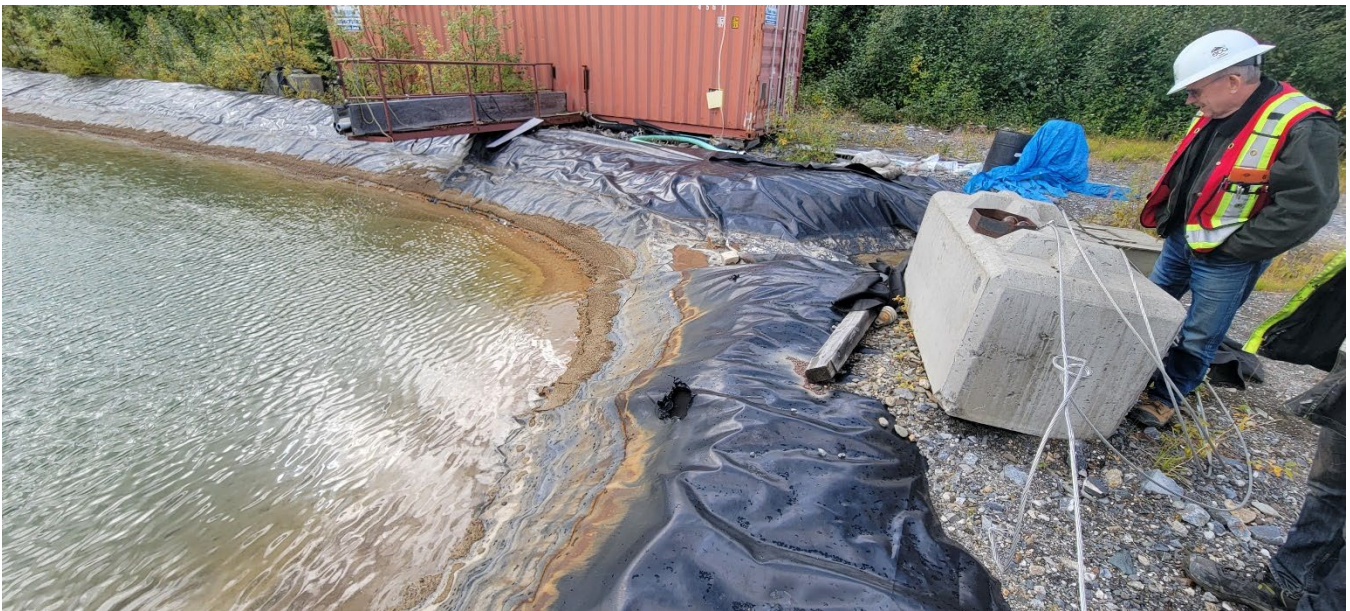
The rip in the liner near the end of the secondary pond noted in 2021 was still evident and does not appear to have increased in size. Any rips or tears in the liner should be repaired.

Photo 4: Bellekeno 625 Water Treatment Ponds, north end, rip visible (I. MacIntyre, Aug. 28, 2022)

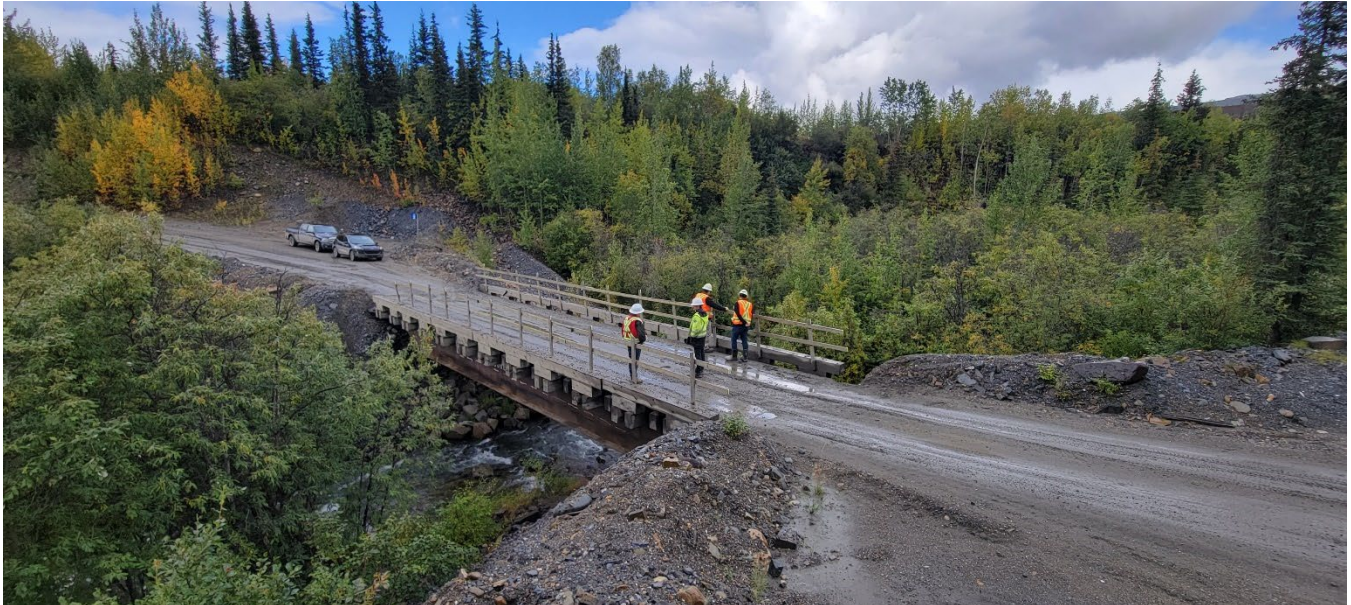
The bridge consists of a single span steel structure with a wooden deck and is founded on earth filled timber crib abutments.

Photo 5: Lightning Creek Bridge - Bellekeno Haul Road (I. MacIntyre, Aug. 28, 2022)

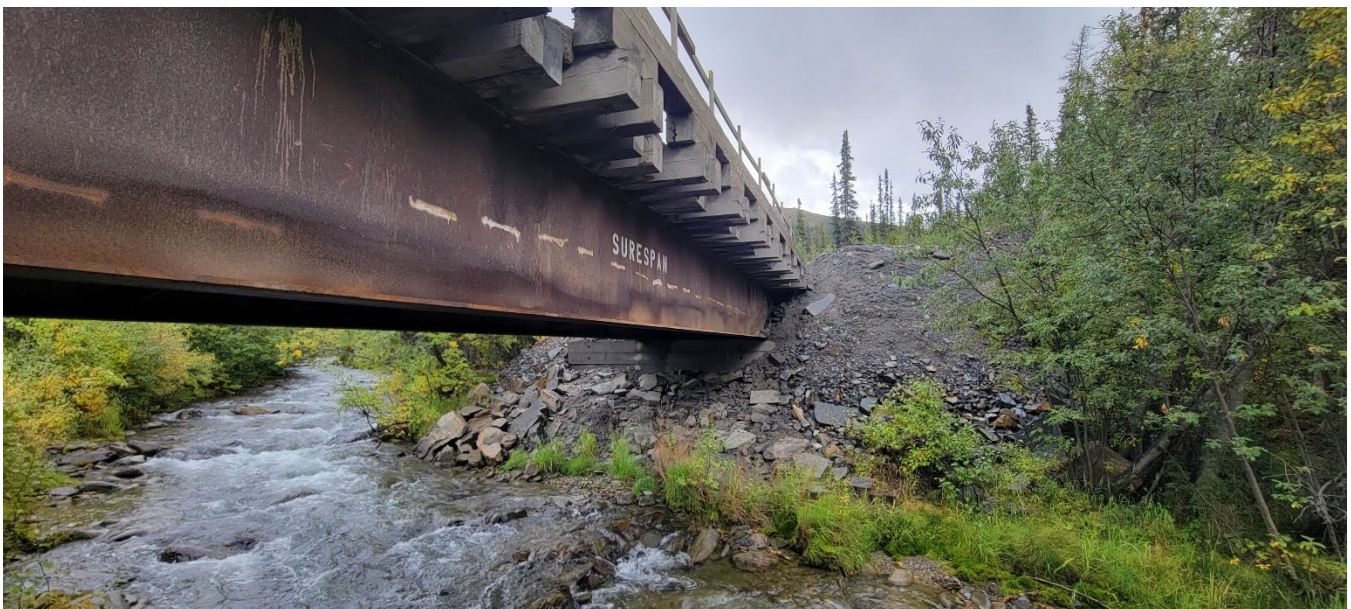
At the time of the inspection the bridge abutments appeared stable and sufficiently protected from erosion by riprap armoring. As has been documented in previous inspections, some erosion was noted along the road edge.

Photo 6: Lightning Creek Bridge - Bellekeno Haul Road, abutment armoring (I. MacIntyre, Aug. 28, 2022)

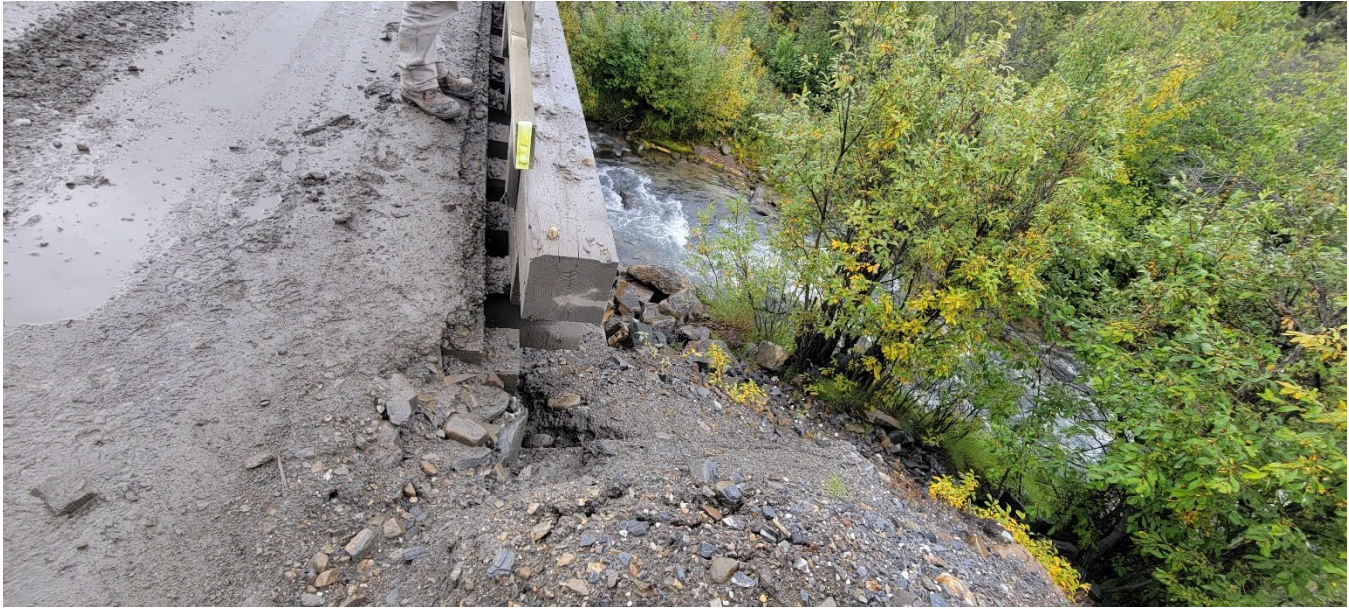
Photo 7: Lightning Creek Bridge - Bellekeno Haul Road, erosion gully forming along road edge (I. MacIntyre, Aug. 28, 2022)

The formed erosion gully should be backfilled using coarse grained material and proper road drainage established to minimize erosion.

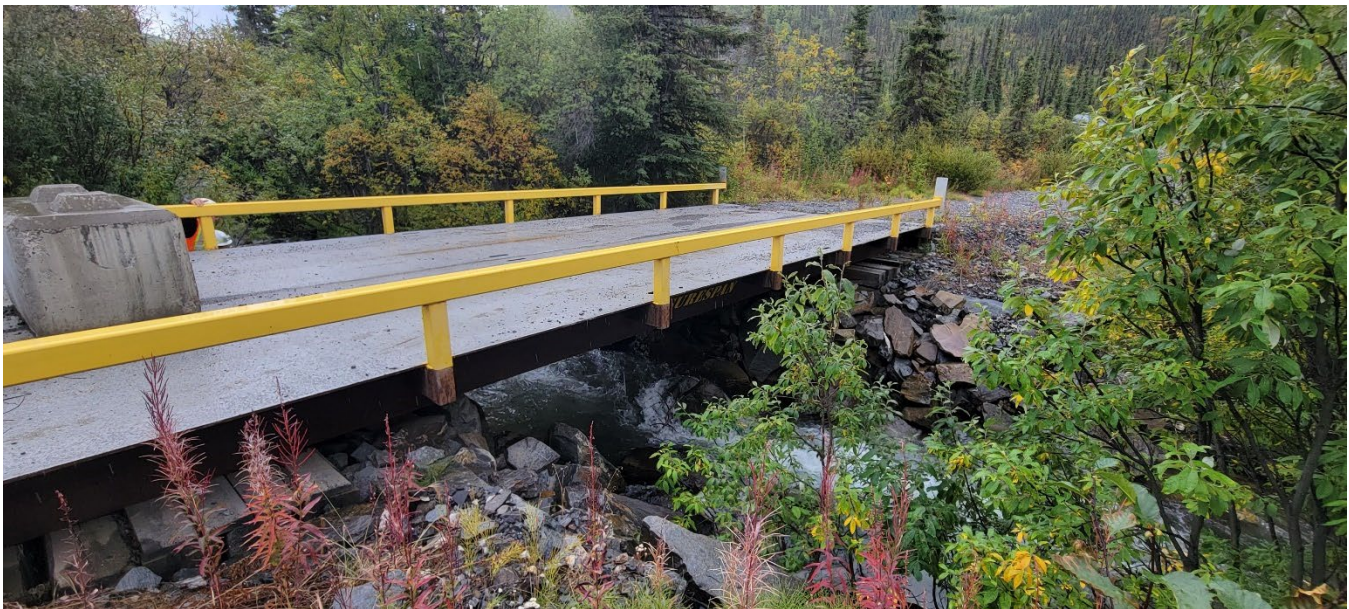
At the time of the inspection the bridge abutments appeared stable and sufficiently protected from erosion by riprap armoring. No remedial actions related to geotechnical performance are recommended at this time.

Photo 8: Lightning Creek Bridge - Onek Road (I. MacIntyre, Aug. 28, 2022)

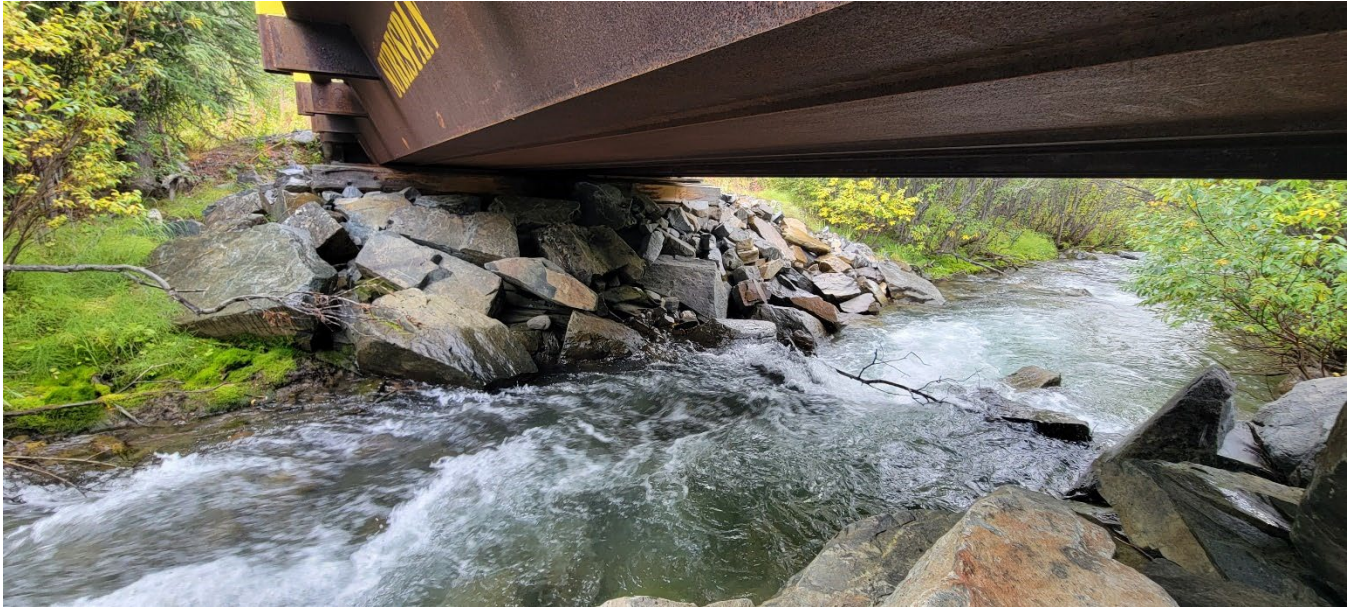
Photo 9: Lightning Creek Bridge – abutment riprap (I. MacIntyre, Aug. 28, 2022)

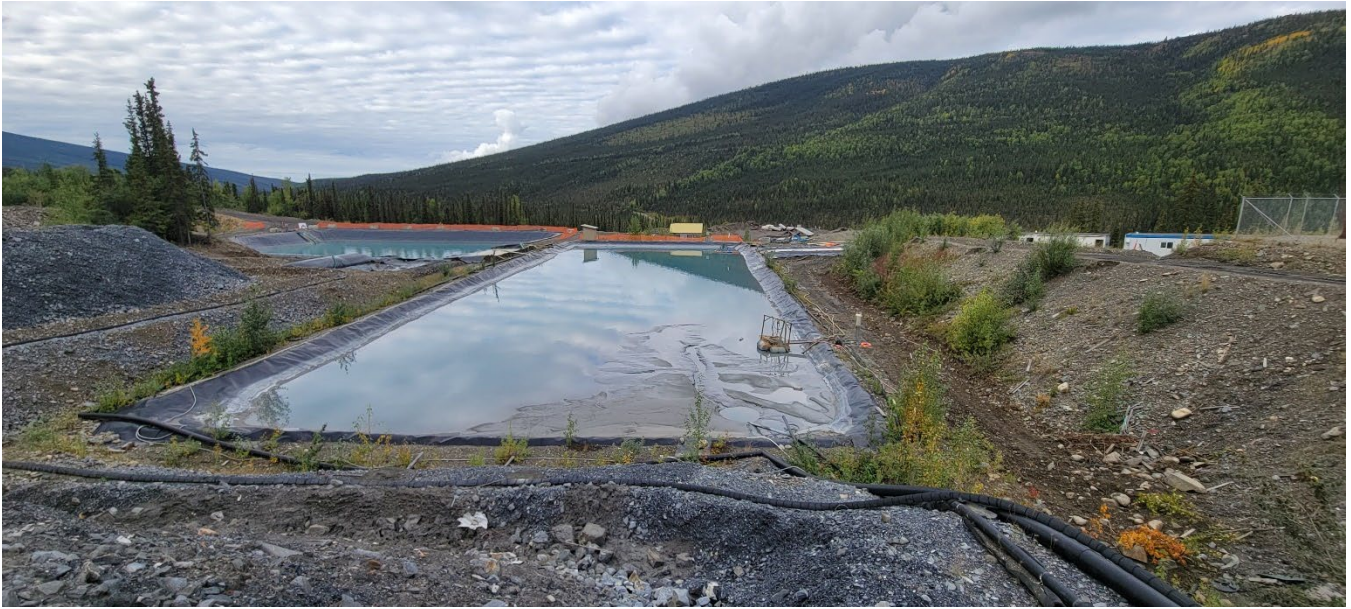
The liners and berms of each pond appeared to be in generally good condition.

Photo 10: Mill water storage ponds – facing southwest (I. MacIntyre, Aug. 28, 2022)

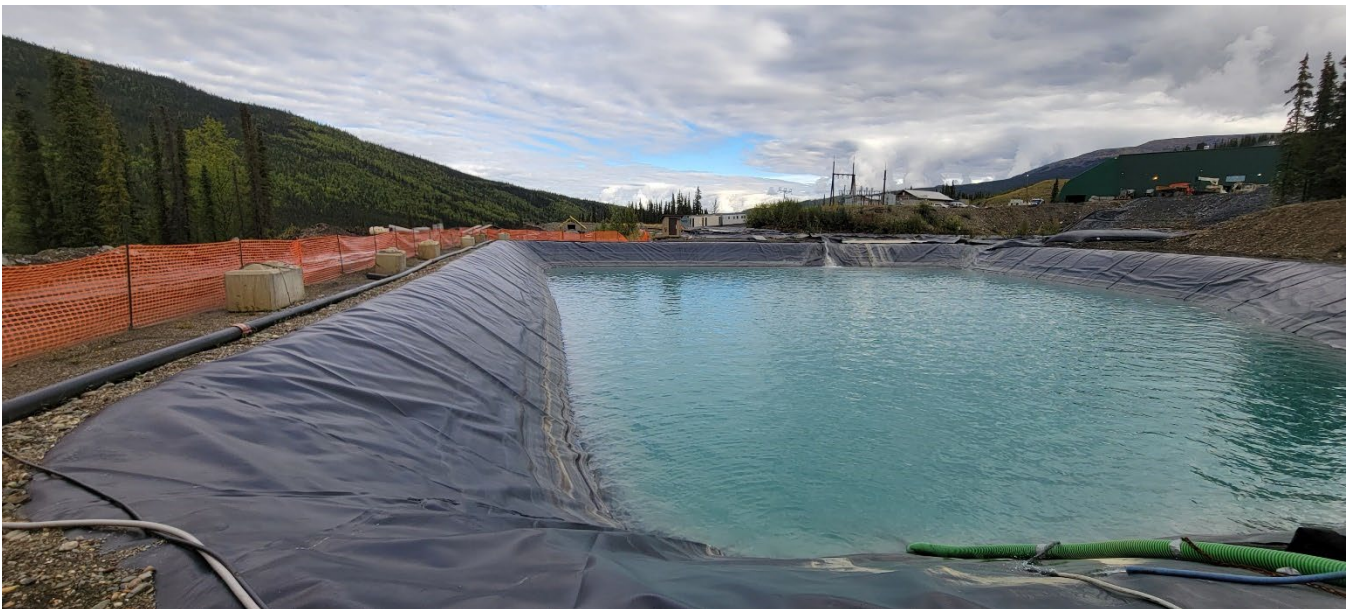
Photo 11: Mill water storage ponds – facing north (I. MacIntyre, Aug. 28, 2022)

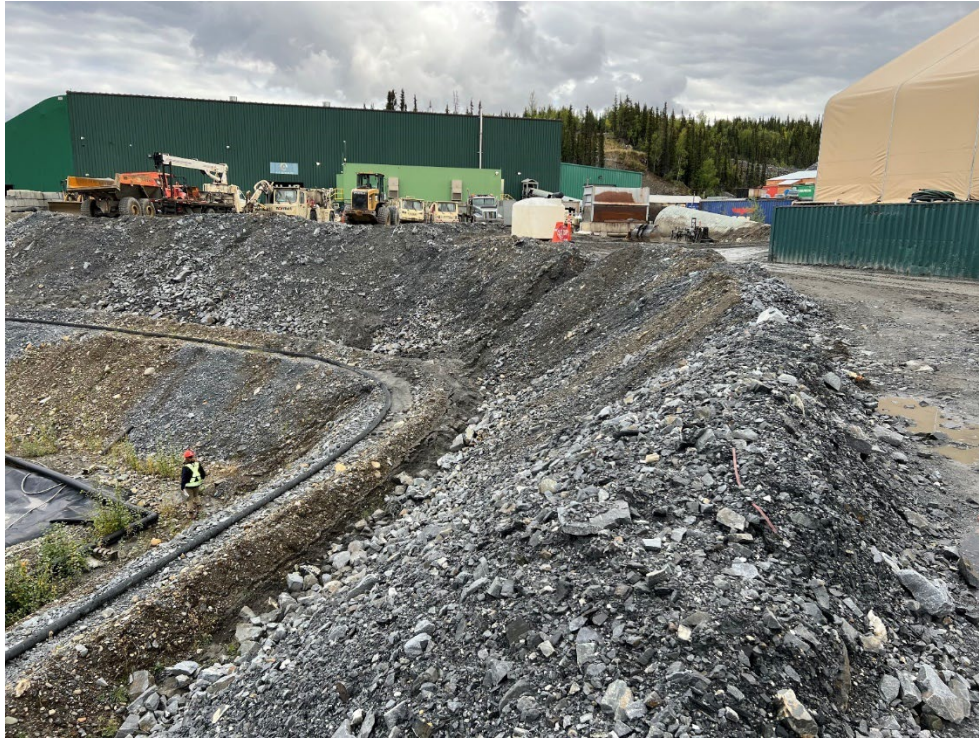
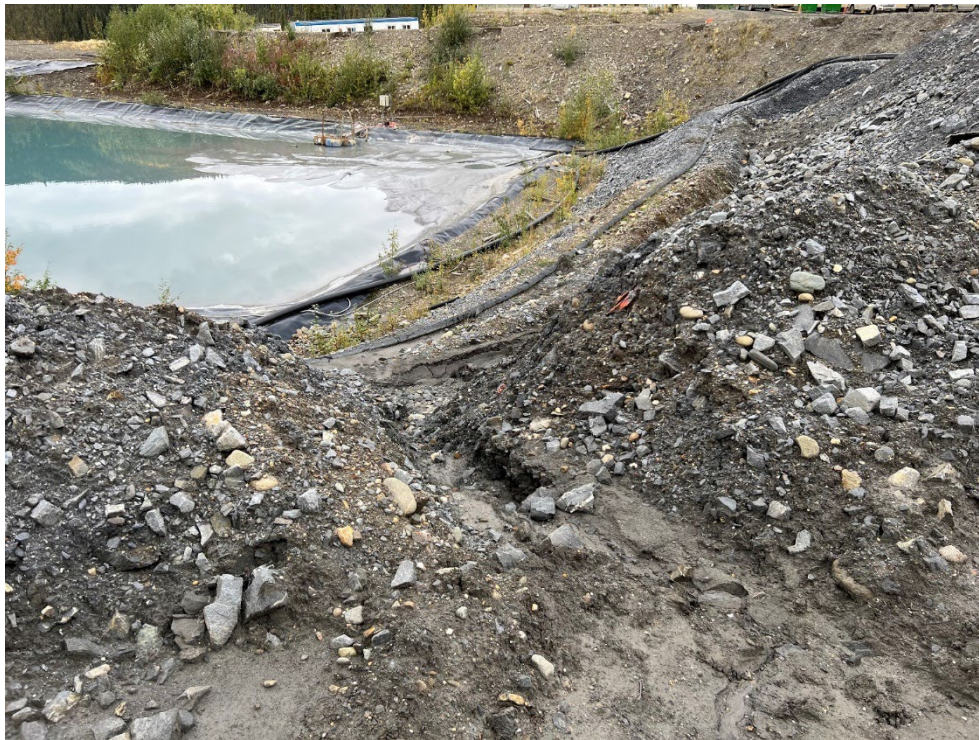
An erosion gully was noted in the area above the north pond near its southeast corner. While the erosion has not yet impacted the pond, it should be repaired, and proper drainage established to prevent future issues.

Photo 12: Mill water storage ponds, erosion gully – facing northeast (R. Trimble, Aug. 28, 2022)

Photo 13: Mill water storage ponds, erosion gully – facing east (R. Trimble, Aug. 28, 2022)

Mill Water Storage Ponds	<ul style="list-style-type: none"> ▪ None 	<ul style="list-style-type: none"> ▪ Repair erosion gully above facility.
Dry Stacked Tailings Facility	<ul style="list-style-type: none"> ▪ Spread, grade, and compact loose tailings (completed September 2022). ▪ Repair sinkholes (completed September 2022). ▪ Survey and photograph all indications of instabilities (sinkholes, cracks, etc.) and provide to Tetra Tech when observed. 	<ul style="list-style-type: none"> ▪ Compact loose cover material using tracked equipment. ▪ Monitor / inspect VDS and maintain / clean out as required. ▪ Consider completing some proactive snow removal prior to freshet to minimize surface runoff erosion potential. ▪ Update OMS Manual as part of Phase II design process.
Birmingham Sludge Containment Facility	<ul style="list-style-type: none"> ▪ Remove visible organics and trees and replace with compacted granular fill. Monitor performance during freshet. 	<ul style="list-style-type: none"> ▪ None

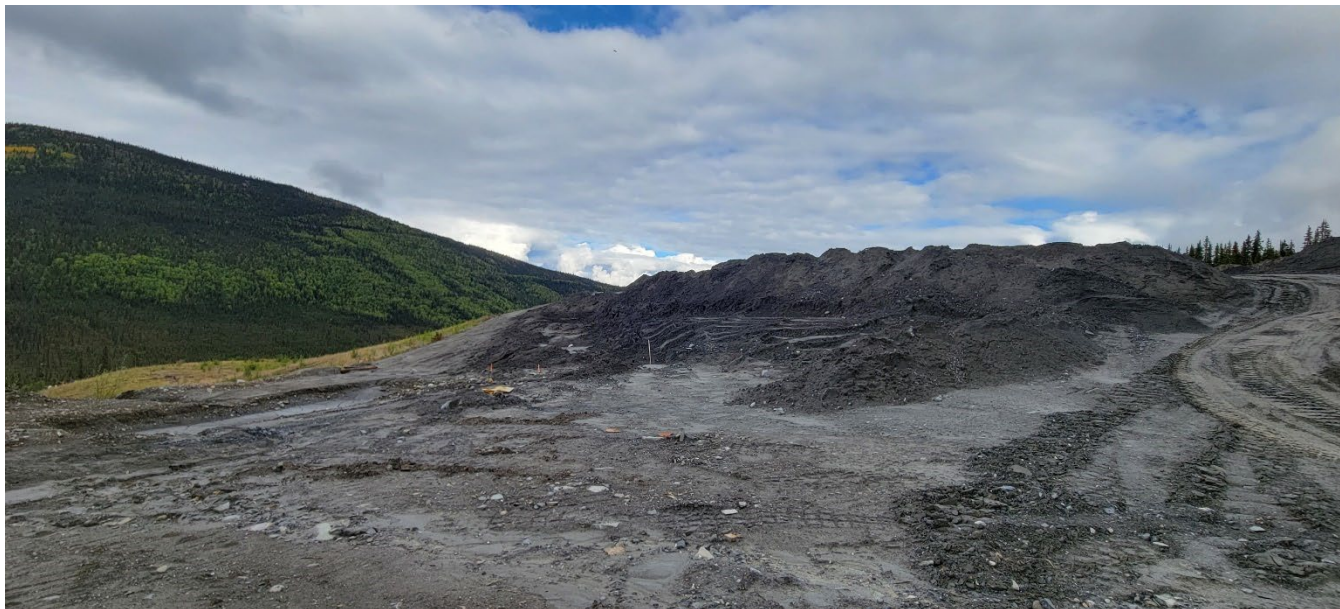
- Near the south end of the upper bench of the DSTF, tailings were observed to have been dumped loose and not placed per proper procedure. Tetra Tech recommended the proper placement, grading, and compaction of these tailings.
 - Note: while onsite in September for another scope, these areas and recommendations were noted to have been addressed.
- Several small sinkhole-like features were noted within the cover material along the southwest facing slope of the DSTF. Tetra Tech recommended these be backfilled and repaired with properly compacted material.
 - Note: while onsite in September for another scope, these areas and recommendations were noted to have been addressed.

Photo 14: DSTF Phase 1A area, near top, south end. Loose, poorly graded, and uncompacted tailings visible. VDS visible in left of frame. Facing north. (I. MacIntyre, Aug. 28, 2022)

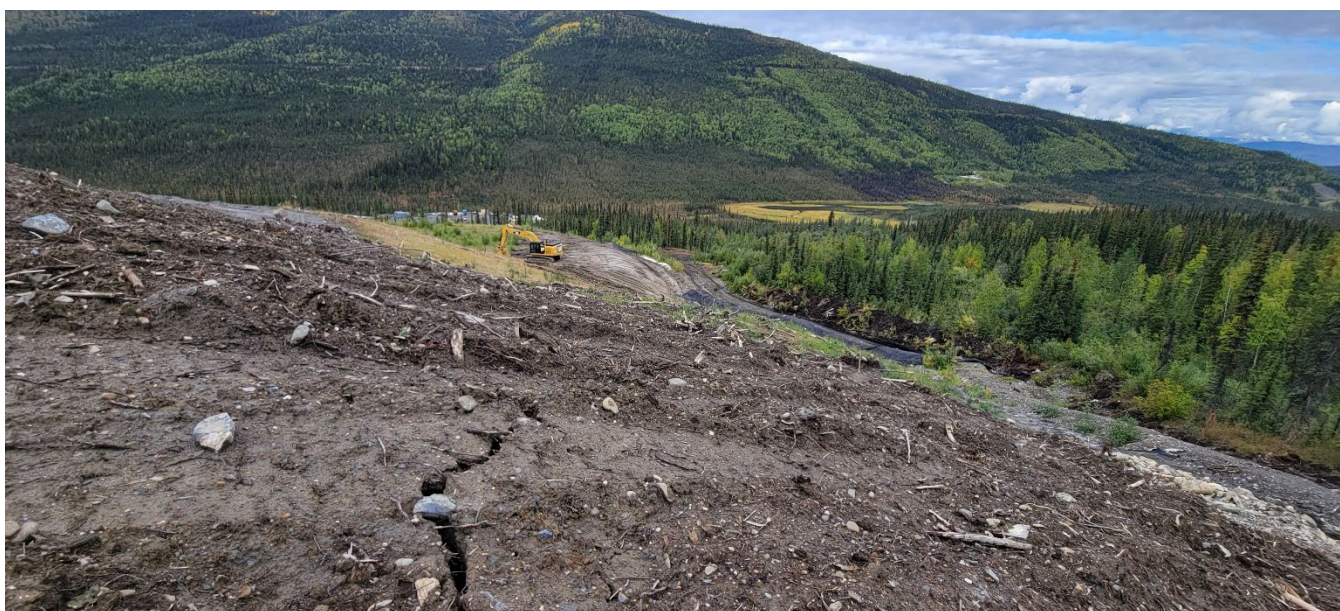
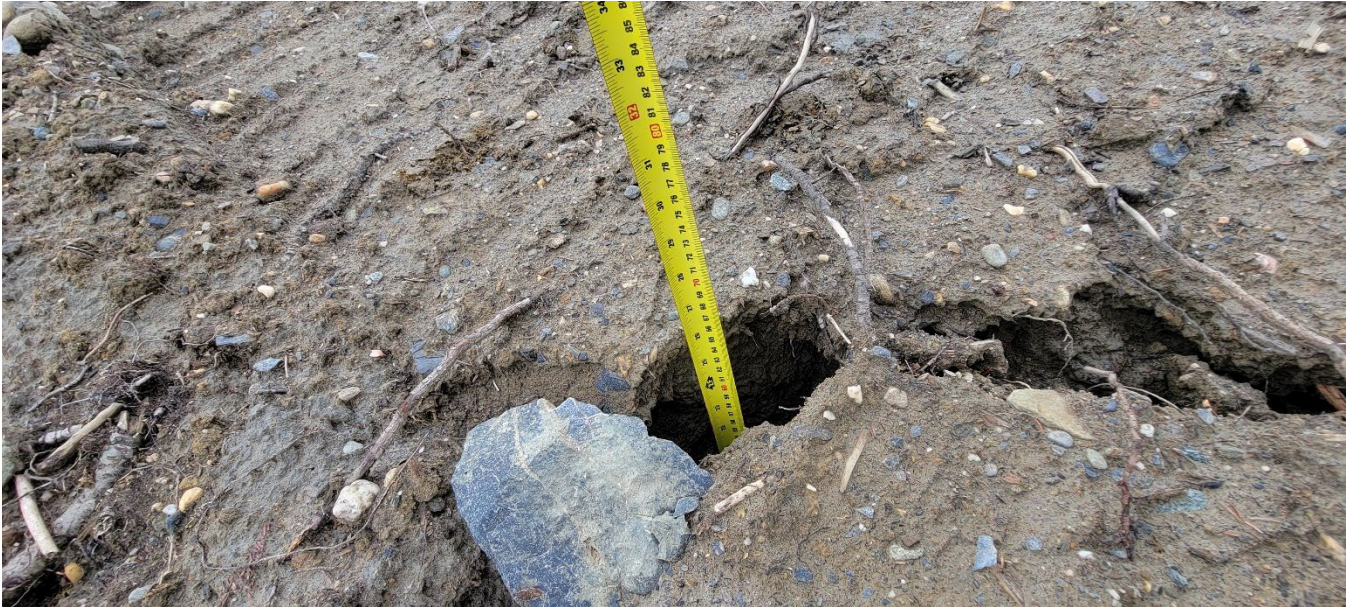
An area of the cover material along the north facing slope was also observed to be sloughing, with a notable tension crack near the crest. It appears this failure surface is primarily restricted to the cover material layer, and likely not deep-seated. This cover material appears to be relatively uncompacted and loose. It should be compacted using tracked equipment operating parallel to slope contours to minimize runoff erosion impacts.

Photo 15: DSTF Phase 1A area, near top, north end. Sloughing and cracking of loose, uncompacted cover material. Facing west. (I. MacIntyre, Aug. 28, 2022)

Photo 16: DSTF Phase 1A area, near top, north end. Sloughing of loose, uncompacted cover material. Crack approx. 60 cm deep. (I. MacIntyre, Aug. 28, 2022)

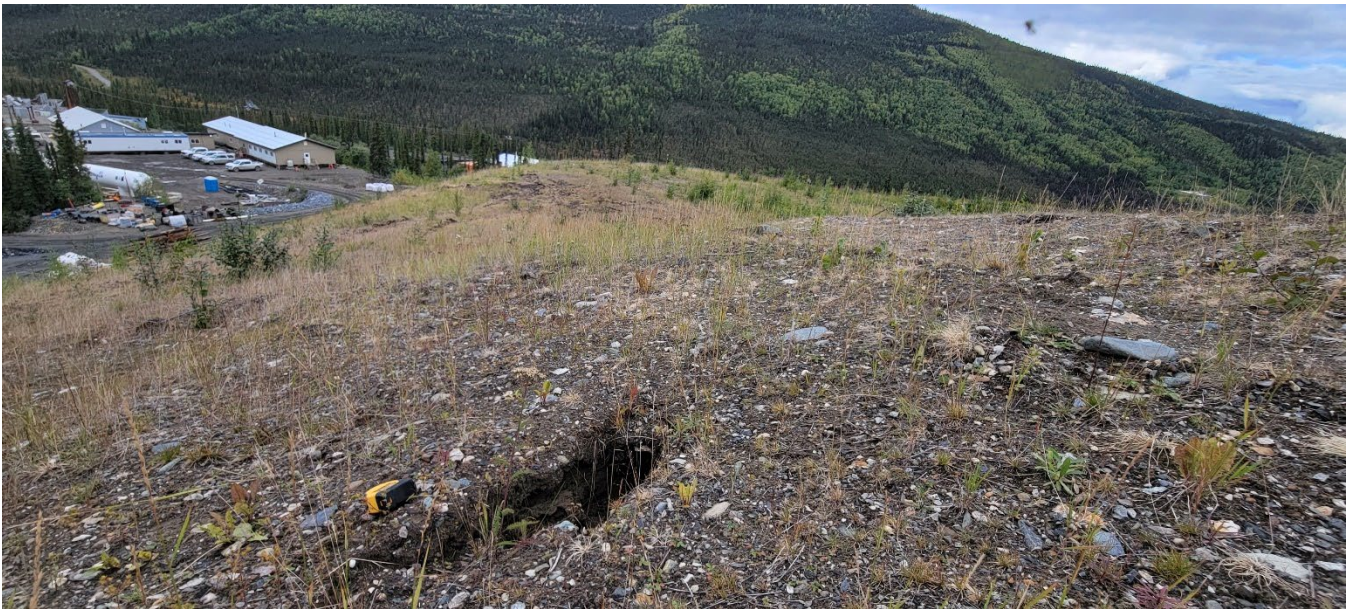
Photo 17: DSTF Phase 1A area, southwest slope. Small sink hole indicating migration of materials. Appears to be limited mostly to cover material. Facing west. (I. MacIntyre, Aug. 28, 2022)

As recommended in 2021, any of these occurrences (i.e., sinkholes, blow outs, tension cracks, etc.) should be surveyed and reported to Tetra Tech along with photos immediately when they are observed.

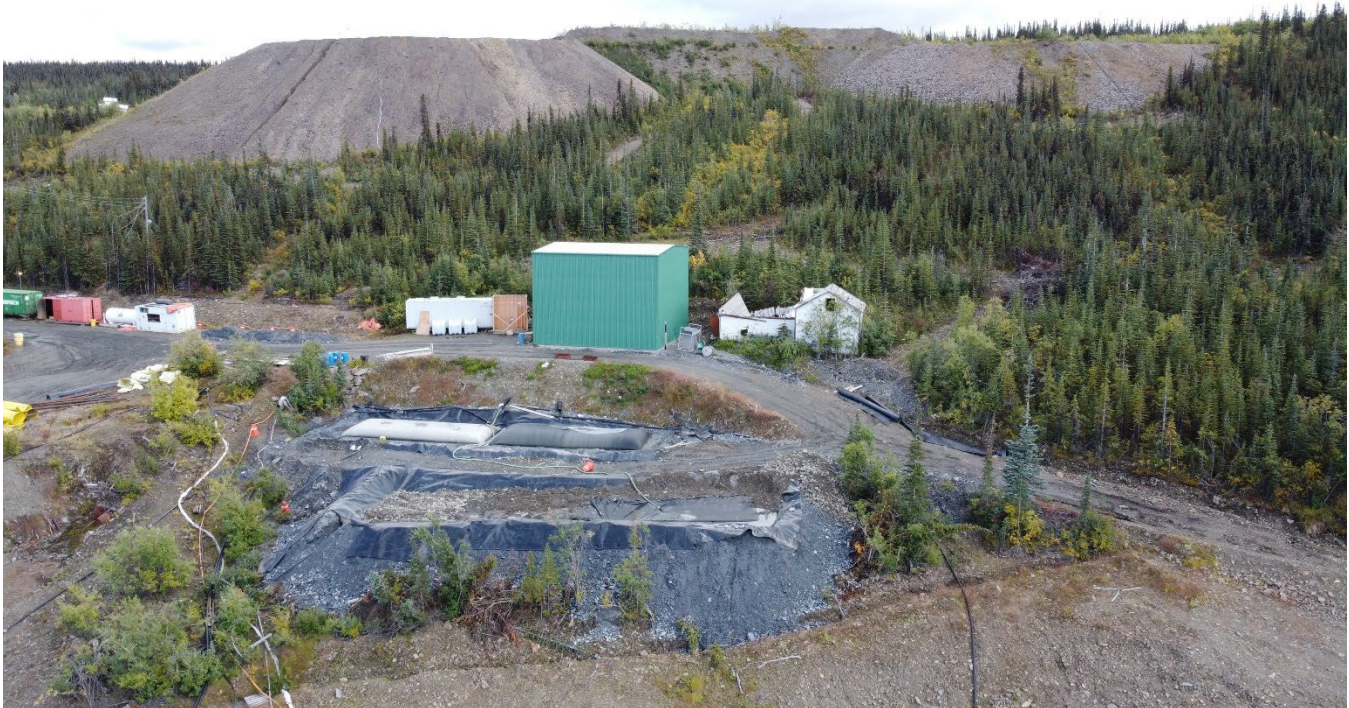
At the time of the inspection the facility crest, slopes, and toe showed no signs of deep-seated instabilities, significant movement, distress, sloughing or bulging. However, it was noted that the newer facility appears to have been constructed without removing all organics within the footprint. Hecla noted they believe most organics were removed, while acknowledging some remaining along the facility toe. The facility should be monitored closely, and the remaining exposed organics should be removed and replaced with compacted granular fill.

Photo 18: Birmingham Mine Sludge Waste Containment Facility – buried organics and trees visible in bottom of frame. (I. MacIntyre, Aug. 28, 2022)

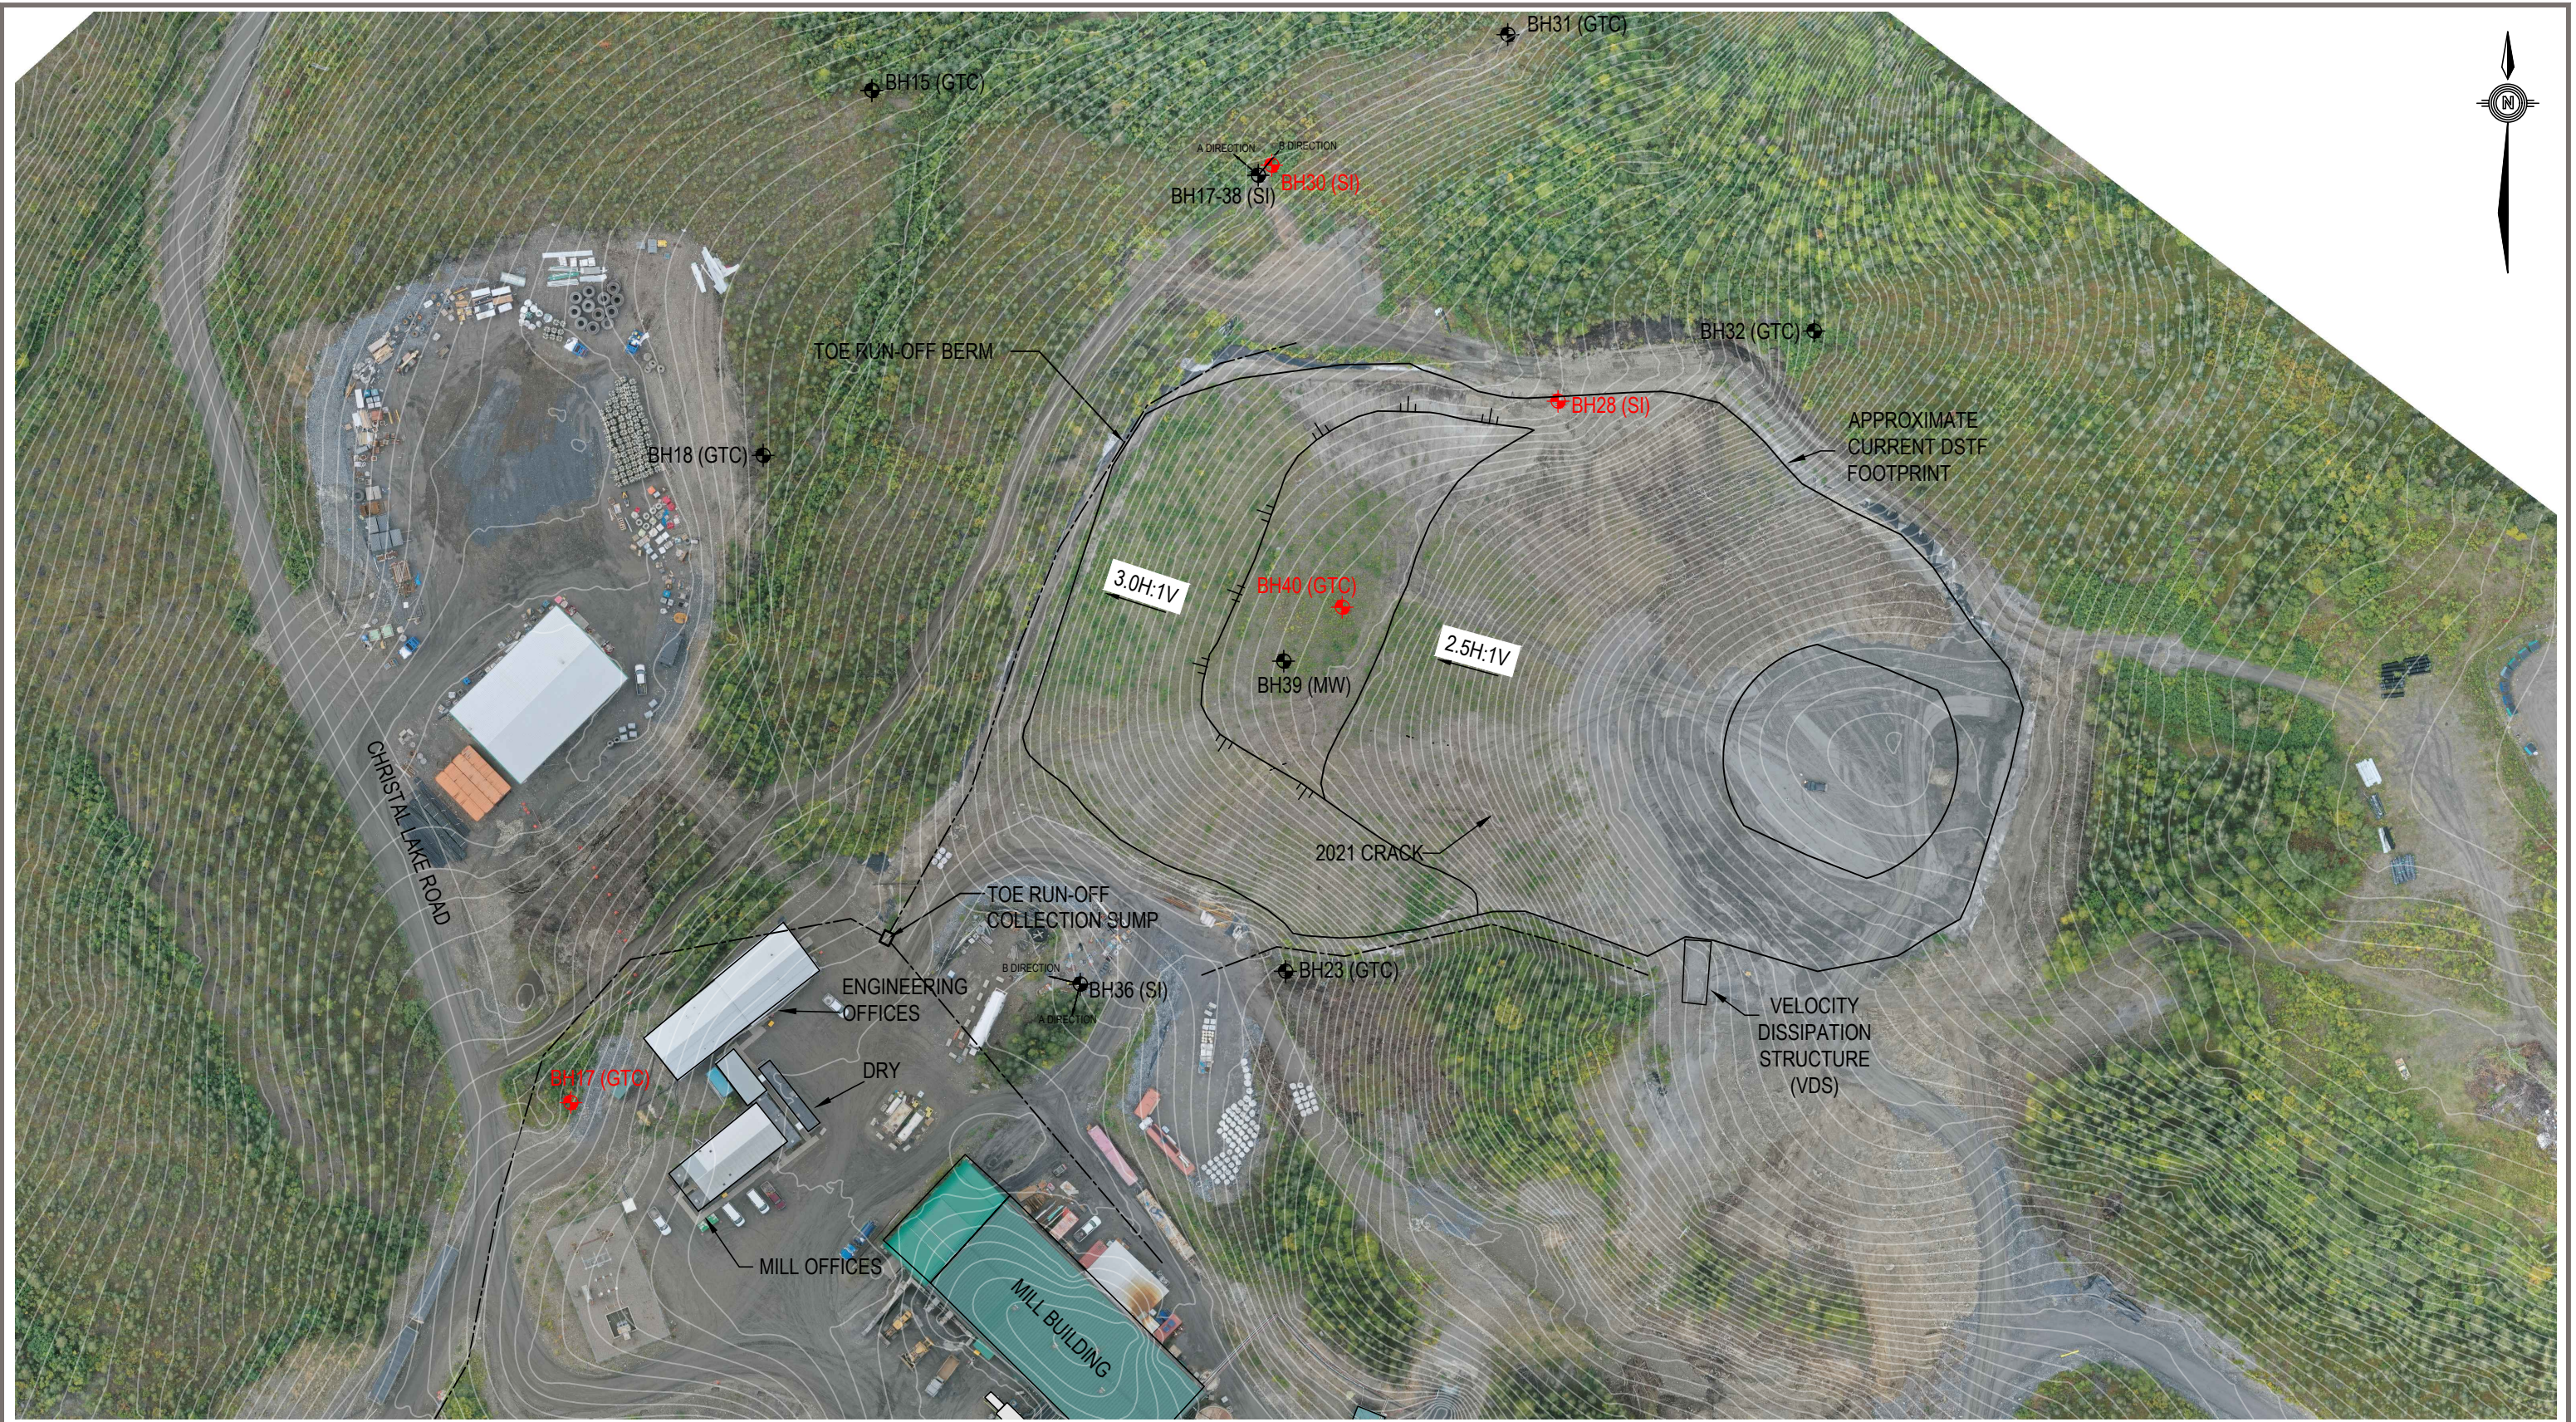
Q:\Whitehorse\Data\0201drawings\Keno\ENG.WARC04286-01 2022 AKHM Annual Inspection\ENG.WARC04286-01 Fig.2-RO_US.dwg [FIGURE 2] November 29, 2022 - 12:31:20 pm (BY: SWARTZ, JACOB)

Updated ground temperature readings were collected from accessible and functioning cables, and are presented in Appendix B. As with the previous inspection, the protective casing for BH17 is damaged and the cable is not accessible to confirm functionality or collect readings. BH23 was not located. The cable located in BH40, extending through the tailings into the underlying foundation soils, was previously recommended to be replaced. During a drilling program in Fall 2022, piping was installed to lower a new cable into a new borehole, immediately adjacent to BH40. A summary of the cables is provided below:

NOTES:
 1: INSTRUMENTATION SHOWN IN RED HAS BEEN DAMAGED OR DESTROYED AND IS NOT READABLE. SOME OF THESE NEED TO BE REPAIRED AND/OR REPLACED. SEE ACCOMPANYING REPORT TEXT.
 2: DRONE IMAGERY COLLECTED BY HECLA ON AUGUST 29, 2022. CONTOURS ARE APPROXIMATE, BASED ON PROCESSED DRONE IMAGERY.

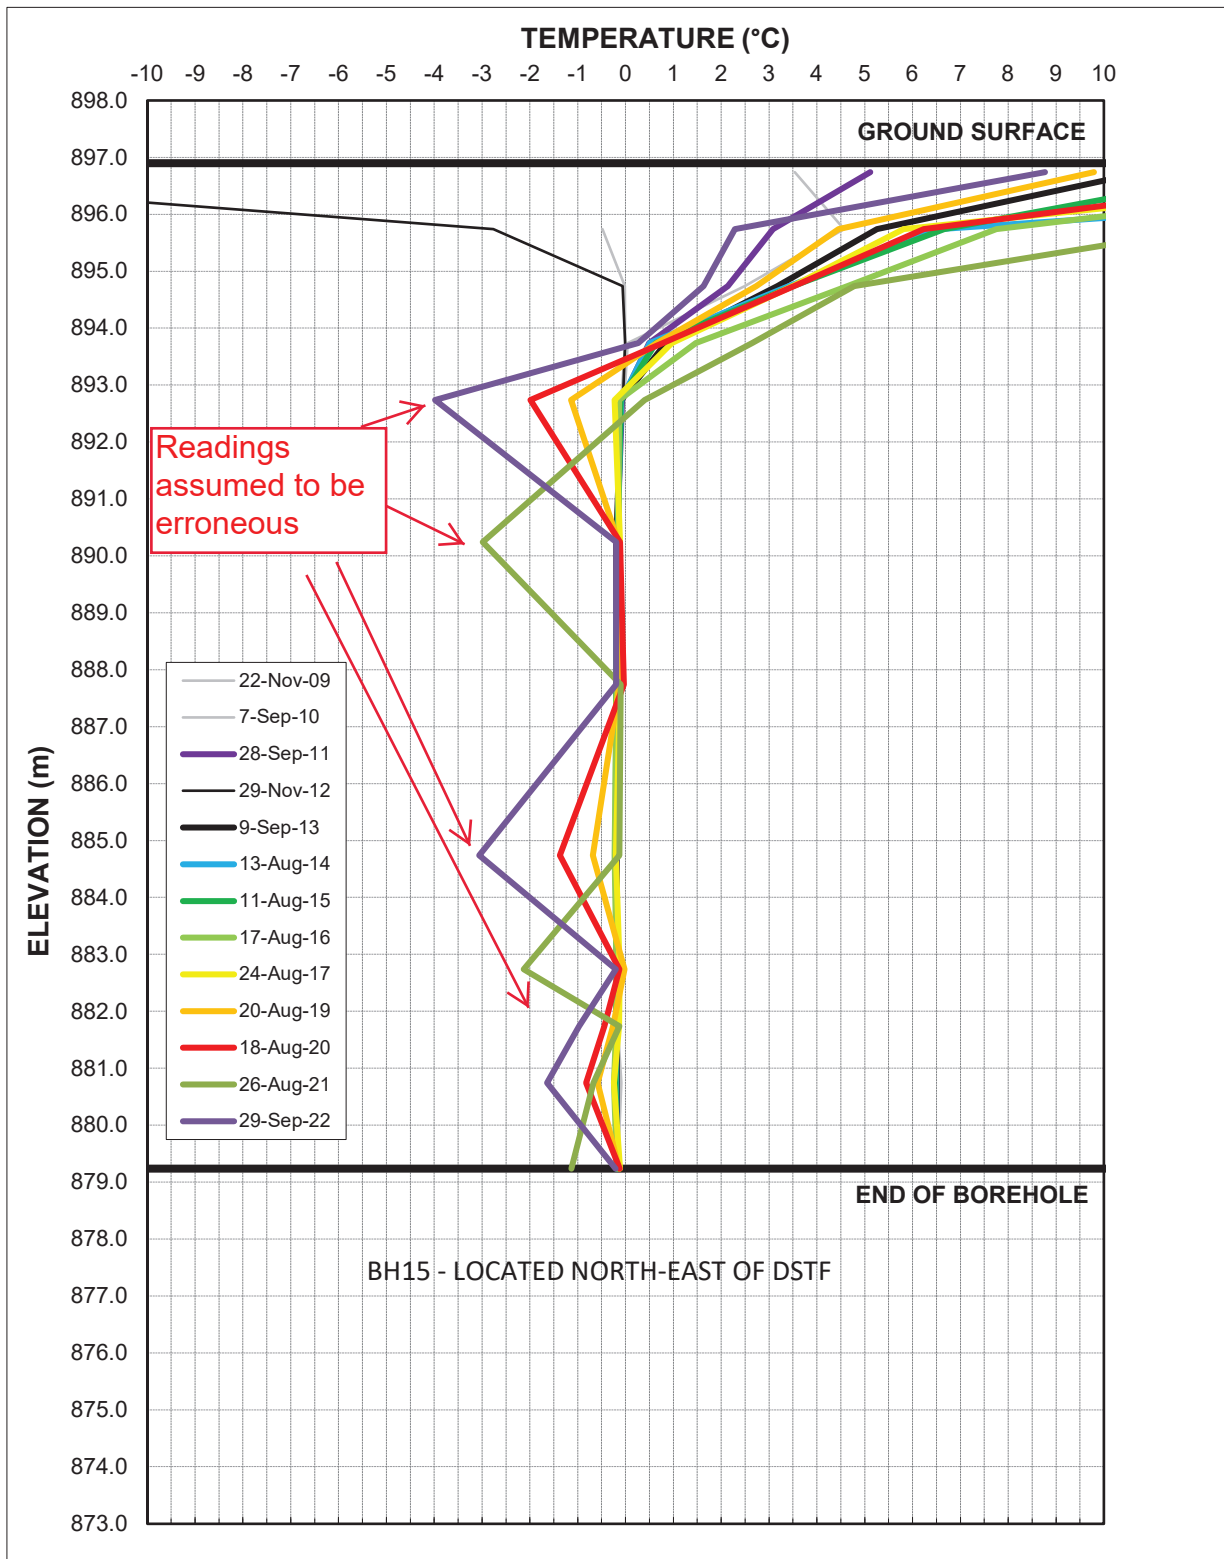
Ground Temperature Profile
Keno Hill District Mill Site Borehole BH15
Figure T1

Cable ID	Status	Additional Comments
BH15	Functioning	Possible erroneous readings at depth
BH17	Cable not accessible due to damaged casing. Functionality not known	NA
BH18	Functioning	NA
BH23	Not located – status unknown	Previous erroneous readings at depth
BH31	Functioning	Possible erroneous readings at depth
BH32	Functioning	NA
BH40	Not functioning	Replacement in progress.
