2016 Geotechnical Inspection Tailings Management Facility Sä Dena Hes, Yukon Territory

Teck Resources Limited

SRK Consulting (Canada) Inc.
1CT008.057
October 2016

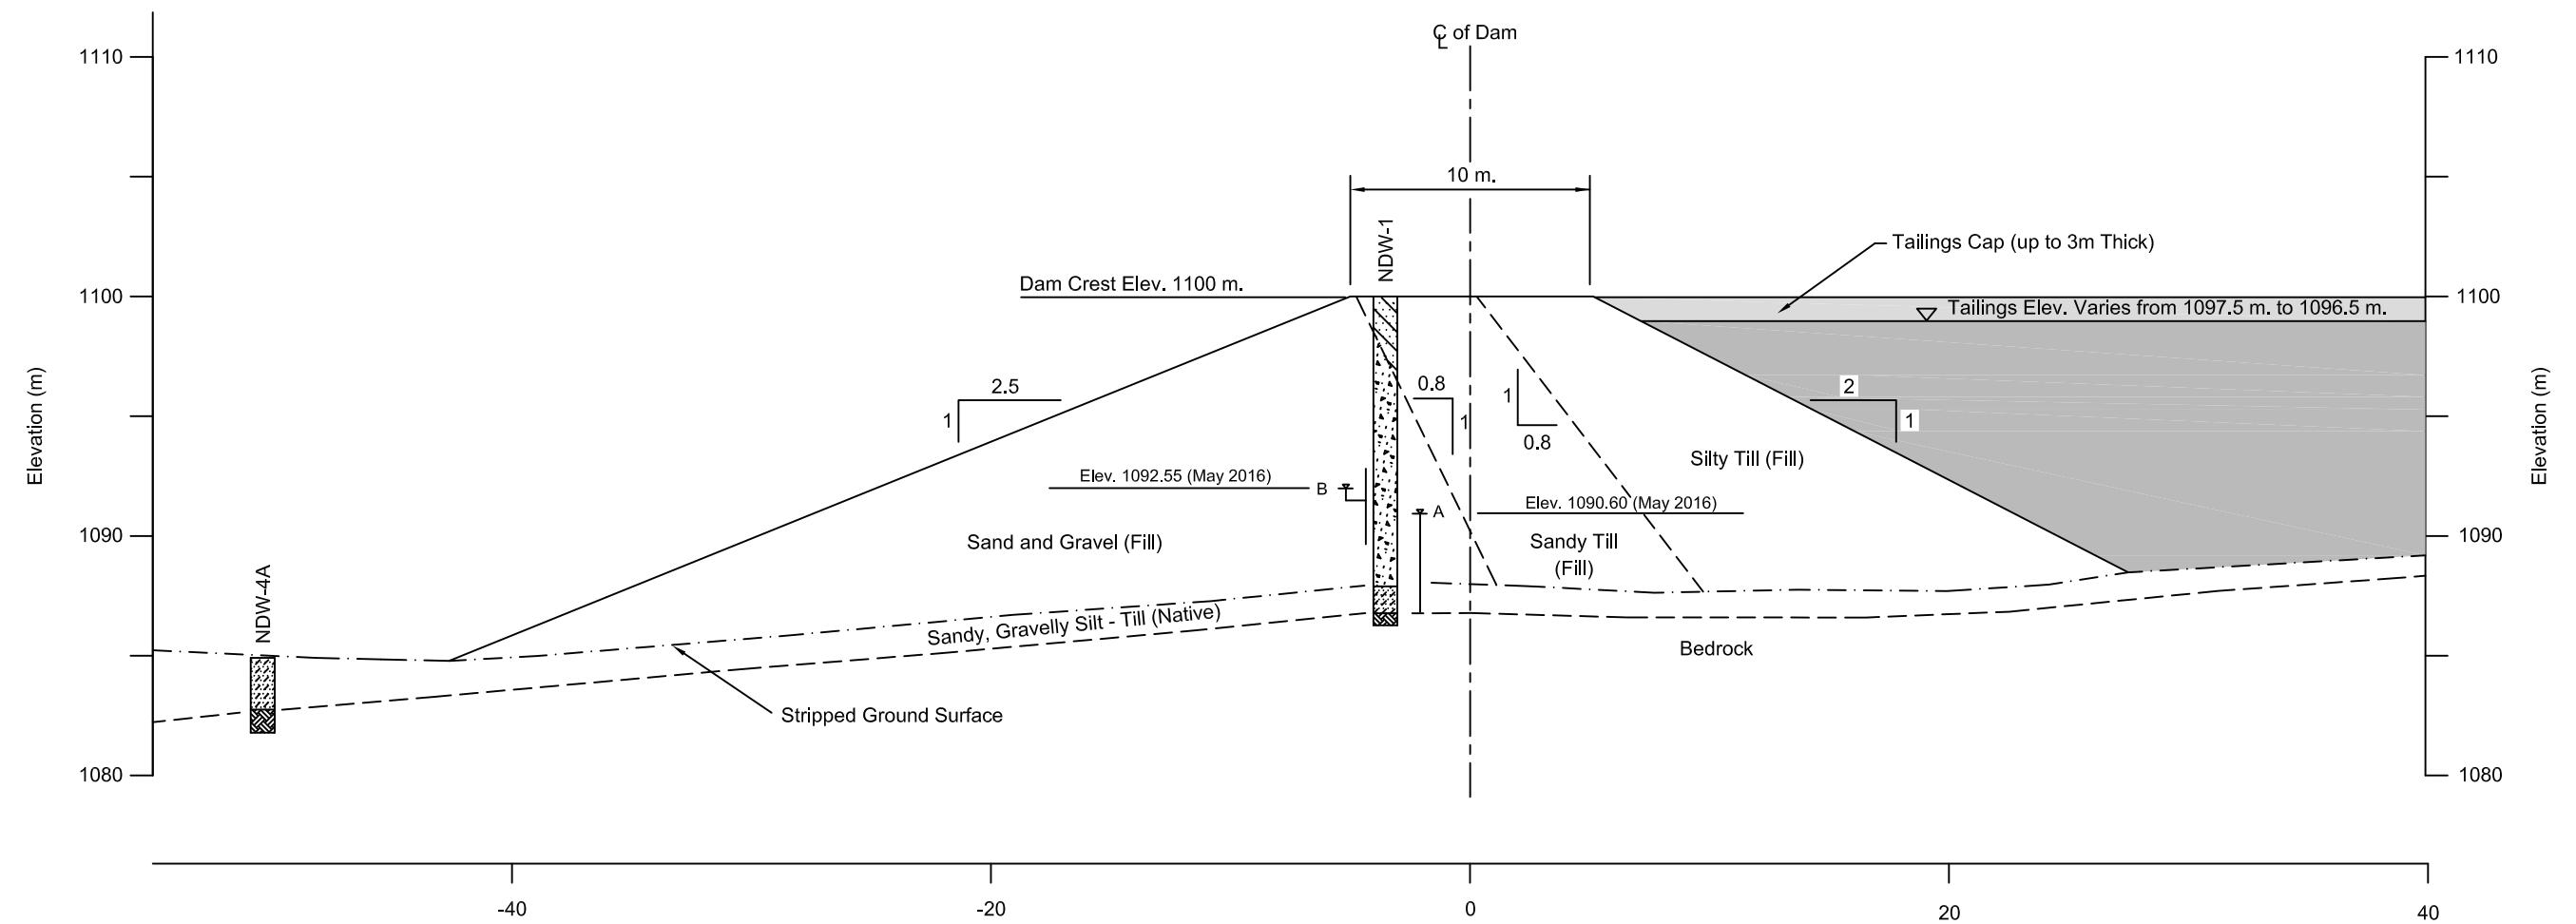
SRK JOB NO.: 1CT008.057 FILE NAME: 1CT008.057 - North Dam XS.dwg	 Sä Dena Hes Project	2016 Geotechnical Inspection		
		North Dam Section 0+400		
		DATE: September 2016	APPROVED: PMH	FIGURE: 4

The peak levels recorded in May, 2016 are plotted on the dam section shown on Figure 4.

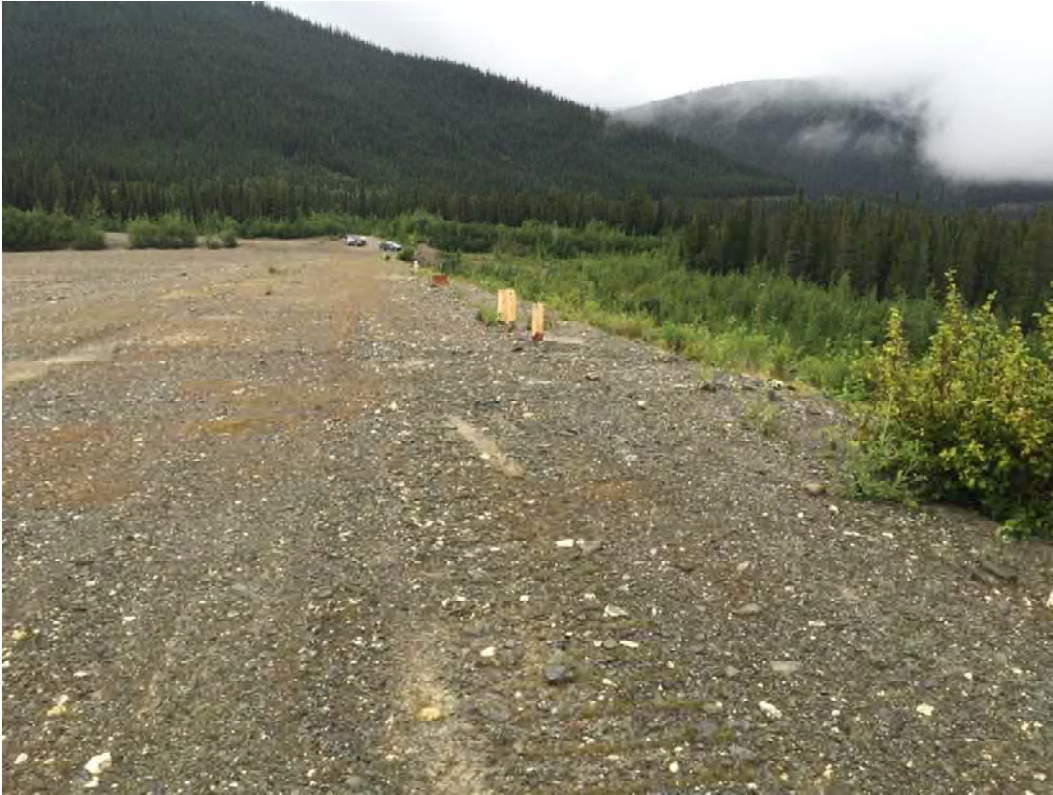
The crest of the North Dam (Photo 1), which is at an elevation of 1,100 m, shows no signs of deformation or abnormal settling. The downstream slope of the dam (Photo 2) shows no signs of surficial movement or erosion nor is there any sign of bulging at the downstream toe.

Photo 1: View West along the North Dam Crest

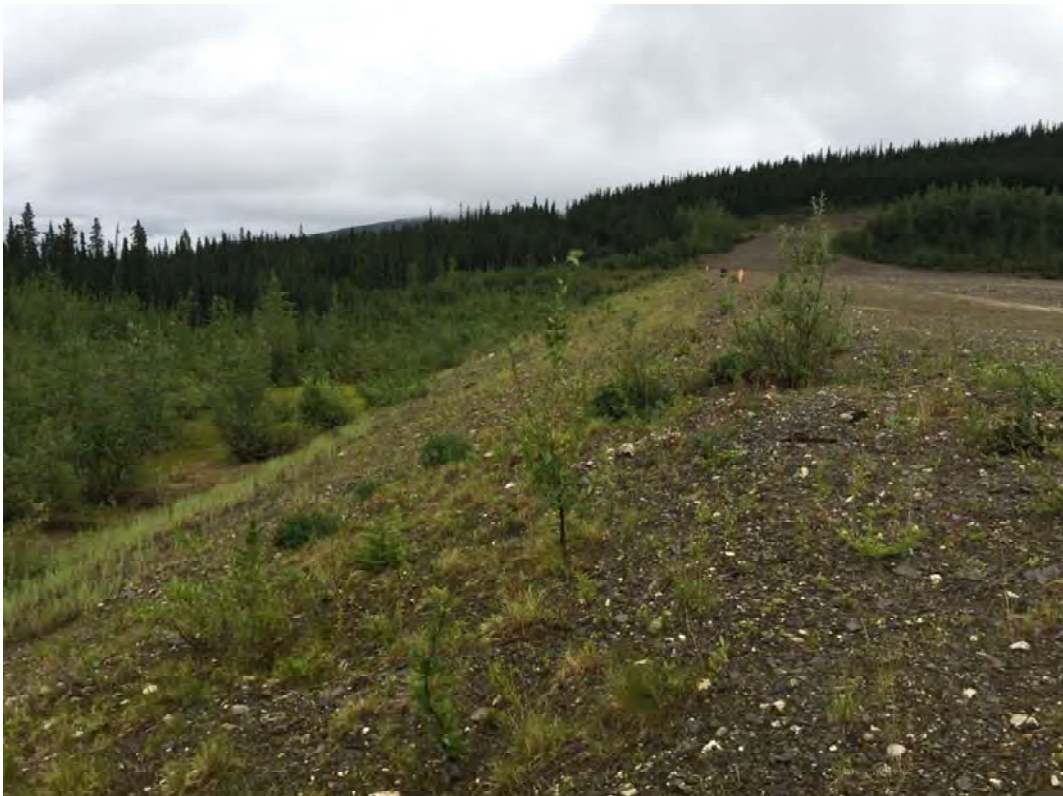
Photo 2: View East along the Downstream Face of the North Dam

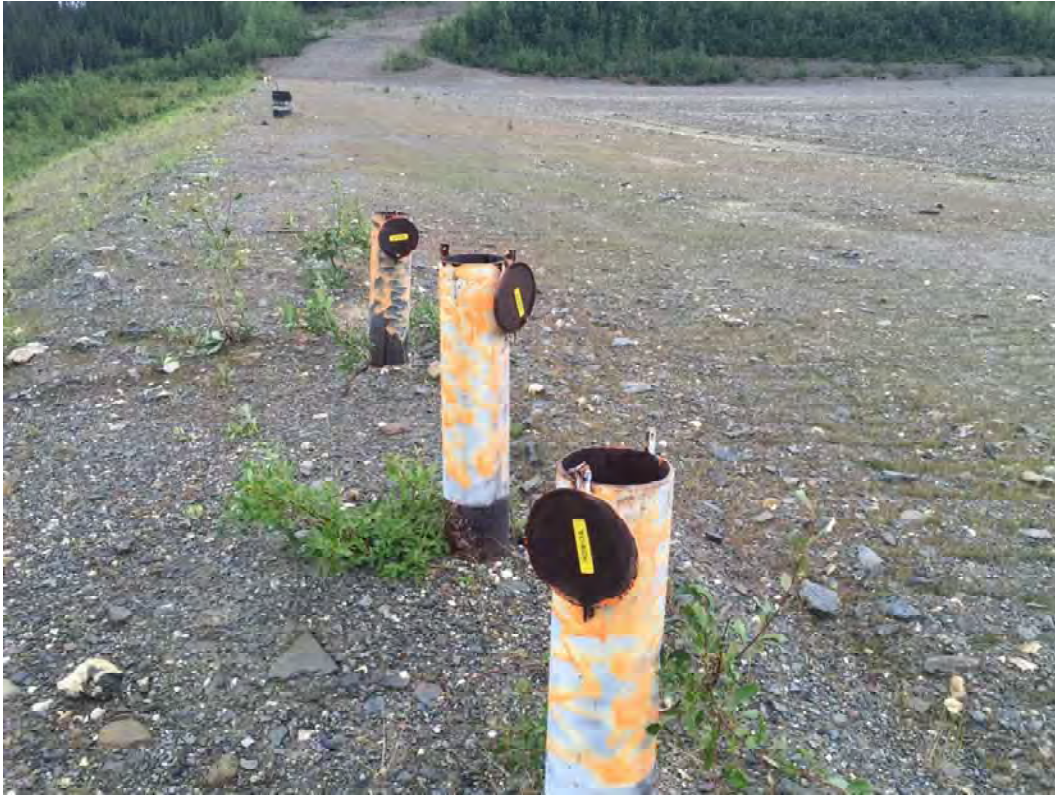
The three sets of piezometers and protective caps (Photos 3 and 4) along the crest of the North Dam remain intact. Some of the deformation monitoring pins and the original settlement gauges protected by 40-gallon drums are still evident on the crest of the dam but currently serve very little purpose. Labels on each of the piezometers were recently upgraded and have weathered the elements well.

Photo 3: Protective Steel Caps for Piezometers NDM 3A and 3B, Settlement Gauge NDS 3

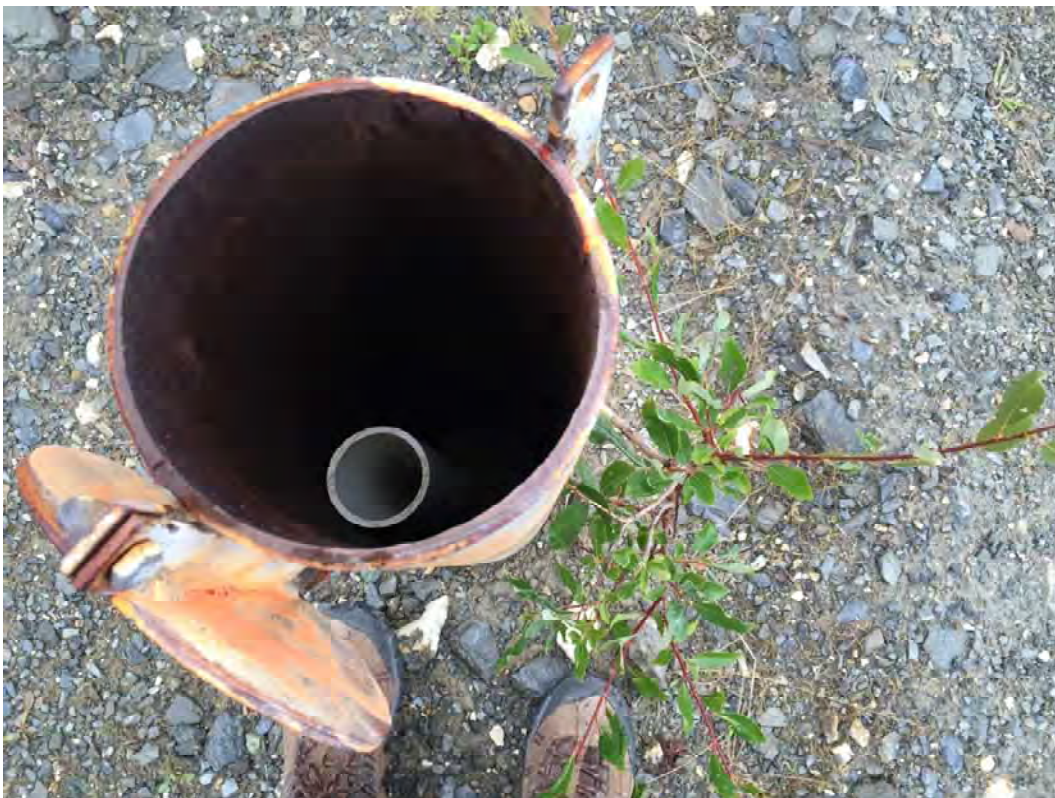
Photo 4 PVC Piezometer Inside the Protective Caps

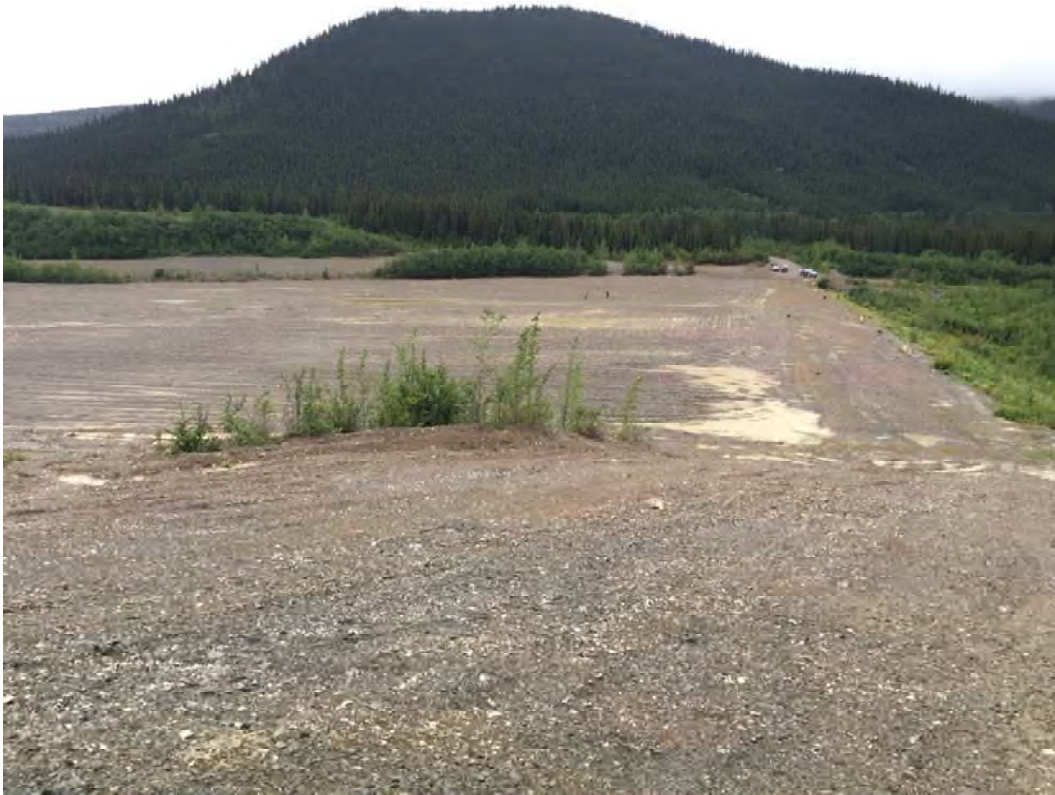
Photo 5 provides a view looking west over the tailings cover at the north end of the TMA. The cover has an overall gentle downslope gradient away from the North Dam. A drainage channel was constructed down the middle of the cover to assist in directing runoff away from the dam. At the time of the site inspection, ponding was noted along the channel as shown in Photos 6 and 7. However, flow in the channel was moving in a southerly direction away from the dam.

Photo 5: View looking West over the Till Cover Adjacent to the North Dam

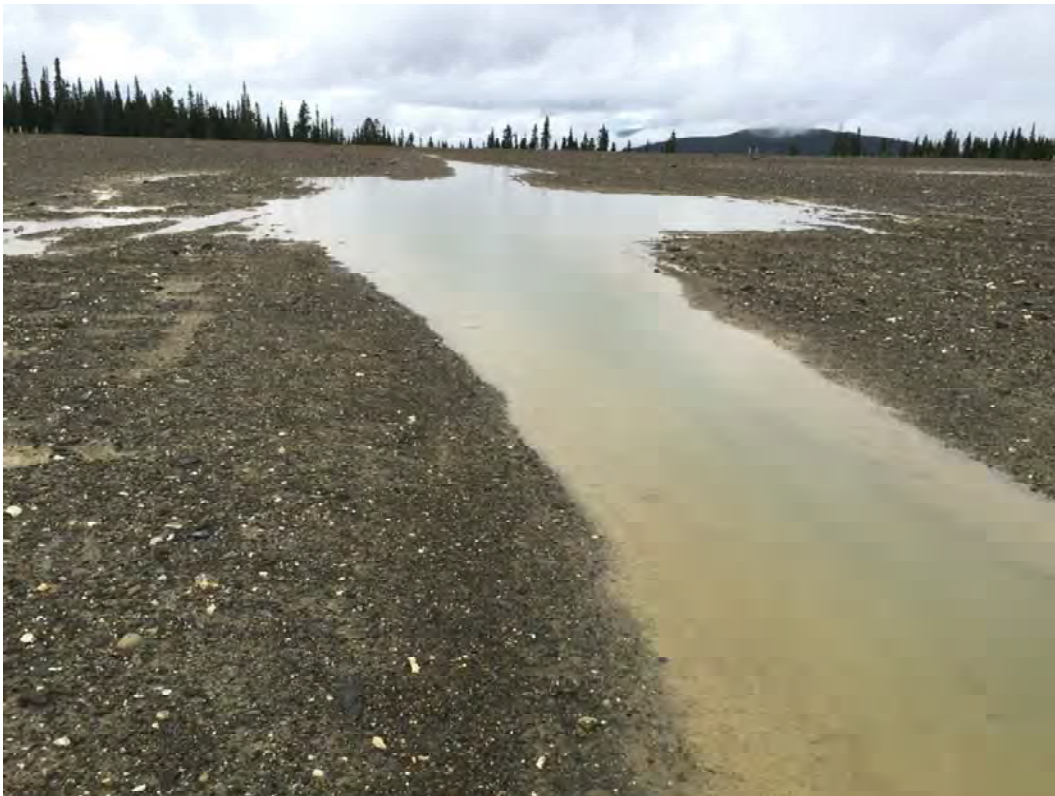
Photo 6: Ponding in the Central Drainage Channel within the Till Cover

SRK recommends that the grade of the central drainage channel down the middle of the till cover be modified to improve drainage of runoff from the cover and the instances of ponding currently observed in the channel.

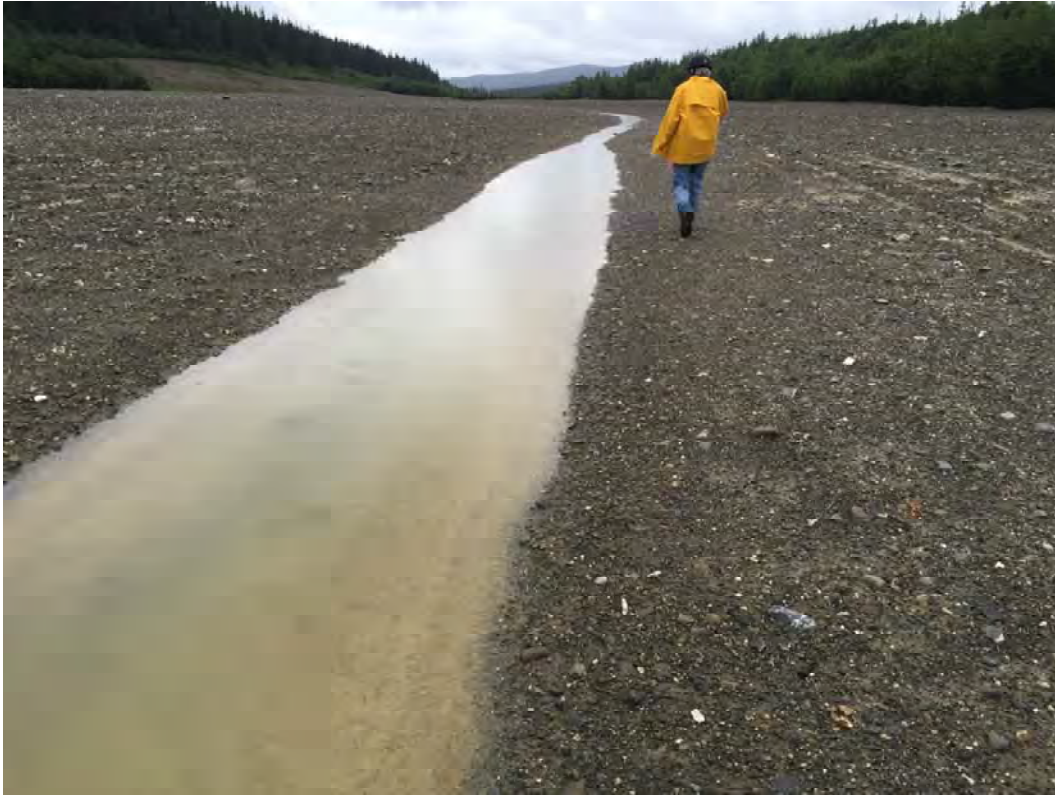
Photo 7: Central Drainage Channel Looking Downstream

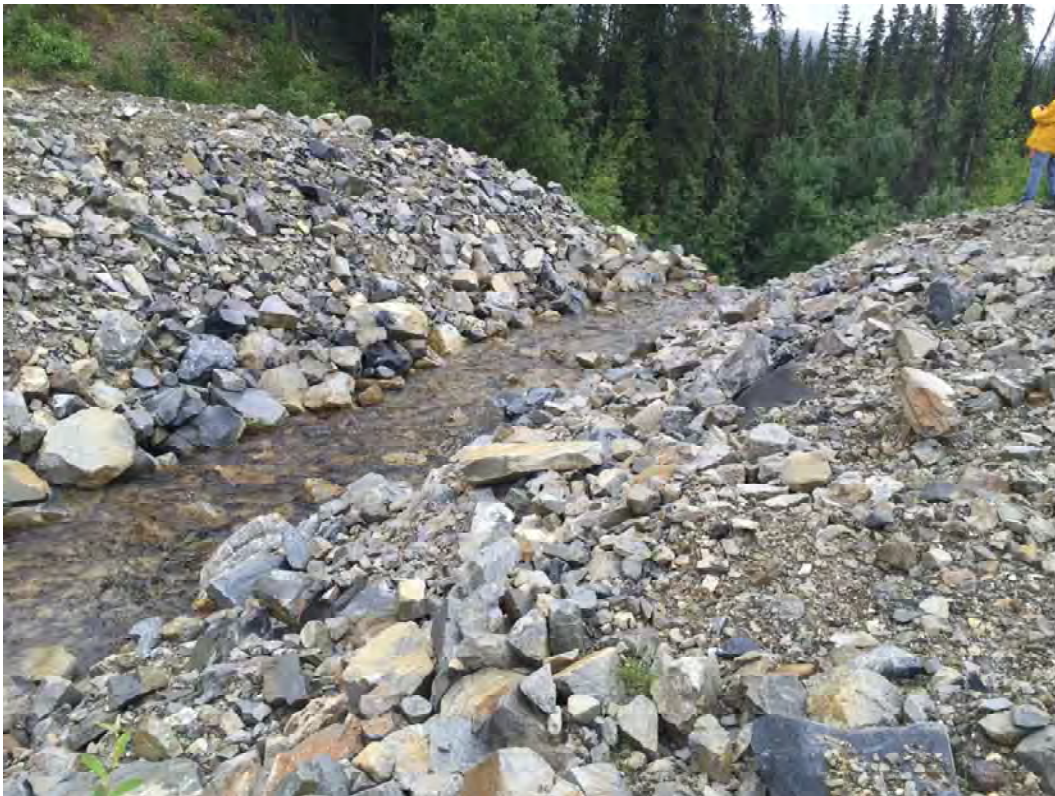
The riprapped channel that conveys North Creek over the location of the decommissioned North Creek Dyke is shown in Photo 8. At the outlet of the channel (Photo 9) some of the riprap has been dislodged by the flow exposing a small area of the underlying filter fabric. However, the channel remains stable and no remediation is required.

Photo 8: Riprapped Section of North Creek at the Location of the Reclaimed North Creek Dyke

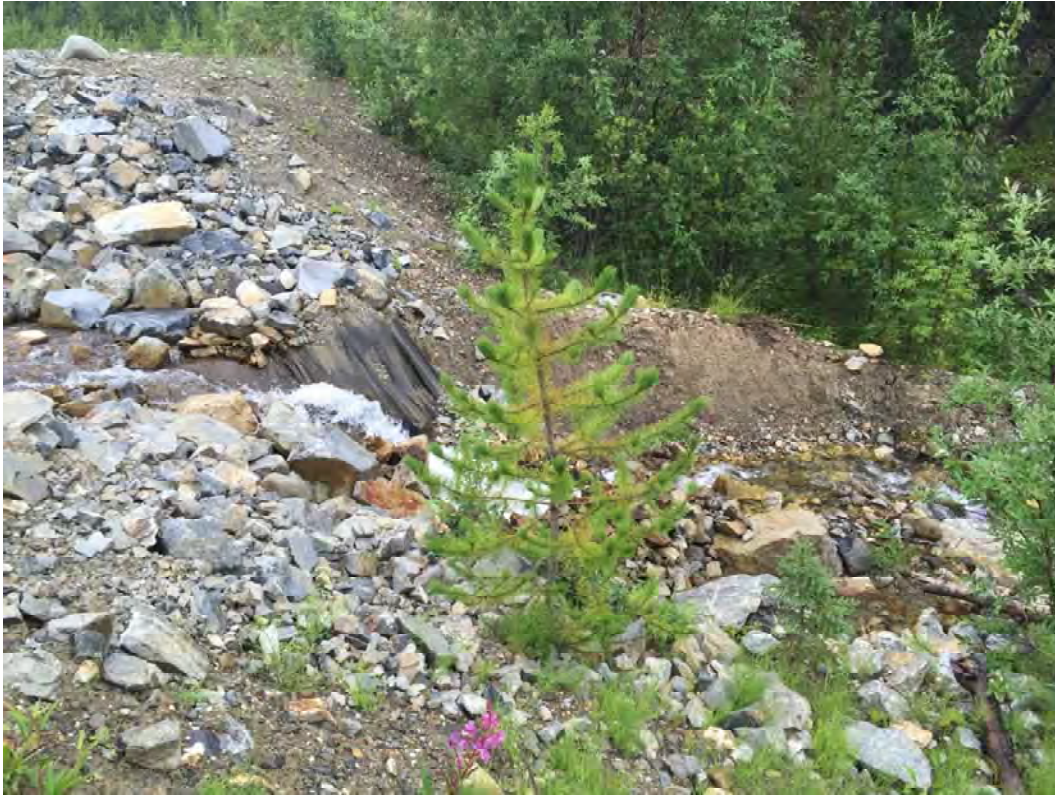
Photo 9: Exposed Fabric at the Outlet of the Ripped Channel in North Creek

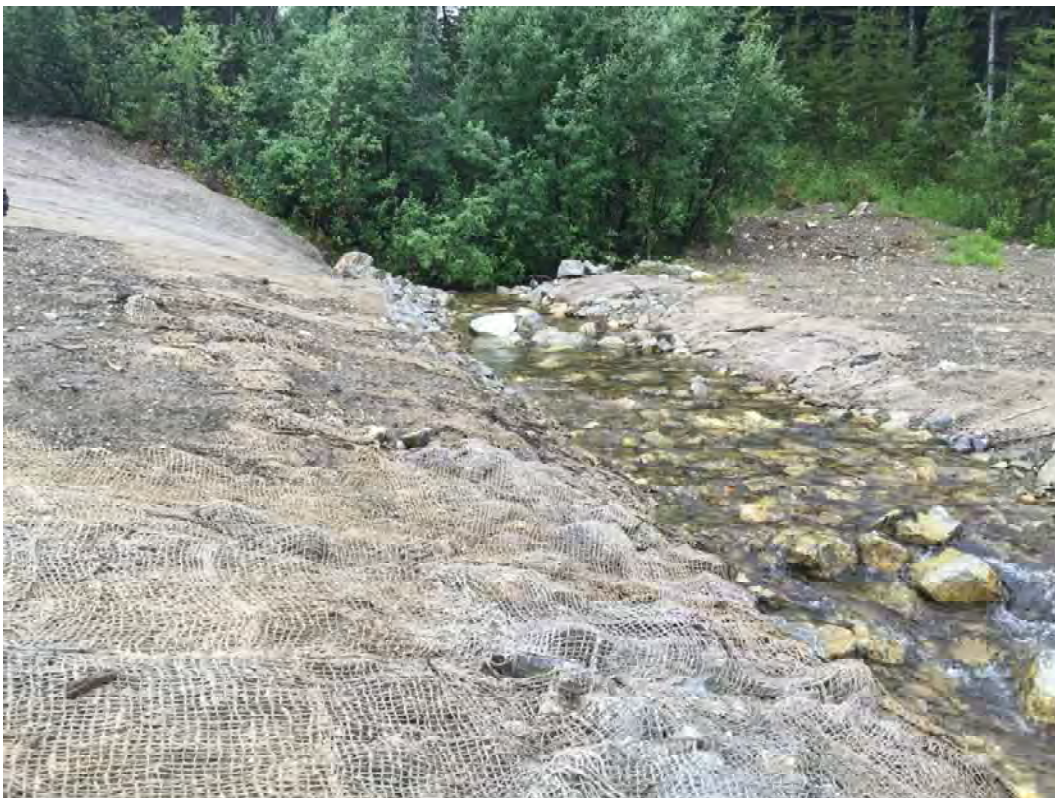
Below the above channel is a second riprapped channel that was built following the removal of the two culverts as part of the site reclamation (Photo 10). The channel is stable and requires no remediation.

Photo 10: Ripped Channel at the Second Crossing of North Creek s

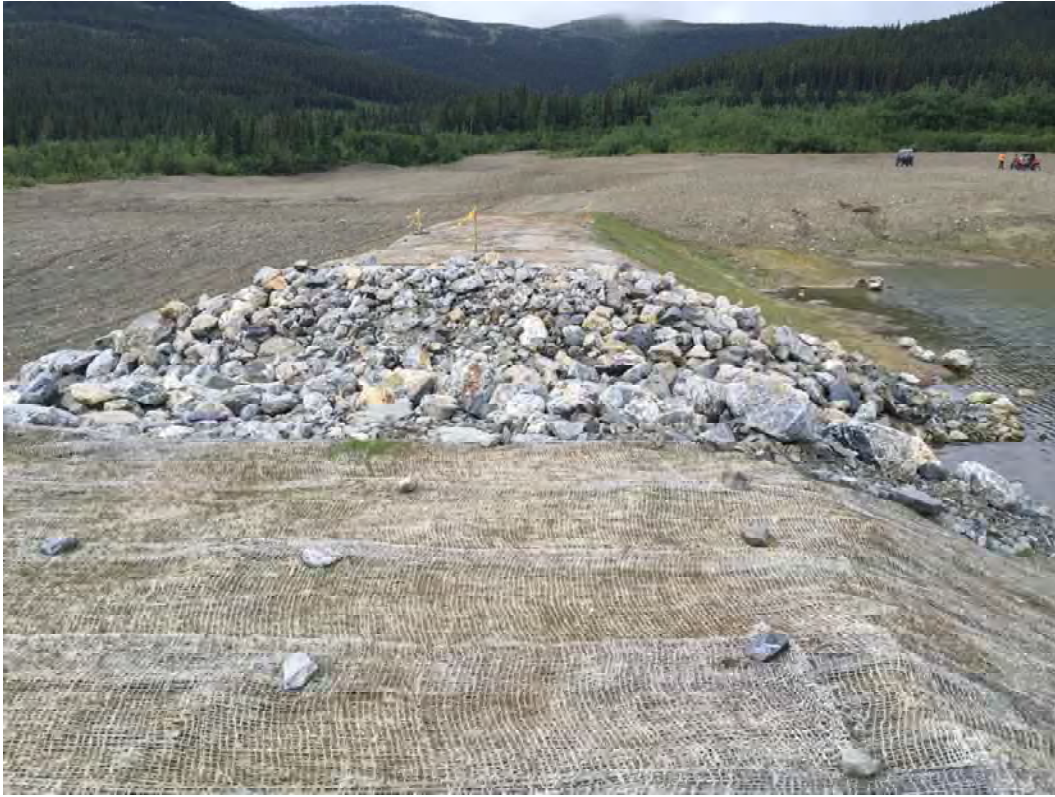
The GeoJute erosion protection and the riprap buttress along the downstream toe of the SRS that Teck installed last year has performed well (Photo 11). No further erosion of the downstream slope or the downstream toe of the structure was evident this year.

Photo 11: Spillway at Sediment Retaining Structure

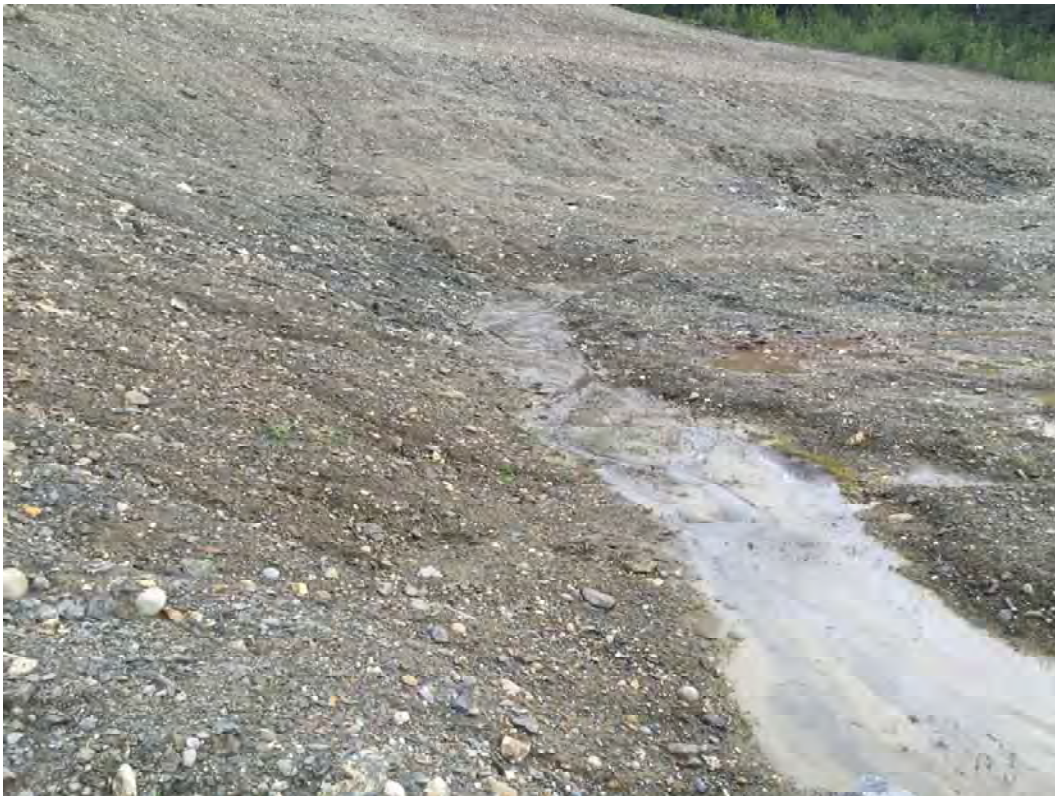
Seepage from the hillside area to the east of the structure is still evident along the downstream toe of the SRS (Photo 12).

Photo 12: Seepage along Toe of the Sediment Retaining Structure from Hillside Springs

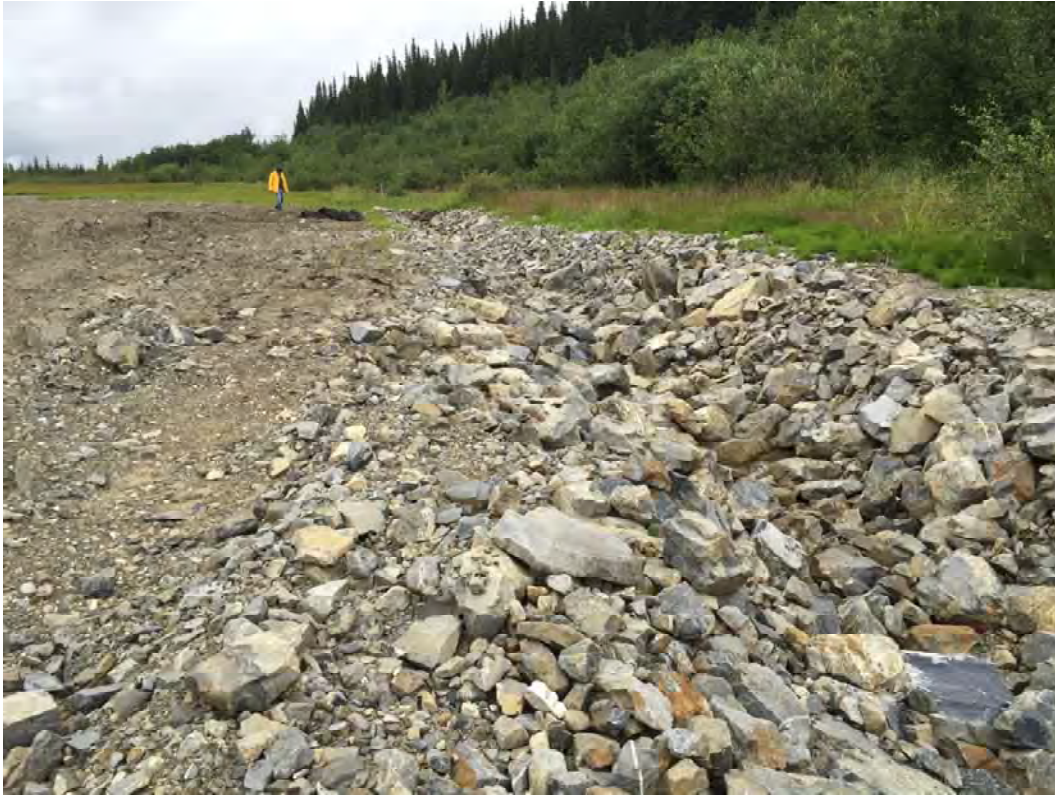
Photos 13 to 15 show the North Channel that drains into the SRS. At the outlet of the channel, there was evidence of some subsidence and erosion of the west embankment (Photo 14). However, the erosion would not impact the performance of the channel and no remediation is required.

Photo 13: Upper Reach of the North Channel

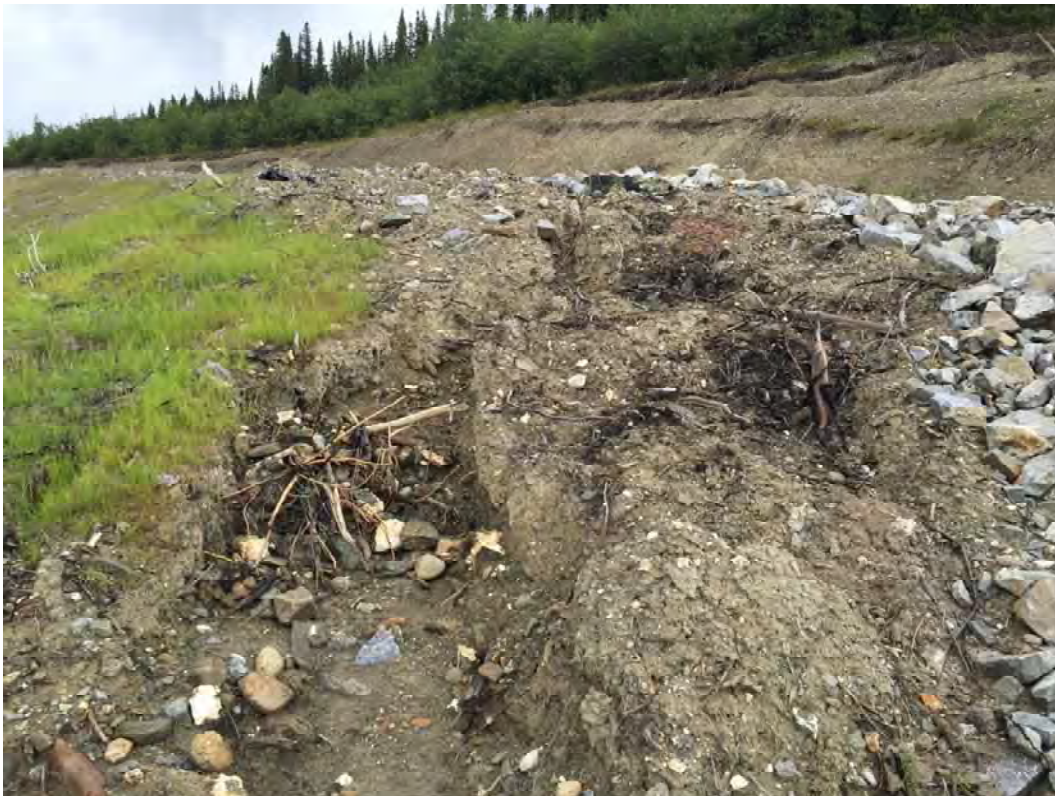
Photo 14: Subsidence Zone adjacent to the outlet of the North Channel

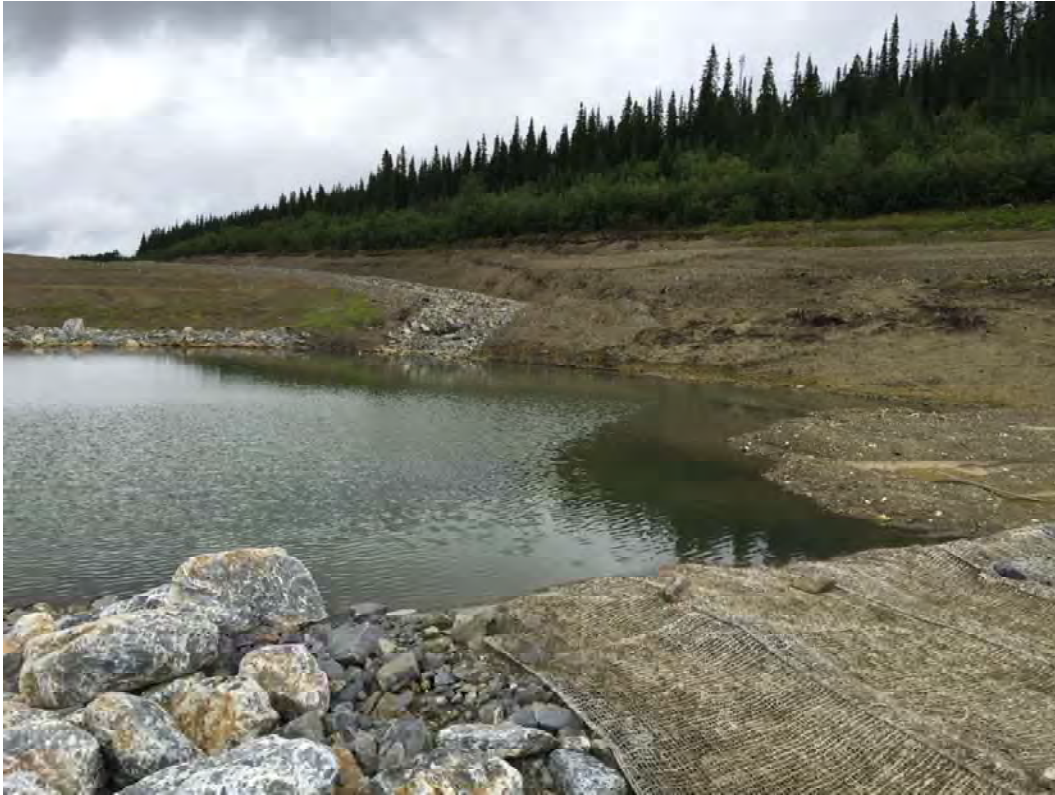
Photo 15: Sediment Pond and outlet from the North Drainage channel in background

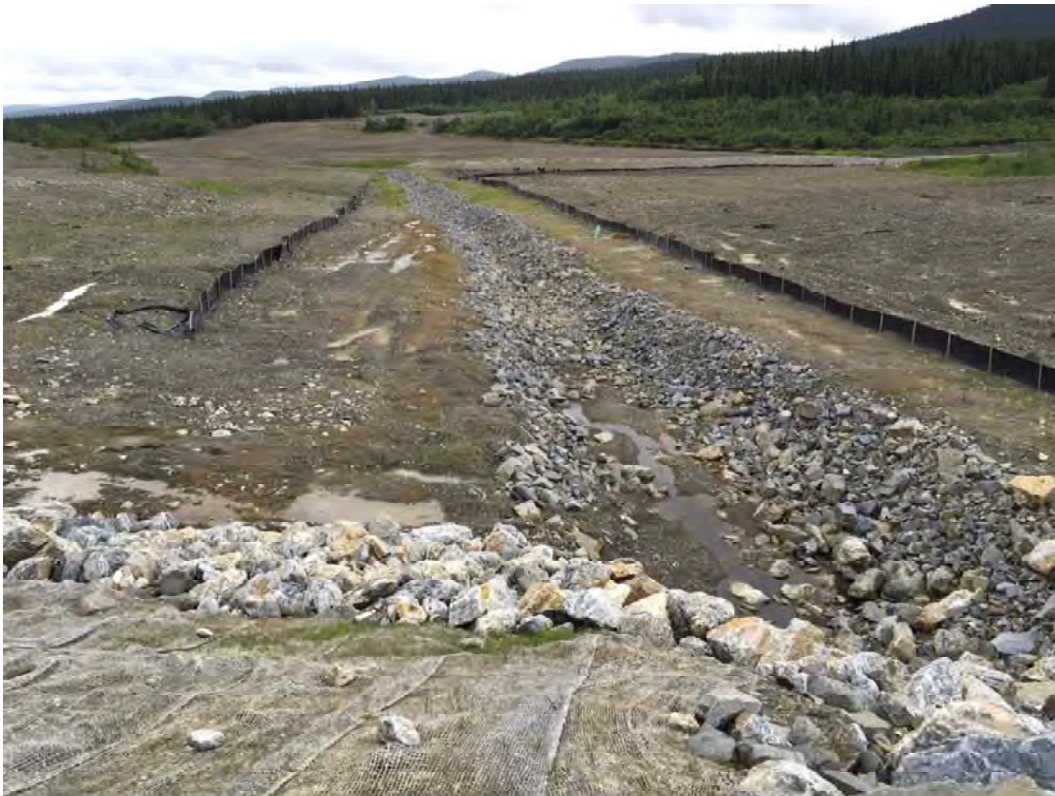
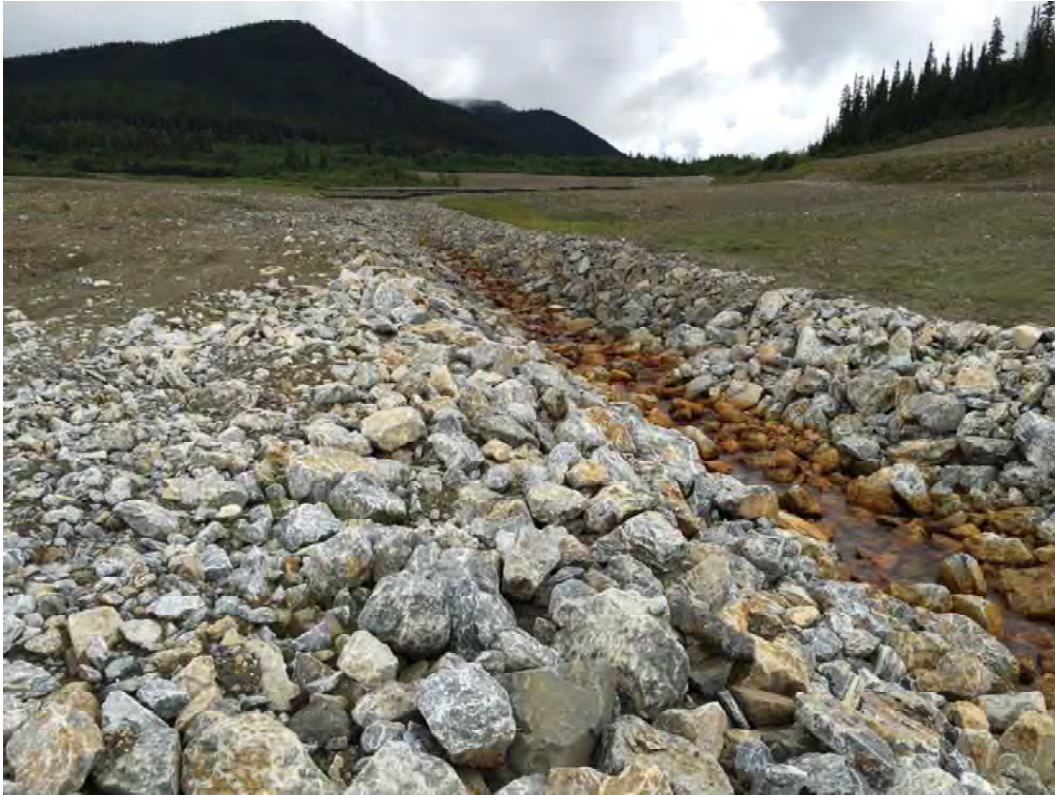
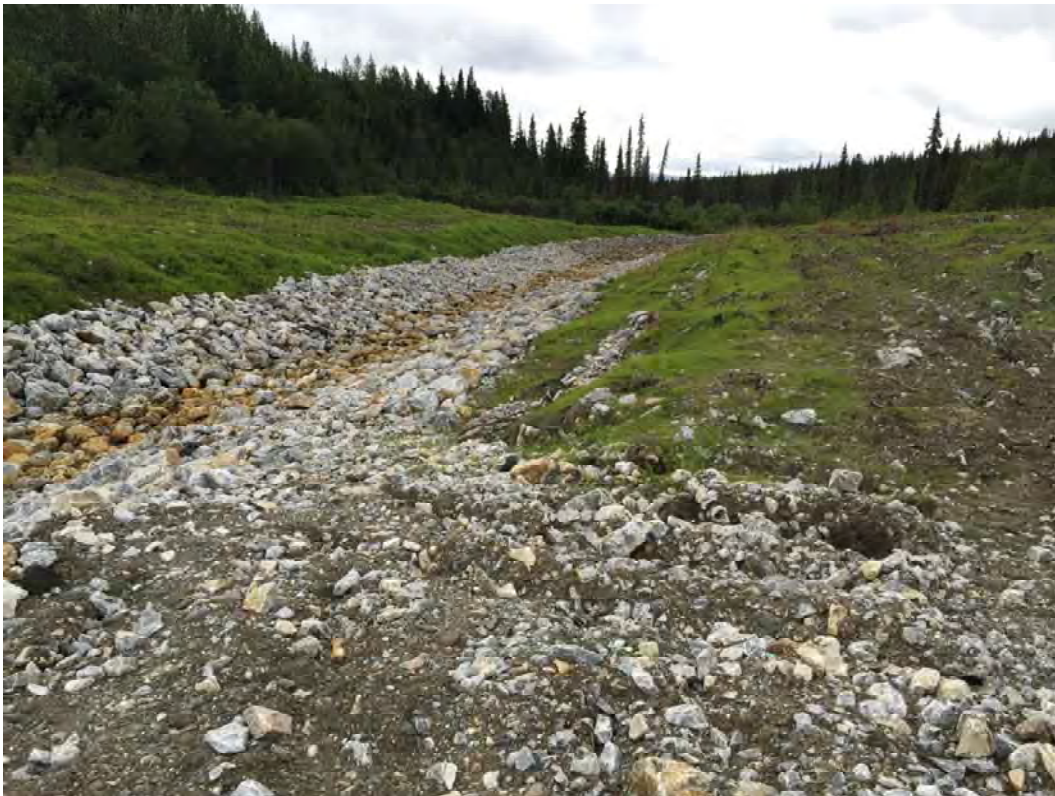
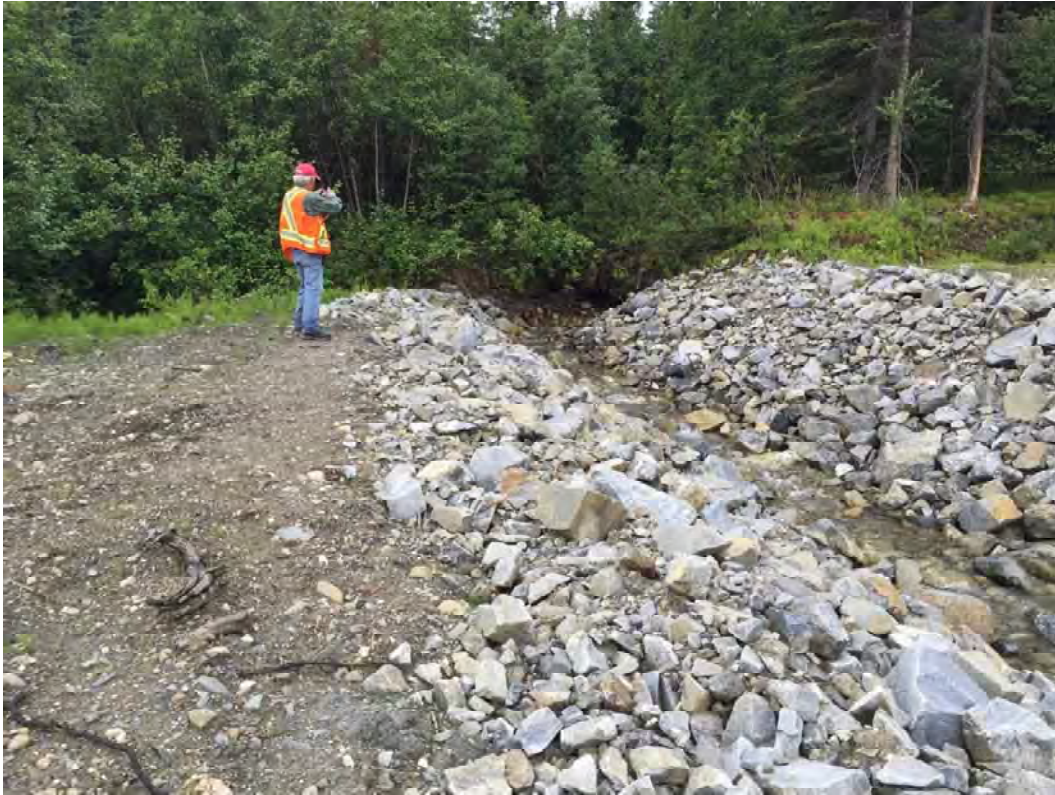
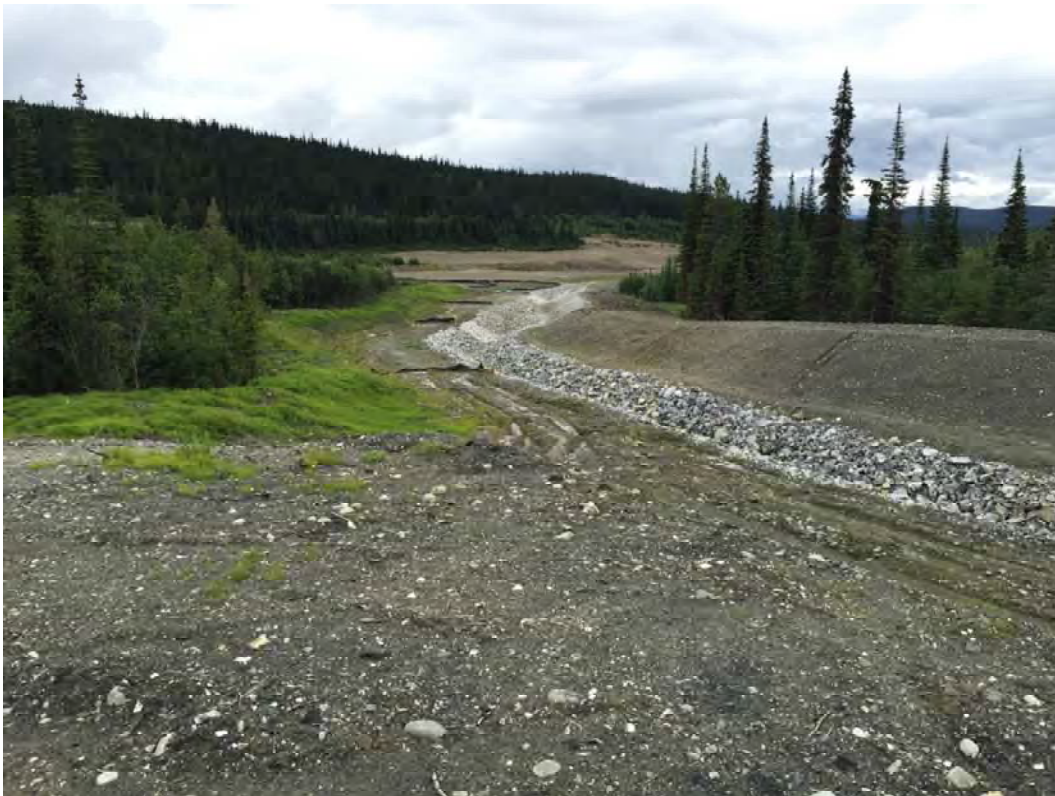
No movement of the riprap or subsidence was evident in the other channels (Photos 16 to 20).

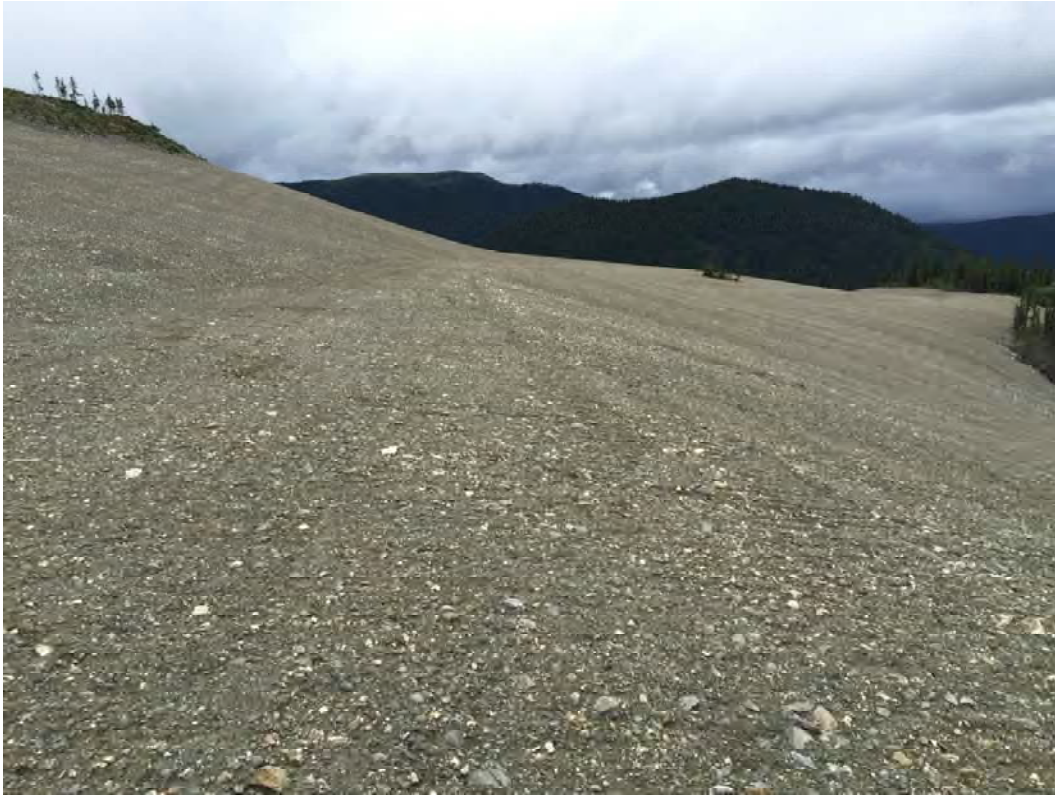
SRK inspected the Burnick waste dump at the 1200 portal and the Main Zone and Jewelbox waste dumps (Photos 21 and 23). The locations of these dumps are shown in Figures 8 and 9. The dumps were recontoured to provide added long-term stability. No subsidence of the slopes was noted.

Photo 21: Regraded areas of the Jewelbox waste rock dump

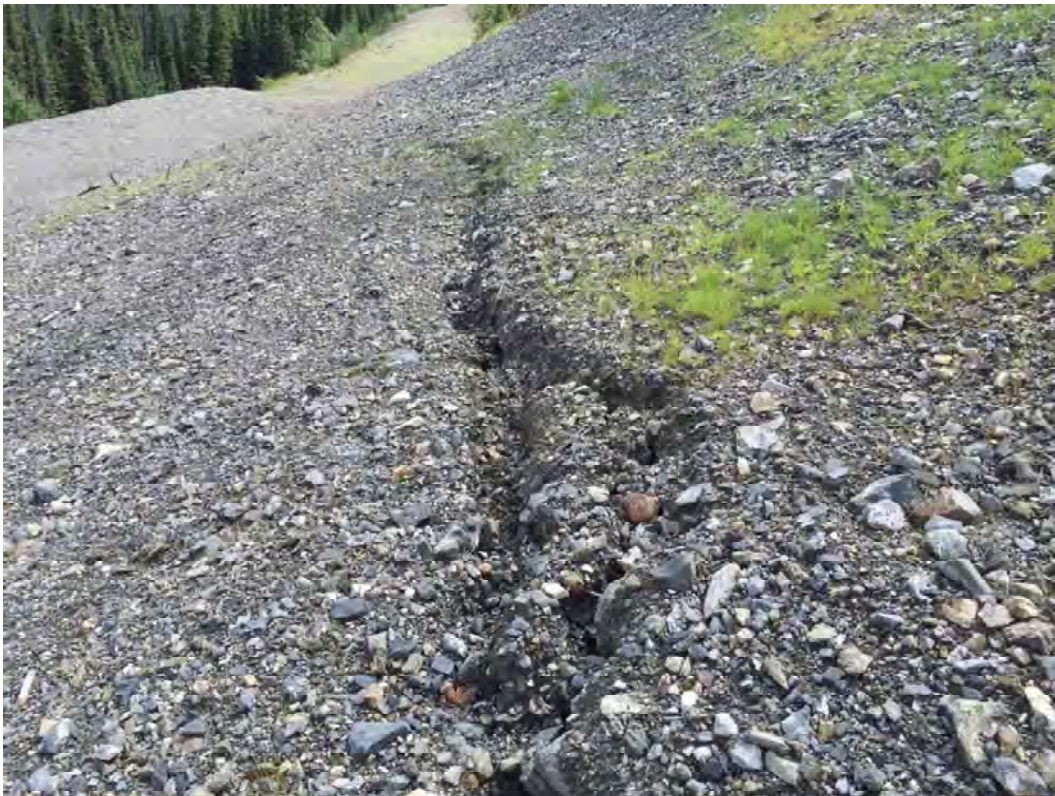
Some minor settlement of the fill that was placed over the 1200 portal was noted (Photo 22). This settlement is to be expected and no remediation is required.

Photo 22: Subsidence Cracks due to Settlement of the Fill Placed over the 1200 Portal

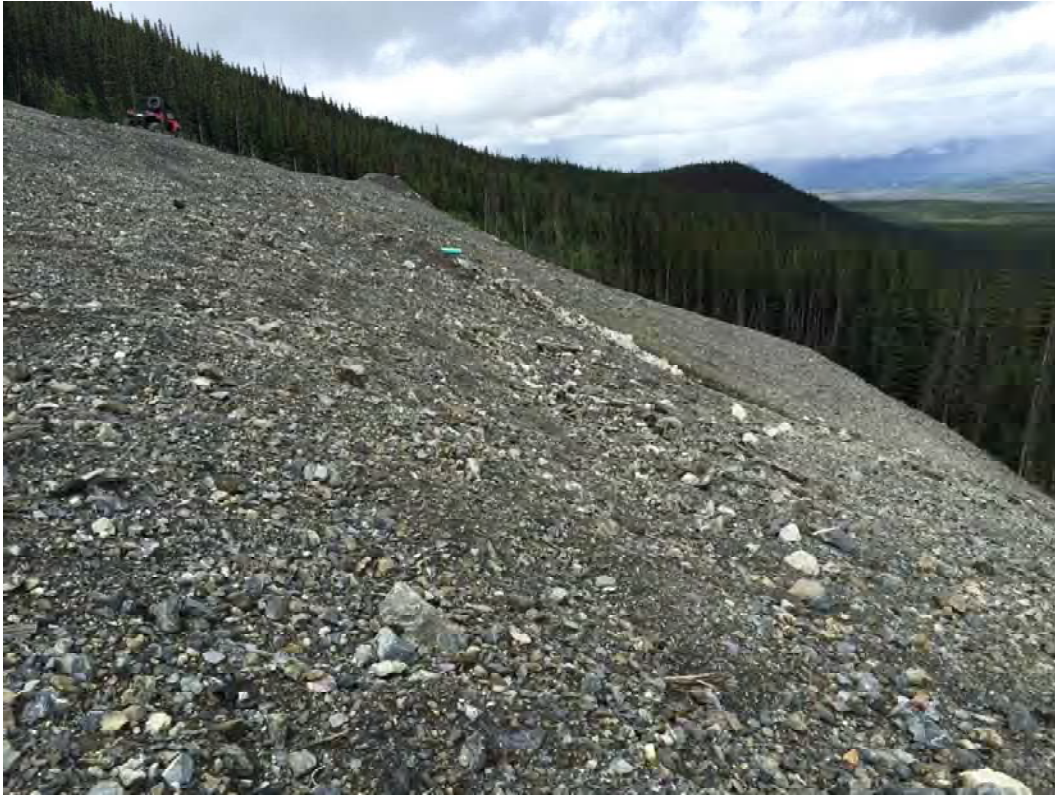
Photo 23: Burnick Dump Slopes
