Operator: John Harding
Property Name: Folle Mtn I Permit #: LQ00461

DESCRIPTION OF ALL EXPLORATION: (Attach additional pages as required)

UNDERGROUND STRUCTURE
 August 30, 2019

Layout of As-Built Camp on Hardrock Claim YC10852

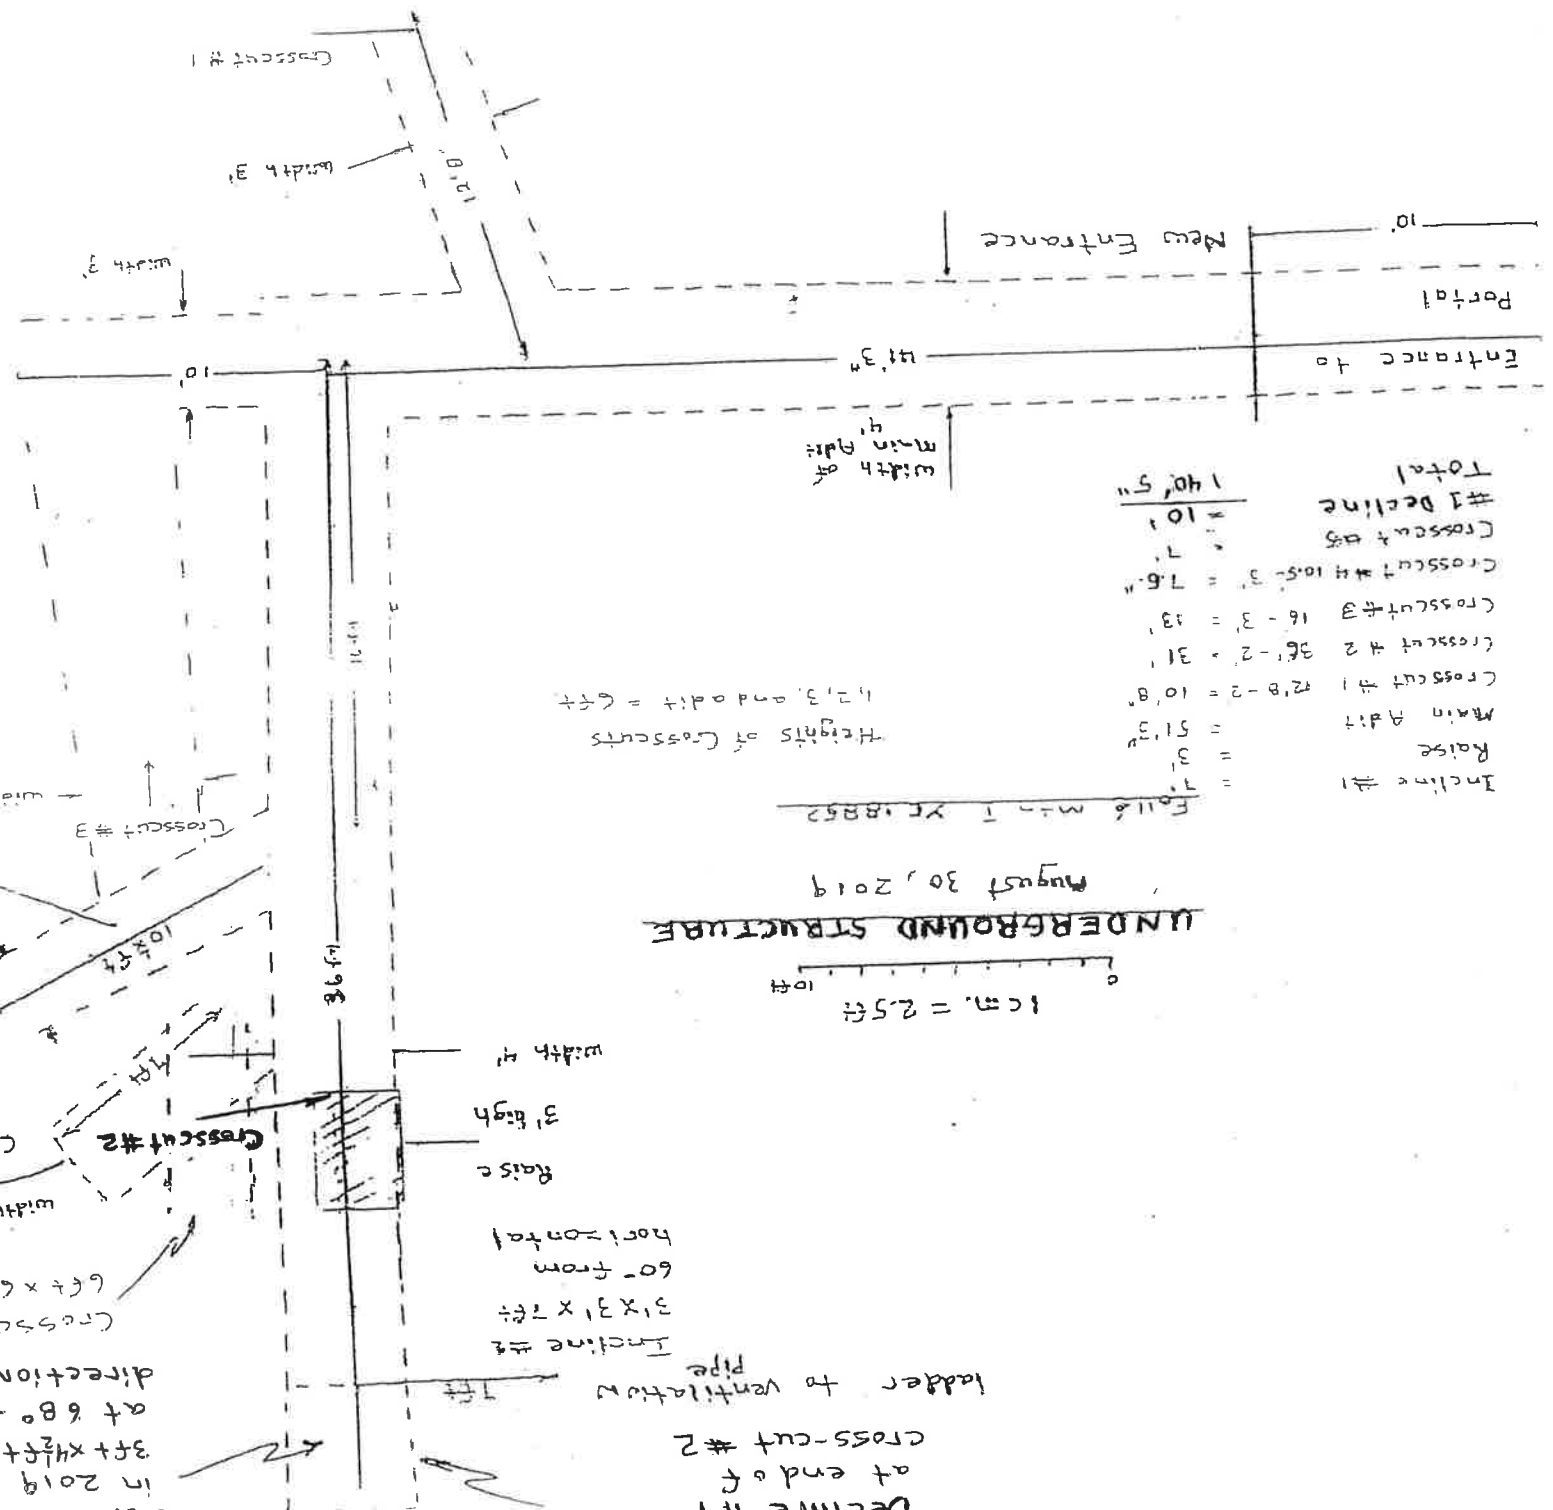
Work done on decline #2 in 2019
 3ft x 4ft x 16ft declining at 68° from horizontal in direction 60° (almost east)

Crosscut #6
 6ft x 6ft x 3ft

Crosscut #5
 3ft x 4ft x 1ft
 width = 3ft

Incline #2
 3ft x 4ft
 width = 3ft

Incline #1	= 7'
Raise	= 3'
Main Adit	= 51.3'
Crosscut #1	12.8 - 2 = 10.8'
Crosscut #2	26' - 2 = 31'
Crosscut #3	16 - 3 = 13'
Crosscut #4	10.5 - 3 = 7.5'
Crosscut #5	= 7'
Crosscut #6	= 10'
#1 Decline	= 140' 5"
Total
