Grew Creek Reclamation Activities Report

On June 22, 2022, Golden Predator (GP)'s environmental consultants attended the Grew Creek site accompanied by Itzi Mountain Lodging to complete the outstanding reclamation identified in the Inspection of Grew Creek (Mining Land Use Approval LQ00341a; February 3, 2022) report by John Minder, Natural Resource, Compliance Monitoring, and Inspections for the Tintina District.

Grew Creek Reclamation Report

July 5th, 2022

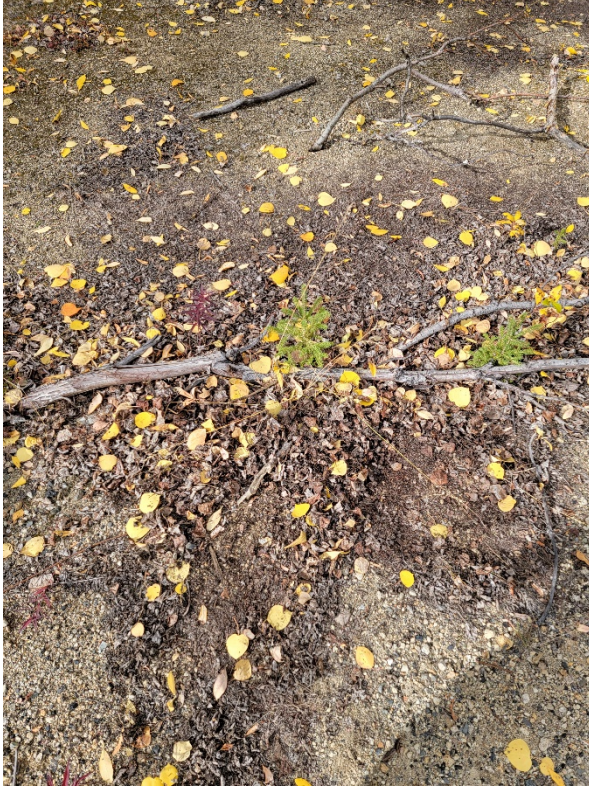
A steel rod was marking this drill hole location. The rod was removed and disposed of.

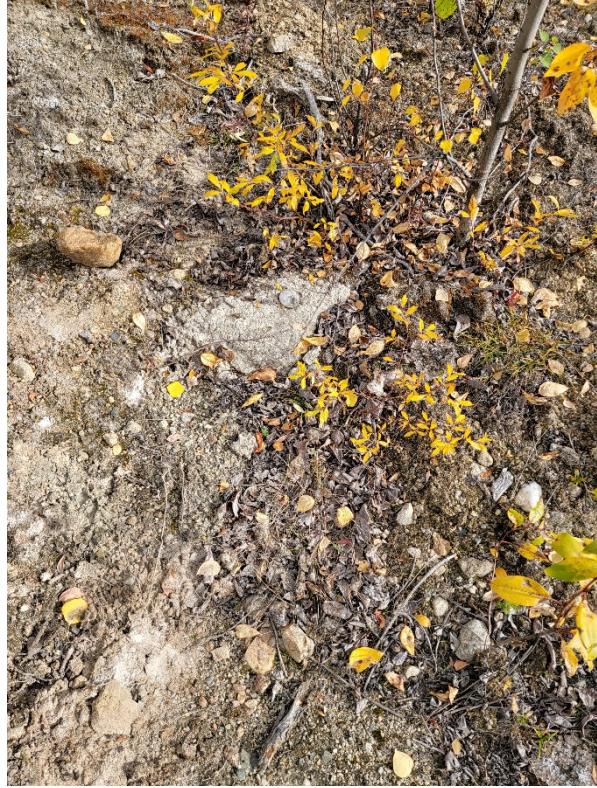
A steel rod was making the drill hole; it was removed.

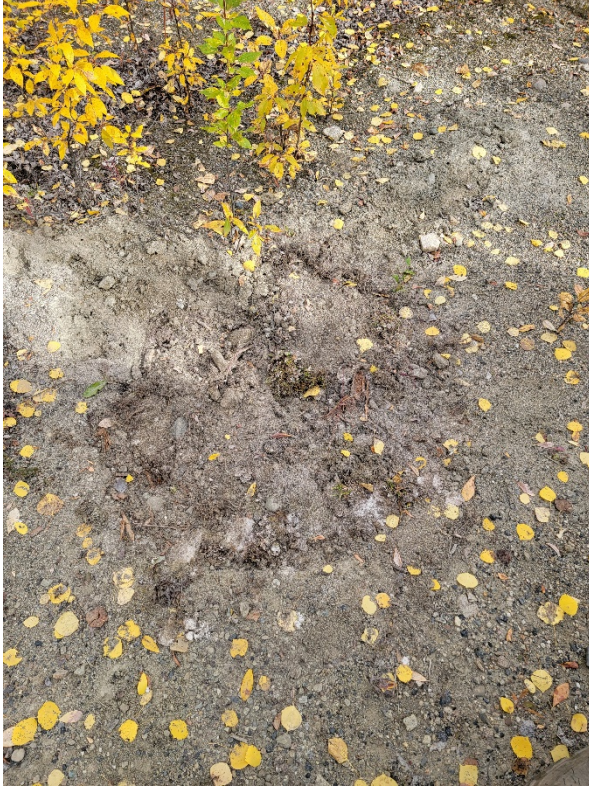
The drill hole had slightly collapsed. It was backfilled using material from the adjacent bank and then seeded using native seed from the area (GPS 08 V 6611376 E, 6881672 N).

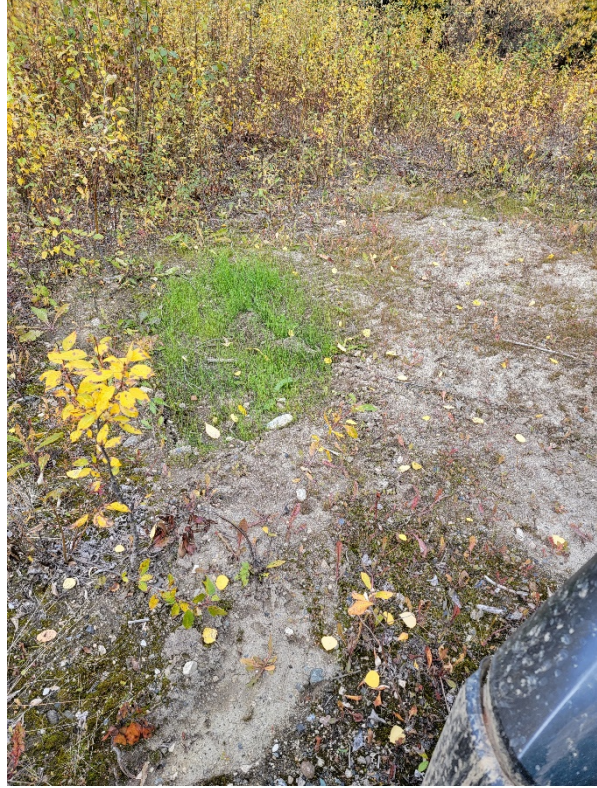
Drill hole that was backfilled in July and subsequent results of revegetation. (GPS 08 V 611241 E, 6881580 N).

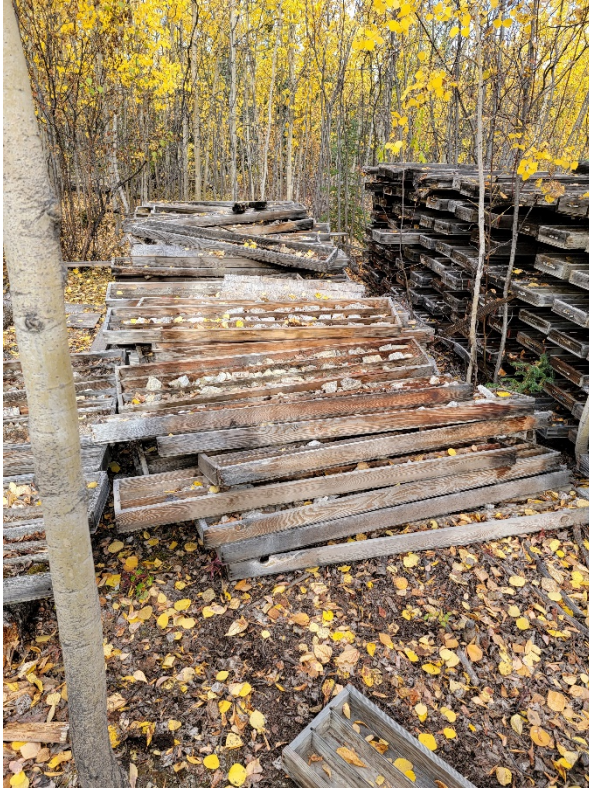
The disorganized core boxes.

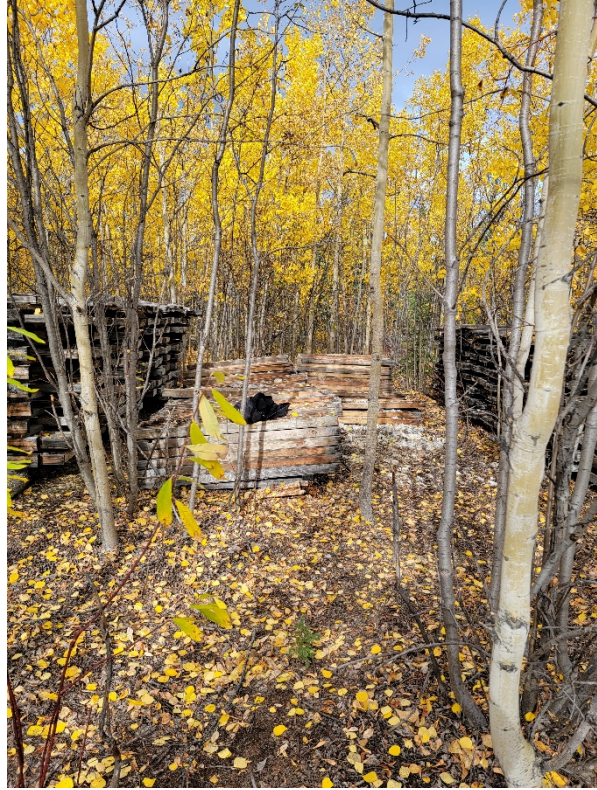
The core boxes were restacked, and any damaged core boxes were removed.

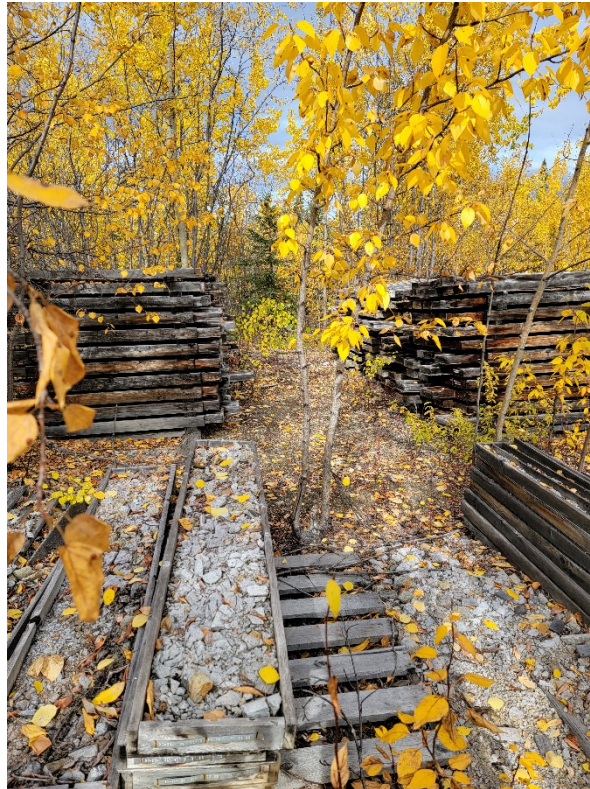
The core that had been removed was restacked on the wooden storage rack.

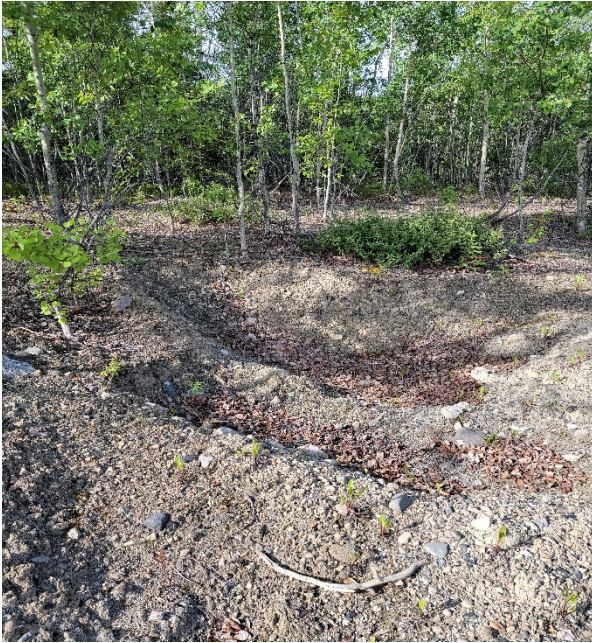
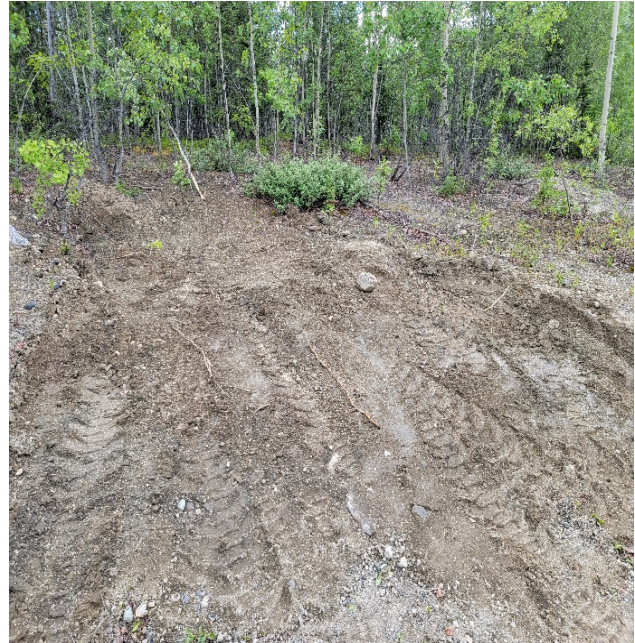
A disturbance (08 V 611342, 6881611) was backfilled with adjacent material and seeded.

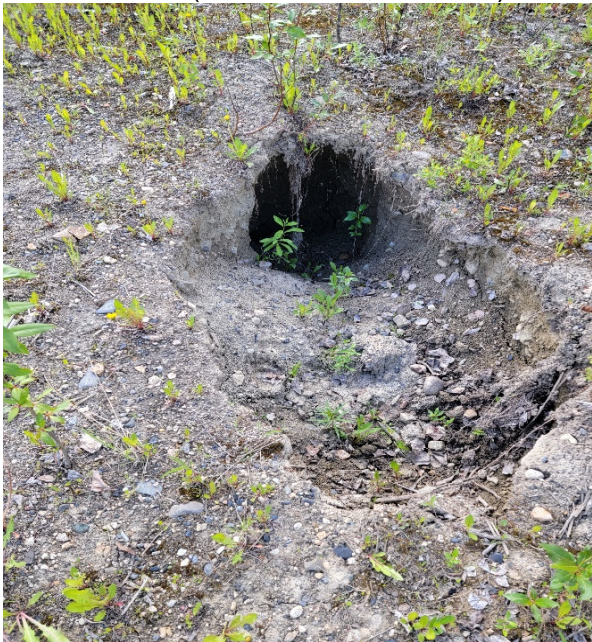
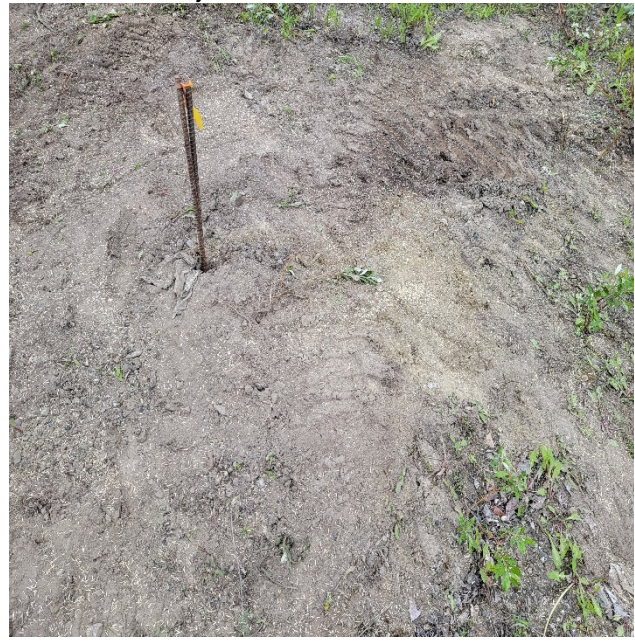
Collapsed drill hole (08 V 611244, 6881575)

The drill hole was backfilled and seeded. The steel rod was removed on July 25, 2022.

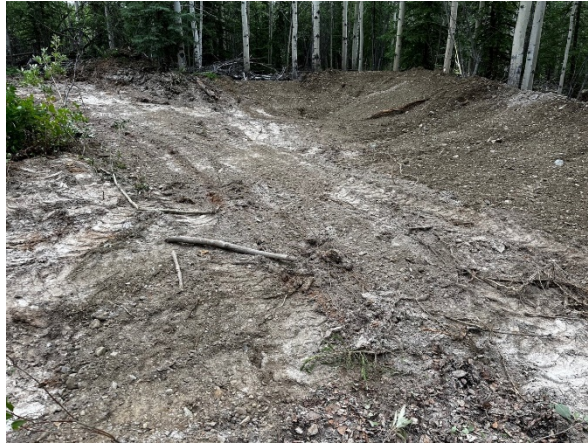
The pit identified in the initial report was reclaimed on July 25th, 2022.

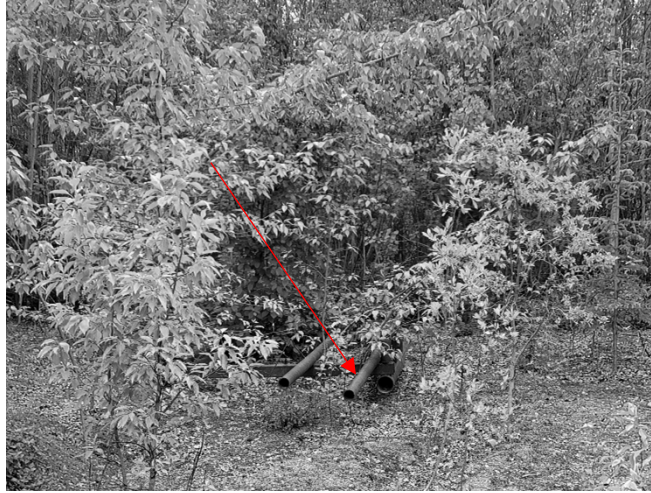
A structure constructed from drill rods to store drill rods (photo below) was found in the bushes. This structure is enormous and heavy, and vegetation has started to grow around the structure. GP is making arrangements to deal with this item, but it isn't very likely to occur before September 30th, 2022.

The red arrow illustrates this structure and how the vegetation has grown around the structure.

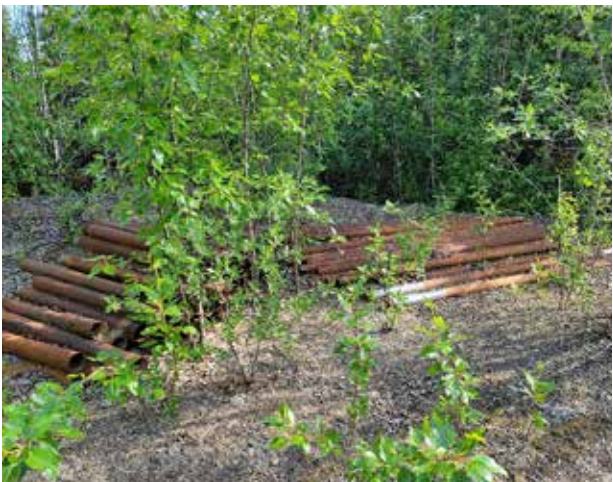
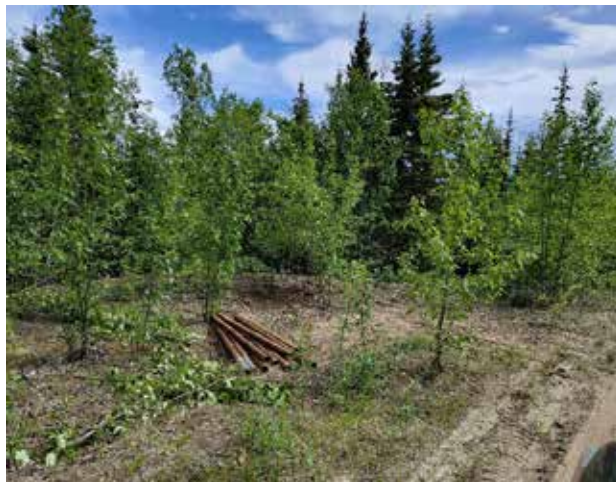
Drill Rod (08 V 611434, 6881627) – Drill rod removed, and remaining pieces were requested by the placer miner in the area.

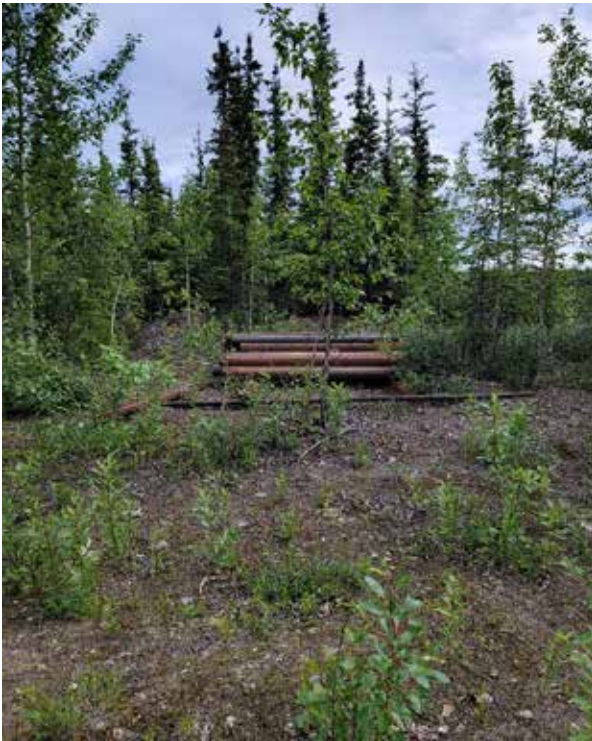
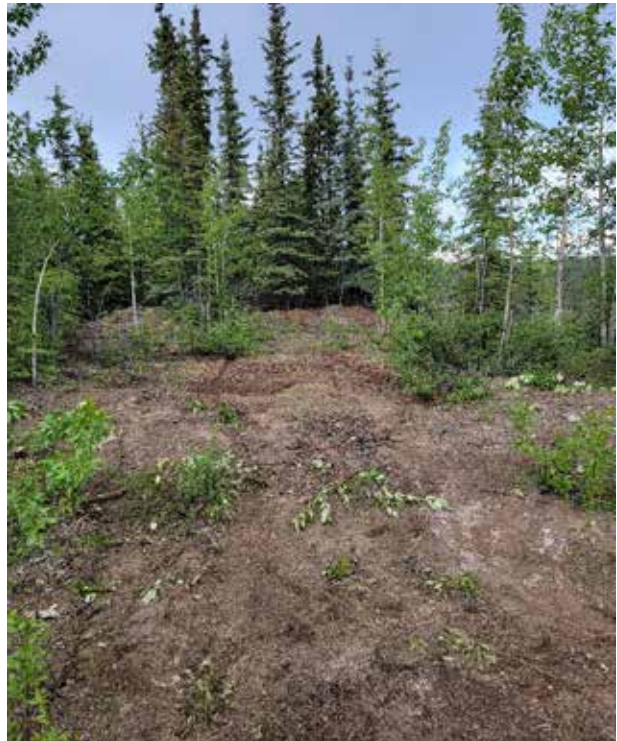
Drill rod which was stored near the access to Grew Creek. The materials were removed, and the area was seeded using a commercial seed mix see *Seeding* section for further information.

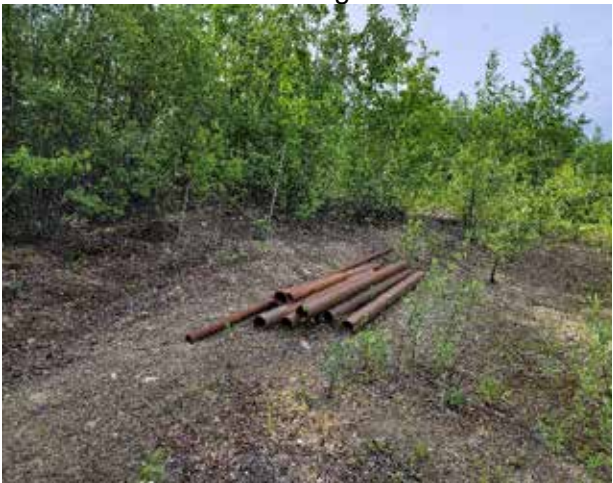
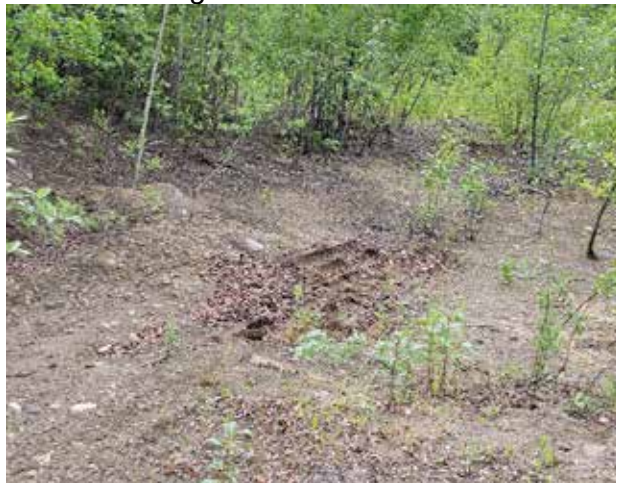
Drill Rod (08 V 611313, 6881596) – the drill rod was removed and relocated to the Ross River Waste Facility.

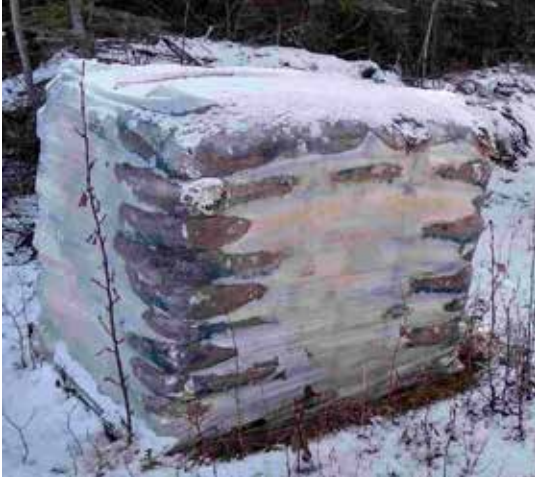
Pallet of drilling additives located on the main access road. Photo: J. Minder

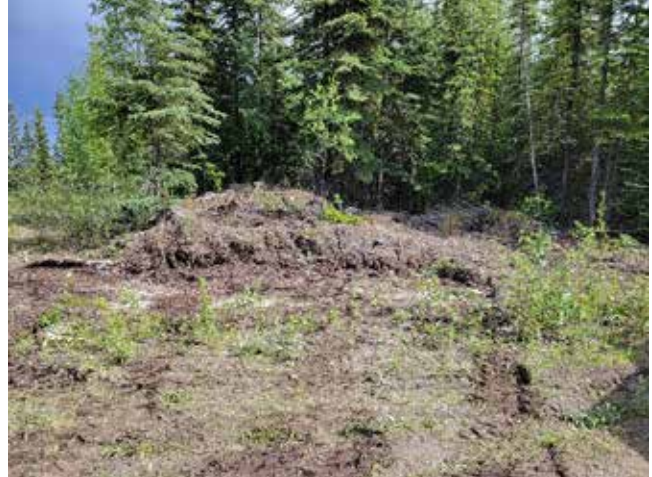
The drilling additives that were located on the main access road were removed and the area seeded.

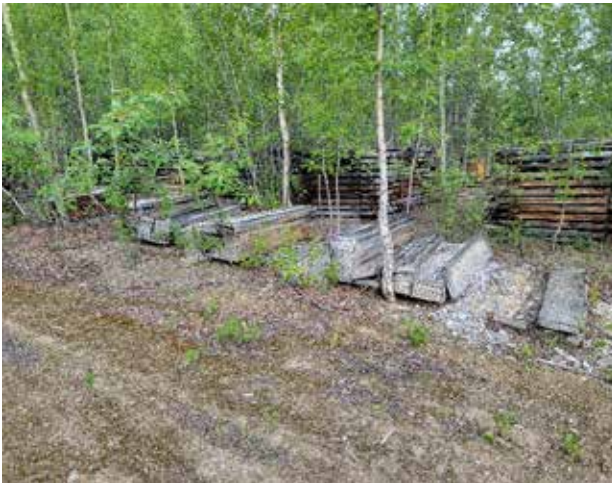
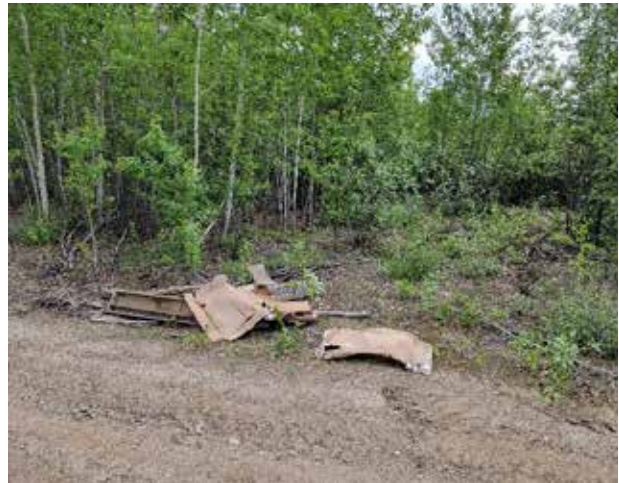
Core area (08 V 611288, 6881430) where there is a large accumulation of core boxes. The core boxes which were empty, were removed and are seen in the adjacent photo. These materials were removed.

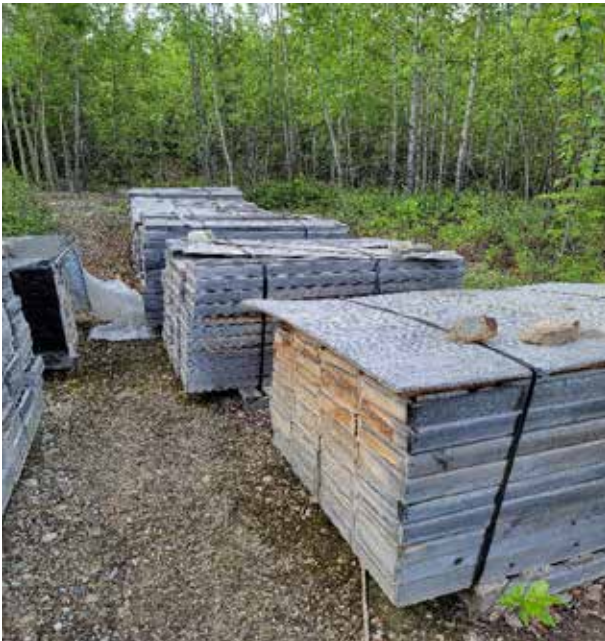
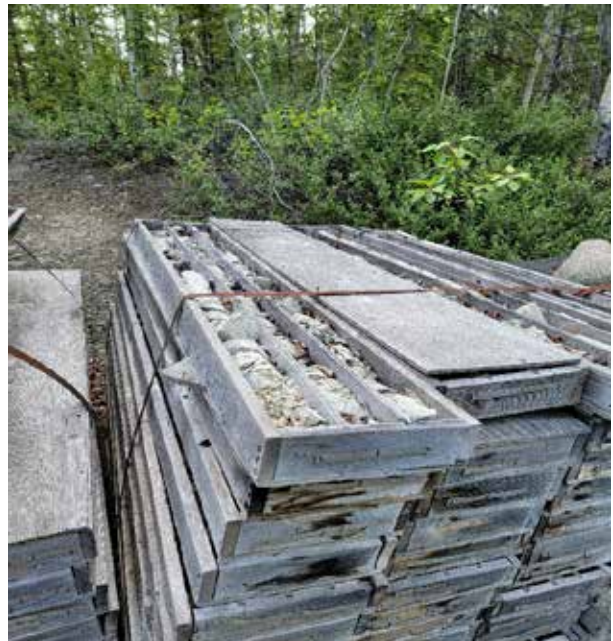
Additional Core Area (08 V 611469 6881753) no empty core boxes found.

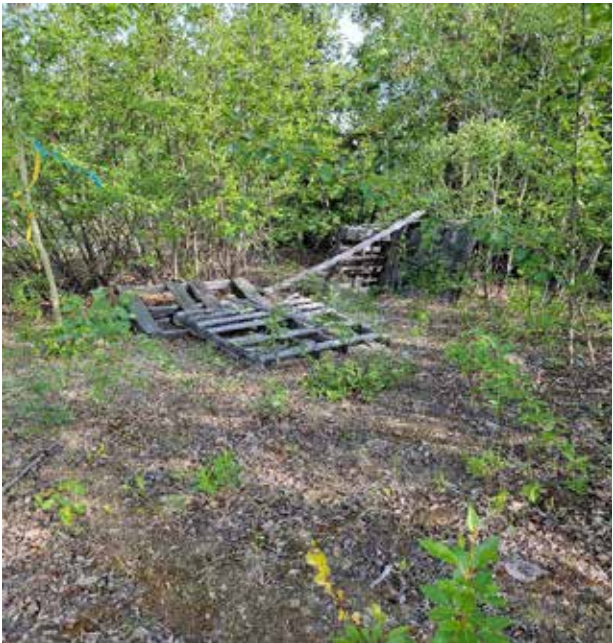
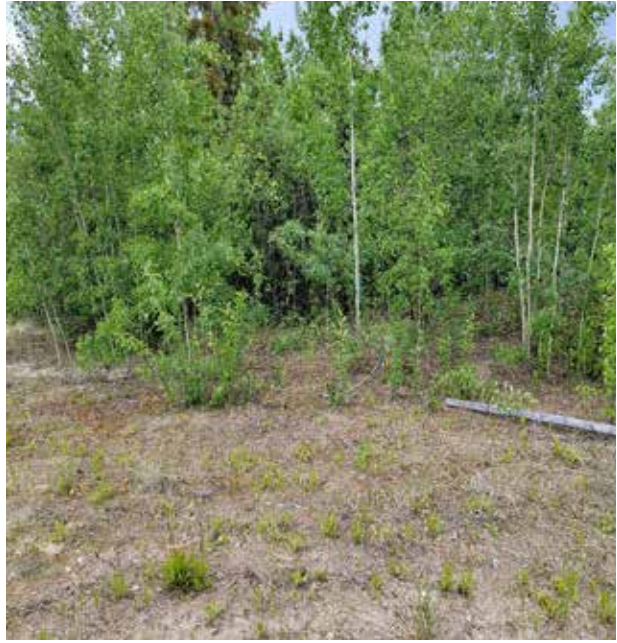
Pallets and other lumber located next to drill rod (08 V 611434, 6881627). These items were removed.

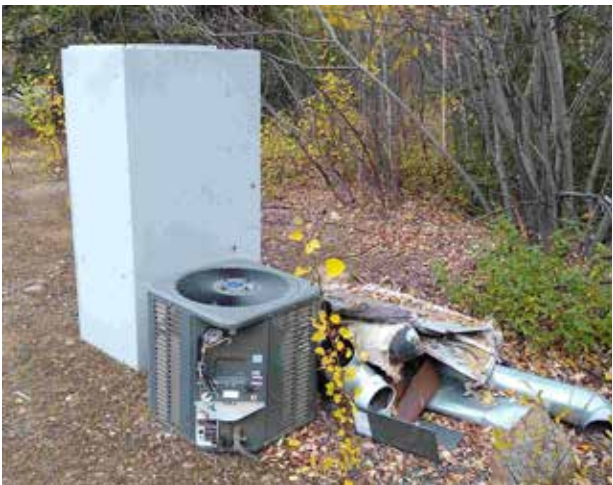
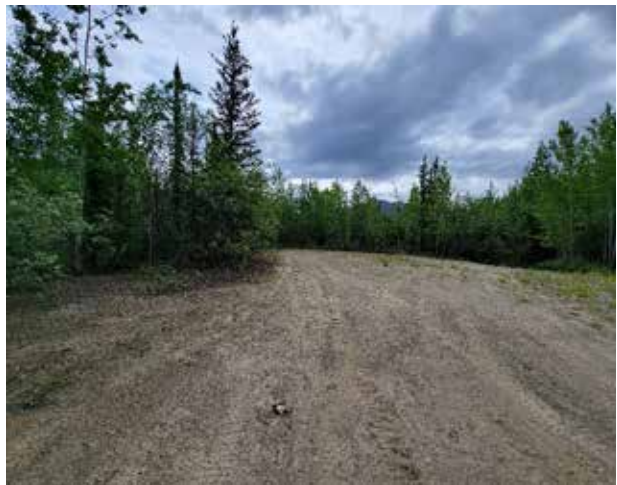
Heating unit adjacent to the top core area. The heating unit was removed.
Photo: J. Minder

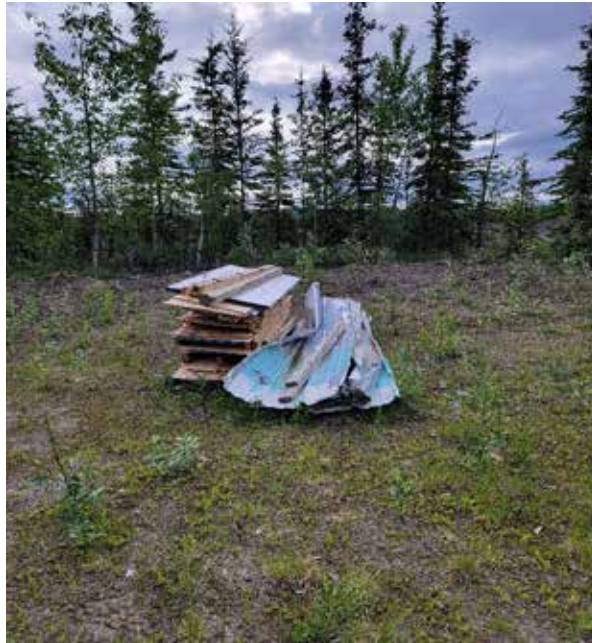
These materials were deposited after Mr. Minder's inspection. These items were removed.

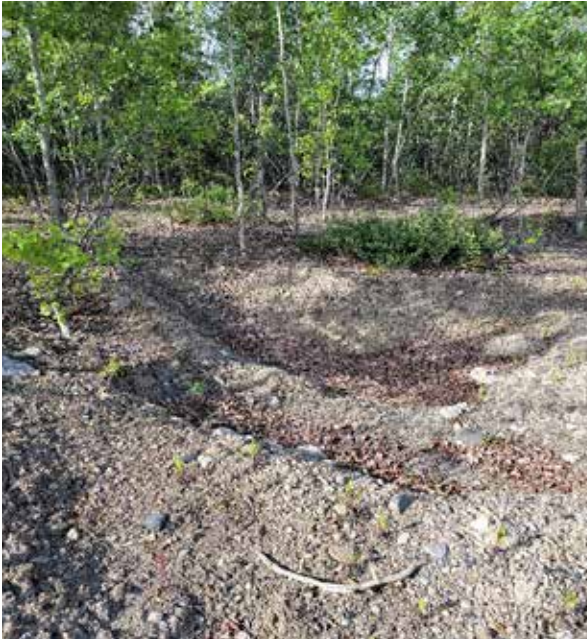
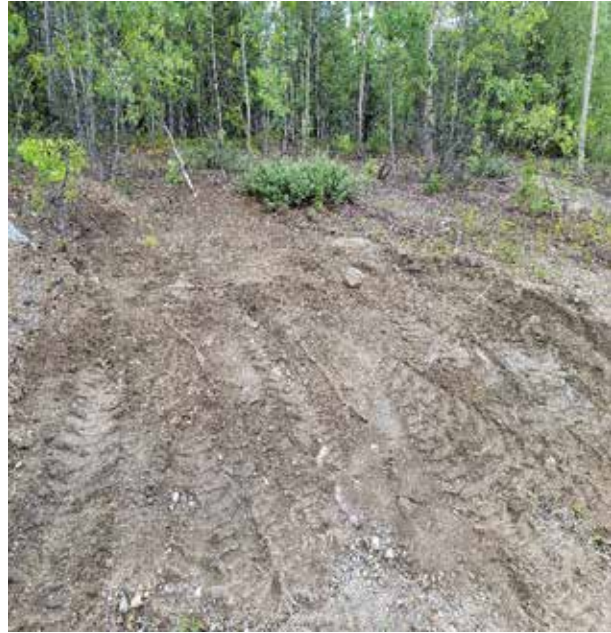
A disturbance (08 V 611342, 6881611) was back filled with adjacent material and then seeded.

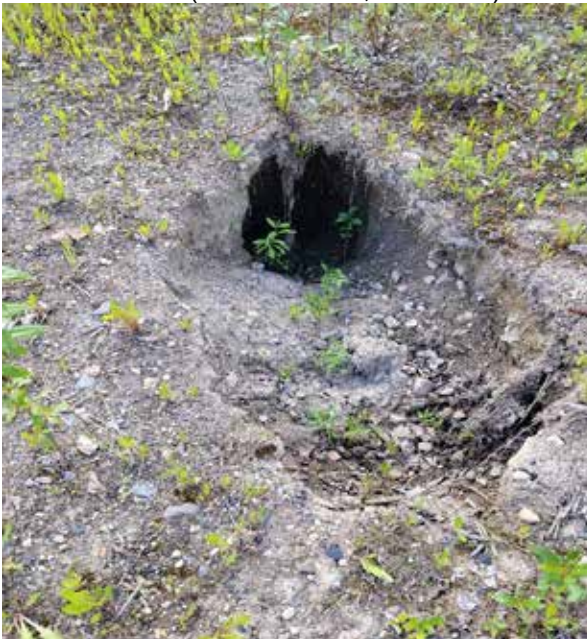
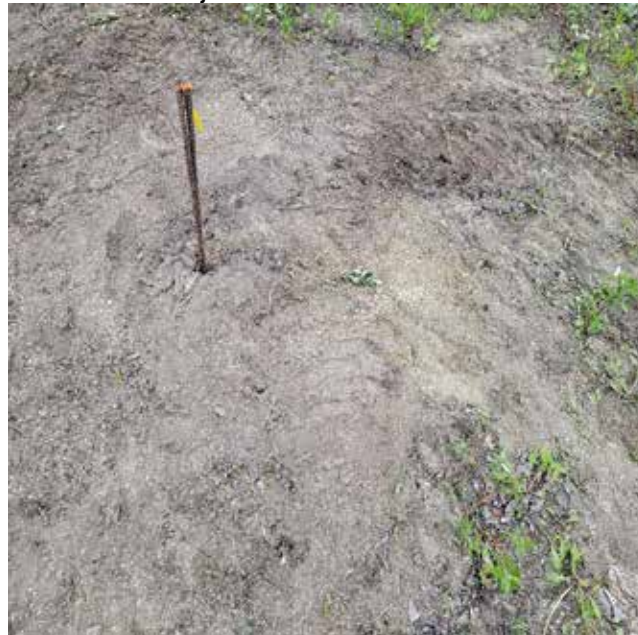
Collapsed drill hole (08 V 611244, 6881575)

The drill hole was backfilled and seeded. The rebar that was found in the hole was placed back on the drill hole.

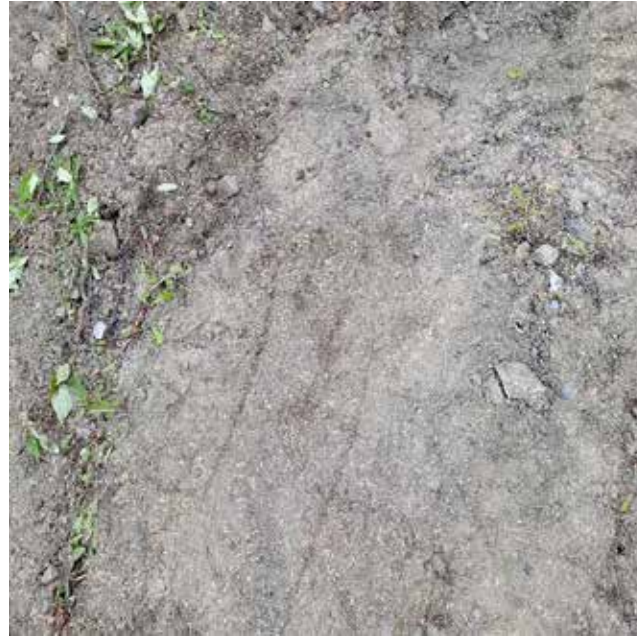
The collapsed drill hole was reclaimed and seeded.
