WELL-SITE INSPECTION REPORT

FROM: Field Office or Area: INUVIK Date: 10 JUL 71

RE: 10E SATAH River YT G-72-67-00-134-00

Location: 66.85778N 139.23250 Status: D&A<sup>Map</sup> 1967

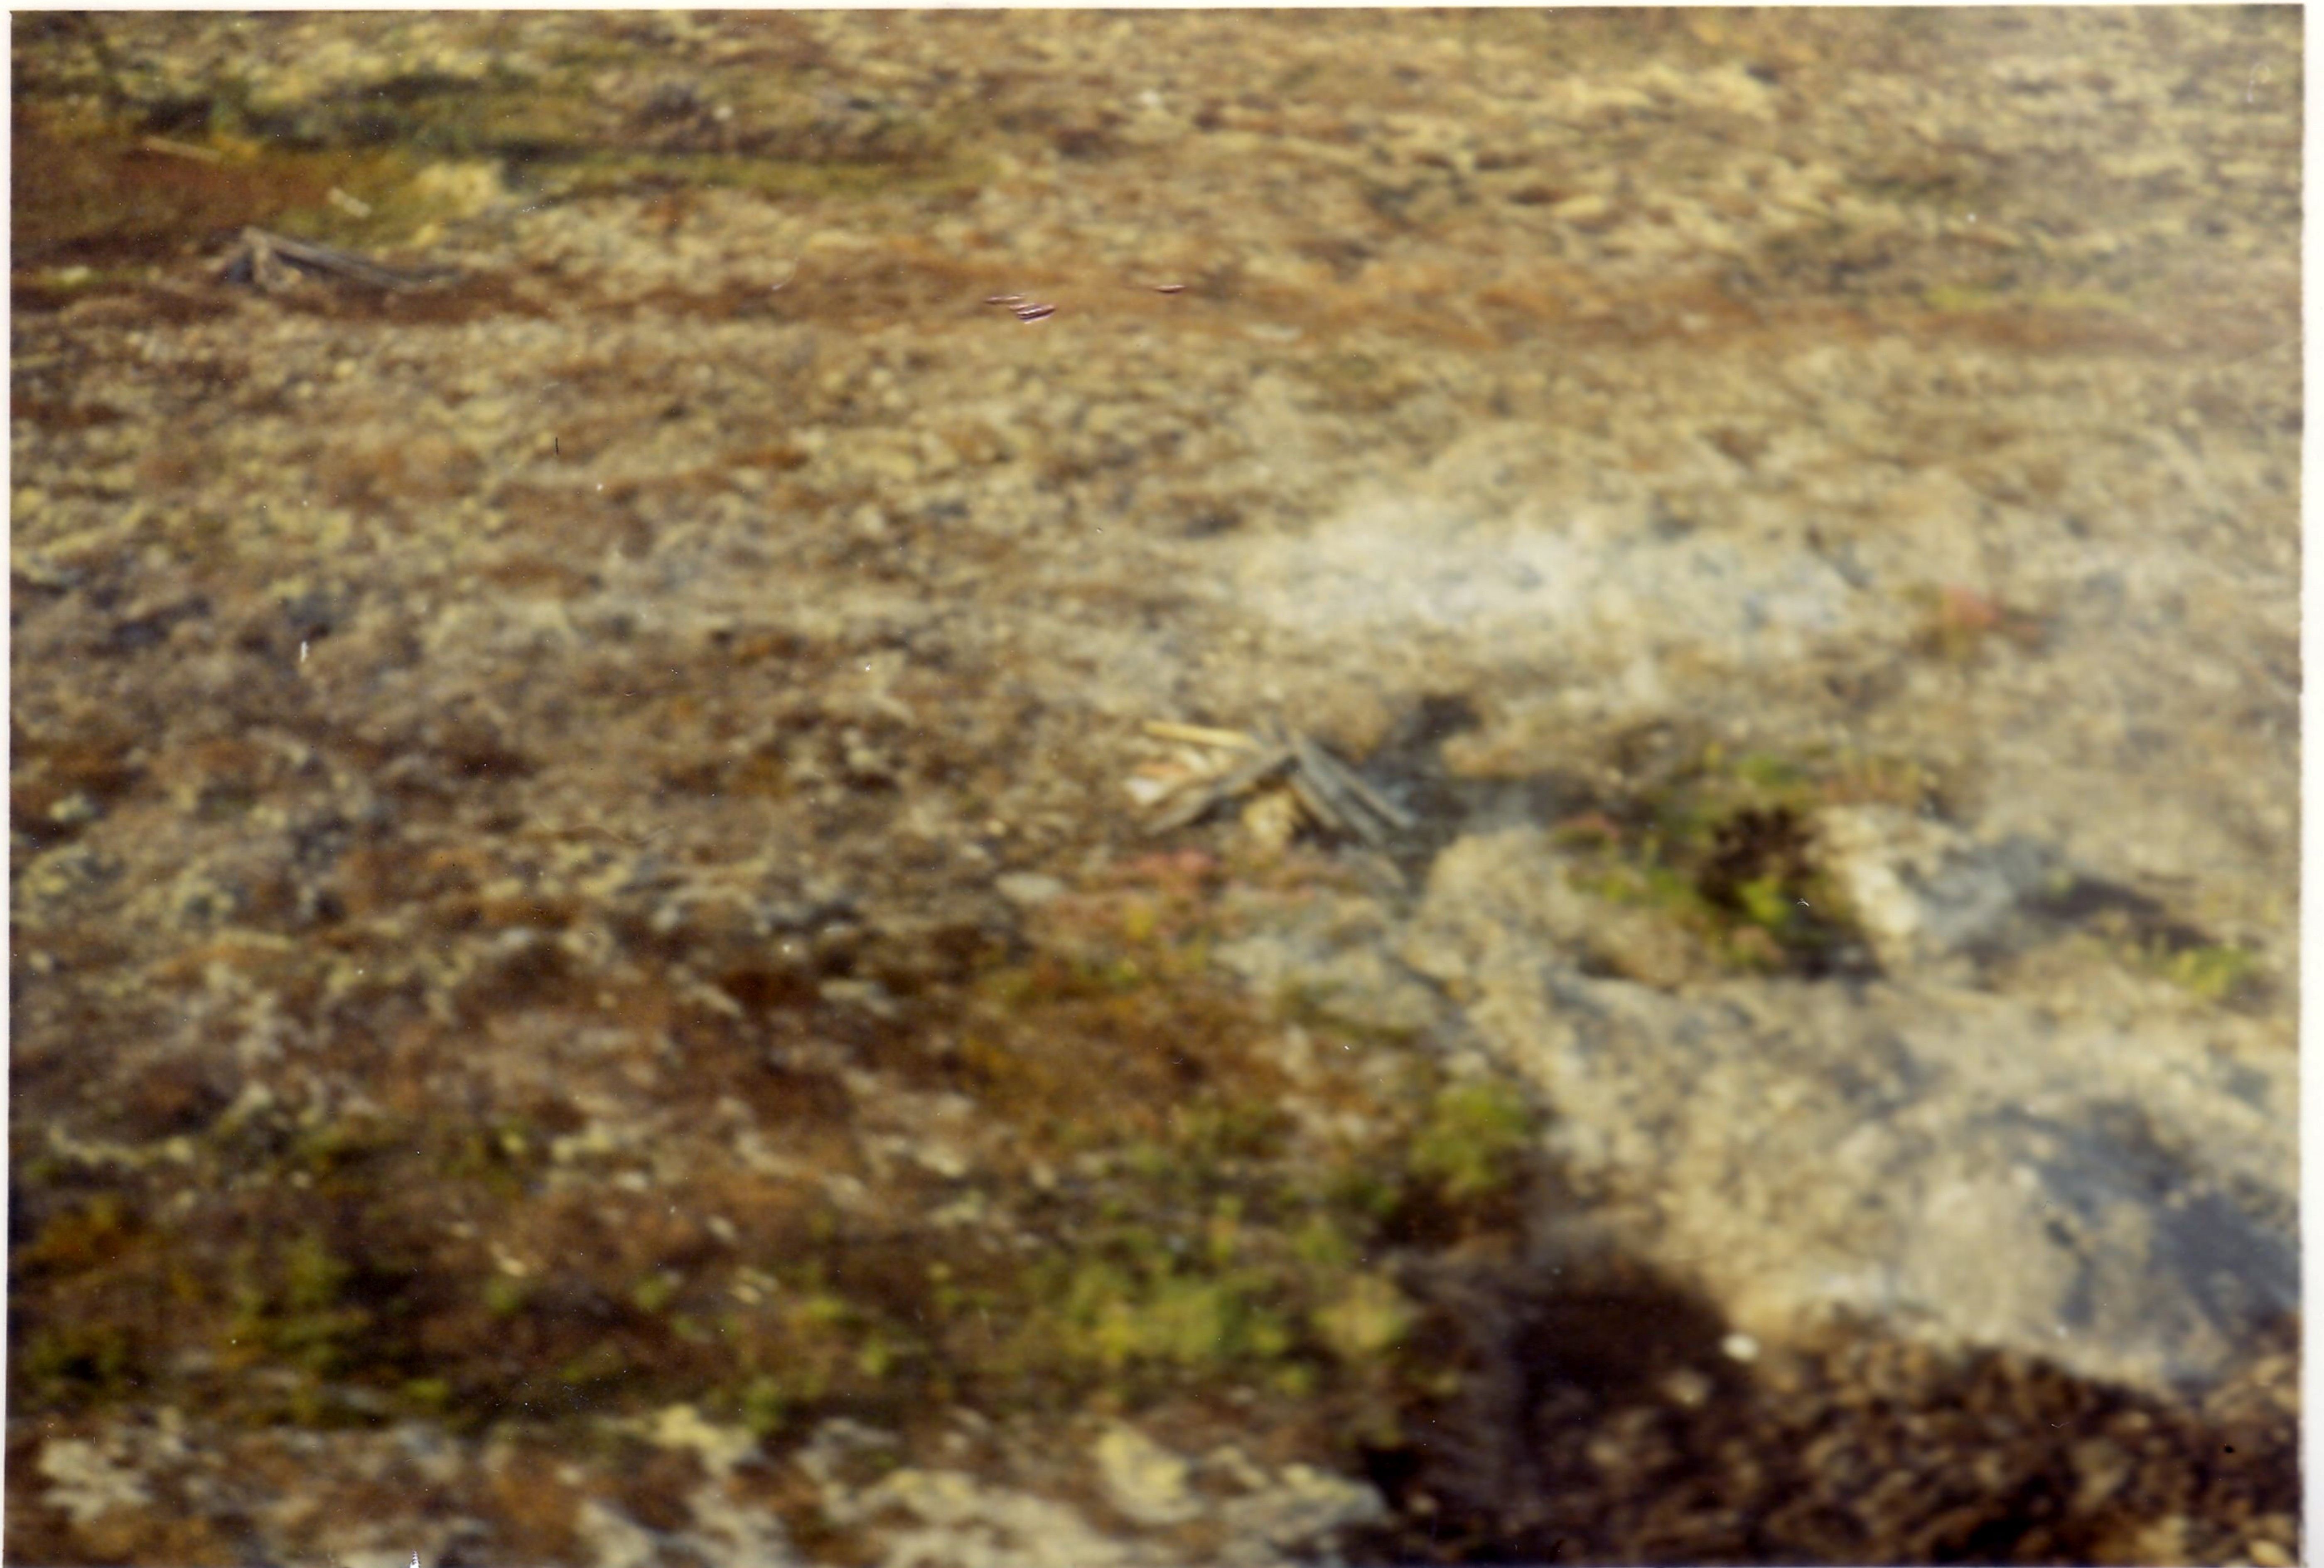
FILM NO 4  
35 MM (16) (17)

WOOD PILED FOR BURNING

1. BURN EXISTING WOOD PILES
2. PAINT IDENTIFIER PIPE AND PLATE FLUORESCENT ORANGE.
3. \_\_\_\_\_
4. \_\_\_\_\_
5. \_\_\_\_\_
6. \_\_\_\_\_
