WELL-SITE INSPECTION REPORT

RE: INC Husky Amoco Blackfly YT M-55

Location: 65.91528° N., 140.4319 ° W. Status: D & A 1970

This location was inspected by the undersigned on 9th July 1971 T. D. 6790

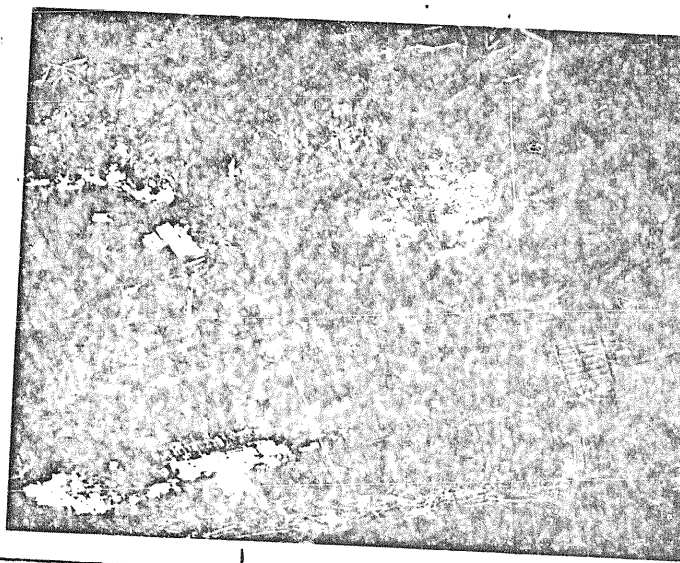
- 7. Identifier pipe not welded - just hanging in hole in top of casing.
- 8. Stream erosion 50' from well.
- 9. Timbers, plastic sheeting, barrels, steel rope all to be buried

- 1. All lumber to be piled and burned.
- 2. Hole in top of casing to be plugged.
- 3. Timber around cellar to be removed and cellar backfilled to a level above casing flange.
- 4. Pipe to be welded to top of casing.
- 5. Paint identifier pipe and plate fluorescent orange.
