WELL-SITE INSPECTION REPORT

FROM: Field Office or Area: Inuvik Date: 9th July 1971

RE: Socony Mobil Western Minerals Tuttle YT N-5 *100-30-26-75*

Location: 66.41422°N., 136.77297°W. Status: D & A July 1965

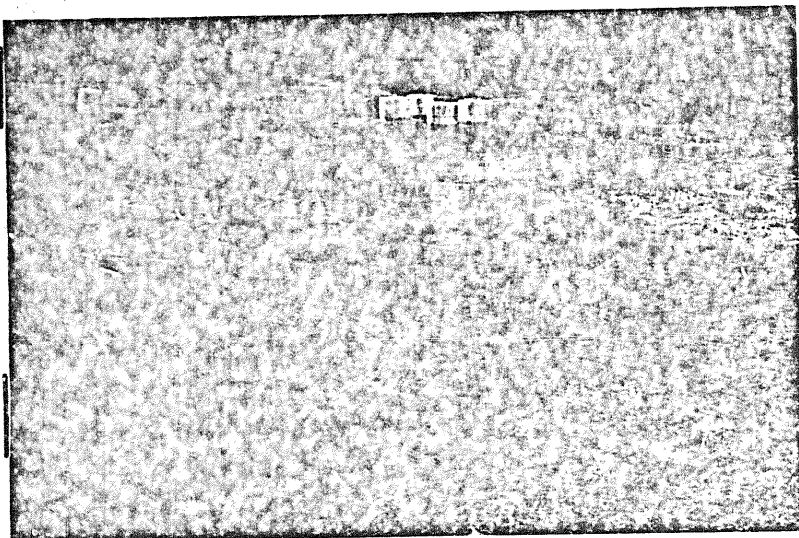
Identified as SM-WM South Tuttle YT B-34

Lease never cleaned up.

2" x 3" angle iron used instead of 2" pipe. The angle iron was not welded to top of casing properly and has fallen off.

6 tanks on lease.

- 1. Incorrectly identified.
- 2. Identifier to be welded or cemented on top of casing.
- 3. Remove storage tanks
- 4. Paint identifier angle and plate fluorescent orange.
- 5. Cut off all piles at G.L.
- 6. Burn or bury all lumber

- 7. Bury all scrap iron, pipe, etc.
