WELL-SITE INSPECTION REPORT

FROM: Field Office or Area: INUVIK Date: 10th July 1971

RE: SHELL PEELE R YT K-9 66-20-234-00

Location: 66.30992°N., 134.01728°W. Status: DEA March 1967

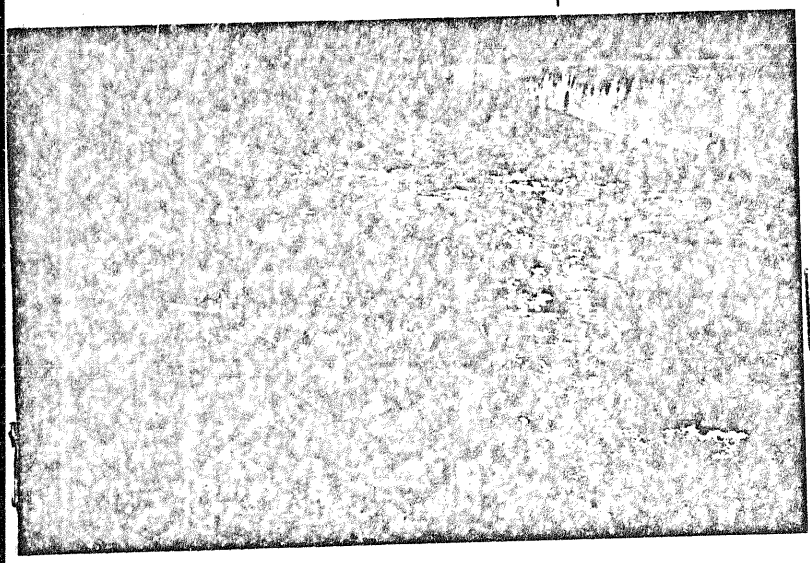
Identified as Shell Peel K-9

1" pipe stead of minimum 2"

Lease never cleaned up

Sump never backfilled

15 drums on lease

4 coils wire rope

- 1. Pile and burn all lumber
- 2. Bury or remove all drums, scrap iron and wire rope.
- 3. Paint identifier pipe and plate fluorescent orange.
- 4. _____
- 5. _____
- 6. _____
