WELL-SITE INSPECTION REPORT

RE: SOBC Blackstone YT D-77

Location: 65.76966°N., 137.24855°W. Status: D & A January 1963

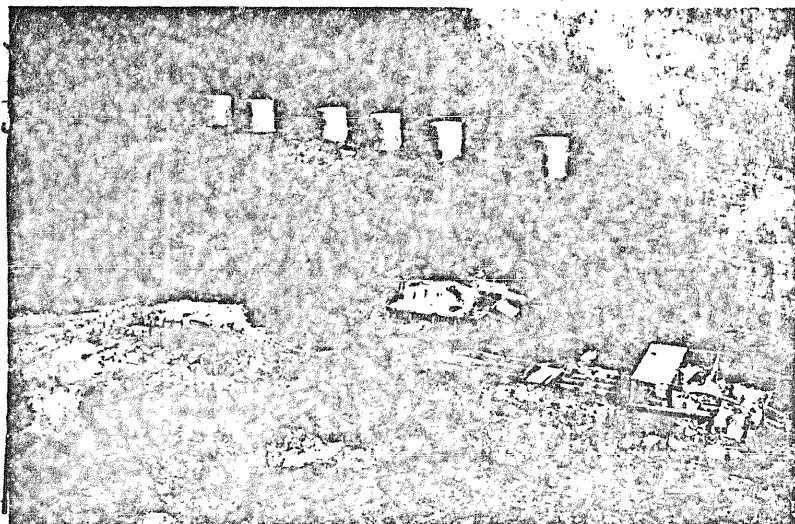
Identifie as Cal-Std YT D-77

Looks like there was a fire here.

1. Incorrectly identified
  2. Identifier pipe to be welded to top of casing or placed in cement block above casing.
  3. Paint identifier pipe and plate fluorescent orange.
  4. Cut off piles flush with G.L. Backfill cellar.
  5. Pile and burn all lumber
  6. Bury or remove all iron, sacks (stacked on wooden platform) steel drums and other junk.
  7. Remove storage tank.
- Very bad lease, never cleaned up.
