NATIONAL ENERGY BOARD/OFFICE NATIONALE DE L'ÉNERGIE

Memorandum/Note de Service

Subject/Objet: (DRAFT) Yukon Well Inspection

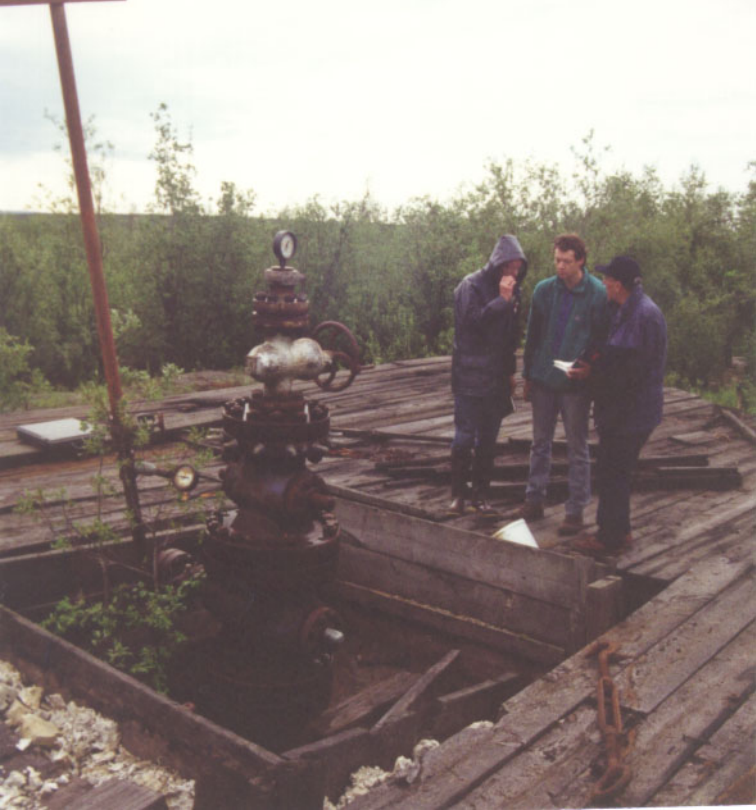
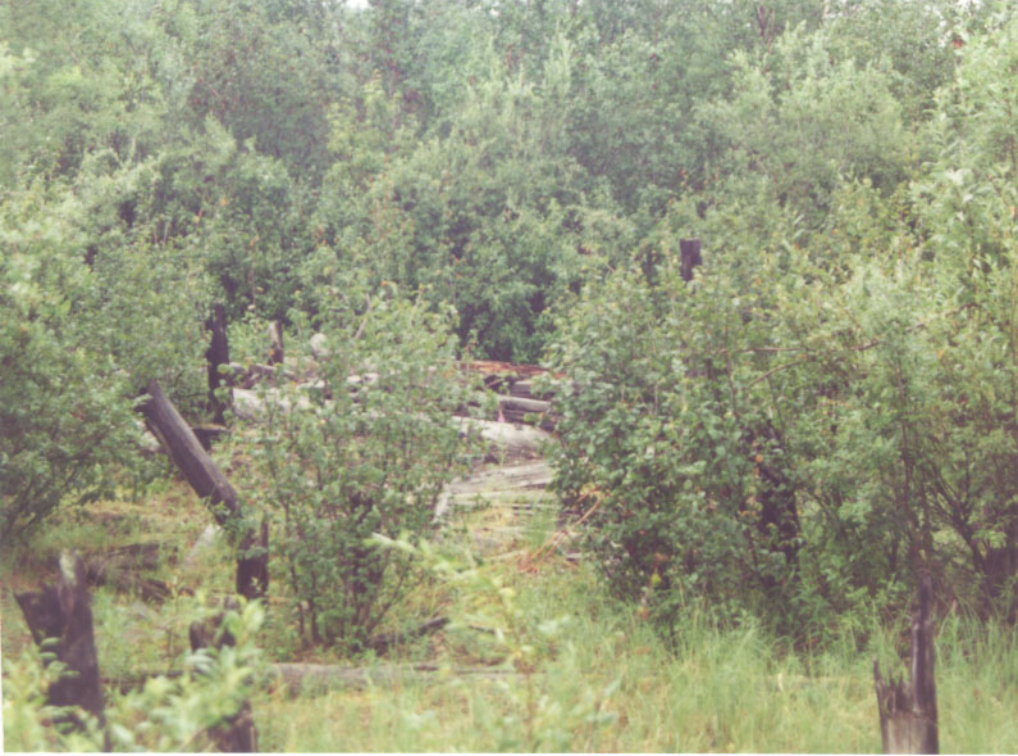
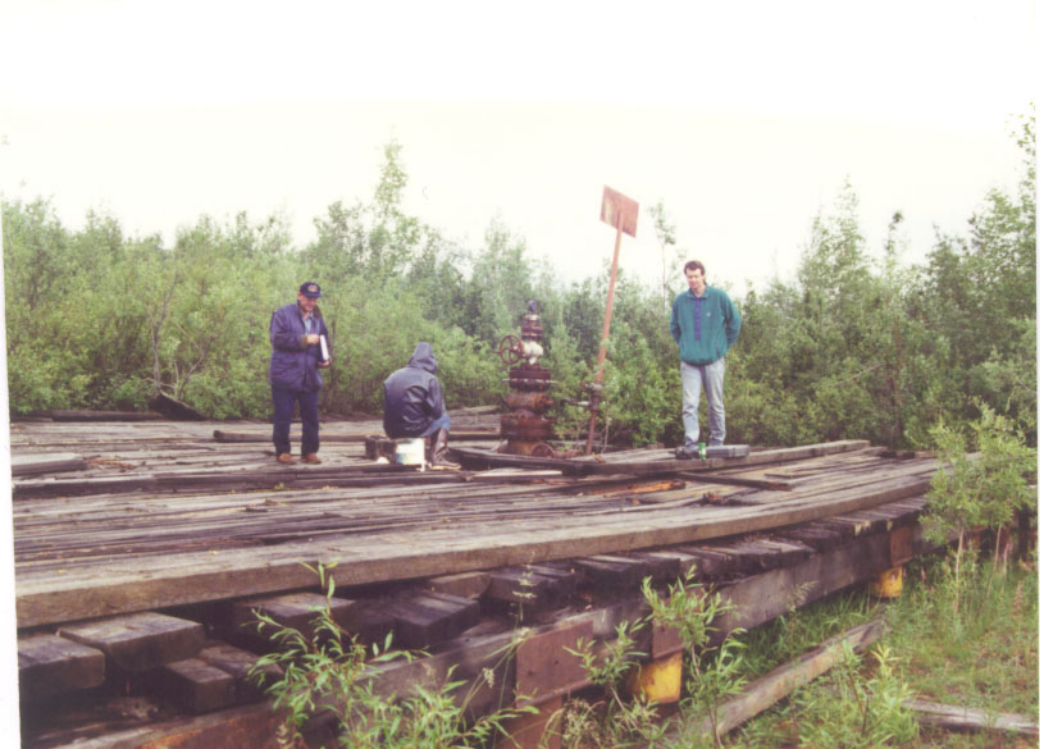
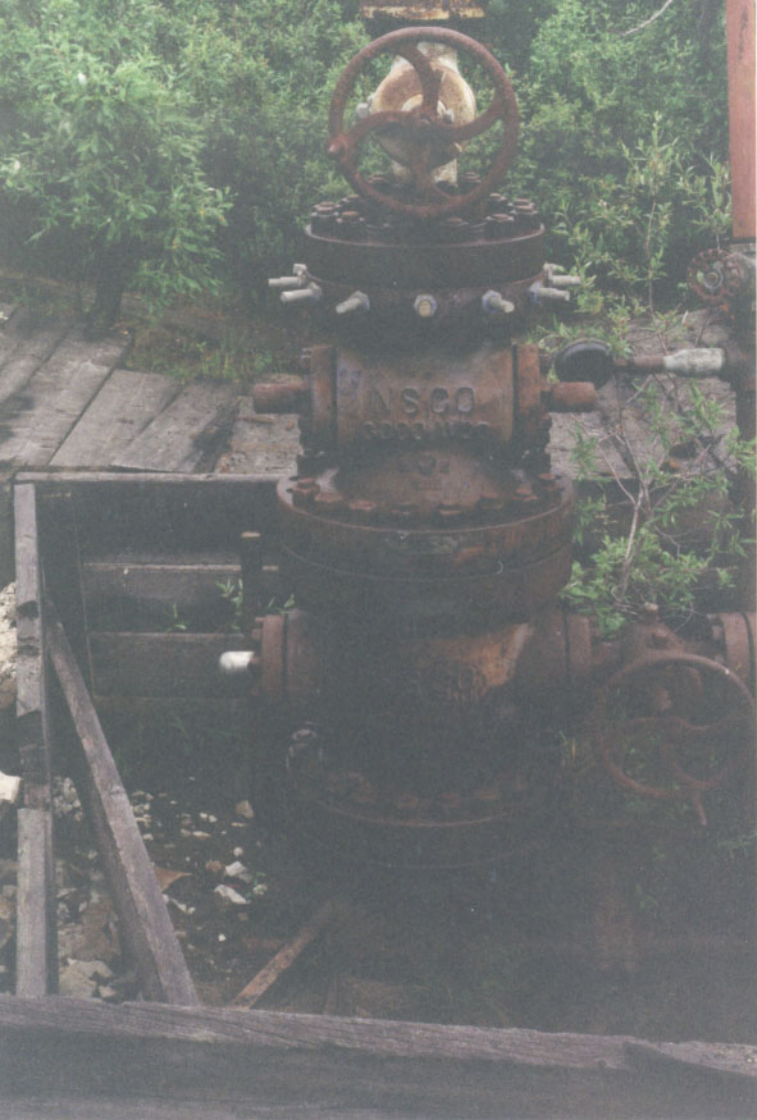
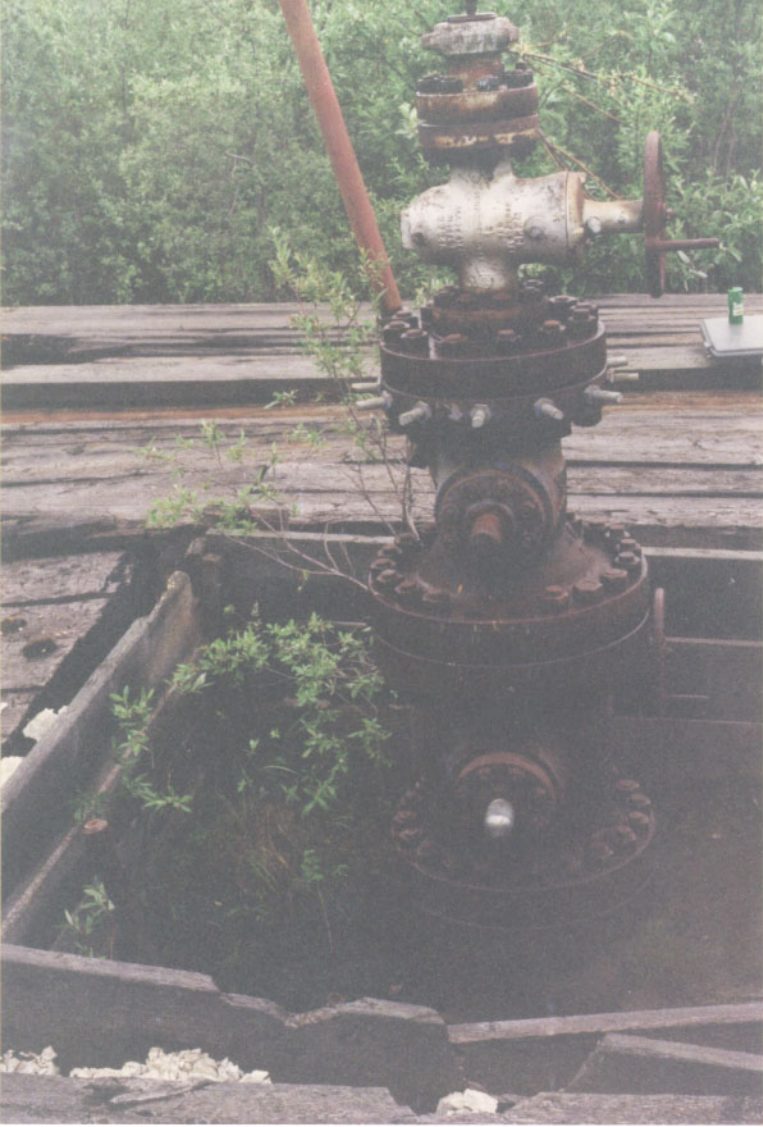
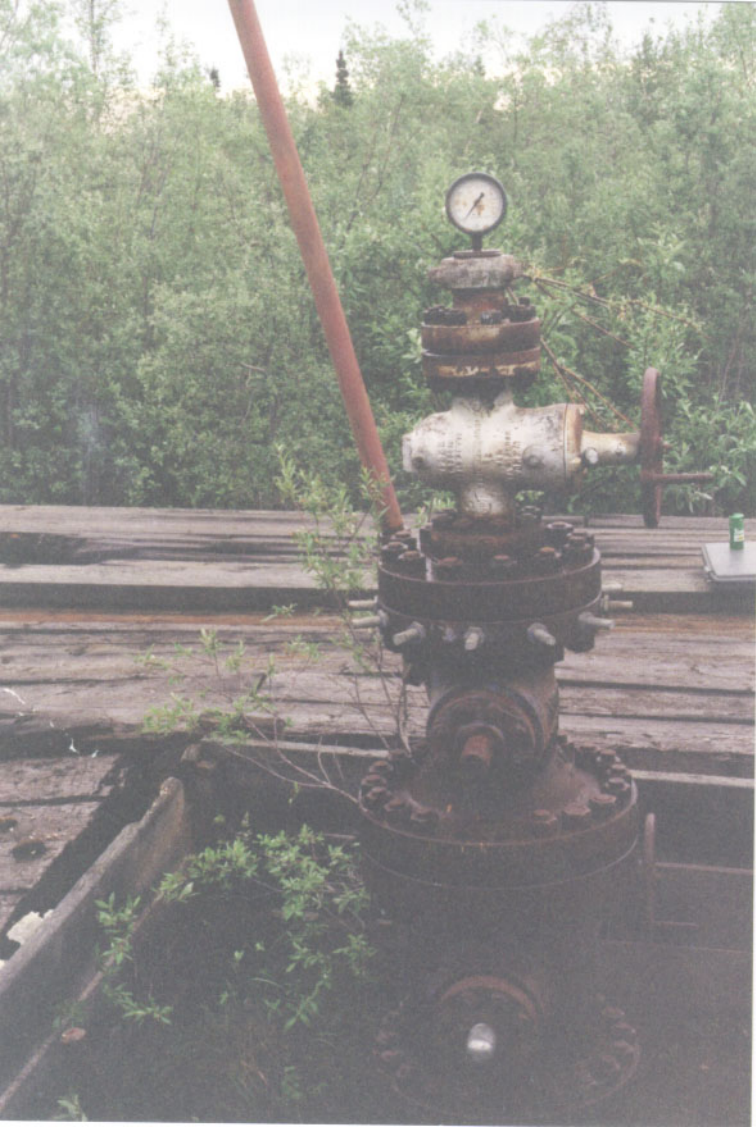
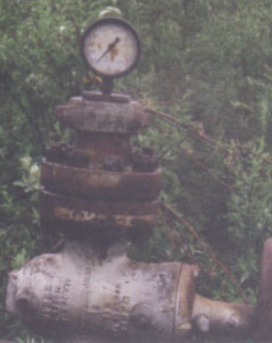
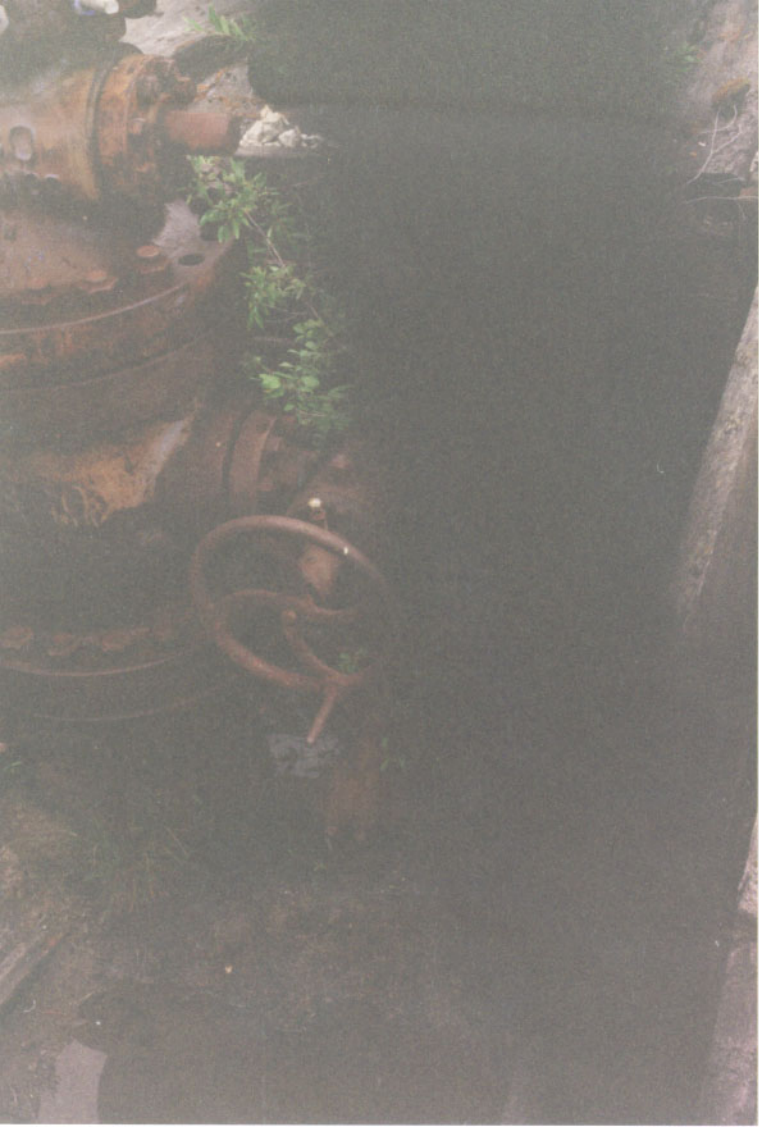
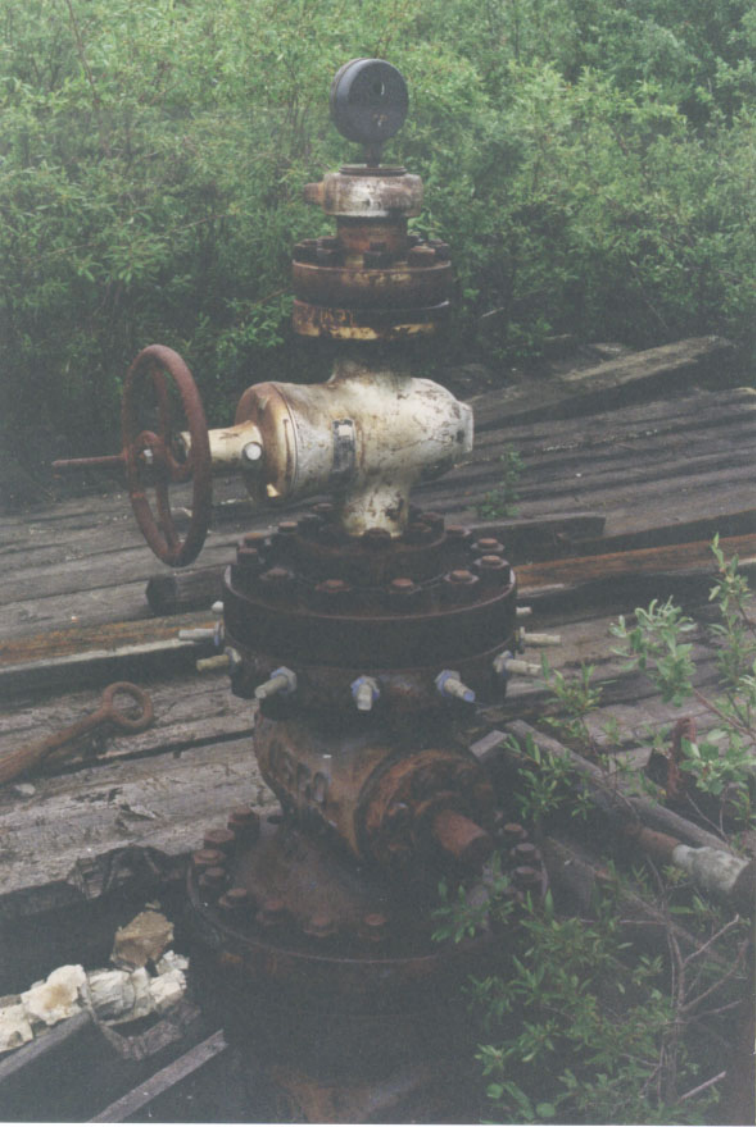
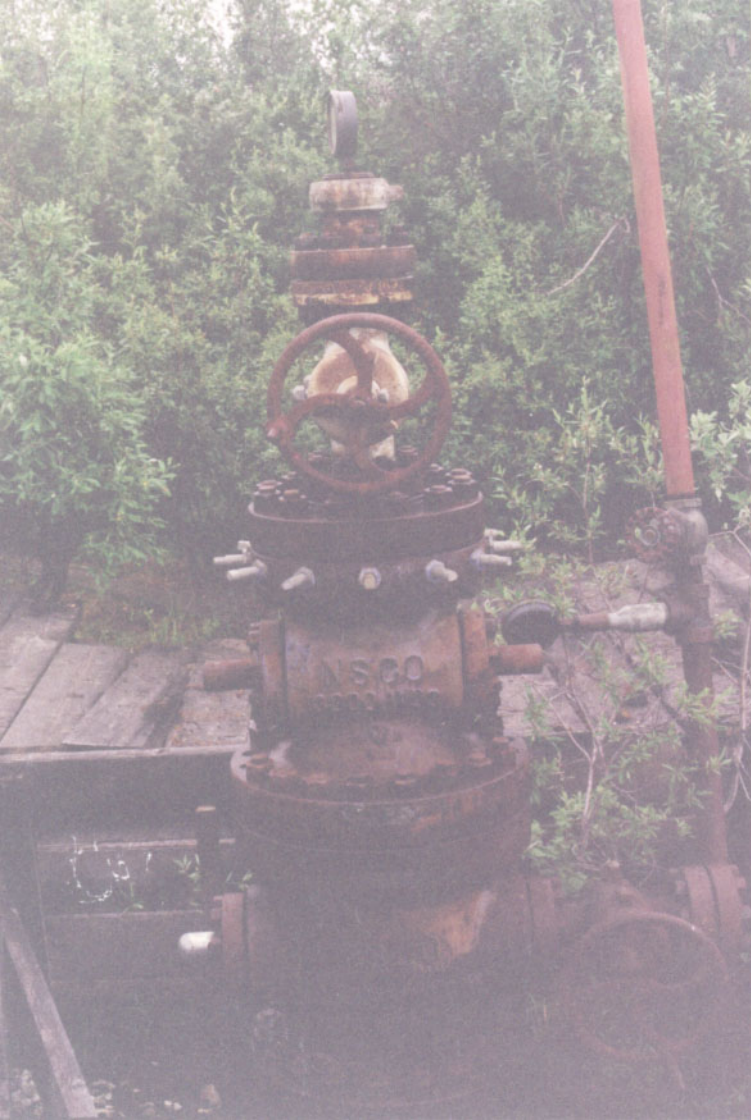
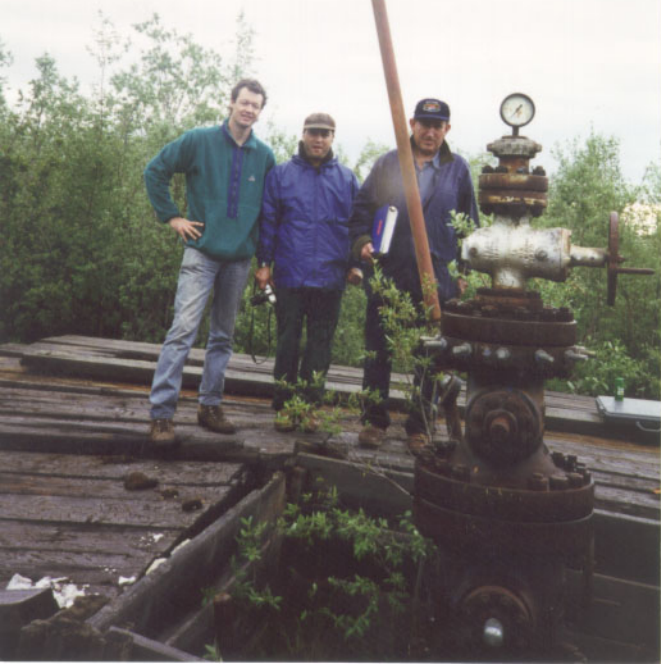
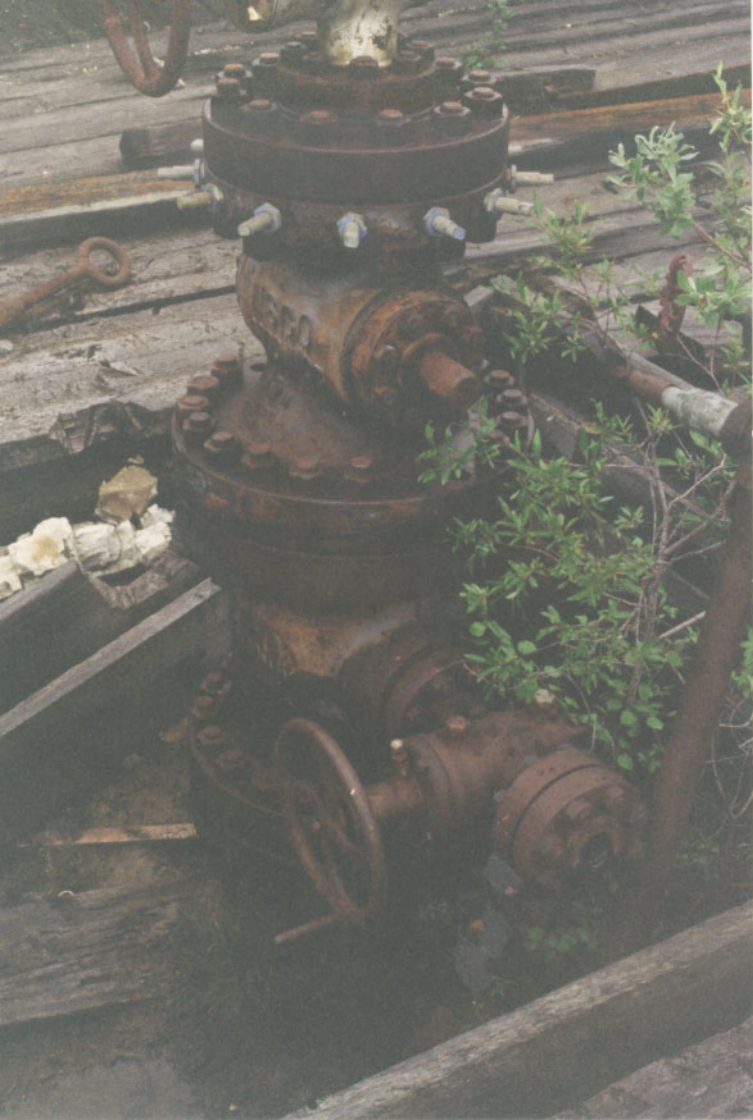
Page 17 & 18

The eight photographs are of Peel Plateau Eagle Pains YT No. 1, ADW 0041. This was the first well ever to be drilled in the Yukon Territory. This well was drilled in 1957 and abandoned in 1958. There was no pressure on the wellhead. The down hole abandonment has been done satisfactorily and it only requires a surface abandonment. There are no concerns with this well except that the surface abandonment has never been completed. As was suggested perhaps the wellhead could be cleaned up, painted and left; as this was the first well in the Yukon.
