Subject: 2022 Annual Geotechnical Inspection – Mining Related Earth Structures – Revision 1

2022 Annual Geotechnical Inspection Mining Related Earth Structures

Revision 1

JANUARY 3, 2023 ISSUED FOR USE FILE: 704-ENG.WARC04286-01

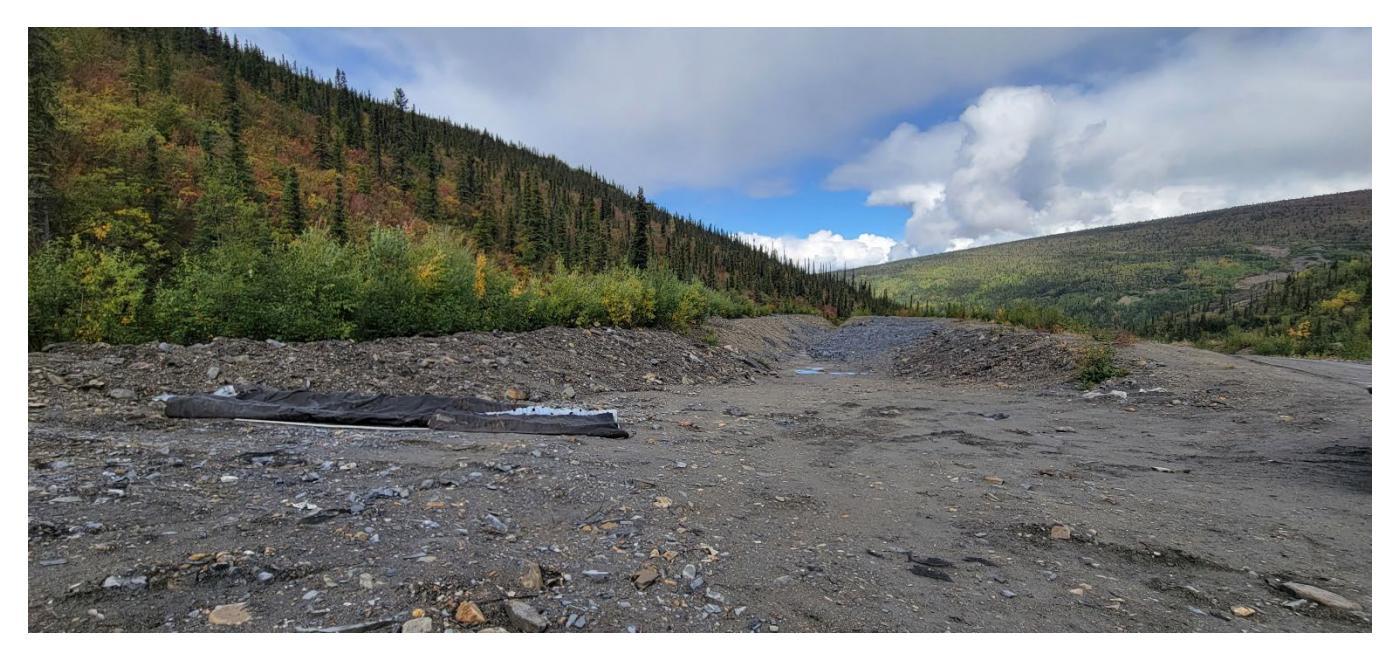
The PAG waste storage facility is located south of the Bellekeno portal, as shown on Figure 1, and has not been used since 2013, but currently stores some waste rock.

The PAG observed during previous inspections appears to have been removed, and Tetra Tech understands it was placed underground.

At the time of the inspection, the remaining perimeter berms appeared intact with no visible signs of instability or distress. A drainage relief was excavated at the downstream end of the facility to minimize water ponding.

No remedial actions related to geotechnical performance are recommended at this time.

Photo 1: Bellekeno PAG Storage Facility, facing north (I. MacIntyre, Aug. 28, 2022)

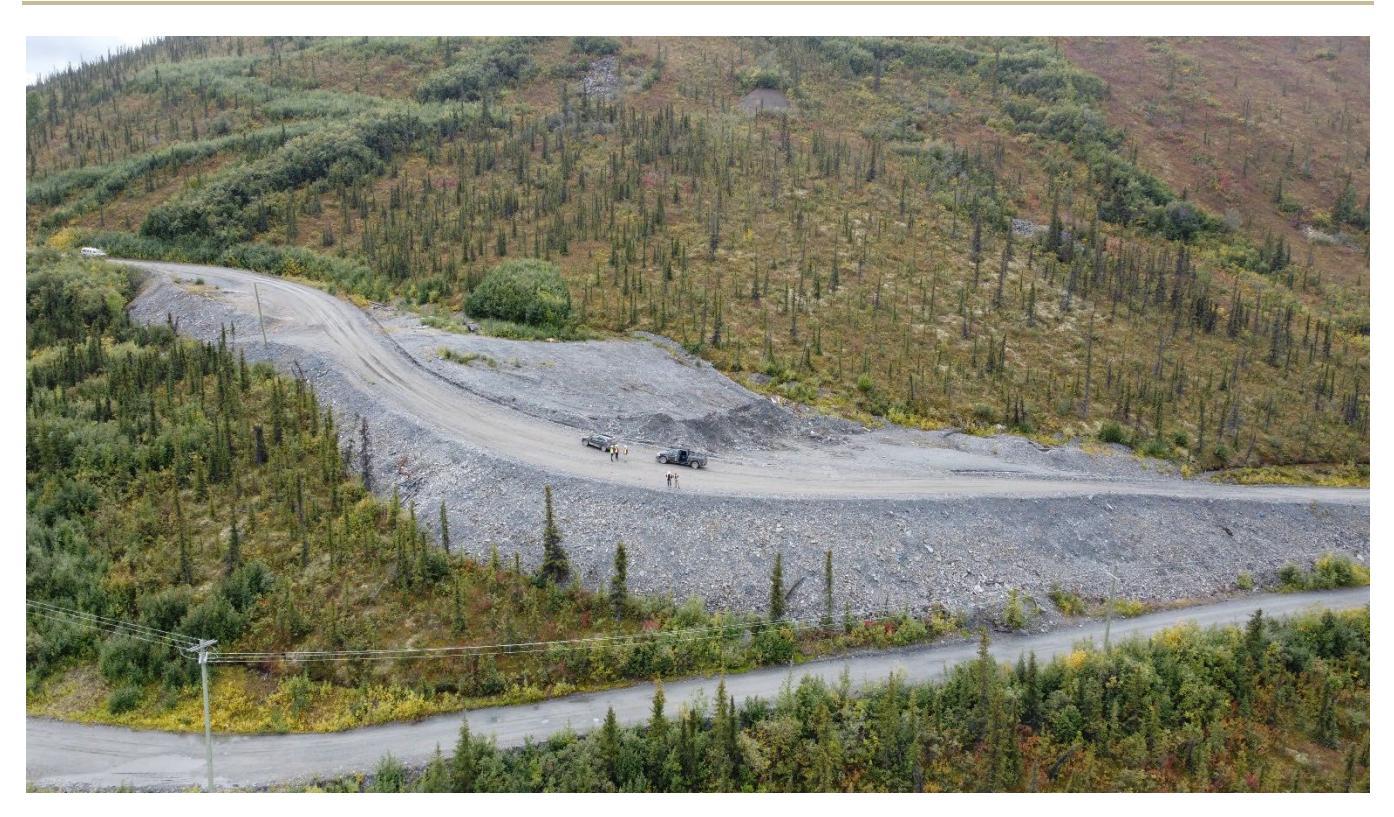
At the time of the inspection the waste rock pile crest, slopes, and toe showed no signs of deep-seated instabilities, significant movement, distress, sloughing or bulging. The condition of the facility appears generally unchanged from previous inspections.

No remedial actions related to geotechnical performance are recommended at this time.

Photo 2: Bellekeno Road Waste Rock Pile, facing southwest (I. MacIntyre, Aug. 28, 2022)

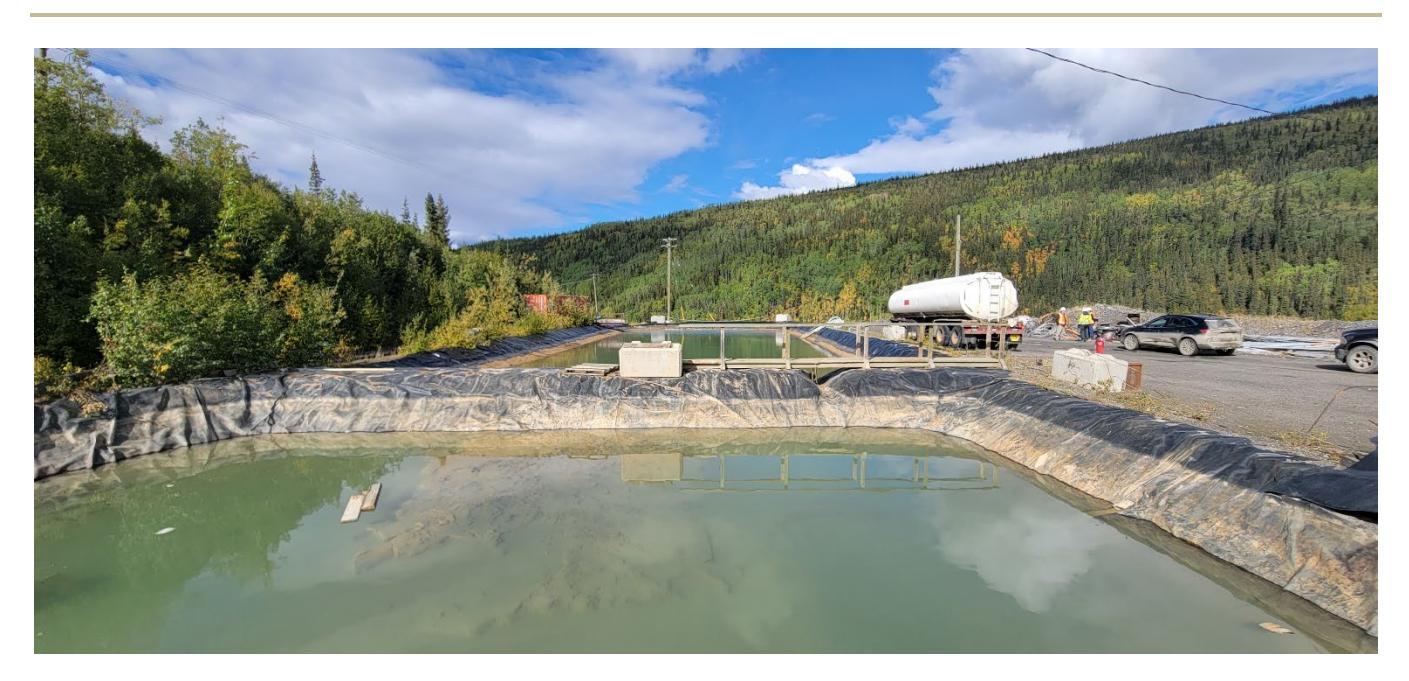
The primary treatment pond was operating at below its discharge elevation with a freeboard of approximately 1.0 m below the perimeter berm. The secondary treatment pond was also below its discharge elevation with a freeboard of approximately 1.0 m below the perimeter berm.

The conditions at the discharge do not appear to have changed. Flow is discharged directly onto the natural slope. While the slope is vegetated, some erosion is visible immediately around the discharge. While minor for now, the erosion may increase in severity, and options should be evaluated to provide some armoring around the discharge point.

Photo 3: Bellekeno 625 Water Treatment Ponds, facing northwest (I. MacIntyre, Aug. 28, 2022)

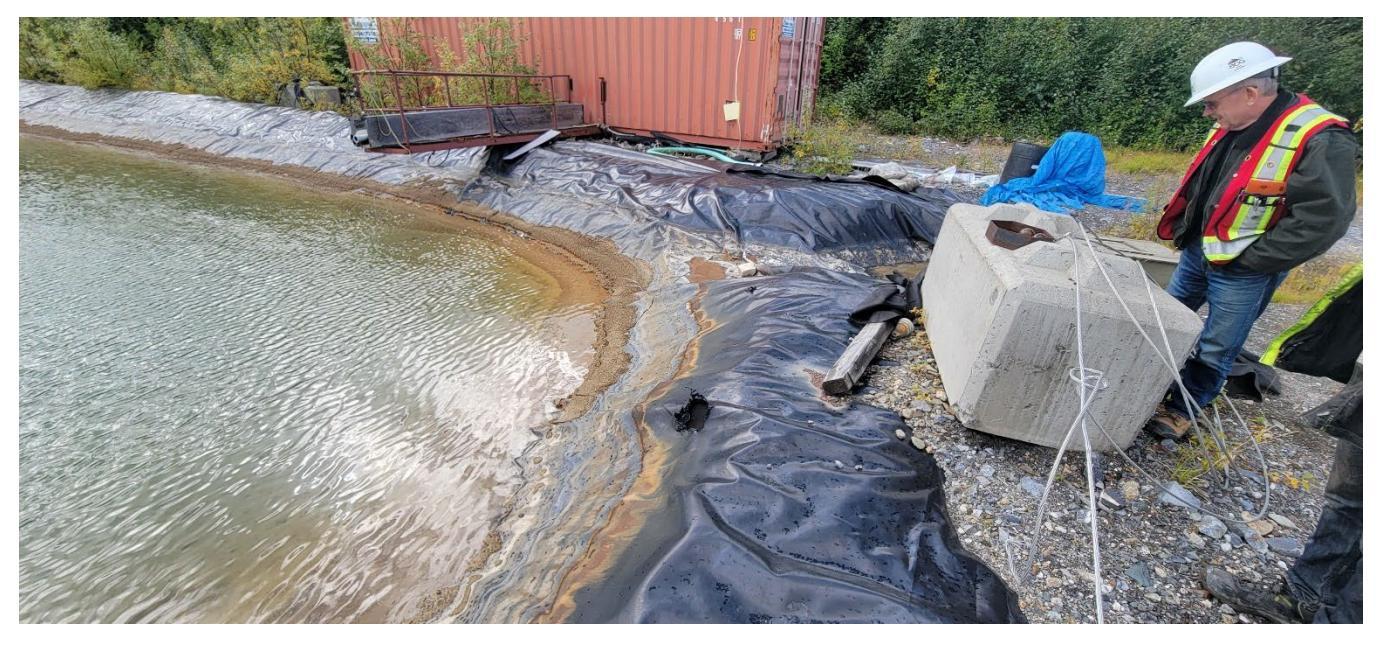
The rip in the liner near the end of the secondary pond noted in 2021 was still evident and does not appear to have increased in size. Any rips or tears in the liner should be repaired.

Photo 4: Bellekeno 625 Water Treatment Ponds, north end, rip visible (I. MacIntyre, Aug. 28, 2022)

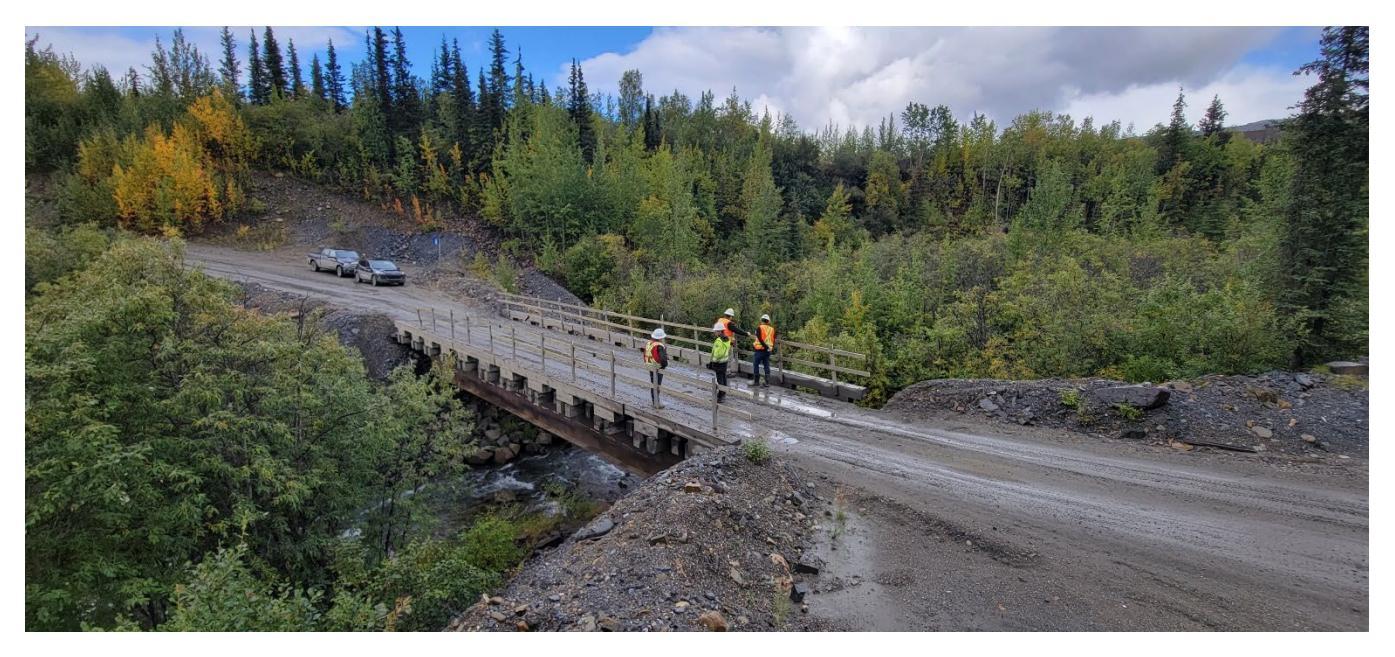
The bridge consists of a single span steel structure with a wooden deck and is founded on earth filled timber crib abutments.

Photo 5: Lightning Creek Bridge - Bellekeno Haul Road (I. MacIntyre, Aug. 28, 2022)

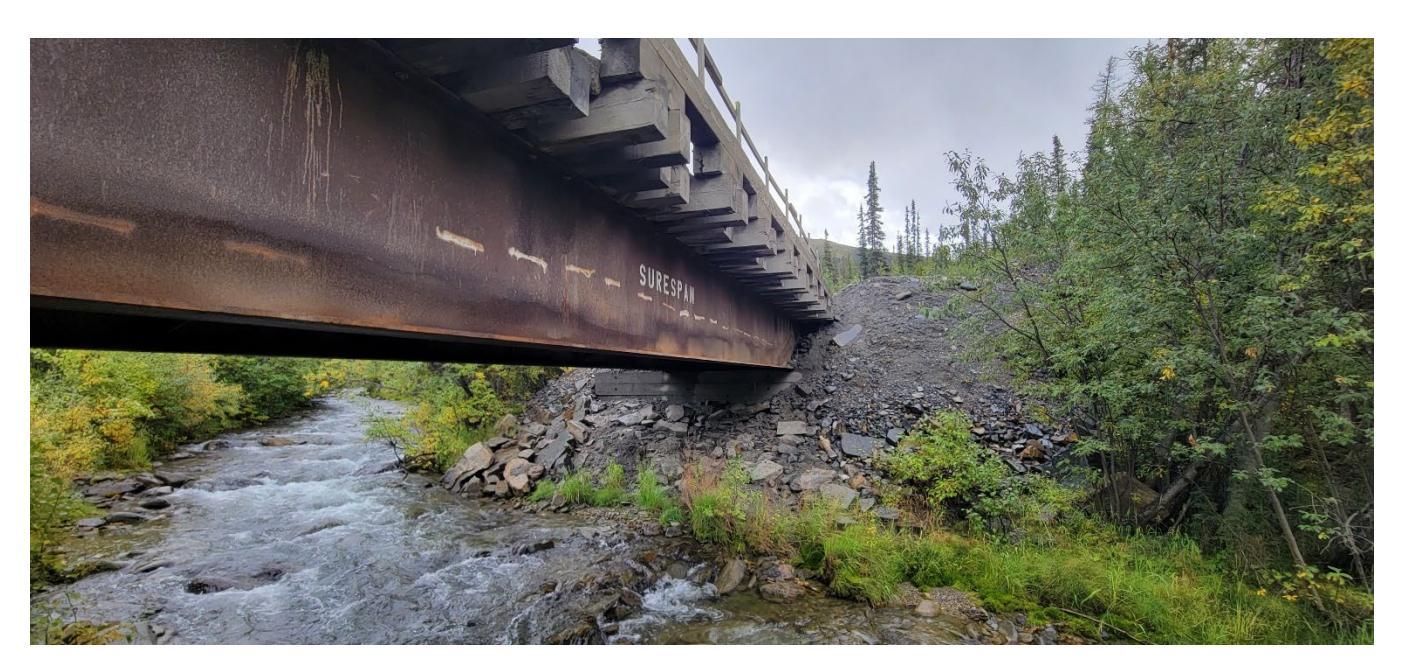
At the time of the inspection the bridge abutments appeared stable and sufficiently protected from erosion by riprap armoring. As has been documented in previous inspections, some erosion was noted along the road edge.

Photo 6: Lightning Creek Bridge - Bellekeno Haul Road, abutment armoring (I. MacIntyre, Aug. 28, 2022)

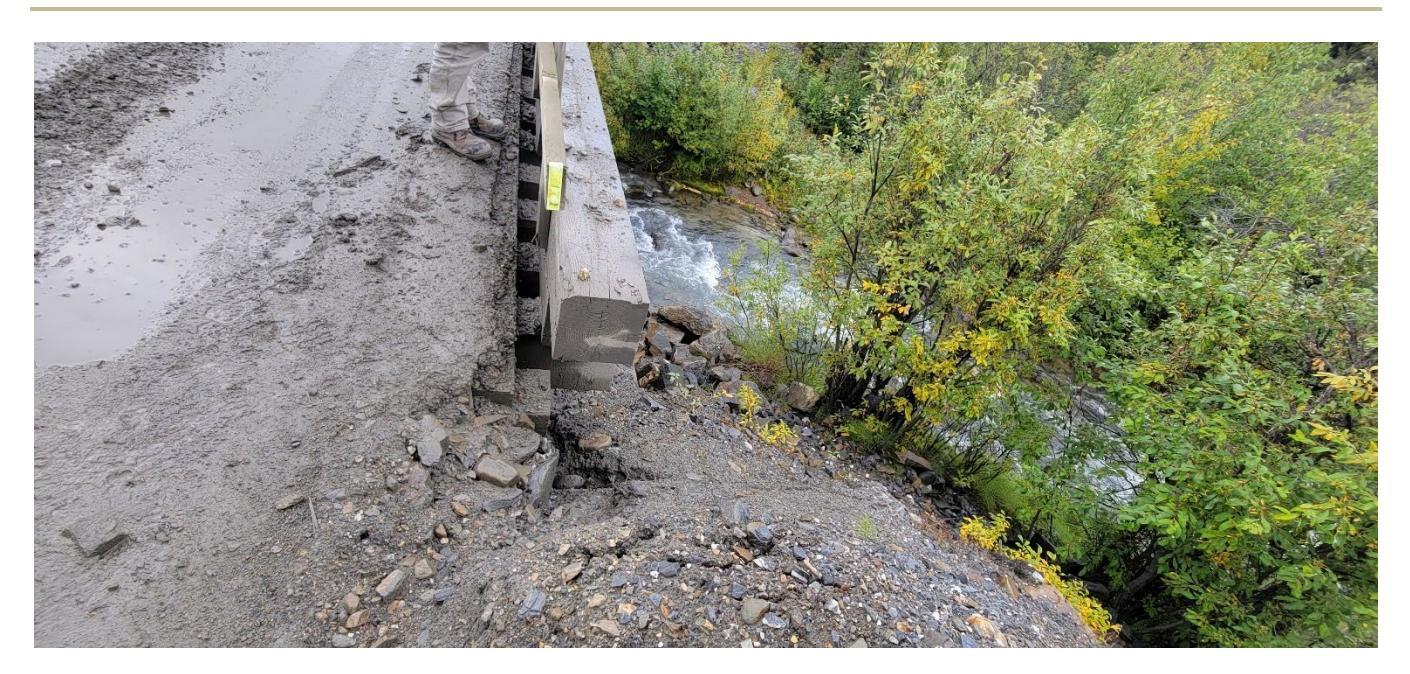
Photo 7: Lightning Creek Bridge - Bellekeno Haul Road, erosion gully forming along road edge (I. MacIntyre, Aug. 28, 2022)

The formed erosion gully should be backfilled using coarse grained material and proper road drainage established to minimize erosion.

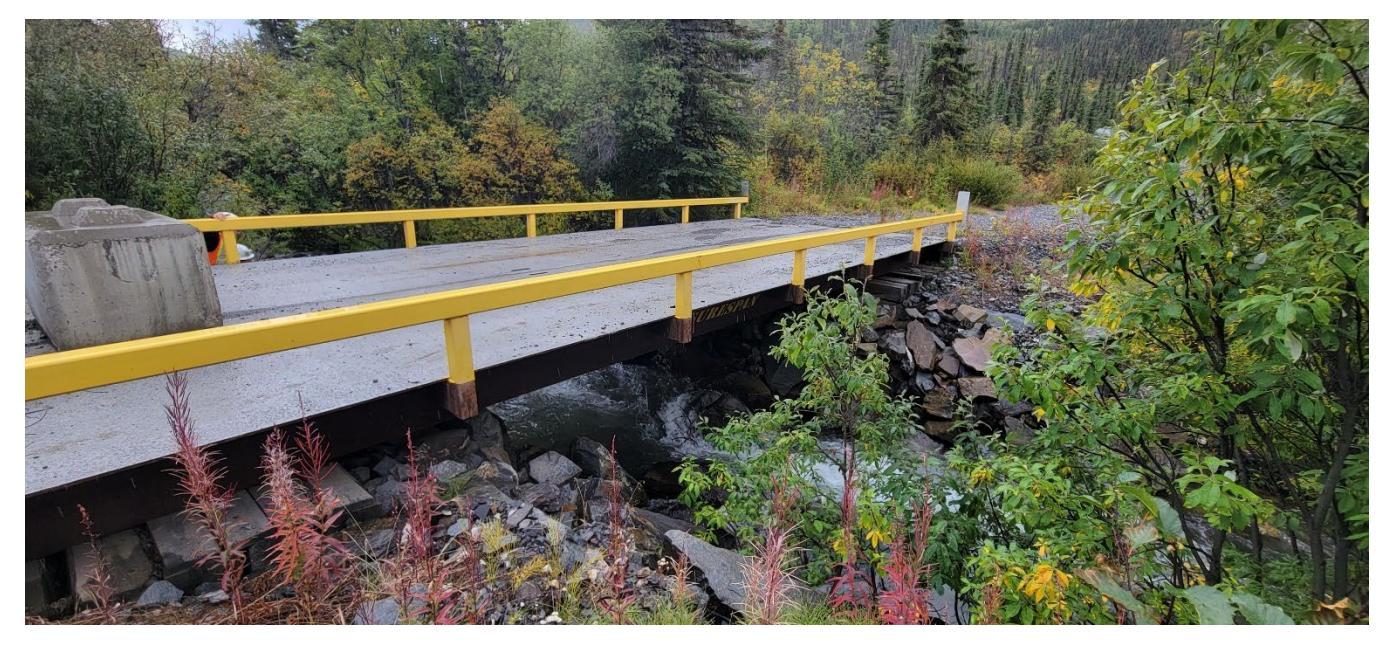
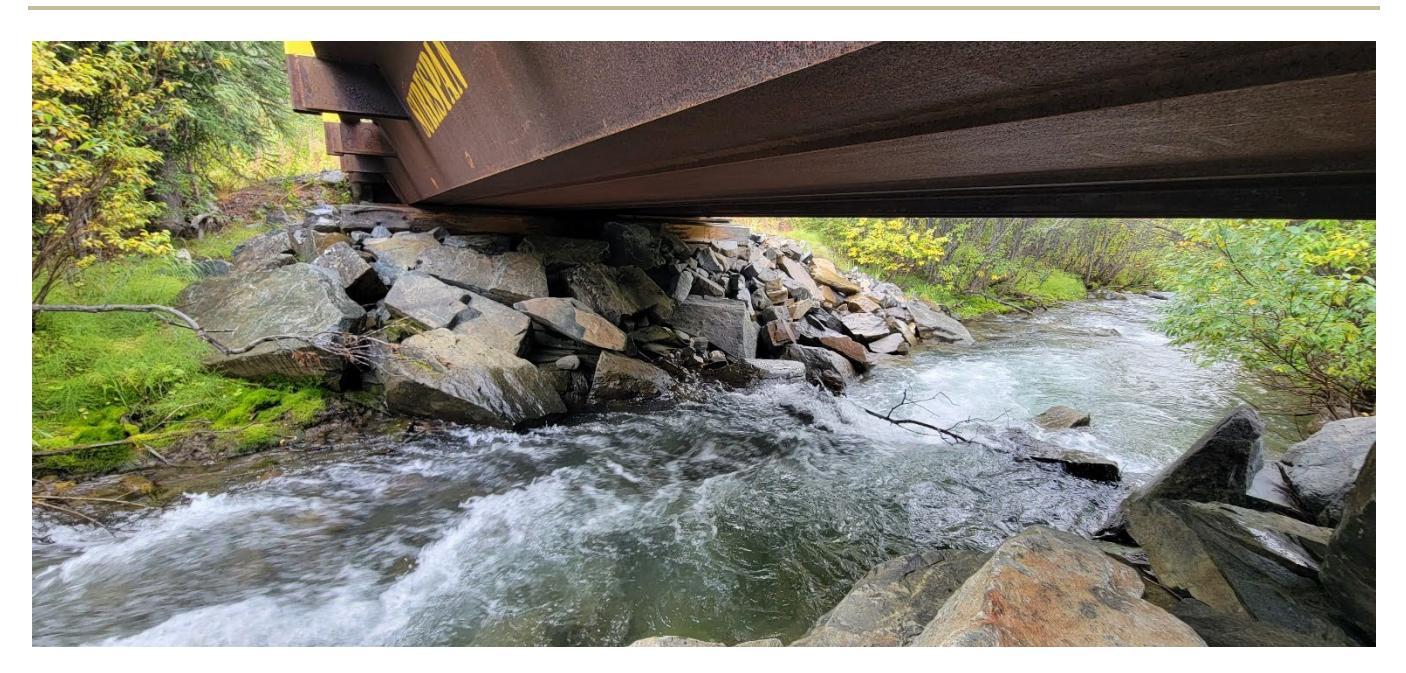
The Lightning Creek bridge crossing on the Onek Road is located east of Keno City, as shown on Figure 1. The bridge consists of a single span steel structure founded on earth-filled cribbing abutments. Access across the bridge is currently blocked. At the time of the inspection the bridge abutments appeared stable and sufficiently protected from erosion by riprap armoring. No remedial actions related to geotechnical performance are recommended at this time.

Photo 8: Lightning Creek Bridge - Onek Road (I. MacIntyre, Aug. 28, 2022)

Photo 9: Lightning Creek Bridge – abutment riprap (I. MacIntyre, Aug. 28, 2022)

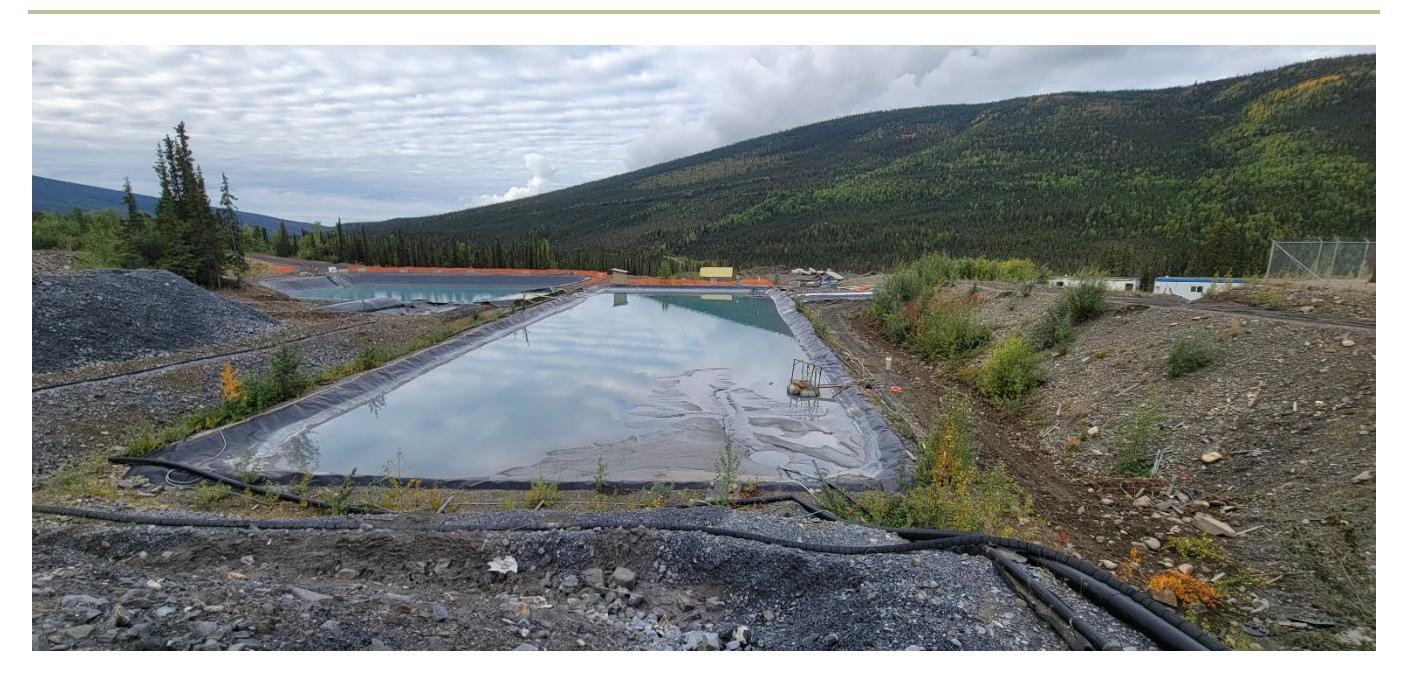
The liners and berms of each pond appeared to be in generally good condition.

Photo 10: Fill Water Treatment Plant pond – facing southwest (I. MacIntyre, Aug. 28, 2022)

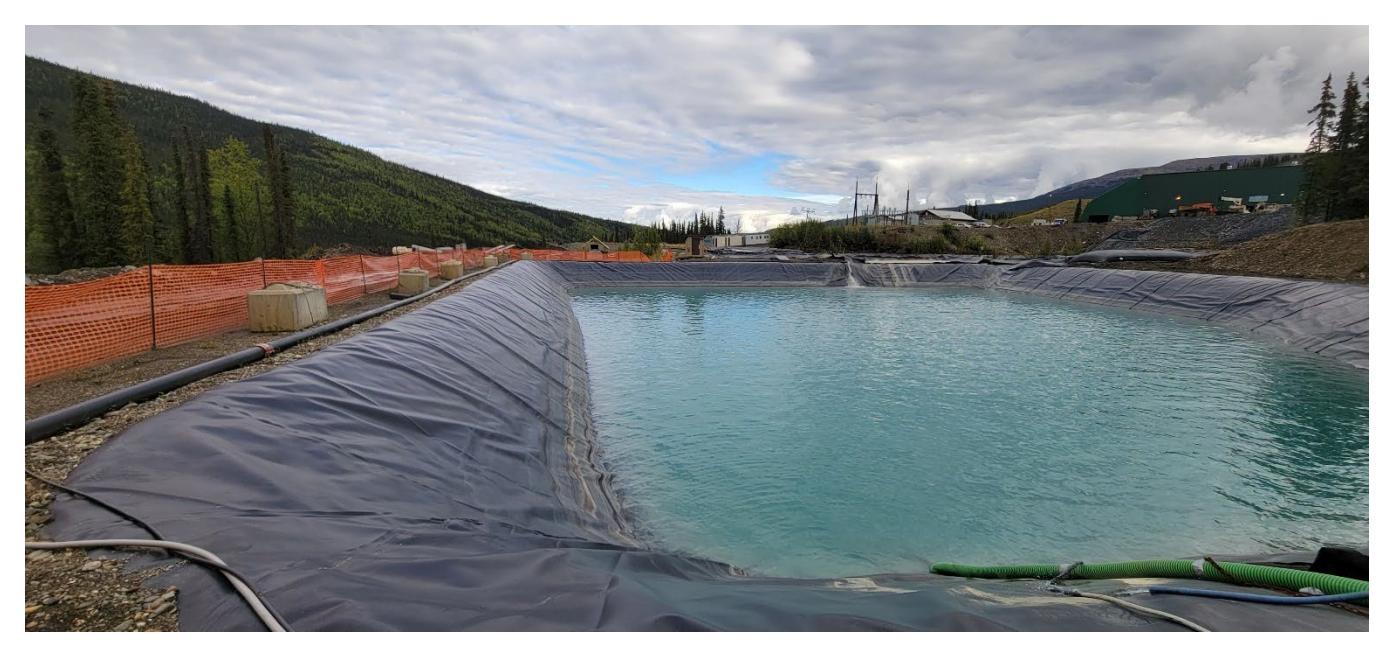
Photo 11: Mill Water Storage pond – facing north (I. MacIntyre, Aug. 28, 2022)

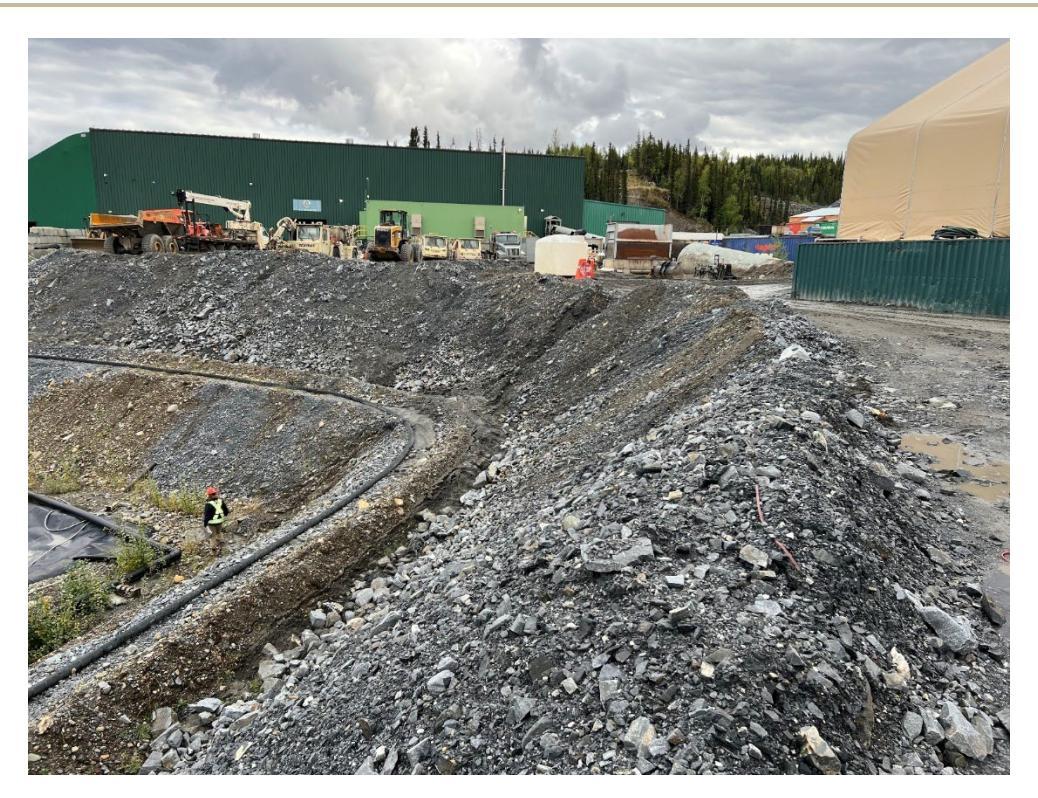
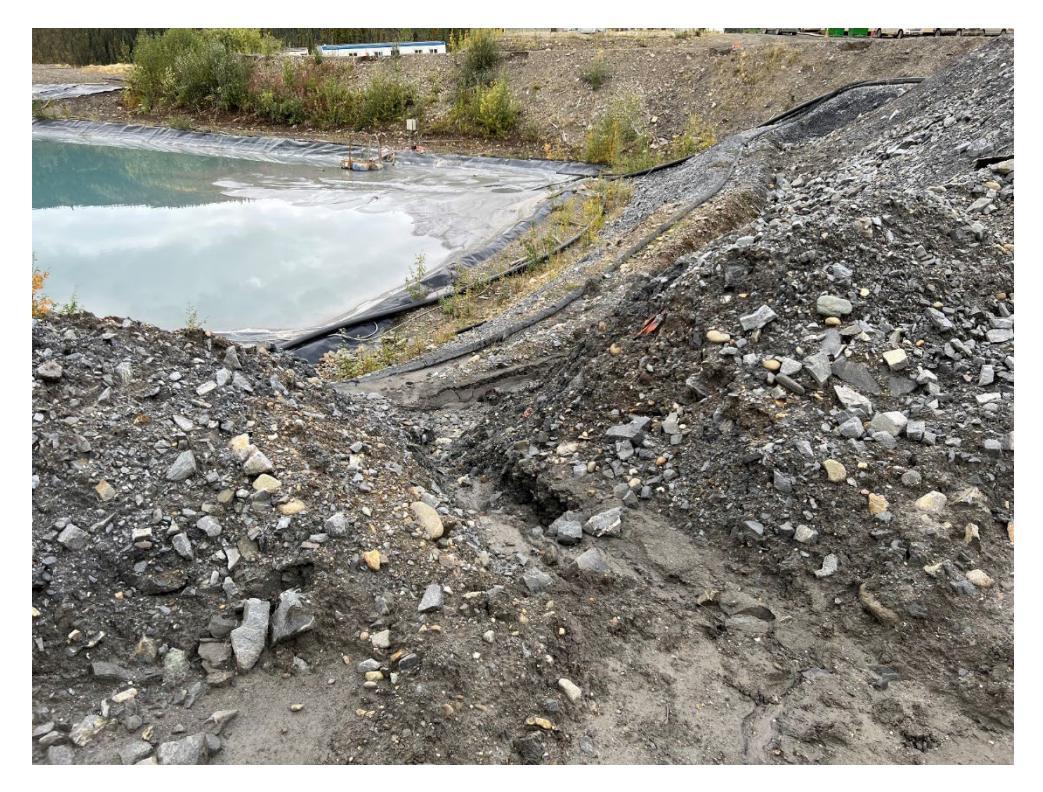
An erosion gully was noted in the area above the Fill Water pond near its southeast corner. While the erosion has not yet impacted the pond, it should be repaired, and proper drainage established to prevent future issues. Surface water must not be allowed to flow directly into the pond.

Photo 12: Fill water storage pond, erosion gully – facing northeast (R. Trimble, Aug. 28, 2022)

Photo 13: Fill water storage pond, erosion gully – facing east (R. Trimble, Aug. 28, 2022)

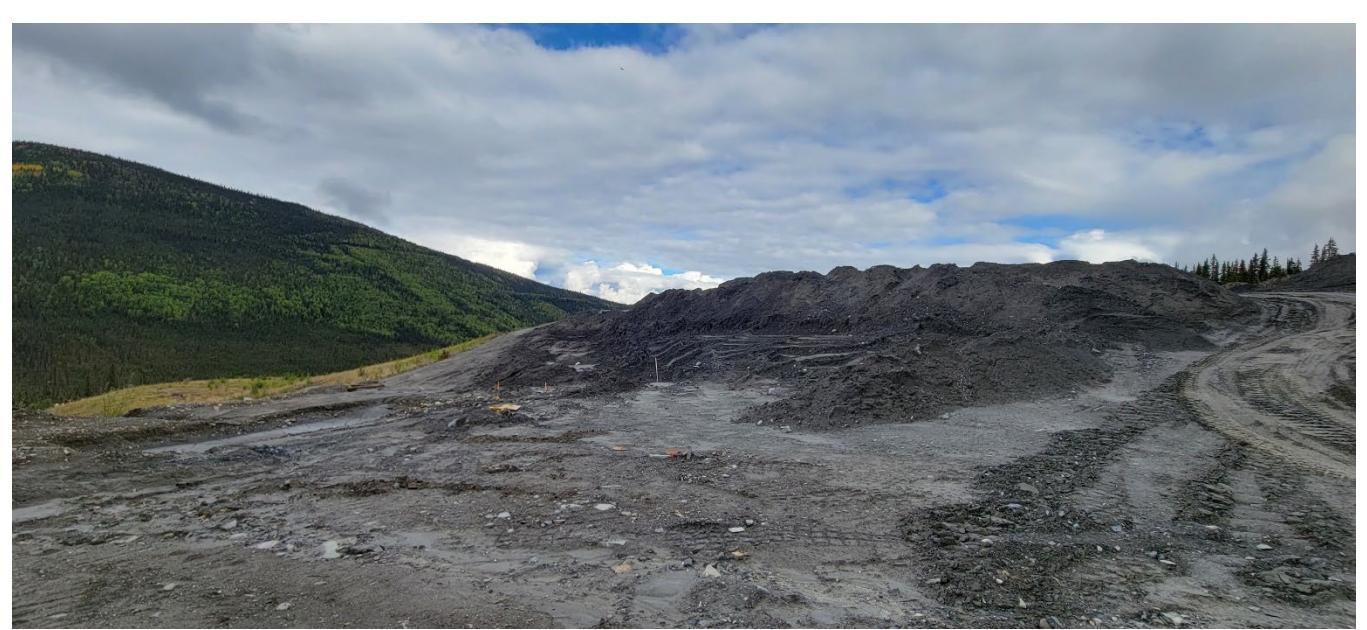
- Near the south end of the upper bench of the DSTF, tailings were observed to have been dumped loose and not placed per proper procedure. Tetra Tech recommended the proper placement, grading, and compaction of these tailings.
 - Note: while onsite in September for another scope, these areas and recommendations were noted to have been addressed.
- Several small sinkhole-like features were noted within the cover material along the southwest facing slope of the DSTF. Tetra Tech recommended these be backfilled and repaired with properly compacted material.
 - Note: while onsite in September for another scope, these areas and recommendations were noted to have been addressed.

Tetra Tech was also asked to comment on the performance of a velocity dissipation structure (VDS) Hecla constructed southeast of Phase 1A, and within the footprint of Phase 1B. The intent of this structure is to minimize the accumulation of eroded material within the DSTF drainage ditches, thereby reducing the required maintenance efforts. Some recommendations related to the construction of the VDS were provided in the previous 2021 Annual Inspection Report (Tetra Tech 2021). The VDS structure was excavated into the in-situ granular material.

Based on a visual review of the VDS, and discussion with site staff regarding its performance, Tetra Tech believes the temporary structure is performing adequately and not negatively impacting the overall stability of the DSTF. Frequent inspections should be completed, and accumulated debris cleaned as required. If changing conditions are noted Tetra Tech should be contacted to provide additional recommendations. The temporary nature of this structure was also discussed, as it is located within the DSTF Phase 1B footprint and will likely be covered with tailings in the near future.

Photo 14: DSTF Phase 1A area, near top, south end. Loose, poorly graded, and uncompacted tailings visible. VDS visible in left of frame. Facing north. (I. MacIntyre, Aug. 28, 2022)

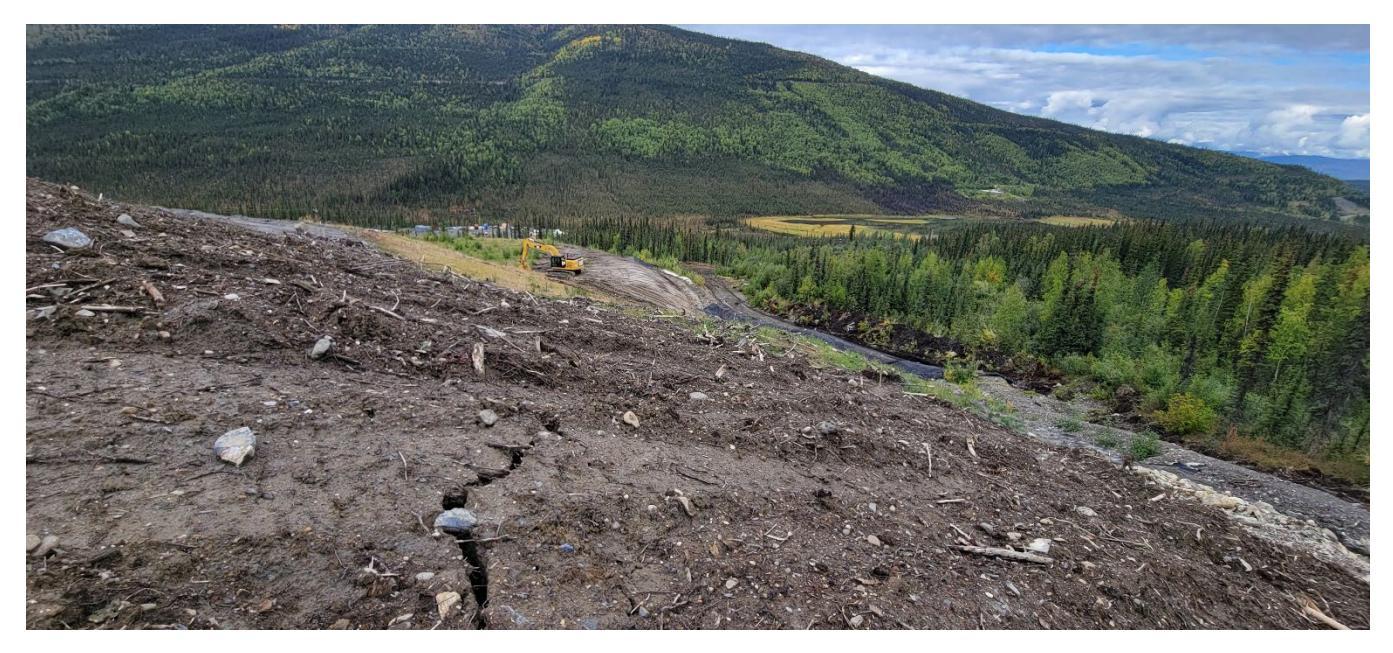
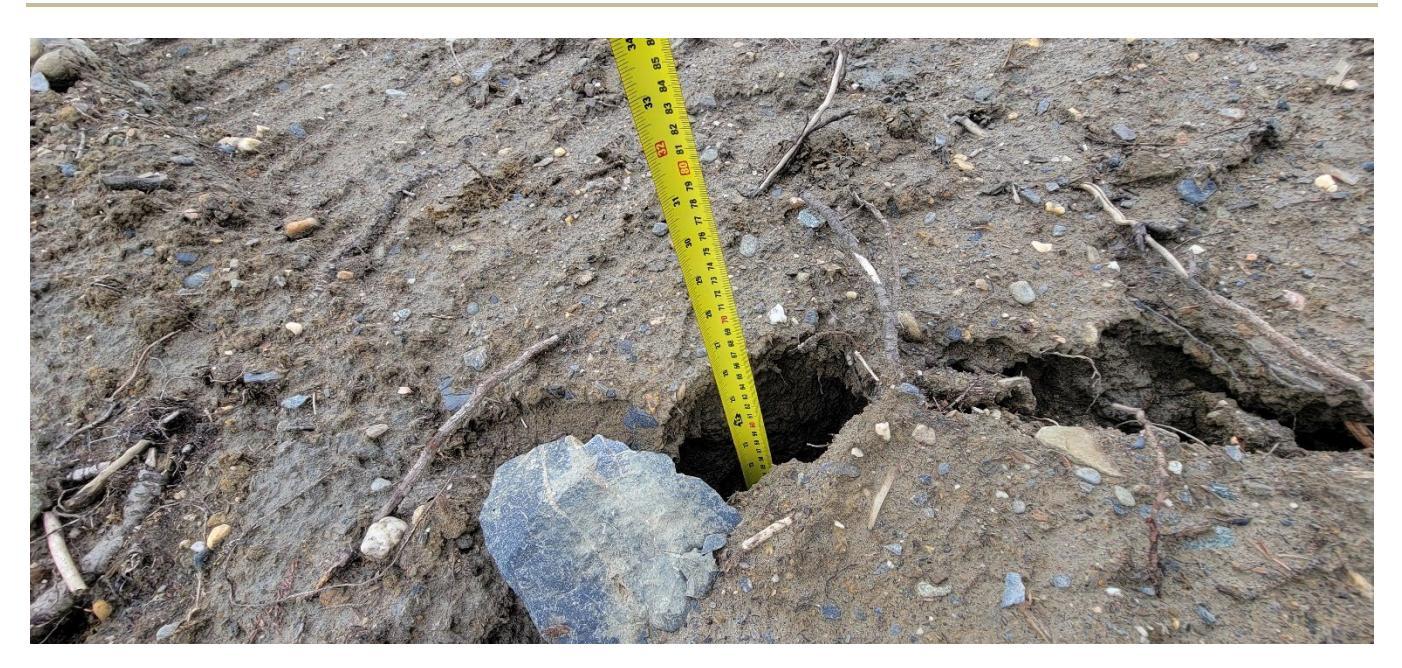
An area of the cover material along the north facing slope was also observed to be sloughing, with a notable tension crack near the crest. It appears this failure surface is primarily restricted to the cover material layer, and likely not deep-seated. This cover material appears to be relatively uncompacted and loose. It should be compacted using tracked equipment operating parallel to slope contours to minimize runoff erosion impacts.

Photo 15: DSTF Phase 1A area, near top, north end. Sloughing and cracking of loose, uncompacted cover material. Facing west. (I. MacIntyre, Aug. 28, 2022)

Photo 16: DSTF Phase 1A area, near top, north end. Sloughing of loose, uncompacted cover material. Crack approx. 60 cm deep. (I. MacIntyre, Aug. 28, 2022)

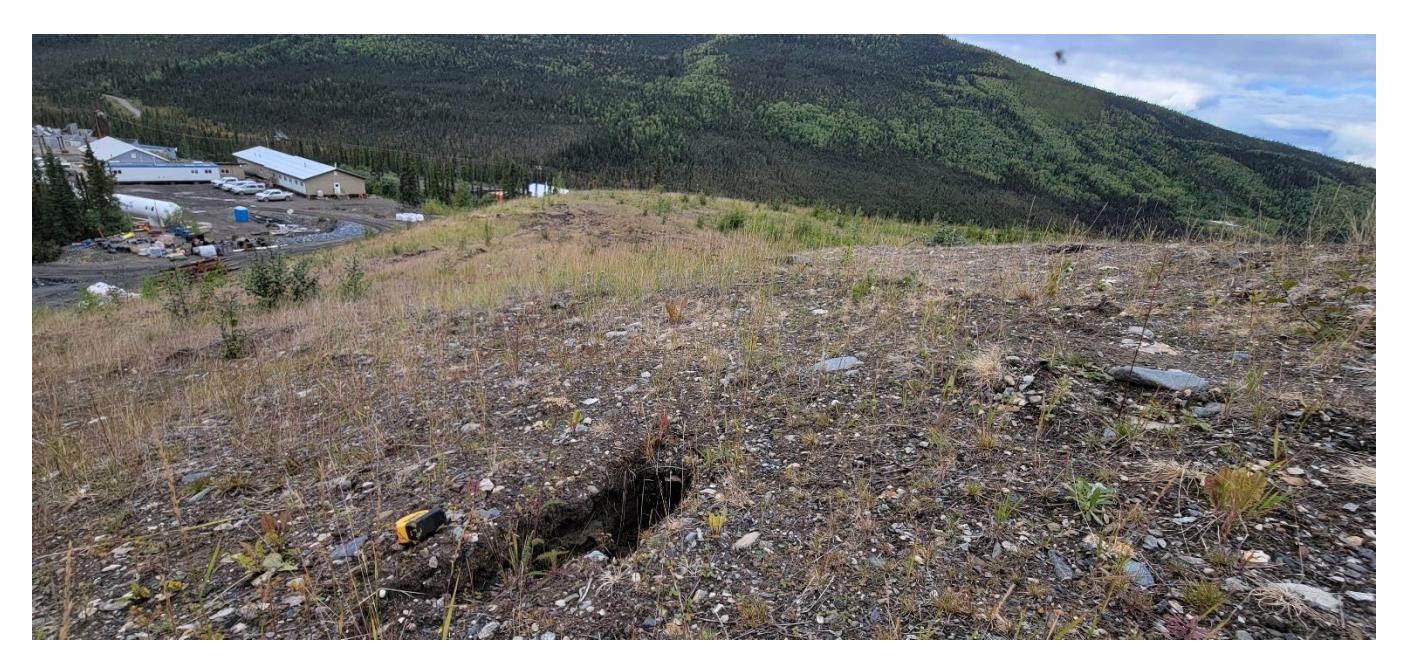
Photo 17: DSTF Phase 1A area, southwest slope. Small sink hole indicating migration of materials. Appears to be limited mostly to cover material. Facing west. (I. MacIntyre, Aug. 28, 2022)

As recommended in 2021, any of these occurrences (i.e., sinkholes, blow outs, tension cracks, etc.) should be surveyed and reported to Tetra Tech along with photos immediately when they are observed.

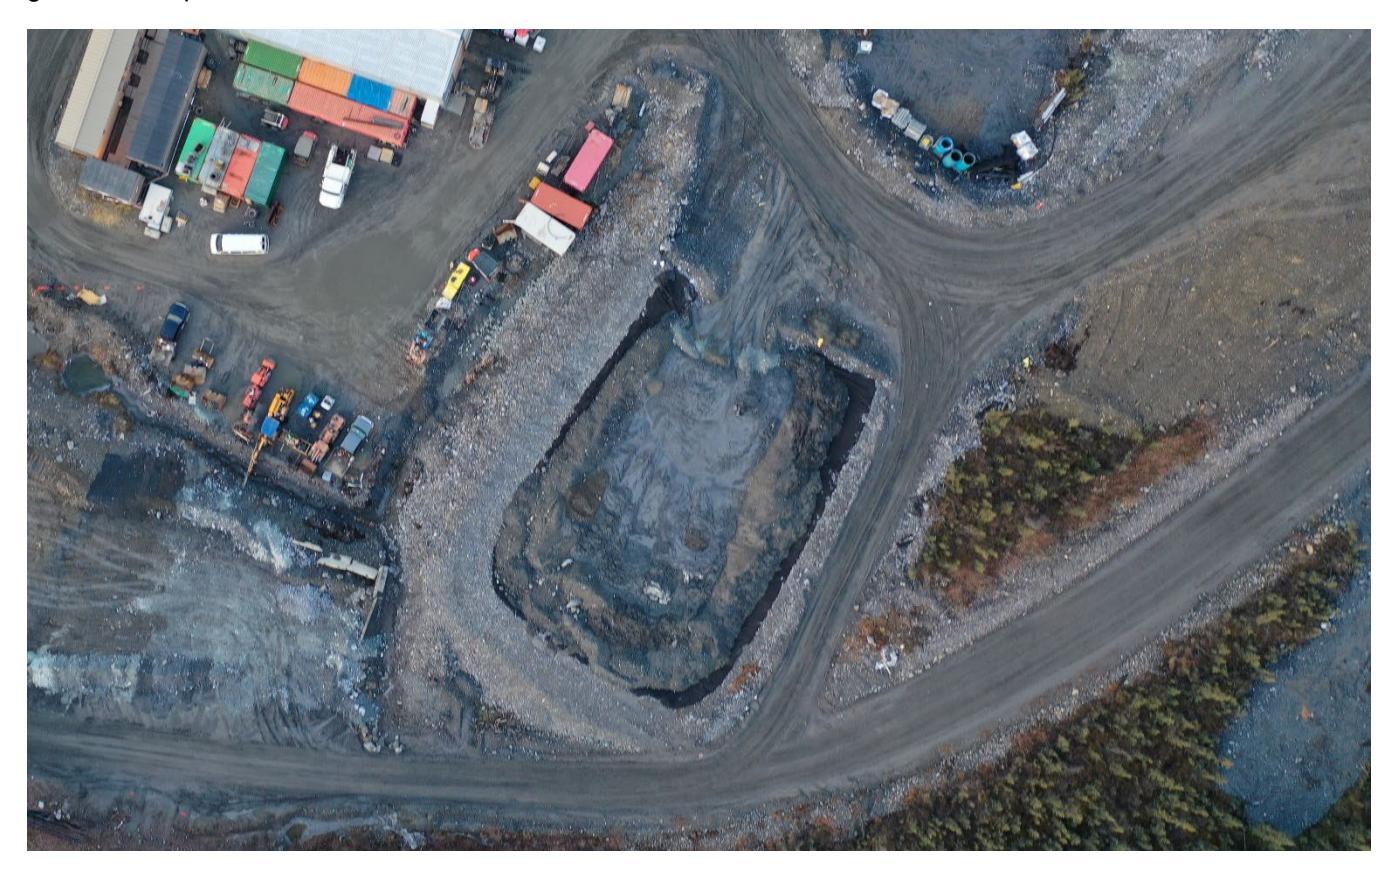
The Flame and Moth PAG waste storage facility is located south of the mill. At the time of the inspection, the perimeter berms appeared intact with no visible signs of instability or distress. No remedial actions related to geotechnical performance are recommended at this time.

Photo 18: Flame and Moth PAG waste storage facility, aerial view. (P. Johnson, August 29, 2022)

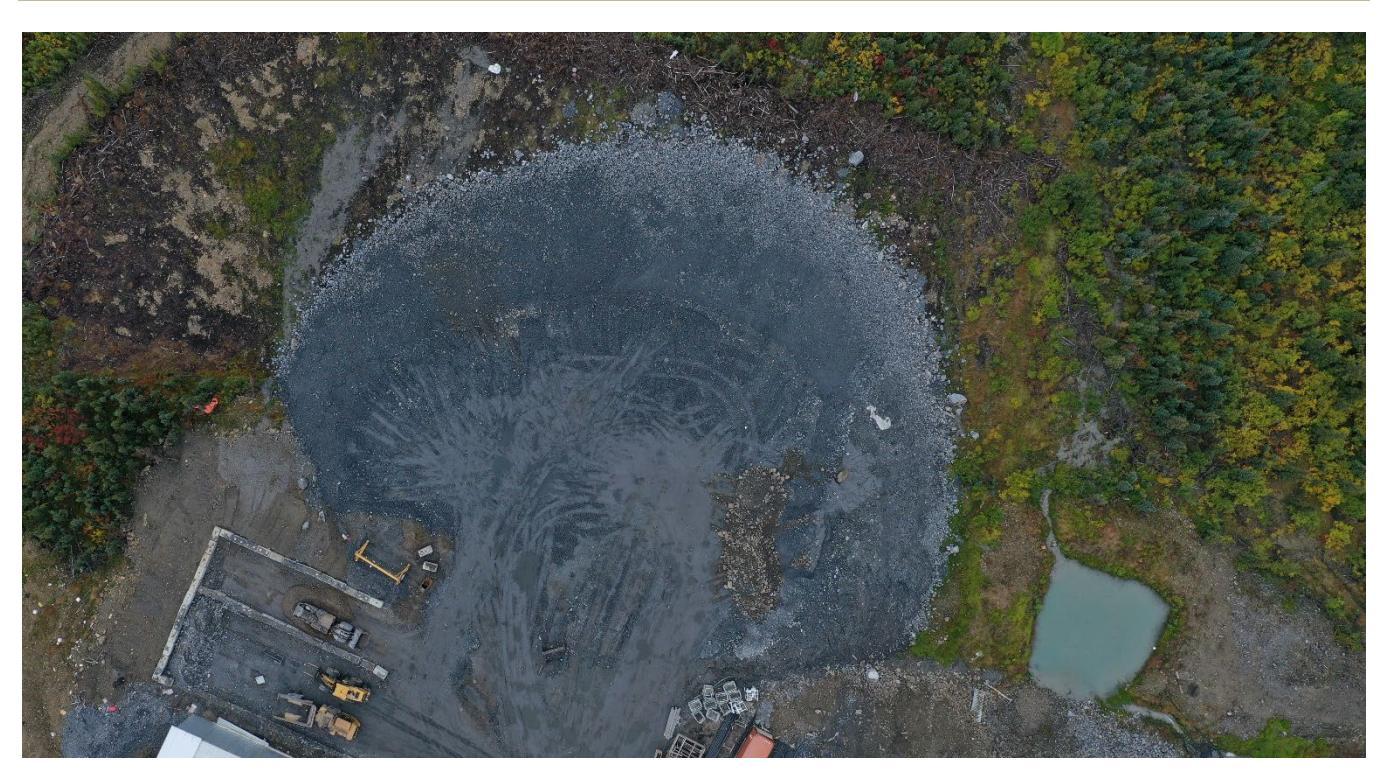
At the time of the inspection, no visual signs of deep-seated instabilities, significant movement, distress, sloughing or bulging were observed. No remedial actions related to geotechnical performance are recommended at this time.

Photo 19: Bermingham NAML waste dump, aerial view. (P. Johnson, August 30, 2022)

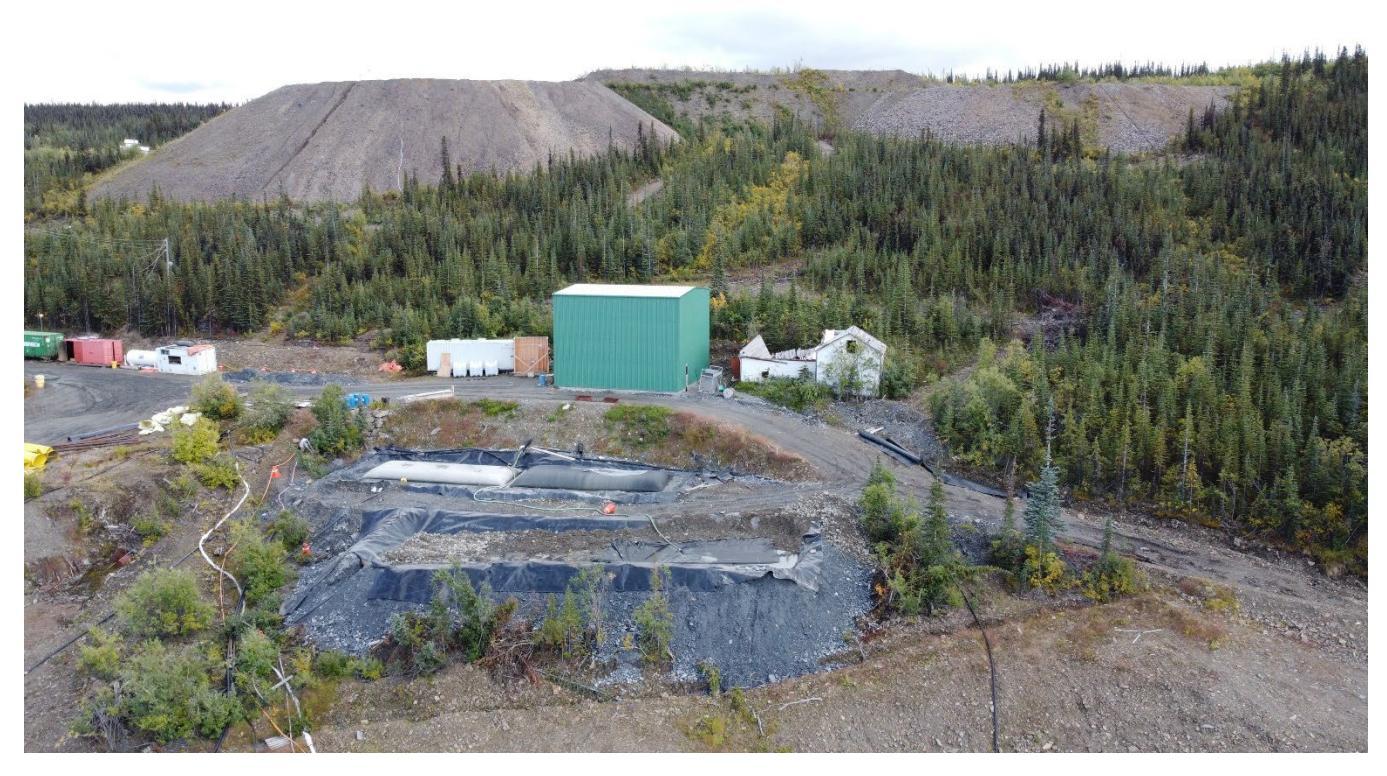
At the time of the inspection the facility crest, slopes, and toe showed no signs of deep-seated instabilities, significant movement, distress, sloughing or bulging. However, it was noted that the newer facility appears to have been constructed without removing all organics within the footprint. Hecla noted they believe most organics were removed, while acknowledging some remaining along the facility toe. The facility should be monitored closely, and the remaining exposed organics should be removed and replaced with compacted granular fill.

Photo 20: Bermingham Mine Sludge Waste Containment Facility – buried organics and trees visible in bottom of frame. (I. MacIntyre, Aug. 28, 2022)
