Subject: 2022 Annual Geotechnical Inspection – Mining Related Earth Structures – Revision 1

2022 Annual Geotechnical Inspection Mining Related Earth Structures

Revision 1

JANUARY 3, 2023 ISSUED FOR USE FILE: 704-ENG.WARC04286-01

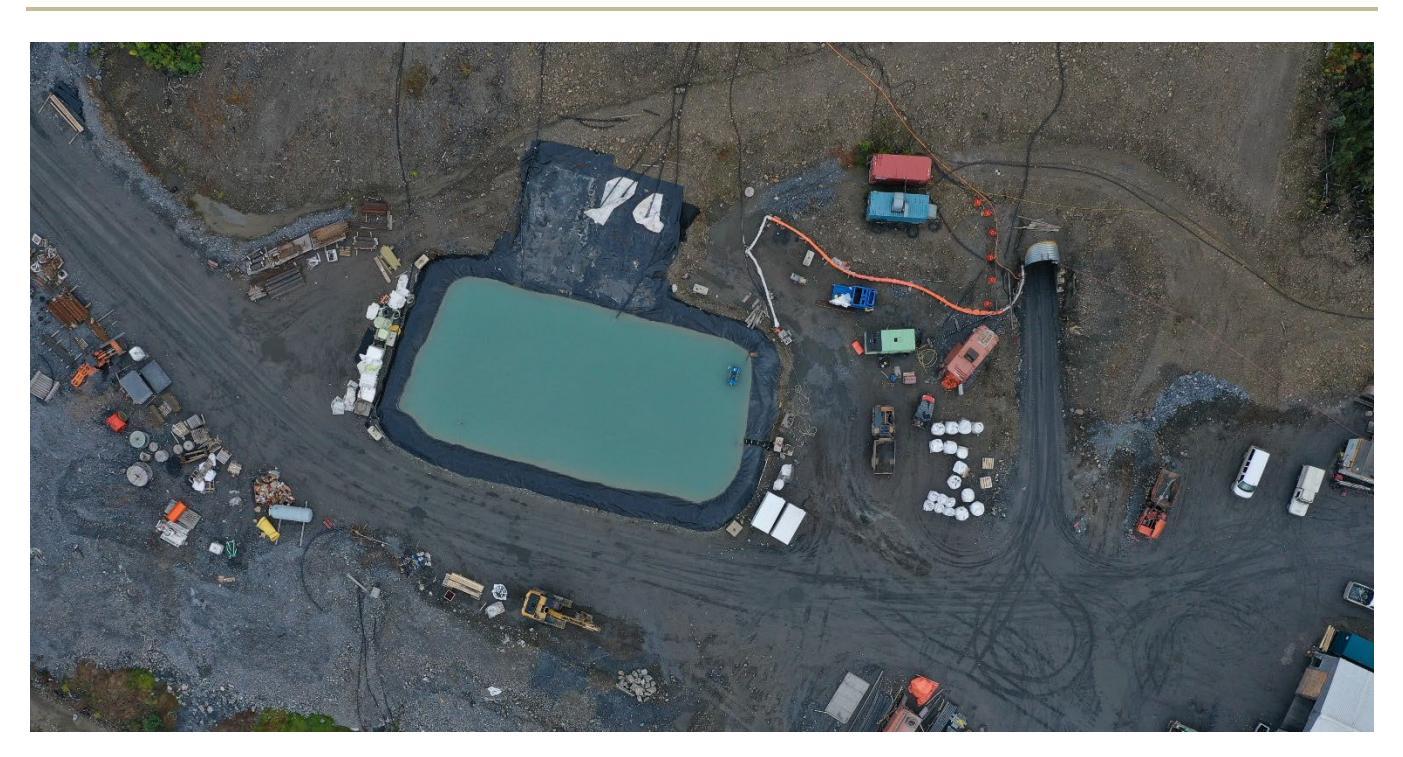
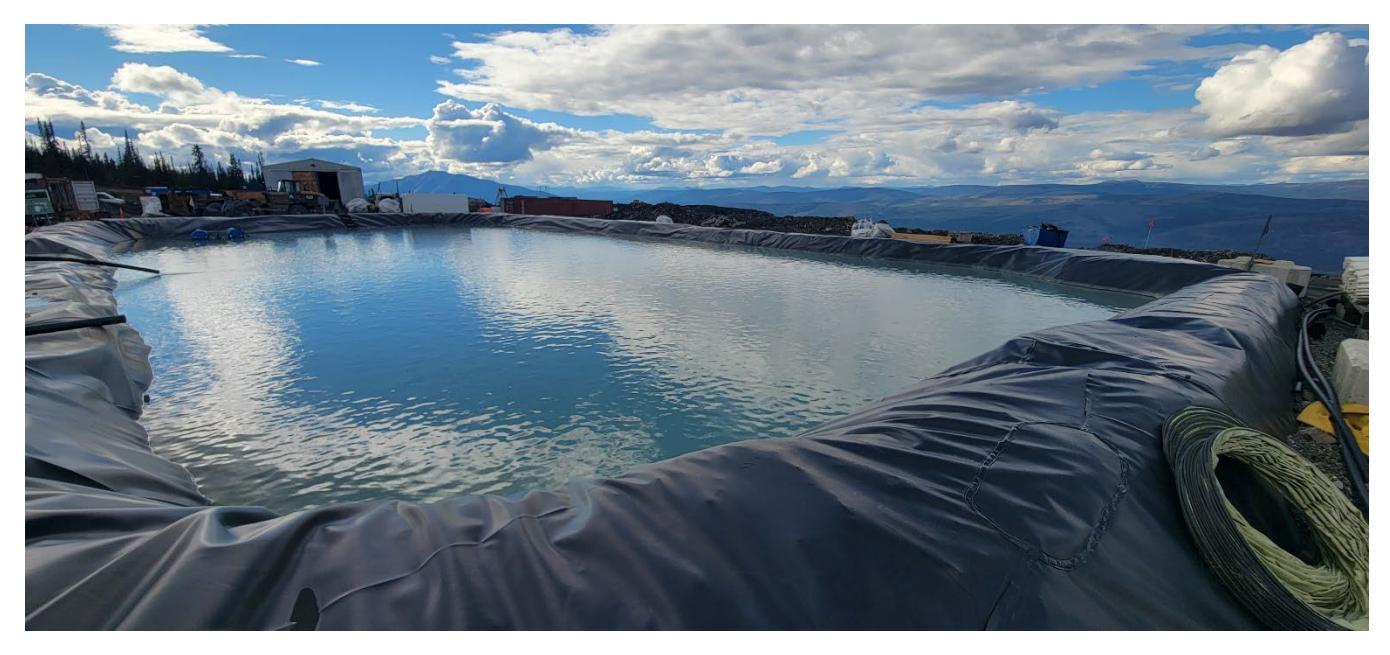
The Bermingham storage pond is located northeast of the portal. At the time of the inspection, the freeboard observed were approximately 1.0 m. The liners and berms of appeared to be in generally good condition.

No remedial actions are recommended at this time.

Photo 21: An aerial view of the Bermingham storage pond (P. Johnson, August 30, 2022)

Photo 22: Bermingham storage pond, facing west. (I. MacIntyre, Aug. 28, 2022)

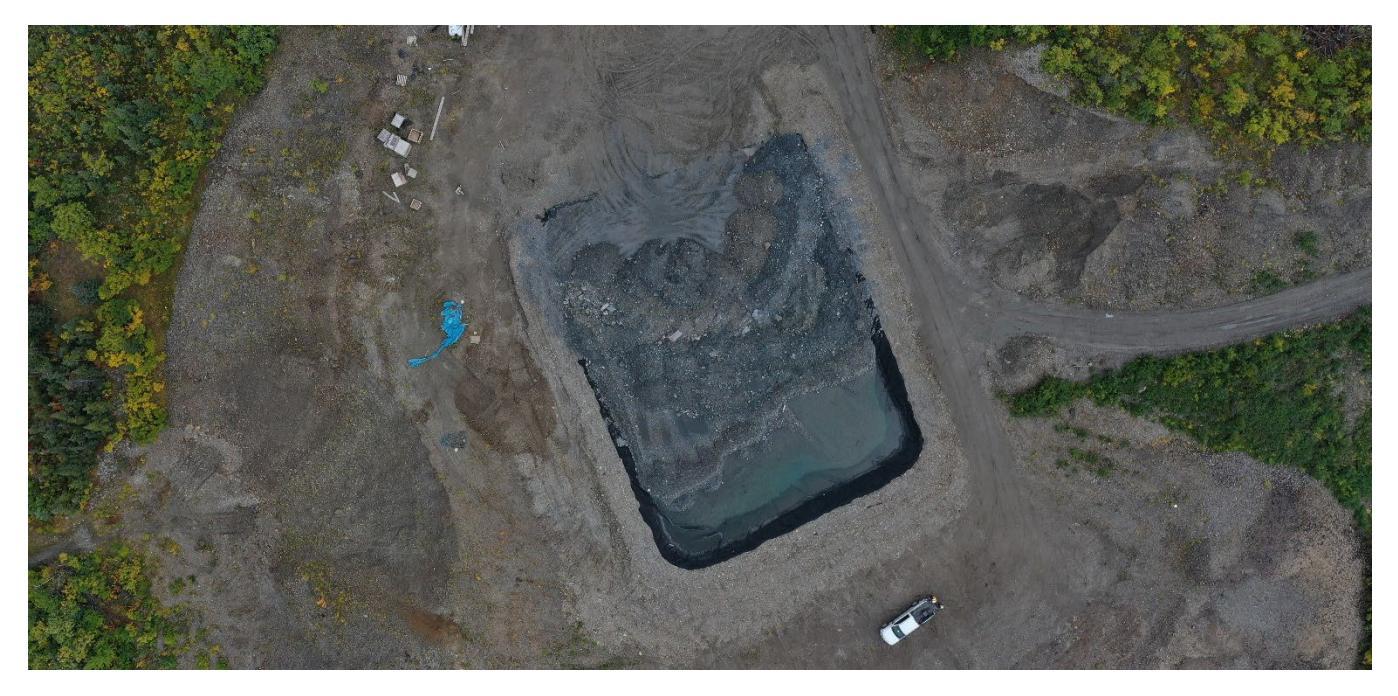
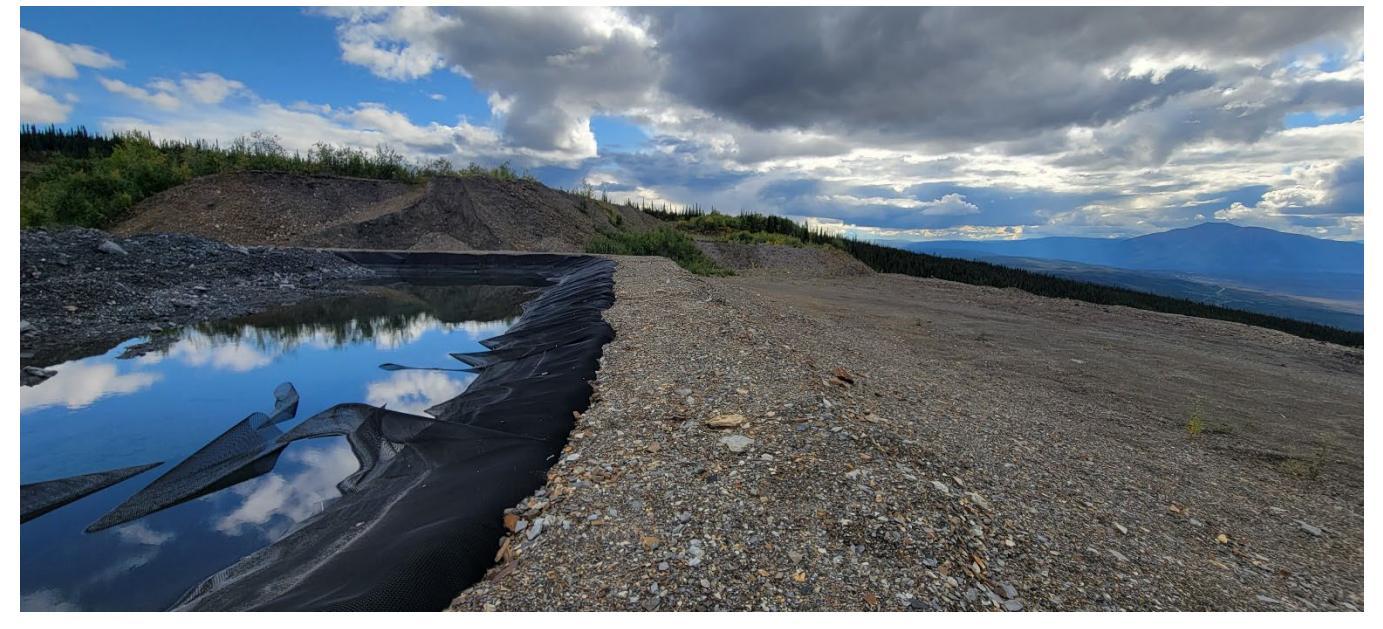
At the time of the inspection the storage facility berms showed no signs of deep-seated instabilities, significant movement, distress, seepage, sloughing or bulging.

No remedial actions related to geotechnical performance are recommended at this time.

Photo 23: Bermingham PAG waste storage facility, aerial view (P. Johnson, August 30, 2022

Photo 24: Bermingham PAG waste storage facility, north berm, facing west (I. MacIntyre, Aug. 28, 2022)
