| From: | Kai Woloshyn <kwoloshyn@alexcoresource.com></kwoloshyn@alexcoresource.com> |
|---|---|
| Subject: | FW: Annual geotech inspection |

October 27, 2016

Alexco Resource Corp. 3 – 151 Industrial Road Whitehorse, YT Y1A 2V3 ISSUED FOR USE FILE: ENG.WARC03152-01 Via Email: kwoloshyn@alexcoresource.com

Subject: 2016 Annual Geotechnical Inspection – Surface Engineered Earth Structures Bellekeno Mine, Keno City, YT

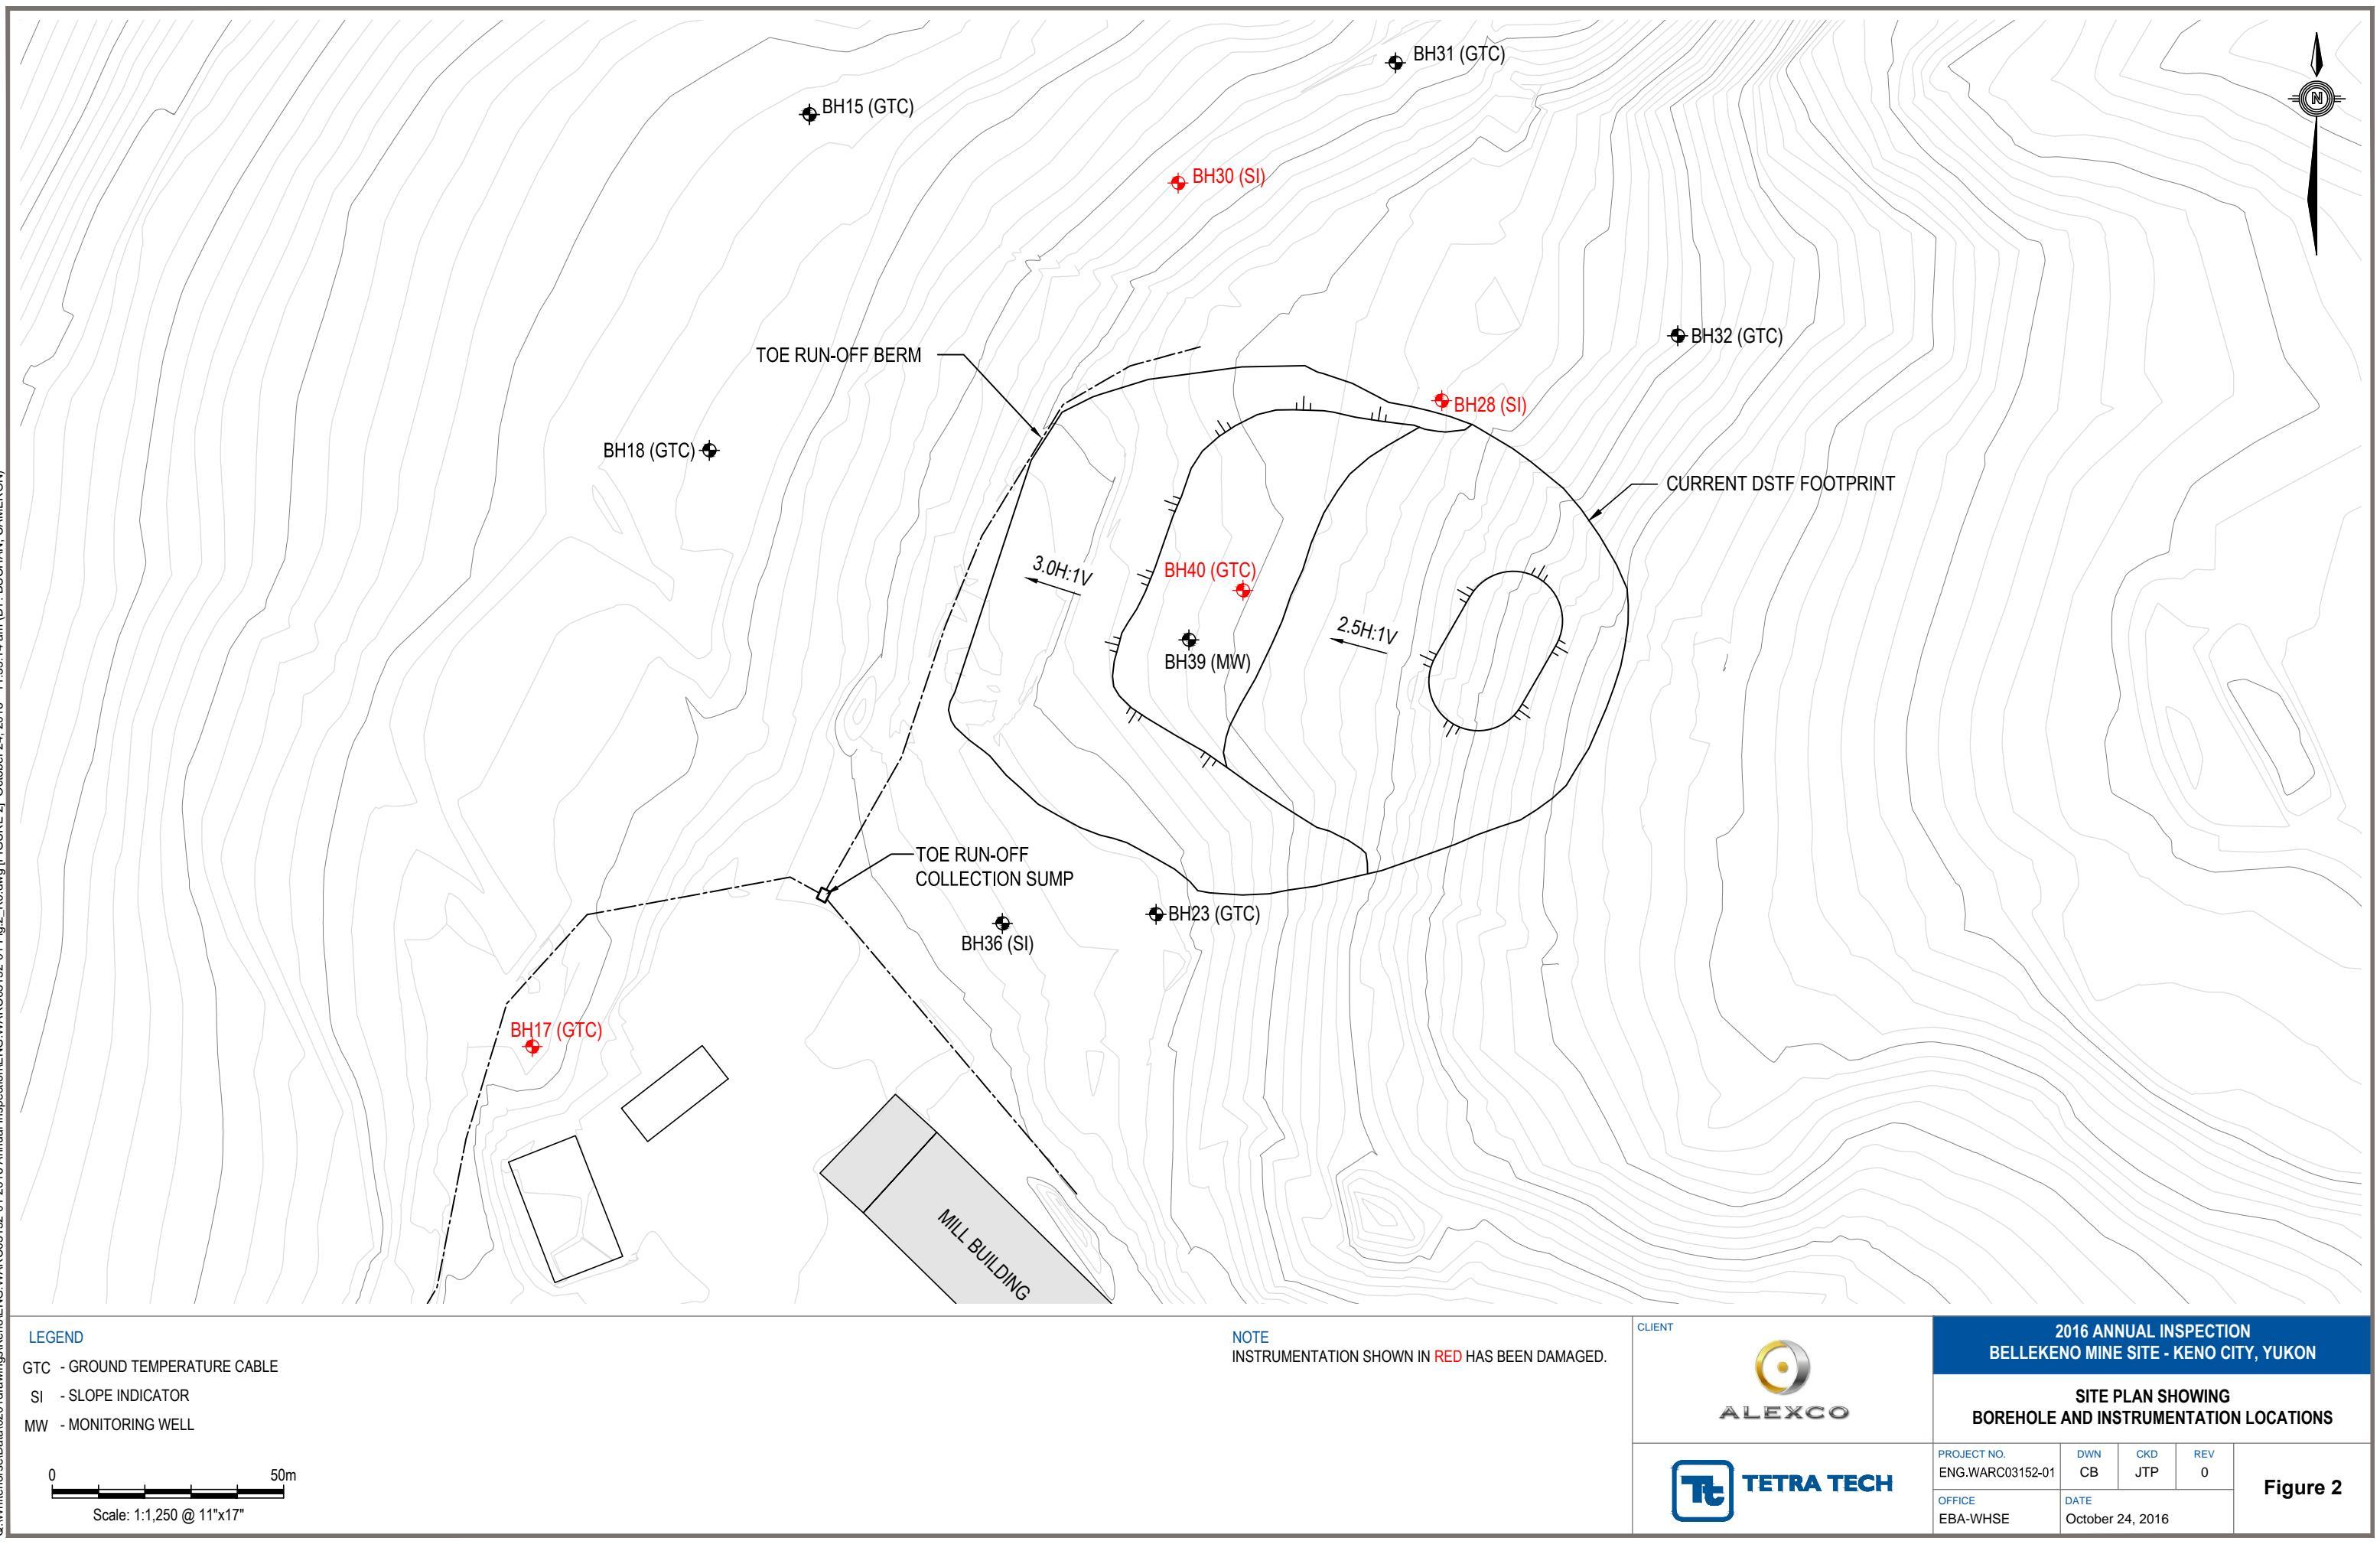
Figure 2 DSTF Site Plan Showing Instrumentation Locations

Performance of the DSTF is monitored with compaction testing during tailings placement and regular instrumentation readings. DSTF instrumentation consists of seven ground temperature cables installed to monitor permafrost conditions (six in natural soils adjacent to the DSTF and one through tailings placed within the DSTF footprint), three slope indicators installed to monitor lateral movement of the foundation soils, and one monitoring well installed to the base of the placed tailings in BH39. The locations of installed DSTF instrumentation are shown on Figure 2.

It should be noted that some critical instrumentation located within and adjacent to the DSTF is in need of repair and/or replacement.

The ground temperature cable installed in BH40, through the placed tailings and into the foundation soils below the DSTF has been damaged and requires replacement. This is a critical installation needed to confirm design assumptions and provide ongoing temperature monitoring.

Readings were not possible in BH30 despite efforts to steam out the blockage at 3.5 m below the ground surface. Inspection of the blockage with a downhole camera indicated that the casing is likely blocked with a large rock or accumulation of surficial soil that inundated the installation. Salvage of the installation is not considered likely, a replacement borehole should be advanced near BH30 the next time a geotechnical drill program is conducted near the DSTF.

Readings were not possible in BH28 as the casing was blocked at 3.7 m below the ground surface. Inspection with a downhole camera confirmed the installation is blocked with ice and requires steaming. Partial ice blockage was likely the cause of the probe derailment experienced during prior reading attempts. At the time of the inspection there was not enough hose available for the steam unit to reach BH28 to remove the ice blockage.

BH28 should be steamed and purged of water. The casing should then be filled using liquid with a depressed freezing point to allow for future readings. Tetra Tech has had success with Envirobind (dust suppressant) and glycol based liquids in permafrost conditions on other sites. We would be pleased to assist with the rehabilitation of the installation, if requested.

| Structure | Stability Recommendations | Maintenance Recommendations | | |
|---|---|---|--|--|
| | Advance replacement borehole for BH40 within DSTF and install ground temperature cable | | | |
| Dry Stacked Tailings Facility | Advance replacement borehole for BH30 and install slope indicator Rehabilitate BH28 by steaming, purging, and filling slope indicator casing with liquid suitable for use in permafrost conditions | Continue regular instrumentation readings to monitor DSTF foundation conditions | | |

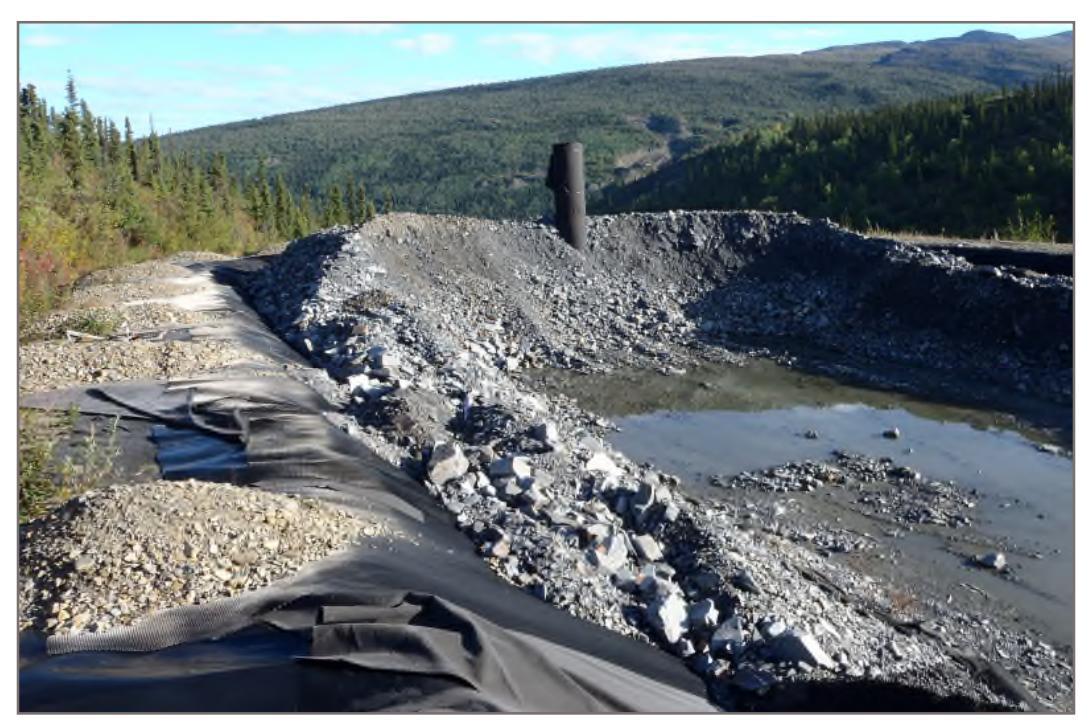
The PAG waste storage facility is located south of the Bellekeno portal, as shown on Figure 1. The facility has not been used since mining operations were suspended in winter 2013. As noted in previous inspections, the geonet and geotextile components of the liner system have only been installed in the north half of the facility (Photo 1). If the facility is to be used in the future, the installation of the liner system should be completed as per the original design.

Photo 1: PAG Waste Storage Facility Unfinished liner installation Facing north - August 18, 2016

| Structure | Stability Recommendations | Maintenance Recommendations | |
|---|---|---|--|
| PAG Waste Storage Facility | None | Complete liner installation as per the original design if facility is to be used in the future | |

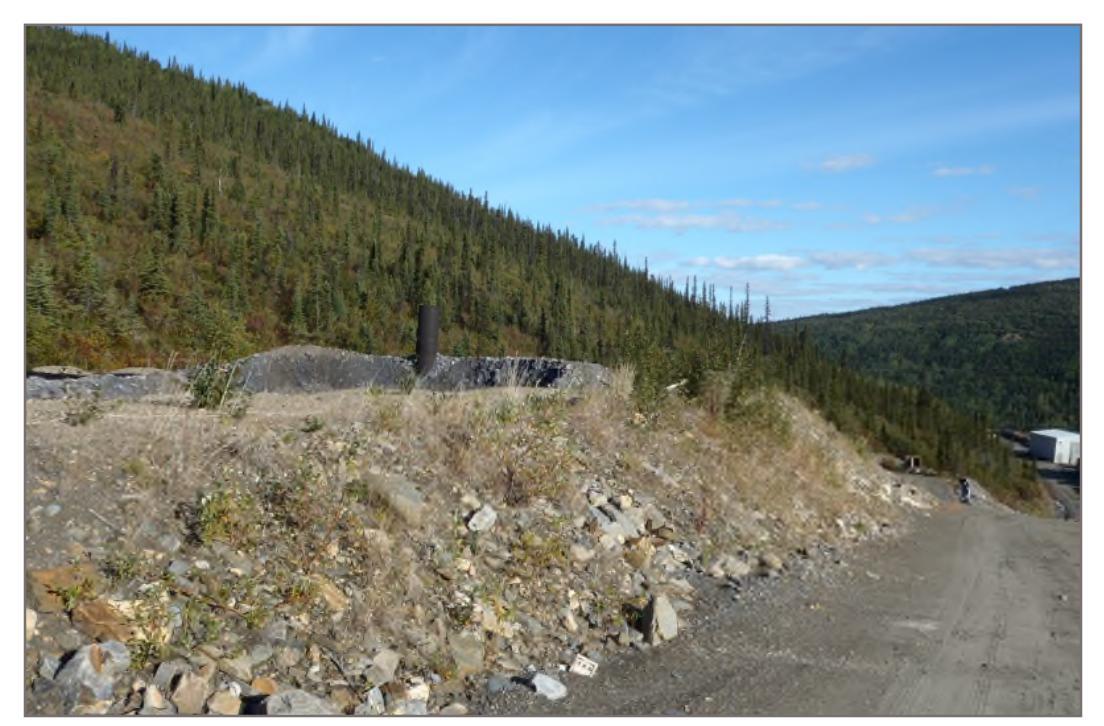
At the time of the inspection, the perimeter berms appeared intact with no visible signs of instability (Photo 2).

Photo 2: PAG Waste Storage Facility Stable perimeter berm Facing north - August 18, 2016

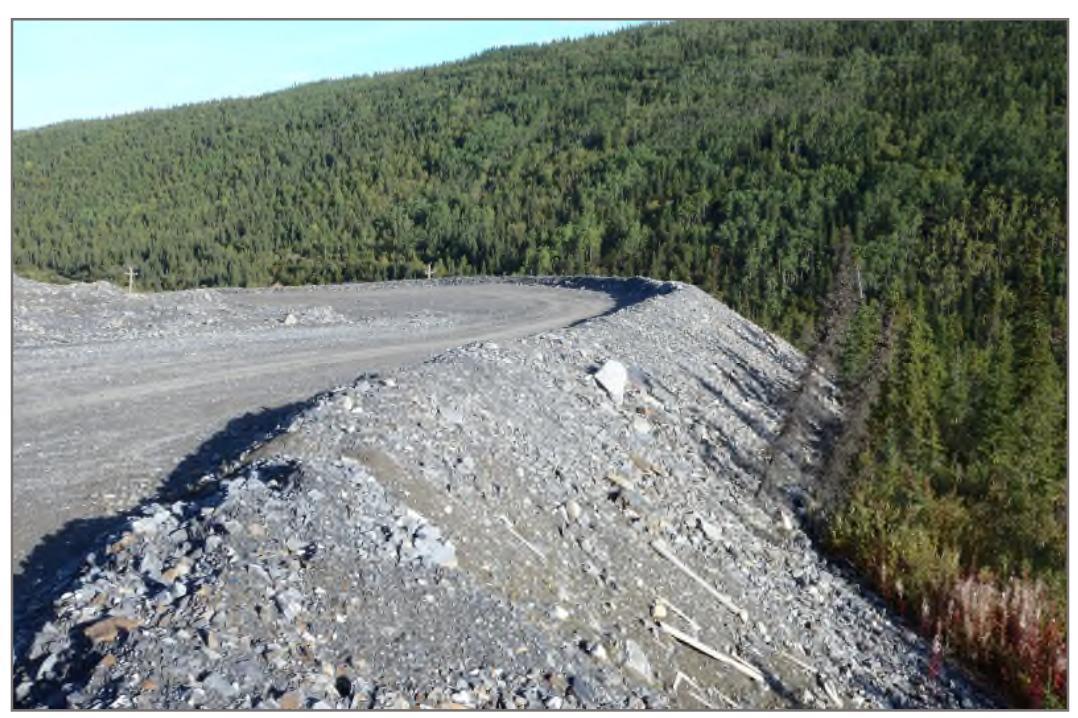
The Bellekeno waste rock pile forms a portion of the Bellekeno Haul Road and is located north of the Bellekeno portal, as shown on Figure 1. At the time of the inspection the waste rock pile sideslopes appeared intact and stable (Photo 3). No remedial action is required for the Bellekeno waste rock pile at this time.

Photo 3: Bellekeno Waste Rock Pile Stable pile sideslope Facing north - August 18, 2016

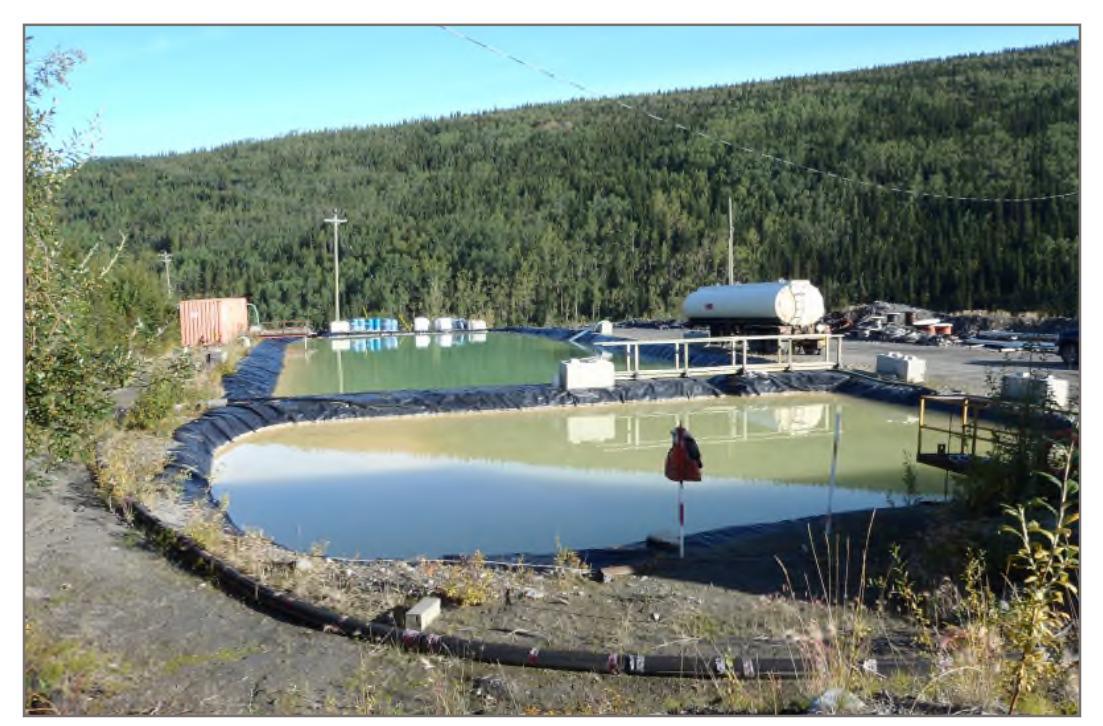
Photo 4: Bellekeno 625 Water Treatment Ponds Operating water treatment ponds Facing north - August 18, 2016

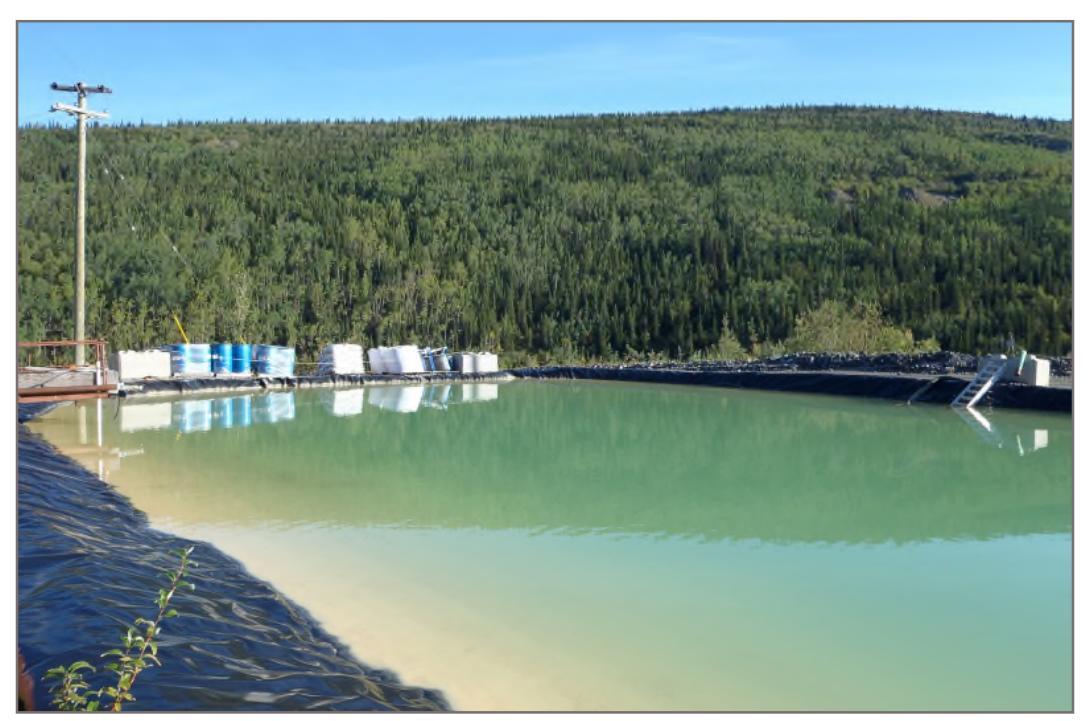
The Bellekeno 625 water treatment ponds are located north of the Bellekeno portal, as shown on Figure 1. The facility consists of two water treatment ponds that were both operating at the time of the inspection (Photo 4). The primary treatment pond was operating at the discharge invert elevation with a freeboard of 0.5 m below the perimeter berm crest at the time of the inspection. The secondary pond was also operating at the discharge elevation. Freeboard in the secondary pond ranges from about 0.5 m at the south end to about 0.3 m at the north end. Settlement of the north end of the pond has likely caused the diminished freeboard (Photo 5).

Careful examination of the perimeter berms and surrounding ground surface during the inspection did not yield any visual evidence of movement and despite suspected settlement, the liner and perimeter berms appeared intact with no visible signs of distress. Elevation surveys to monitor for settlement of the north end of the pond should be completed monthly during the snow free season. If more settlement occurs, additional geomembrane and fill must be added to restore the design freeboard (0.6 m).

Photo 5: Bellekeno 625 Water Treatment Ponds Diminished freeboard at north end of facility Facing north - August 18, 2016

| Structure | Stability Recommendations | Maintenance Recommendations | |
|---|---|---|--|
| Bellekeno 625 Water Treatment Ponds | Conduct monthly elevation surveys during snow free season of perimeter berm crest of secondary pond to monitor for settlement | Add geomembrane and fill if freeboard decreases to less than 0.3 m | |

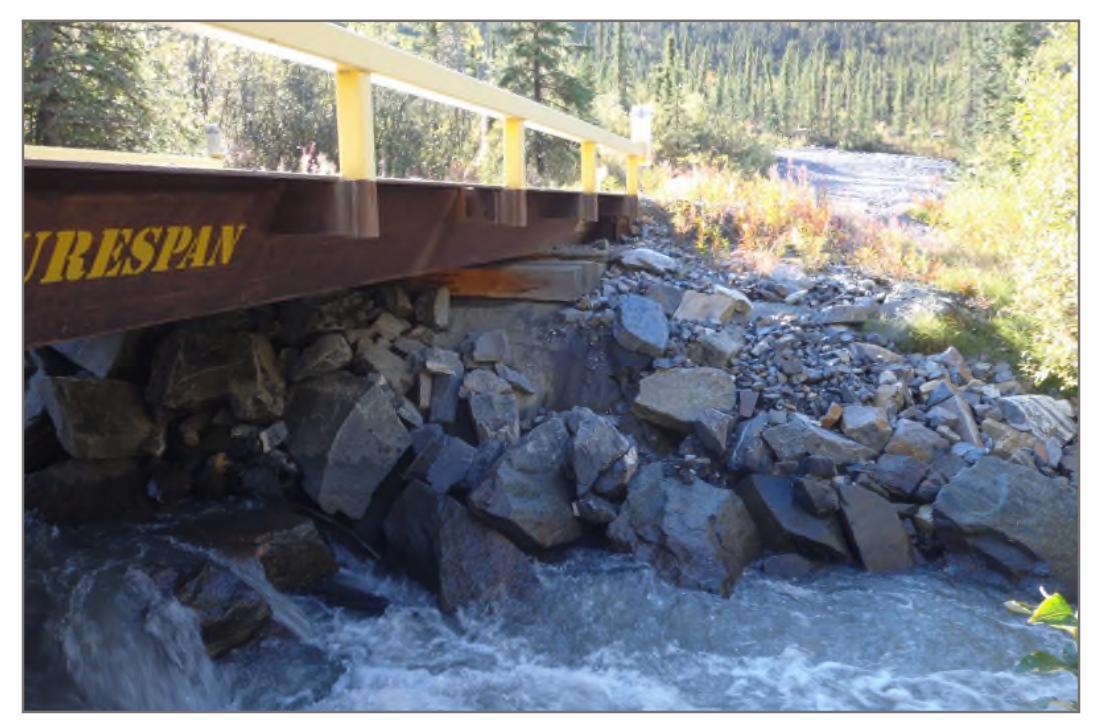
The Lightning Creek bridge on the Onek Road is located east of Keno City, as shown on Figure 1. The bridge is a single span steel structure founded on earth filled timber cribbing abutments. The abutments appeared stable at the time of the inspection. Consistent with previous inspections, some of the rip-rap armouring on the south abutment on the downstream side of the bridge has been displaced exposing the underlying geotextile (Photo 6). The rip-rap should be repaired as part of ongoing site maintenance to prevent erosion.

Photo 6: Lightning Creek Bridge (Onek Road) Exposed geotextile on south abutment Facing south - August 18, 2016

| Structure | Stability Recommendations | Maintenance Recommendations | |
|---|---|---|--|
| Lightning Creek Bridge Abutments (Onek Road) | None | Repair displaced rip-rap on south abutment (downstream side) | |

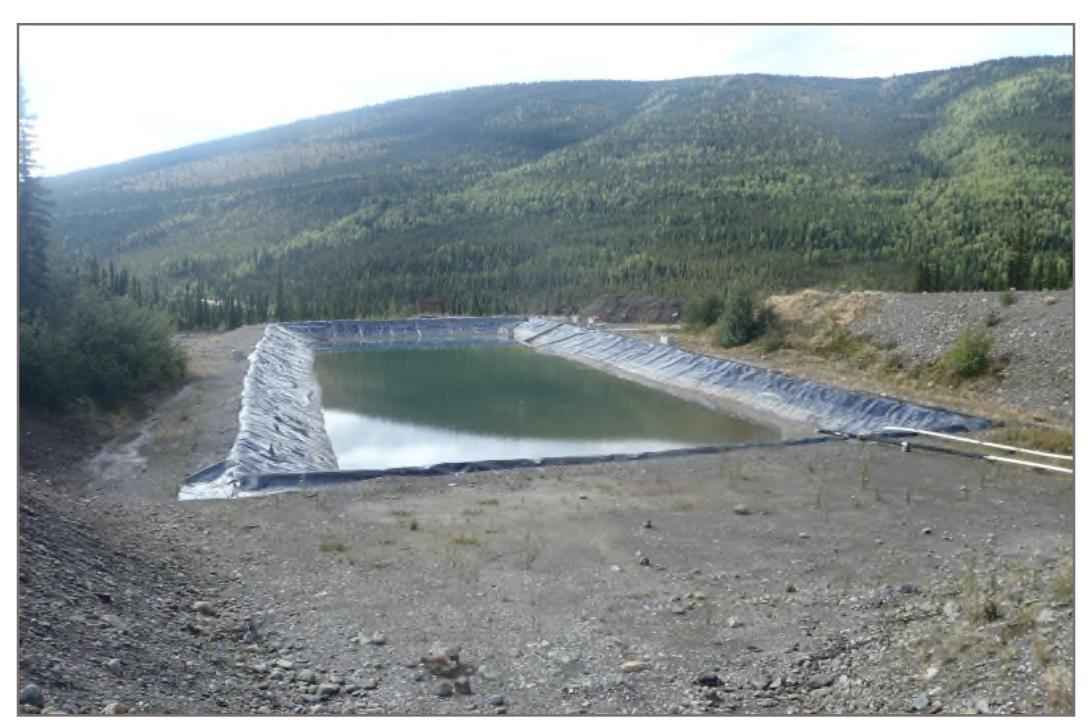
Photo 7: Mill Water Storage Pond Water level in pond Facing west - August 18, 2016

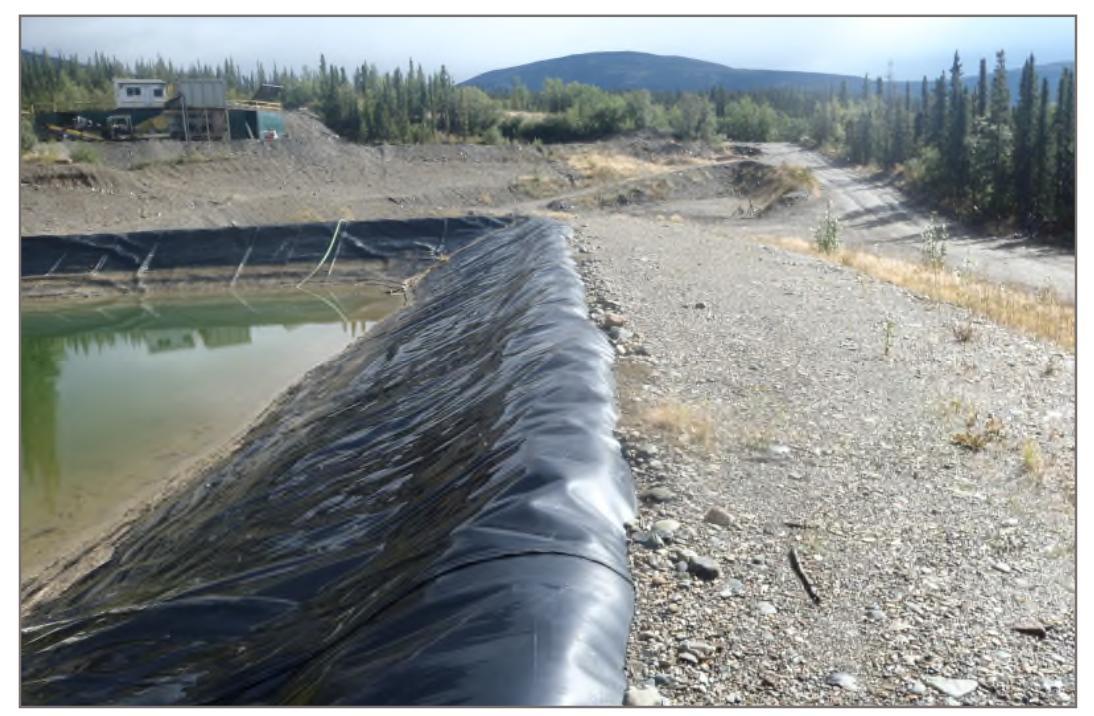
The mill water storage pond is located at the Keno Hill District Mill Site, west of Keno City, as shown on Figure 1. At the time of the inspection the pond was not operating but contained some water, with a freeboard of about 2 m below the perimeter berm crest (Photo 7). The perimeter berms and pond liner appeared intact with no visible signs of instability (Photo 8). No remedial action is required for the mill water storage pond at this time.

Photo 8: Mill Water Storage Pond Intact liner and stable perimeter berm Facing south - August 18, 2016

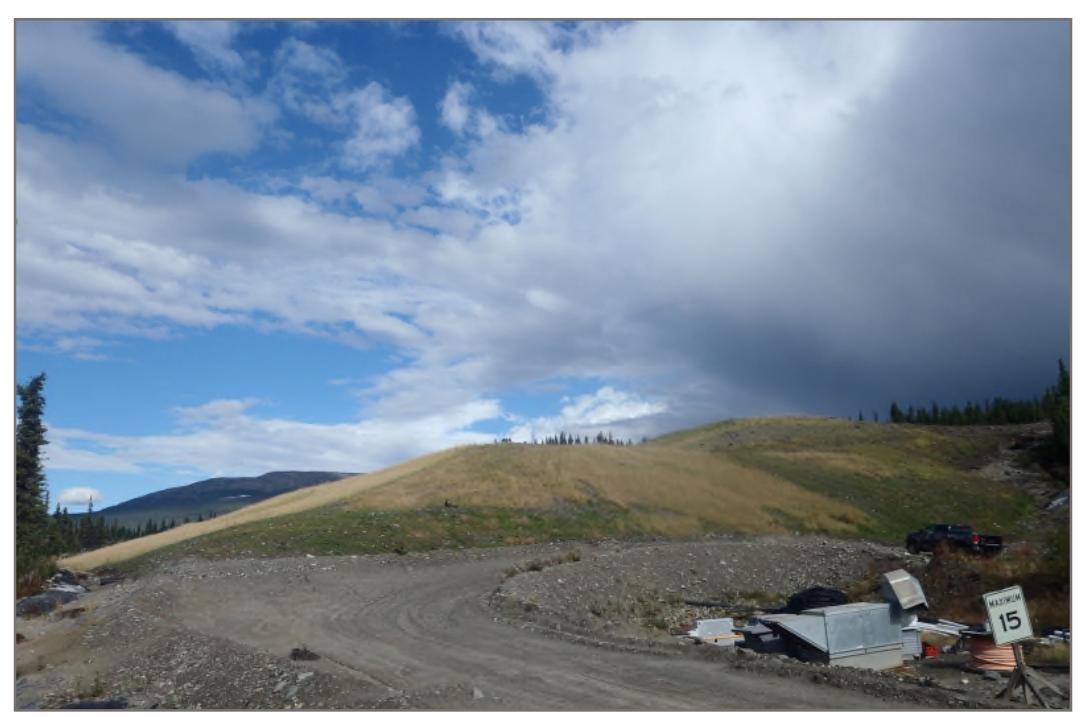
The dry stacked tailings facility (DSTF) is located at the Keno Hill District Mill Site west of Keno City, as shown on Figure 1. No tailings have been placed in the DSTF since mining operations were suspended in winter 2013. The tailings placed to date have been regraded, covered with organic growth medium, and seeded as part of progressive reclamation activities (Photo 9). No visible signs of instability were observed at the time of the inspection and to date, operation and performance of the DSTF has been consistent with the design.

Photo 9: Dry Stacked Tailings Facility Covered and seeded tailings Facing north - August 18, 2016

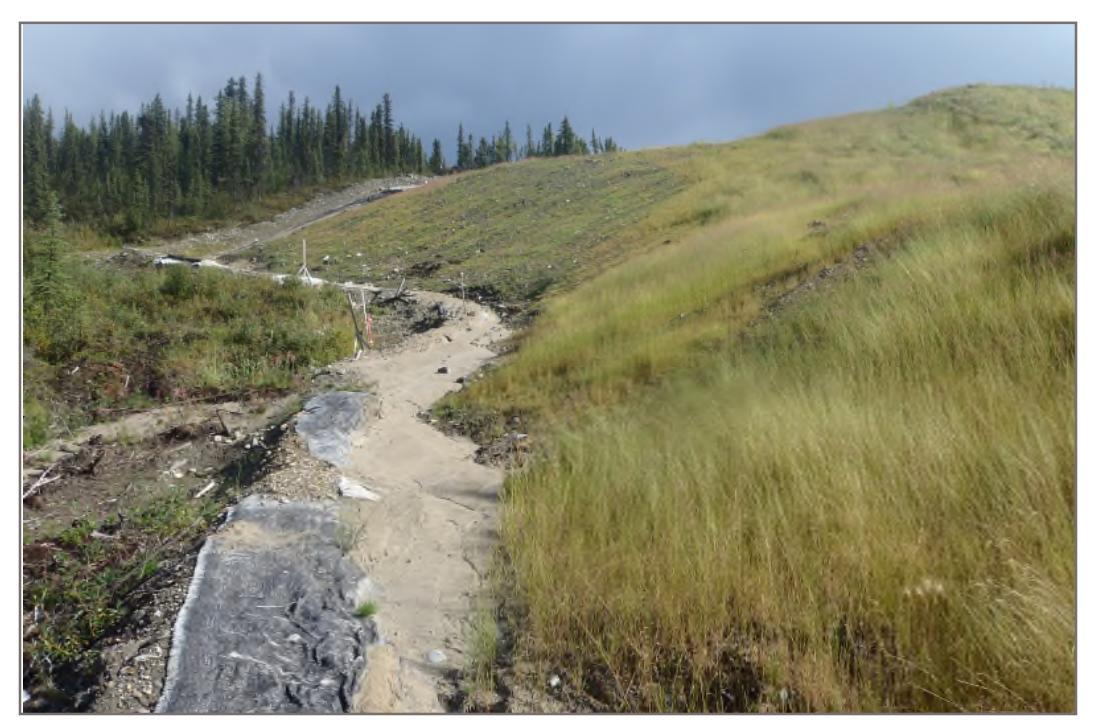
The lower bench of the DSTF has been constructed to the extents of the design footprint and the tailings covered as described above. The toe runoff collection ditch below the facility was designed to collect surface water from the exposed tailings. As part of ongoing progressive reclamation activities, Alexco could consider removing the toe runoff collection ditch to limit the amount of surface water reporting to the mill water storage pond (Photo 10).

Photo 10: Dry Stacked Tailings Facility Toe runoff collection ditch below facility Facing east - August 18, 2016
