## Site Assessment Report – 2013 – YPS-016

Site	YPS-016
Sample Date	Aug 7 2013
Latitude	N 63.9270
Longitude	W 139.3243
Altitude	1555 ft
Feature Name	Bonanza Creek
Stream Order	4

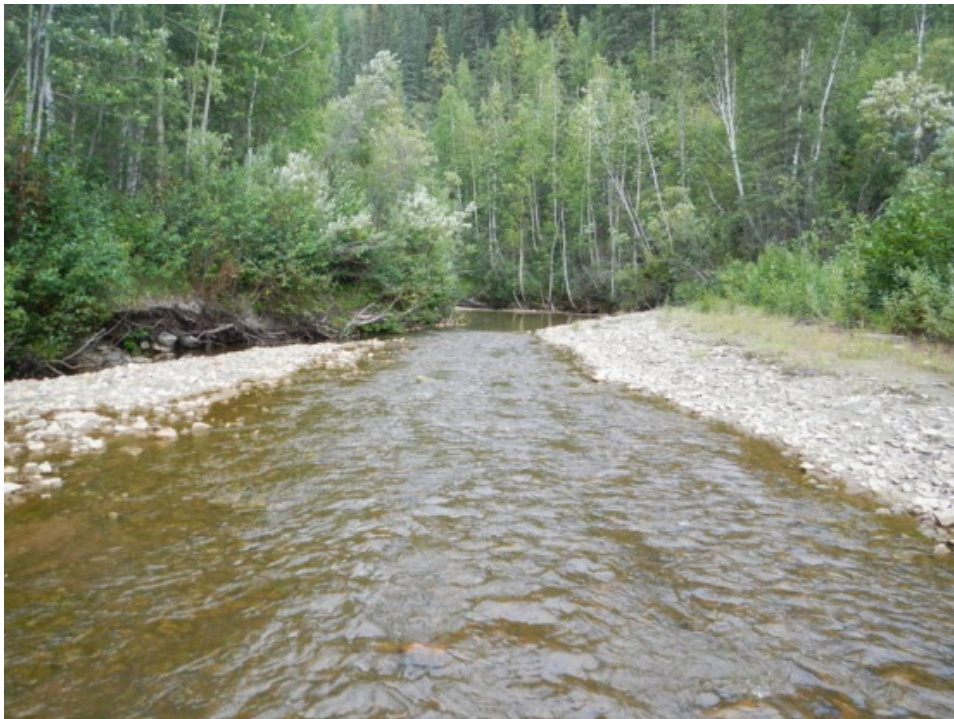
Downstream view

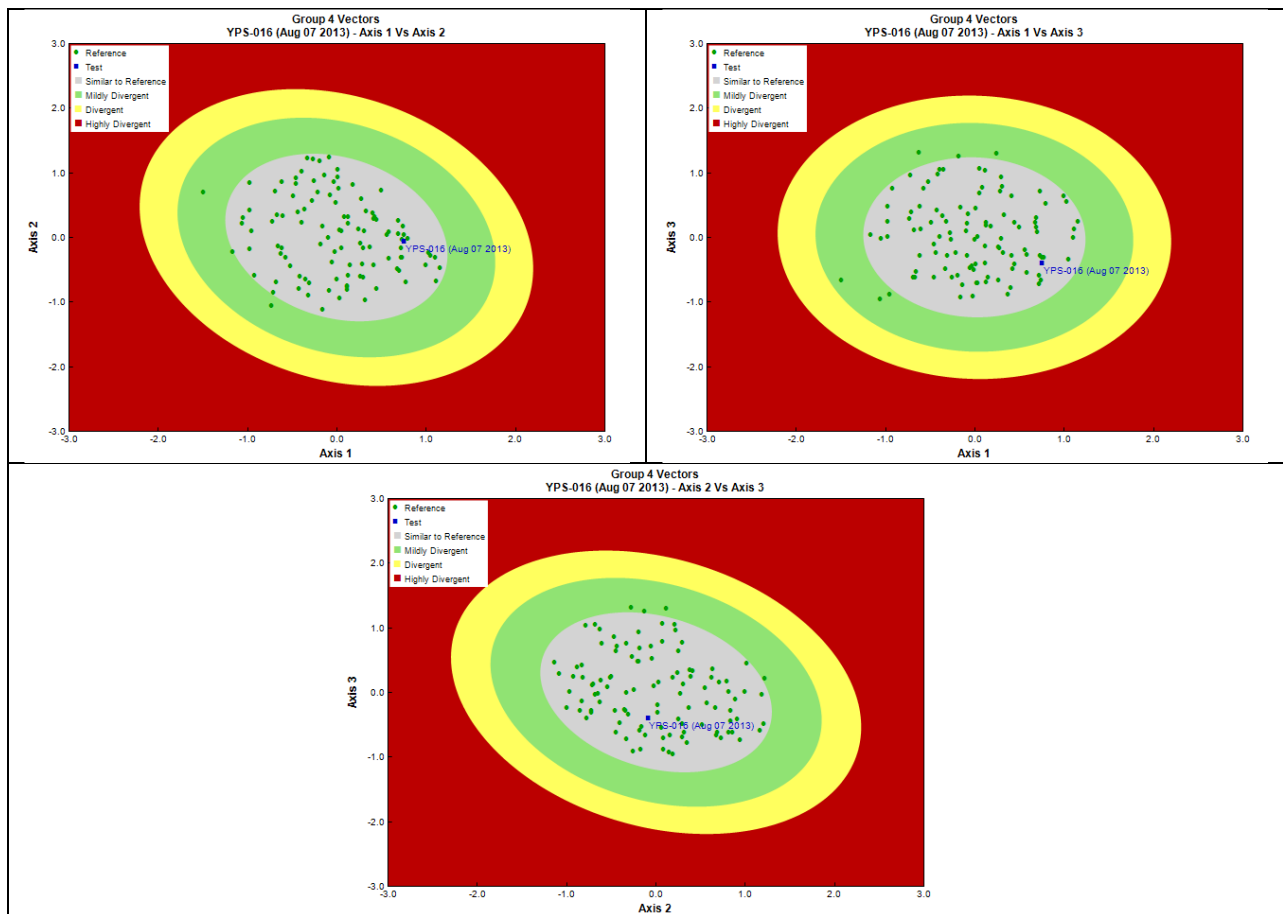
This figure displays three site assessment graphs which show the site relative to the group of reference sites to which it is compared. The three axes (or vectors) represent three dimensional space, and the probability bands (from center) are 75 - 90% (Similar to Reference), 90 – 99% (Mildly Divergent from Reference), 99 – 99.9% (Divergent from Reference), and outside 99.9% (Highly Divergent from Reference).

Vector 1 vs Vector 2	Similar to Reference
Vector 1 vs Vector 3	Similar to Reference
Vector 2 vs Vector 3	Similar to Reference
Overall	Similar to Reference

Using CABIN, YPS-016 is assessed as Similar to Reference.
