Site Assessment Report – 2013 – YPS-081

Site	YPS-081
Sample Date	August 7 2013
Latitude	N 64.03078
Longitude	W 139.38913
Altitude	1089 ft
Feature Name	Bonanza Creek
Stream Order	4

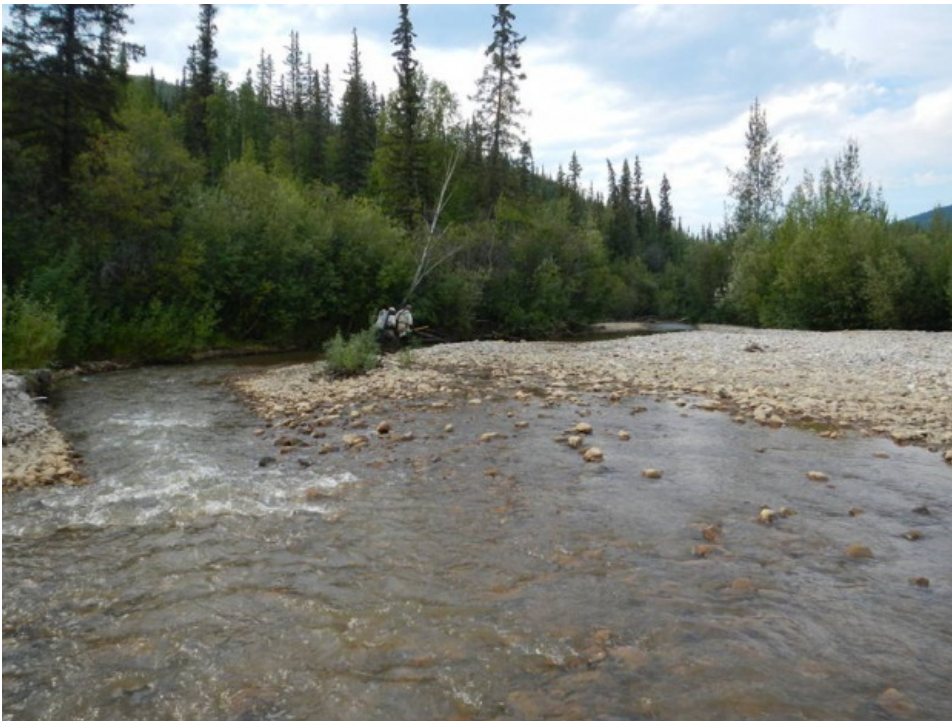
Site Photograph

Downstream view

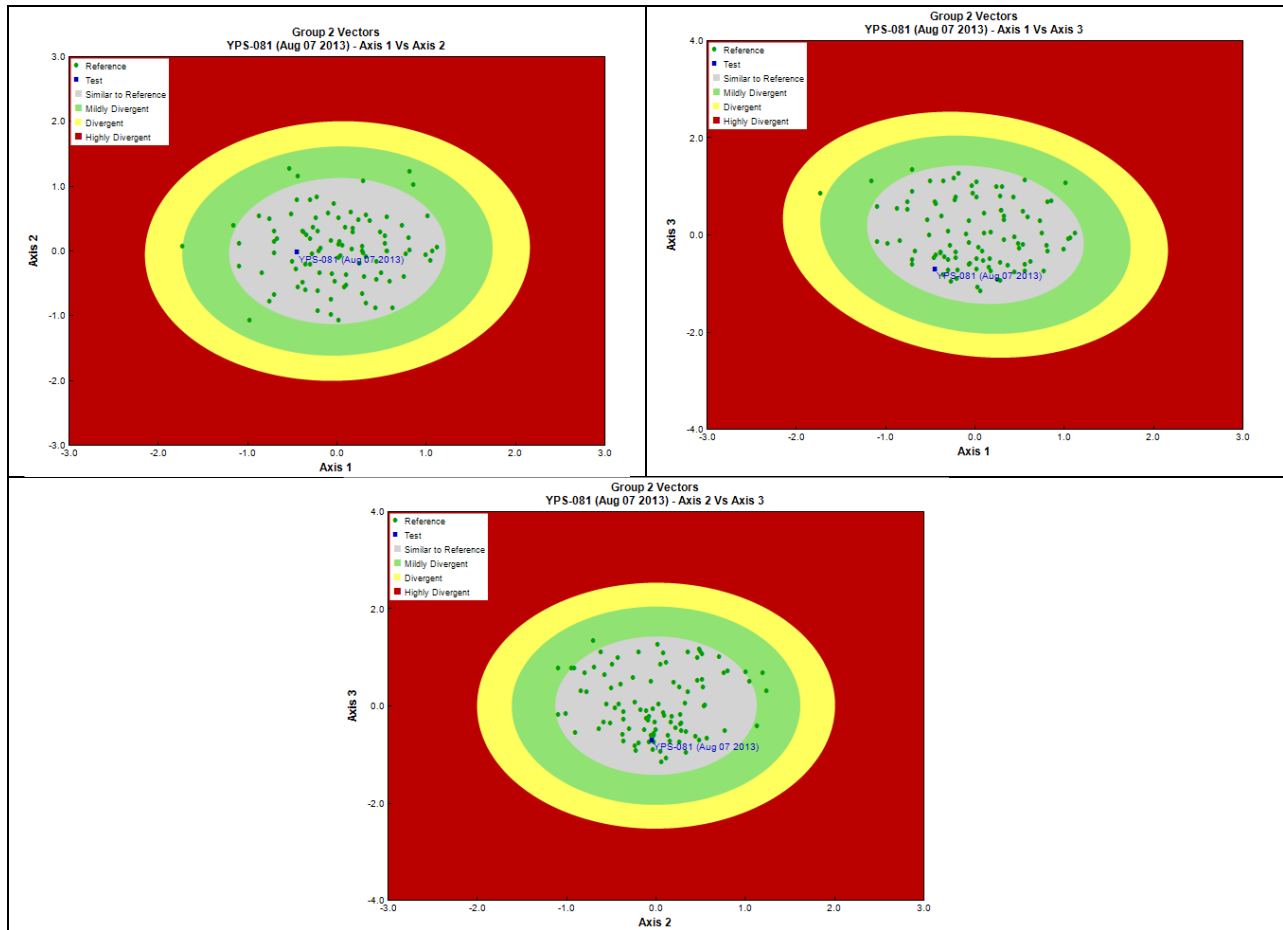
Visual Reports on Site Condition

This figure displays three site assessment graphs which show the site relative to the group of reference sites to which it is compared. The three axes (or vectors) represent three dimensional space, and the probability bands (from center) are 75 - 90% (Similar to Reference), 90 – 99% (Mildly Divergent from Reference), 99 – 99.9% (Divergent from Reference), and outside 99.9% (Highly Divergent from Reference).

Vector 1 vs Vector 2	Similar to Reference
Vector 1 vs Vector 3	Similar to Reference
Vector 2 vs Vector 3	Similar to Reference
Overall	Similar to Reference

Using CABIN, YPS-081 is assessed as Similar to Reference.
