Site Assessment Report – 2013 – YPS-083

Site	YPS-083
Sample Date	August 7 2013
Latitude	N 63.91946
Longitude	W 139.3138
Altitude	1574 ft
Feature Name	Eldorado Creek
Stream Order	2

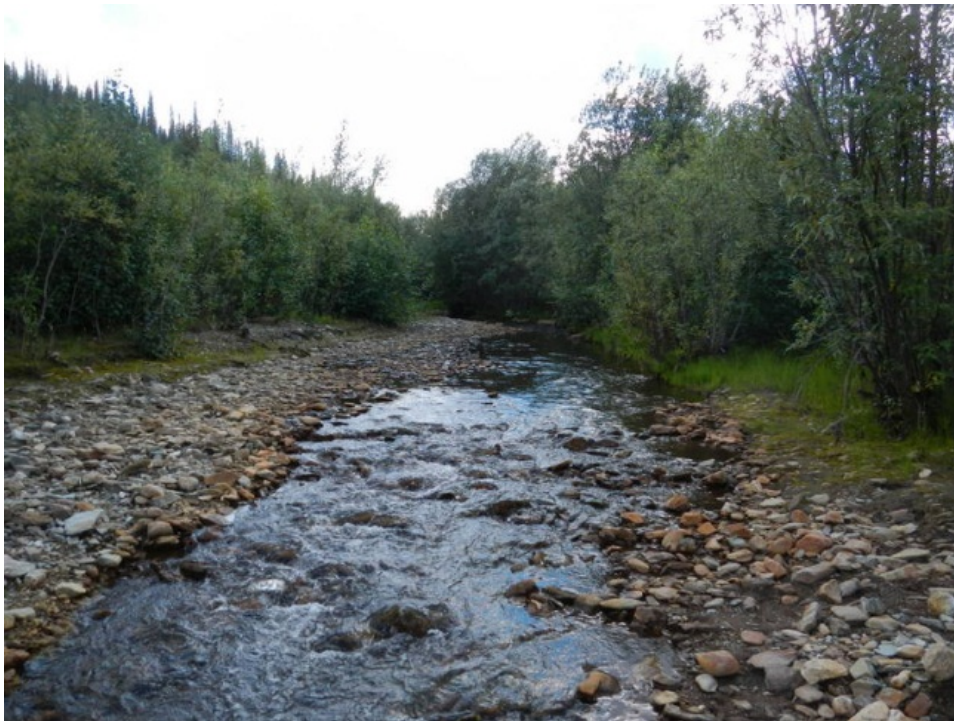
Site Photograph

Upstream view
