Site Assessment Report – 2013 – YPS-164

Site	YPS-164
Sample Date	August 8 2013
Latitude	N 63.0747
Longitude	W 139.3197
Altitude	1533 ft
Feature Name	Thistle Creek
Stream Order	5

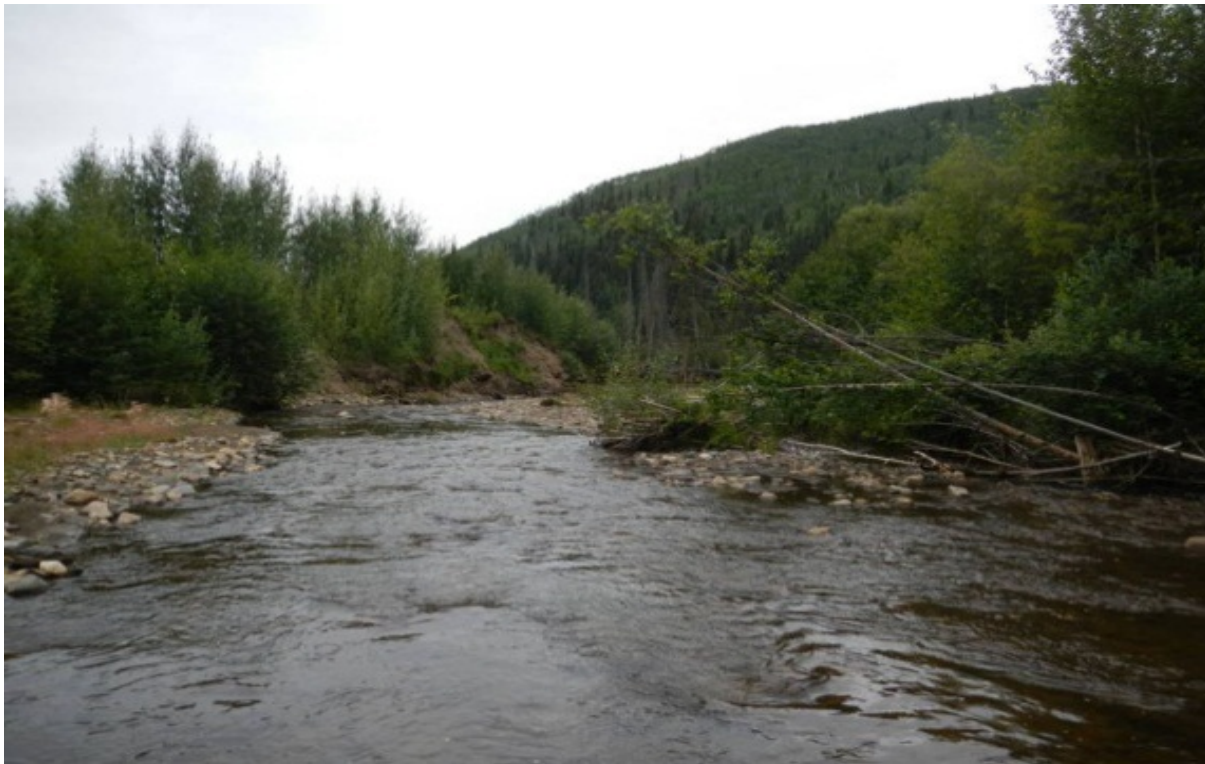
Site Photograph

Downstream view

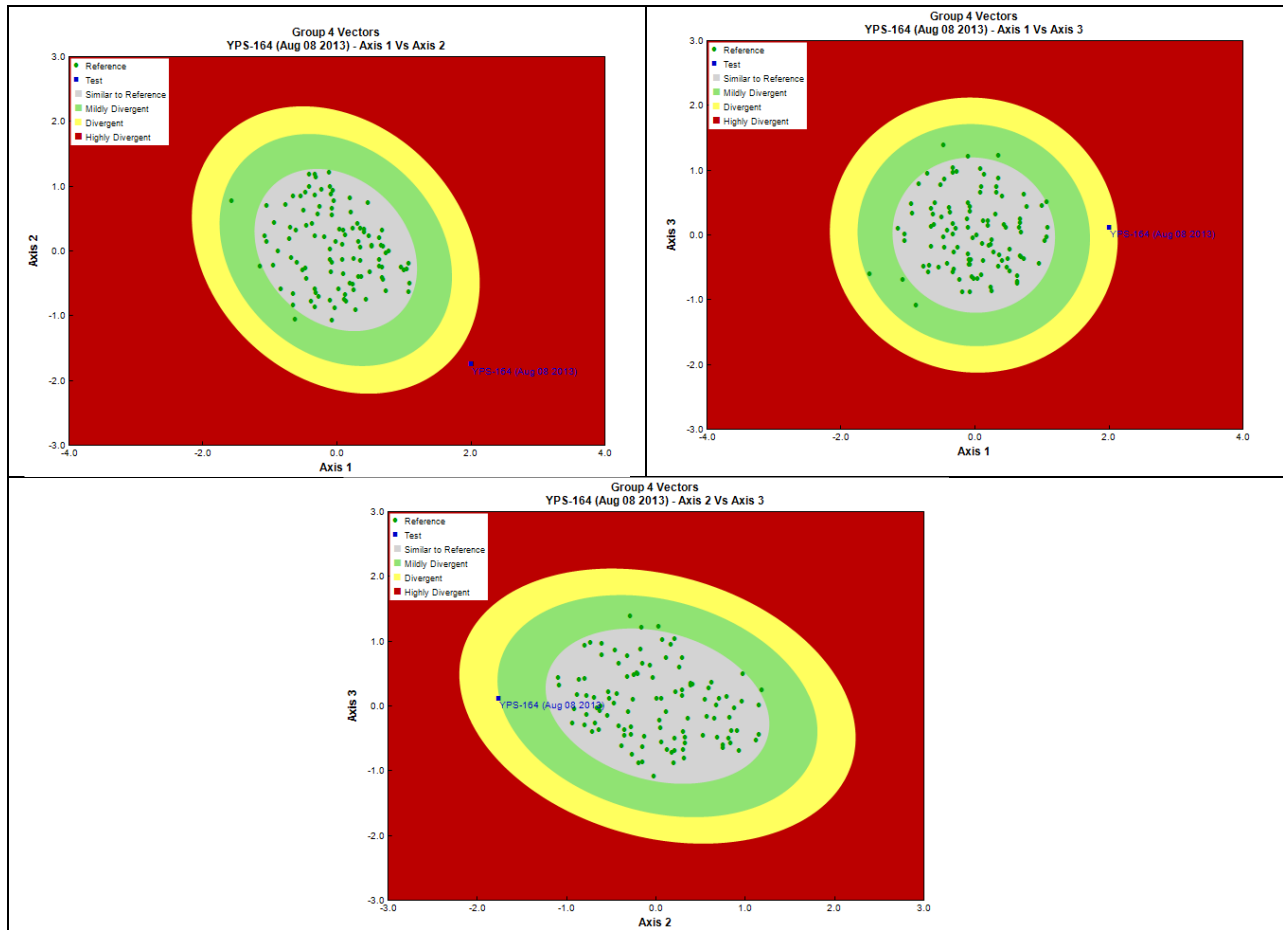
This figure displays three site assessment graphs which show the site relative to the group of reference sites to which it is compared. The three axes (or vectors) represent three dimensional space, and the probability bands (from center) are 75 - 90% (Similar to Reference), 90 – 99% (Mildly Divergent from Reference), 99 – 99.9% (Divergent from Reference), and outside 99.9% (Highly Divergent from Reference).

Vector 1 vs Vector 2	Highly Divergent from Reference Condition
Vector 1 vs Vector 3	Divergent from Reference Condition
Vector 2 vs Vector 3	Divergent from Reference Condition
Overall	Highly Divergent from Reference Condition

Using CABIN, YPS-164 is assessed as Highly Divergent from Reference Condition.
