Site Assessment Report – 2013 – YPS- 535

Site	YPS- 535
Sample Date	Aug 8, 2013
Latitude	N 63.07125
Longitude	W 139.46545
Altitude	1256 ft
Feature Name	Thistle Creek
Stream Order	5

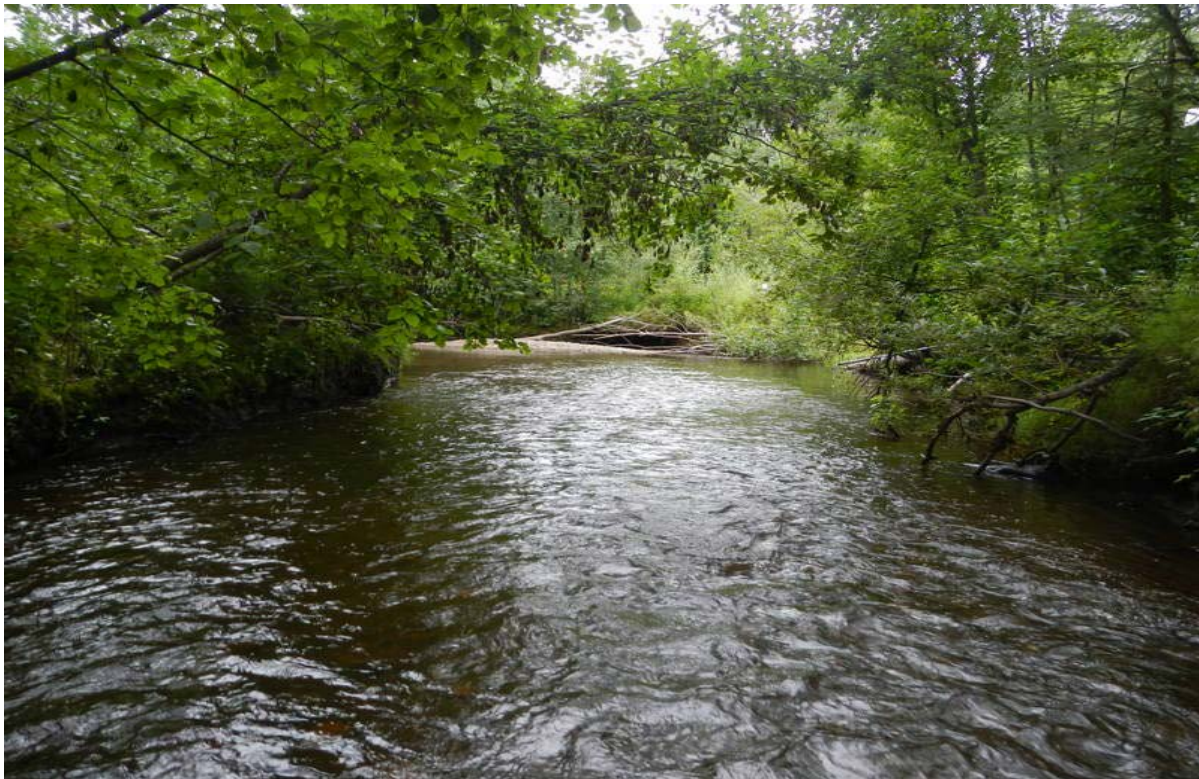
Site Photograph

Downstream view

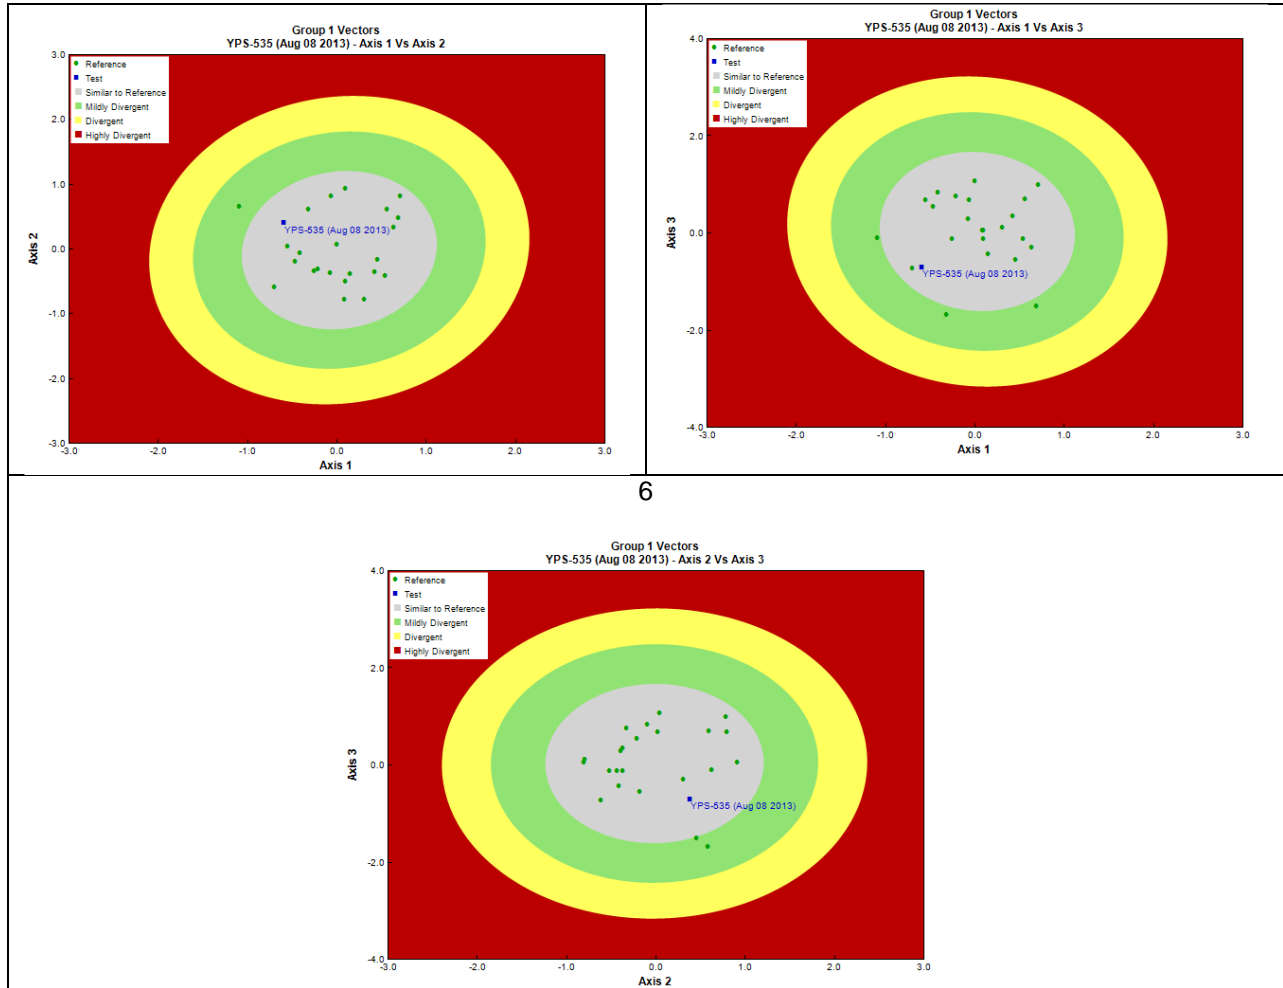
This figure displays three site assessment graphs which show the site relative to the group of reference sites to which it is compared. The three axes (or vectors) represent three dimensional space, and the probability bands (from center) are 75 - 90% (Similar to Reference), 90 – 99% (Mildly Divergent from Reference), 99 – 99.9% (Divergent from Reference), and outside 99.9% (Highly Divergent from Reference).

Vector 1 vs Vector 2	Similar to Reference
Vector 1 vs Vector 3	Similar to Reference
Vector 2 vs Vector 3	Similar to Reference
Overall	Similar to Reference

Using CABIN, YPS-535.2 is assessed as Similar to Reference.
