Site Assessment Report – 2013 – YPS- 547

Site	YPS- 547
Sample Date	July 17, 2013
Latitude	N 63.6174
Longitude	W 138.7064
Altitude	1660 ft
Feature Name	Dominion Creek
Stream Order	5

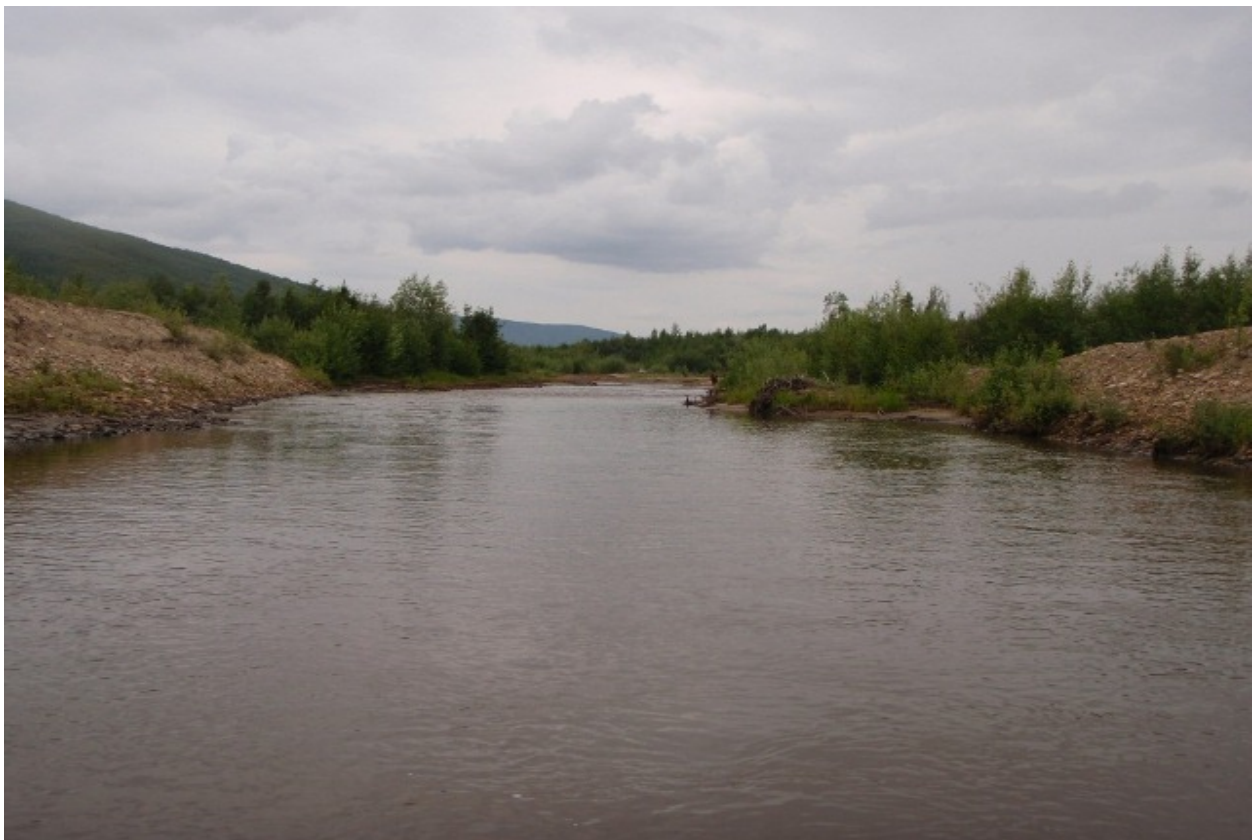
Site Photograph

Upstream view
