Site Assessment Report 2014 – YPS-326

Site	YPS-326
Sample Date	Jul 25, 2014
Latitude	61.30084 N
Longitude	134.32138 W
Altitude	2923
Feature Name	Marten Creek
Stream Order	2

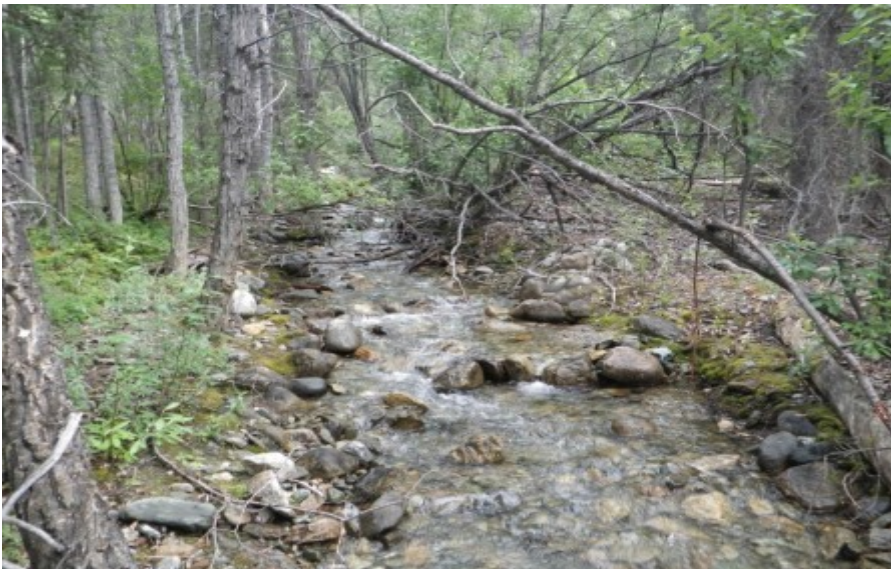
Site Photograph

Upstream view

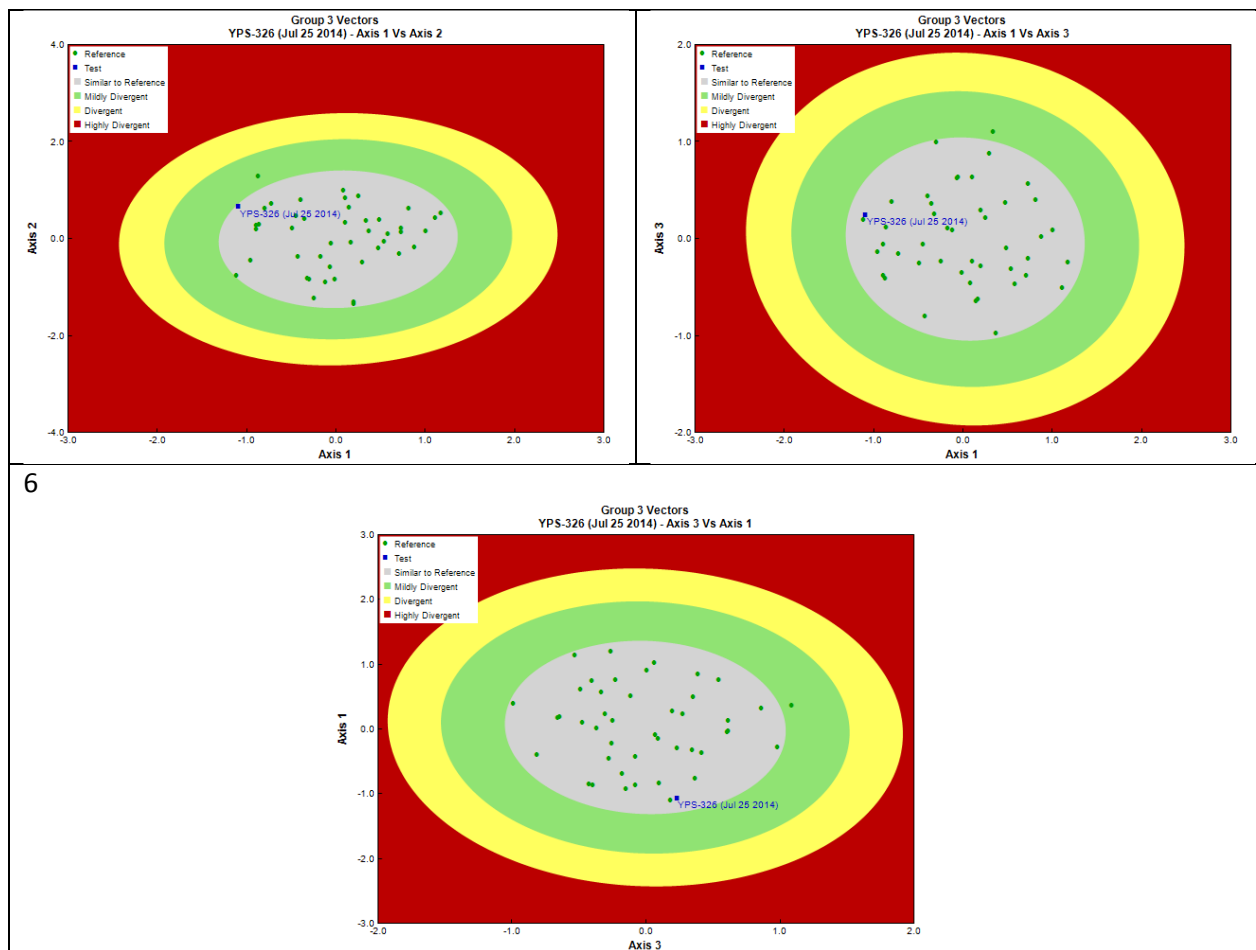
Visual Reports on Site Condition

This figure displays three site assessment graphs which show the site relative to the group of reference sites to which it is compared. The three axes (or vectors) represent three dimensional space, and the probability bands (from center) are 75 - 90% (Similar to Reference), 90 – 99% (Mildly Divergent from Reference), 99 – 99.9% (Divergent from Reference), and outside 99.9% (Highly Divergent from Reference).

Vector 1 vs Vector 2	Similar to Reference
Vector 1 vs Vector 3	Similar to Reference
Vector 2 vs Vector 3	Similar to Reference
Overall	Similar to Reference

Using CABIN, YPS-326 is assessed as Similar to Reference.
