Site Assessment Report 2014 - YPS-350

Site	YPS-350
Sample Date	Jul 21, 2014
Latitude	63.97312 N
Longitude	-138.73834
Altitude	1453
Feature Name	Leotta Creek
Stream Order	3

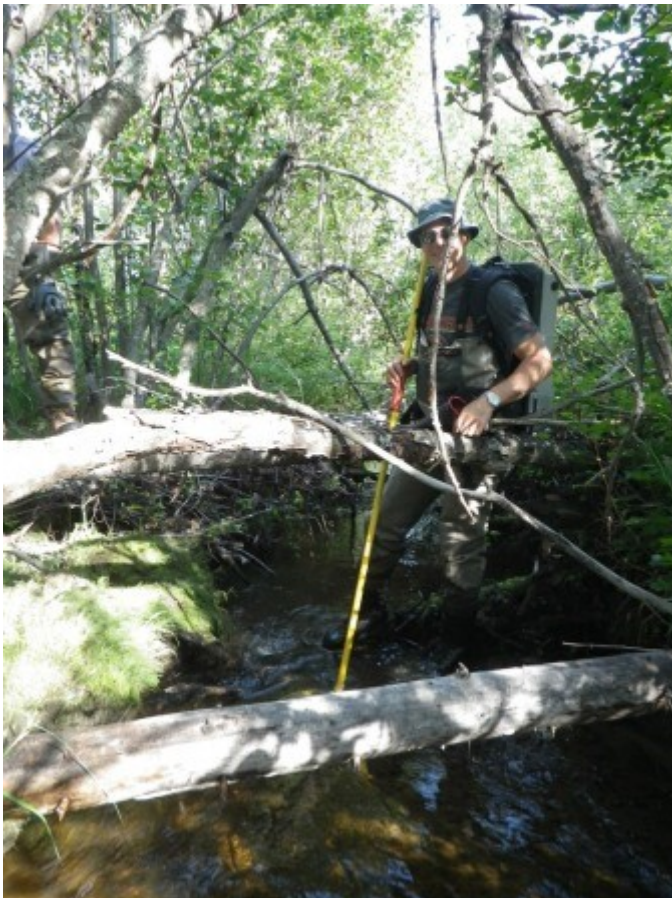
Site Photograph

Upstream view

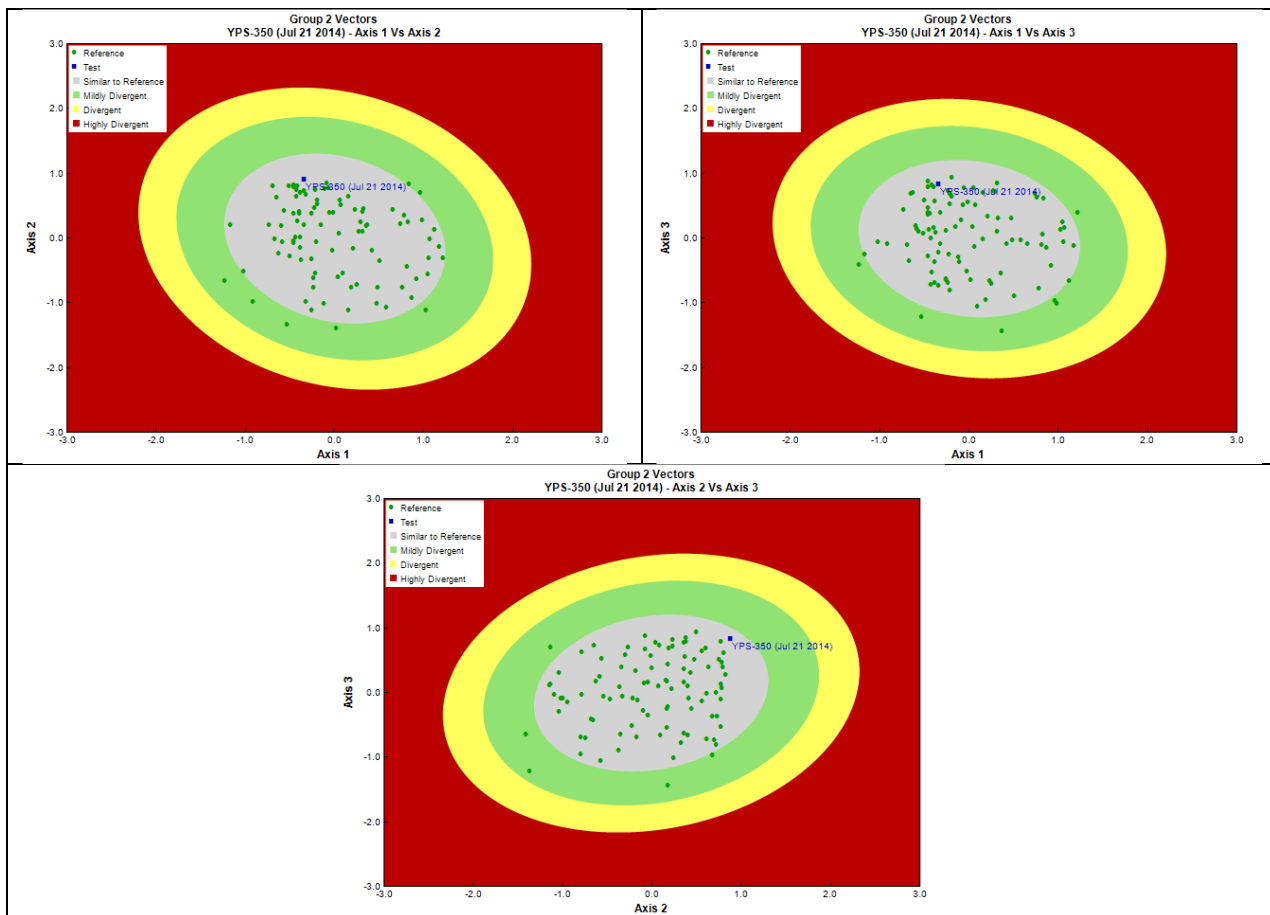
Visual Reports on Site Condition

This figure displays three site assessment graphs which show the site relative to the group of reference sites to which it is compared. The three axes (or vectors) represent three dimensional space, and the probability bands (from center) are 75 - 90% (Similar to Reference), 90 – 99% (Mildly Divergent from Reference), 99 – 99.9% (Divergent from Reference), and outside 99.9% (Highly Divergent from Reference).

Vector 1 vs Vector 2	Similar to Reference
Vector 1 vs Vector 3	Similar to Reference
Vector 2 vs Vector 3	Similar to Reference
Overall	Similar to Reference

Using CABIN, YPS-350 is assessed as Similar to Reference.
