# Site Assessment Report 2014 – YPS-375

Site	YPS-375
Sample Date	Jul 22 2014
Latitude	64.38639 N
Longitude	140.63556 W
Altitude	1007
Feature Name	Maiden Creek
Stream Order	3

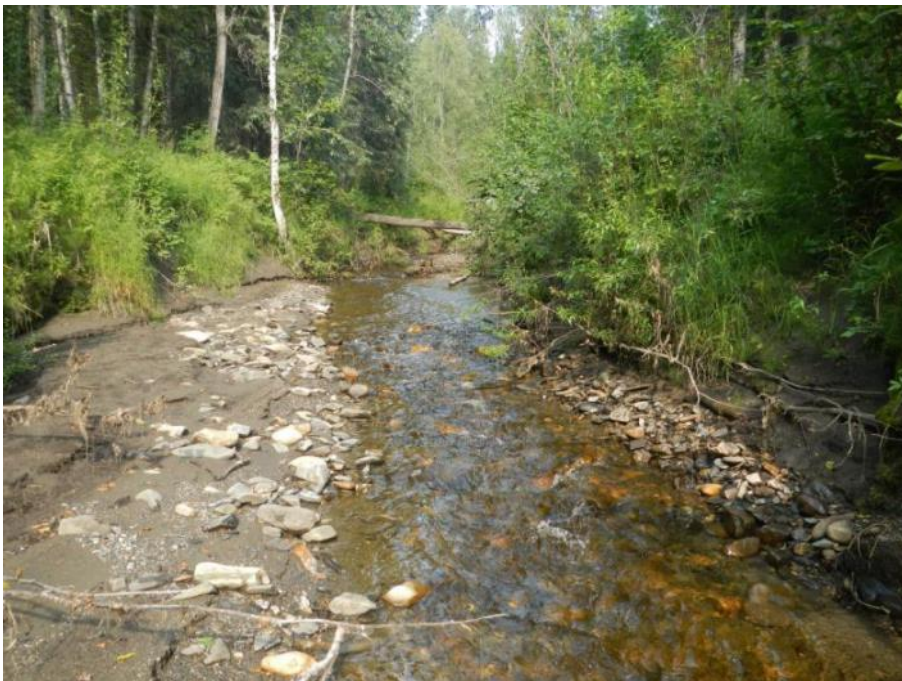
Downstream view
