2020 Adaptive Management Report for the Fish Habitat
Management System for Yukon Placer Mining

Appendix A: 2020 Water Quality Objective Monitoring and Aquatic Health Monitoring Report

Fish Habitat Management System for Yukon Placer Mining – 2020 Aquatic Health and Water Quality Objective Monitoring Results

Project No. 105125-01

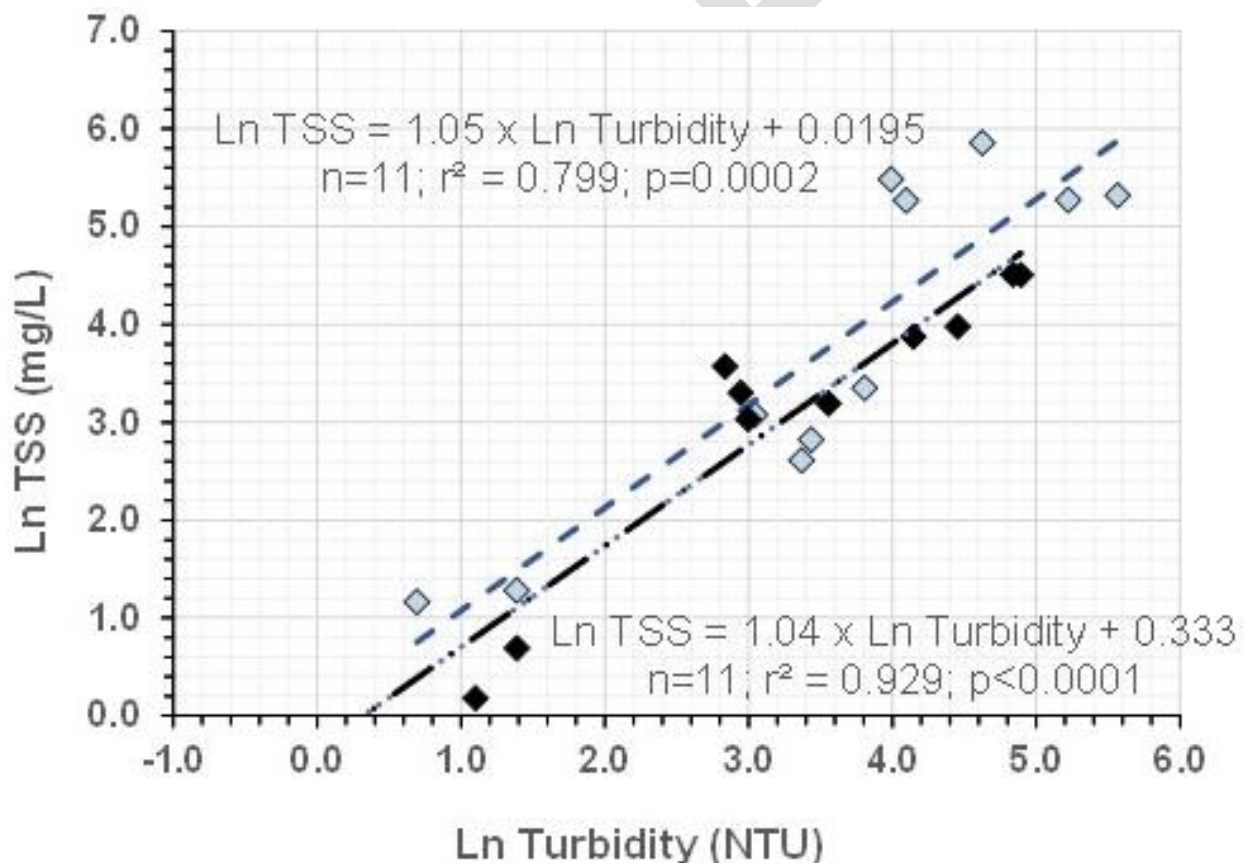
Figure 3.1 Log-log TSS Turbidity Relationship for Hunker Creek Samples in 2020. Solid symbols and lower line show September data. Lighter symbols and upper dashed line show July data

The slope of the log-log linear regression relationship between TSS and turbidity for Hunker Creek stations was the same for the July and September sampling periods (**Figure 3.1** and **Figure 3.2**). The intercept was slightly different between the two sampling periods, reflective of a higher TSS for a given turbidity measurement in July than September.

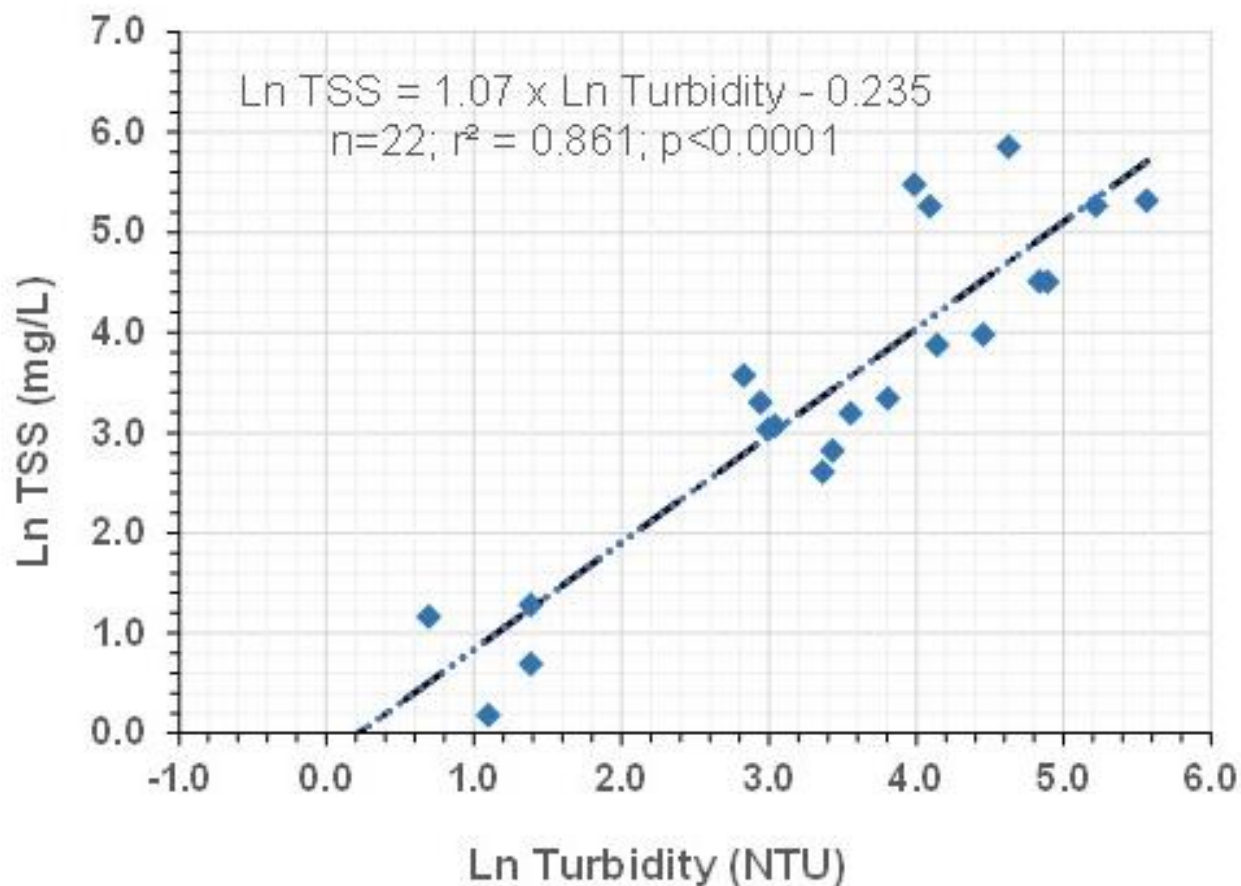
Figure 3.2 Log-log TSS Turbidity Relationship for Adams Creek Samples; Both Sampling Events Combined

The TSS and turbidity in Adams Creek were very low in both July and September, with the exception of the monitoring during the afternoon of September 23rd, 2020, at stations YPS-622 and 623. The elevated TSS was observed to be directly related to placer mining in the lower reaches of Adams Creek, near its mouth. For the purpose of evaluating this bivariate relationship, turbidity values recorded as below the detection limit were substituted with an assumed value of 0.5 NTU.

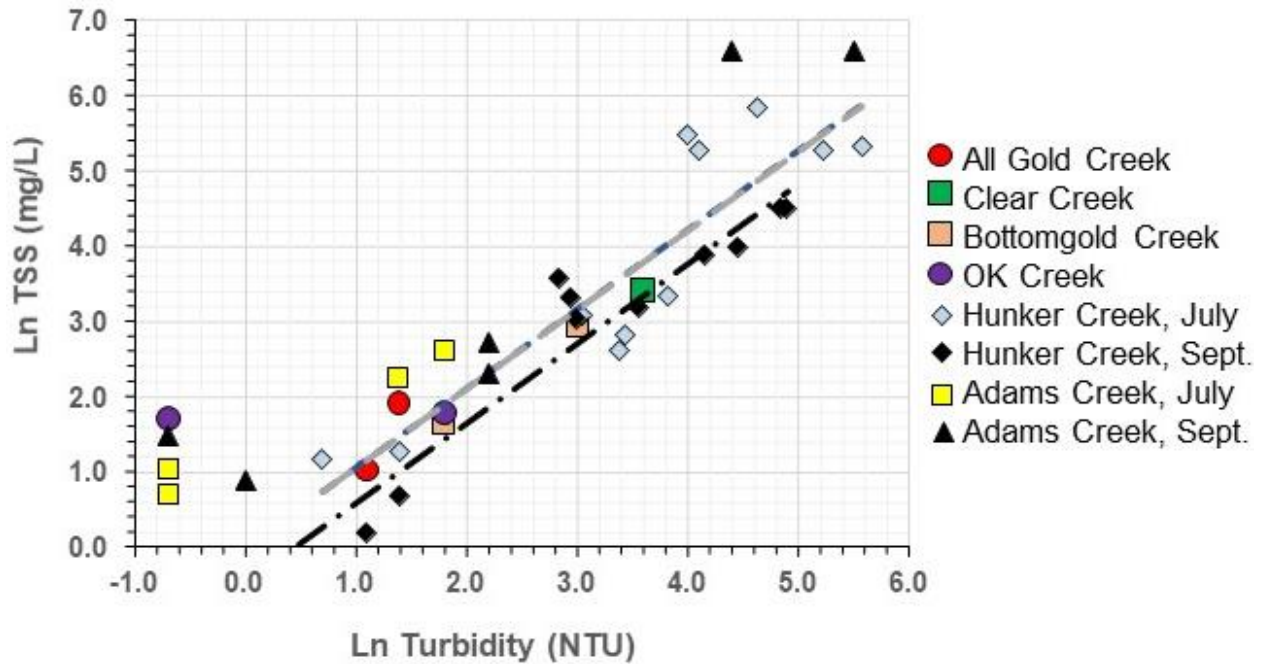
Figure 3.3 TSS-turbidity Relationship for Majority of 2020 Sites

The relationship between TSS and turbidity was generally consistent across all WQOM stations monitoring in 2020 (**Figure 3.3**: data for Swede Creek and Stampede Gulch stations are not included since all turbidity measurements were lower than the detection limit). Excluding those samples with a non-detected turbidity value, the overall regression relationship for the natural log of TSS on the natural log of turbidity is illustrated in **Figure 3.3**.

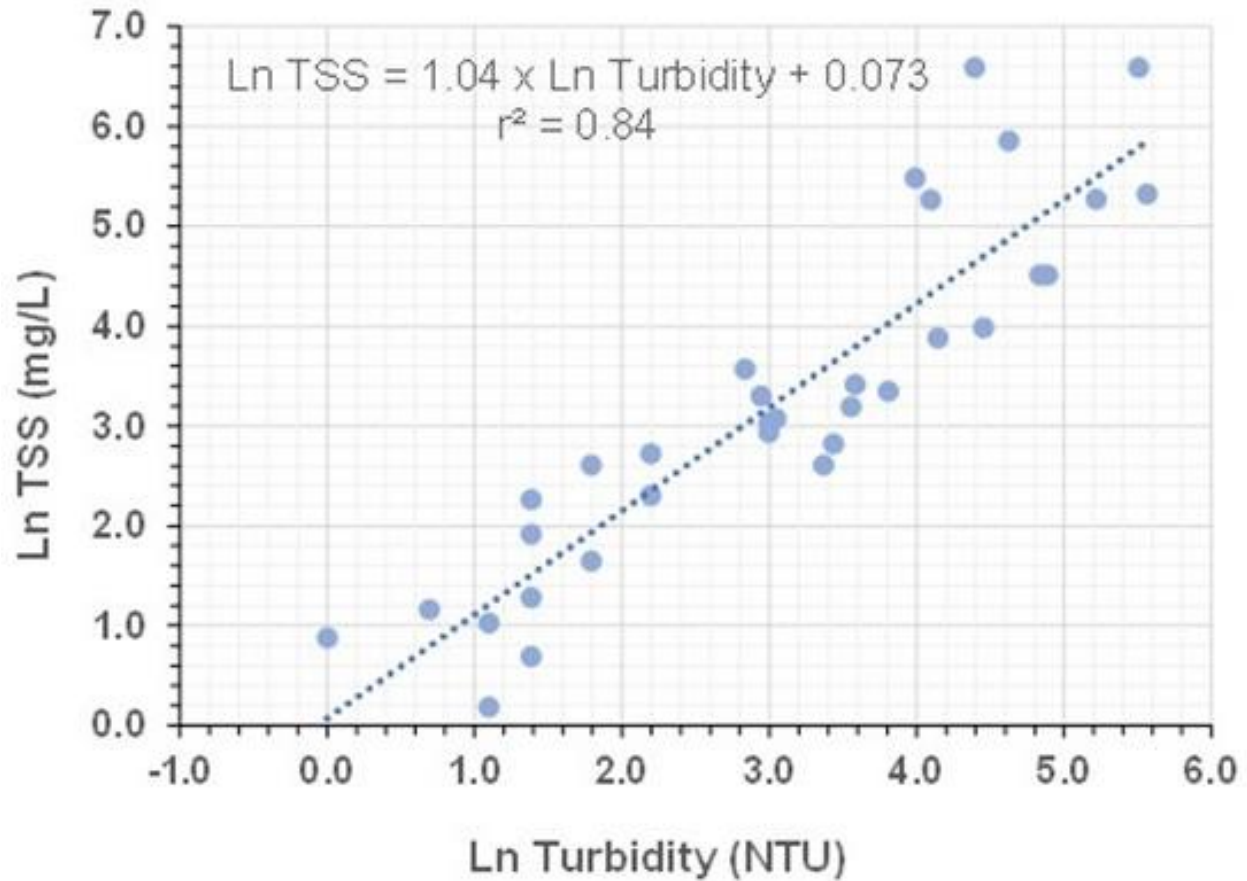
Figure 3.4 Generalized Form of TSS-turbidity Regression Equation Based on 2020 Monitoring Data

The overall regression of the natural logarithm of TSS on the natural logarithm of turbidity is provided in **Figure 3.4** for all 2020 data combined. The associated equations for the upper and lower 95% confidence limits on the log-log linear relationship provided in **Figure 3.4** are as follows:

Upper 95% Confidence Limits: $\text{Ln TSS} = 0.881 \times \text{Ln Turbidity} - 0.46$ [2]

Based on this regression relationship, the turbidity associated with various WQO based on TSS concentrations are provided in **Table 3.11**.

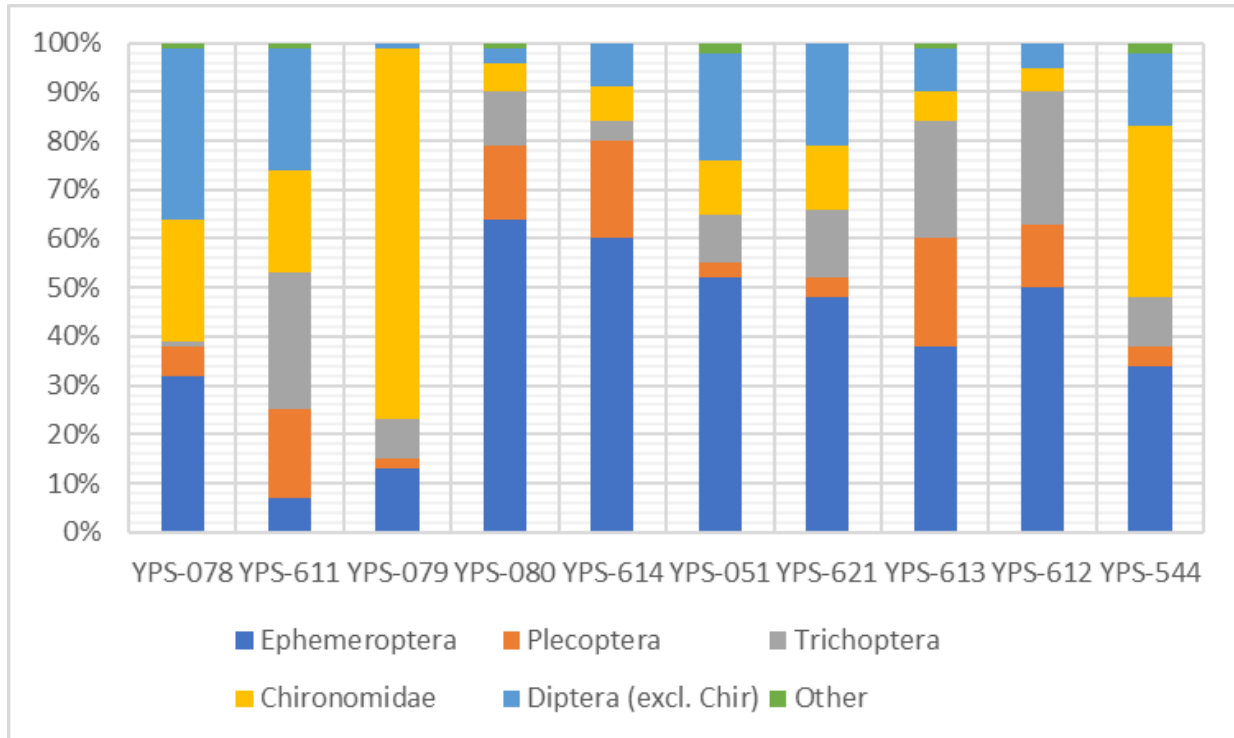
Figure 4.1 Relative Abundance of Major Taxonomic Groups in Hunker Creek in 2019

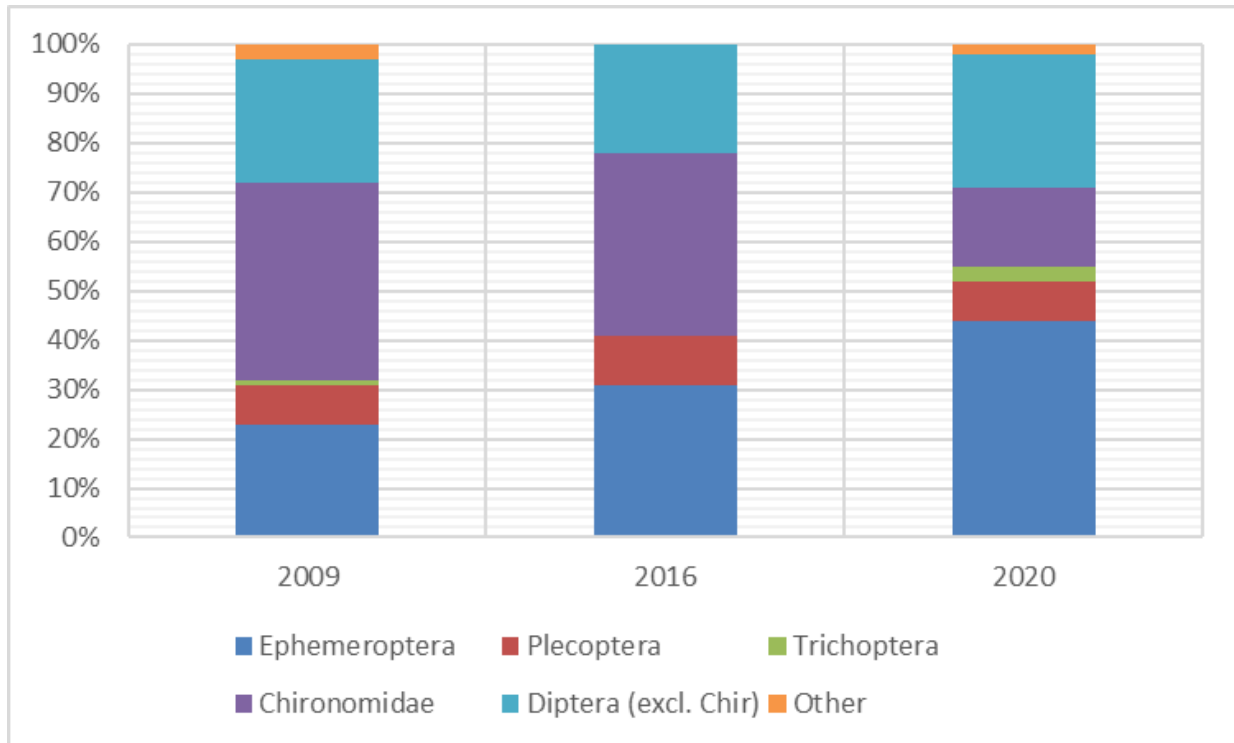
Figure 4.12 Relative Abundance of Major Taxonomic Groups at YPS-386 in Swede Creek, 2009, 2016 and 2020

Total abundance at the site shows an increasing trend from the years of monitoring at YPS-386. Family richness decreased from 2009 to 2016 and increased from 2016 to 2020. SDI values calculated for the site are generally high with a range from 0.80 to 0.90. The SEI values (0.20 to 0.31), however, suggest that there is a high degree of dominance by one or few types of organisms. Community composition has changed since the sampling commenced in 2009. Percent *Chironomidae* has decreased since 2009, whereas % EPT has increased since 2009. This shift is observed in percent ephemeroptera but not in plecoptera, which remained steady since 2009. Similar to Adams Creek, there is very little representation from trichoptera in any of the years sampled with only one percent in 2009, no representation in 2016, and three percent in 2020.

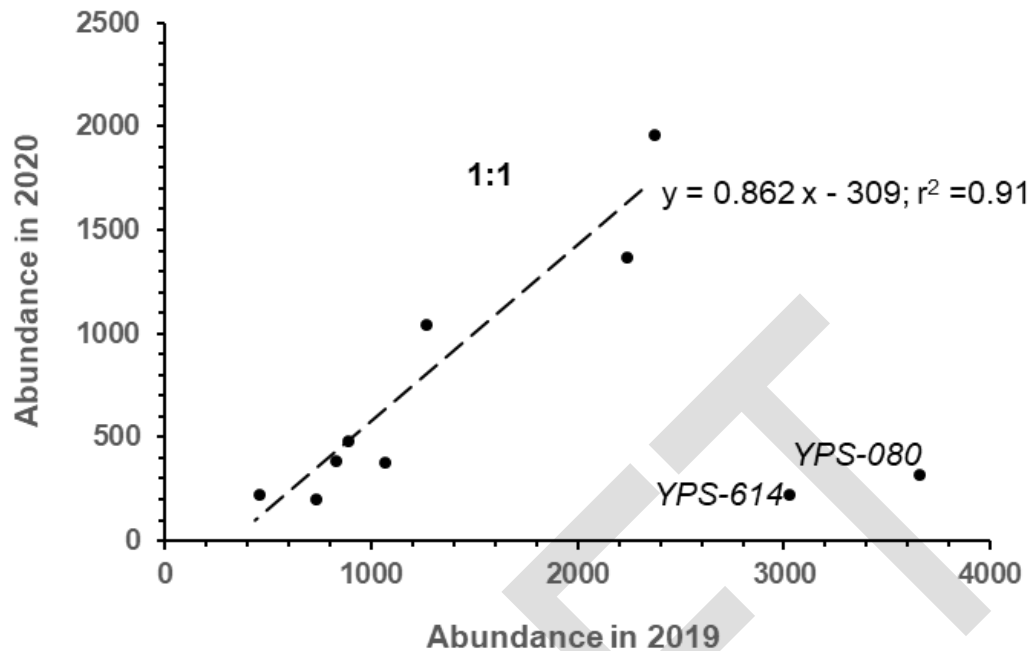
Figure 4.31 Total Invertebrate Abundance in 2019 and 2020 in Hunker Creek

Approximately 91% of the variability in abundance between stations in 2020 could be explained by the co-variation with the 2019 abundance data, for those monitoring stations other than YPS-080 and YPS-614.

Note that there was a lower abundance across all eight sites in 2020 in comparison with 2019, which might be related either to a general interannual variability in productivity in relation to interannual climate variability and/or the period of field sampling relative to benthic invertebrate egg deposition, larval development, and hatching / emergence.

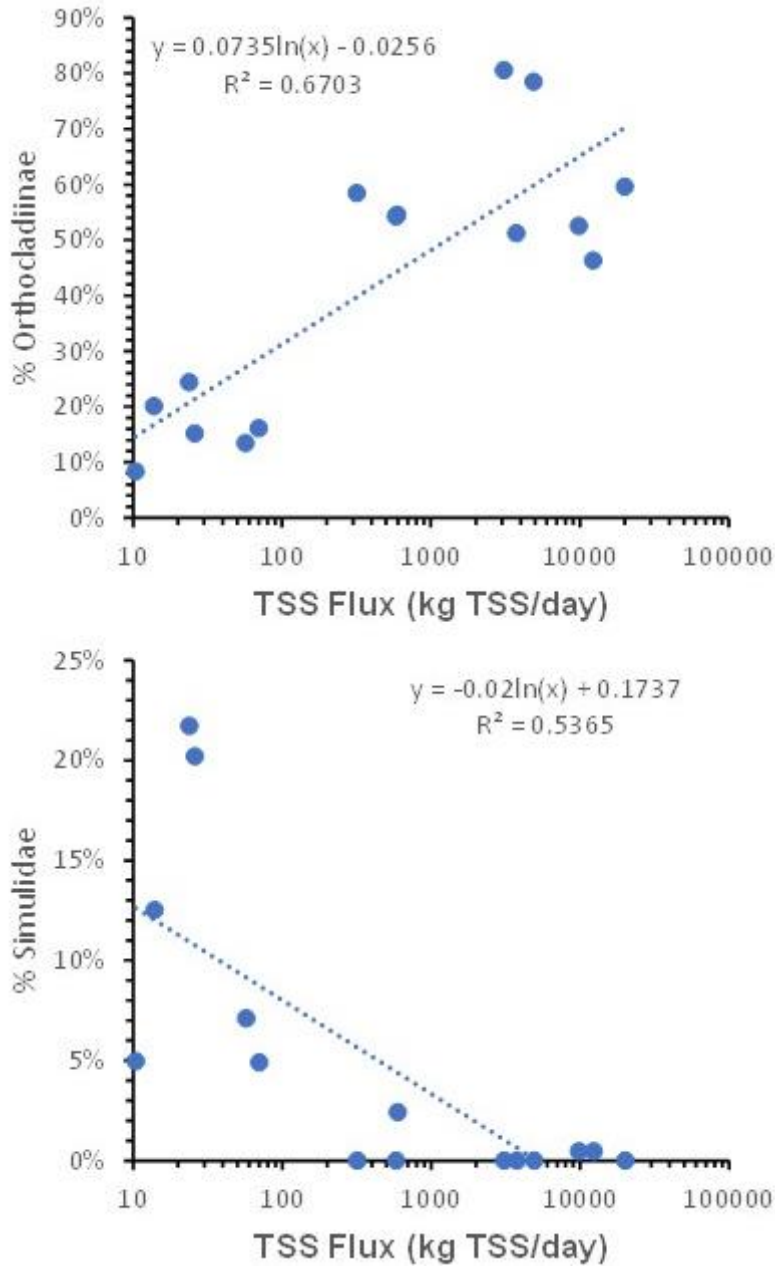
Figure 5.2 Overall stream invertebrate abundance as Orthoclaadiinae or Simuliidae as a function of daily TSS transport in for all Adams Creek and Hunker Creek monitoring sites

The dominance of stream invertebrate communities by taxa other than ephemeroptera, plecopteran or trichopteran (EPT), and distributions of specific dipteran taxa in relation to stream habitat preferences may vary across other Yukon streams in addition to those monitored under the AHM monitoring program in 2020. A better understanding of community compositional differences across watersheds, and along natural gradients from headwater areas to valley bottom confluences with mainstem flows will be useful for re-evaluation of AHM metrics and approaches that reflect ecological responses to anthropogenically-increased suspended sediment loads and inventories.

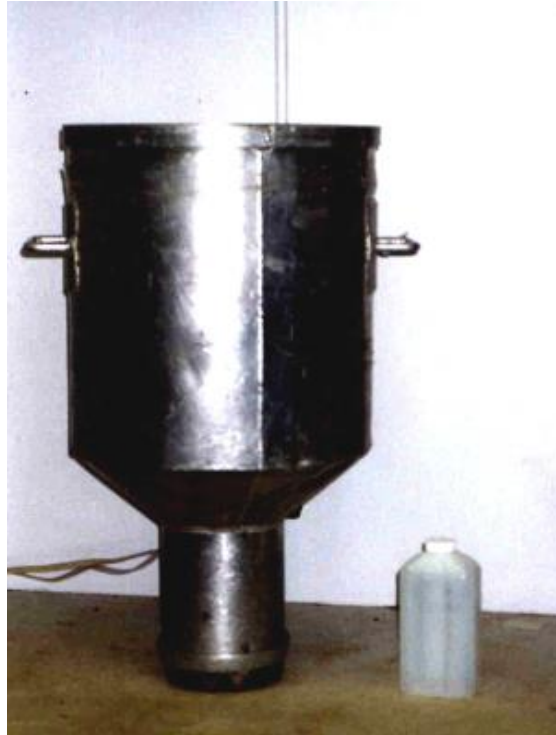
Figure 5.4 McNeil core design, 1 liter bottle for scale
