GOVERNMENT OF YUKON – ENERGY, MINES AND RESOURCES

CASE STUDY OF BREWERY CREEK

REPORT

MARCH 2011
ISSUED FOR USE
EBA FILE: V15101033

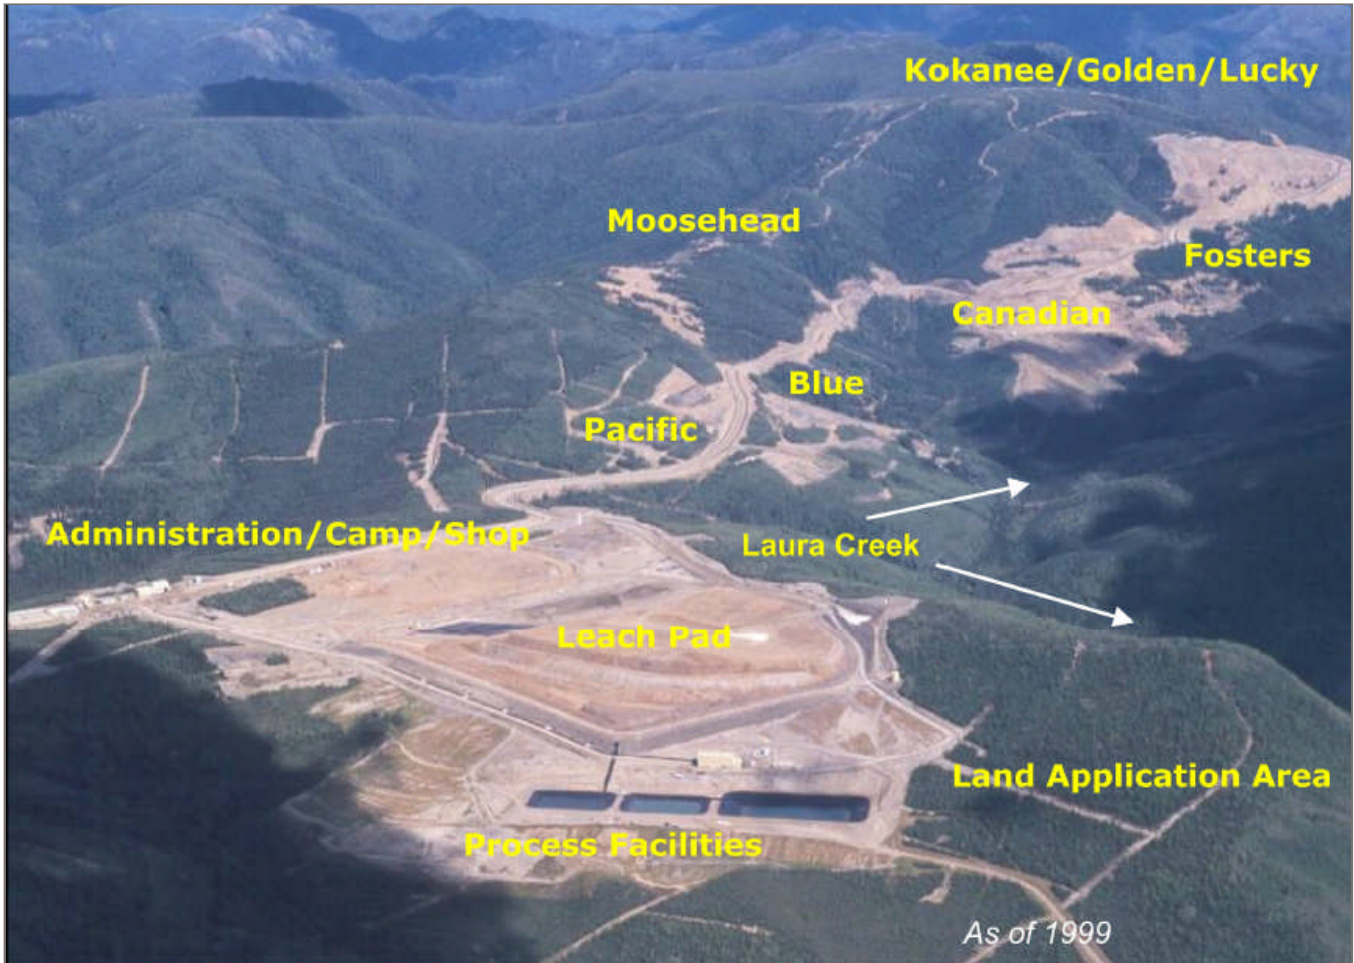
Photo 1: General Mine Site Layout (1999)
Source: Access Consulting, 2006

Brewery Creek's processing facilities included a heap leach pad, adsorption/desorption recovery plant (ADR plant), two process ponds, and an overflow pond (Photographs 1 and 2). A second overflow pond was planned for but never built due to the early closure of the mine. The design of the facilities at Brewery Creek was drawn from experience gained at the Zortman Landusky Mine in northern Montana, USA, which also operated under cold climate conditions.

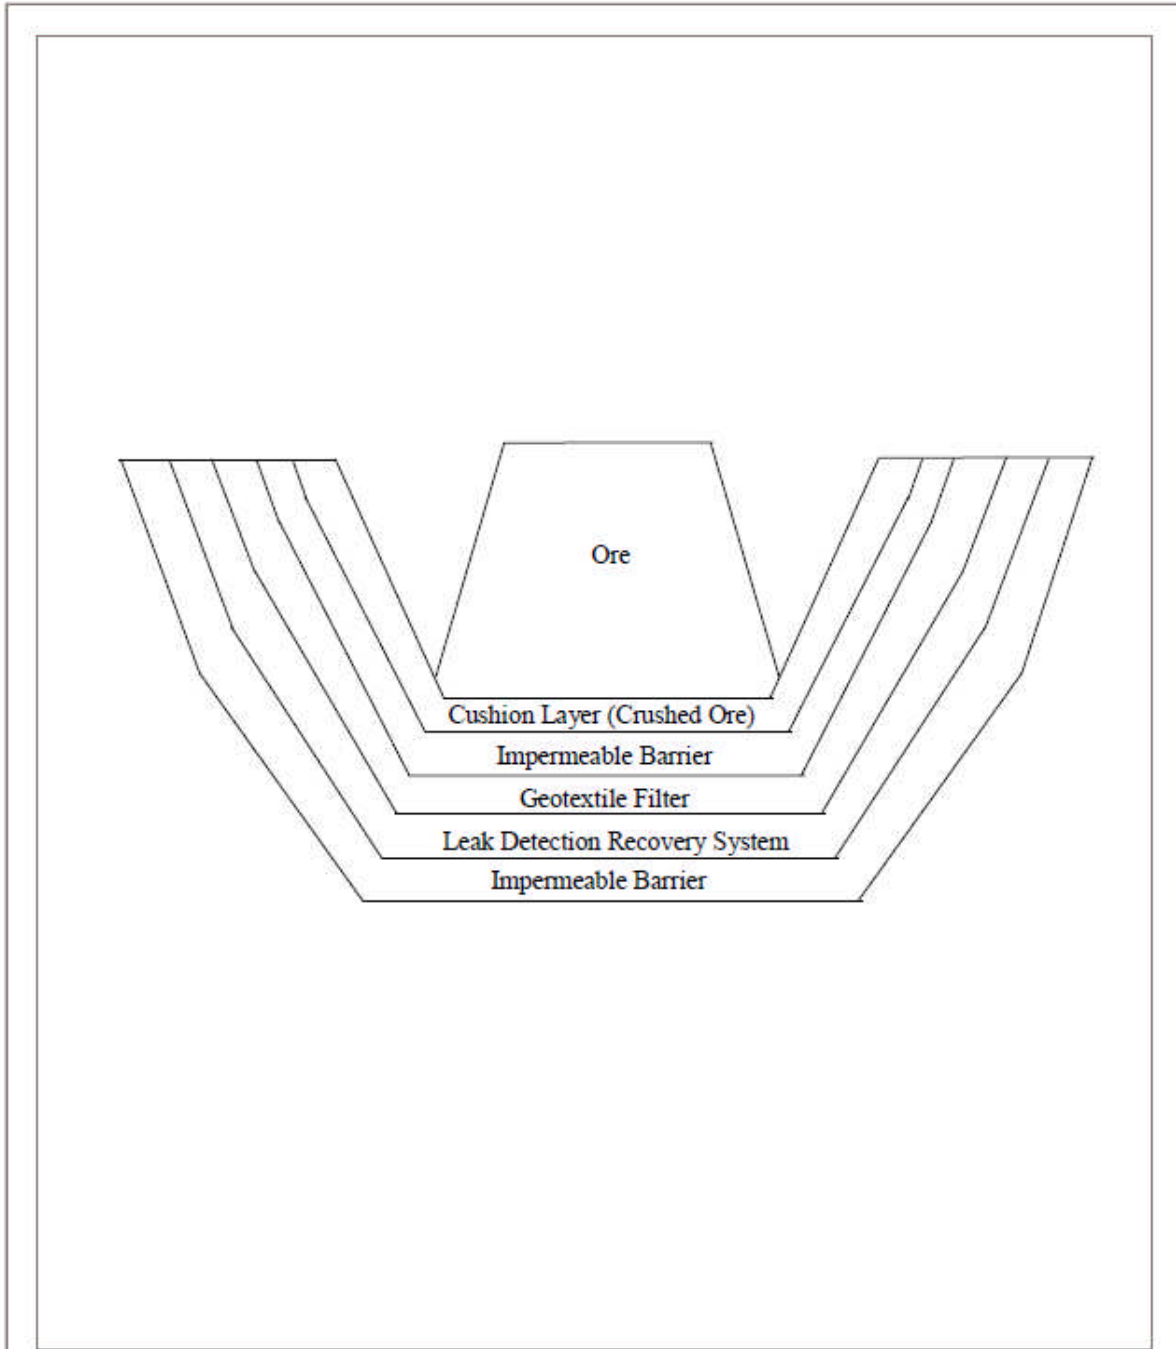
LEGEND	NOTES	CLIENT     A TETRA TECH COMPANY	CASE STUDY OF THE BREWERY CREEK MINE				Figure 4
			GENERAL LEACH PAD DESIGN				
STATUS ISSUE FOR USE		PROJECT NO. V15101033	DWN MO	CKD TP	APVD MO	REV 1	
		OFFICE EBA-VANC	DATE March 17, 2011

The Brewery Creek leach pad design involved the use of several liners to capture all liquids that entered the heap leach pad. The liners were composed of the following materials (Figure 4):

- **Crushed Ore (600 to 1,000 mm thick):** This liner was used to help cushion the weight of the ore being placed on the heap leach pad. This provided support so the liners below would not break or tear apart.
- **Primary Synthetic Liner:** This liner was the primary liner used to capture and pump the liquid to the ADR plant.
- **Geotextile Filter:** This liner was used to capture solids and separate the primary liner from the leak detection recovery system (LDRS)
- **Gravel:** This liner was permeable and was used as the main LDRS layer. Any liquid that may have bypassed the original primary synthetic liner plastic liner would flow inside the gravel and be pumped into the two process ponds.
- **Secondary Synthetic Liner:** This liner was used to capture any liquids that might have bypassed the liners above.

Another design consideration that was taken into account was the potential for leach pad liners to become damaged. These concerns were addressed by creating individual heap cells for loading within the heap leach pad. Each cell was designed to segregate ore and were built adjacent to each other. If a leak was detected in the cell, the operators could load the ore on another adjacent cell. Operators could then inspect the liners and fix any damaged parts.
