EAGLE GOLD MINE

WASTE ROCK AND OVERBURDEN FACILITY MANAGEMENT PLAN

Version 2022-01

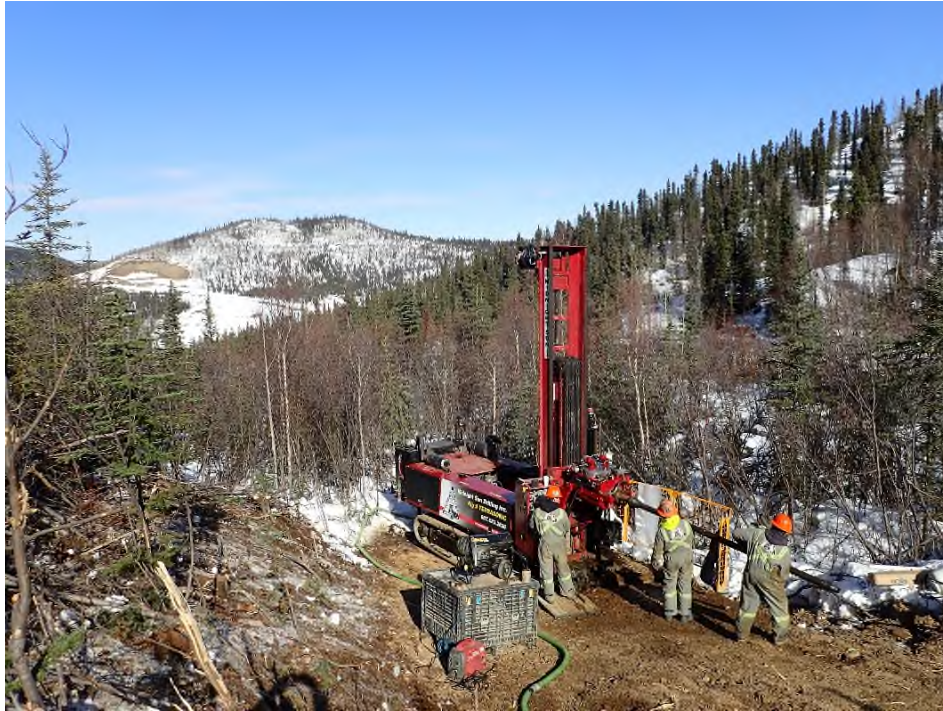
Photo 1: Compact crawler TerraSonic CC150 Drill Rig, Borehole GT18-05 site. Eagle Pup WRSA, looking north. Photo taken April 9, 2018

Thirteen completed boreholes were drilled using a Compact Crawler TerraSonic CC150 Sonic drill rig operated by MSD (Photo 1). A sonic drill was selected for the program due to its ability to consistently recover high percentages of samples in the overburden. Sonic drilling is not particularly effective in coring bedrock but this was not a concern given that the program was designed with the primary focus of soil and permafrost sampling. Bedrock was already well sampled and characterized using diamond core drilling during the previous BGC investigations (BGC 2009; 2010; 2011a,b; and 2012b,c). The maximum depth drilled by the sonic drill was 21.25 m. Overburden soil and bedrock core samples were recovered using an HQ bit (4" ID and 4.75" OD) for all boreholes.

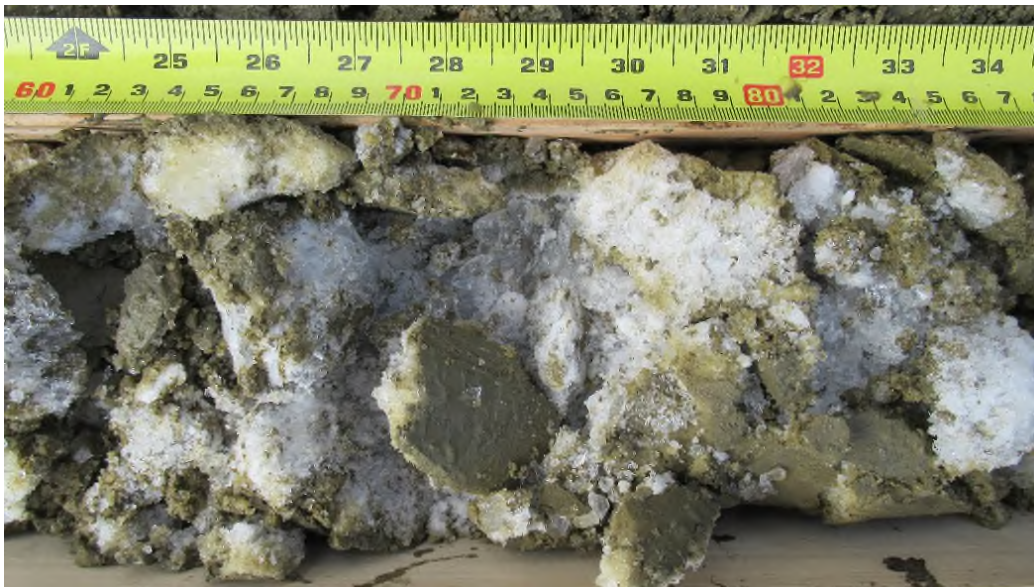
Photo 2: Ice and sand, silty between 1.05 m and 1.2 m in GT18-07.

Warm permafrost conditions (-0.1°C) with excess ice (V_x, V_c, V_s, V_r) were observed in the borehole and were confirmed by SBTS installed at a depth of 8.5 m (Table 5). A layer of ice with sand and silt approximately 1.3 m thick was observed at a depth of 0.3 m BGL (Photo 2). The ice mass was clear to cloudy. It is believed that this ice is a result of the borehole being located within a depression on the slope face that channels runoff, resulting in higher than normal water content. Ice coatings and inclusions (V_c, V_x 21%) were observed in silty sand with some gravel from 1.6 m to 1.8 m. Excess ice (V_x 3.0% to 5.0%) was logged in sand and gravel from 1.8 m to 2.5 m. Well-bonded permafrost (N_{bn}) was observed in sand and gravel from 2.5 m to the top of bedrock, which was encountered at a depth of 5.5 m.

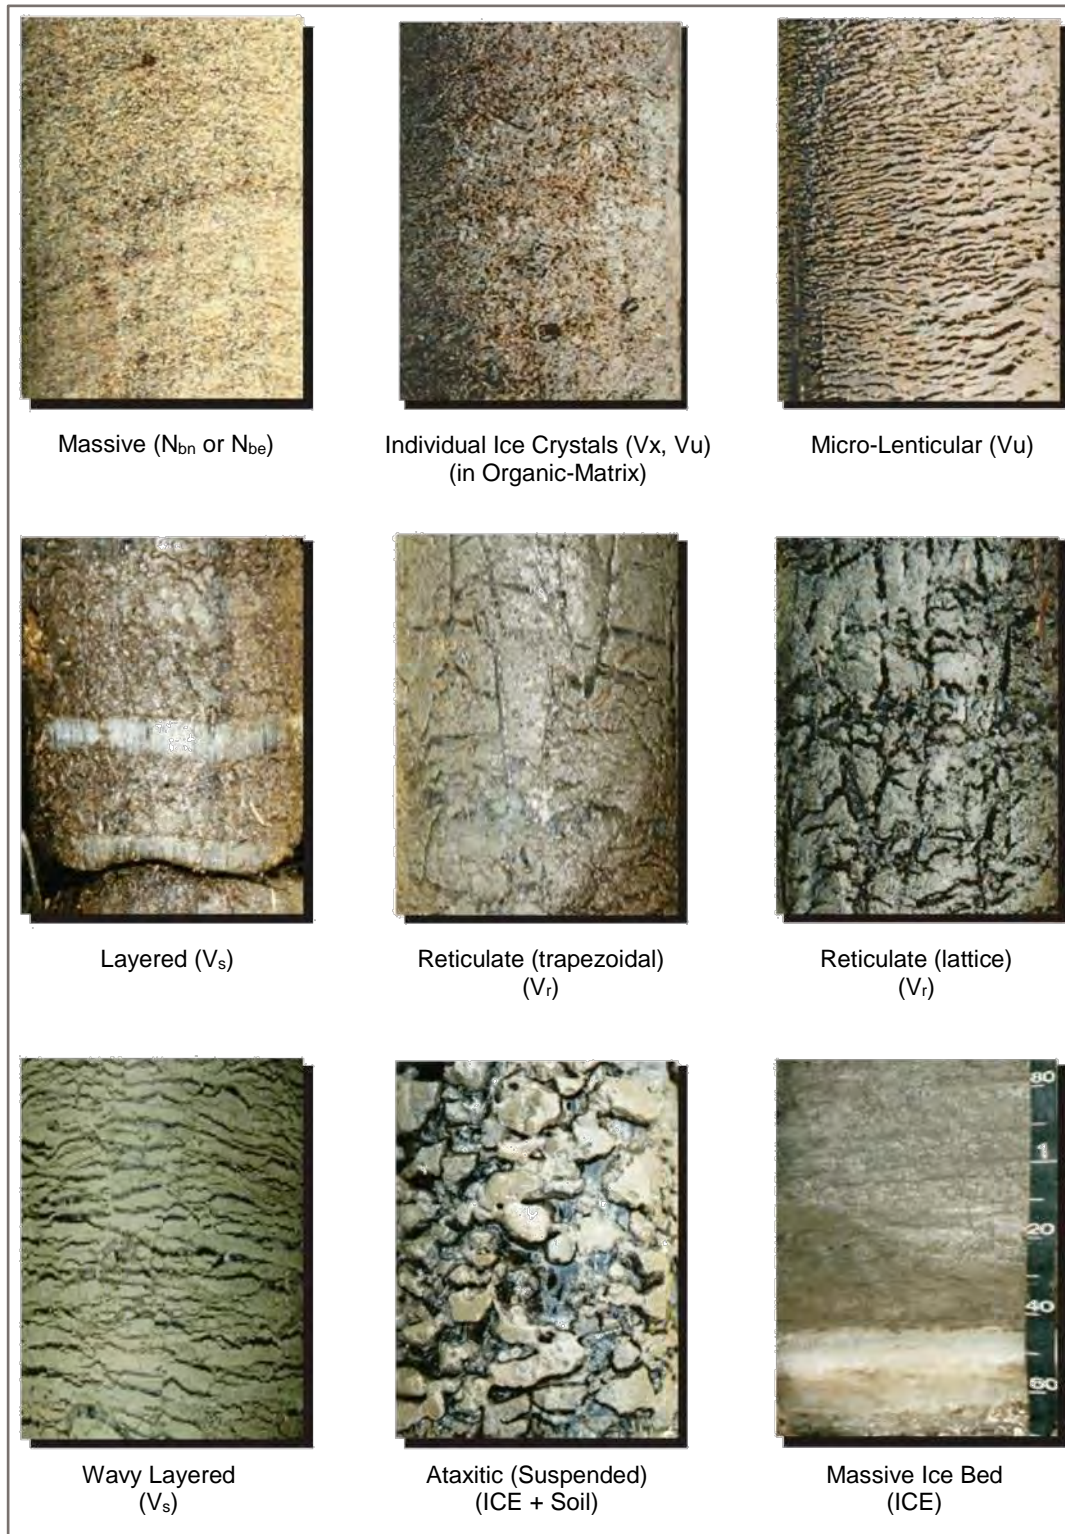
Photo 1: Photographs of simple cryostructures found in perennially frozen soils in the Colville River Delta, Alaska.

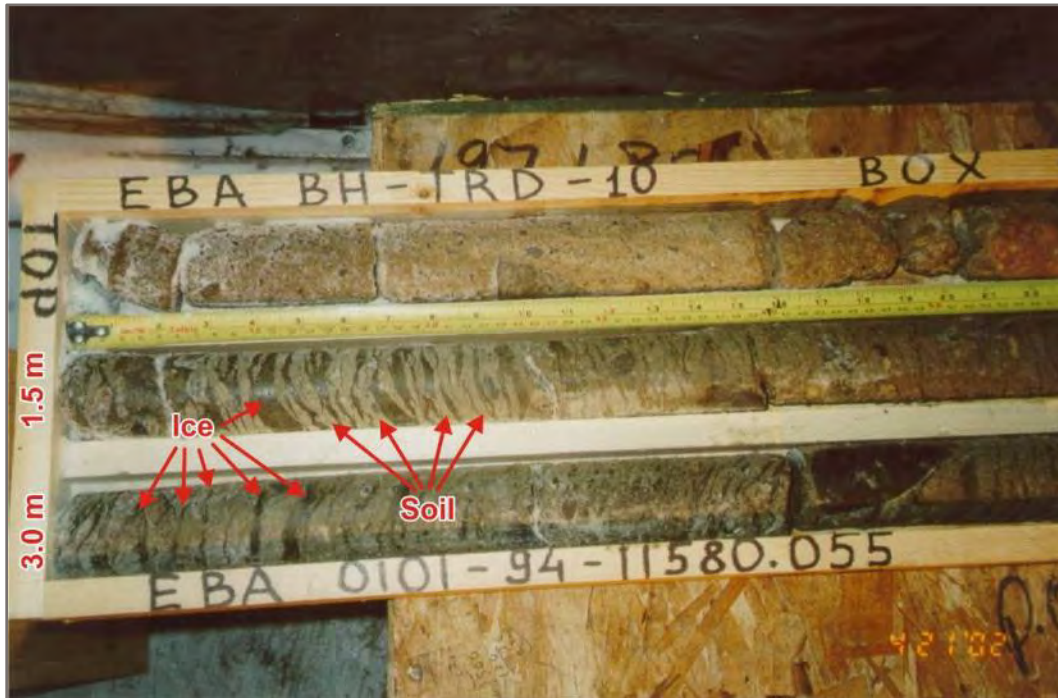
Photo 3: Layered cryostructure (Vs 30-40%) in perennially frozen till (at depths of 1.5 m and 3.0 m). Note distinctly oriented ice lenses.
