Well Site # 2

Chevron SOBC WM N Parkin YTD-61

Location 66°20'12"
137°13'01"

Drilling completed May 6, 1972

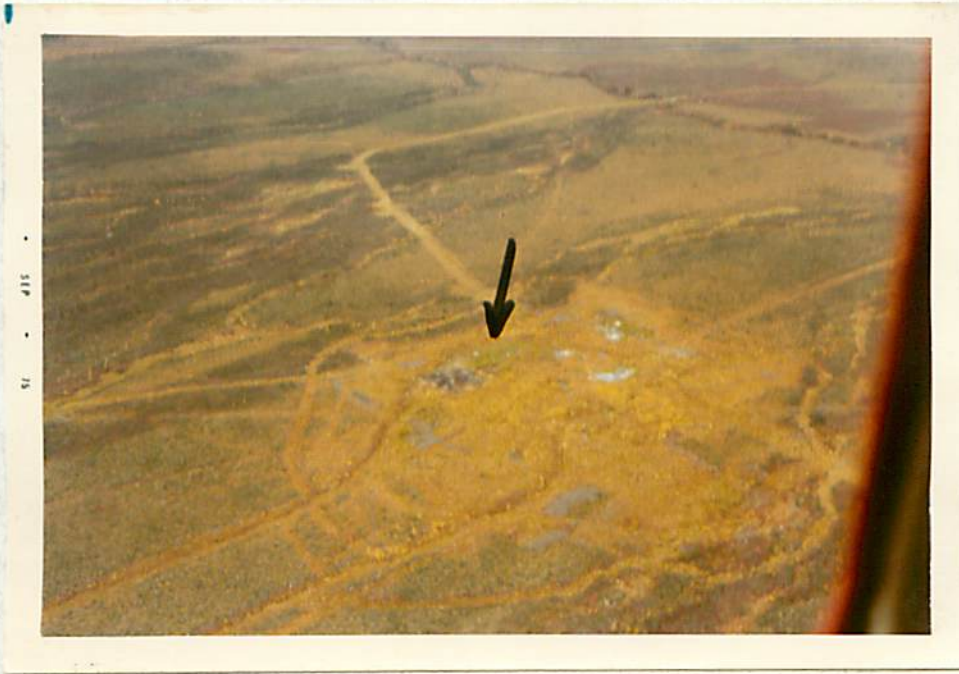
Photo # 6 N Parkin YTD_61 September 10, 1975

This wellsite has not revegetated as well as the W Parkin YTC-33 site.

The introduced grasses are found in densely concentrated clumps around the well marker. The remainder of the site is patchy with mostly natural regeneration.

The arrow in Photo #6 indicates the reseeded grasses on the wellsite.

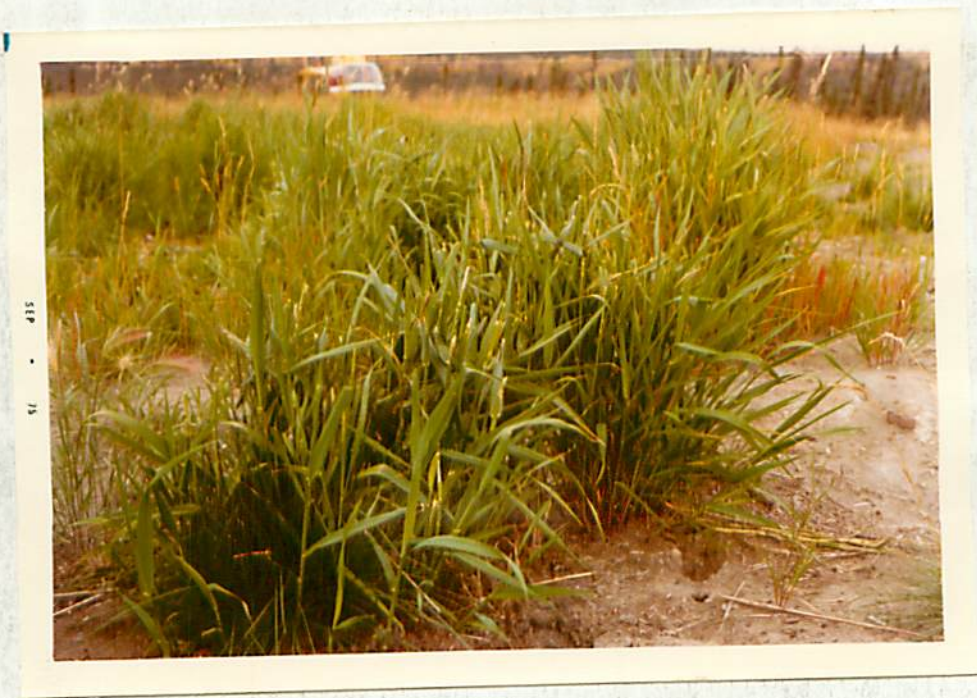
Photo # 7 N Parkin YTD-61 September 10, 1975

The concentrations of lush timothy near the well head (see Photo #7) leads one to believe that an excessive amount of nitrogen fertilizer was applied.

This thick mat of timothy has been repeatedly browsed by moose.
