Sä Dena Hes Mine
Decommissioning and Reclamation Status Report - November 2013

Yukon Water Licence QZ99-045 and Quartz Mining License QML-0004

prepared by: Teck Resources Limited
November 28, 2013

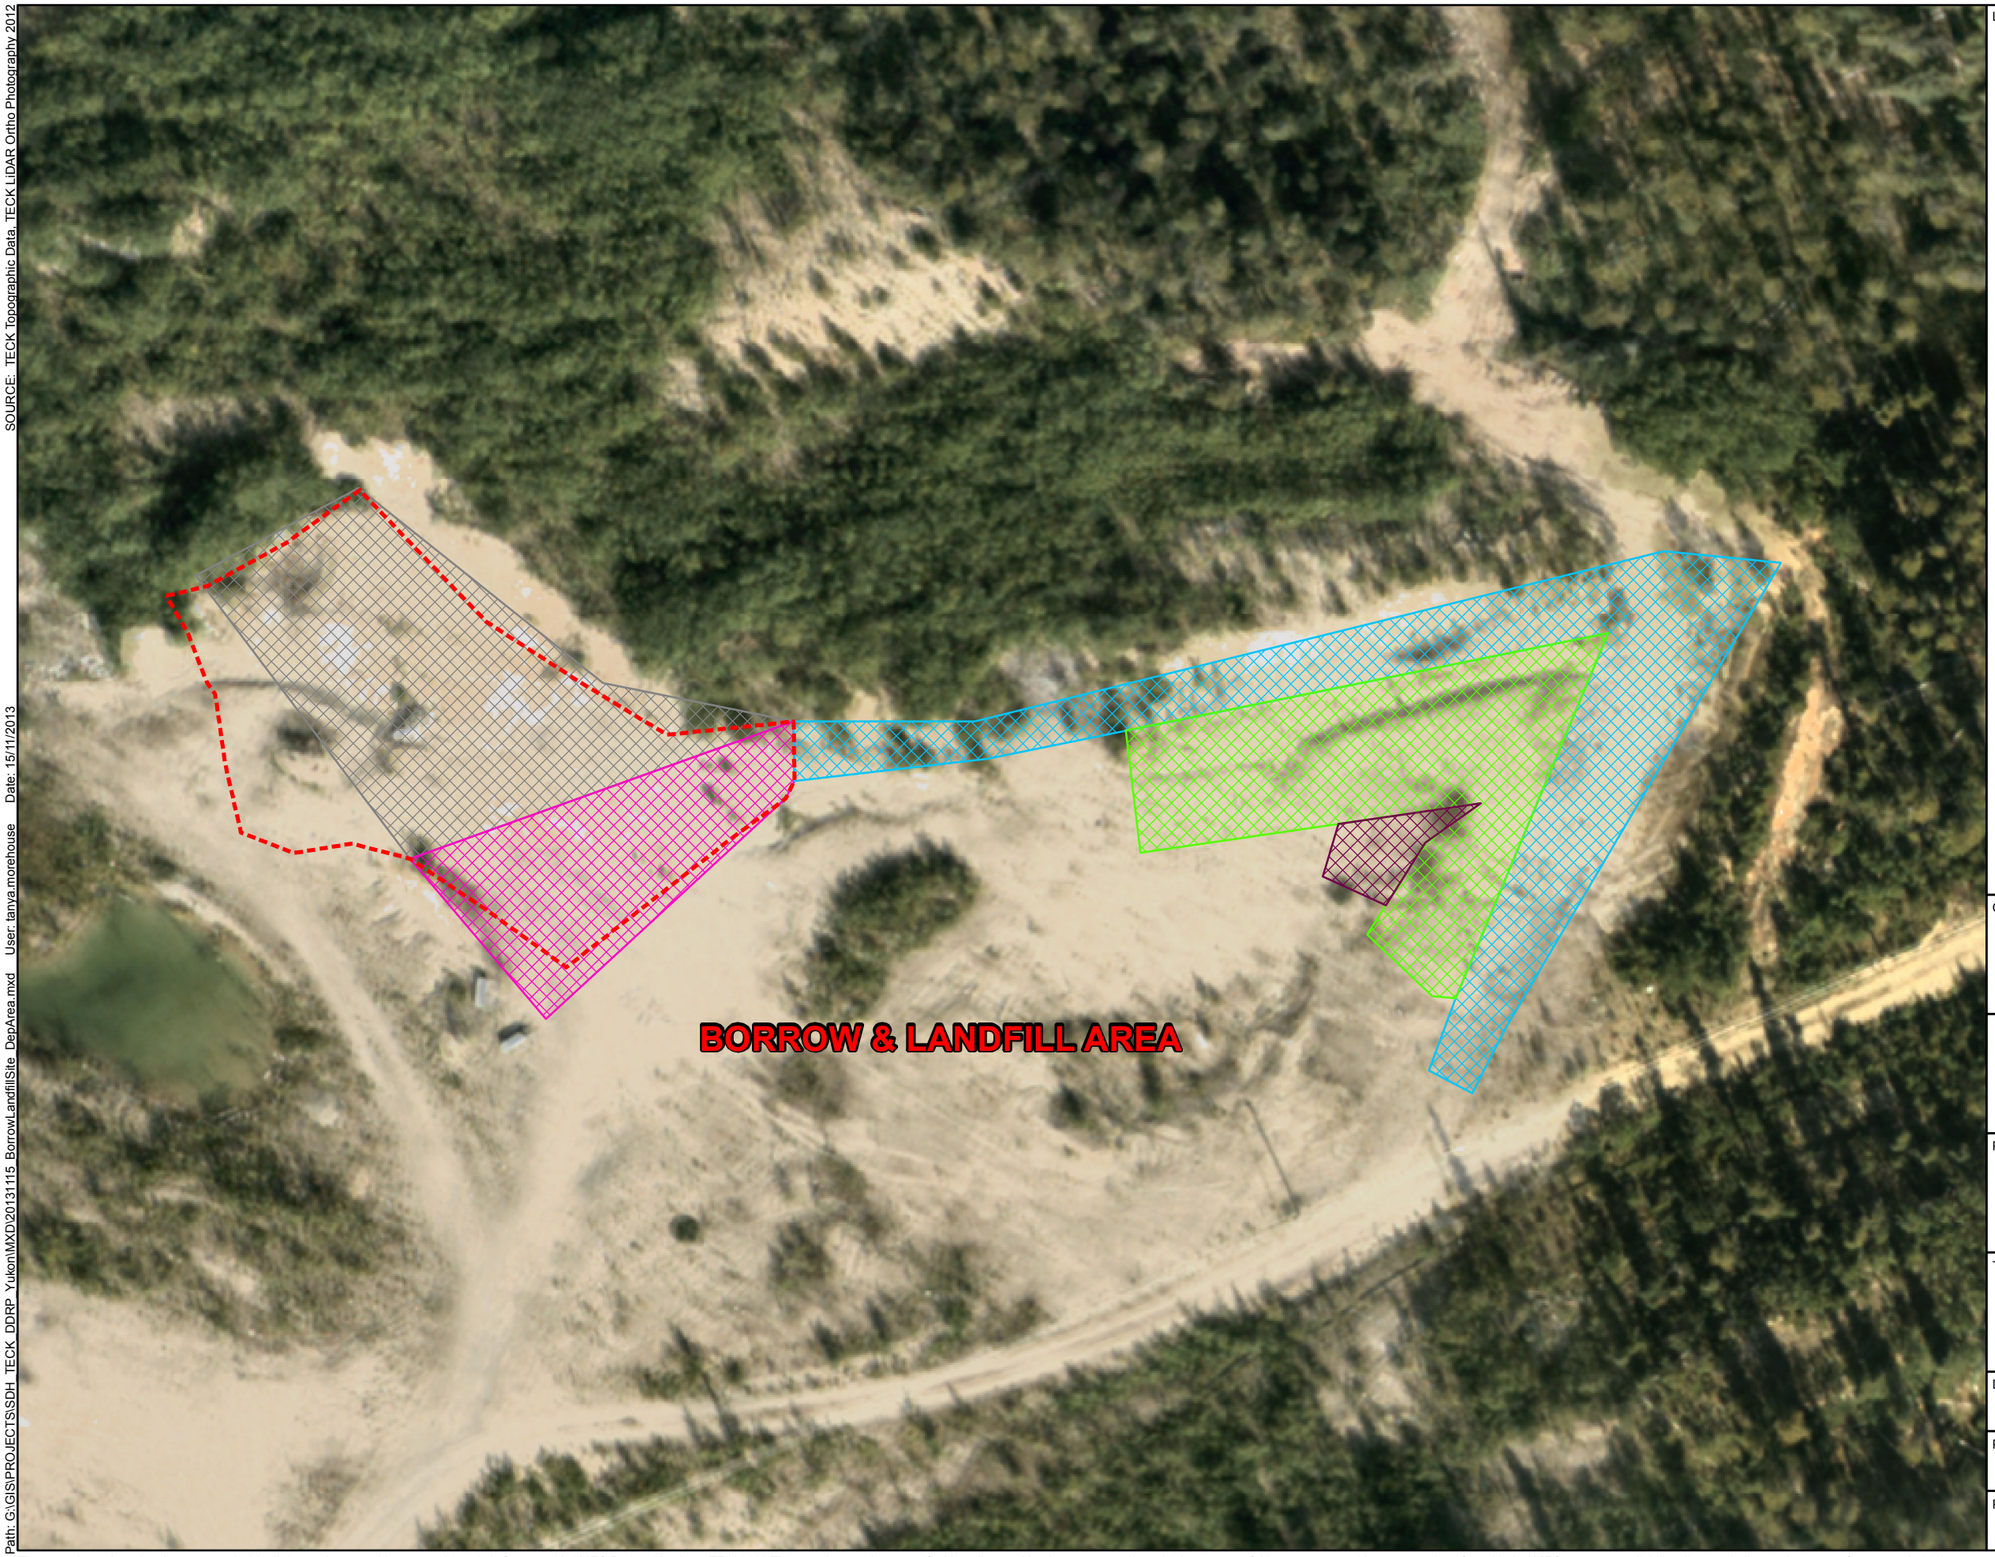
BORROW & LANDFILL SITE DEPOSITION ZONES

- Landfill preparation and deposition
    - The permitted landfill was prepared by excavating and removing existing native material to a depth of approximately 4 meters. The landfilled materials included industrial classed wastes only; no hazardous materials were landfilled. The materials were delivered by tandem truck and dozer into the open trenches in approximately 0.5 to 1.0 meter lifts. As discussed in Attachment 1, non-friable asbestos containing flooring were hauled to the landfill using a lowbed trailer and buried using an excavator. Existing granular materials were mixed into the landfilled debris and compacted. The lift was them re-graded. This was procedure was used to fill the excavated trench. The surface was then capped with a minimum of 1 meter of clean fill. AMEC site manager tracked all the materials and a total of 672 tandem loads and 28 lowbed trailer loads of demolition material from the camp buildings and office complex were placed in the landfill. In addition, 22 loads from the Golden Hills shop that was previously demolished in 2012 was buried. A survey plan of the landfill and deposition zones is included in Attachment 2. Pictures of the area during and after construction are included in Attachment 3.

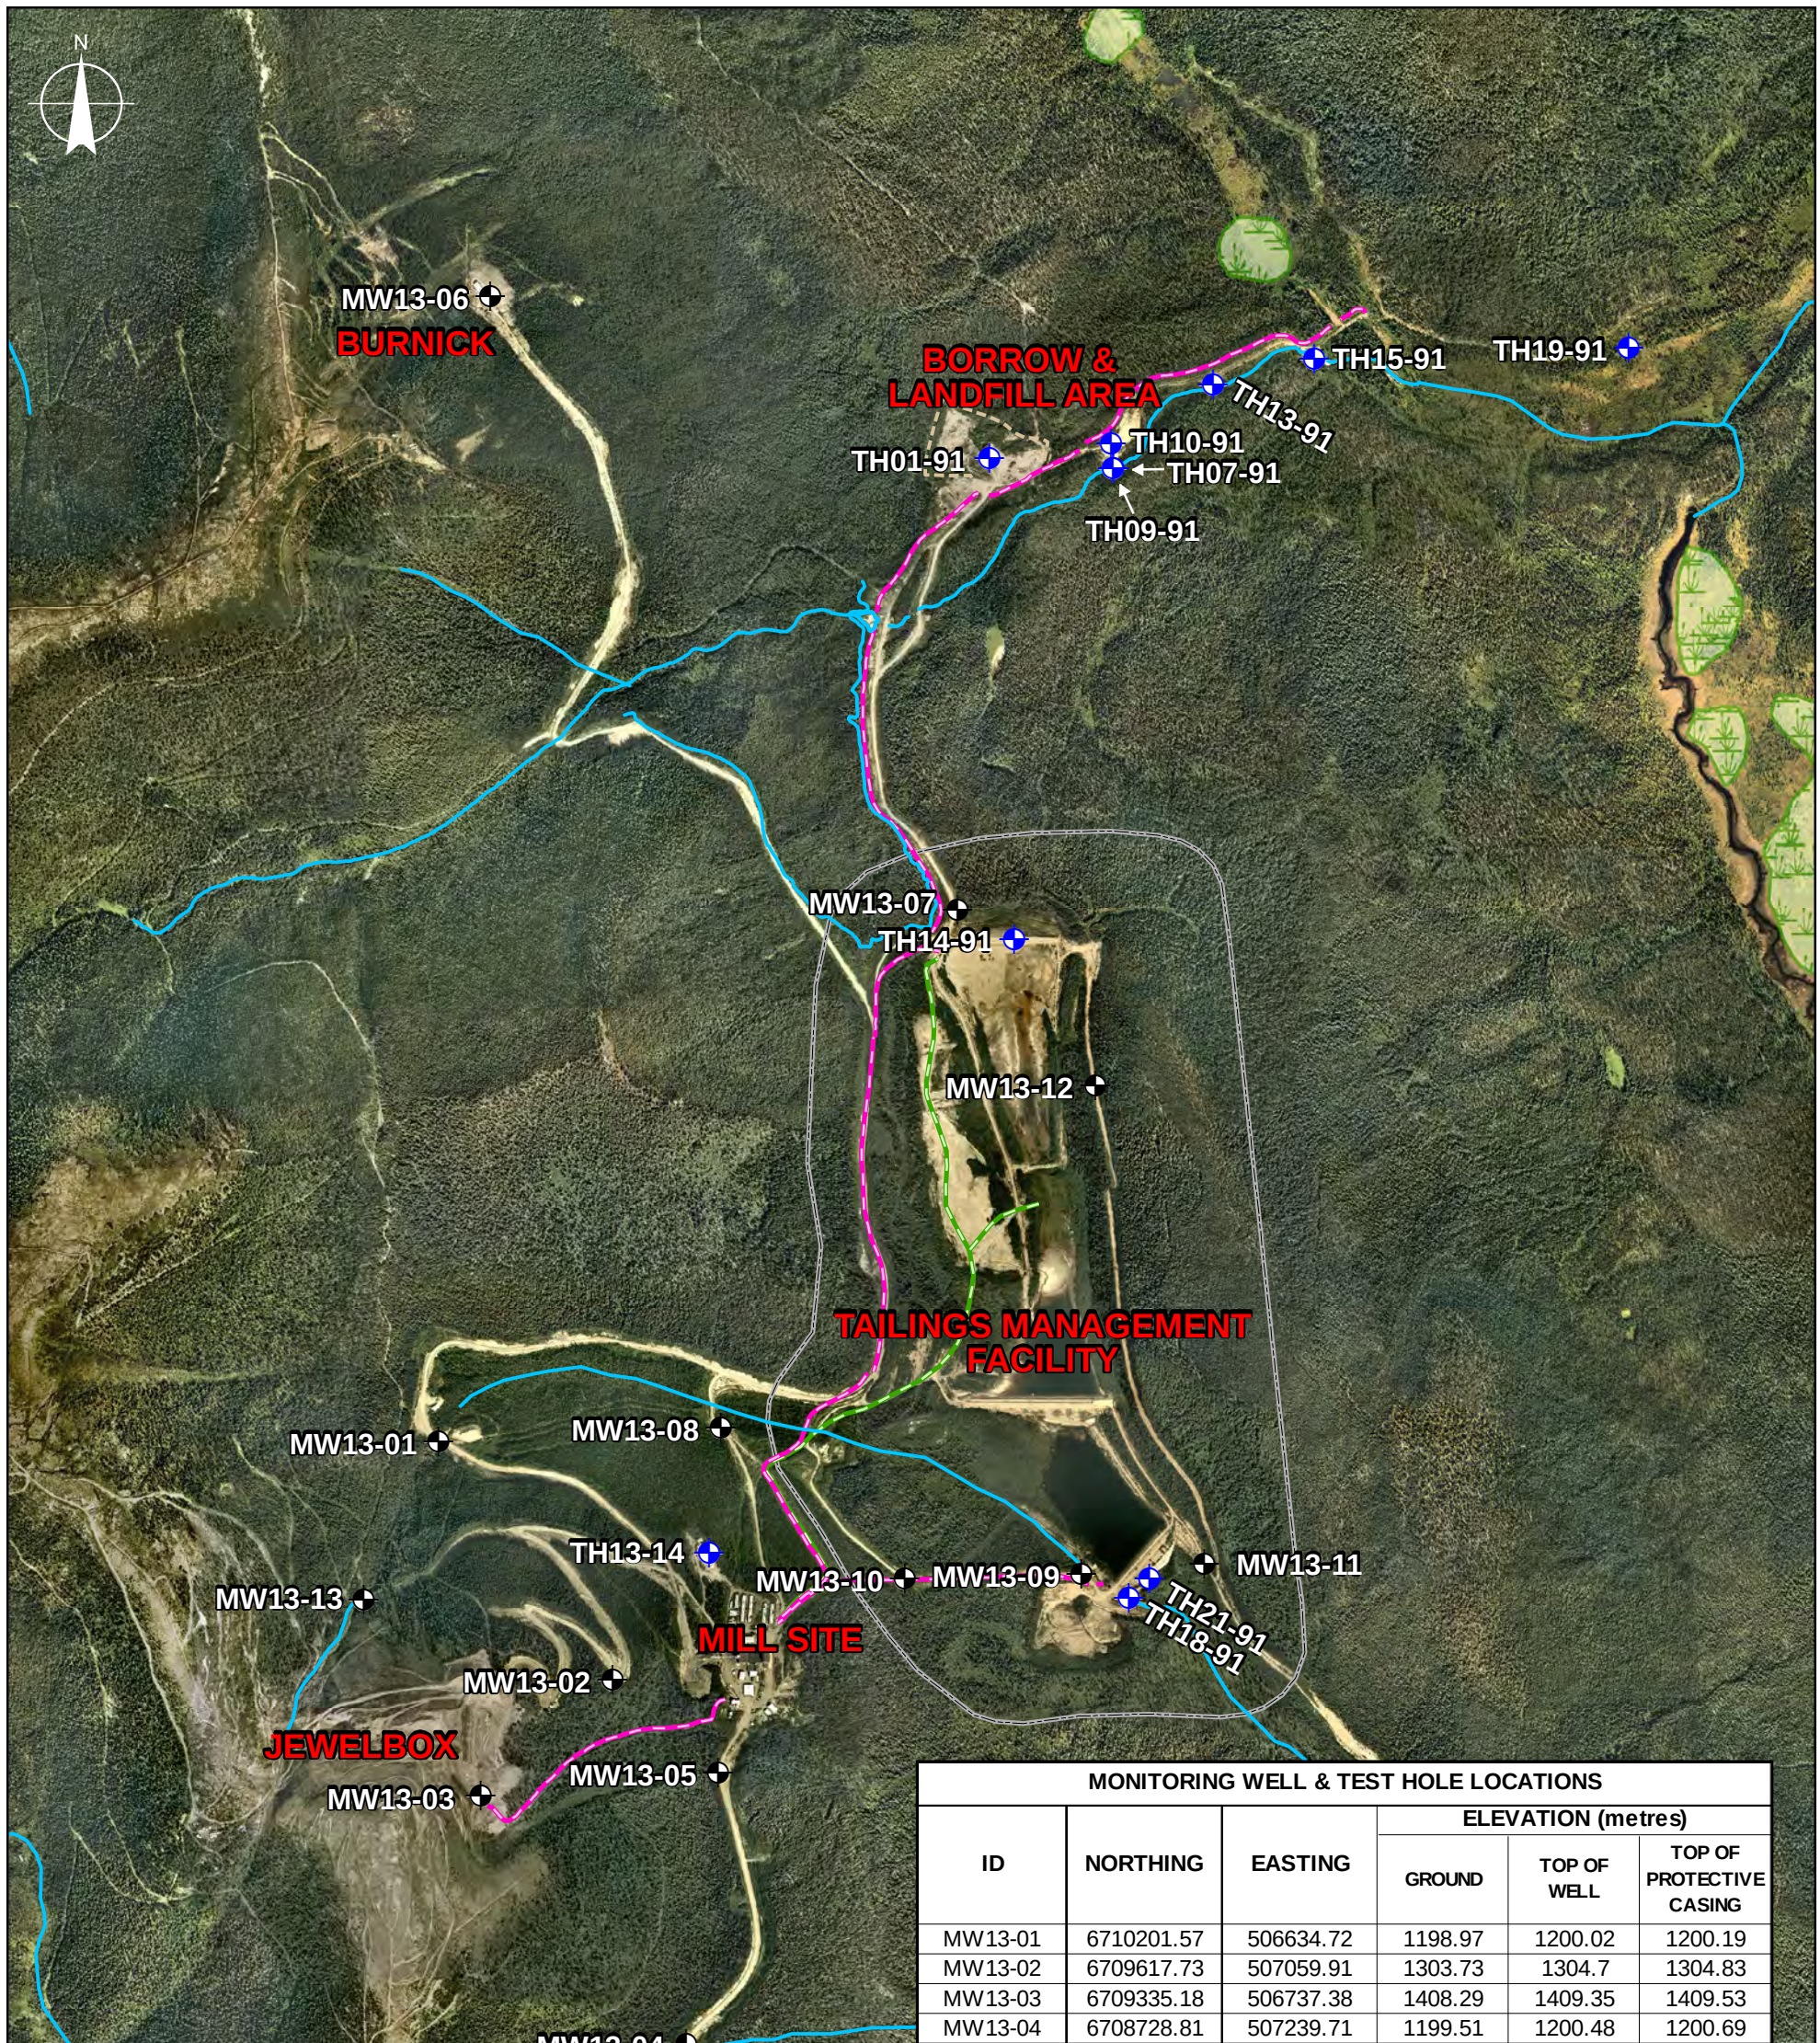
ATTACHMENT 5
Monitoring Well Figure

MW13-13) were installed as shown on the Figure included in Attachment 5. The new wells and existing were monitored and sampled for a minimum of two events. The hydrogeological report is currently being developed.
