November 6, 2015

Reference No. 1417183-006-L-Rev0-1000

**ANNUAL INSPECTION, OCTOBER 14, 2015  
CARMACKS COPPER PROJECT, CARMACKS, YUKON**

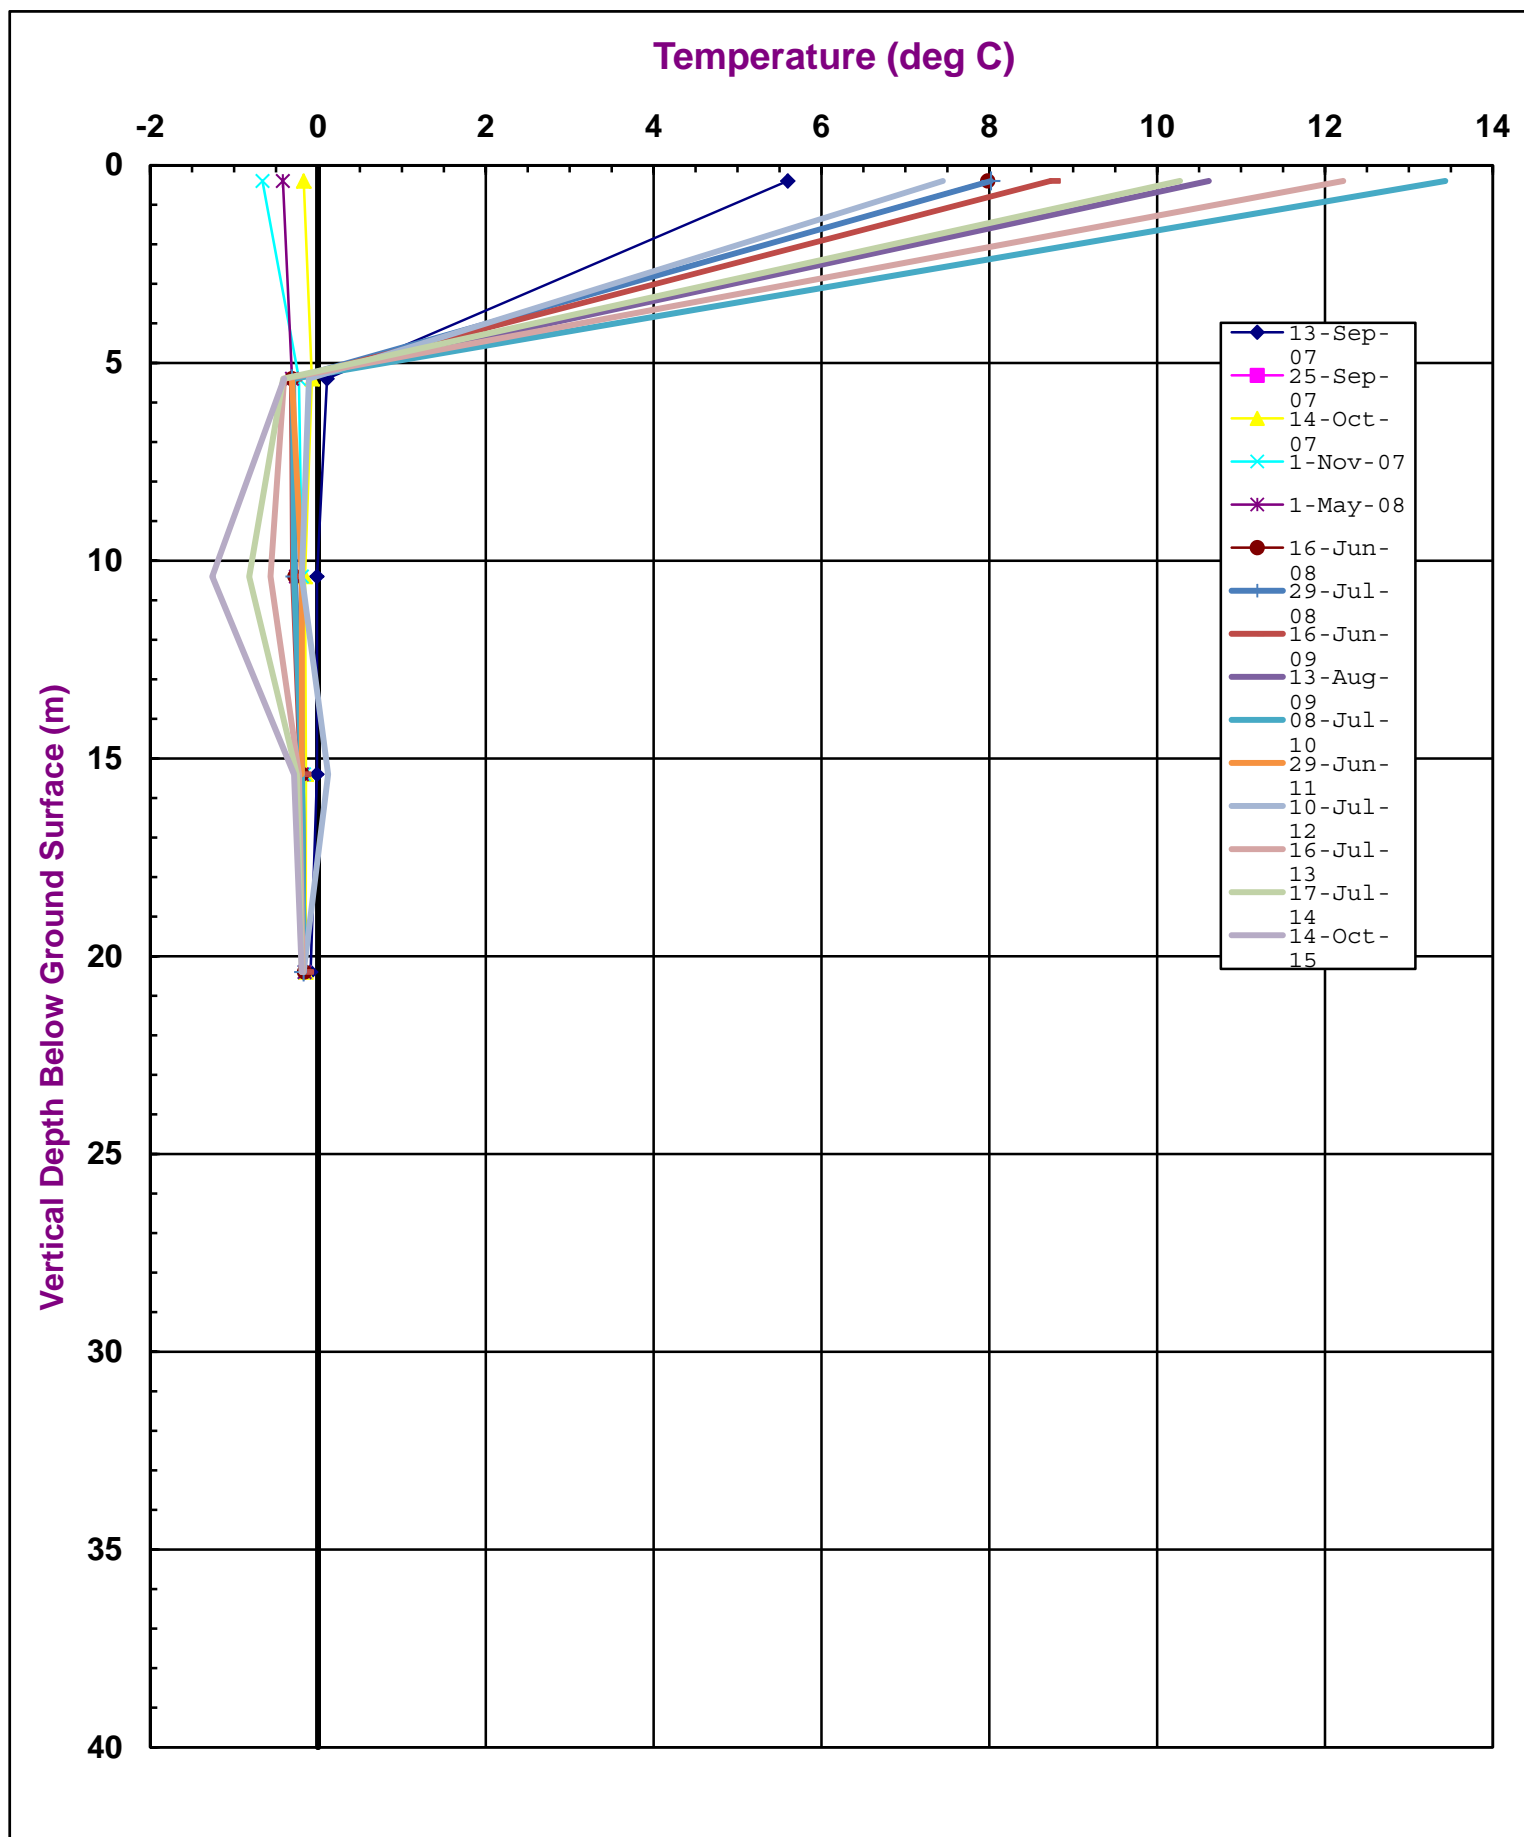
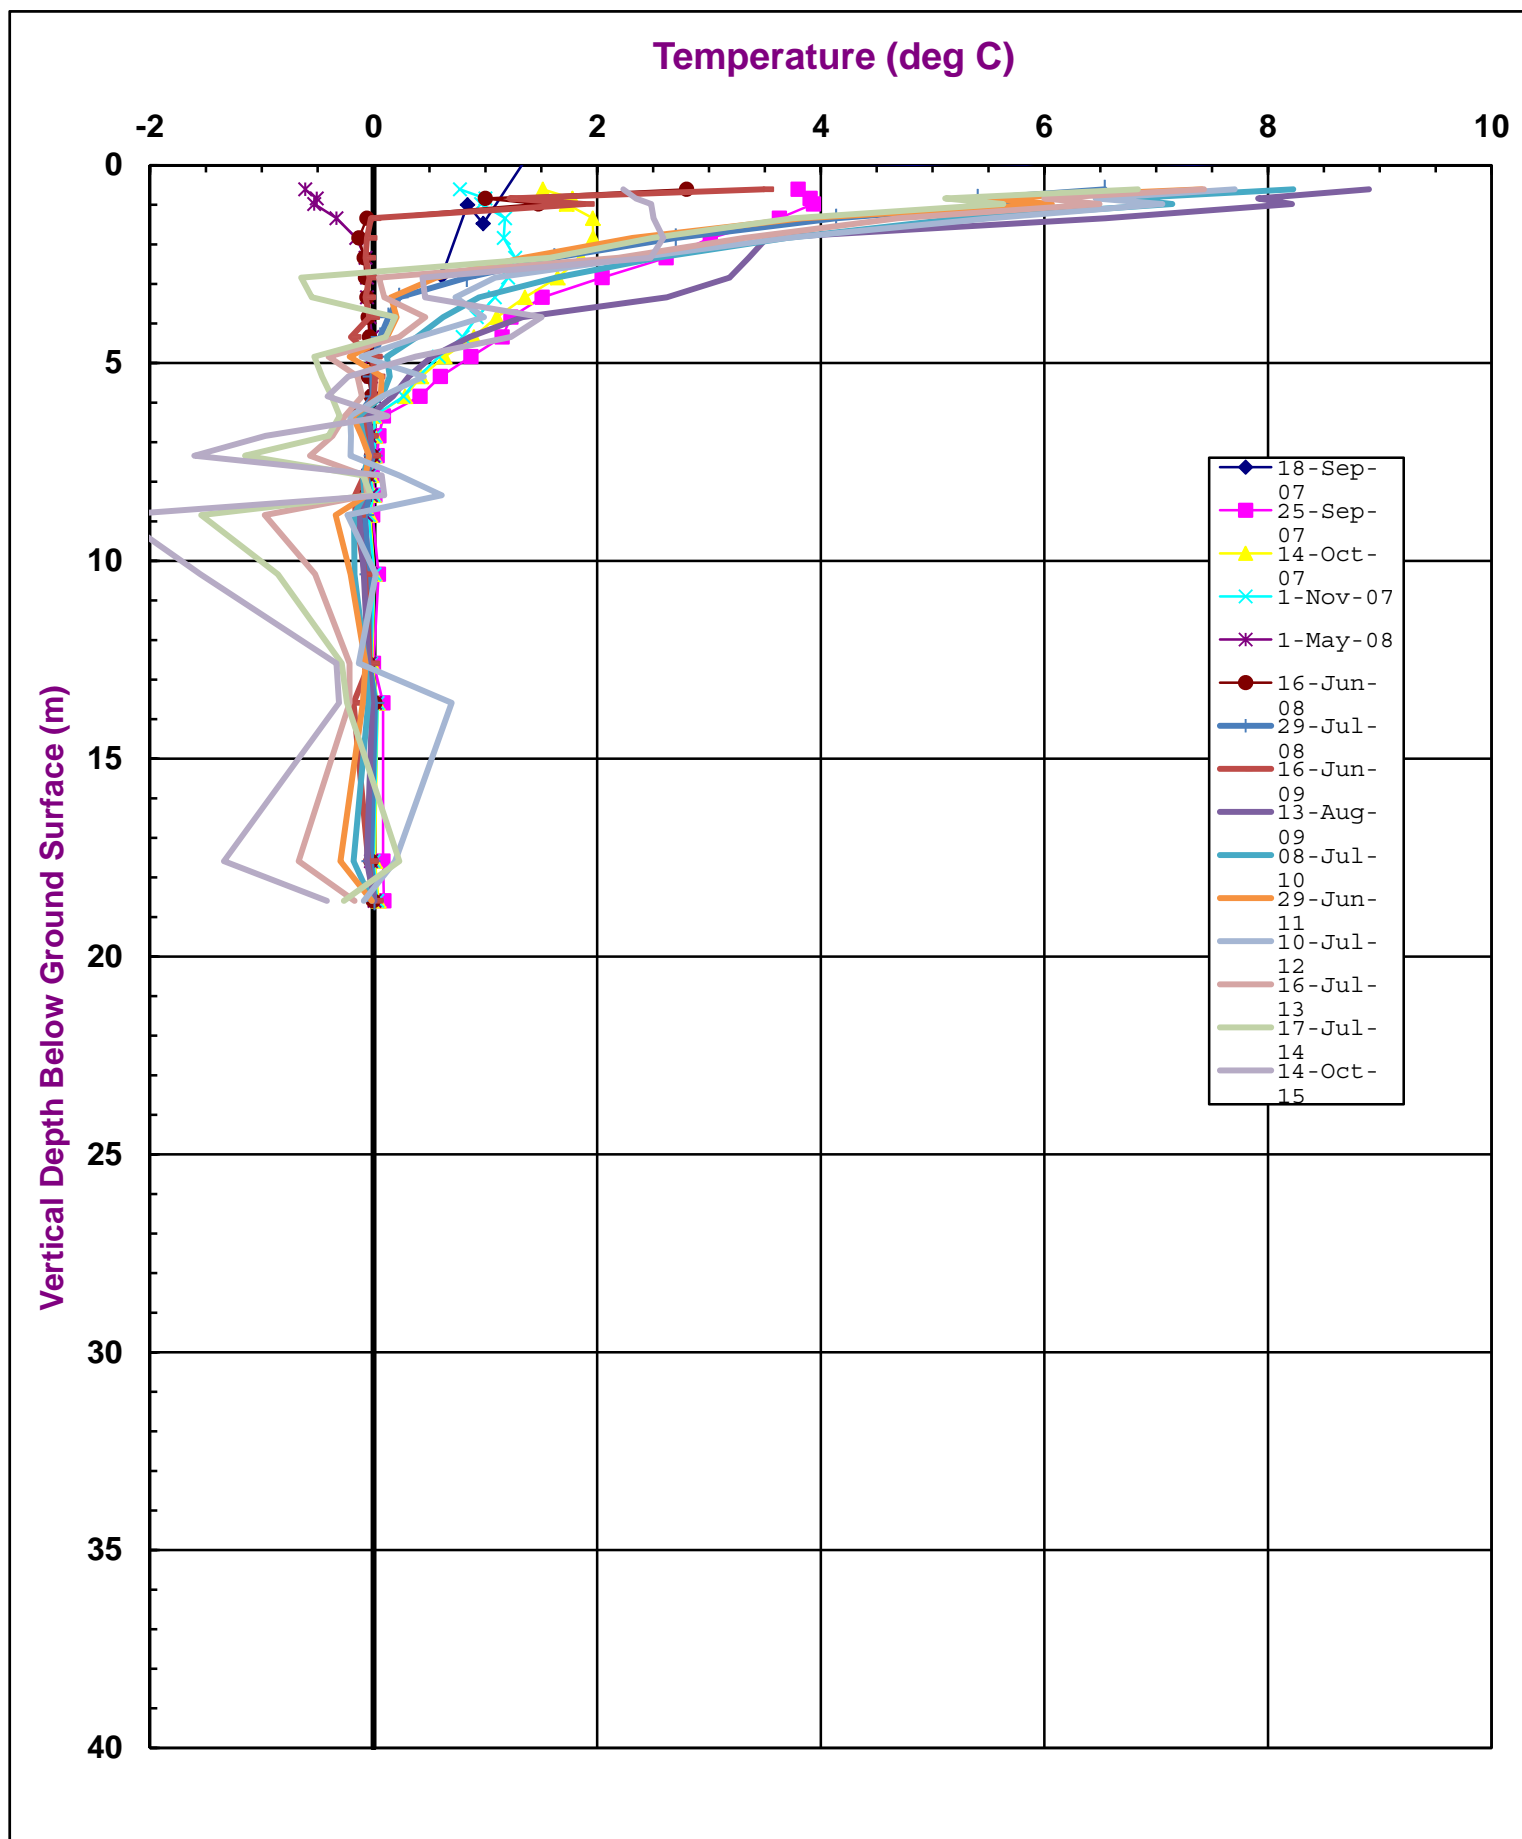
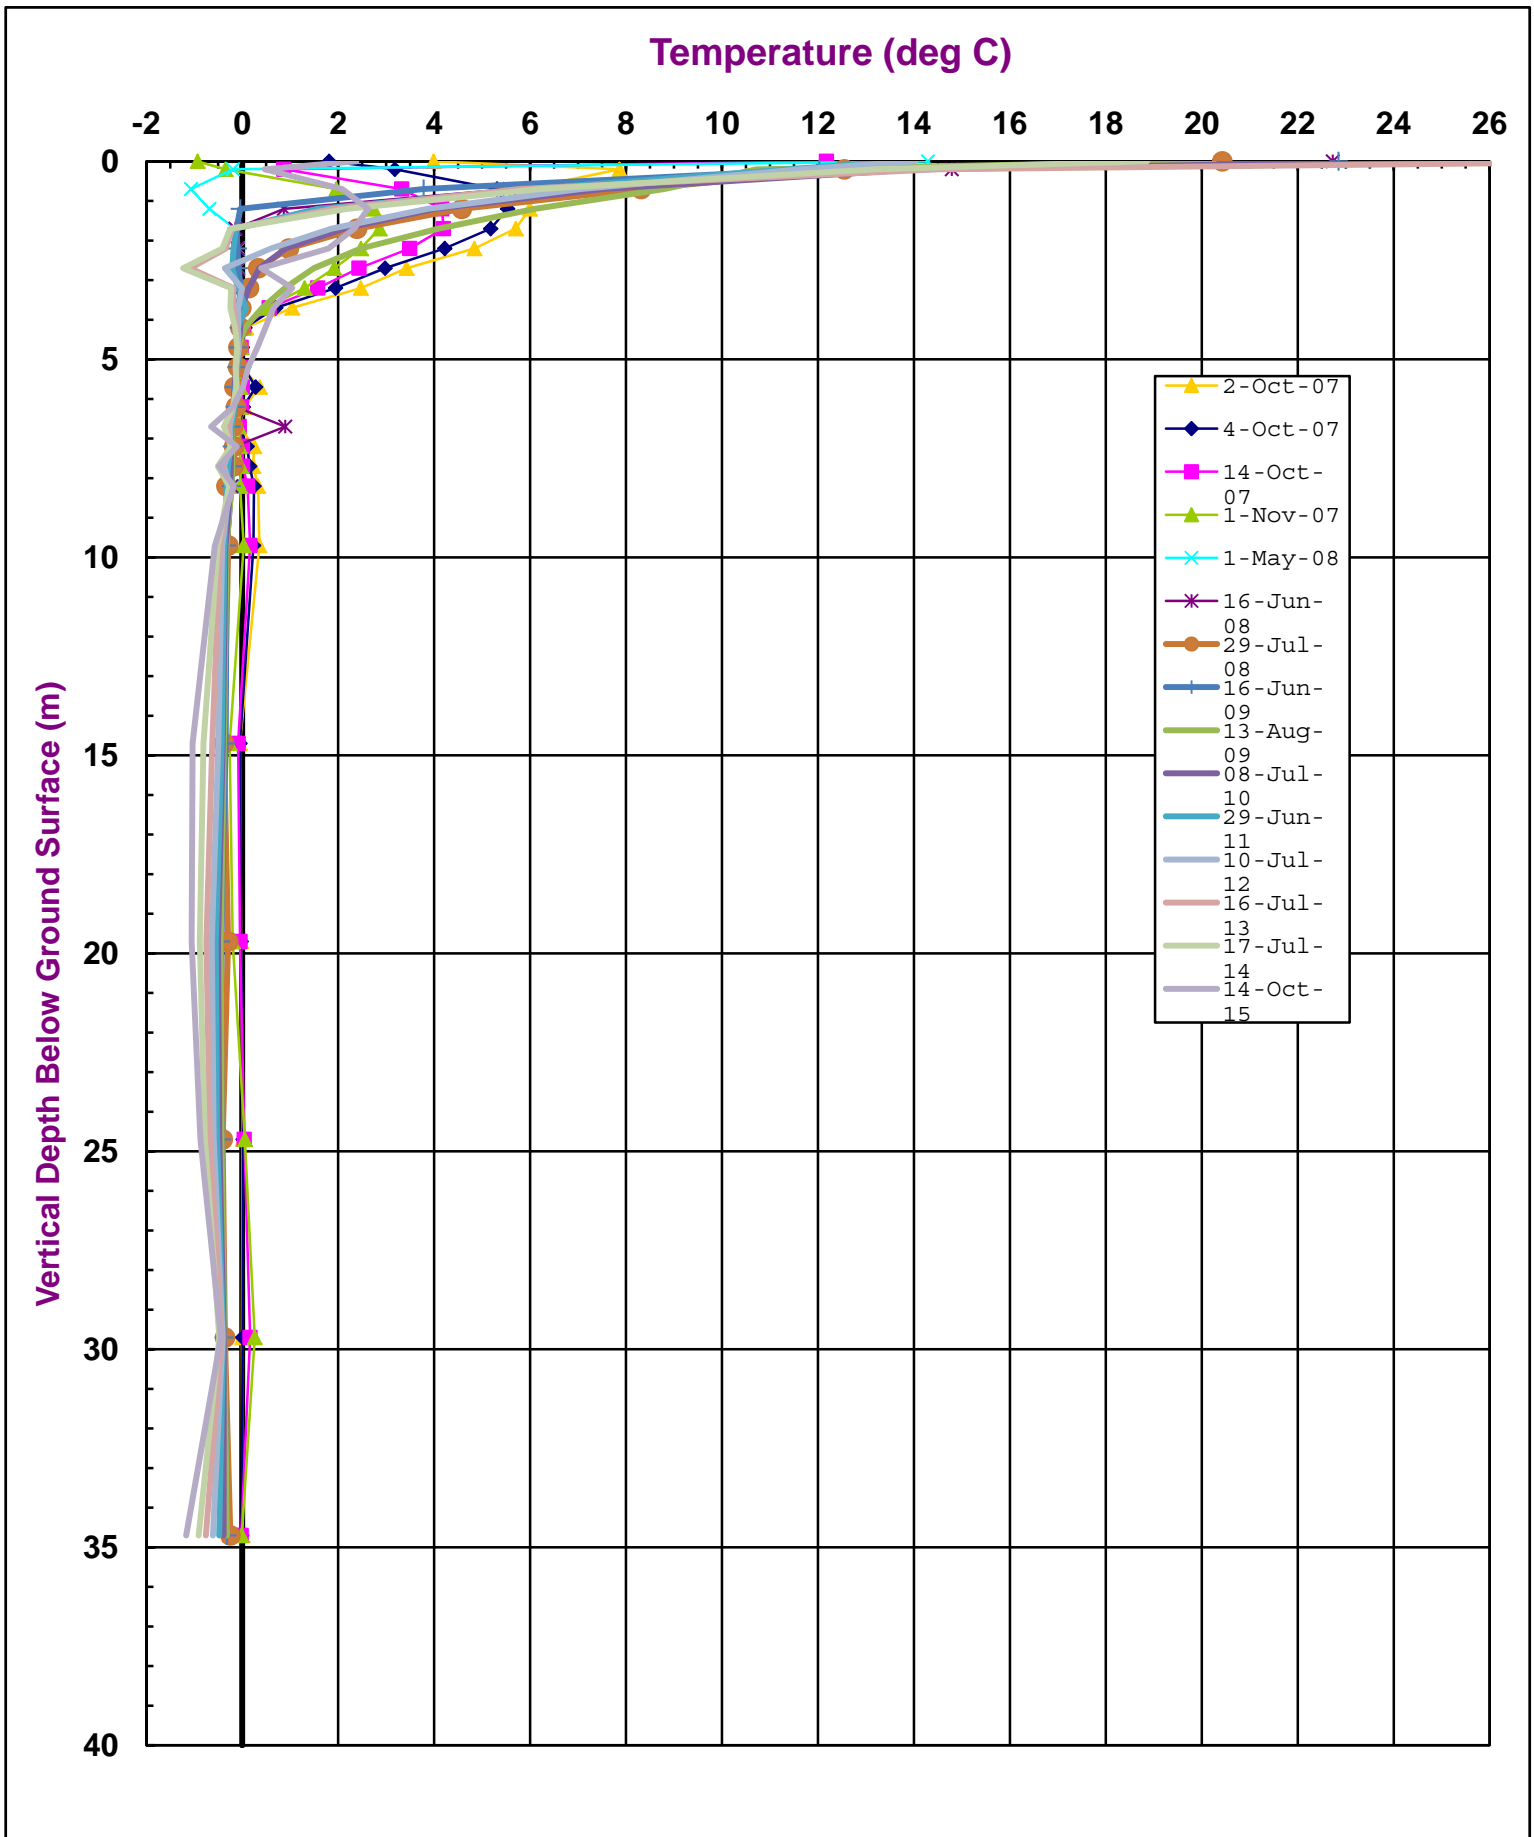
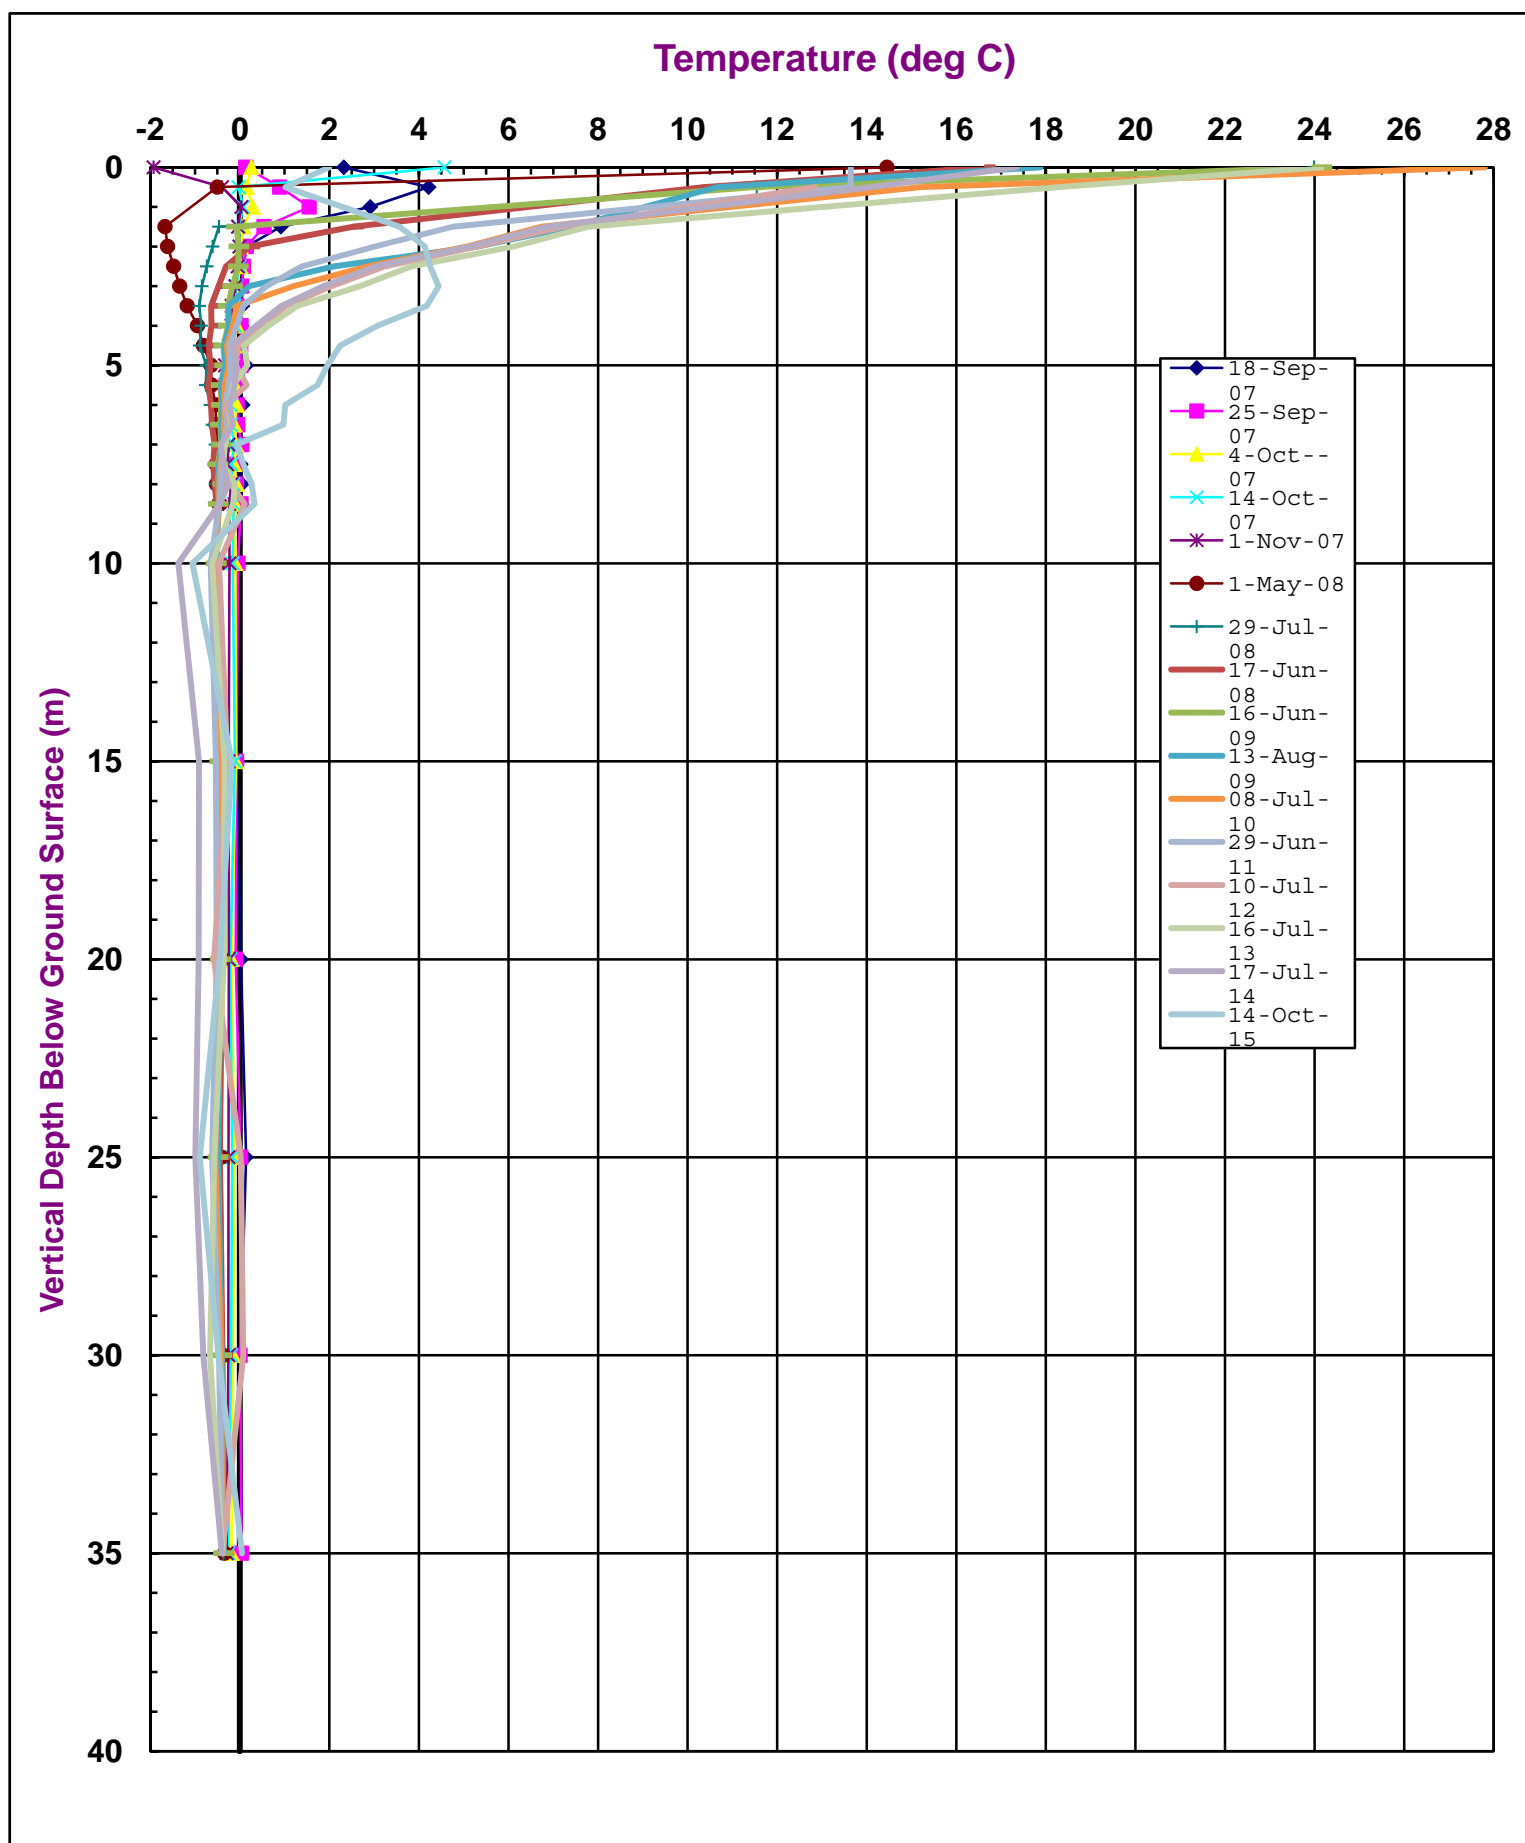
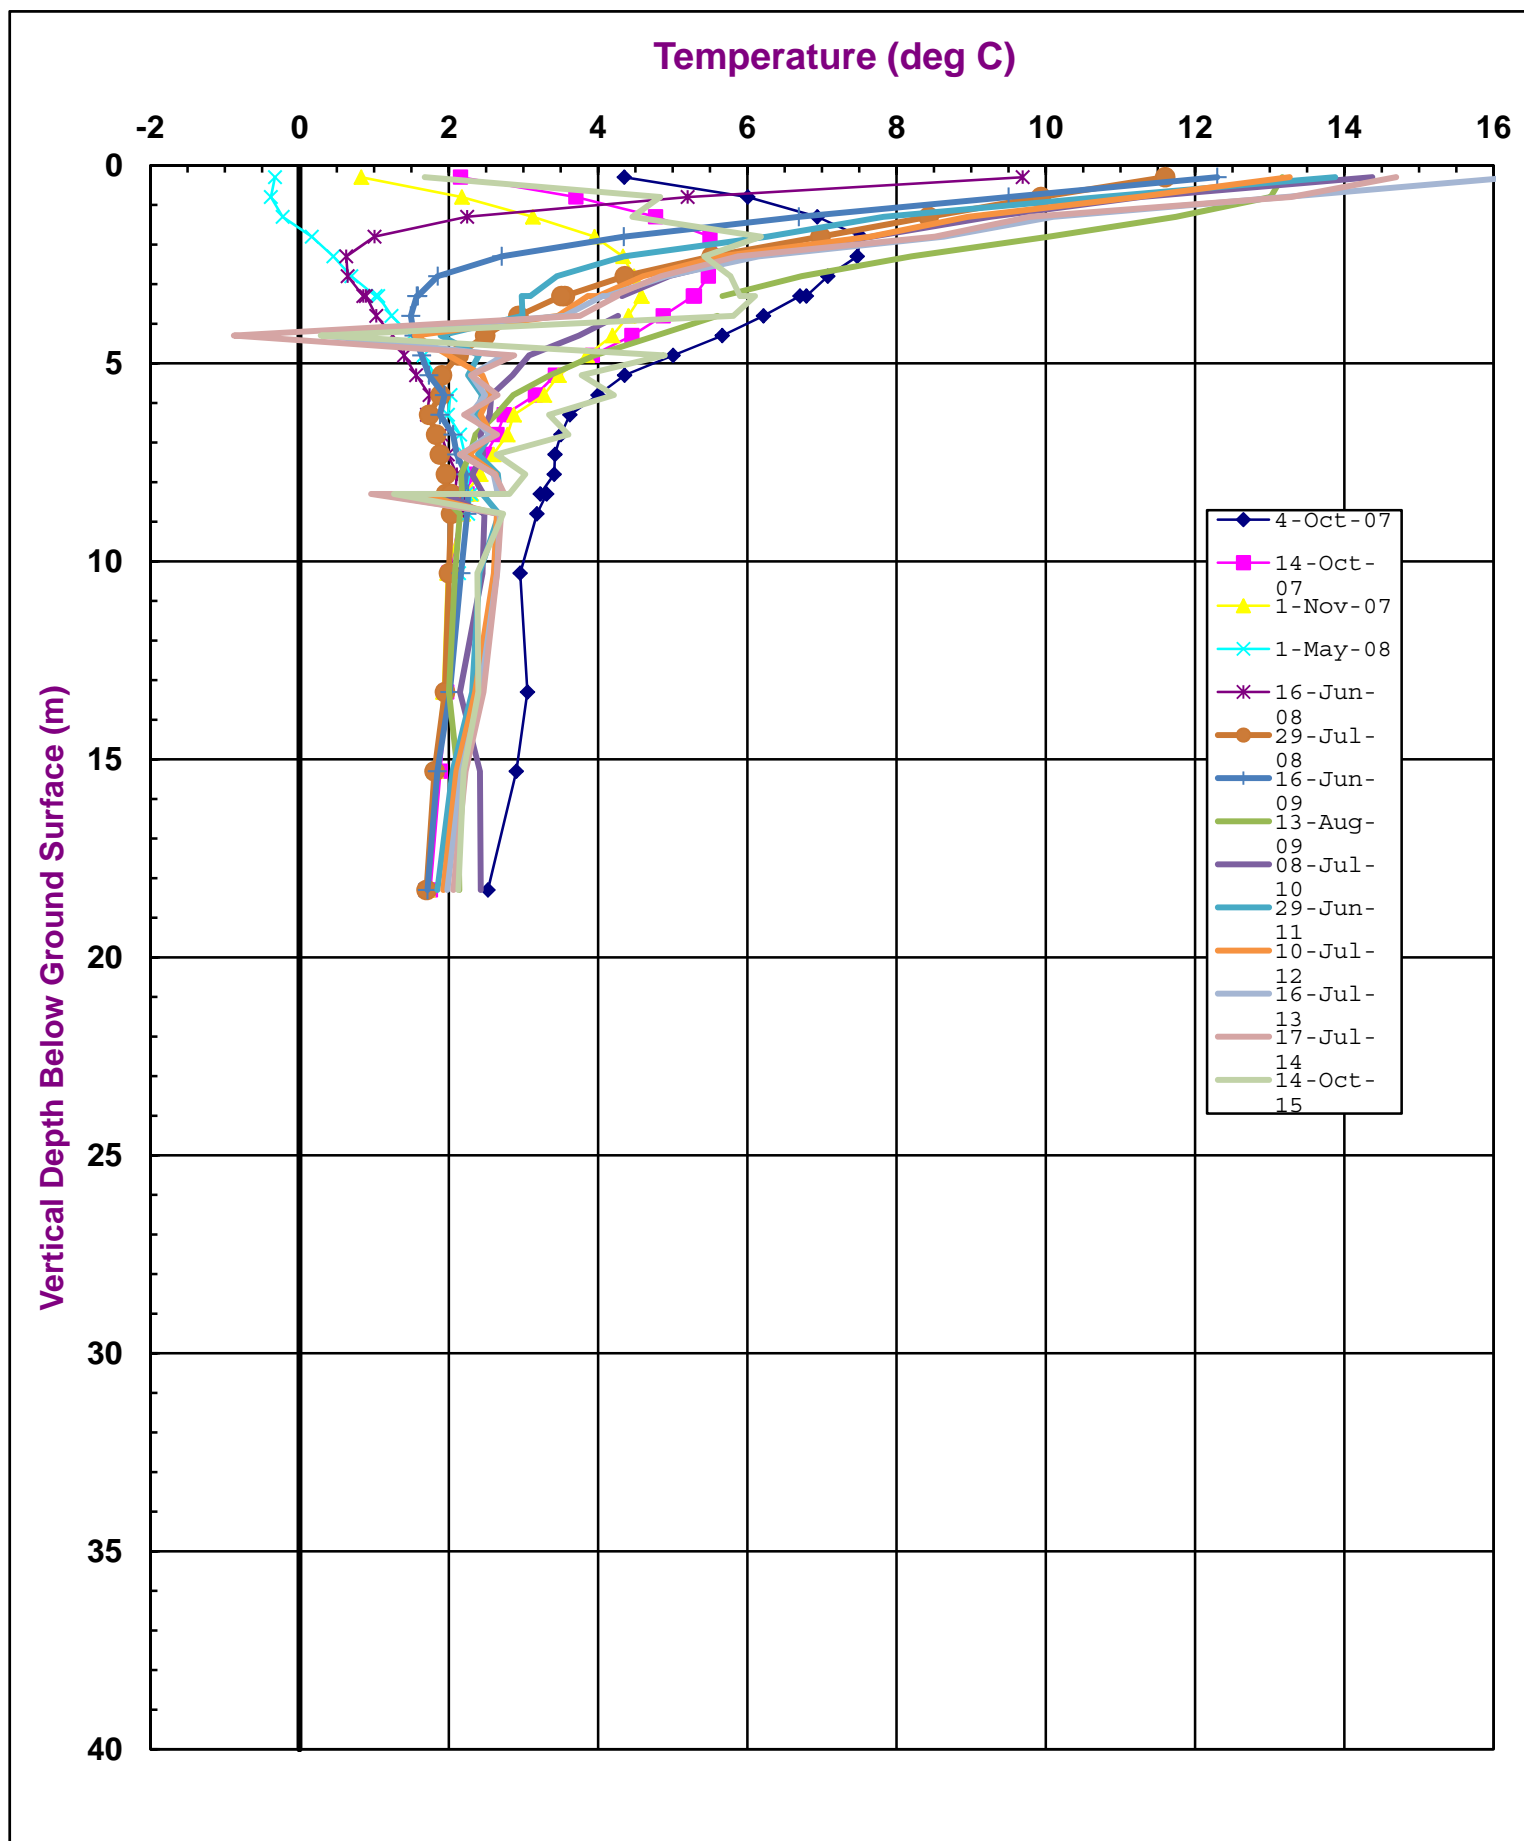
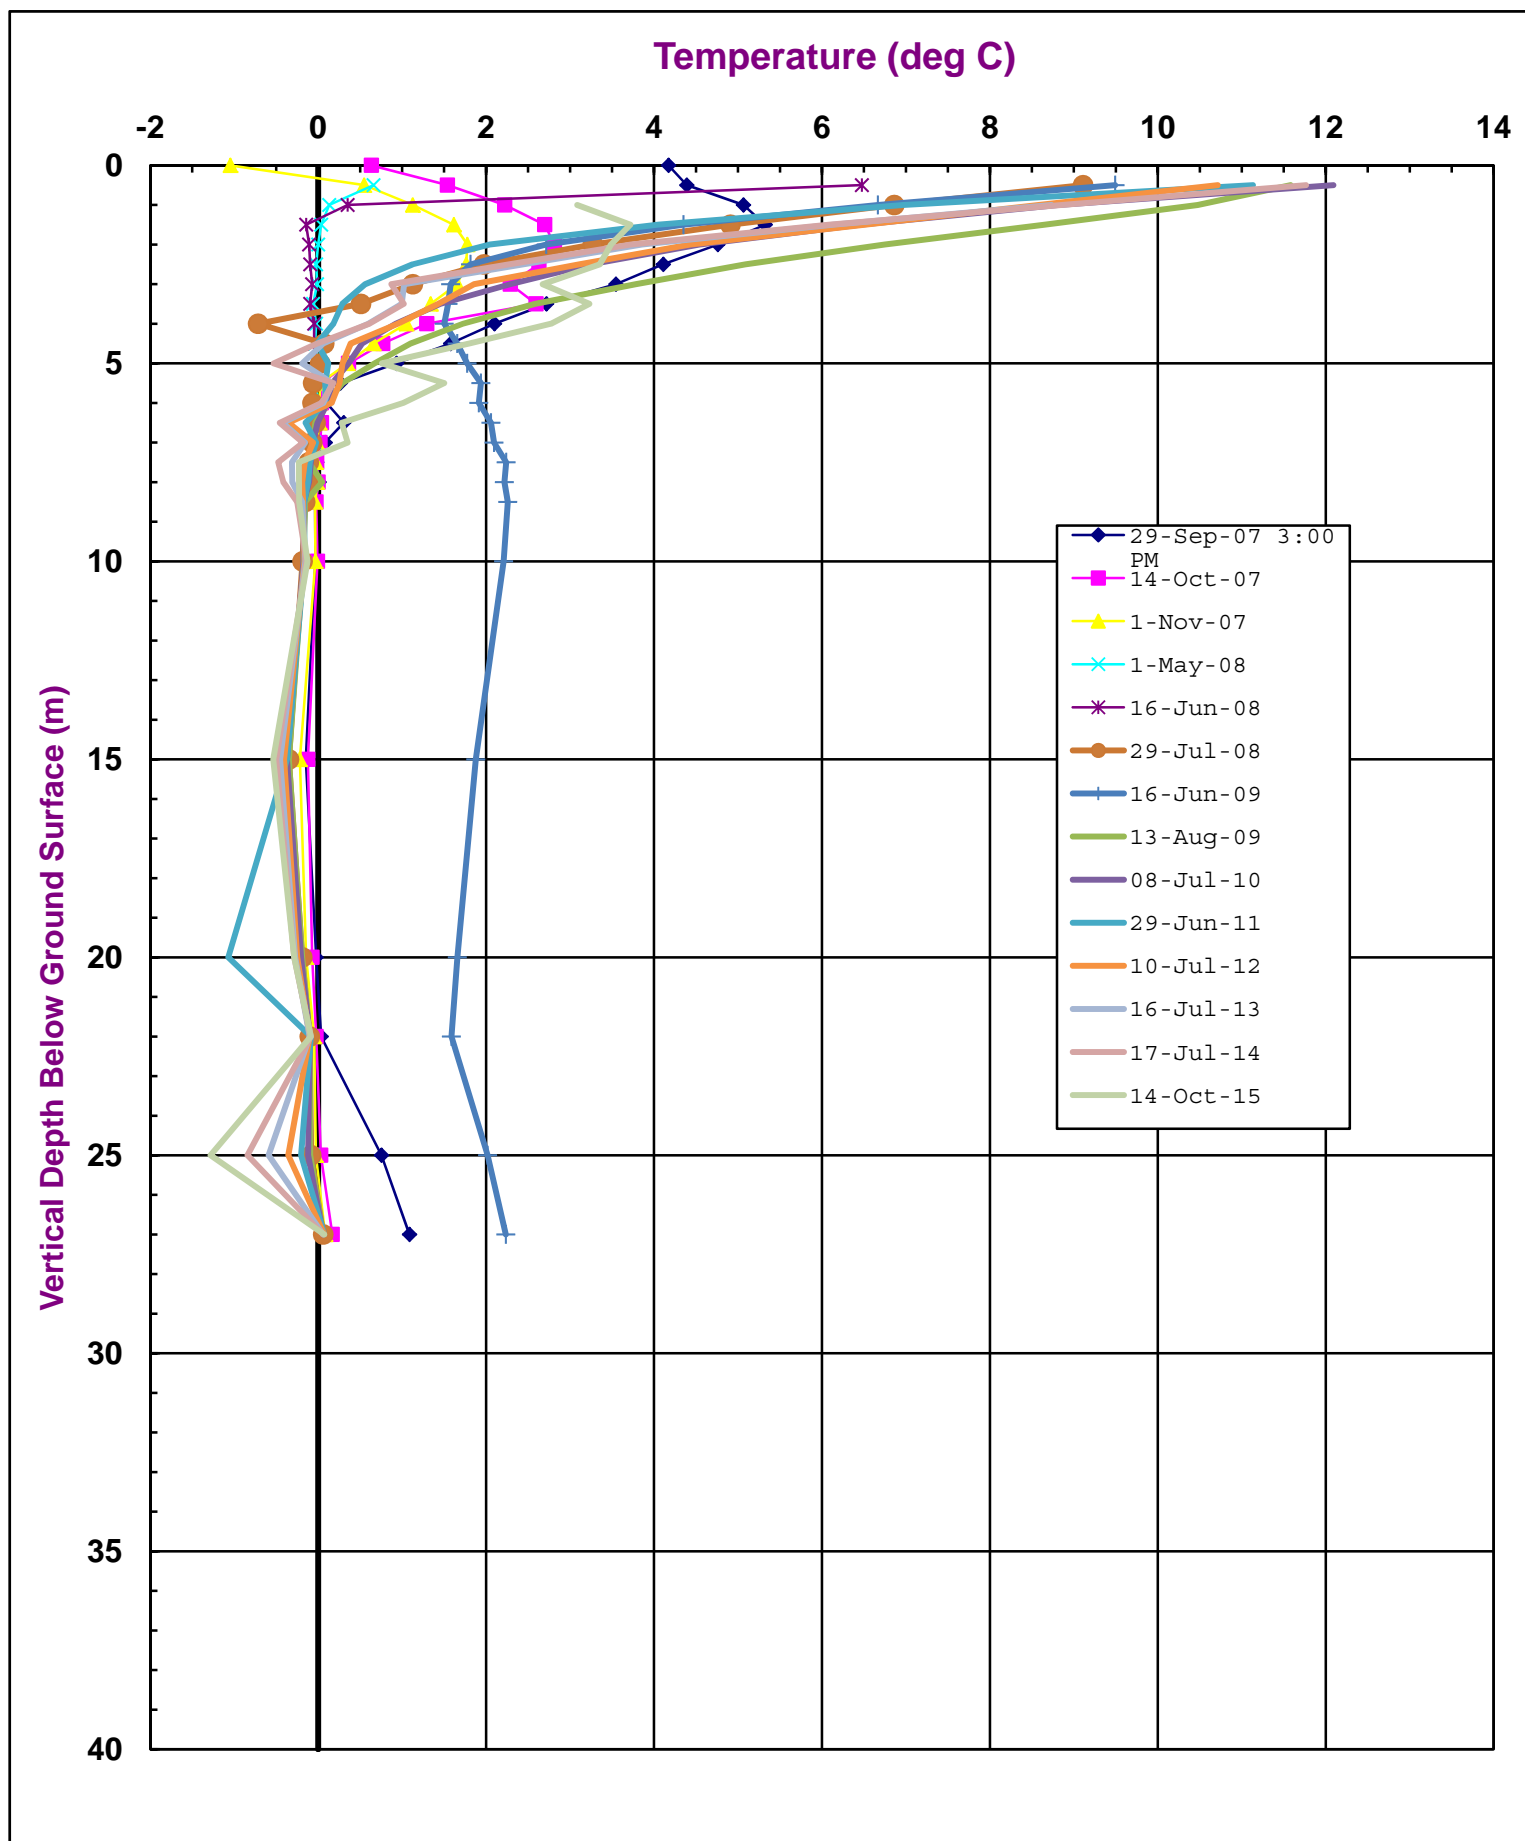
## Thermistor Data

The depth of the active thaw layer is observed from the resulting thermistor plots. The difference in the plots can be attributed to the inspection occurring later in the year (October compared to previous readings in July), which is approaching the maximum thaw of the active layer. The thermistor plots indicate the thickness of the active thaw layer and permafrost in the following locations:

- Southwest of proposed heap leach facility area in BH-01-07 and BH-03-07 the active thaw layer is approximately 5 m thick with permafrost below 5 m;
- Proposed water management pond, south of the proposed heap leach facility area, in BH-06-07 the active thaw layer is approximately 5 m thick with permafrost below 5 m;
- Proposed heap leach facility area in BH-13-07, BH-23-07, and BH-26-07 there is no indication of permafrost and the bedrock ranged from a depth of 12 m to 17 m;
- Proposed heap leach facility area in BH-17-07 the active thaw layer is approximately 7 m with permafrost below 7 m; and
- Proposed waste rock storage area in BH-18-07 and BH-29-07 the active thaw layer is approximately 5 m thick with permafrost below 5 m.
