November 9, 2016

Document No. 1655978_LT0003_Rev0

2016 ANNUAL INSPECTION OF THE CARMACKS COPPER PROJECT, CARMACKS, YUKON

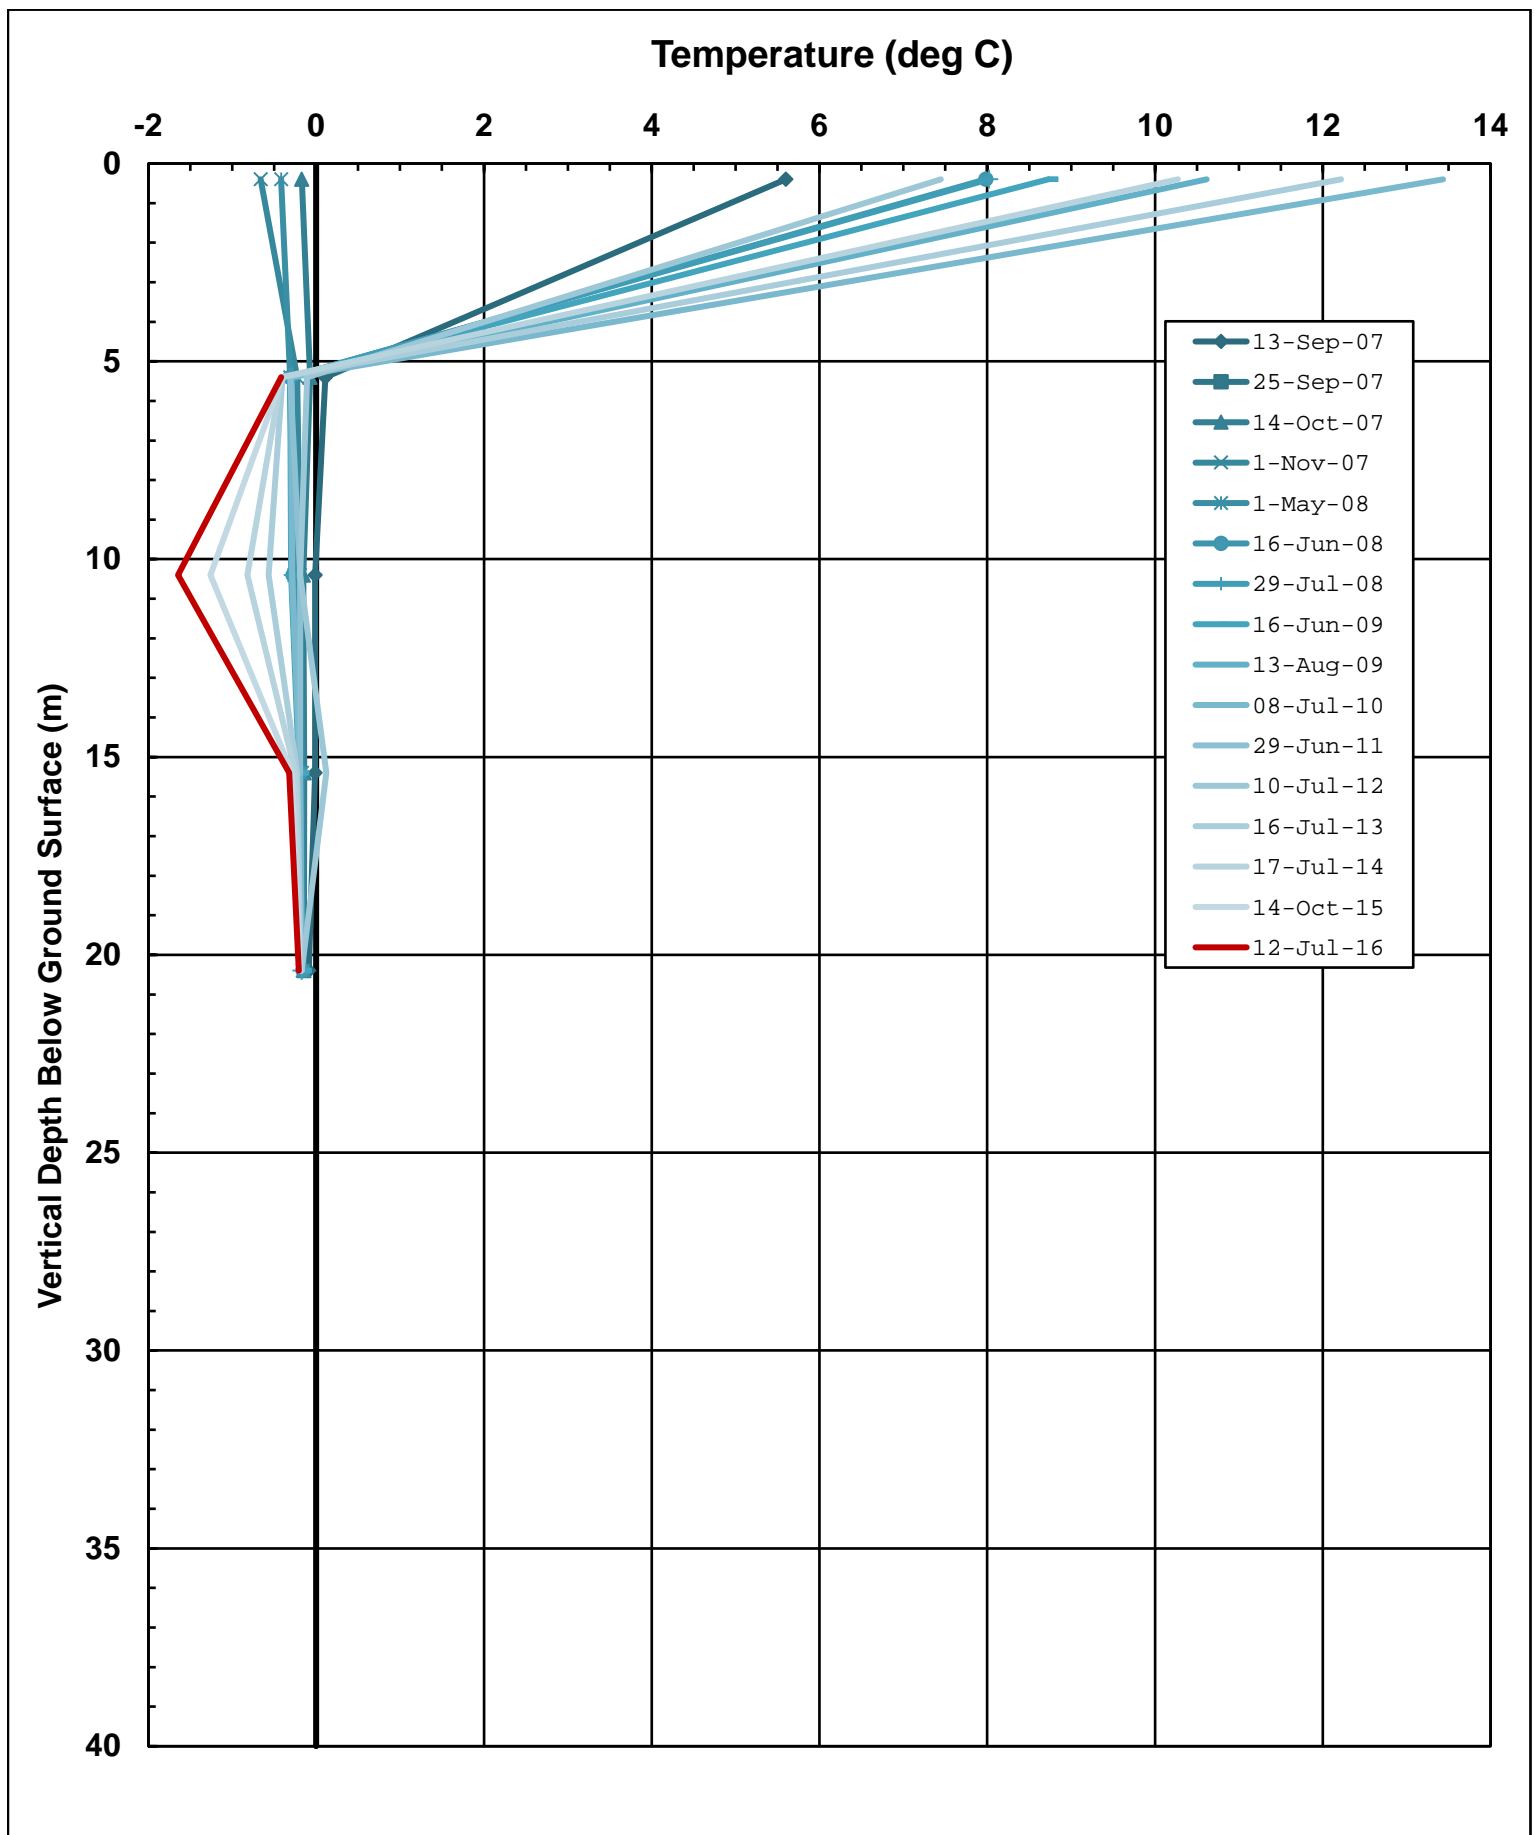
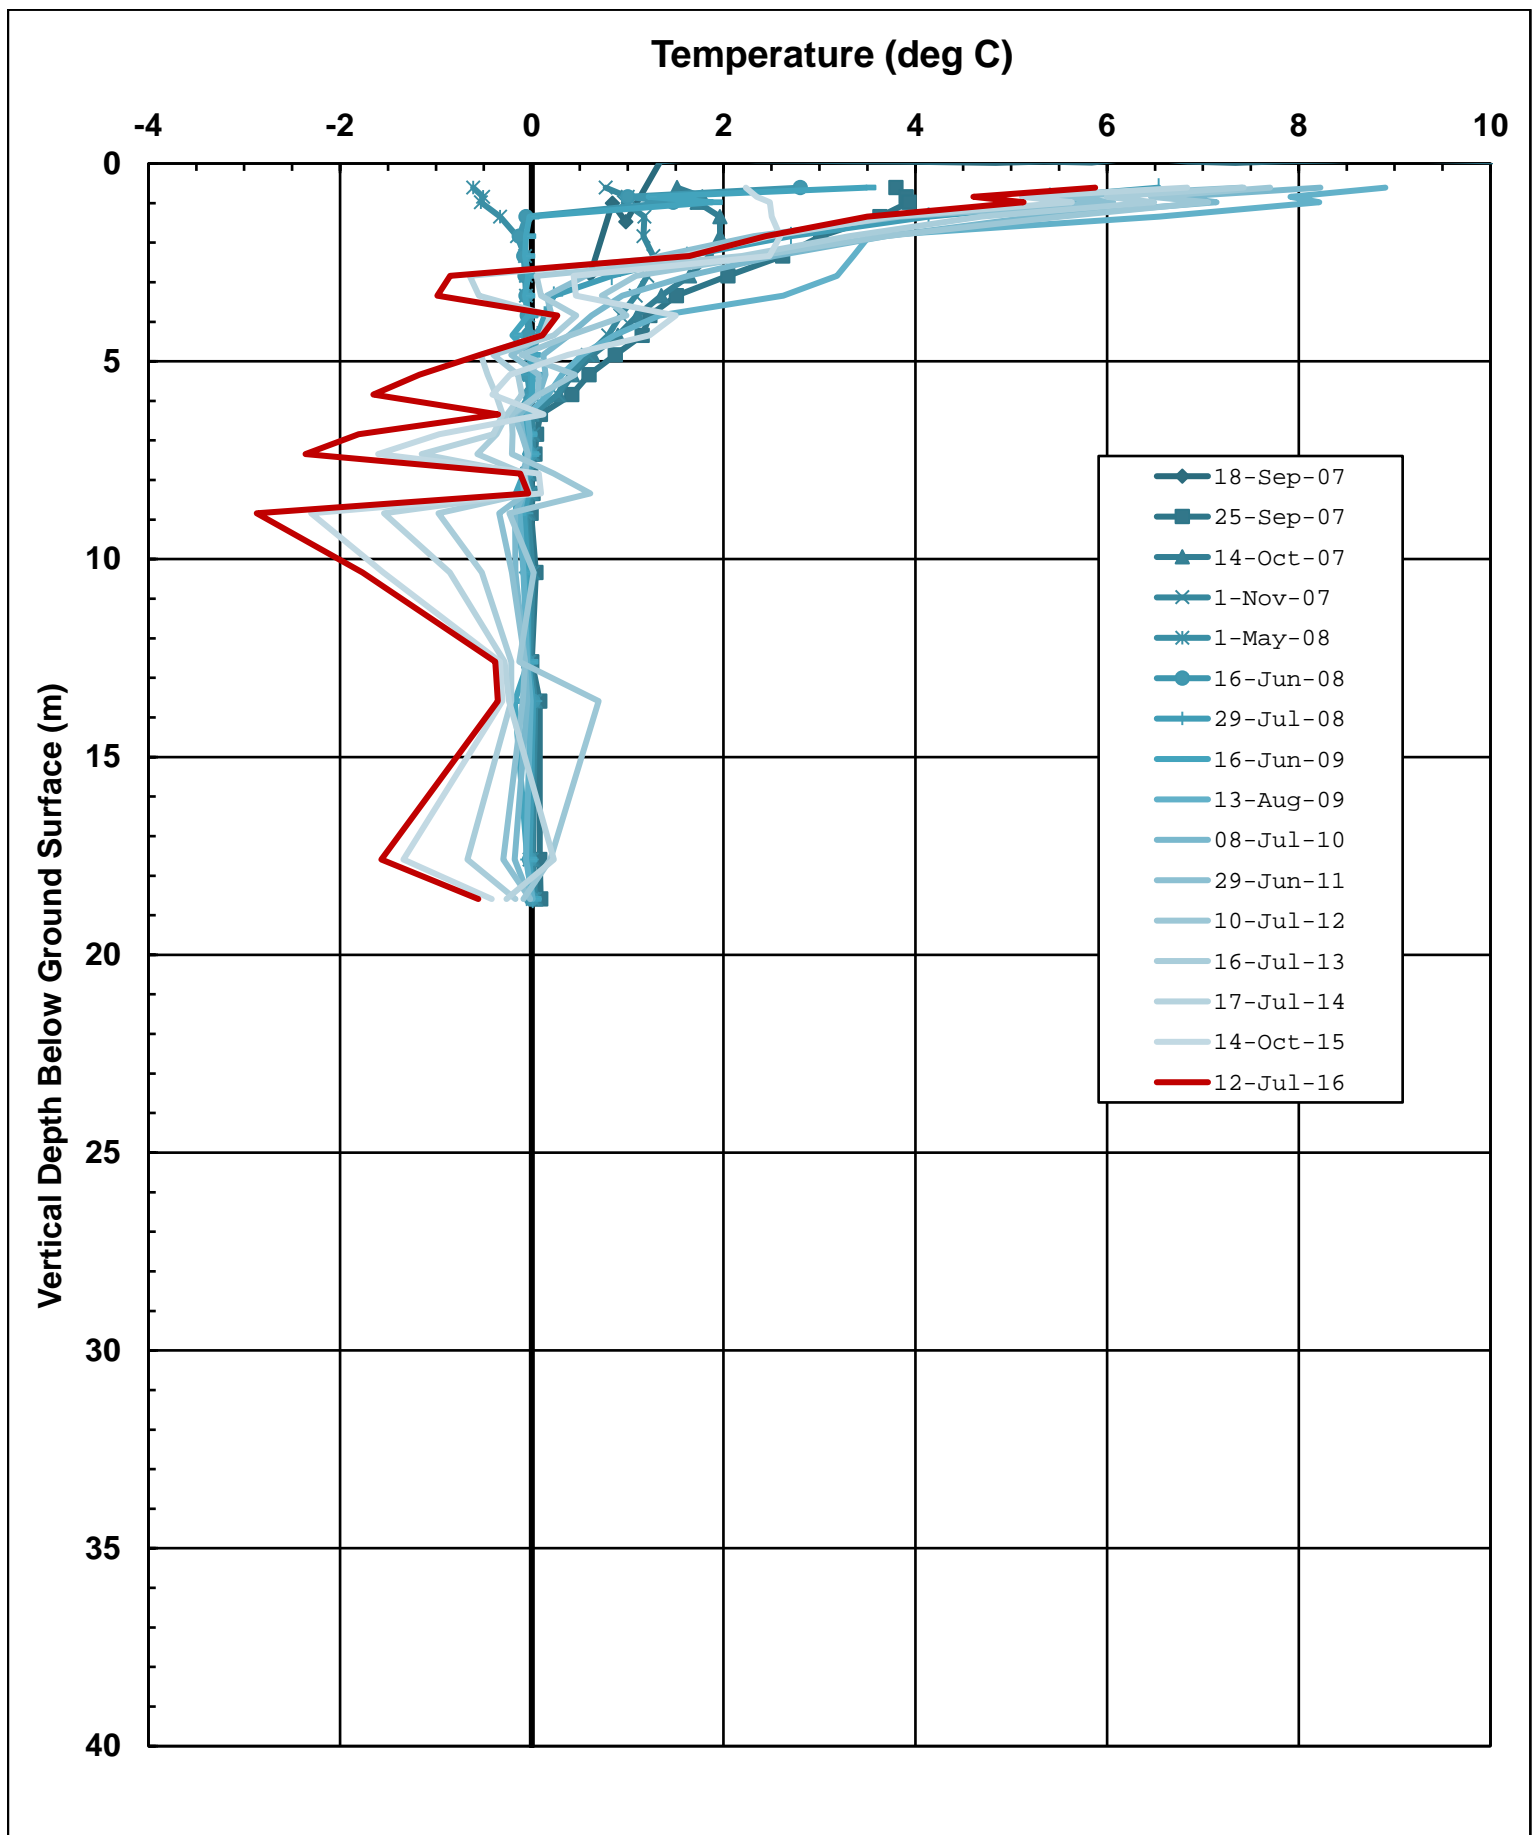
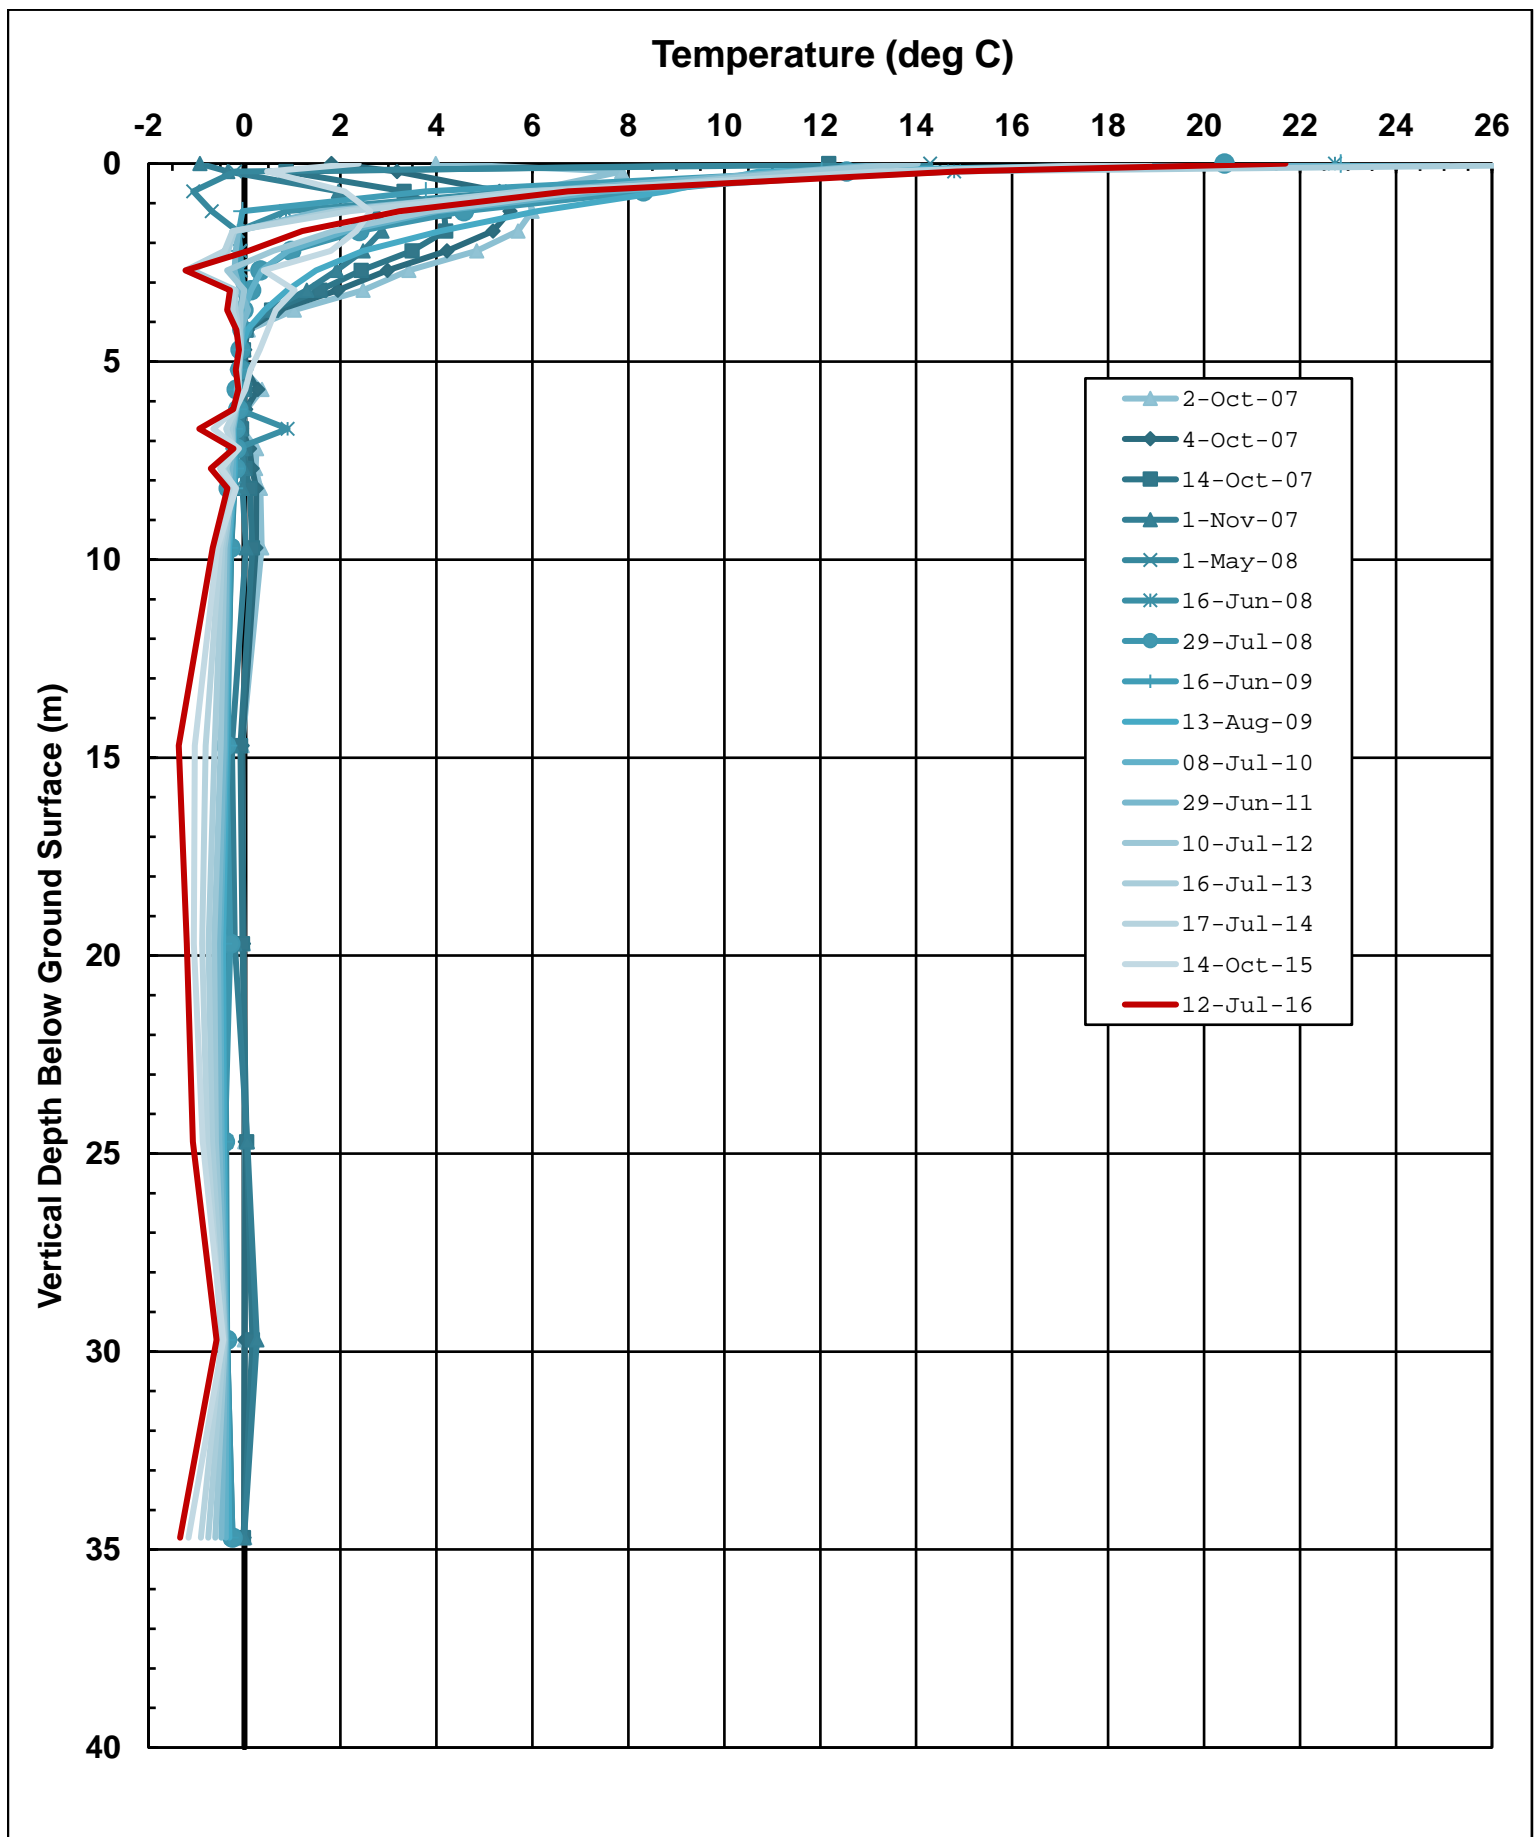
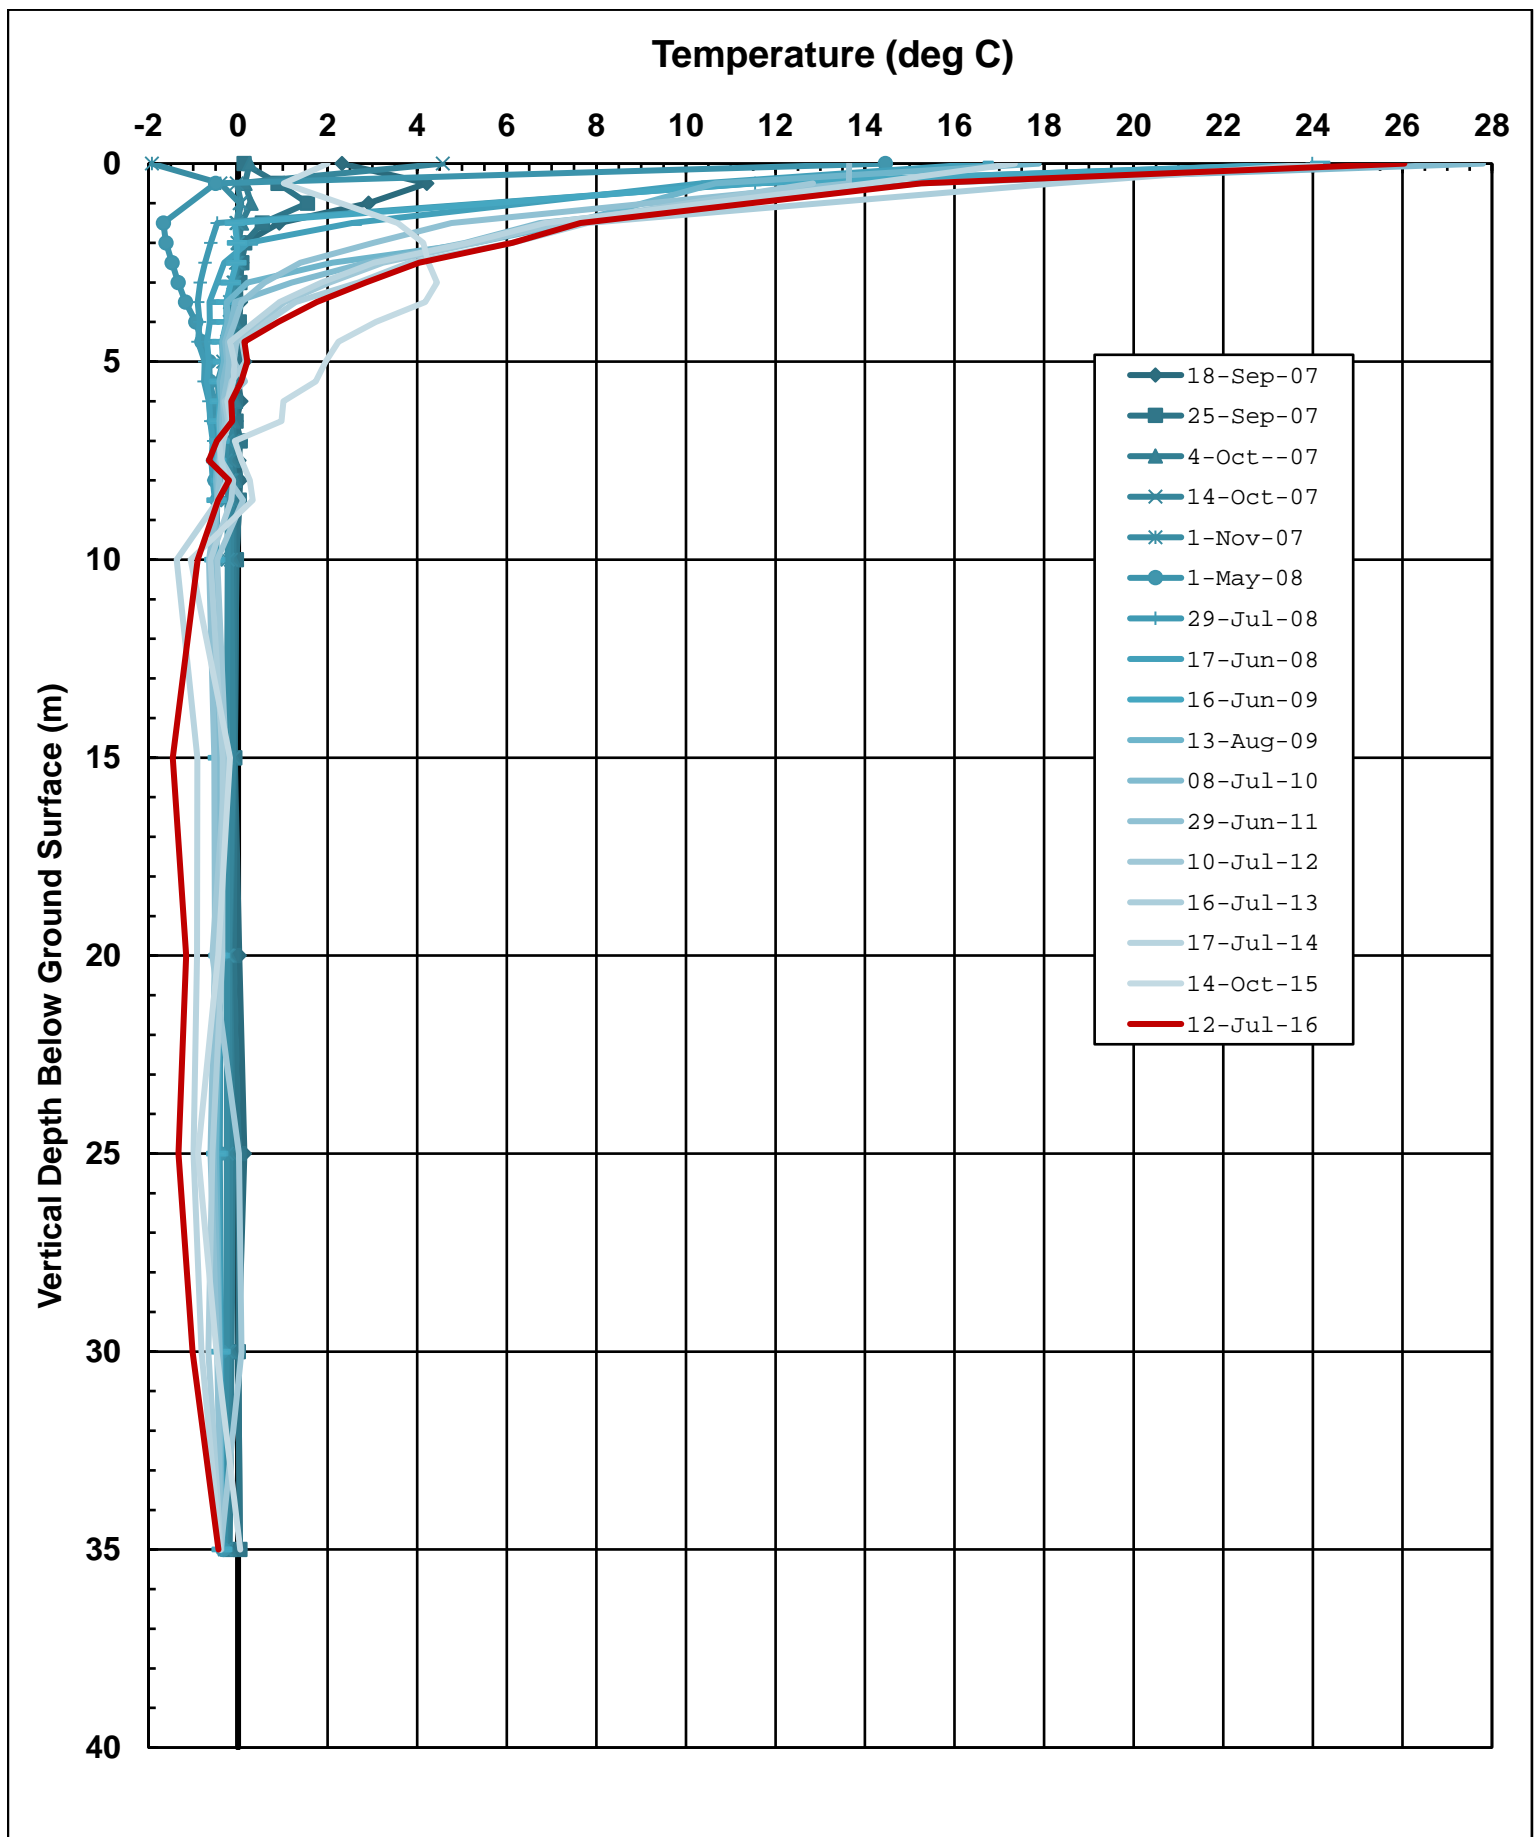
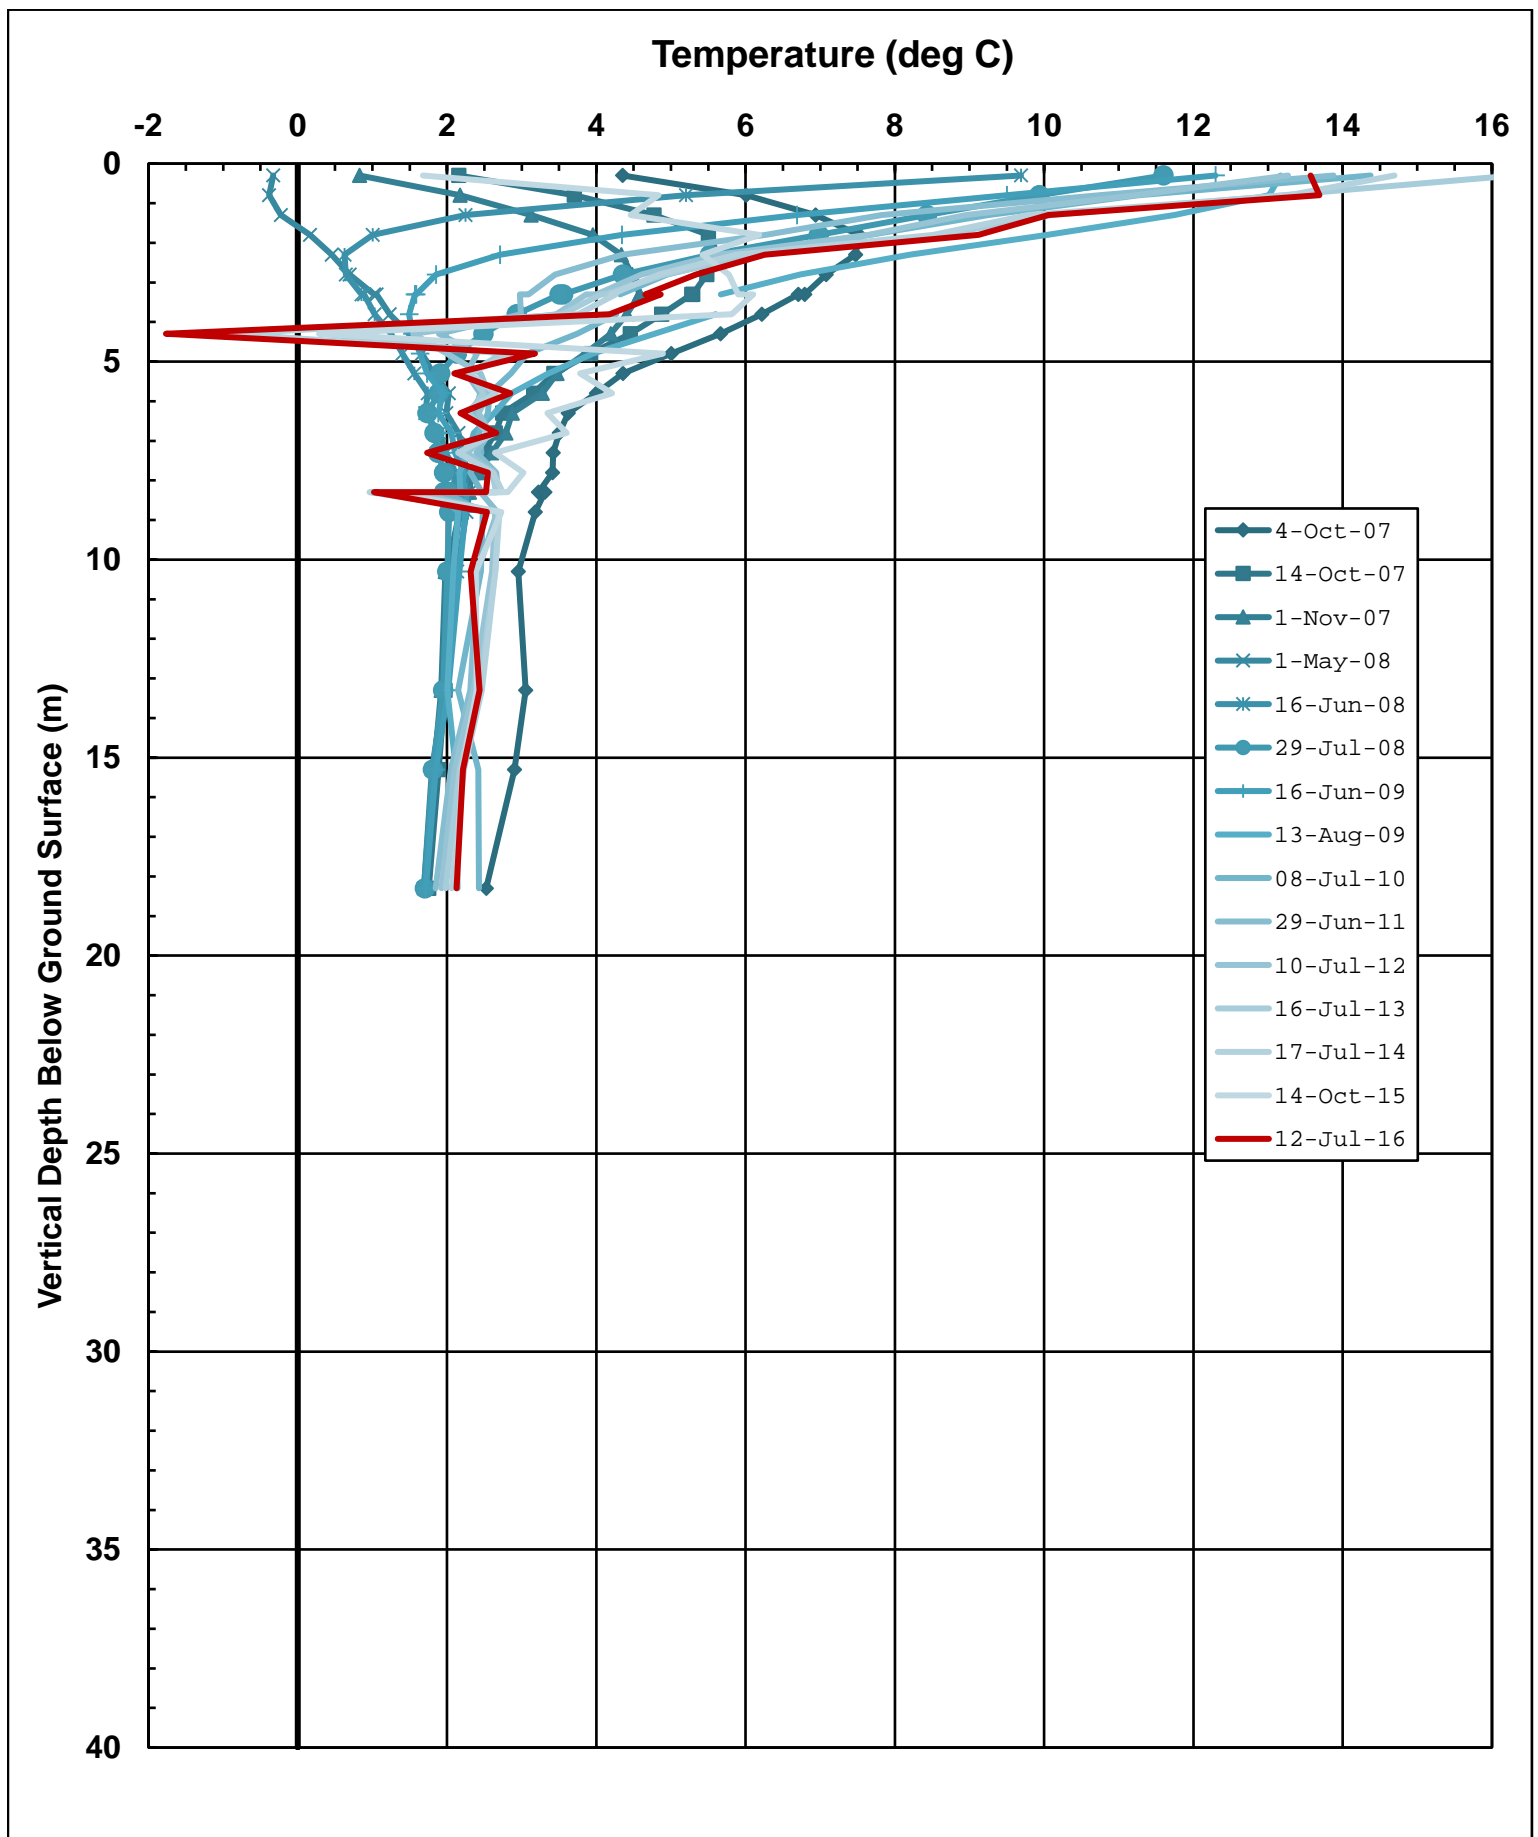
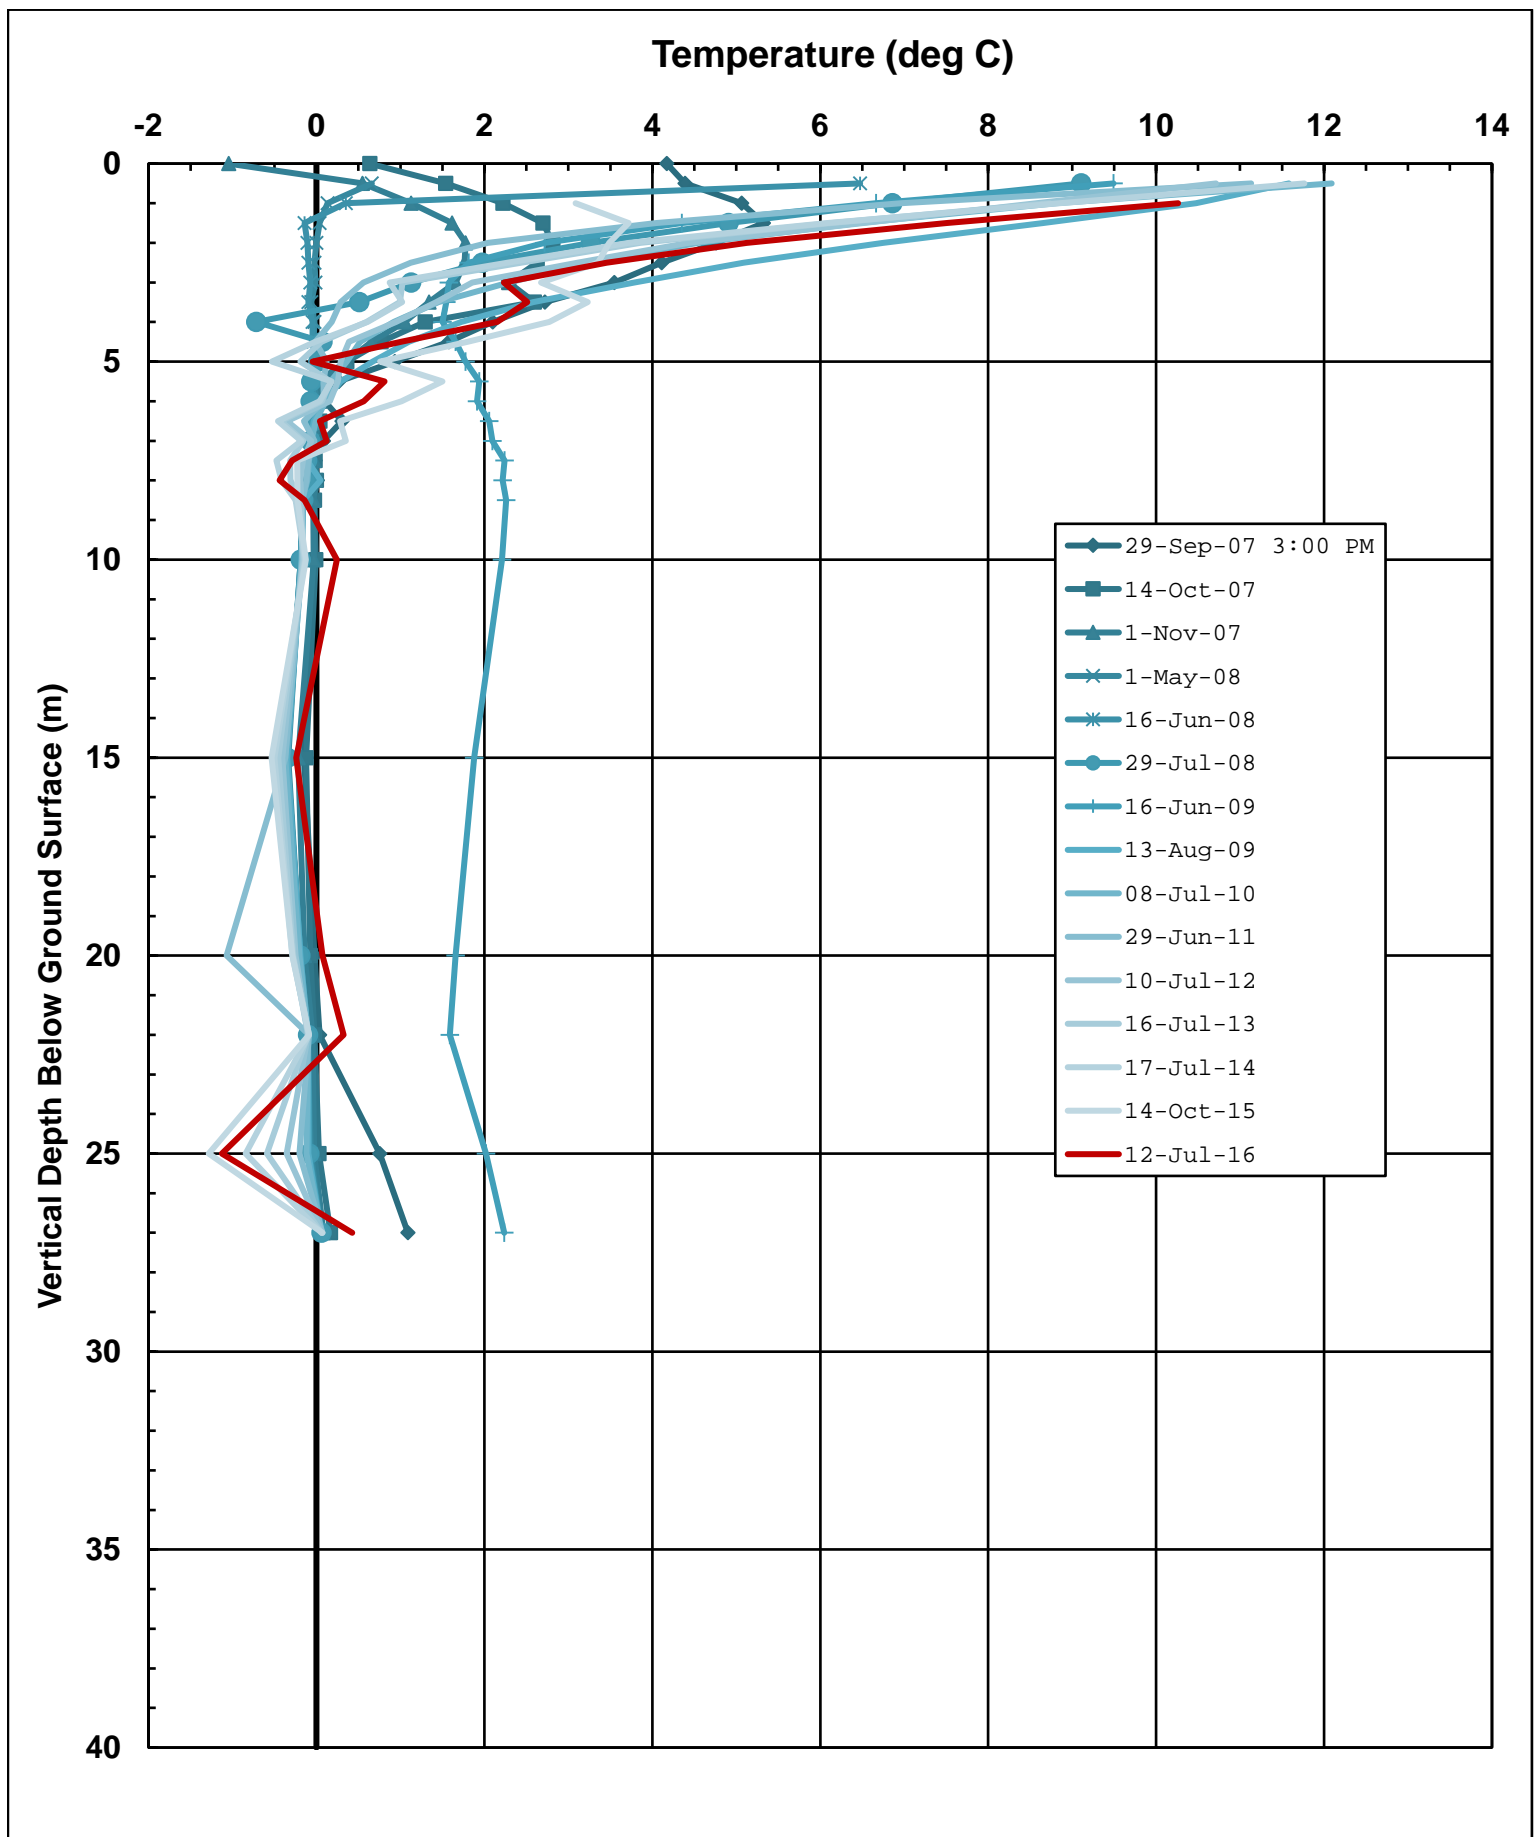
Thermistor Plots

The inspection was carried out by Mr. David Anstey of Golder, in the company of Mr. Doug Ramsey of Copper North on July 12, 2016. The inspection focused on the existing site infrastructure and a review of the general site conditions. Photographs of the site at the time of the inspection are presented in Attachment 1. Data collected from thermistors during the site visit are presented, together with data from previous years, in Attachment 2.
