2017 ANNUAL QUARTZ MINING LICENCE REPORT

**Submitted to Yukon Government, Energy Mines and Resources
Yukon Quartz Mining Licence QML-0007**

Carmacks Copper Project, Yukon Territory

Carmacks Copper Project - 2017 Annual Inspection

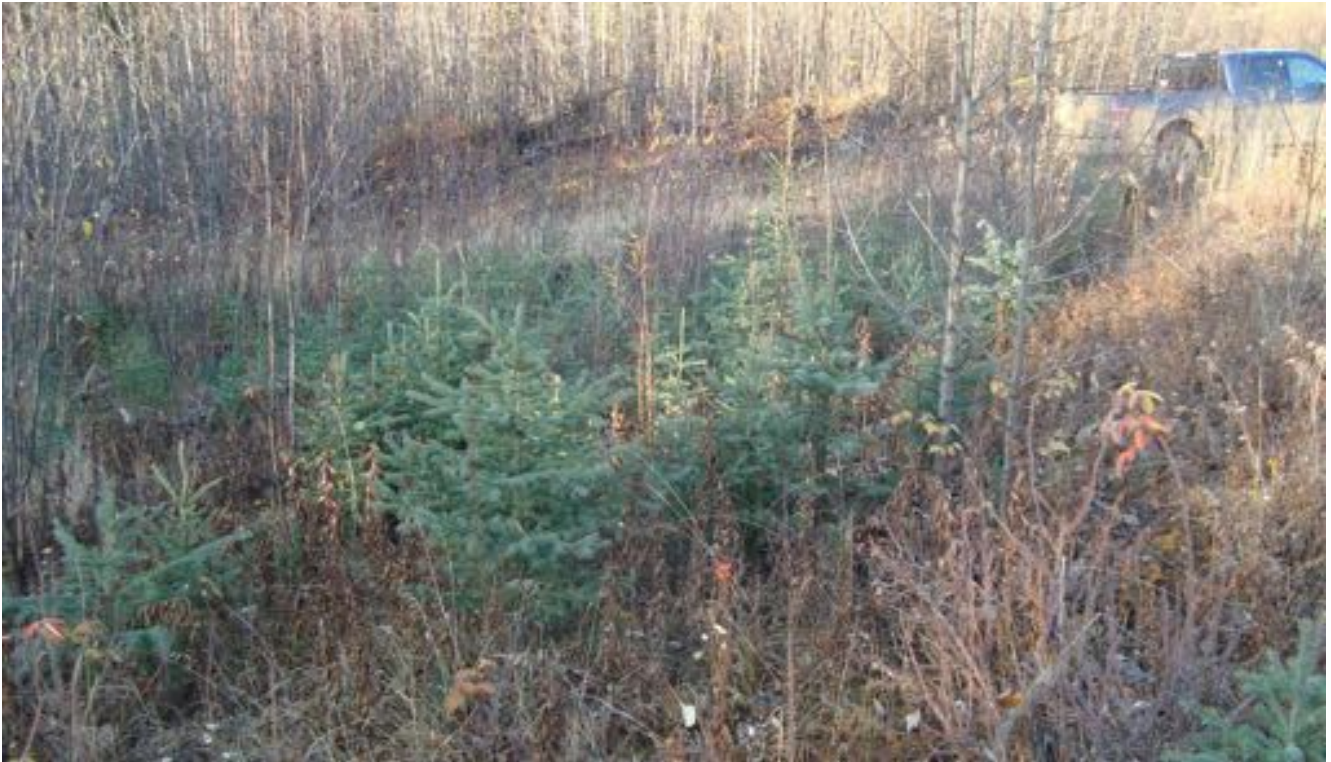
Since the initial clearing in 1997 and 1998, regrowth of vegetation has been occurring in the area. Small coniferous trees, approximately 1 m in height, are established throughout this area (Photograph 5). Erosion and sediment control measures in this area were initially installed in September 2008 and further maintained in September 2009 and August 2010. The sediment control measures include ditches and berms to divert water into sediment catch basins, silt fences, and vegetated areas to break up flow and reduce the potential for erosion. There continues to be some minor erosion of sediments along the access roads, however, this appears to be attenuating as vegetation growth on the access roads increases (Photographs 6 and 7). Sediment basins and controls are functioning adequately in areas that have seen no new activity.

Photograph 5: Vegetation regrowth in area of proposed heap leach pad facility

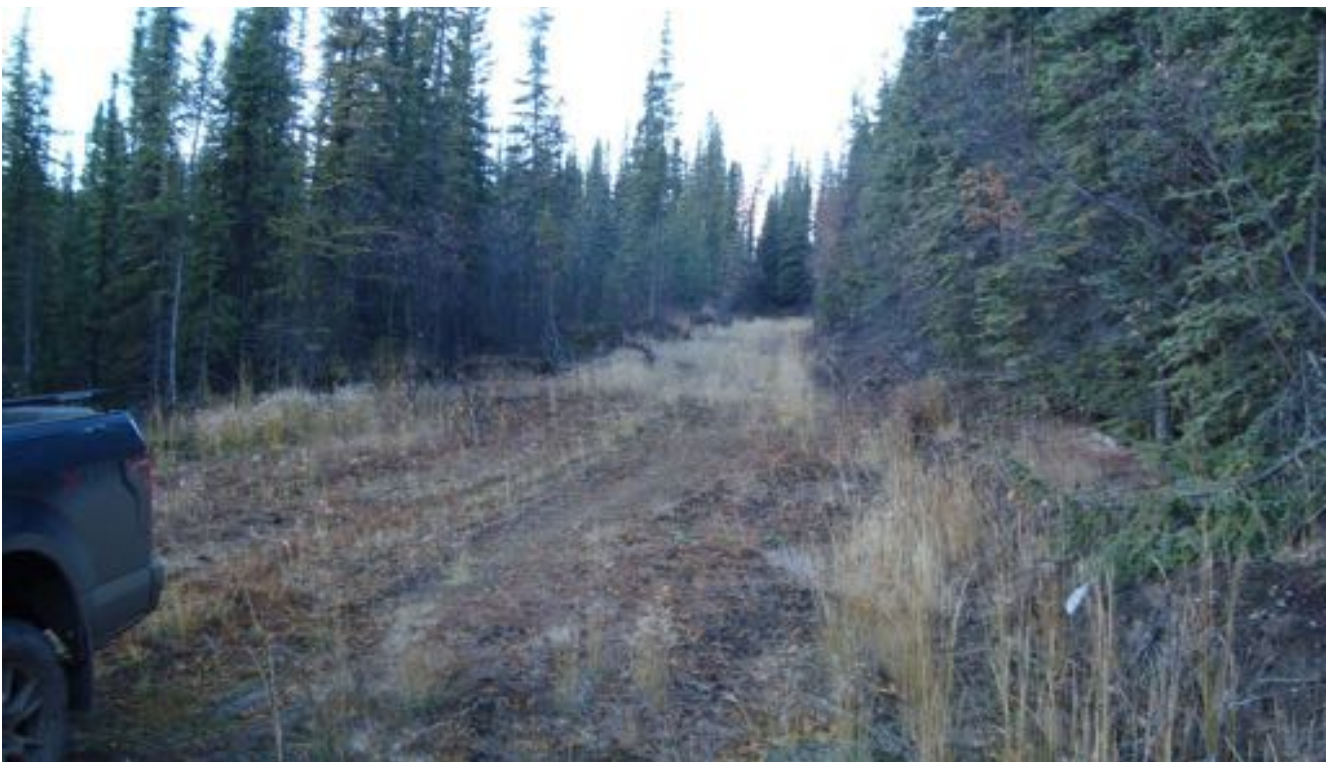
Photograph 6: Vegetation regrowth on access roads

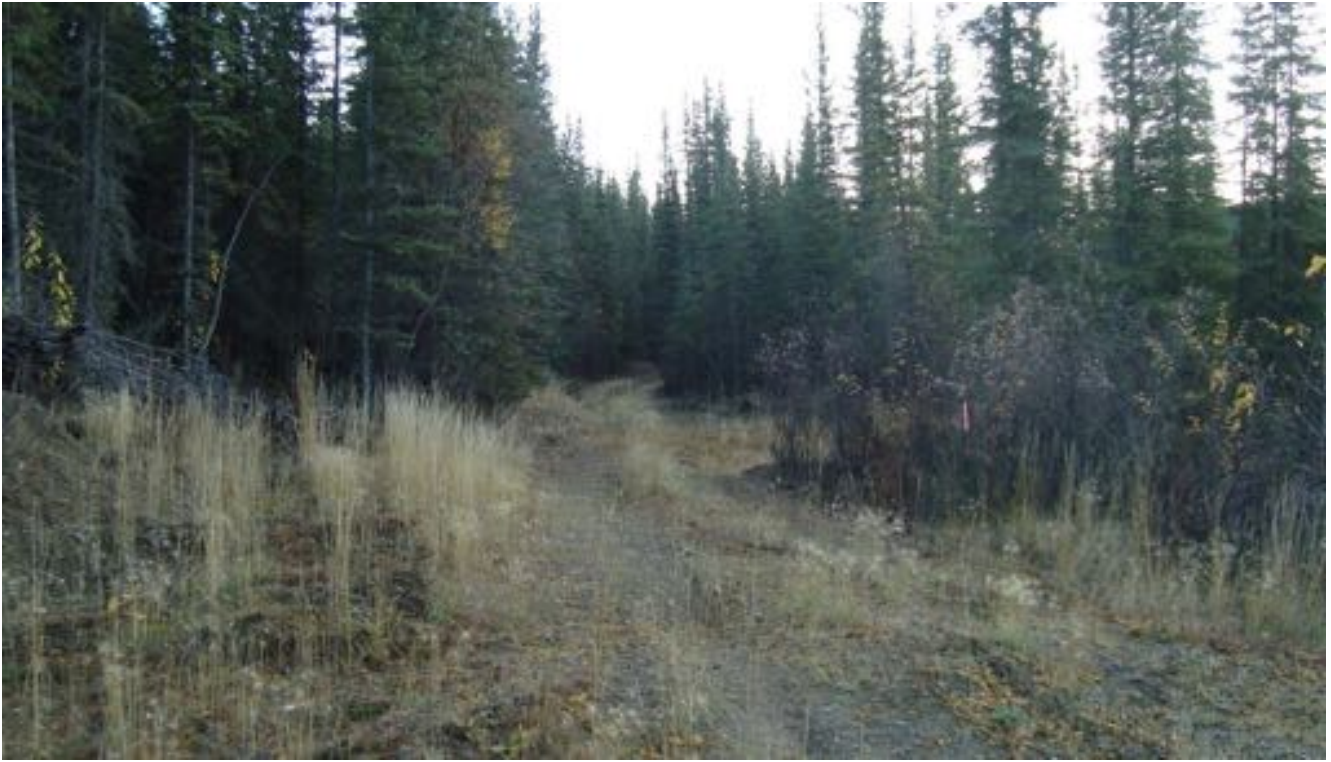
Photograph 7: Vegetation regrowth on access roads

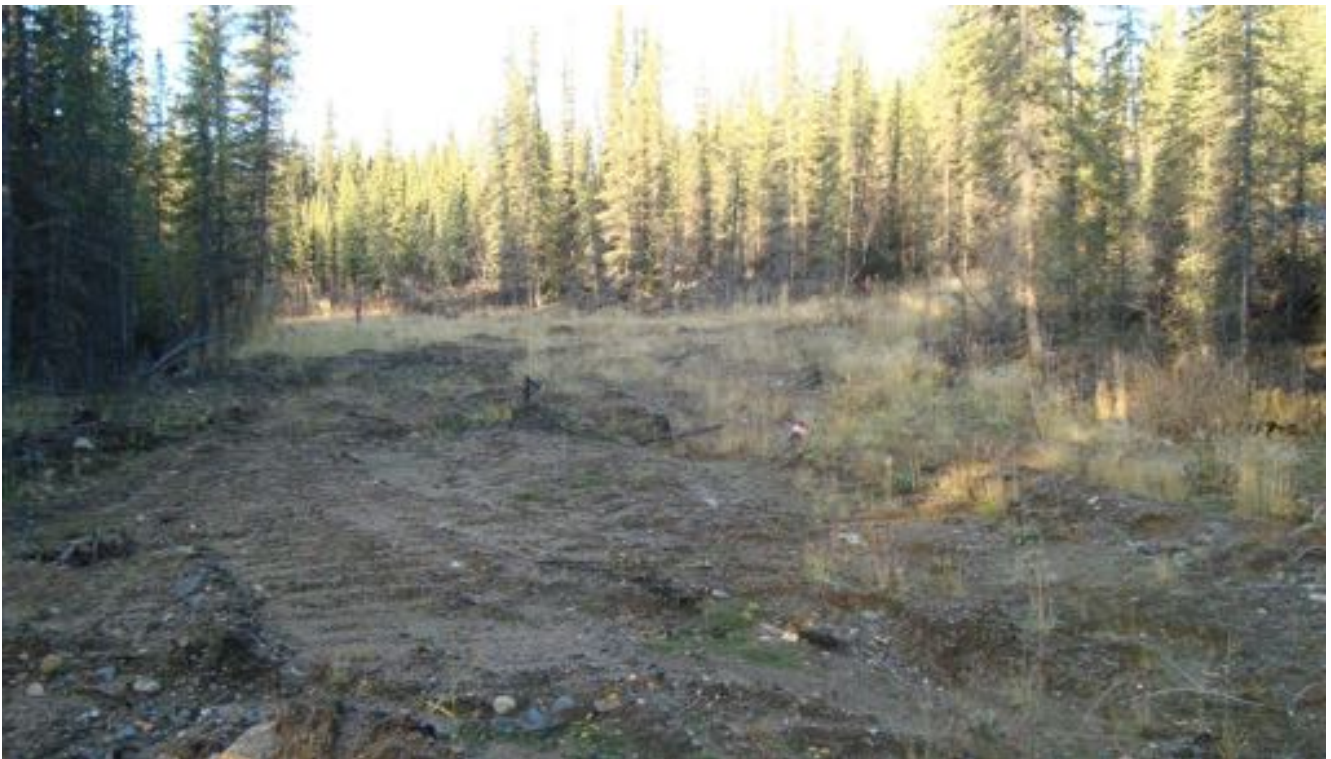
Clearing and drilling activities were carried out in 2015 and 2016 at a location down slope of the proposed heap leach facility, near the proposed water management pond (Photograph 8). Regrowth of vegetation, primarily volunteer species of grass, has mitigated loss of sediment from the former drill pads and is suitably rehabilitating.

Photograph 8: Vegetation regrowth on former drill pad

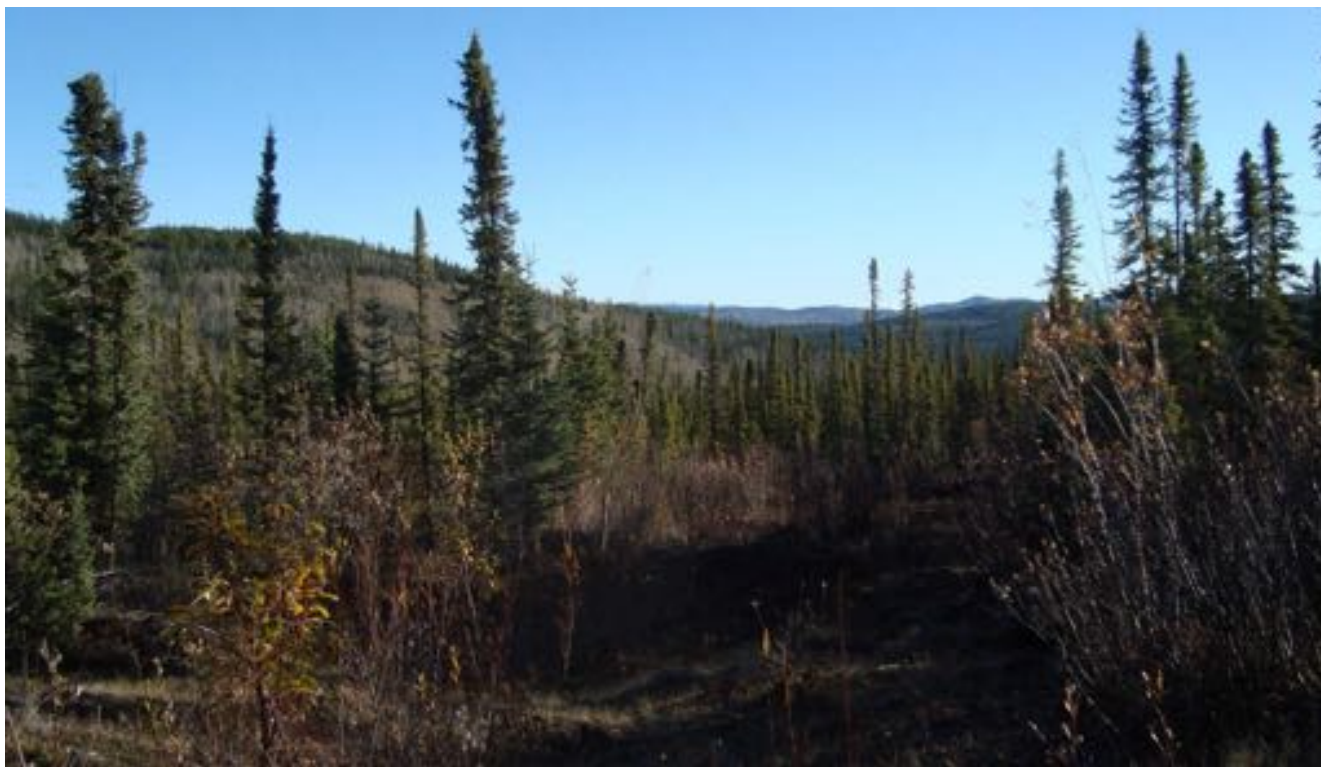
The proposed waste rock storage area was inspected. The waste rock storage area is tree covered and the drill pads and access roads in the area are re-vegetating by volunteer species to the extent that access on foot is now difficult (Photograph 11).

Photograph 11: Vegetation regrowth on access road in proposed waste rock storage area

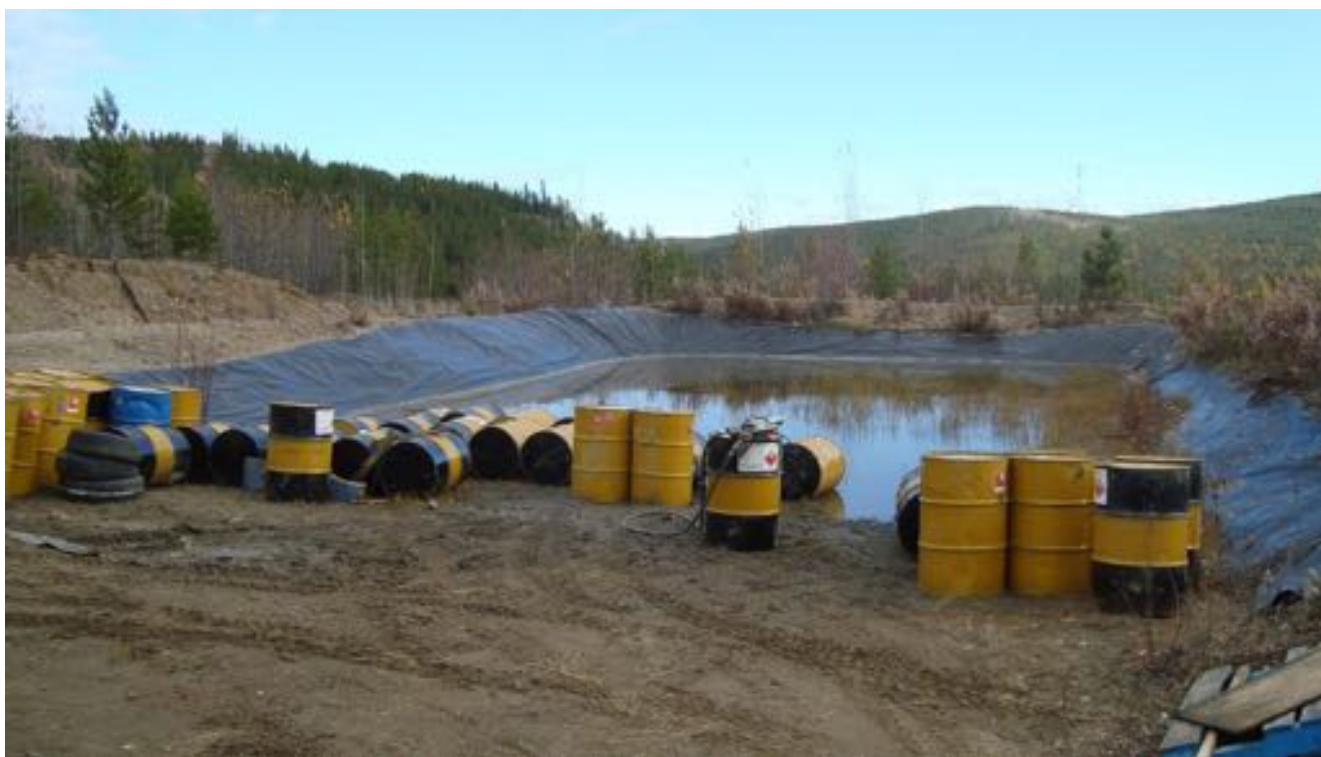
The fuel storage area was inspected. The fuel storage area comprises a bunded and lined basin constructed to contain any spilled fuel and currently a few dozen drums of diesel fuel. After several days of rain prior to the inspection, approximately 0.3 m of water had accumulated in the basin (Photograph 12). The bund is less than 3 m in height and the basin capacity is less than 10,000 m³; therefore, the fuel storage area is appropriately permitted under the QML without need for a water license (Yukon Environment Dam Guide).

Photograph 12: Lined basin at fuel storage area

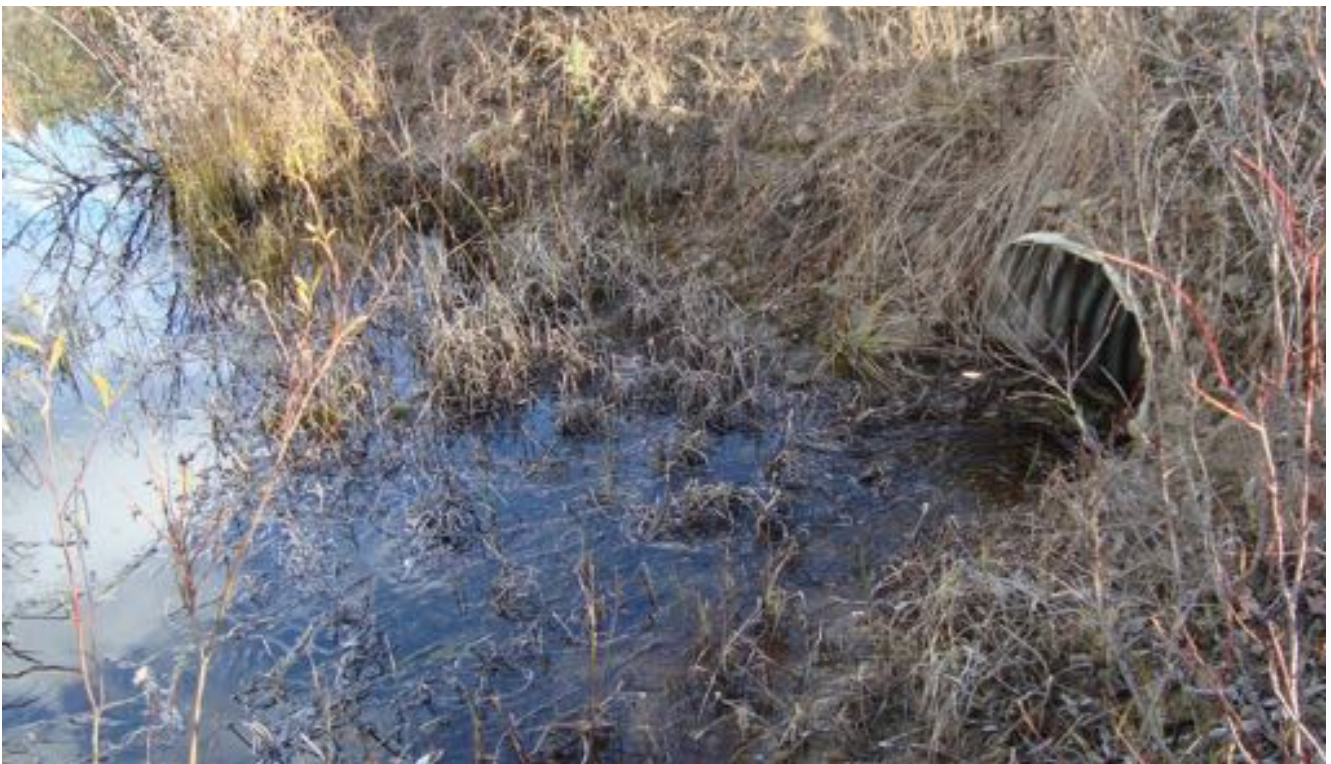
The main access road to the north of the waste rock storage area was observed to be in good condition with only minor erosion observed. Minor erosion of the road shoulders was observed near at the culvert on North Williams Creek. The culvert has undergone some crushing and has accumulated some sediment (Photograph 14). However, the culvert remains more than adequate to accommodate the relatively minor flows at this location. The access road should be inspected annually and ongoing maintenance of drainage features and erosion should be anticipated. The combination of recent rain and high traffic due to current drilling activities have resulted in a rutted, muddy area at the low point in the road near North Williams Creek (Photographs 15 and 16). The road in this area should be regraded and gravel placed, as required to improve trafficability at this location.

Photograph 14: Culvert beneath road at North Williams Creek

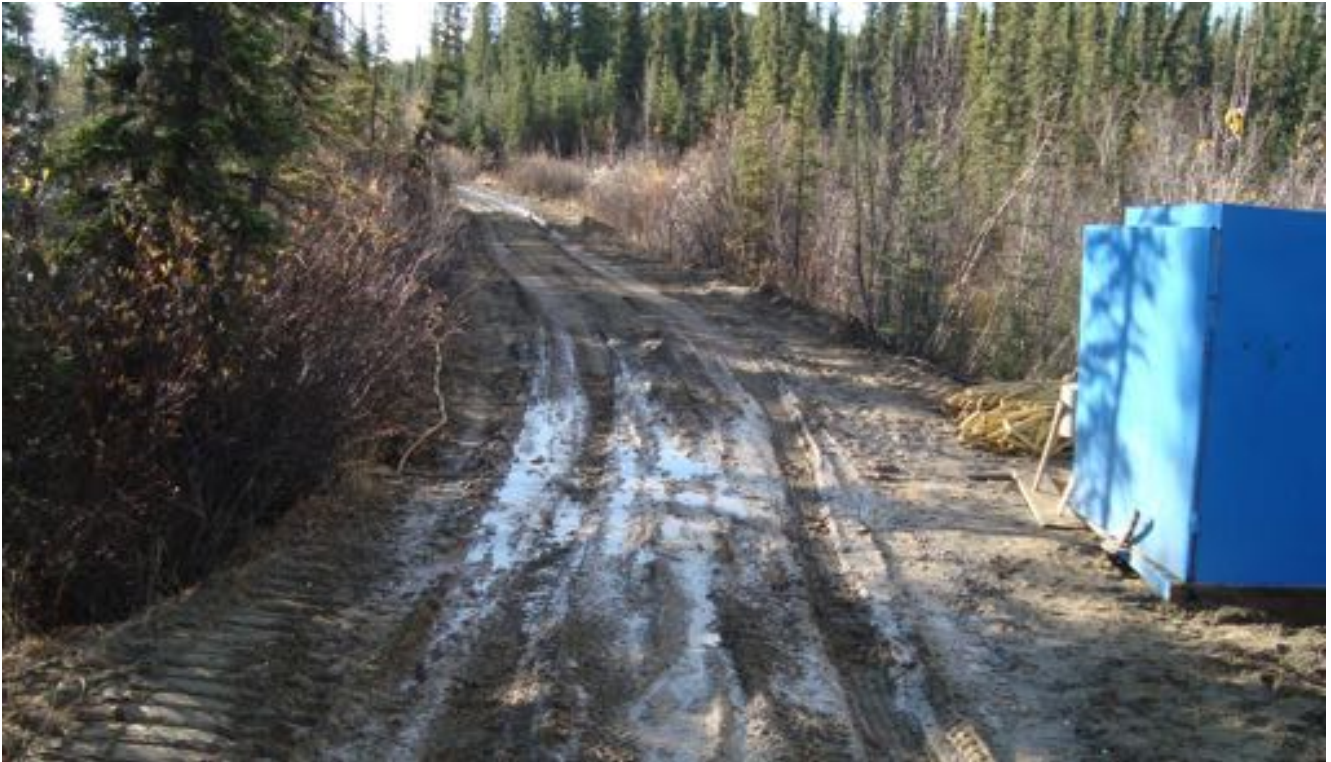
Photograph 15: High traffic area at North Williams Creek

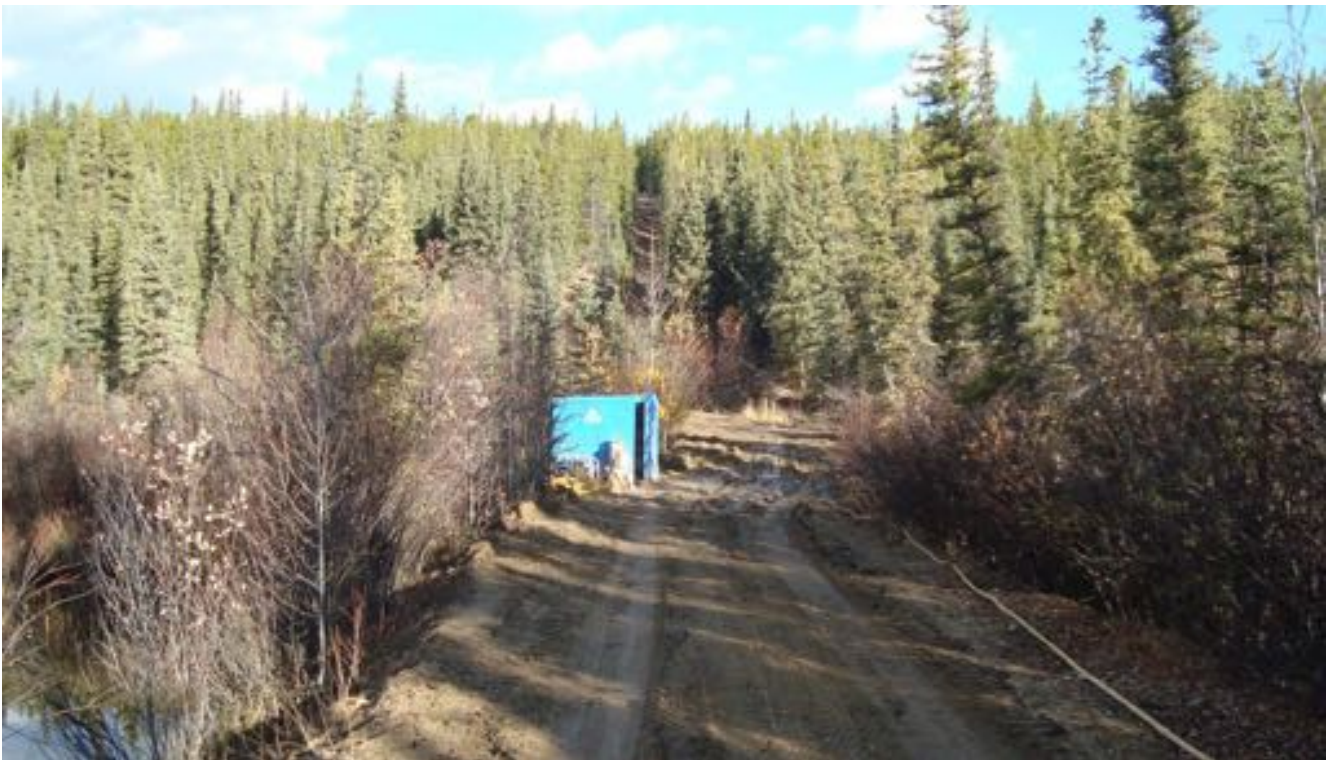
Photograph 16: High traffic area at North Williams Creek
