December 19, 2014

ISSUED FOR USE – REVISION I

FILE: W14103450-01

**Subject:** 2014 Annual Inspection – Surface Engineered Earth Structures  
Bellekeno Mine, Keno City, YT

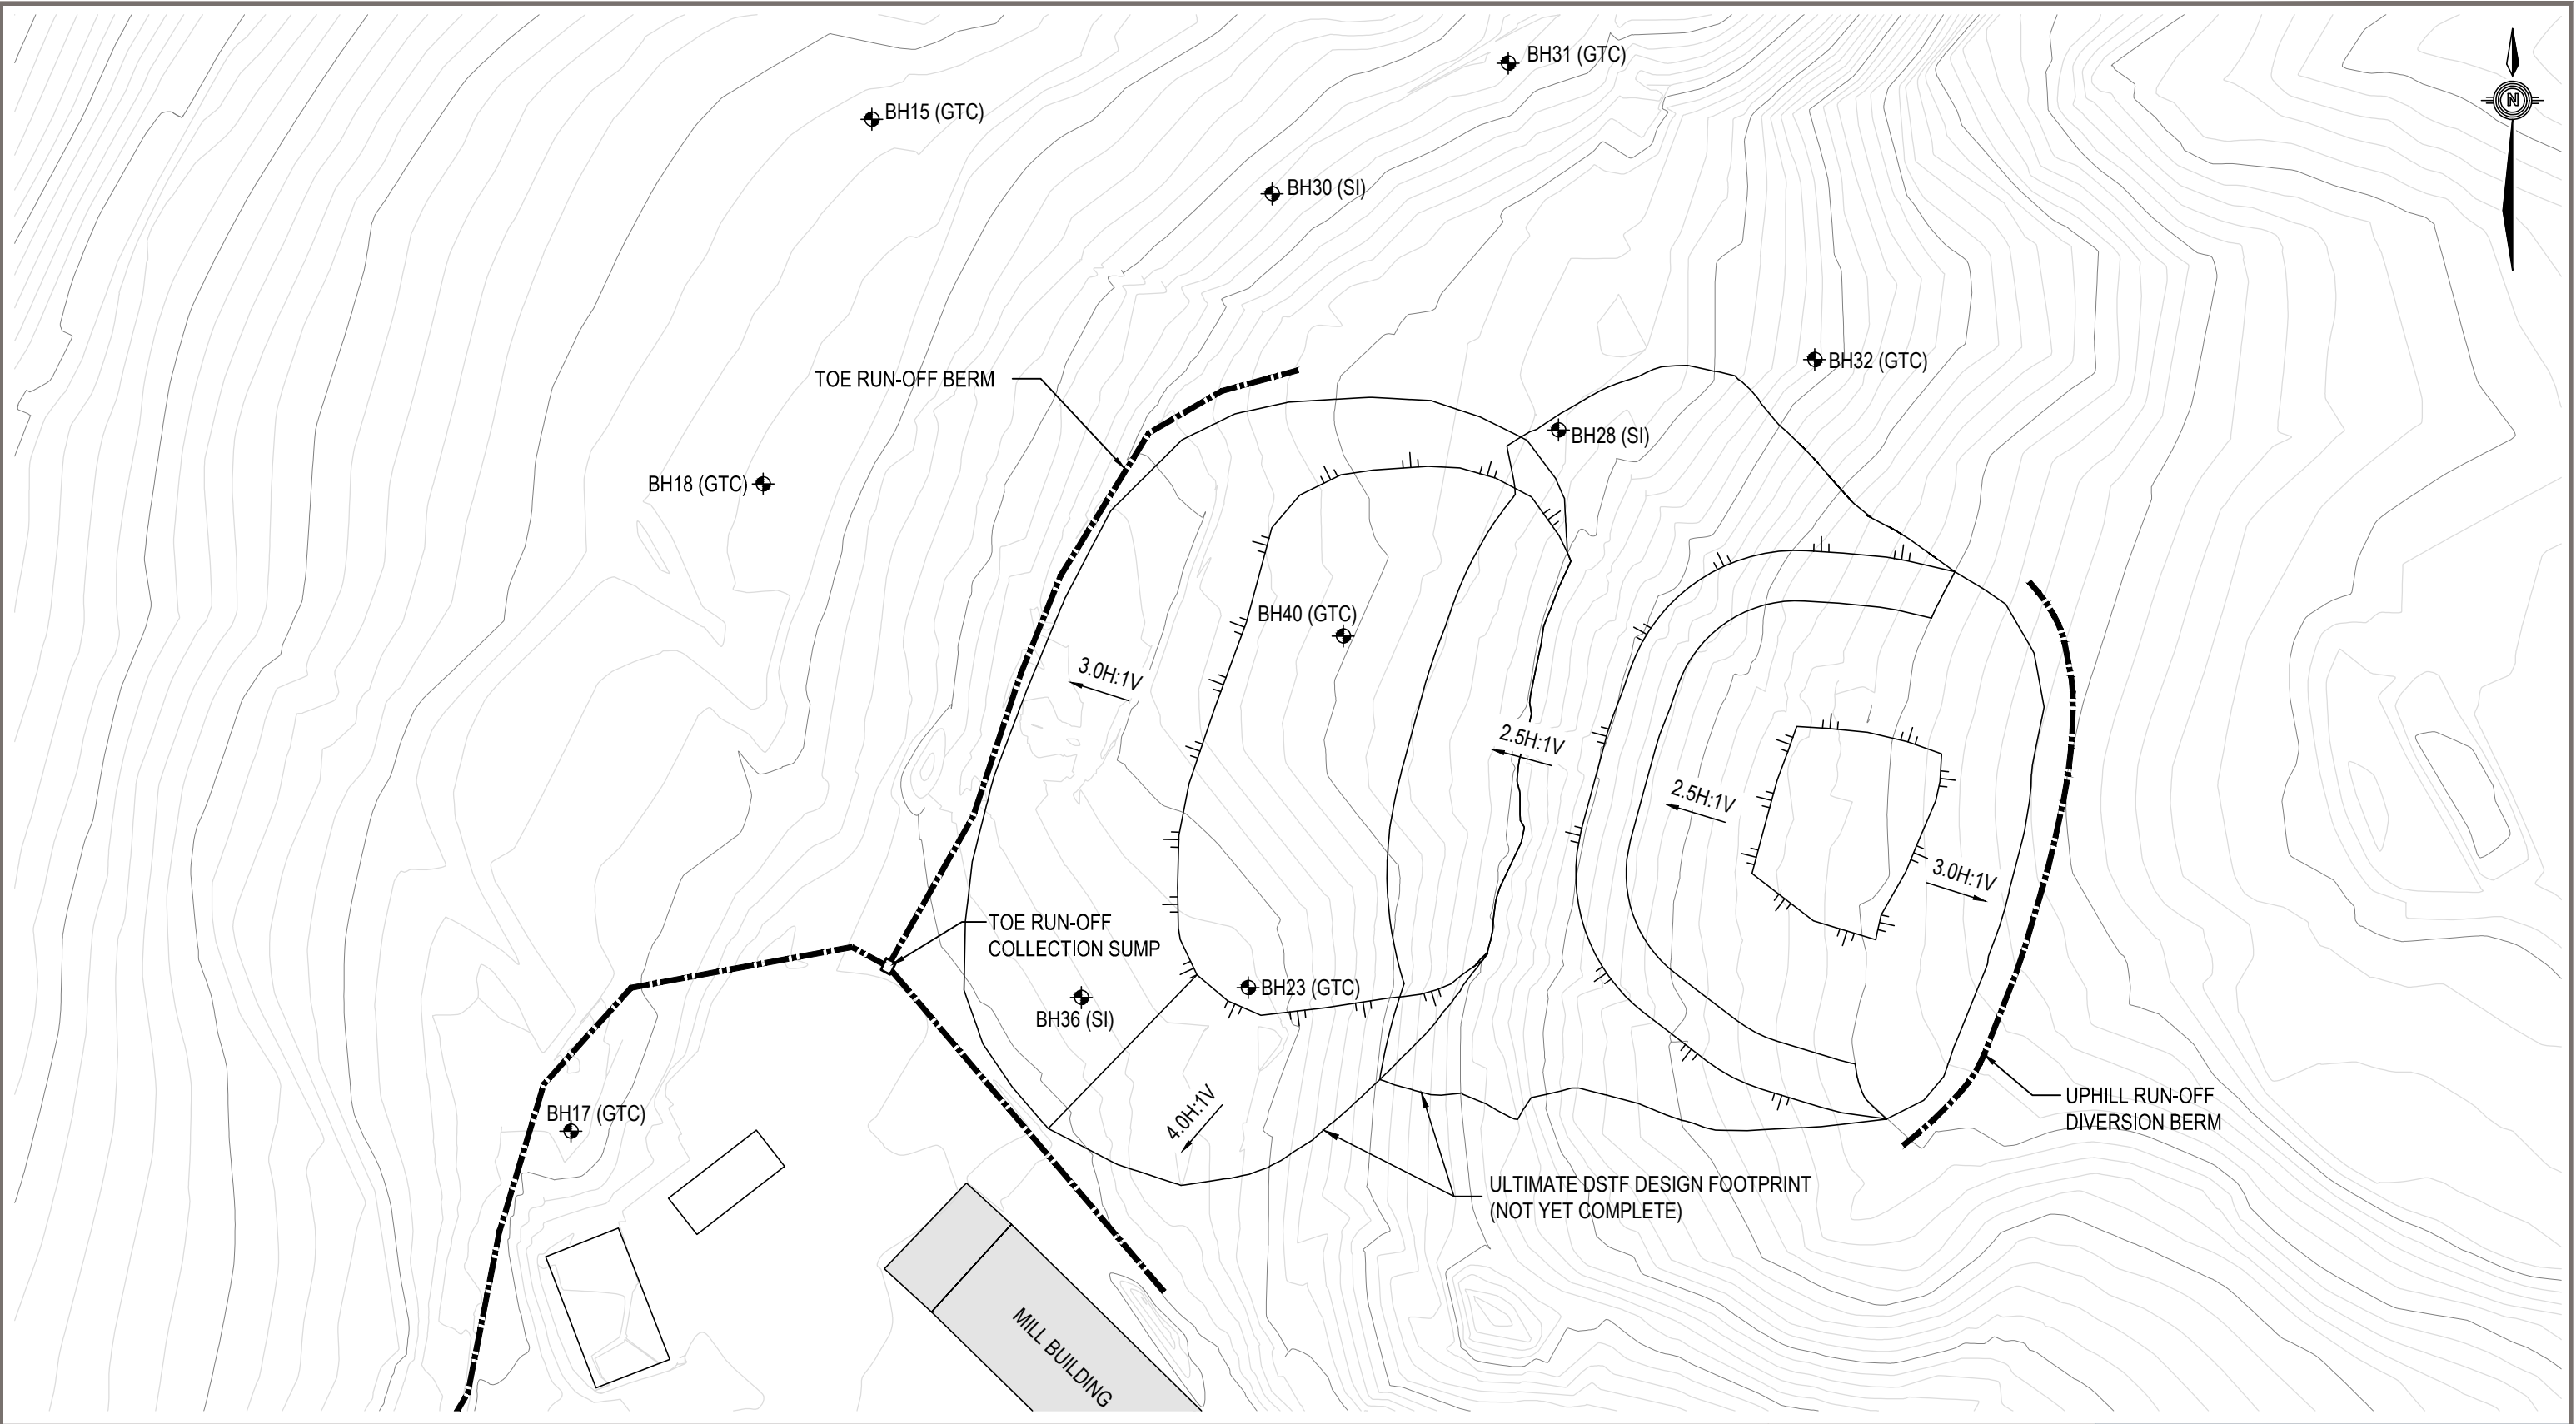
<b>TETRA TECHEBA</b>	PROJECT NO. W14103450-01	DWN CB	CKD JTP	REV 0	Figure 2
	OFFICE EBA-WHSE	DATE November 17, 2014

Performance of the DSTF is monitored with compaction testing during tailings placement and regular instrumentation readings. DSTF instrumentation consists of seven ground temperature cables installed to monitor permafrost conditions (six in natural soils adjacent to the DSTF and one through tailings placed within the DSTF footprint) and three slope indicators installed to monitor lateral movement of the frozen foundation soils. The locations of installed instrumentation are shown on Figure 2.

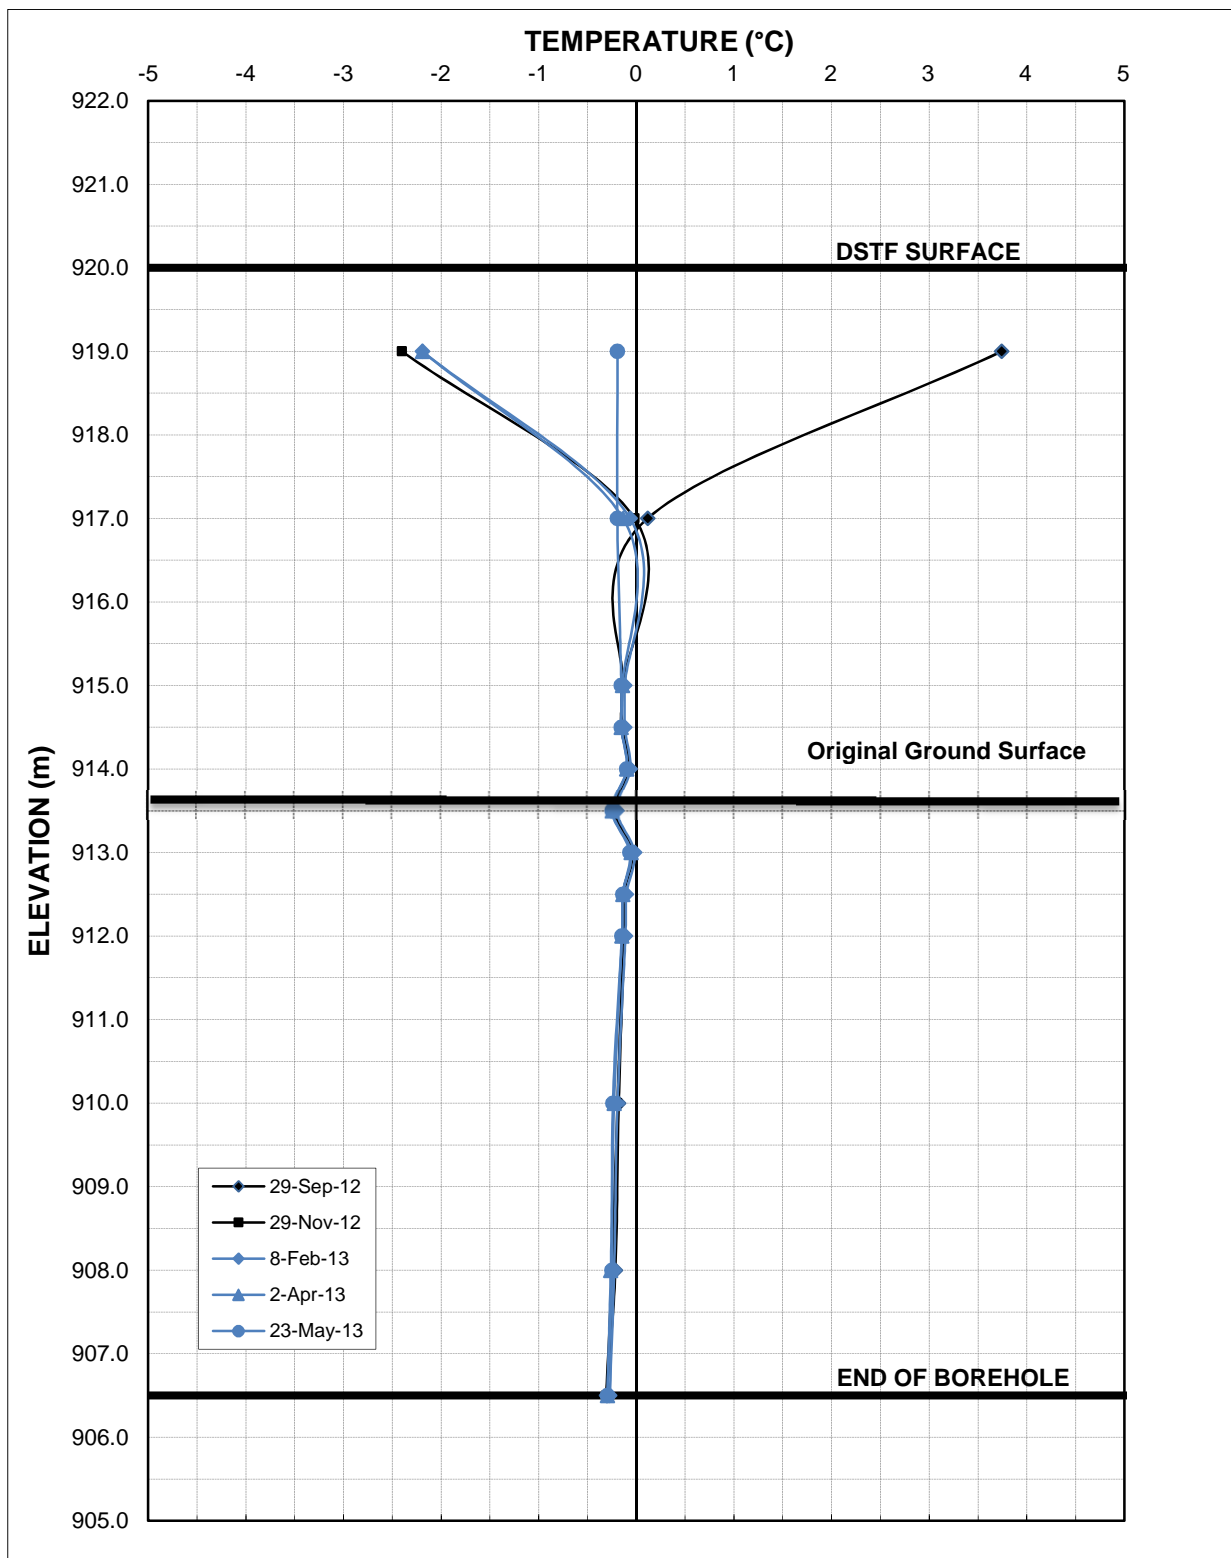
**Ground Temperature Profile**  
**Keno Hill District Mill Site Borehole BH40**  
**Figure T7**

**Photo 26: Dry Stacked Tailings Facility**  
Attempted repair of the ground temperature cable in BH40  
Facing north – August 13, 2014
