2014 Geotechnical Annual Review, Minto Mine, YT

Minto Explorations Ltd.

SRK Consulting (Canada) Inc.
1CM002.028
November 2014

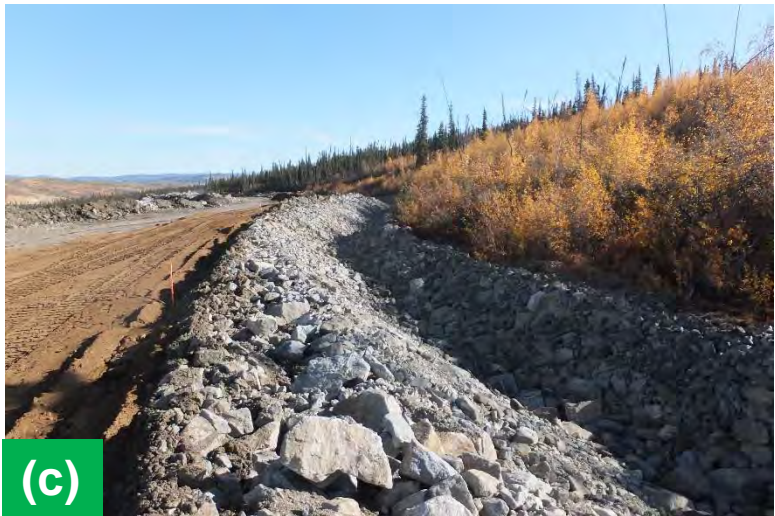
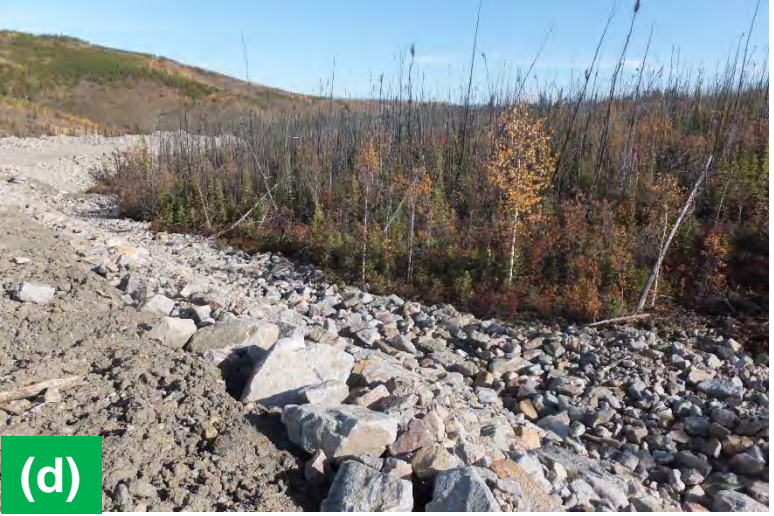
- Photo (d): View of the regraded slope taken from the mid-bench toe. Minor rills and gullies are present at the base of the slope. No signs of instability were observed.

- Photo (e): Location of the small surficial slough noted in the previous 2012 and spring 2013 inspections. The slough is contained within the cover material with minor bulging present at the base of the slope. The slough appears to be self-healing and no action is required.

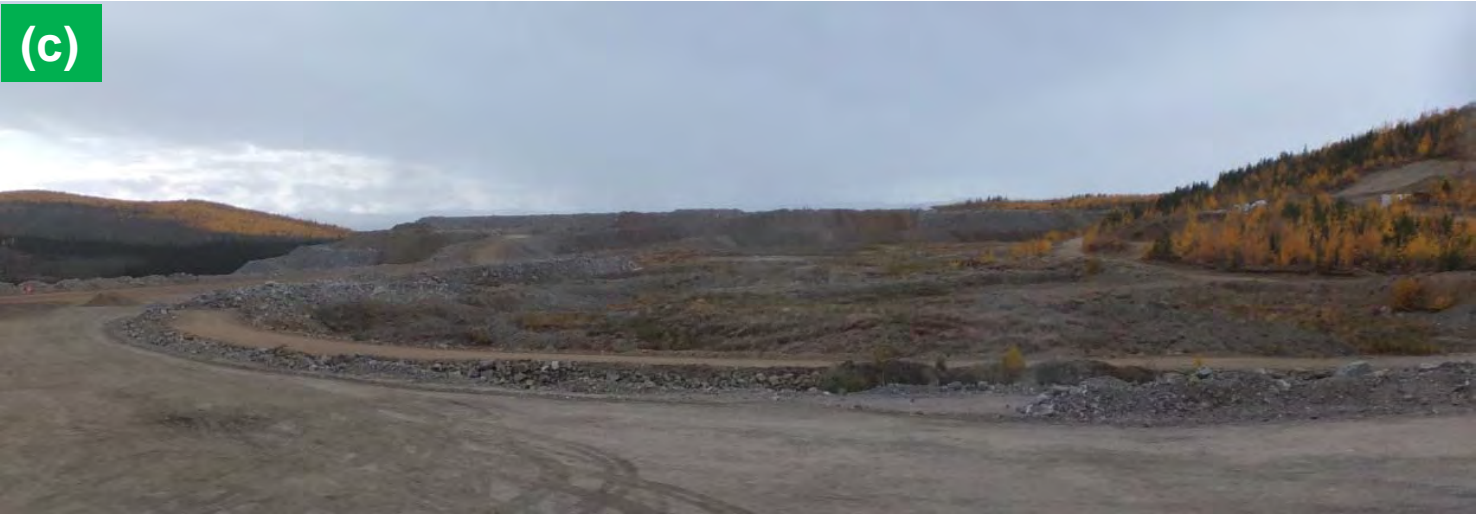
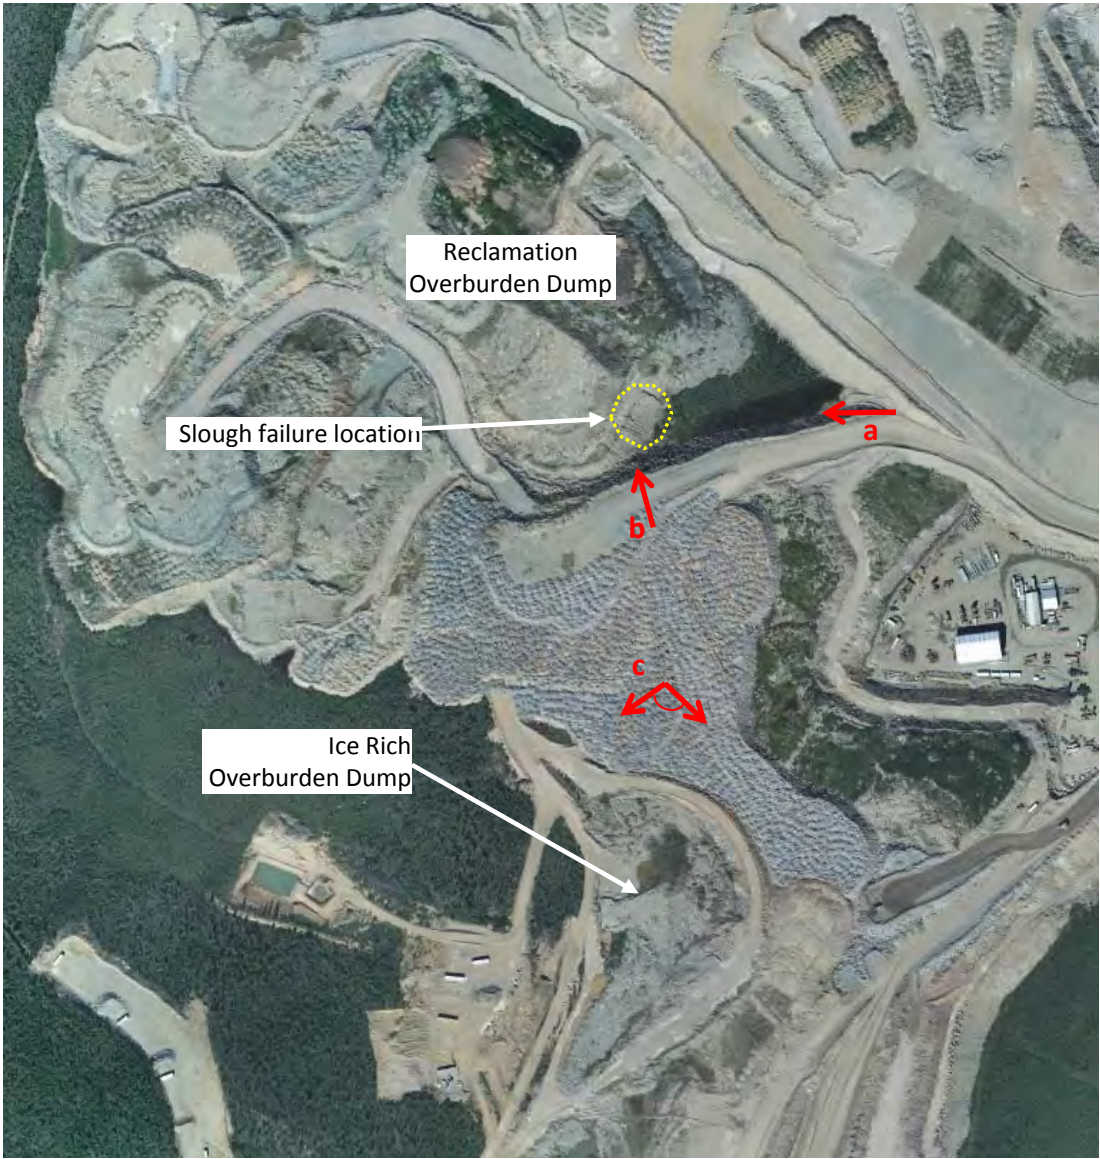
5 Ice Rich Overburden Dump

- A containment berm constructed of coarse waste rock is present on the north, east and south sides of the dump.
- Since the previous years' inspection, additional waste rock has been placed outside of the berm up to the crest elevation as part of the Southwest Waste Dump Expansion (Zero and Low Grade Waste).
- Photo (c) shows the waste material that has now encapsulating the berm.
- No signs of instability were observed along the containment berm.
- No pooled water was observed against the berm indicating that water inside of the berm is still able to drain through the berm as per the original design intent.

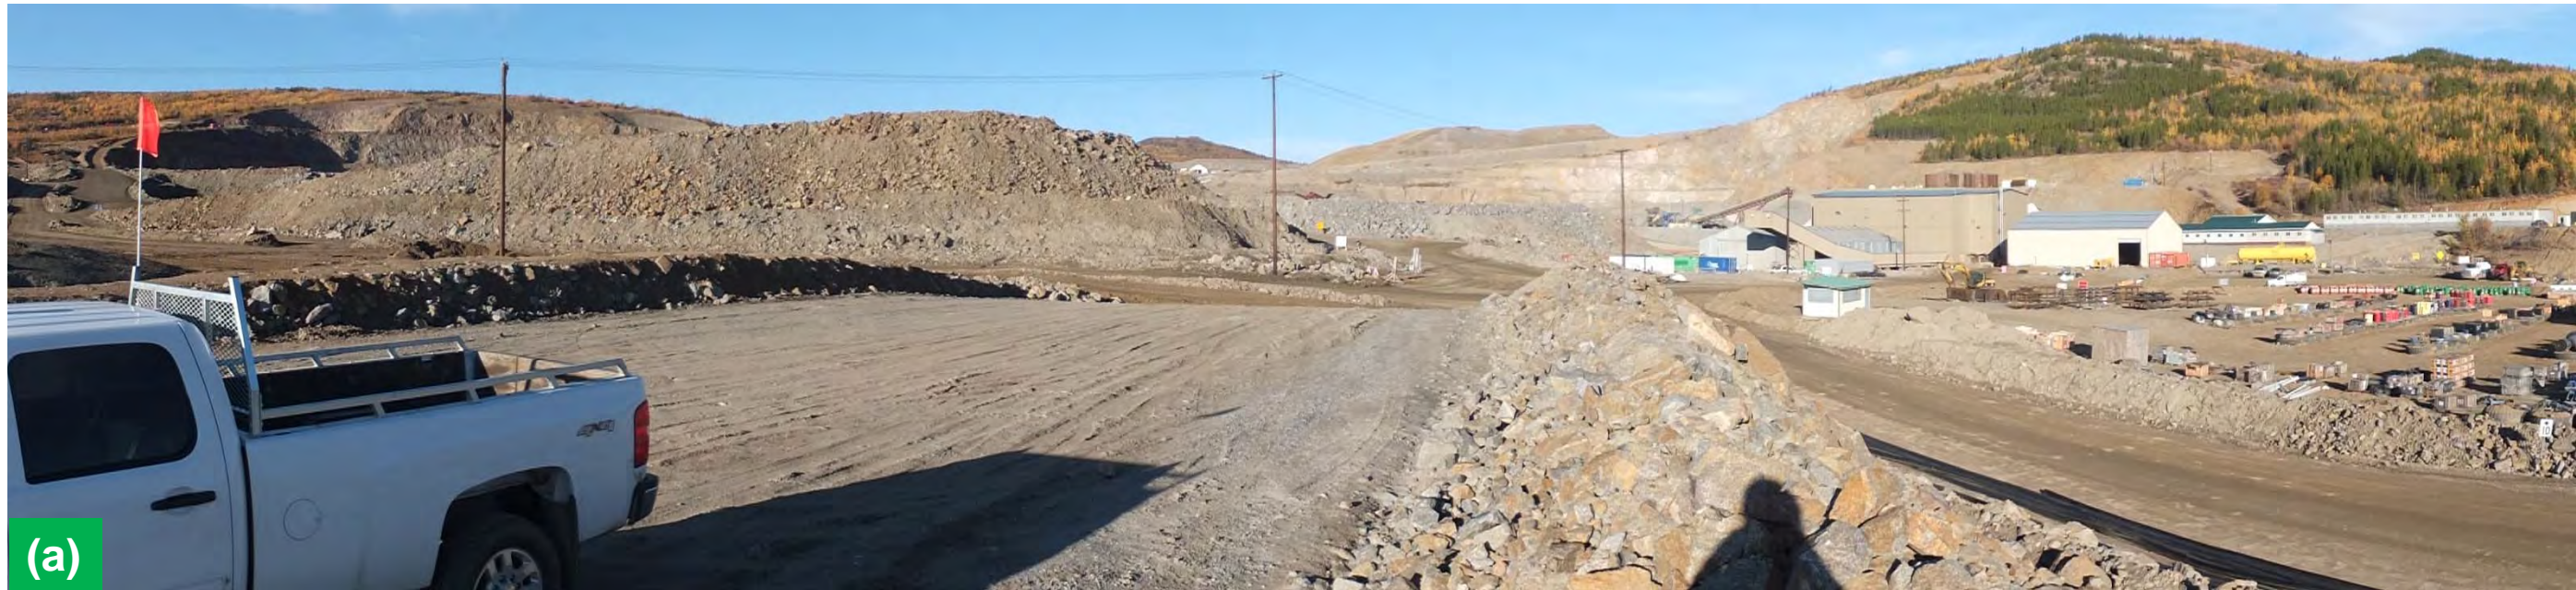
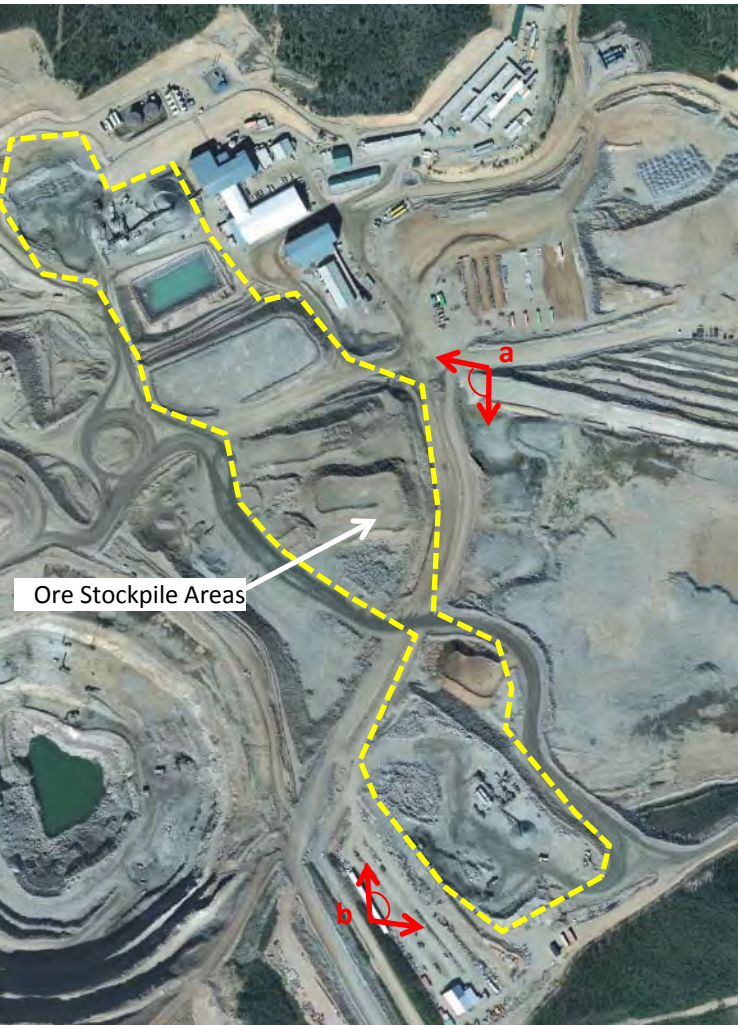
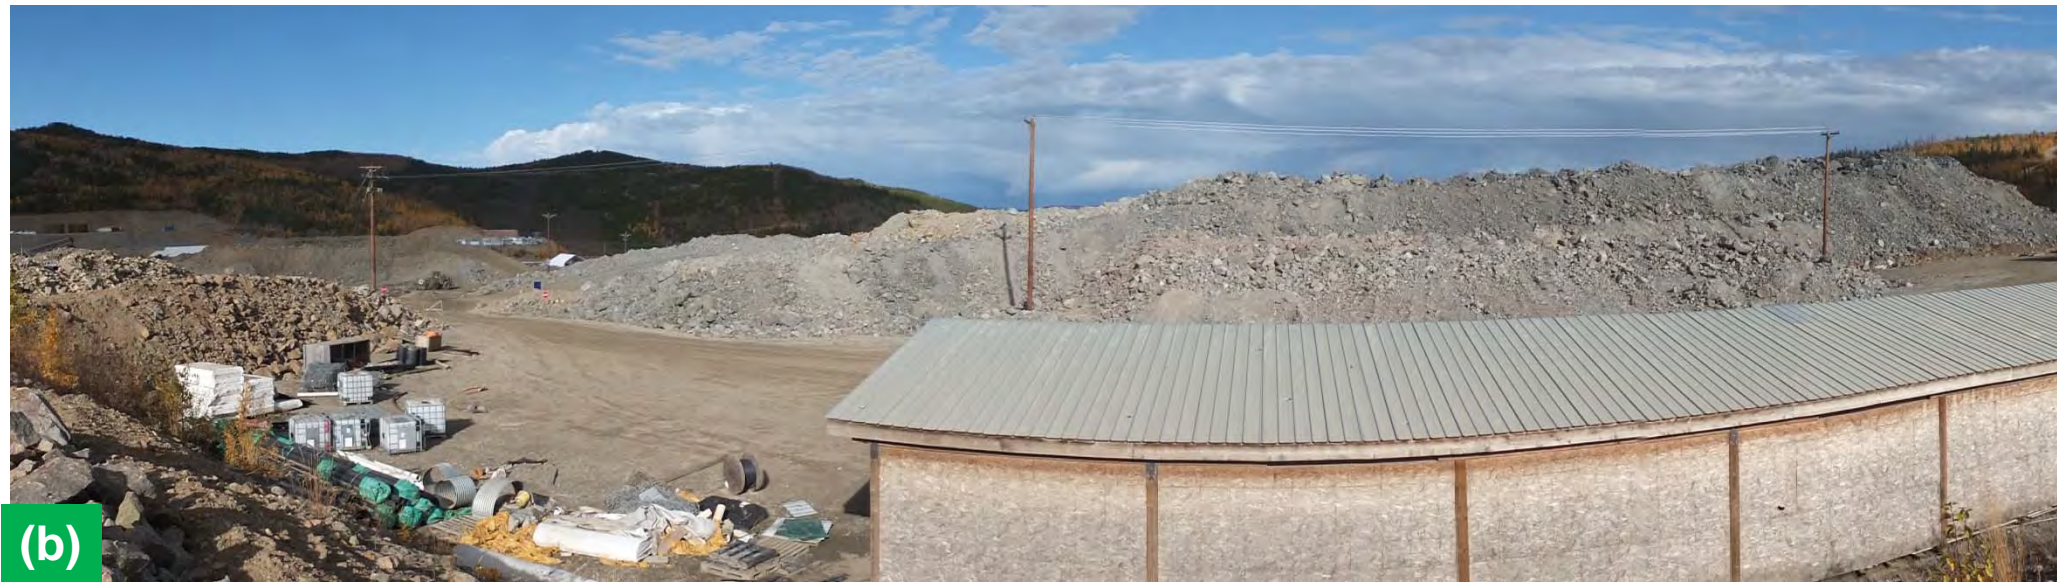
6 Ore Stockpiles

- The ore stockpile area was investigated briefly in passing. All slopes appeared in good condition: no slumping, bulges, cracks, or other signs of instability were observed.

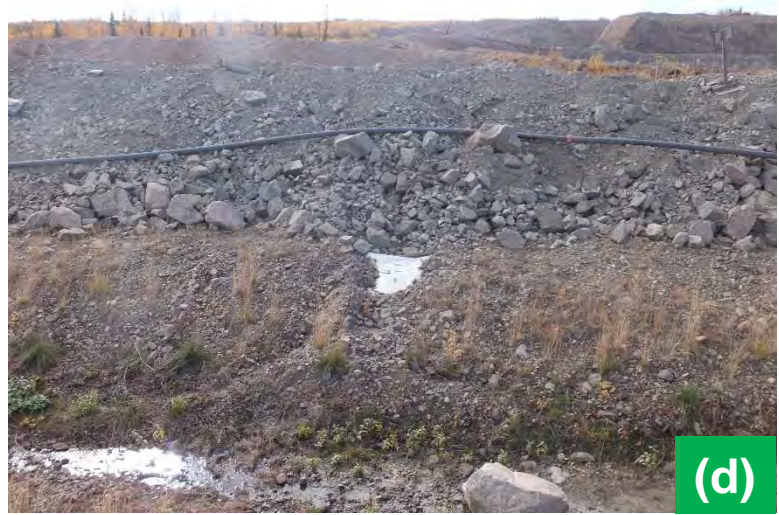
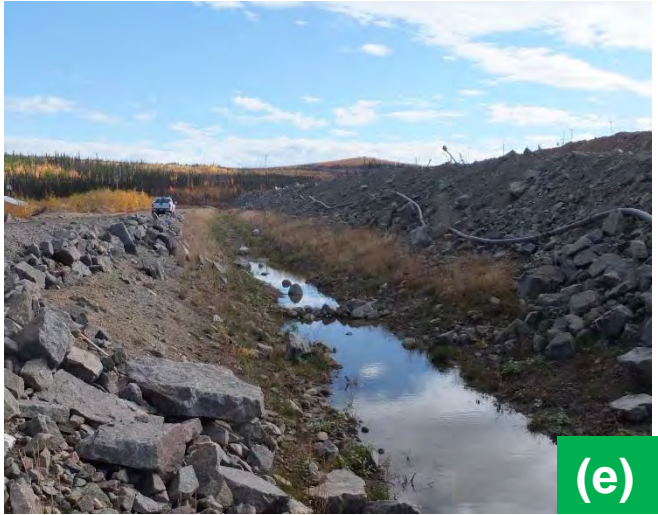
- The South Diversion Ditch was inspected between the areas shown in Photos (a) to (e) adjacent to the Airport Laydown area. The pipeline intake structure at the Photo (c) location diverts water to the confluence area located near the Main Pit. The pipeline alignment was not inspected during the site visit.

- Since the September 2013 inspection, the following conditions have changed:
 - Ditch vegetation have been removed to improve the ditch capacity.
 - The three large boulders at the overflow spillway have been removed as recommended in the Fall 2013 inspection as to not impede flow.

- No signs of instability were noted along the side-slopes.
- a) View of the inlet structure at the upstream end of the ditch.
b) View from the inlet structure looking downstream.

d) Exposed liner at the top of the west bank. Conditions the same as noted in previous inspections.
e) View looking upstream taken from near the downstream end of the channel.

- All areas of exposed liner should be covered to protect the liner and prevent degradation.

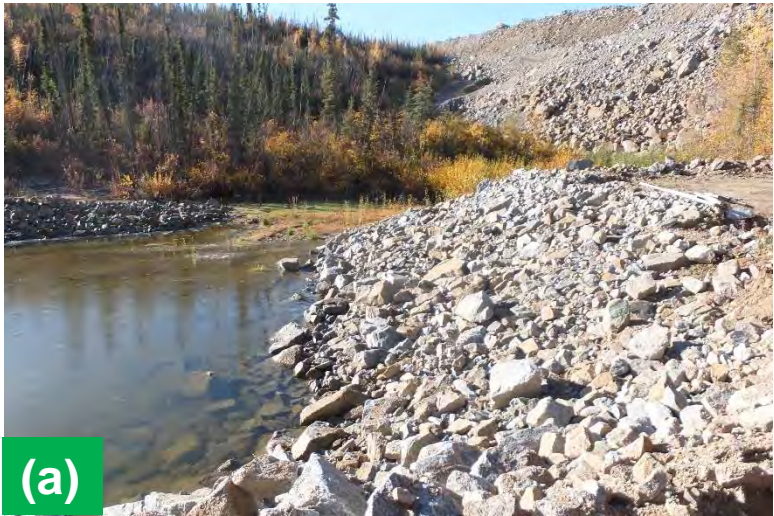
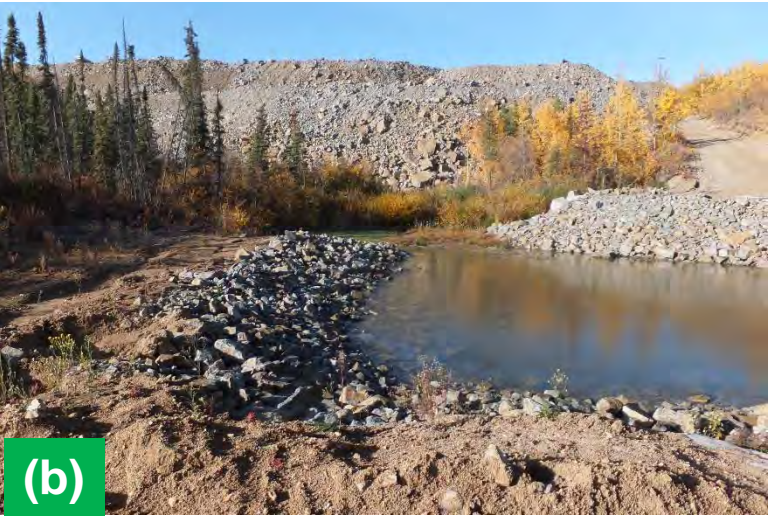
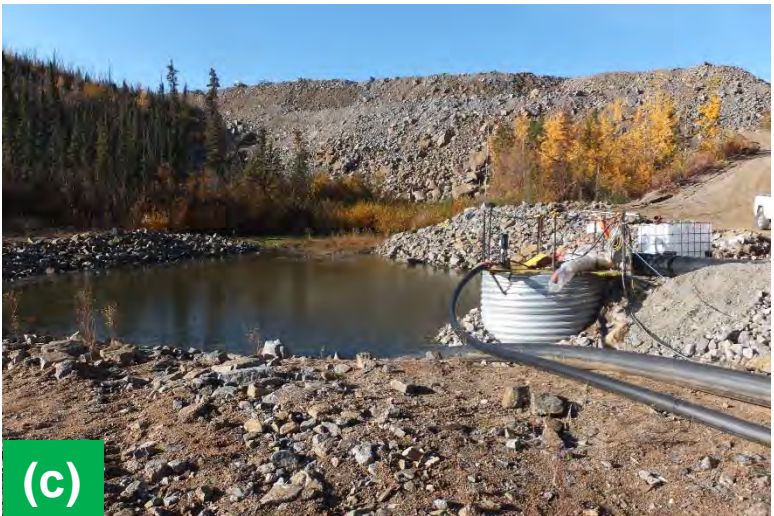
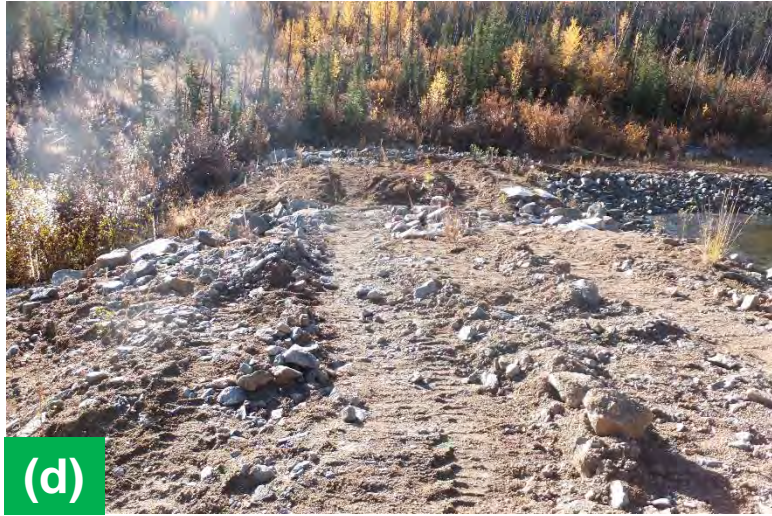
VANCOUVER	  MINTO MINE OPERATED BY MINTO EXPLORATIONS LTD.	Fall 2014 Geotech Inspection		
		Minto Creek Detention Structure		
Job No: 1CM002.012.028 Filename: Minto 2014 Fall Inspection.pptx	Minto Mine	Date: November 2014	Approved: PHM	Figure: 15

- Since the Fall 2013 inspection, a new intake structure has been installed. Otherwise conditions are generally the same as previous inspections.
 - No signs of instability were noted along the downstream slopes and no seepage was observed downstream of the Minto Creek Detention Structure (MCDS). The surface cracking noted in previous inspections were less noticeable due to recent equipment trafficking along the east and south ends of the facility.

- The seepage entering the MCDS from the Mill Valley Fill Extension (MVFE) was clear. There appears to be some sediment accumulation upstream of the structure; however, conditions along the flow path into the MCDS are similar compared to 2012 and 2013 inspection photographs, and there are no sediments observed immediately downstream of the MVFE toe.

- a) View of the MCDS looking southwest.
b) View of the south side of the MCDS. Excavator traffic along the south end of the crest has created some rutting; however, the upstream slope/berm are functional and in generally good condition.

c) View of the new intake structure at the northeast corner of the facility.
d) View of the overflow spillway looking south. Same as noted in previous inspections, some exposed GCL is present on the upstream side of the spillway.

- Continue regular annual monitoring for further signs of instability or seepage on the downstream slope of the MCDS.

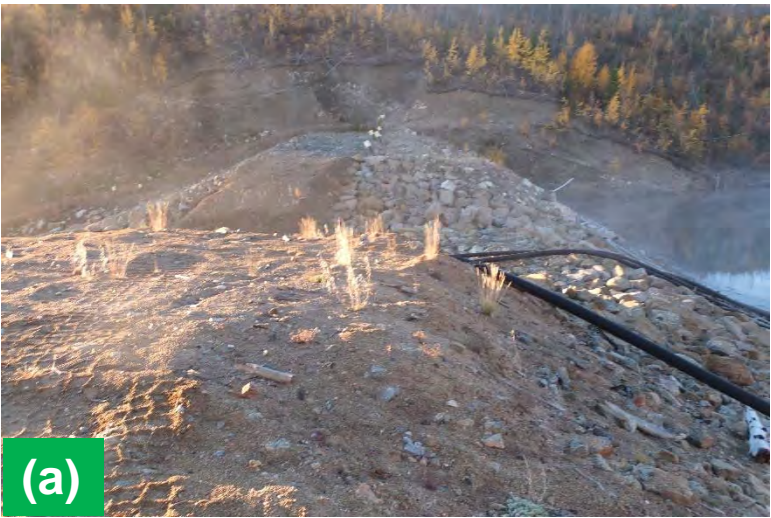
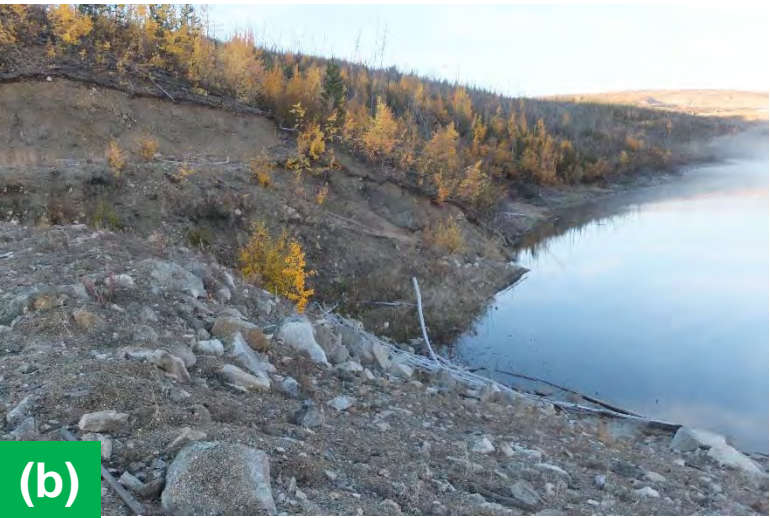
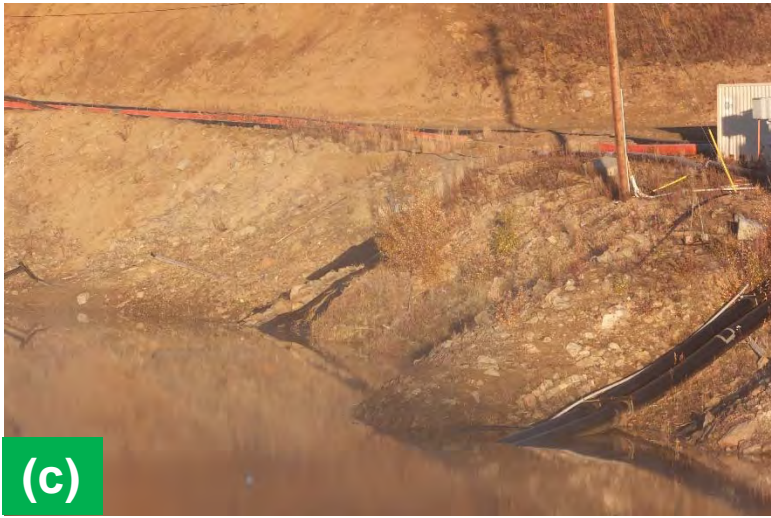
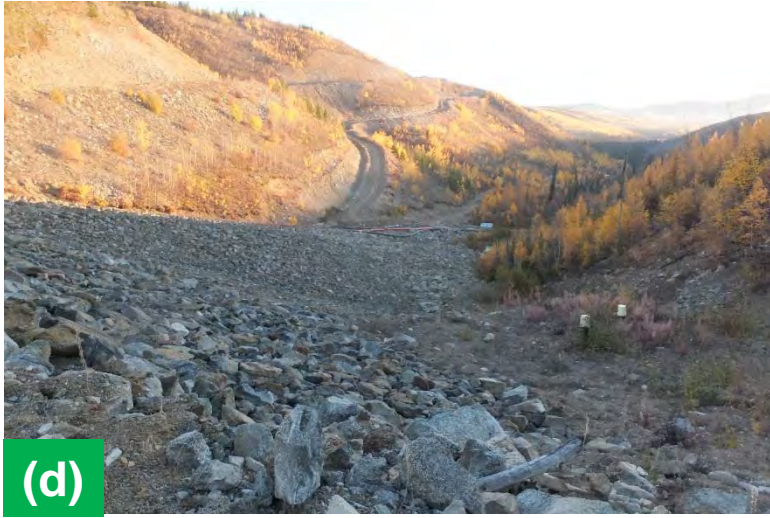
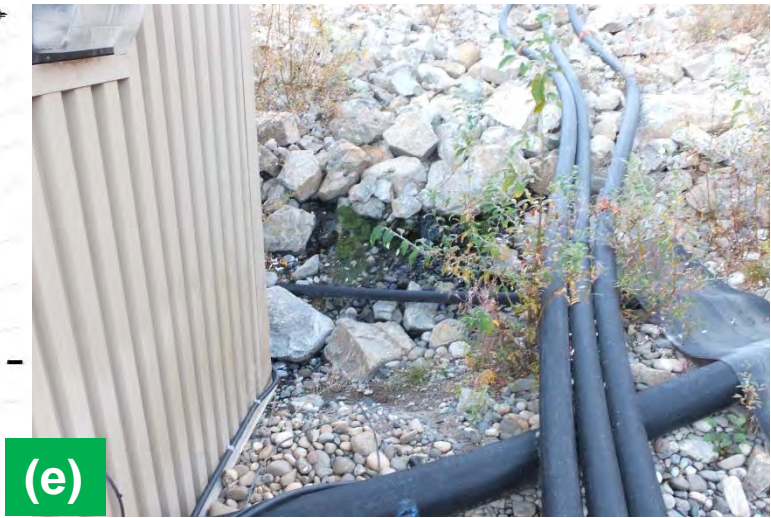
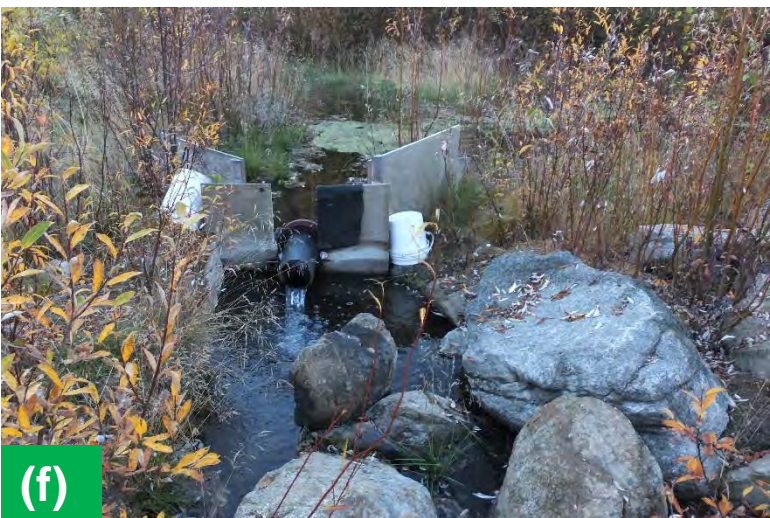
13 Water Storage Pond Dam

- Conditions of the dam are unchanged since the Fall 2013 inspection.
- a) a) & b) View of the crest, upstream slope and south abutment. These areas (including the north abutment) show no signs of instability (settlement, bulging, slumping).

- d) View of the downstream slope and spillway. Three 200 mm diameter siphon pipelines are present in the spillway that run from the WSP to the pump house. No signs of instability, settlement or erosion were observed on the downstream slopes or abutment areas.

- e) View of the stilling basin upstream of the seepage pump house. The seepage water was clear with no turbidity. No accumulation of sediments was observed.

- Condition of the seepage water appears unchanged compared to the 2013 inspection.
 - Water flow could not be heard in the rockfill adjacent to the seep.

- The water was clear with no turbidity. Rocks in the pond contain a thin coating of fine rusty-brown sediments. The sediments are thought to be due flushing of weathered rip-rap from local run-off on the downstream toe.

- Continue regular monitoring of the dam, noting specifically the clarity of the seepage and flow exiting the stilling basin, and the seepage rate through the weir.
- As noted in previous inspections, the seepage pump flow rates at W-3 in the seepage pump house appears to be influenced by discharge from other sources (the pit, water treatment plant, etc.). Options to obtain accurate seepage measurements should be reviewed. One solution would be to move the discharge point of water a minimum of 20 m down stream of the sump.

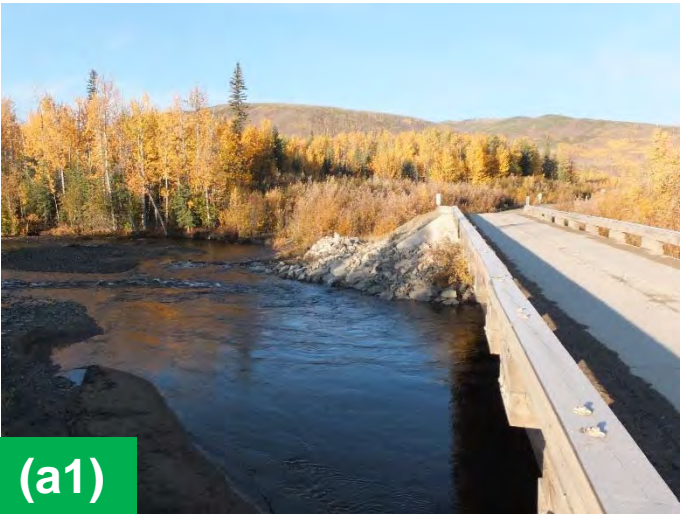
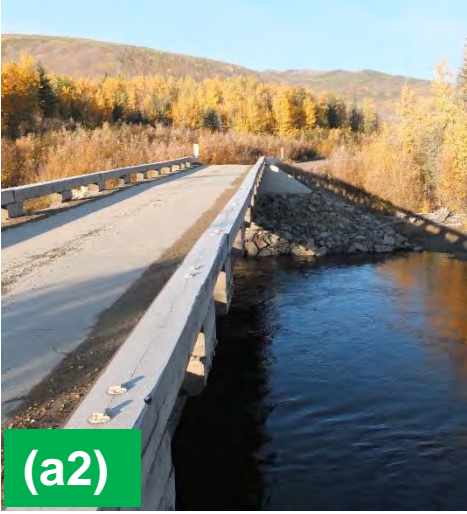
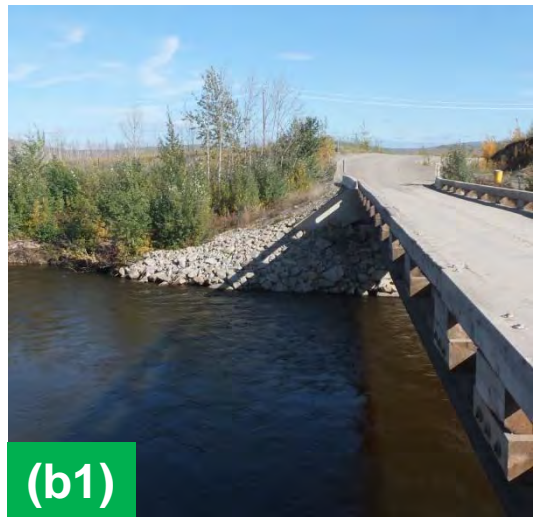
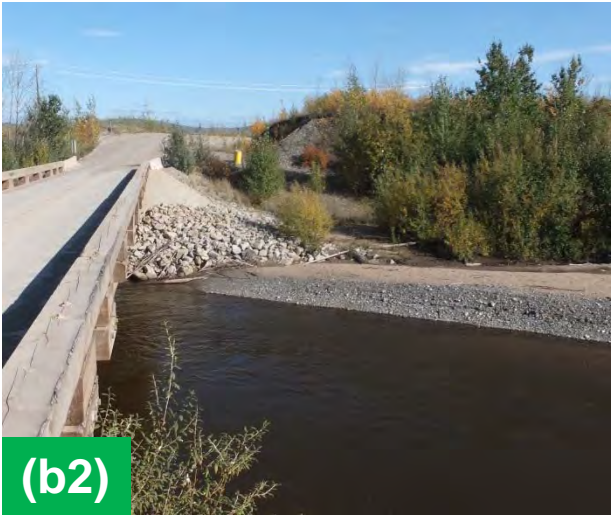
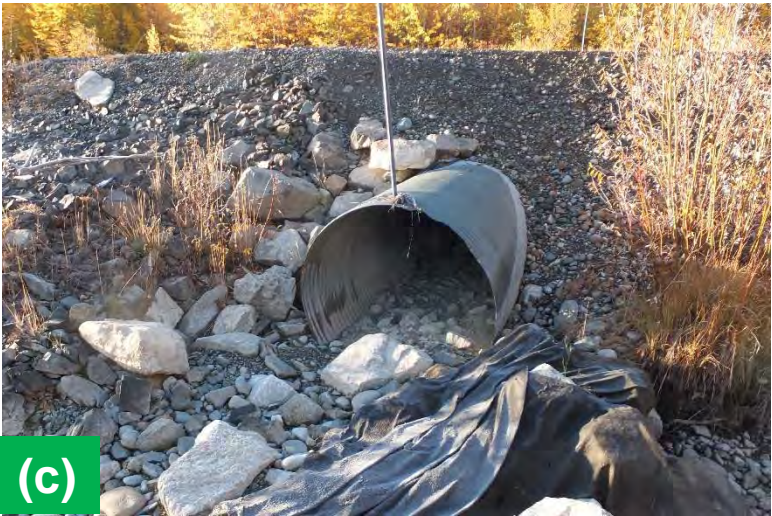
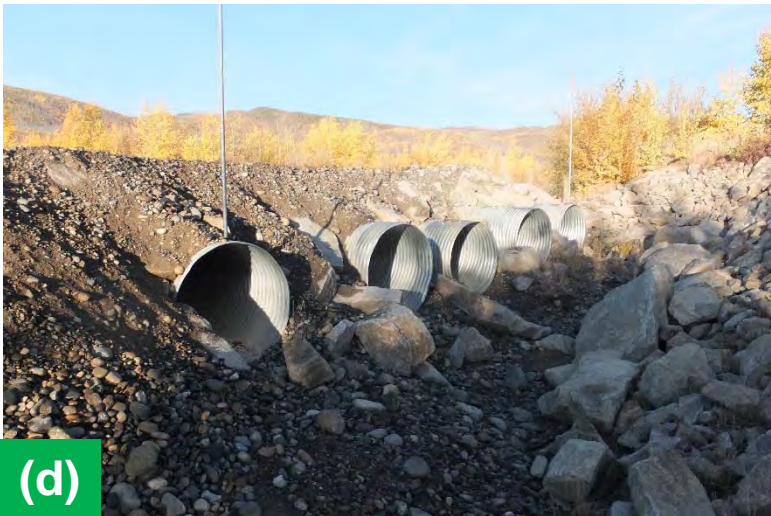
14 Big Creek Bridge

- Photos (a) and (b) show east and west abutments, respectively. The bridge abutments and road approaches are in good condition, no signs of instability were observed.

- Consistent with previous inspections, Ditch Block #1 has not been constructed, Ditch Blocks #2 through #5 are in good condition.
- Conditions of the culverts are unchanged since the previous Fall 2013 inspection.

- The first culvert west of the bridge is in satisfactory condition. The north end of the culvert has been dented by a large rock. It appears that a compacted bedding layer has not been placed outside the culvert.

- Photo (d) shows 5 culverts, each with diameter of 1.1 m. The culverts are in satisfactory condition, with no blockages at either end.

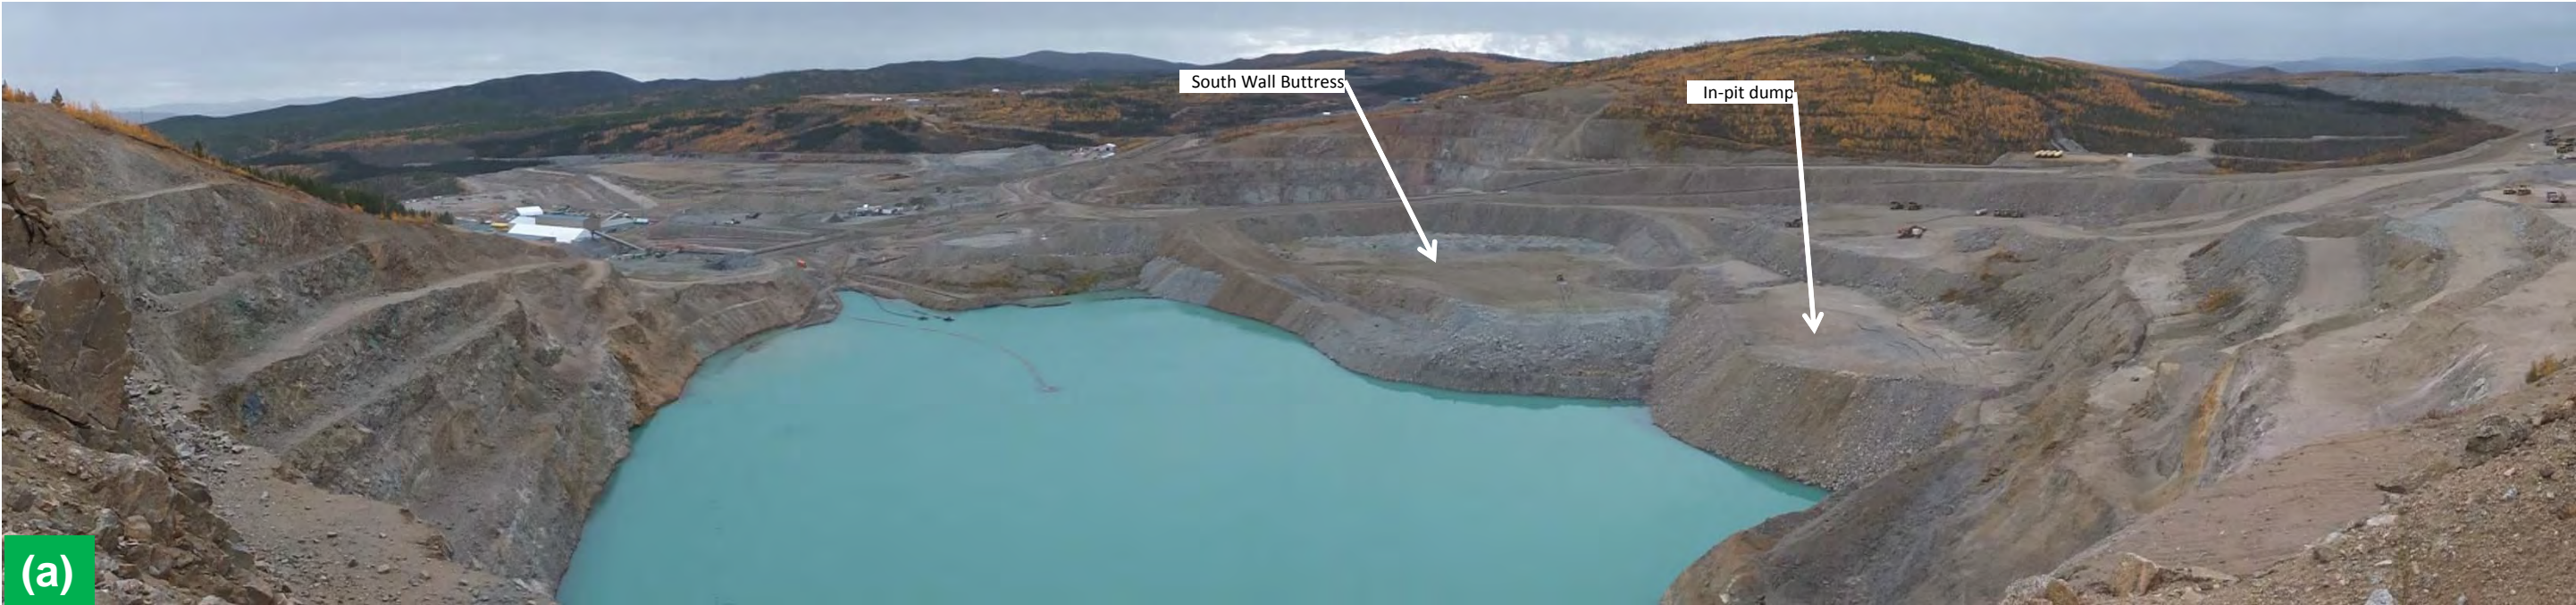
15 Main Pit, South Wall Buttress & In-Pit Dumps

Photo a: View of the Main Pit, South Wall Buttress and In-Pit Dump taken from the north west corner of the pit.
 Photos b and c: View of the tension cracks on the In-Pit Dump located west of the South Wall Buttress. This area has been blocked off and is inaccessible to equipment. Cracks on the In-Pit Dump are up to 50 cm wide with a 40 cm elevation difference across the crack. The movement is believed to be due to the large dump height, with the material end dumped directly into the pit water.

- The tension crack area should be continue to be visually monitored. A photographic record should be maintained to inspect for changes in condition.
- Additional survey hubs should be placed on the South Wall Buttress to monitor movement.

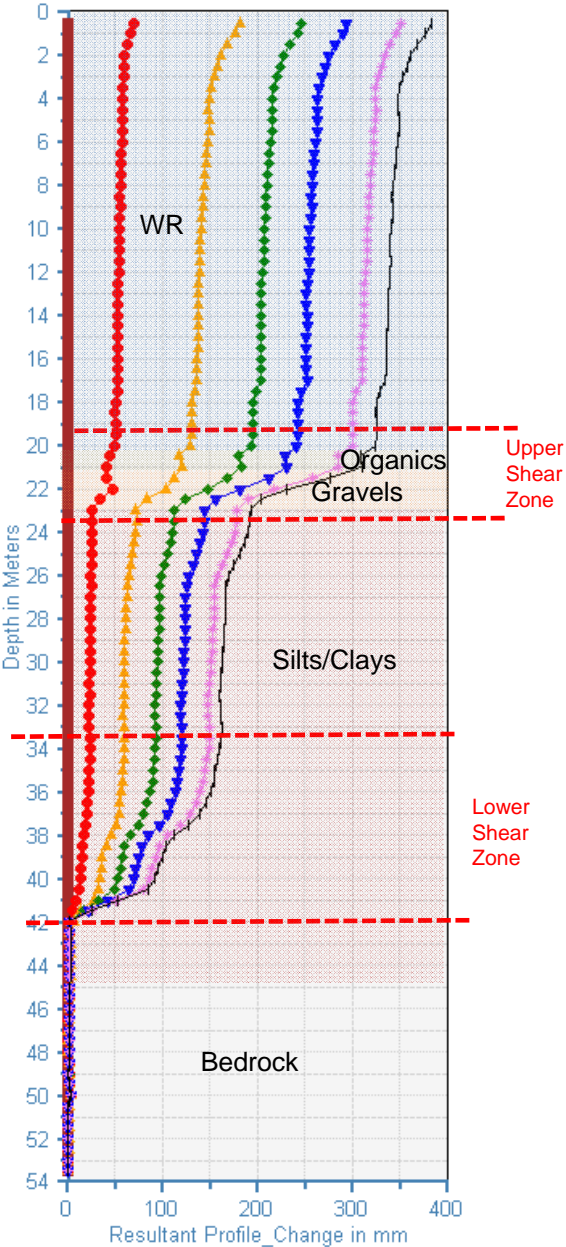
MINTO DSI-14 Magnitude

Ice lenses noted in borehole log:

- 10 mm thick at 31m;
- 75 mm thick at 34 m;
- 125 mm thick at 38 m;
- 50 mm thick at 39 m.

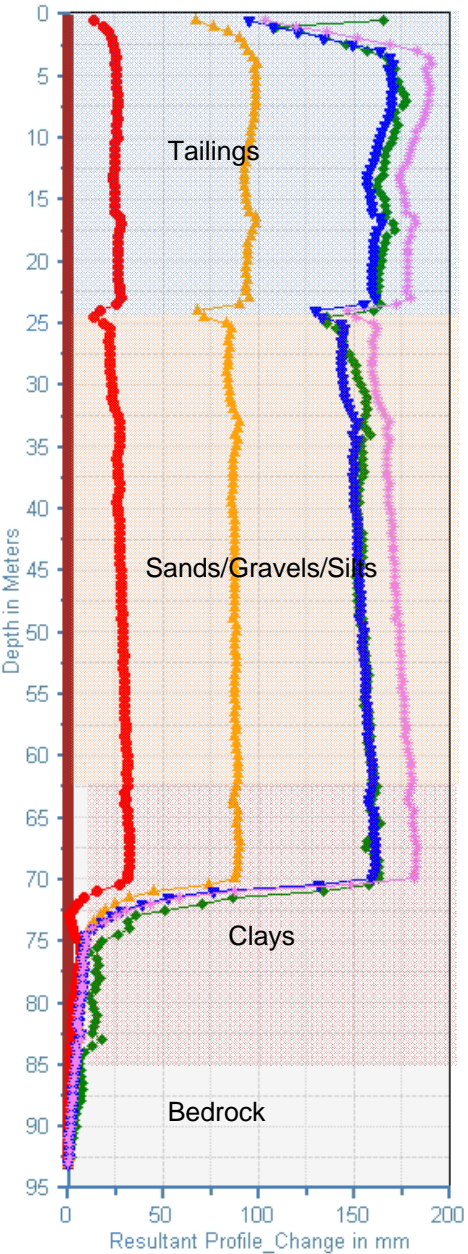
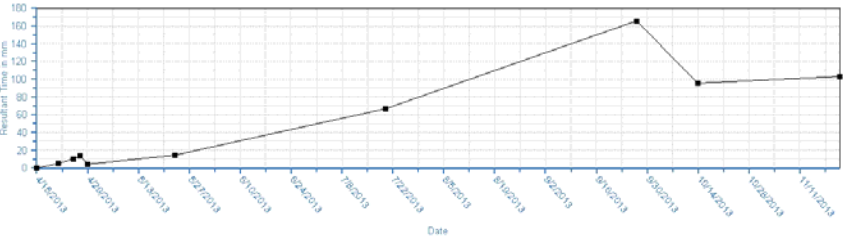
DSI-16

Borehole log features between depths 70 m and 75m:

- Soil generally consists of CLAY, some silts and sands/gravel, high plasticity, moist, stiff.
- Ice descriptions include stratified and random ice formations. Ice lenses are noted up to 50 mm in thickness and orientated at 20 degrees.
- Two slickensides noted at 73 m and 78 m.

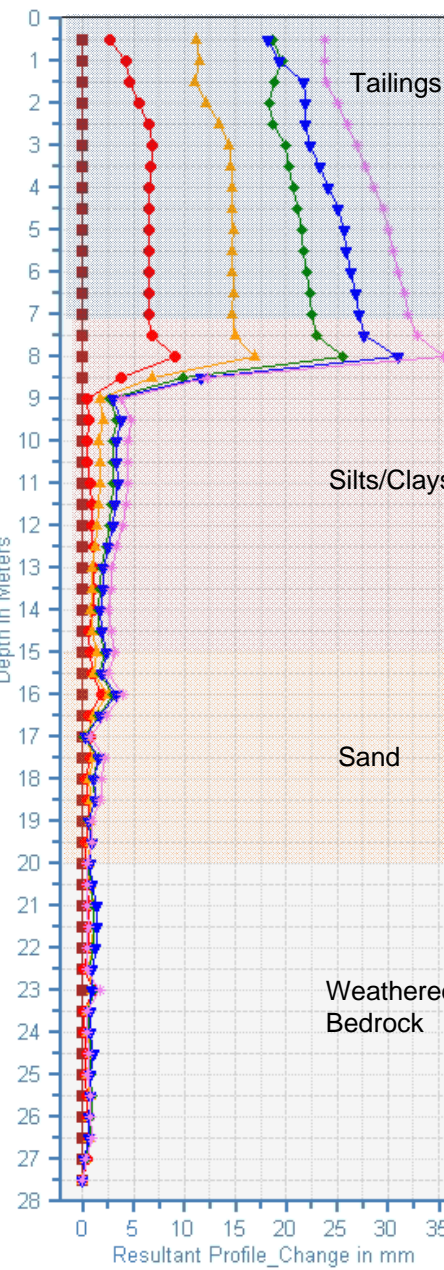
MINTO DSI-21 Magnitude

@ 7-8m: Layered ice+soil, 1-2 mm lenses with 5mm soil separation, 20% excess ice.

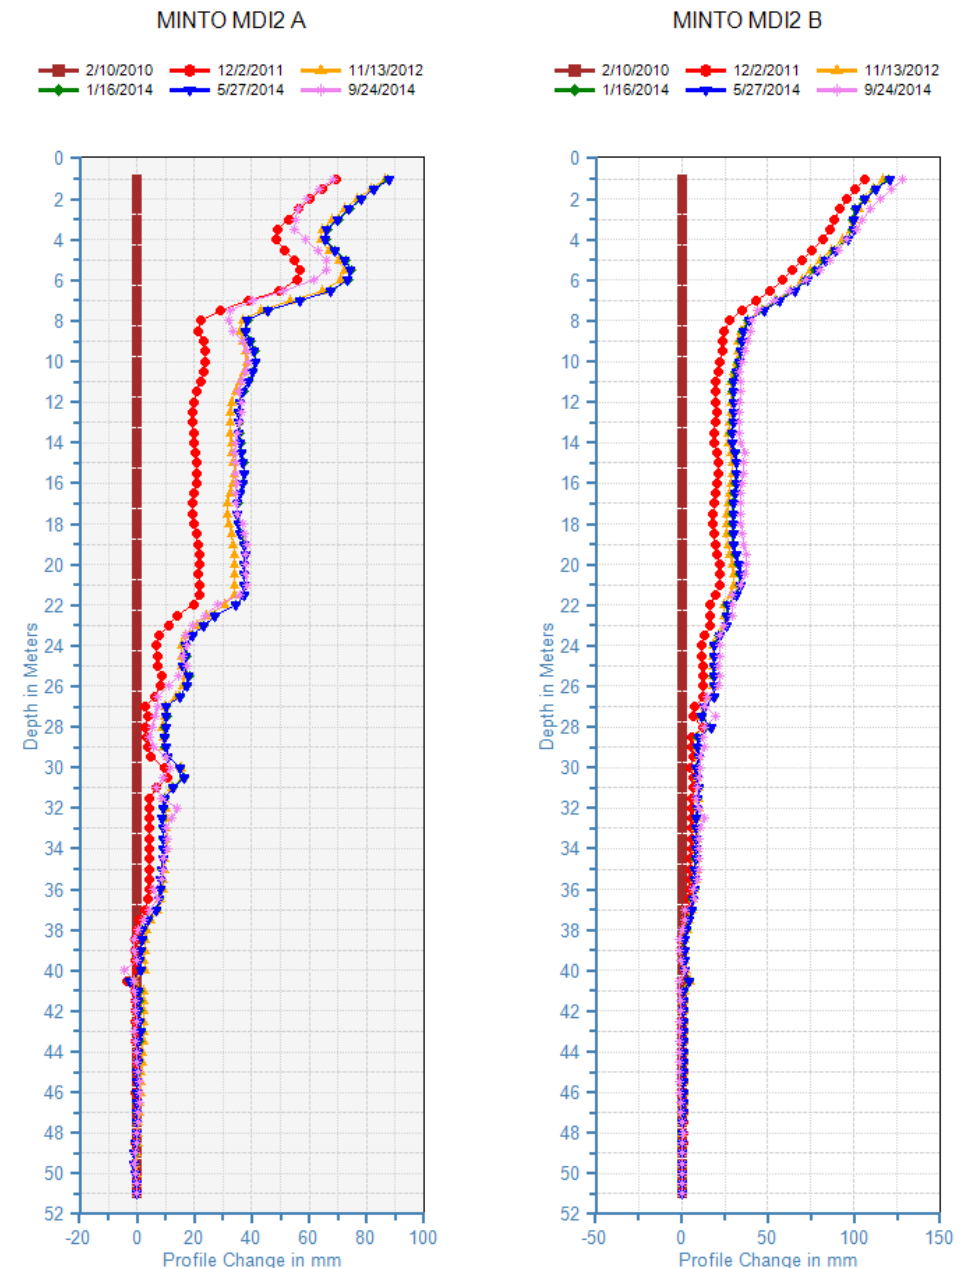
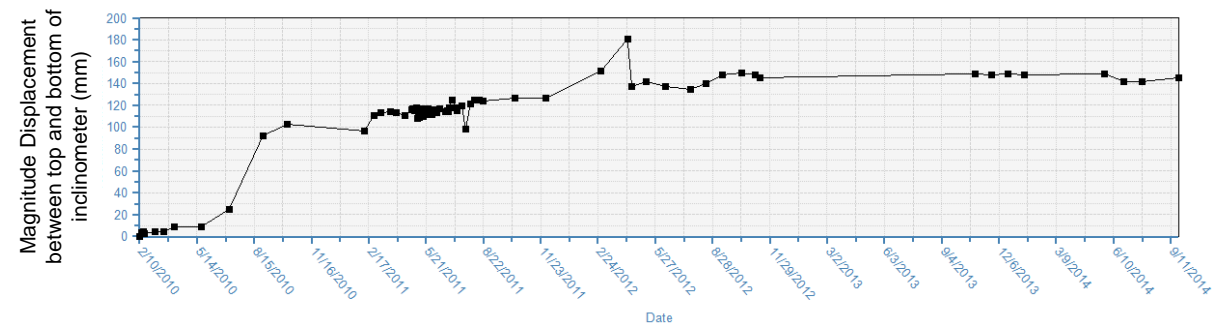
MDI-2

Profiles and time displacement plots for both inclinometers are presented in Figure 10 of Appendix B. There is no movement trend detected in MDI-2.

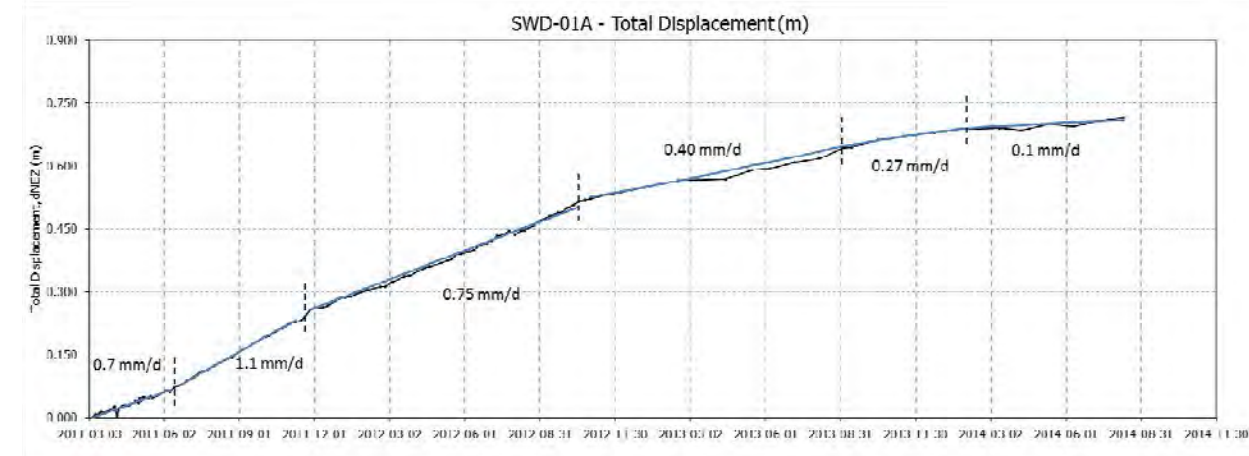
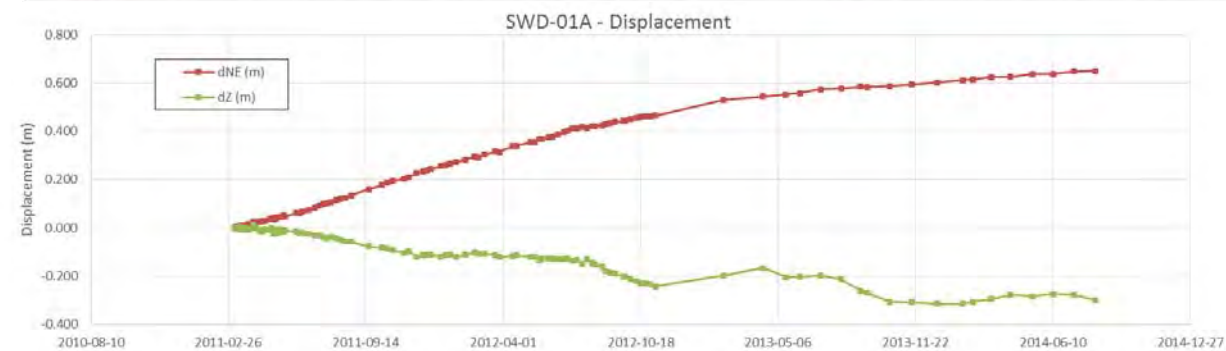
View of SWD-01A;
heaved 30 cm out of
the ground.

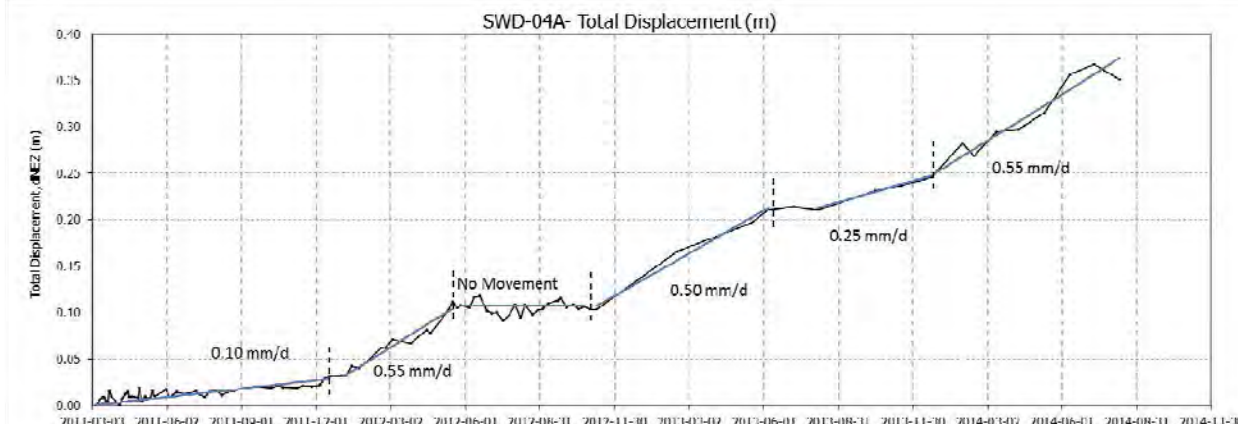
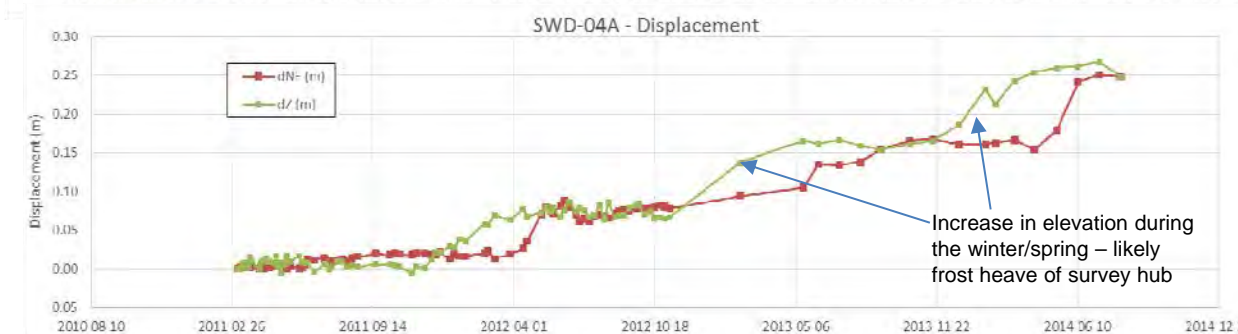
View of SWD-04A; heaved 55 cm out of the ground.
